Preliminary Ignition Investigation Report

Ignition Database Index:	20240953
Electric Incident Investigation (EII) Number:	N/A
Incident Name:	Ridge – 15 Jul 2024
PG&E Facility Ignition?	Yes
CPUC Reportable Ignition?	Yes
Date & Time of Incident:	July 15, 2024@ 1020 hours
Street Address:	11482 Dyerville Loop Road
City:	Myers Flat
County:	Humboldt
Latitude/Longitude:	40.28777, -123.80394
State Responsibility Area (SRA) / Local Responsibility Area (LRA) / Federal Responsibility Area (FRA)	State Responsibility Area (SRA)
PG&E Division:	Humboldt
High Fire Threat District (HFTD):	Tier 2
High Fire Risk Area (HFRA):	Yes
EPSS Buffer:	No
Fire Index Area (FIA):	105
Fire Potential Index (FPI) Rating: FIA	R2
Fire Potential Index (FPI) Rating: Circuit	R2
Was there a PSPS event at the time of ignition?	No
Suspected Initiating Event:	PG&E Equipment
Failure Driver:	All types of equipment/facility failure
Failure Sub-driver:	Insulator failure
Circuit:	Fruitland 1142 (192311142)

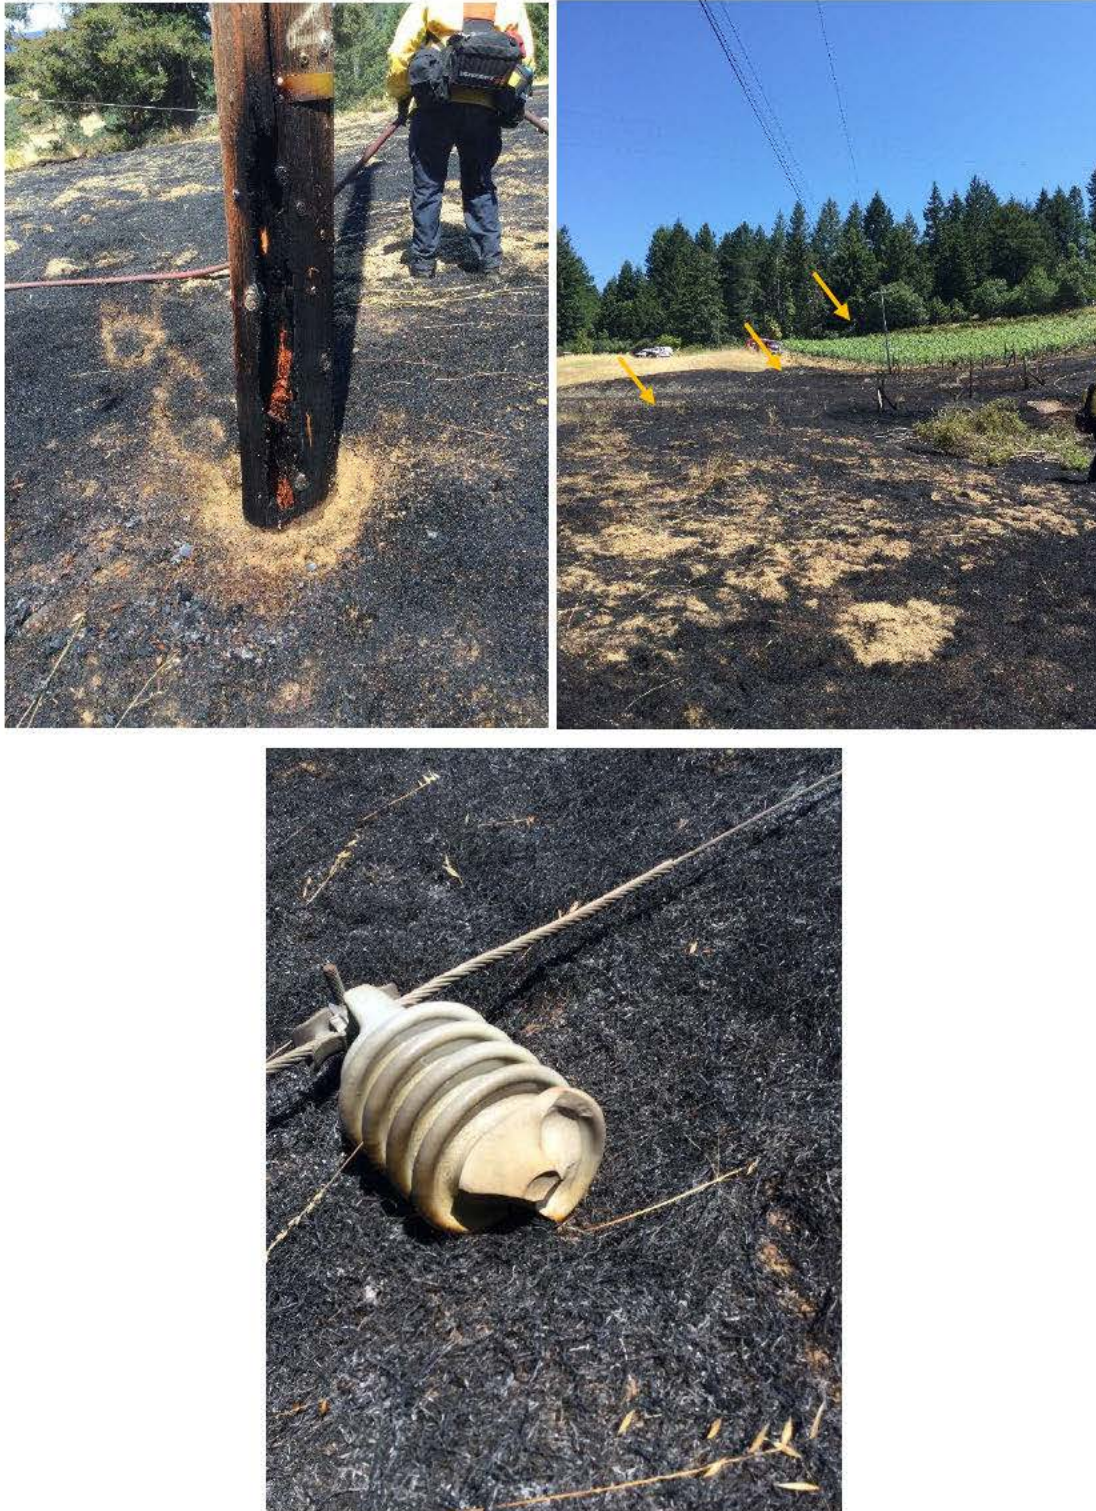
At 1118 hours, Troubleshooter #1 opened the jumpers on Fuse 6865 to deenergize the line to make the area safe. At 1123 hours, Troubleshooter #1 arrived at the Incident Location and observed CAL FIRE clearing a vegetation fire, a failed ceramic post-type LAPP insulator, and one phase of 4-ACSR primary overhead conductor on the ground at wood pole SAP ID # 100989592 ("Incident Pole") located on the Fruitland 1142 distribution circuit (see Figure 3 and Figure 4). The failed insulator caused one phase of 4-ACSR primary overhead conductor to come down between the Incident Pole and the two adjacent poles, Pole #2, SAP ID # 100989591 ("Incident Span #1", source side) and Pole #3, SAP ID # 100989594 ("Incident Span #2", load side) (see Figure 2). The conductor was not broken. The failed insulator was retained for further evaluation. At 1322 hours, Troubleshooter #1 created EC Notification #129223091 to replace the damaged Incident Pole (including crossarm and insulators).

Figure 3 Photographs of damaged Incident Pole (top left), extent of vegetation fire looking towards source side Pole # 2 from the Incident Pole (top, right) and the failed insulator (bottom). Arrows in top right photograph indicate downed wire. Source: Google Maps, image undated.

Corrective Notification EC 129223091 was created to replace the damaged pole (including crossarms and insulators). Replacement of the pole was completed on July 15, 2024.

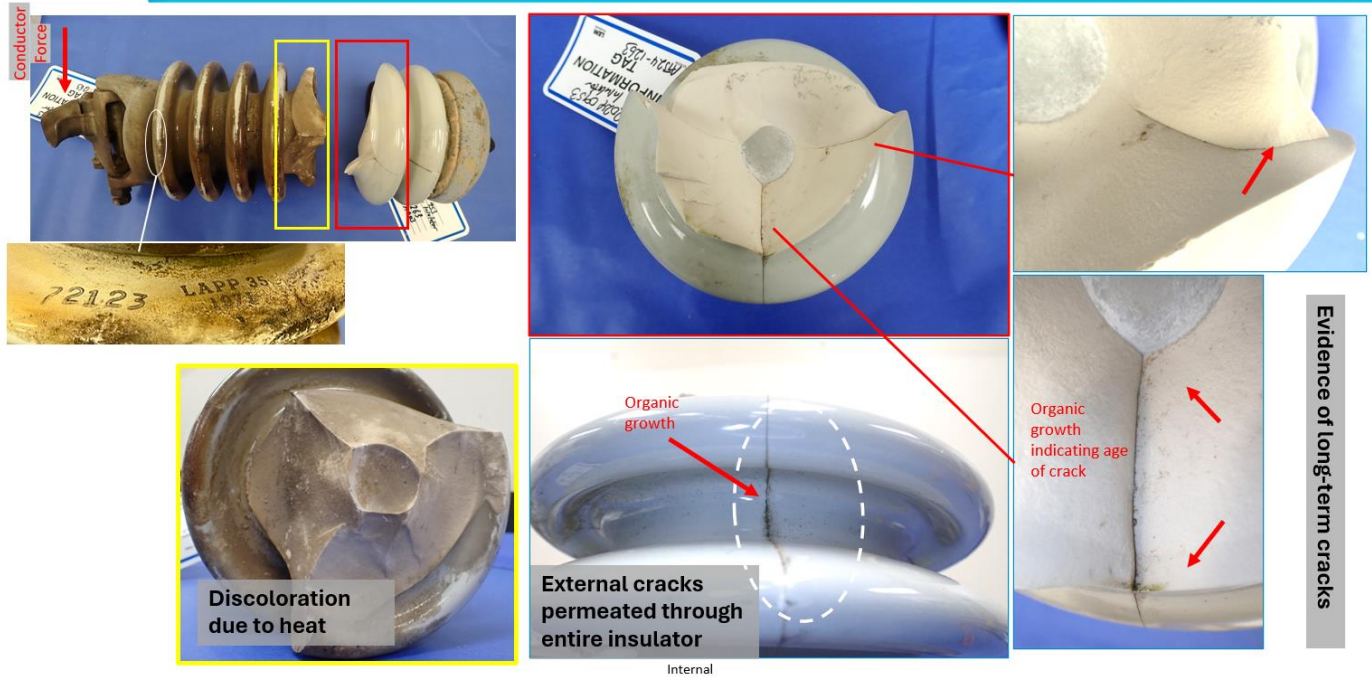
The broken insulator retained from the Incident Location was provided to Applied Technology Services (ATS) for visual examination. ATS determined moisture ingress and cement expansion were possible contributing factors to the mechanical failure (fracture into two pieces) of the post-type ceramic insulator manufactured by LAPP in 1971. ATS visual examination of the insulator revealed the fracture surface was clean, indicative of a "fast fracture." However radial cracks on the ceramic skirt contained algae indicating they had been present for an extended duration of time (on the order of years). The ceramic skirt cracks likely reduced the insulator's load-bearing capacity, resulting in subsequent fracture. The cement around the base of the insulator was cracked which could allow moisture ingress and cement expansion, resulting in radial cracks and possibly contributing to the mechanical failure. Figure 5 provides photographs of the failed insulator condition when received by ATS.

Figure 5 View of failed insulator as received by ATS (top left) and views of the fracture surface and radial cracks. Source: ATS report # 0006.6-24.51.

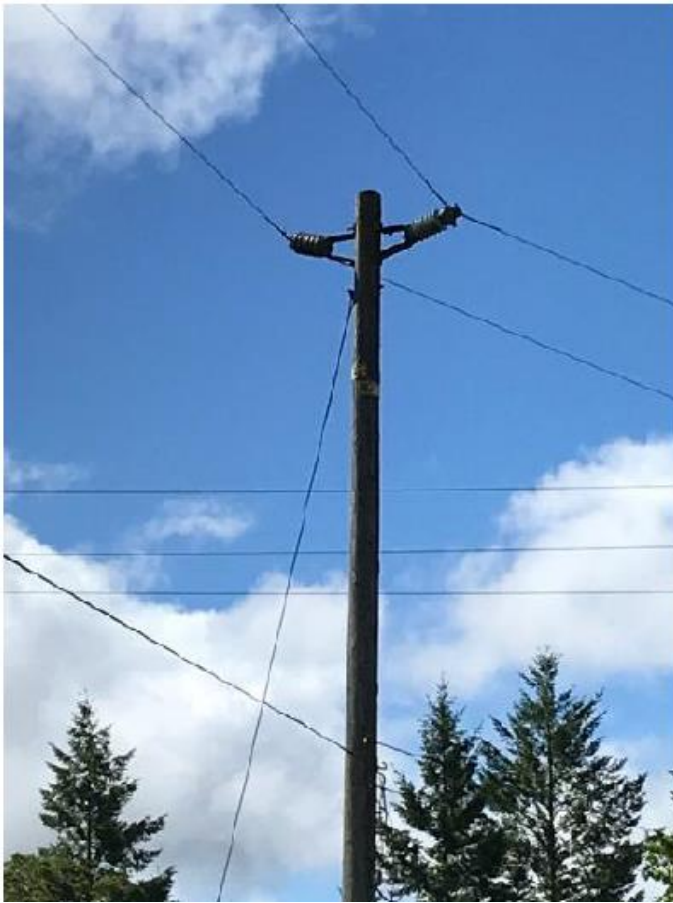
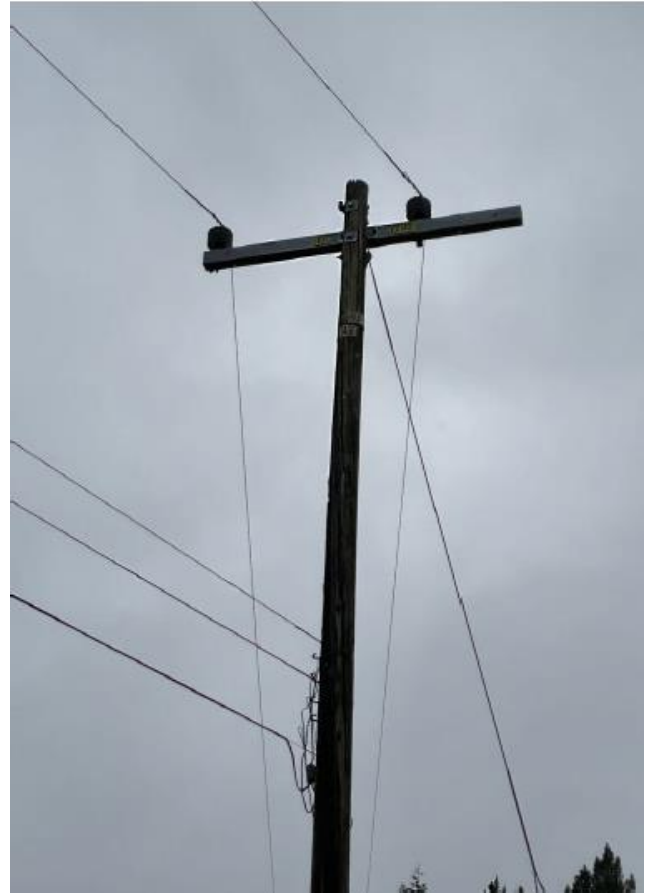
Asset Failure Analysis (AFA) performed an Extent of Condition (XoC) investigation for this ignition. AFA hypothesized that the insulator and crossarm replacement performed on Pole #2 in March 2020 may have also contributed to the mechanical failure of the insulators on the Incident Pole.⁴ AFA is evaluating whether pole work performed on adjacent structures may damage triangular construction porcelain insulators installations.

⁴ EC # 118640462, Priority A, completed March 5, 2020. AFA determined EC # 118640462 erroneously called out the wrong SAP ID (#100989588) and that the corrective work on this notification is associated with Pole 2. Review of 2019 WSIP inspection and 2022 GO165 OH Enhanced Detailed Inspection photographs show the insulators on Pole 2 were changed out during this period (Figure 6).

*Figure 6 Views of Pole #2 (source side of incident pole) showing crossarm and insulators change between 2019 (left) and 2022 (right).
Source: 2019 image: WSIP inspection report # 181-7155634; 2022 image: 2022 GO165 Overhead Inspection report.*
