Preliminary Ignition Investigation Report

Ignition Database Index:	20241108
Electric Incident Investigation (EII) Number:	N/A
Incident Name:	Ziggy - 08 August 2024
PG&E Facility Ignition?	Yes
CPUC Reportable Ignition?	Yes
Date & Time of Incident:	August 08, 2024 @ 1311 hours
Street Address:	In the vicinity of [REDACTED]
City:	Diamond Springs
County:	El Dorado
Latitude/Longitude:	[REDACTED]
State Responsibility Area (SRA) / Local Responsibility Area (LRA) / Federal Responsibility Area (FRA)	State Responsibility Area (SRA)
PG&E Division:	Sierra
High Fire Threat District (HFTD):	Tier 2
High Fire Risk Area (HFRA):	Yes
EPSS Buffer:	No
Fire Index Area (FIA):	340
Fire Potential Index (FPI) Rating: FIA	R5
Fire Potential Index (FPI) Rating: Circuit	R5
Was there a PSPS event at the time of ignition?	No
Suspected Initiating Event:	Vegetation
Failure Driver:	Contact from object
Failure Sub-driver:	Contact – Vegetation
Circuit:	Diamond Springs 1106
Circuit Protection Zone:	Diamond Springs 1106930190

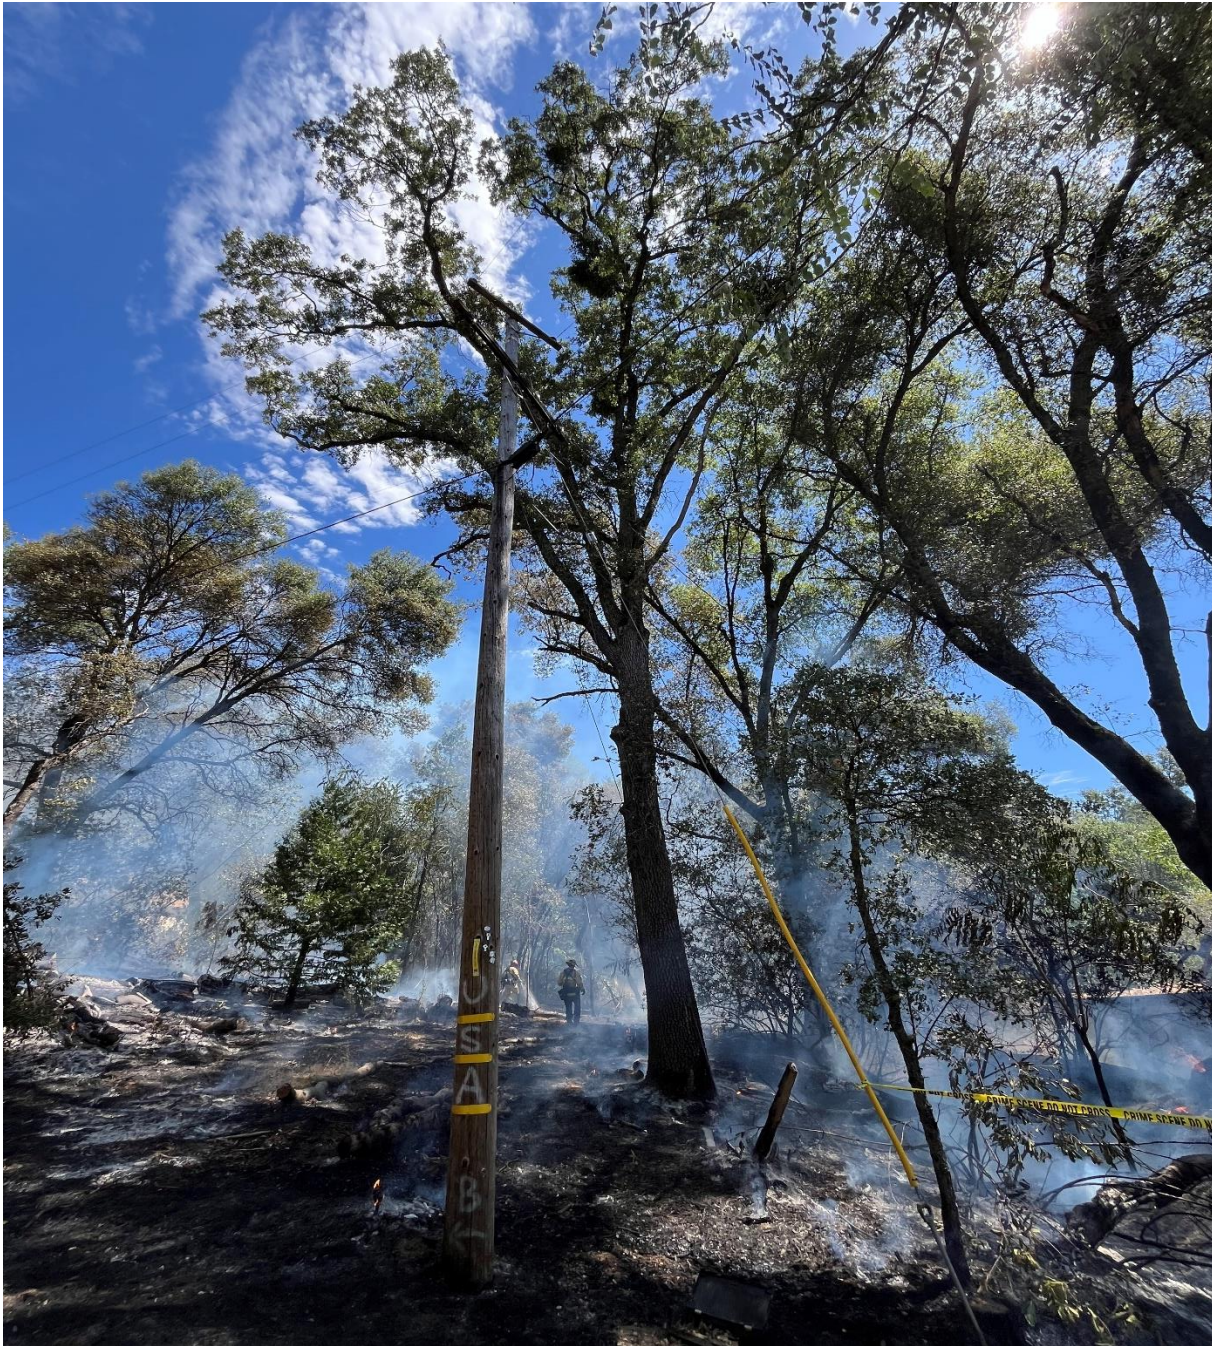
The Field Automation System (FAS) record states that the PG&E troubleshooter arrived on scene at approximately 1314 hours and observed a fire. The troubleshooter indicated that a tree branch fell onto the Secondary Service line conductor and onto the nearby building causing arcing and burned vegetation below (see Figures 3, 4, and 5).

Figure 3 - Fire burn scar area and SAP Pole ID: 101404242. Picture taken by the troubleshooter on August 08, 2024.

The PG&E repair crew arrived onsite at 1745 hours to repair the broken service and to replace a broken secondary cross-arm on SAP Pole ID: 101404242, which was part of an open Priority E-Tag # 127258926, dated October 12, 2023. All work was completed on August 8, 2024.

EC priority “A” Tag (#129352200) was created to replace a broken secondary cross-arm and service wire on SAP Pole ID: 101404242. All repair work was completed by the PG&E crew on August 8, 2024.

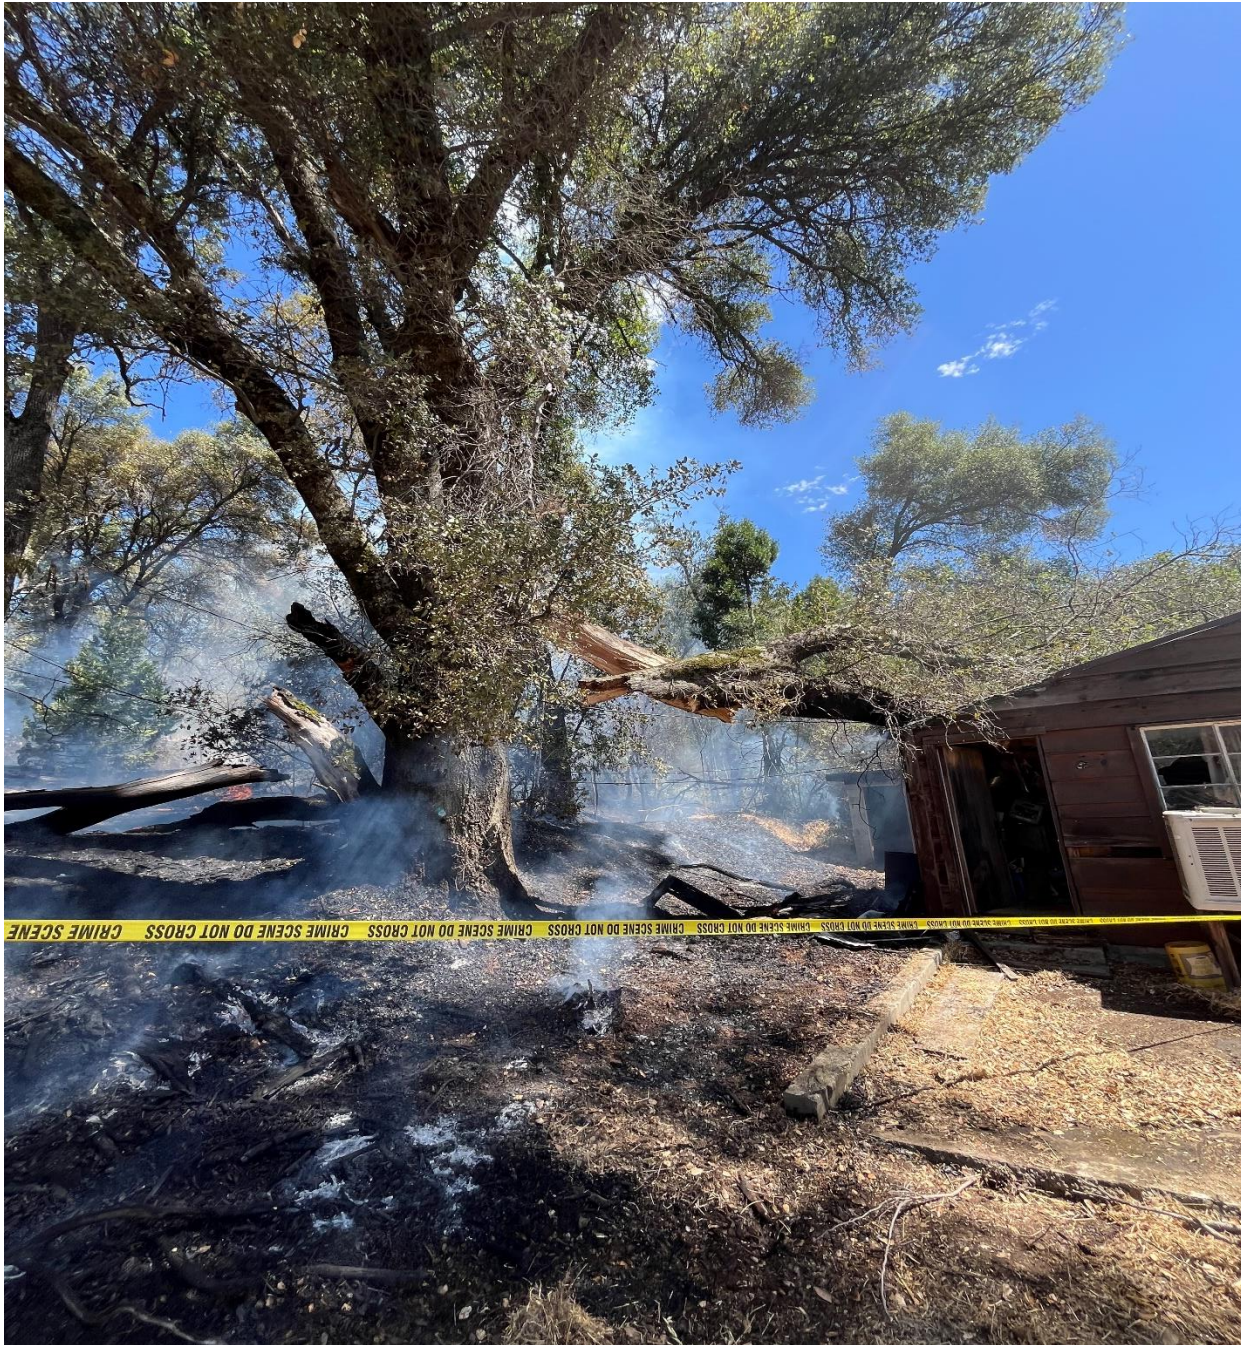
Figure 4 – Ignition and fire origin area where the large tree branch/limb fell onto the Secondary Service line conductor which caused arcing and burned vegetation below. Picture taken by the troubleshooter on August 08, 2024.

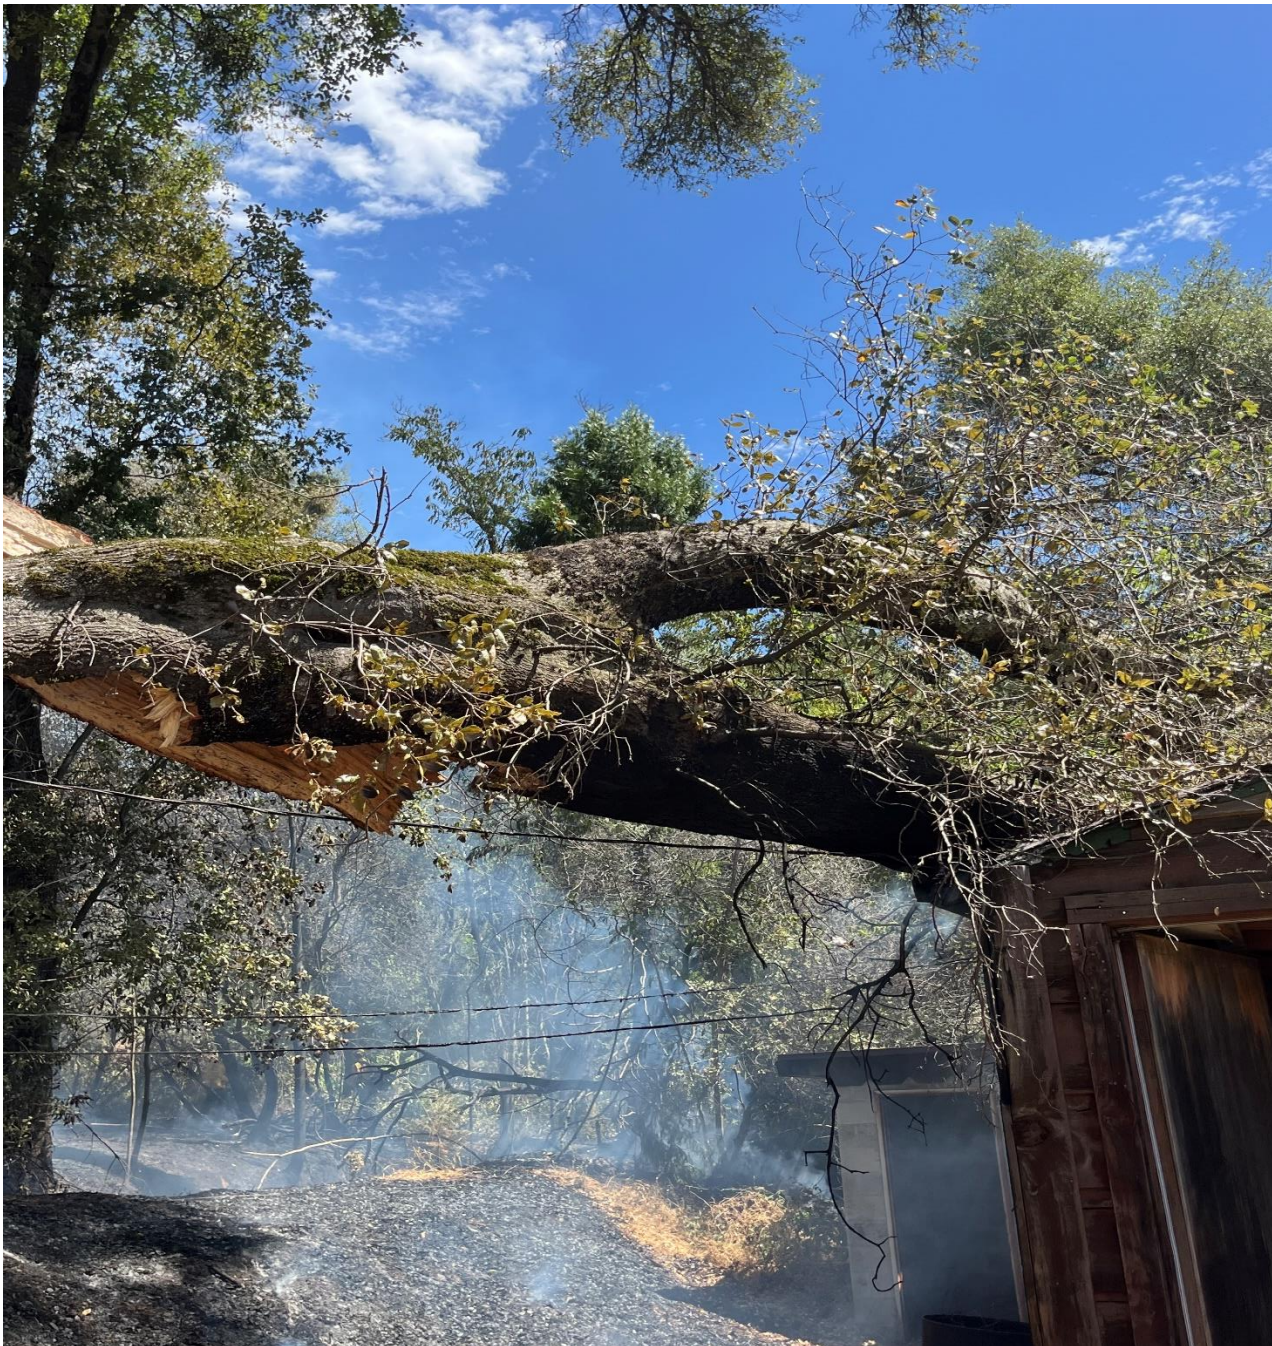
Figure 5 – Close-up of large tree branch/limb fell onto the Secondary Service line conductor which caused arcing and burned vegetation below. Picture taken by the troubleshooter on August 08, 2024.

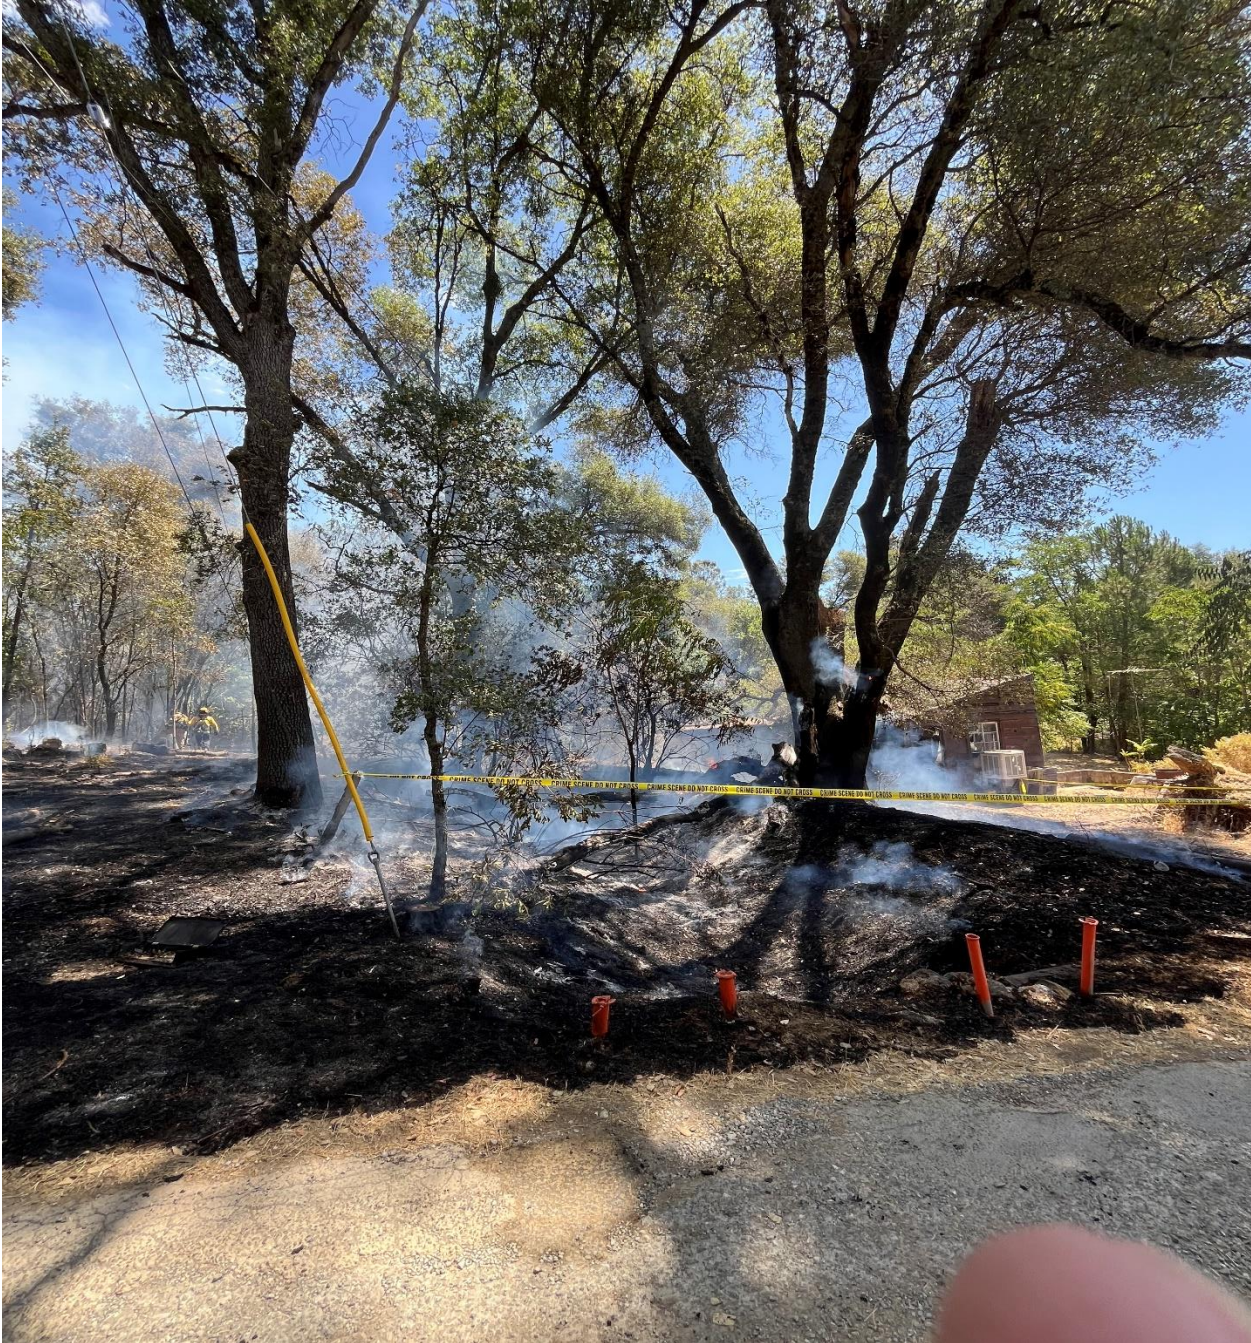
The fire is listed as the "Ziggy" fire in the Hazard Awareness Wildfire Command (HAWC) fire activity report. The ensuing fire had spread to about 0.1 acres (based on the HAWC summary) in size and was suppressed by CAL FIRE on August 8, 2024 (see Figure 6).

Figure 6 – CAL FIRE onsite to assist in controlling and suppressing the fire spread, picture taken by the troubleshooter on August 08, 2024.

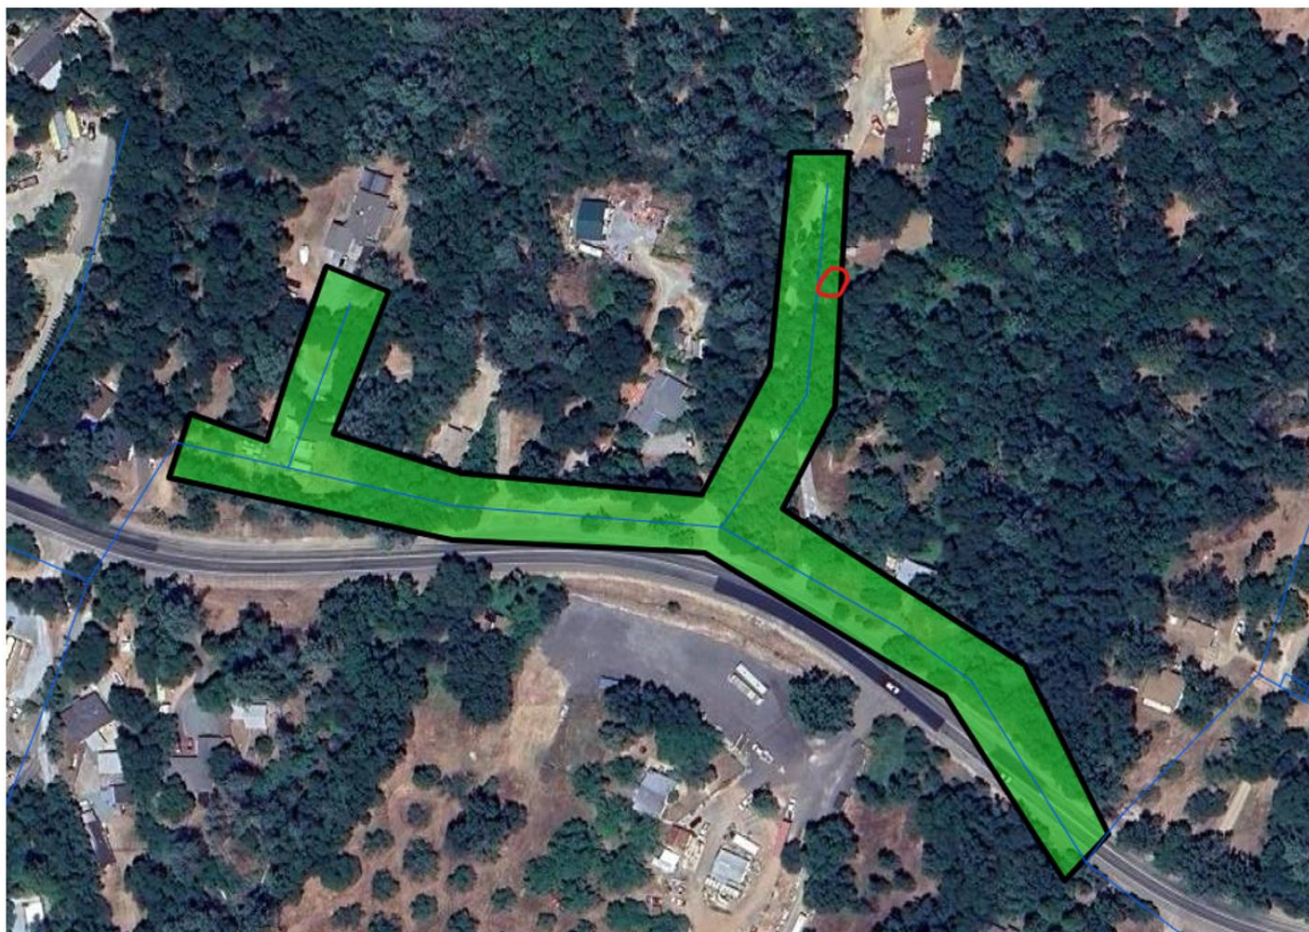
An extent of condition (EOC) investigation was performed by the same VM investigator on August 9, 2024, and noted the same details as the post-incident investigation above. The VM investigator patrolled five spans in each direction and no additional trees were identified or needed to be worked during the inspection (see Figures 7, 8, 9, and 10).

Figure 7 - Five-span patrol completed by the VM inspector on August 9, 2024.

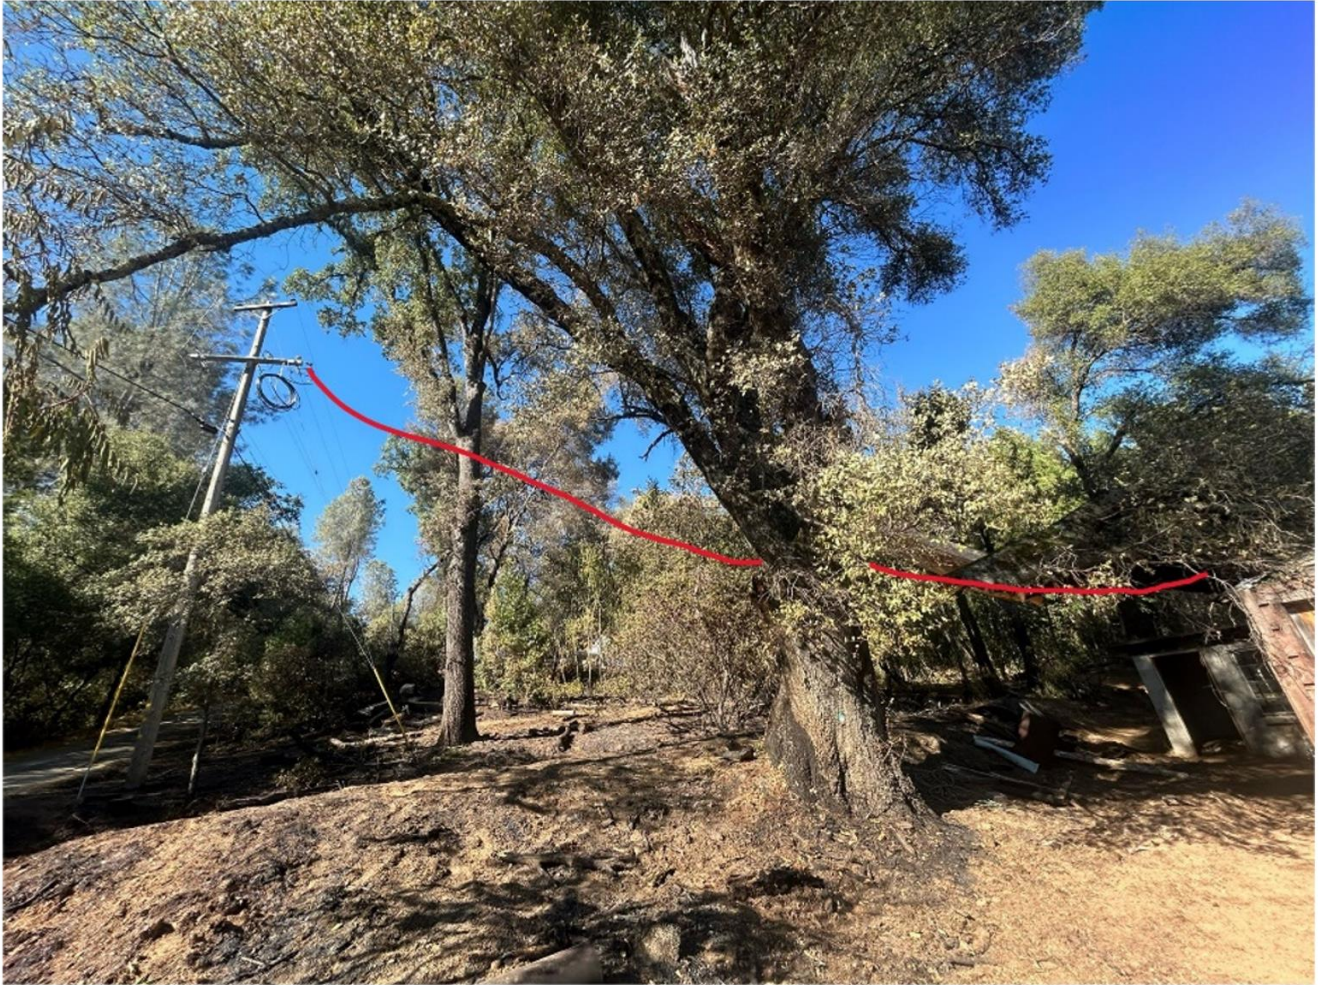
A post-incident investigation was performed by a Vegetation Management (VM) investigator on August 9, 2024, near the Incident Location. The VM investigator observed a large interior live oak tree limb had failed and fallen through a single customer service drop which in effect also broke a secondary cross-arm on SAP Pole ID: 101404242. The inspector also observed that the failed tree limb had an open cavity and minor rot in the compression side of the limb and specified that this failed limb would not have affected the primary distribution facilities.

Figure 8 - Service drop detail picture taken by the VM inspector on August 9, 2024.

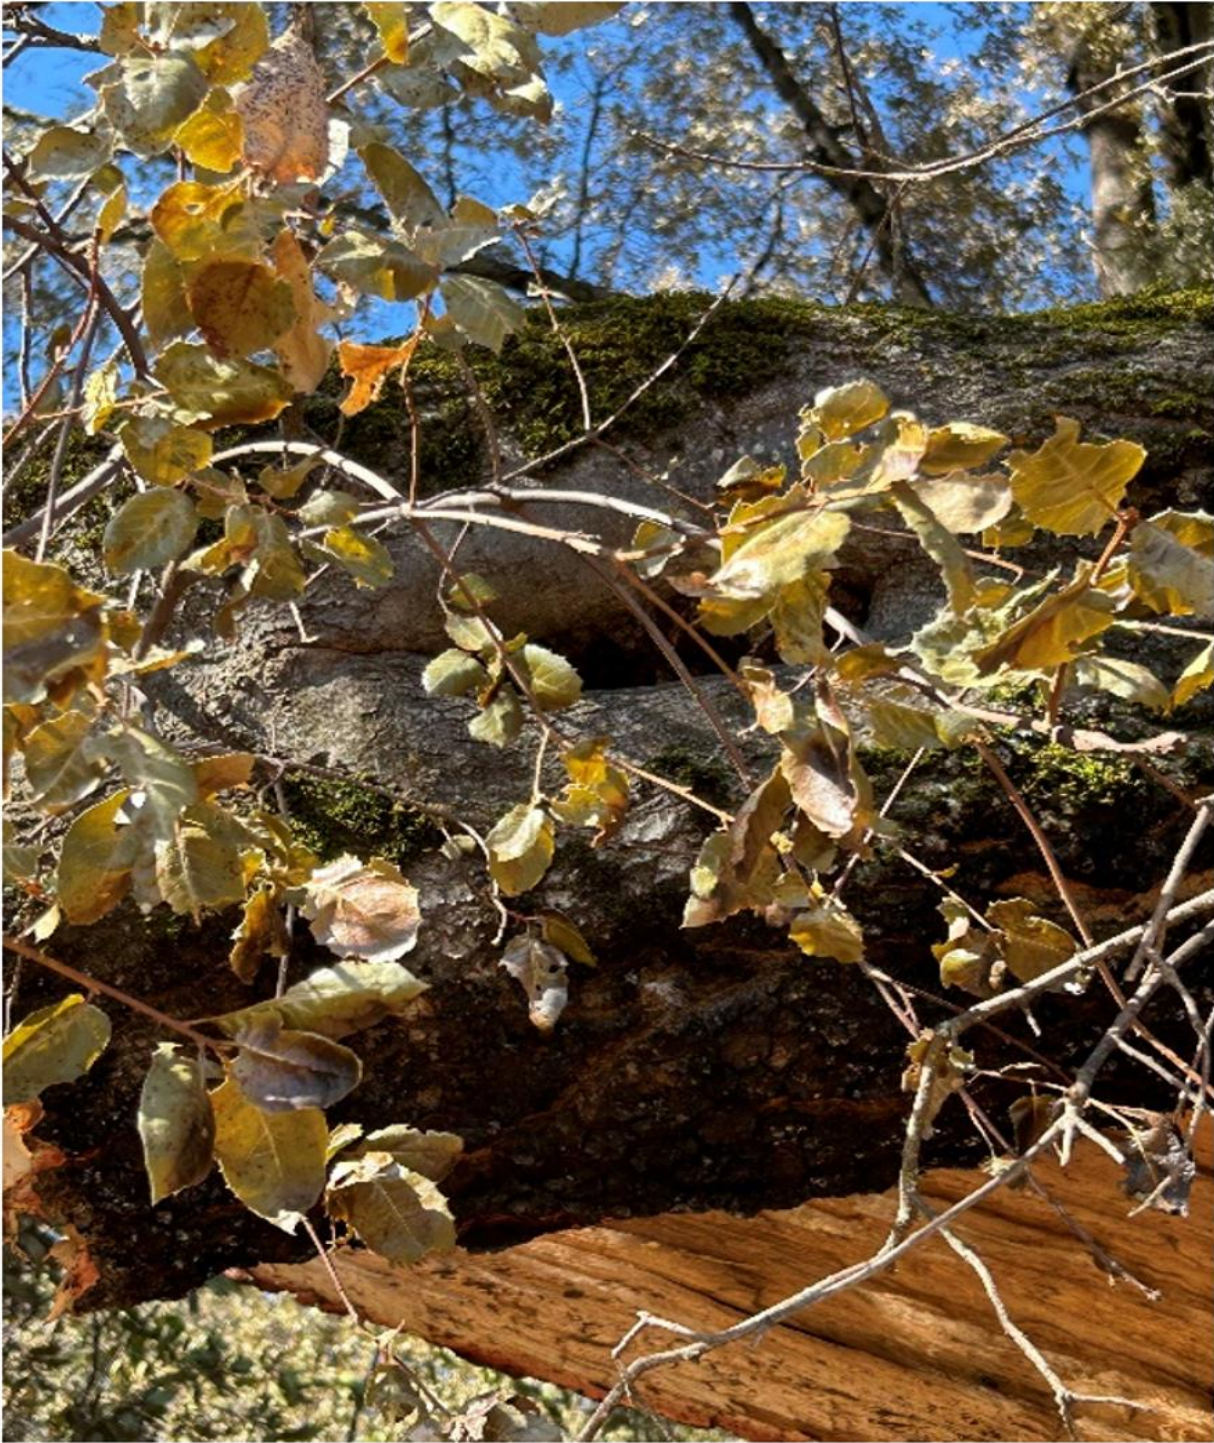
Figure 9 - Limb defect and cavity on failed Live Oak tree, taken by the VM inspector on August 9, 2024.

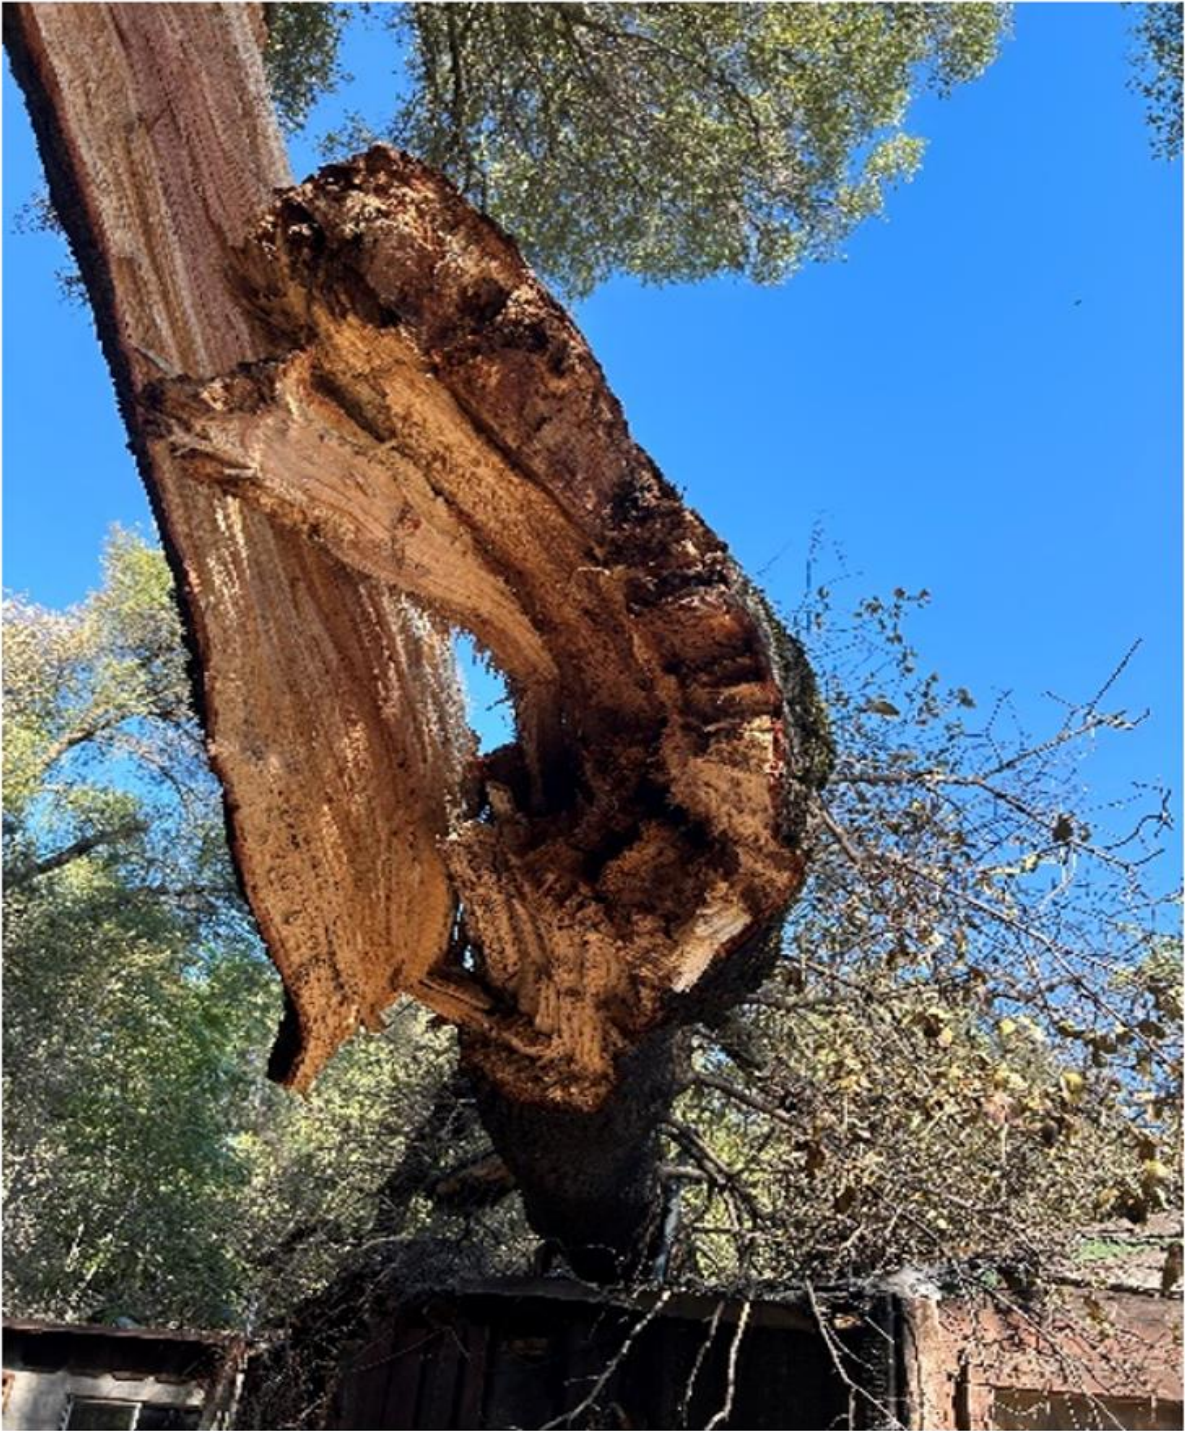
Figure 10 – Failed limb interior on the Live Oak tree, taken by the VM inspector on August 9, 2024.

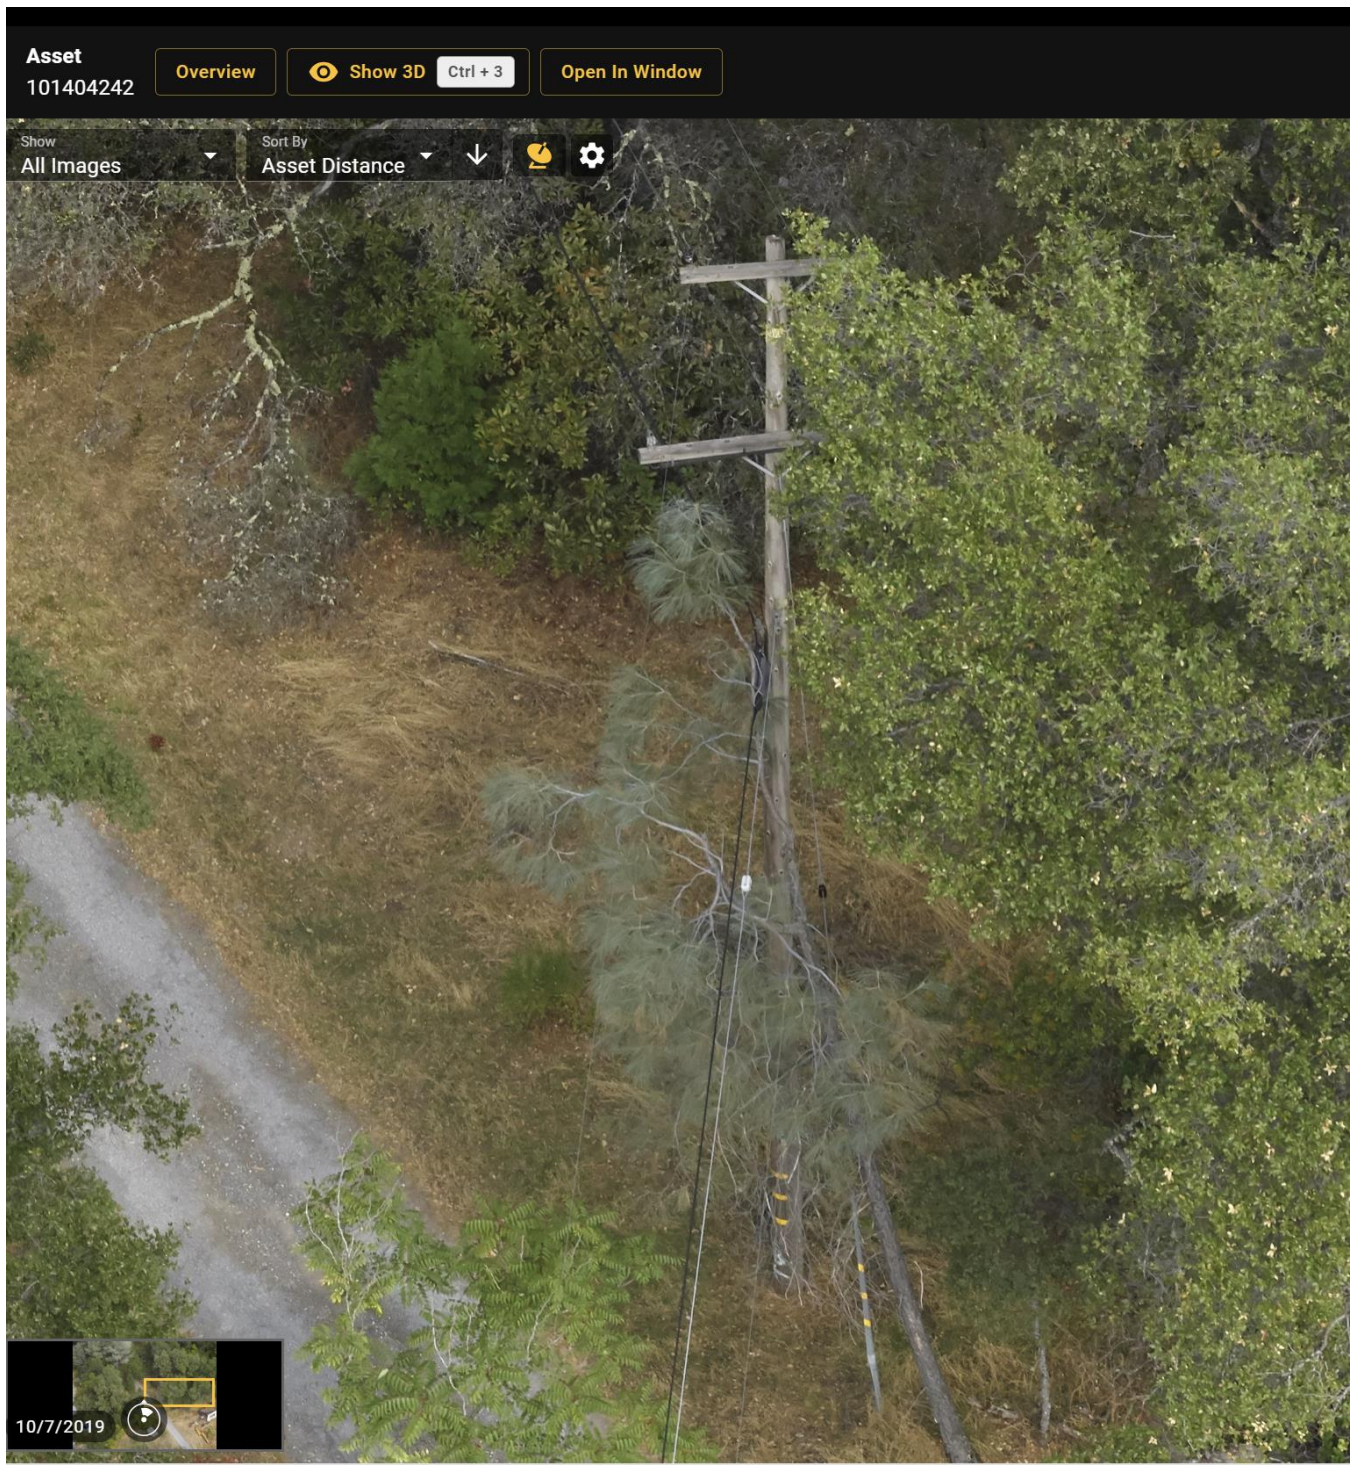
Incident Structure	SAP Pole ID: 101404242	
Info / Inspection	Most Recent Date	Findings
Install Date:	January 1, 1959	Douglas Fir – Class 5 – Height 45'
Inspection:	October 12, 2023	GO165 Inspection – EC priority “E” Tag # 127258926 submitted to replace a decayed cross-arm and damaged insulator. There was still an open tag on the date of the incident.
	N/A	
Patrol:	N/A	
	N/A	
Corrective History:	August 08, 2024	EC priority “A” Tag (#129352200) was created to replace a broken secondary cross-arm and service wire on SAP Pole ID: 101404242.
Aerial Inspection Records:	October 07, 2019	SAP Pole ID 101404242 No abnormal conditions visible, (see Figure 11).
VM Inspection:	May 28, 2024	No findings at the incident location.
EVM Inspection:	N/A	A proximity search was performed in the Enhanced Vegetation Management (EVM) database and no trees were within a 1/8-mile radius of the coordinates provided for this incident.

Figure 11 - SAP Pole ID: 101404242, picture taken from Shaper Shape dated October 07, 2019
