Preliminary Ignition Investigation Report

Ignition Database Index:	20241118N
Electric Incident Investigation (EII) Number:	NR240809A
Incident Name:	Blue
PG&E Facility Ignition?	Yes
CPUC Reportable Ignition?	Yes
Date & Time of Incident:	August 9, 2024 @approximately 1411 hours
Street Address:	Near Blue Mountain Drive & Lyon Road
City:	Fairfield (north, rural area)
County:	Solano
Latitude/Longitude:	38.307036, -122.052407
State Responsibility Area (SRA) / Local Responsibility Area (LRA) / Federal Responsibility Area (FRA)	State Responsibility Area
PG&E Division:	Sacramento
High Fire Threat District (HFTD):	Tier 2
High Fire Risk Area (HFRA):	Yes
EPSS Buffer:	No
Fire Index Area (FIA):	177
Fire Potential Index (FPI) Rating: FIA	R4
Fire Potential Index (FPI) Rating: Circuit	N/A
Was there a PSPS event at the time of ignition?	No
Suspected Initiating Event:	Contact – Animal – Bird
Failure Driver:	Contact from object
Failure Sub-driver:	Contact – Animal – Bird

Circuit:	Vaca Suisun Jameson 115kV
Circuit Protection Zone:	Circuit Breaker (CB) 1332, CB 1322, and CB 122
Nominal Voltage:	115kV
Pole SAP Equipment ID:	40865461 Structure 010/078
Subject to PRC 4292 Veg Pole Clearance:	No
PG&E Equi

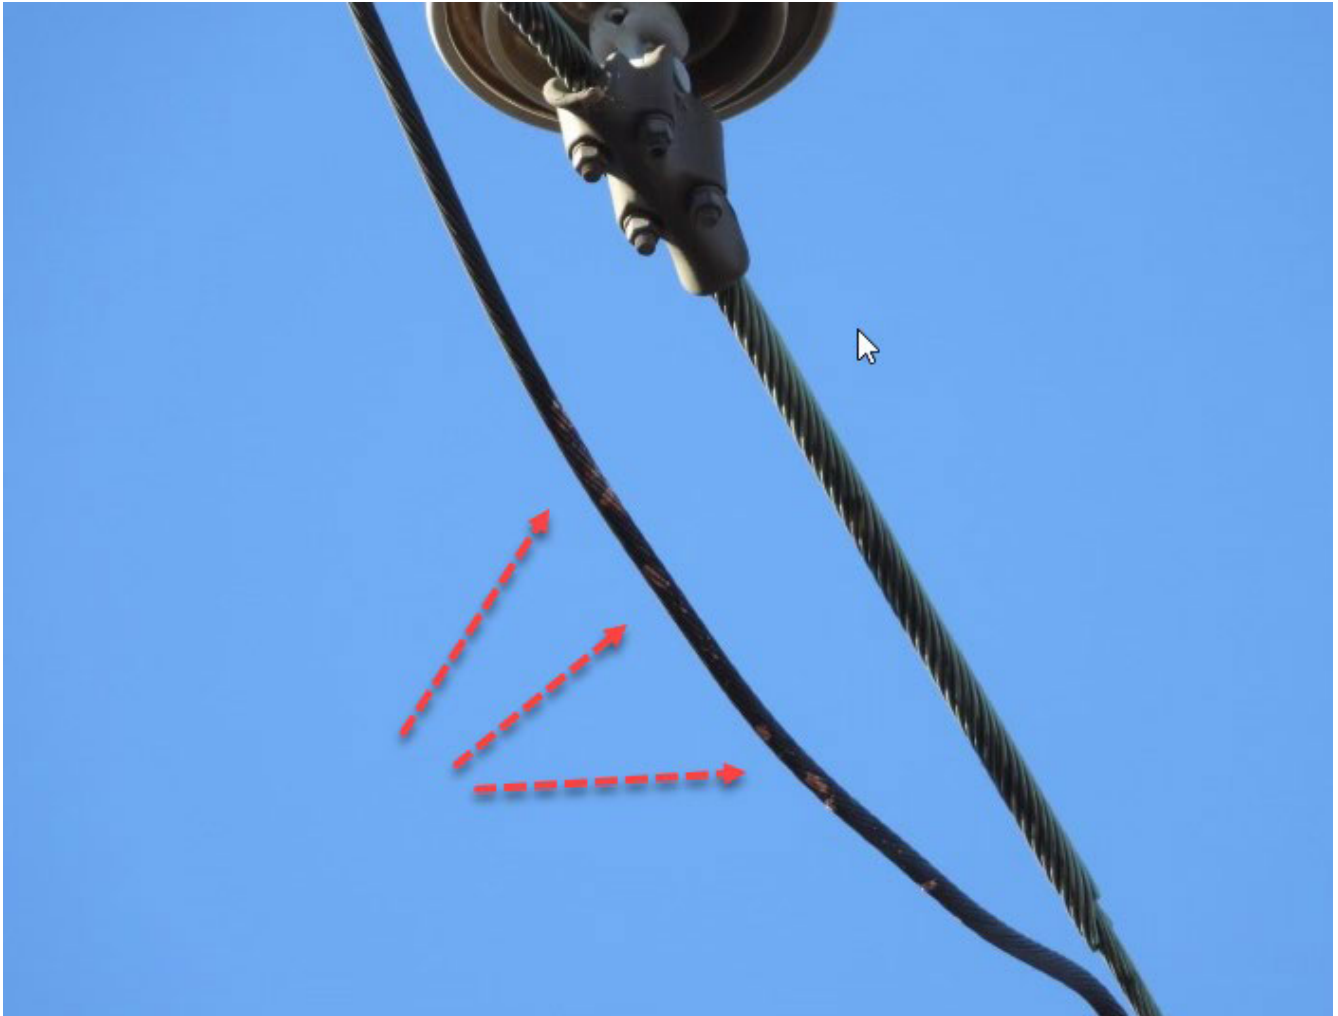
An electric program manager and PG&E's avian subject matter expert (SME) analyzed the incident. They concurred with the hypothesis that the turkey vulture made contact with the jumper directly above the steel crossarm while either landing or taking flight from the crossarm. The arc flash marks (See Figures 2 & 3) observed are indicative of where the bird was landing or taking flight from. It was observed that the jumper has a natural curve (See Figure 4) that closes the clearance space between the jumper and the steel crossarm below it. Due to this curvature, there was a proposal that removing the jumpers from this tower entirely could create the larger clearance needed to mitigate bird contact. The decided mitigation for this location is to install bird guards on the steel crossarms to create a buffer between the energized components and steel crossarm [LC Priority 'E' Tag (#129436259)]. A Bird Incident Report³ was created on August 13, 2024, for the incident.

Figure 2 Jumper on Tower #1 with arc marks pointed out in the photo. Photo taken by troubleshooter on August 9, 2024.

- LC Priority 'E' Tag (#129436259) was created on August 26, 2024, to install bird guards on crossarms (frog leg crossarm). Due date is November 26, 2024.

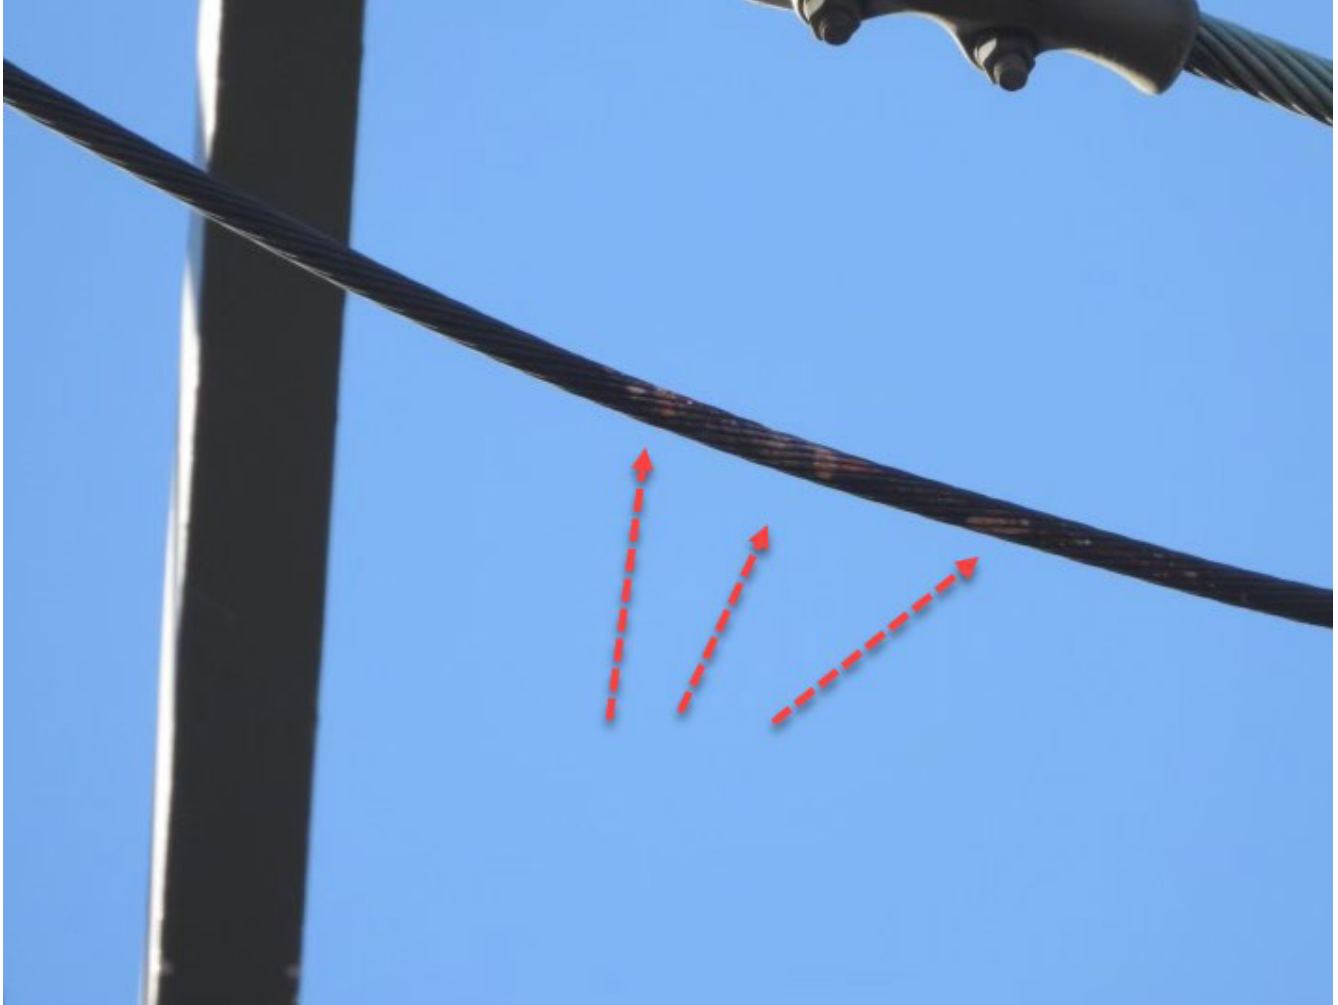
Figure 3 Jumper with arc marks pointed out in the photo. Photo taken by troubleshooter on August 9, 2024.

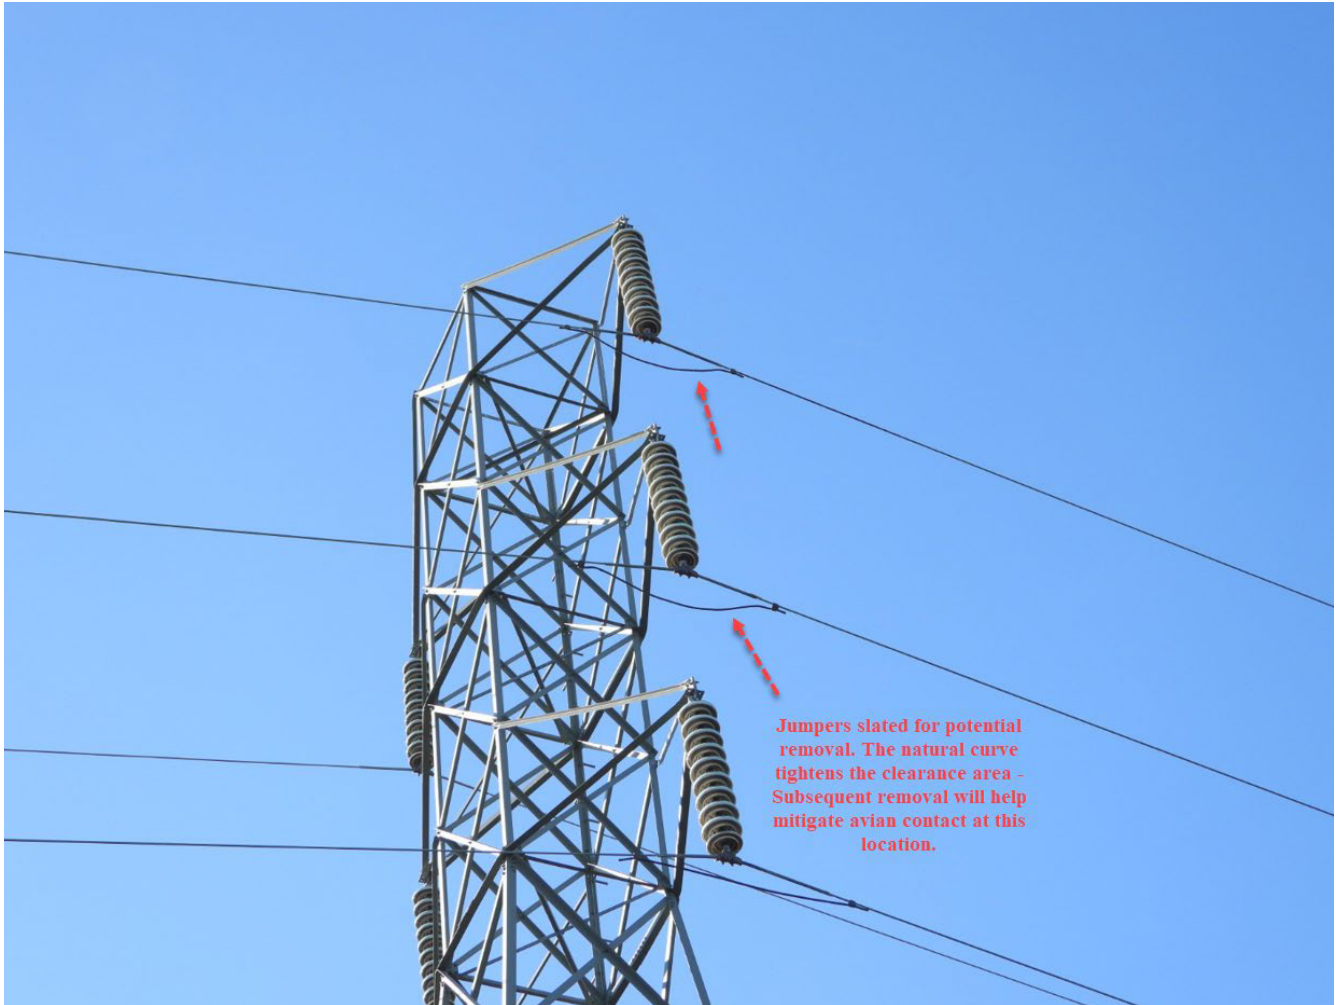
Figure 4 SAP Tower ID 40865461 – Structure 010/078, photo taken by troubleshooter on August 9, 2024.

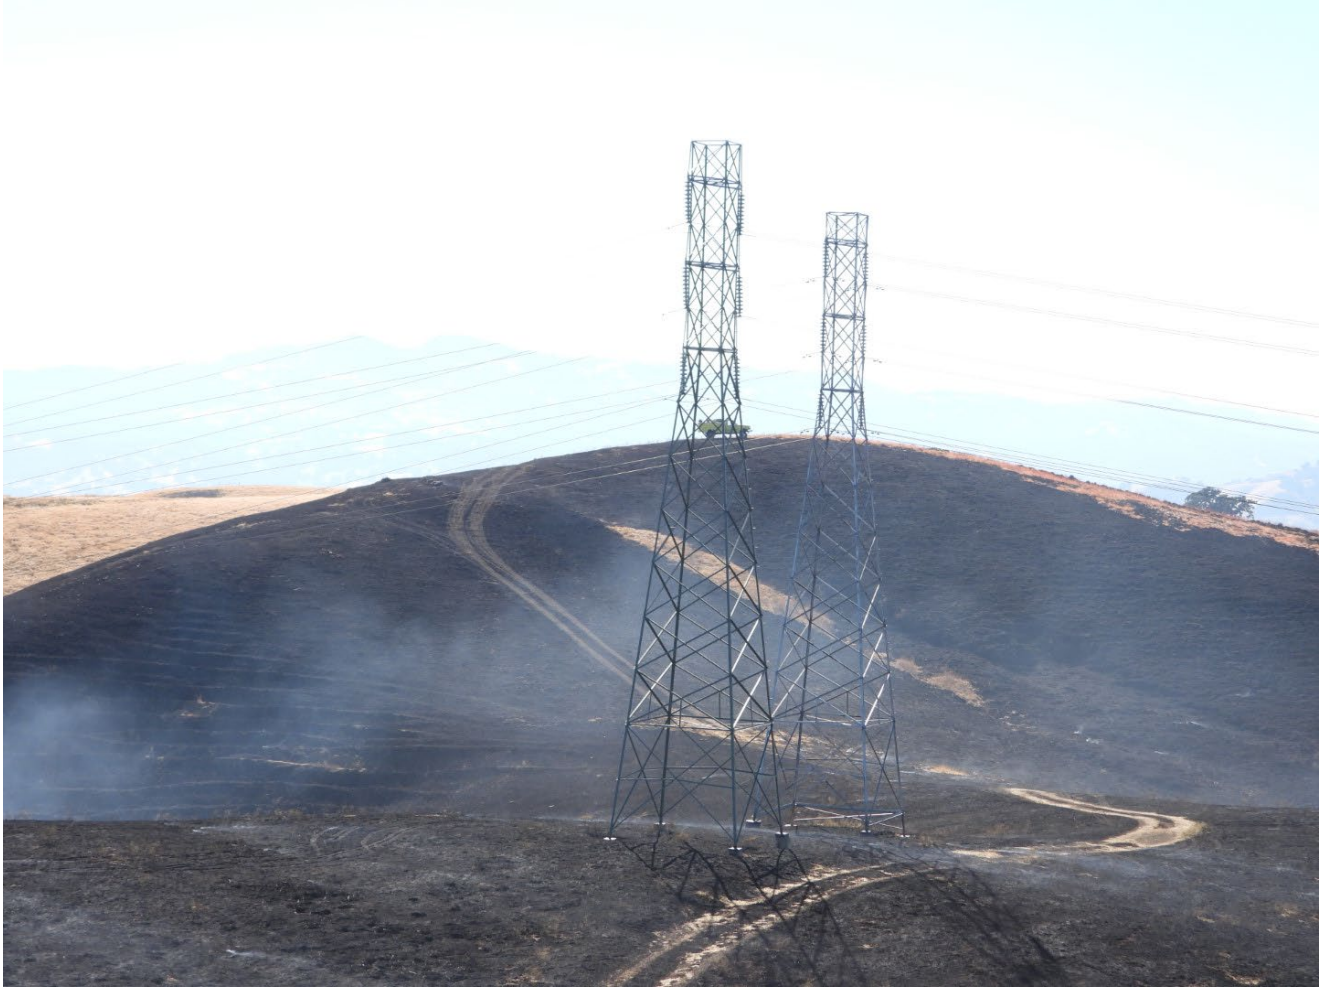
The ignition was isolated to the dry, grassy vegetation on the ground surrounding Tower #1, resulting in an 80 acre burn scar. There were no reports of injuries, fatalities, property damage, or media attention. There was one commercial customer impacted for 328 minutes.

Figure 5 Burn scar with SAP Tower ID 40865461/Structure 010/078 pictured center.

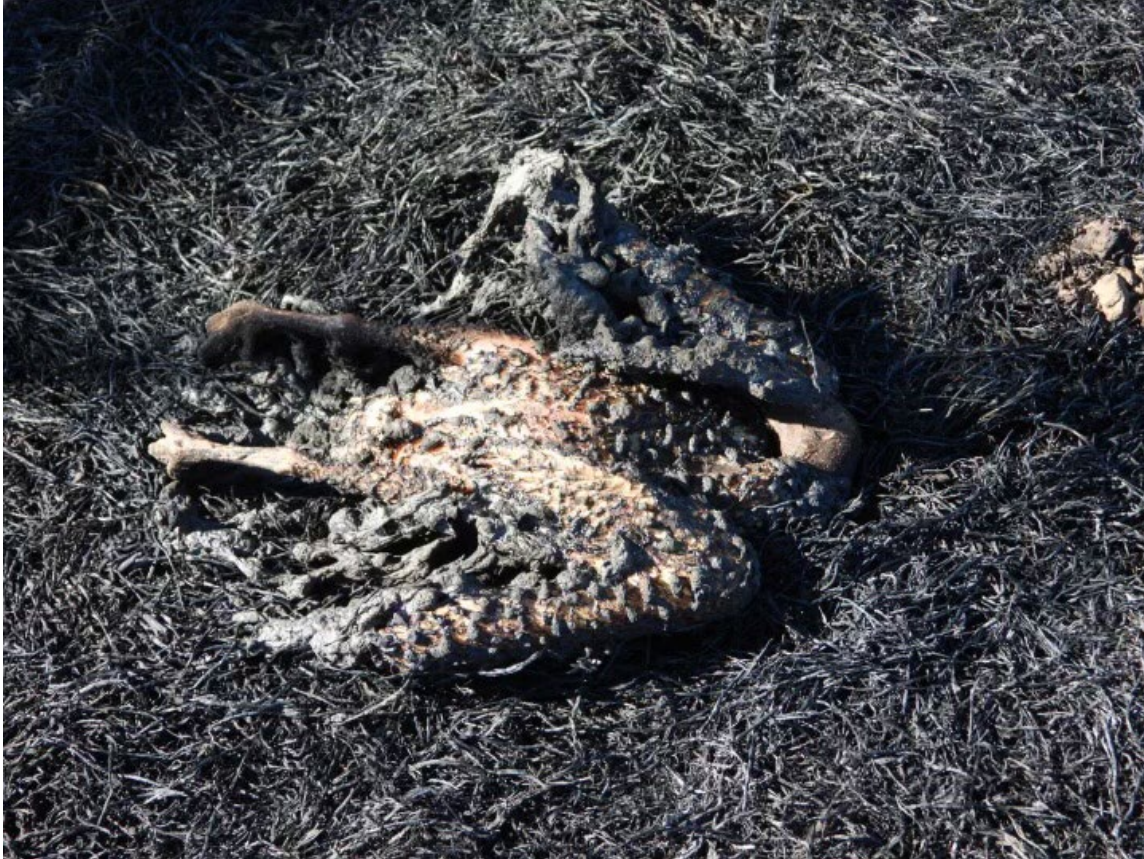
Figure 6 Deceased turkey vulture found at the base of Tower #1. Photo taken by troubleshooter on August 9, 2024.
