Preliminary Ignition Investigation Report

Ignition Database Index:	20241124
Electric Incident Investigation (EII) Number:	N/A
Incident Name:	C Street NCCFD87
PG&E Facility Ignition?	Yes
CPUC Reportable Ignition?	Yes
Date & Time of Incident:	August 10, 2024 at 1207 hours
Street Address:	Near 10570 C Street
City:	Grass Valley
County:	Nevada
Latitude/Longitude:	39.2206916188, -121.0857207054
State Responsibility Area (SRA) / Local Responsibility Area (LRA) / Federal Responsibility Area (FRA)	State Responsibility Area (SRA)
PG&E Division:	Sierra
High Fire Threat District (HFTD):	Tier 2
High Fire Risk Area (HFRA):	Yes
EPSS Buffer:	No
Fire Index Area (FIA):	330
Fire Potential Index (FPI) Rating: FIA	R5
Fire Potential Index (FPI) Rating: Circuit	R5
Was there a PSPS event at the time of ignition?	No
Suspected Initiating Event:	Vegetation
Failure Driver:	Contact From Object
Failure Sub-driver:	Contact - Vegetation
Circuit:	Brunswick 1110
Circuit Protection Zone:	Brunswick 1110LR63100

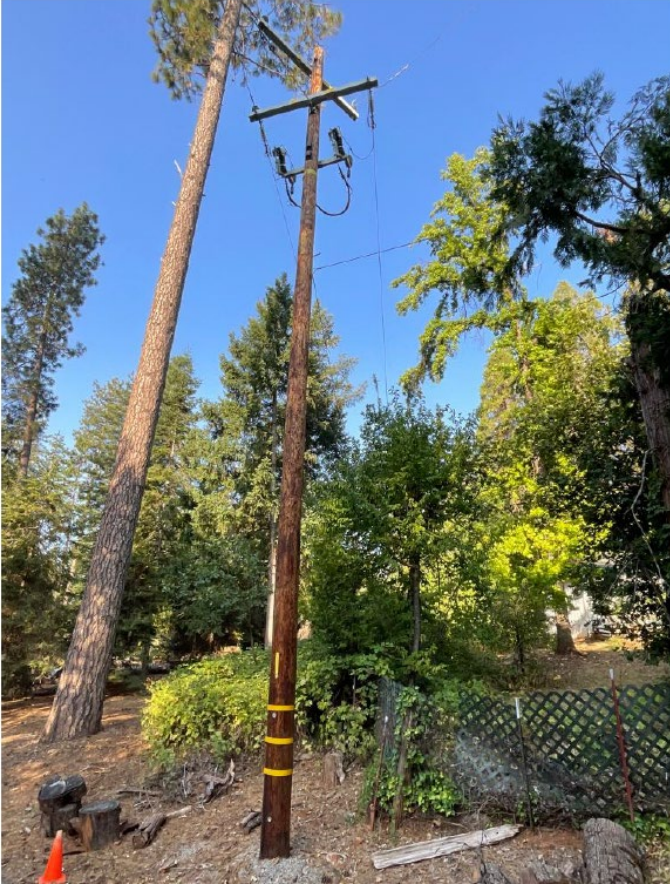
Source Side Structure		
Info / Inspection	Most Recent Date	Findings
Install Date:	2022	50', class 3 wooden pole
Inspection:	09/22/2023	GO 165 Inspection – identified trees/vines within 4'
Patrol:	N/A

Figure 3 -GO 165 Inspection photo from September 22, 2023.

Corrective History:	10/18/2023	Tree work identified in 09/22/2023 inspection completed
Aerial Inspection Records:	N/A	
VM Inspection:	04/03/2024	
EVM Inspection:	09/01/2019	Incident tree was not identified for work
Equipment Test:	N/A	
Pole Intrusive Test:	N/A	
WSIP Inspection:	N/A

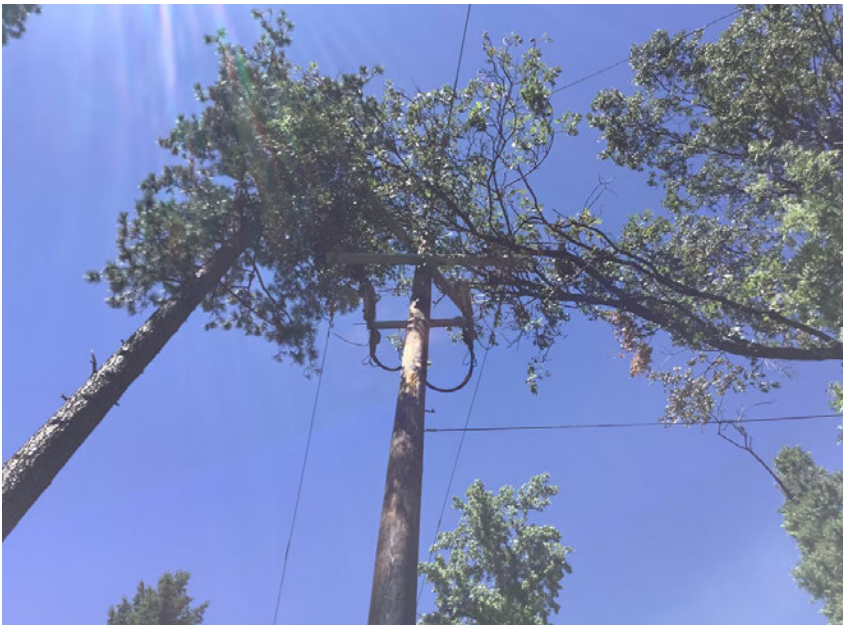
On August 10, 2024 a Vegetation Management (VM) post incident investigation was performed. The subject tree was a black oak that measured thirty-two inches in diameter at breast height (DBH). The partial limb failure occurred six feet above the branch collar. The branch exhibited signs of a past wound that was not able to heal before decay and insects were likely introduced. A section of wood was missing bark and appeared to have been damaged several years prior to the ignition. The post incident inspection identified decay and insect galleries that weakened the structural integrity of the branch, and likely led to its failure. This post incident inspection also identified six trees for priority 2 removals, twelve were prescribed for priority removals and three trees were prescribed for routine pruning work. The incident tree was last inspected on April 18, 2024 and no work was prescribed at that time. The next inspection cycle is slated for the fourth quarter 2024.

Figure 4 -Troubleshooter photo of failed tree branch on Incident Pole.

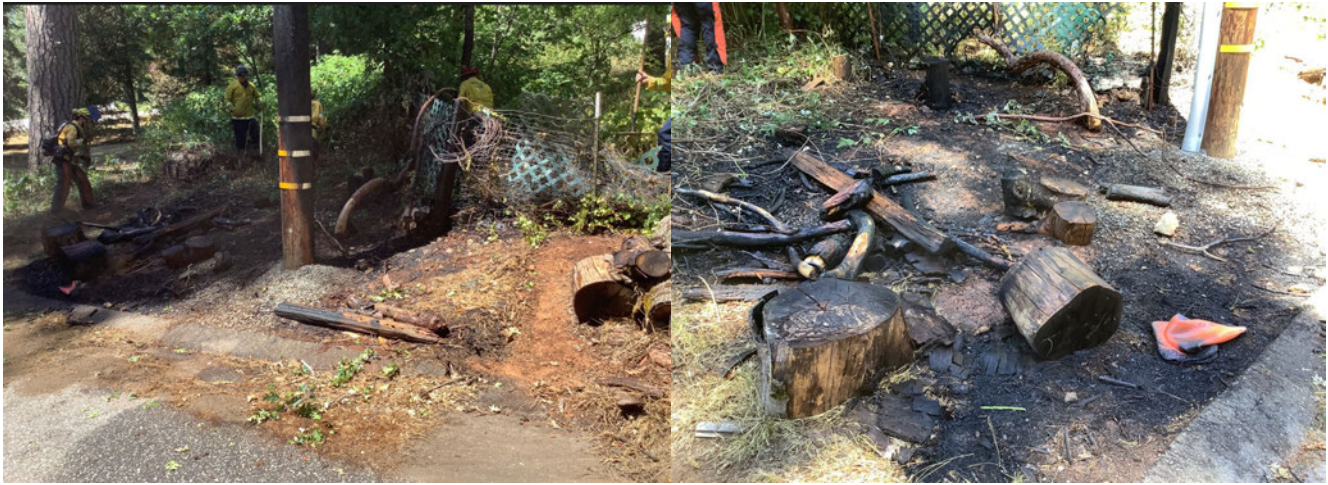
The Troubleshooter arrived onsite near C Street, south of Squirrel Creek Road in Grass Valley at 1238 hours. Upon arrival the troubleshooter located CAL FIRE onsite in the process of suppressing a spot fire caused by a large tree branch that onto the primary. The troubleshooter confirmed Line Recloser (LR) 63100 was open and did not attempt to reclose. He then performed a visual inspection of the area. Upon inspection, the troubleshooter located a large tree branch fell striking the conductor at the riser on the Incident Pole (SAP ID 104116656). The troubleshooter located fuse 77595 in the open position. This fuse feeds the underground service. After the de-energization of the fuse, the troubleshooter cleared the failed tree branch and inspected the molding on the incident pole to see if repairs were warranted. The molding and conductor showed signs of melting near the base of the pole therefore, the troubleshooter requested a PG&E repair crew to repair the damaged infrastructure, (*refer to figure 5*).

The limb of a black oak tree failed onto the 12kV conductor causing a 12-foot x 12-foot vegetation fire. Conductor damage was identified on the riser pole going to the underground feeder to transformer T42448. CAL FIRE responded to the incident and provided suppression efforts. An area wide power outage affected 210 customers for one hour six minutes.

Figure 5- Troubleshooter photo of ignition damage.

A corrective notification was created by the troubleshooter as a priority "A" tag, (EC Notification 129369027). The work order stated to repair the underground conductor connecting to the riser pole, and plastic molding covering. A PG&E repair crew was onsite on August 10, 2024 and completed all repairs at 1605 hours.

A corrective “A” tag was created, (EC notification, 129369027) to repair damages to the riser conductor and molding. The corrective tag was worked by a PG&E repair crew on August 10, 2024.

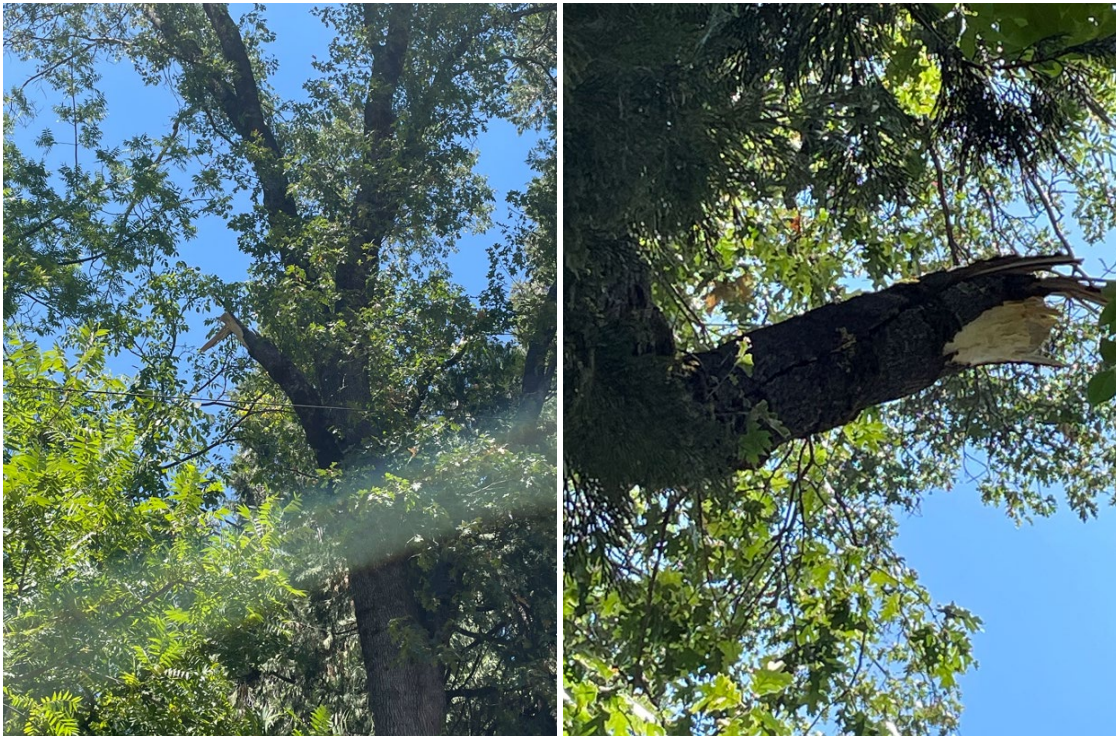
Figure 6 – VM photo of failure point from different angles.

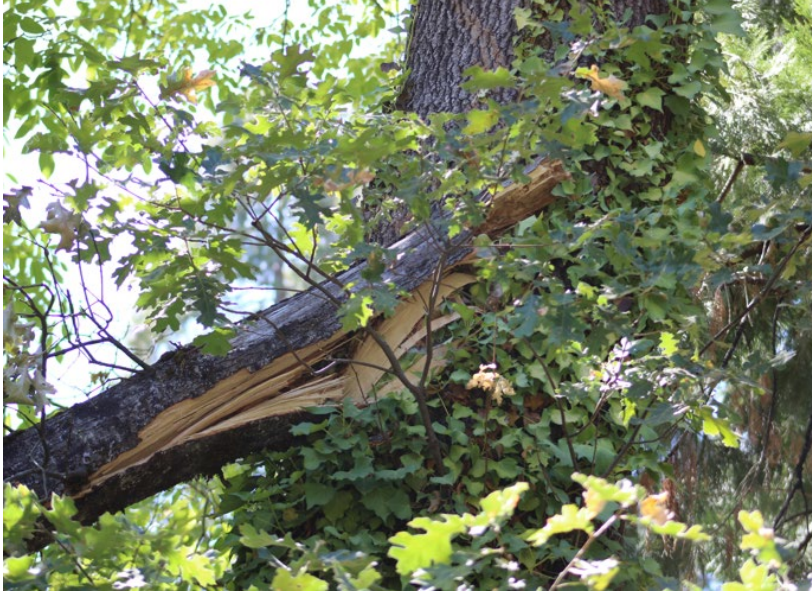
Figure 7 - VM photo showing “gray” discoloration leading to wood decay.

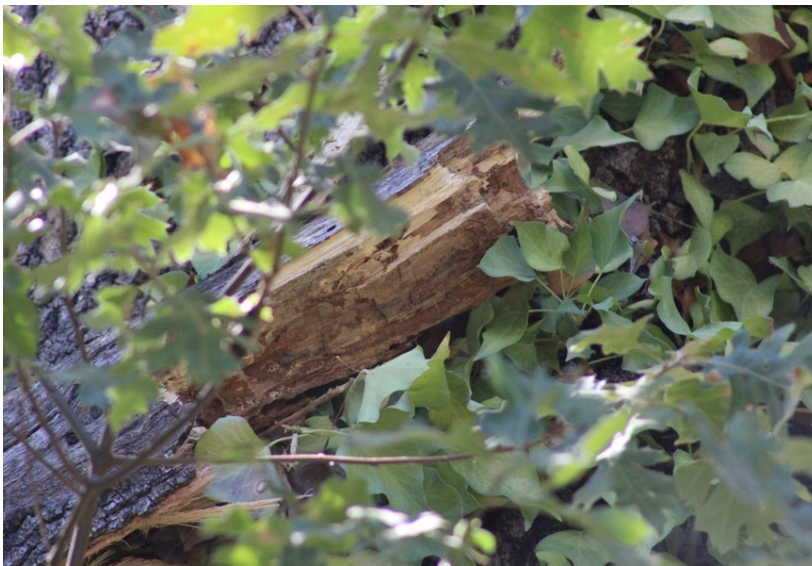
Figure 8 – VM photo showing insect damage and decay.
