Preliminary Ignition Investigation Report

| Ignition Database Index: | 20241240 |
| Incident Name: | Bain |
| Circuit: | Somona 1103 |

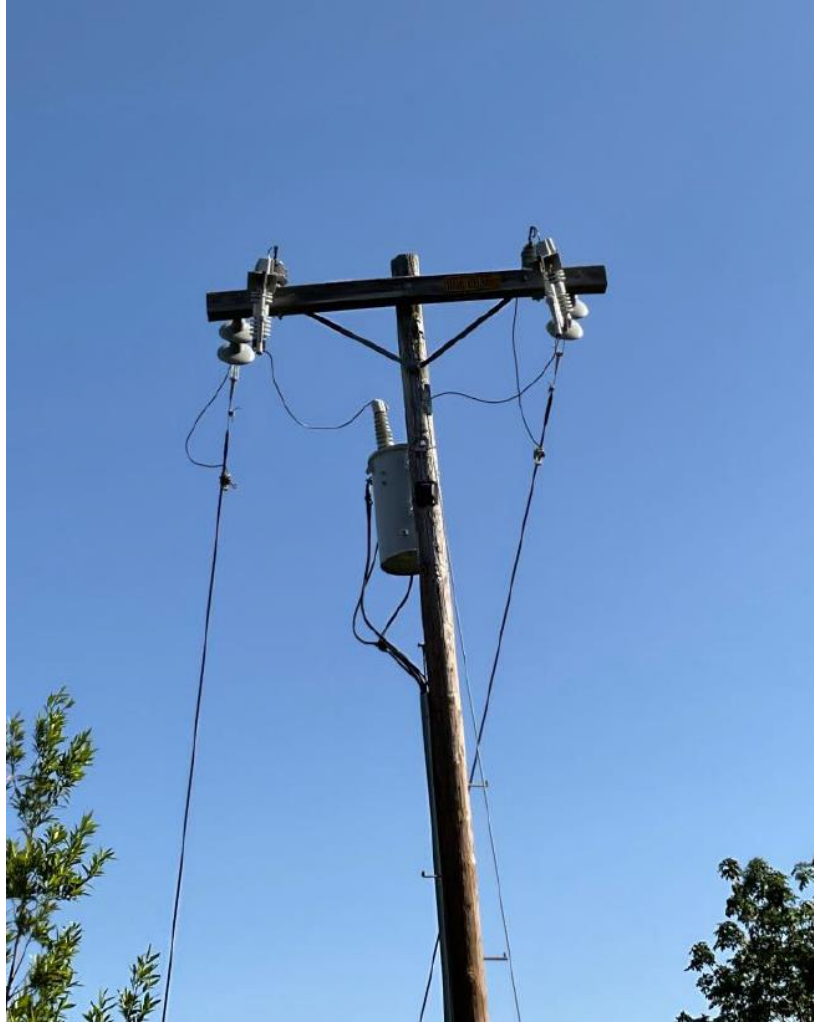
Figure 3 – Inspector photo taken May 23, 2022 of pole top.

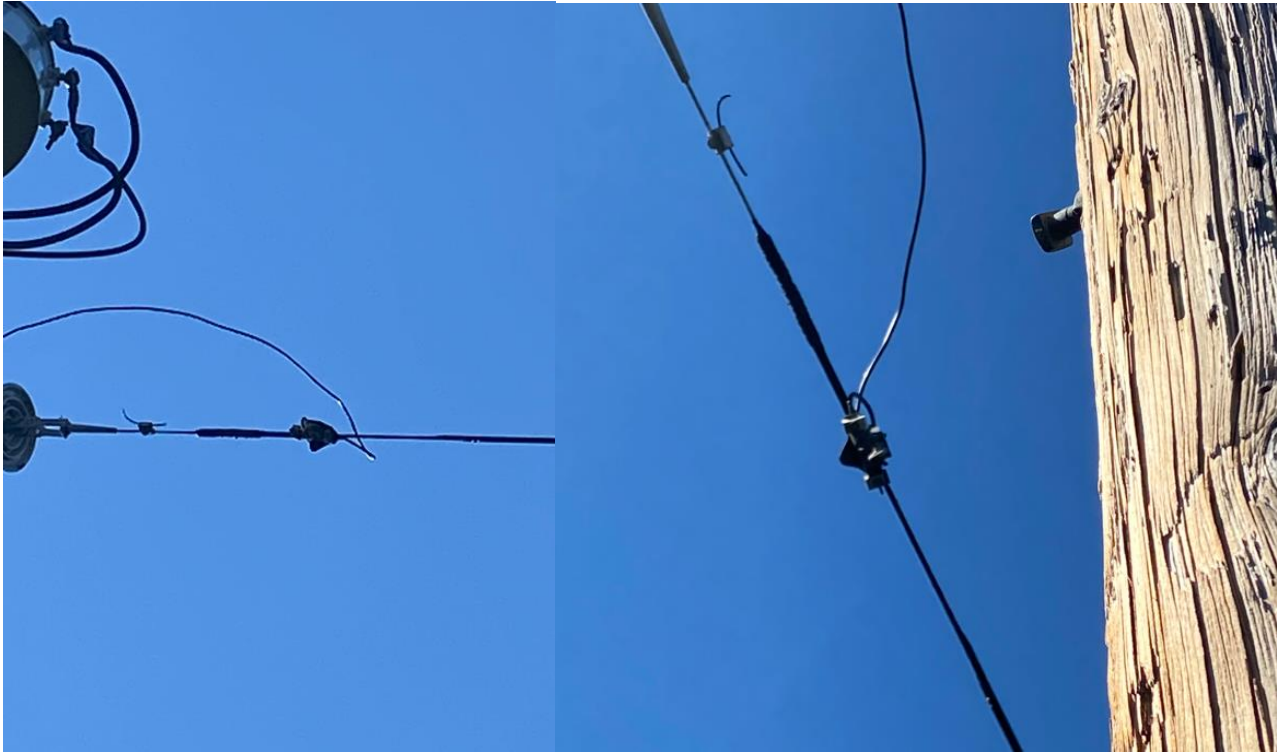
The troubleshooter located a no-good tree wire type conductor, with a plastic coating that had melted due to a bad connection at the tap clamp. A tap clamp is also referred to as a piercing clamp as it has teeth like features which are meant to pierce through the conductor to make a secure connection. The unsecure connection caused arcing to occur at the Incident Location. As the plastic coating on the conductor melted, the burning slag fell to the ground igniting a vegetation fire.

Figure 4 – Troubleshooter photo of failed connection on August 28, 2024.

A corrective notification was created as a priority "A" tag (EC Notification #129450401). The work order requested repairs to the conductor and replaced the tap clamps on the tree wire. A repair crew was onsite on August 28, 2024 and replaced the cut-out connections, the fuses to 6 amp ELF's (Eaton Cooper Power Series, Current-Limiting Drop out Fuse) and replaced bolt covers. Their final step was to close fuse 99309 which occurred at 2237 hours restoring service to the 24 affected customers.

A priority “A” tag, EC Notification 129450401 was created to replace a failed connector at SAP ID 102032629. A PG&E repair crew responded to the corrective tag on August 28, 2024 where the cut out connections were replaced, along with bolt covers. The fuses were updated to 6 Amp ELF fuses.

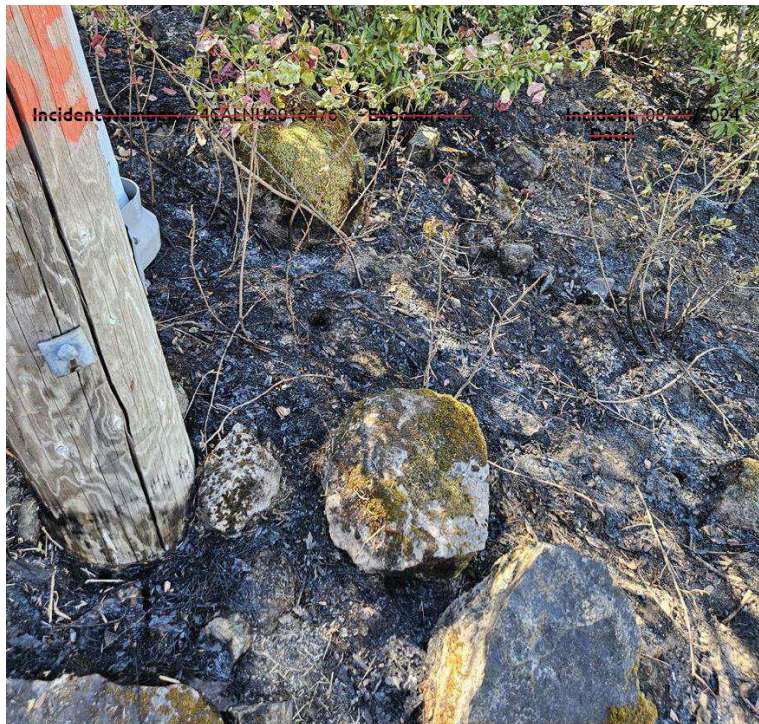
Figure 5 – Fire footprint near pole, photo provided by CAL FIRE.

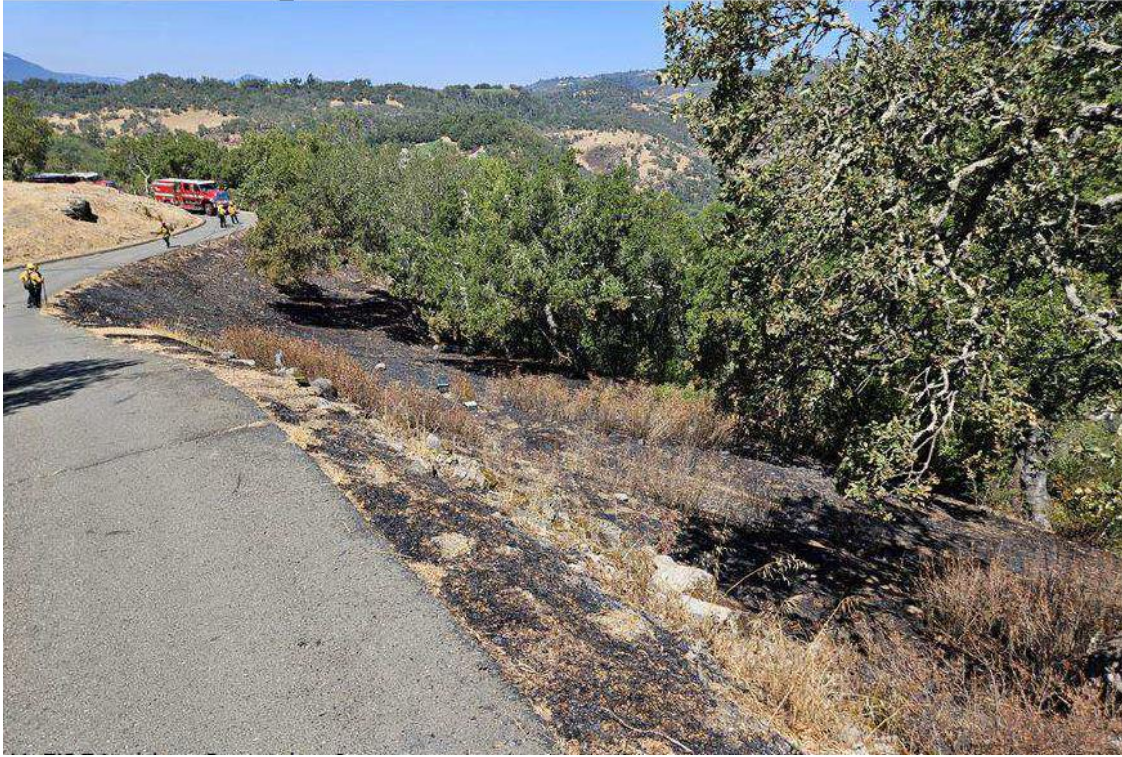
The incident burned dry grasses along with brush at the incident pole. The fire footprint was under one acre in size, totaling 0.63 acres. CAL FIRE responded and provided suppression efforts. The fire was fully extinguished at 1051 hours on August 28, 2024. An area outage related to this ignition affected 24 customers for 537 minutes.

Figure 6 – Overview of fire footprint, photo provided by CAL FIRE.

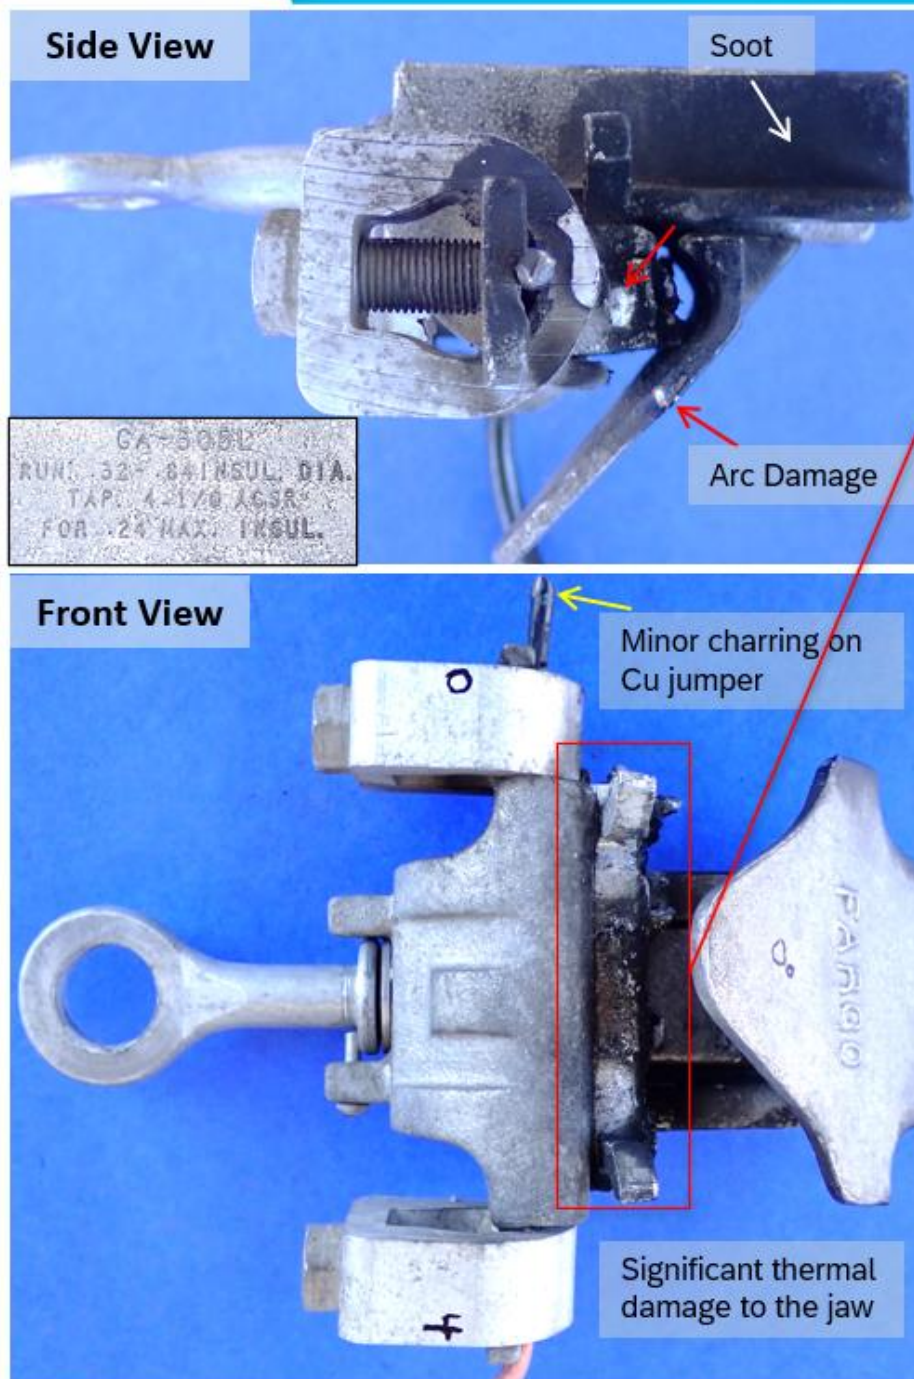
The failed tap clamp was collected by PG&E and sent to Applied Technology Services (ATS) for further analysis. ATS findings conclude a bad high-density polyethylene (HDPE) conductor melted due to a failed tap clamp. The tap clamp was installed on a HDPE conductor. The HDPE conductor has a thick black coating which was designed to use in areas that are vegetated and required a tree wire. Due to the thick plastic-like coating on the conductor, the tap clamp "jaws" could not properly pierce through the conductor, allowing current to flow through the clamp and conductor. The piercing teeth on the clamp either bent or became worn down likely due to the hardness of the HDPE cover and wore down during the failure. Once the clamp reached the end of its lifecycle, arcs occurred through the clamp and conductor, causing the plastic coating on the HDPE wire to drop to the ground, creating a heat source for ignition.

Figure 7 – Tap clamp photo provided by ATS, showing damage.

Several teeth are bent at various levels

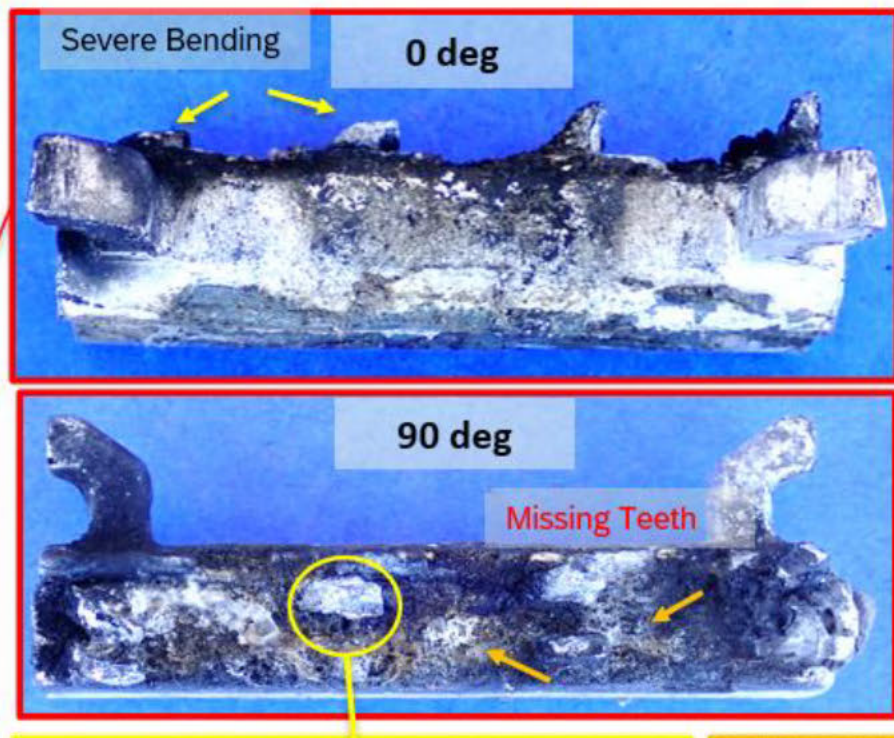
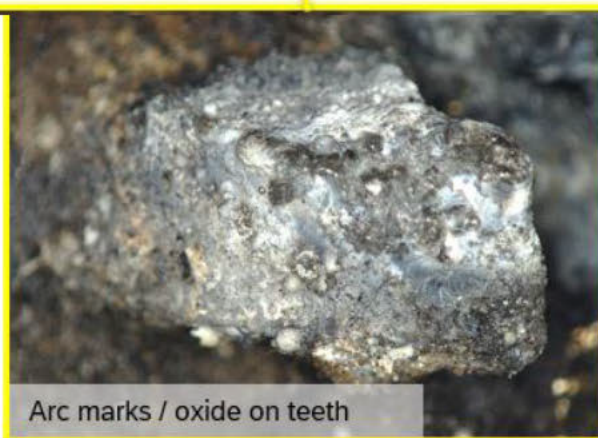
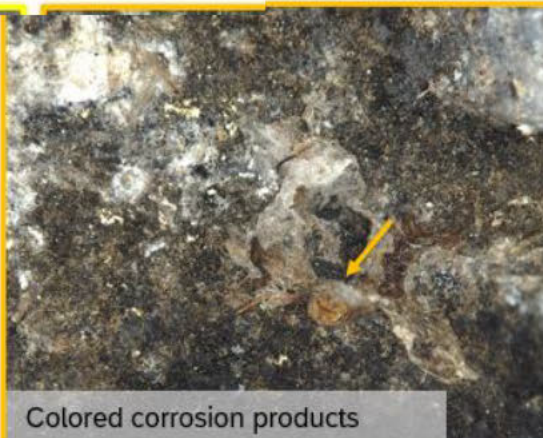
The Asset Failure Analysis (AFA) team also investigated this incident, confirming that the piercing of the insulation may have not been adequate, which resulted in resistance contact. The series fault or high resistance connection created a thermal rise at the location that may have led to series arcing and/or covered conductor insulation ignition. AFA also identified the transformer as showing continual summer overload with a max in July 2024 of 170% overload, which may have also contributed to the failure.

Figure 8 – Tap clamp photo showing defects, photo provided by ATS.

HDPE wire is no longer allowed for new installations as of 2018 per PG&E standards. The current method of connector installation for approved connectors states that the plastic coating must be stripped at the connection point, so any connections have a secure connection that will not be compromised.
