Preliminary Ignition Investigation Report

Ignition Database Index:	20240704
Electric Incident Investigation (EII) Number:	N/A
Incident Name:	N/A
PG&E Facility Ignition?	Yes
CPUC Reportable Ignition?	Yes
Date & Time of Incident:	June 20, 2024 @ approximately 1937 hours
Street Address:	[REDACTED]
City:	Glen Ellen
County:	Sonoma
Latitude/Longitude:	[REDACTED]
State Responsibility Area (SRA) / Local Responsibility Area (LRA) / Federal Responsibility Area (FRA)	State Responsibility Area
PG&E Division:	Sonoma
High Fire Threat District (HFTD):	Tier 3
High Fire Risk Area (HFRA):	Yes
EPSS Buffer:	No
Fire Index Area (FIA):	180
Fire Potential Index (FPI) Rating: FIA	R1
Fire Potential Index (FPI) Rating: Circuit	R1
Was there a PSPS event at the time of ignition?	No
Suspected Initiating Event:	Equipment – PG&E
Failure Driver:	All types of equipment/facility failure
Failure Sub-driver:	Conductor failure – all
Circuit:	Dunbar 1101 12kV
Circuit Protection Zone:	LR 49556

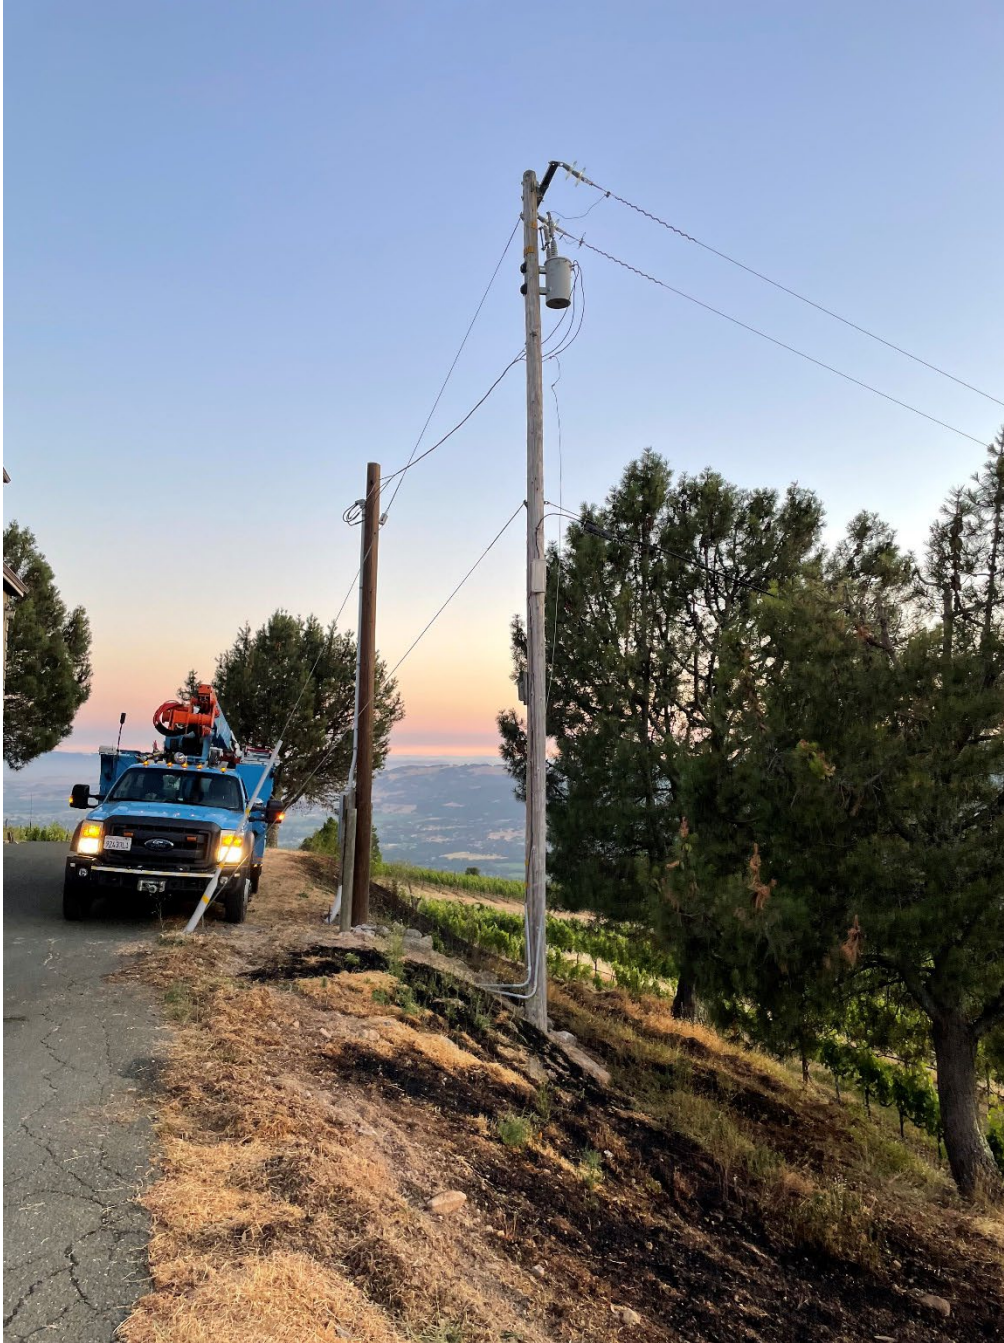
The ignition was isolated to the dry, grassy vegetation at the base of Pole #1, leaving a burn scar approximately 50-feet x 30-feet in size. There were no reports of injuries, fatalities, or property damage. The incident happened on the hot leg/neutral beneath the pole mounted transformer of a pole serving one customer who was impacted for 214 minutes.

Figure 2 Burn scar at the base of Pole #1, photo facing east. Photo taken by troubleshooter on June 20, 2024.

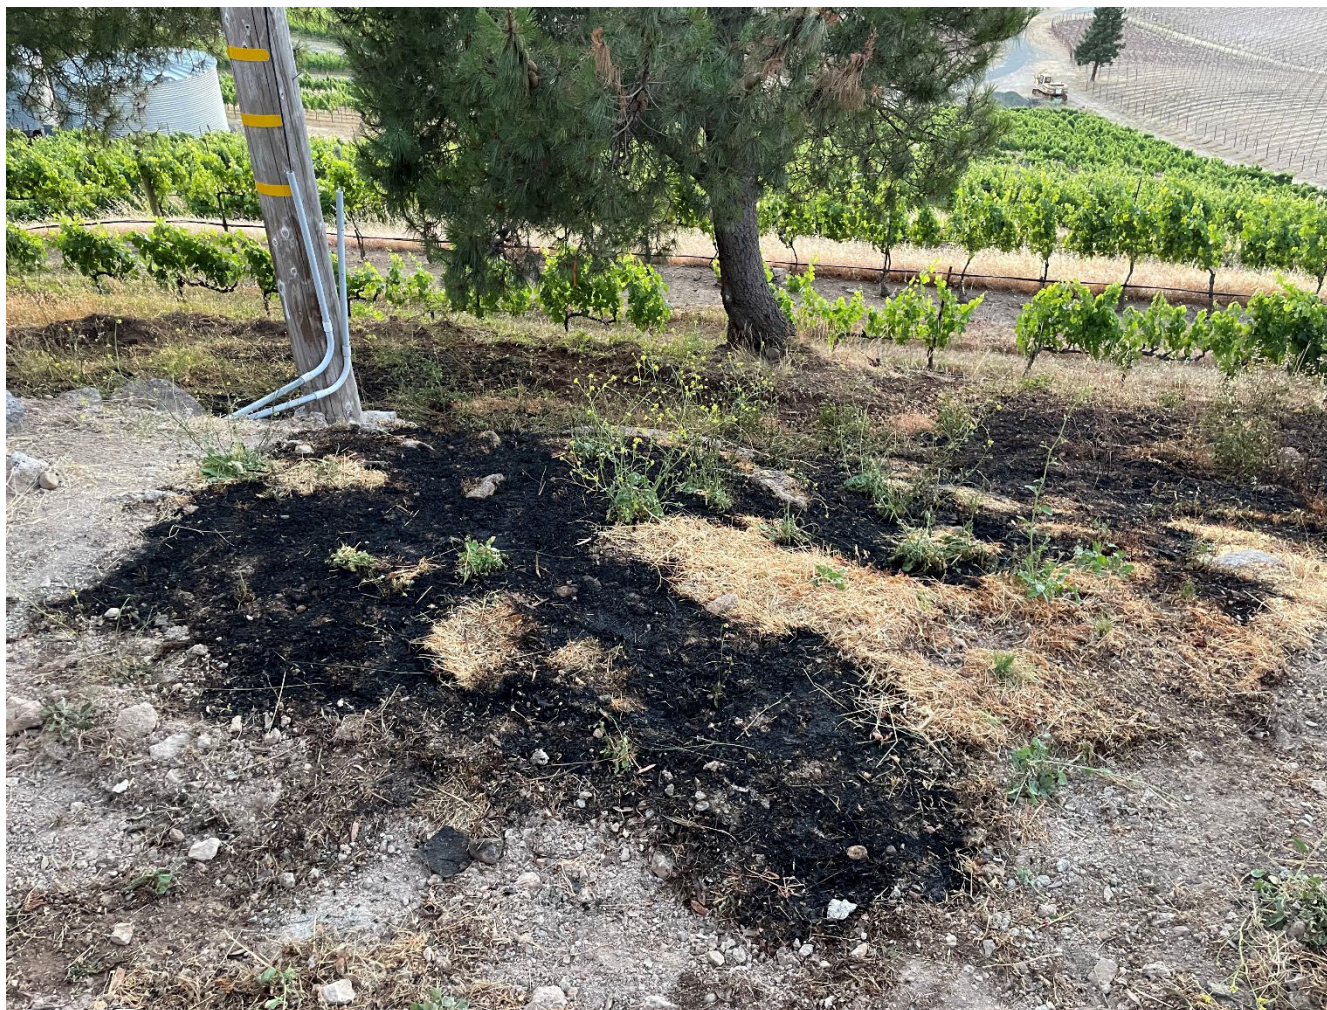
Figure 3 Burn scar at the base of Pole #1. Photo facing south, taken by troubleshooter on June 20, 2024.

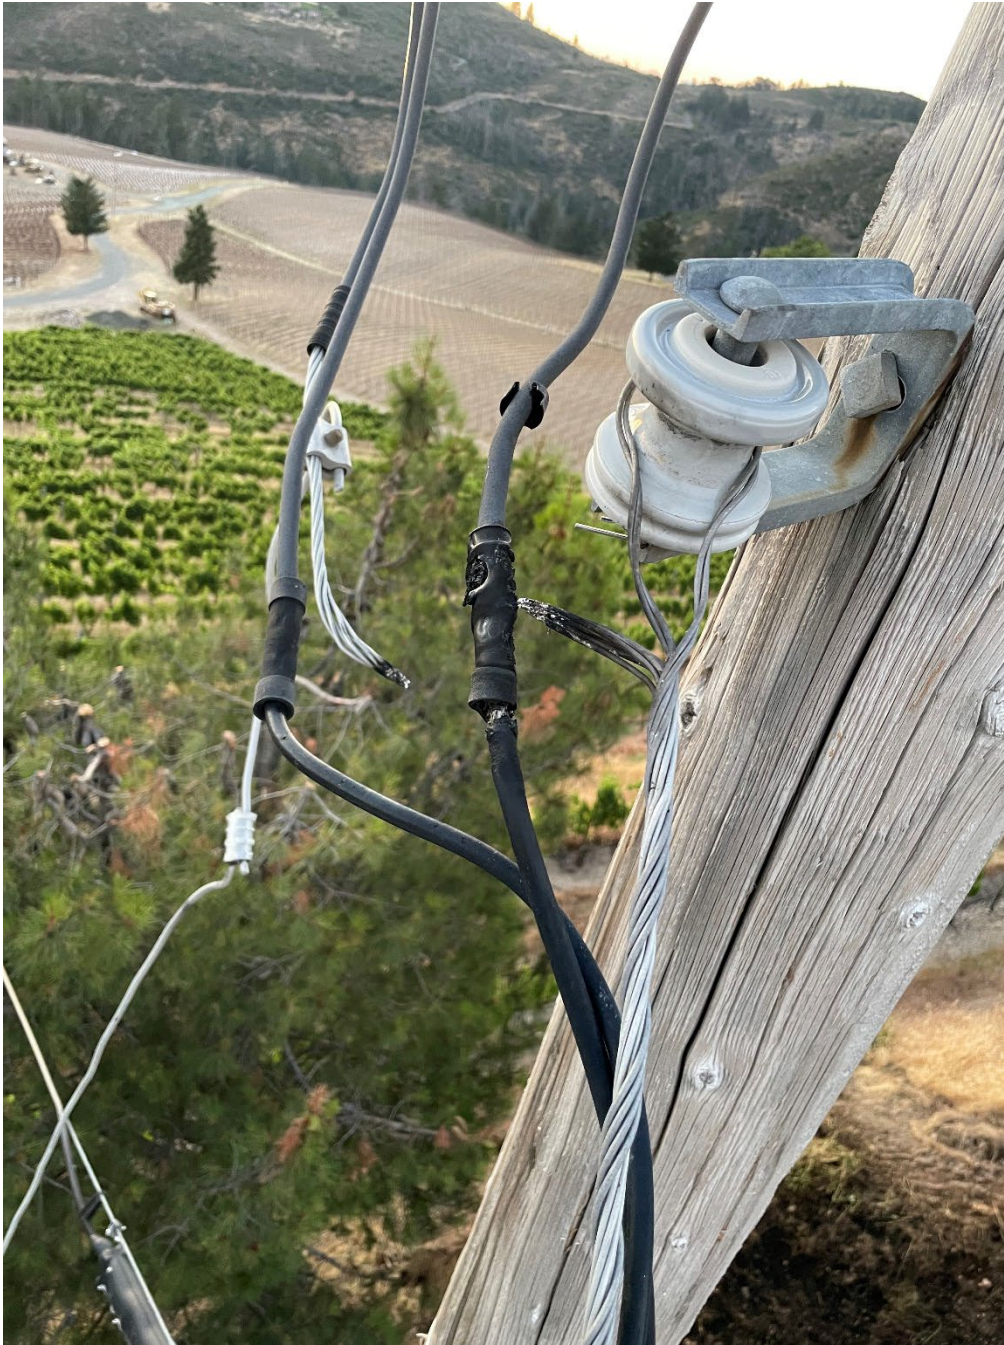
The incident and failure were reviewed by an Asset Failure Analysis (AFA) engineer. AFA concluded that due to a lack of air gap between the impacted hot leg/conductor and neutral messenger, the two components rubbed against each other over the course of several years. The friction from the consistent contact allowed the polymer coating covering the hot leg to become compromised, exposing the conductor underneath. Once the conductor was exposed, the metal components came into contact with the aluminum neutral, creating short circuit/arcing conditions.

The failed hot leg (See Figures 4-6, 8) and failed neutral (See Figures 4-6, 9) were collected and sent to Applied Technology Services (ATS) to be analyzed by an engineer. The surface ignition is likely caused by dripping of molten material from the failed connector (polymer coating) on the triplex hot leg. A visual inspection of the service wire (hot leg) shows significant thermal damage near the sleeve (polymer coating) connector on one of the hot legs. The exposed conductor of the hot leg appears to have made short contact with the neutral messenger which melted the messenger conductor (See Figures 4-6).

Figure 4 Damaged neutral and hot leg. Photo taken by troubleshooter on June 20, 2024.

The responding troubleshooter replaced the damaged neutral and hot leg while they were onsite, working off of the FAS trouble report (#T006425117), on June 20, 2024.

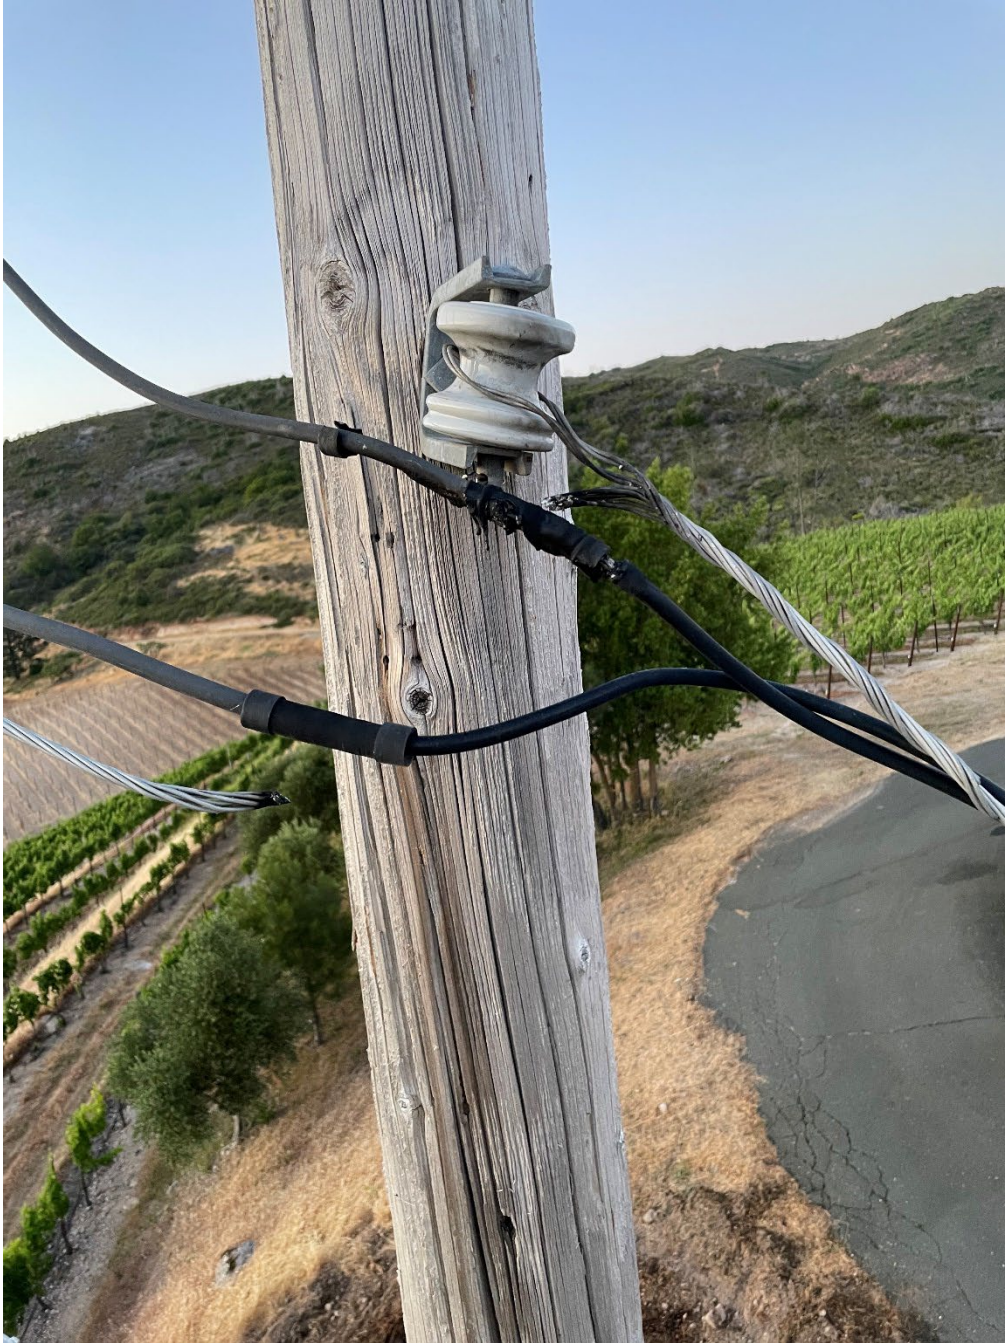
Figure 5 Damaged neutral and hot leg. Photo taken by troubleshooter on June 20, 2024.

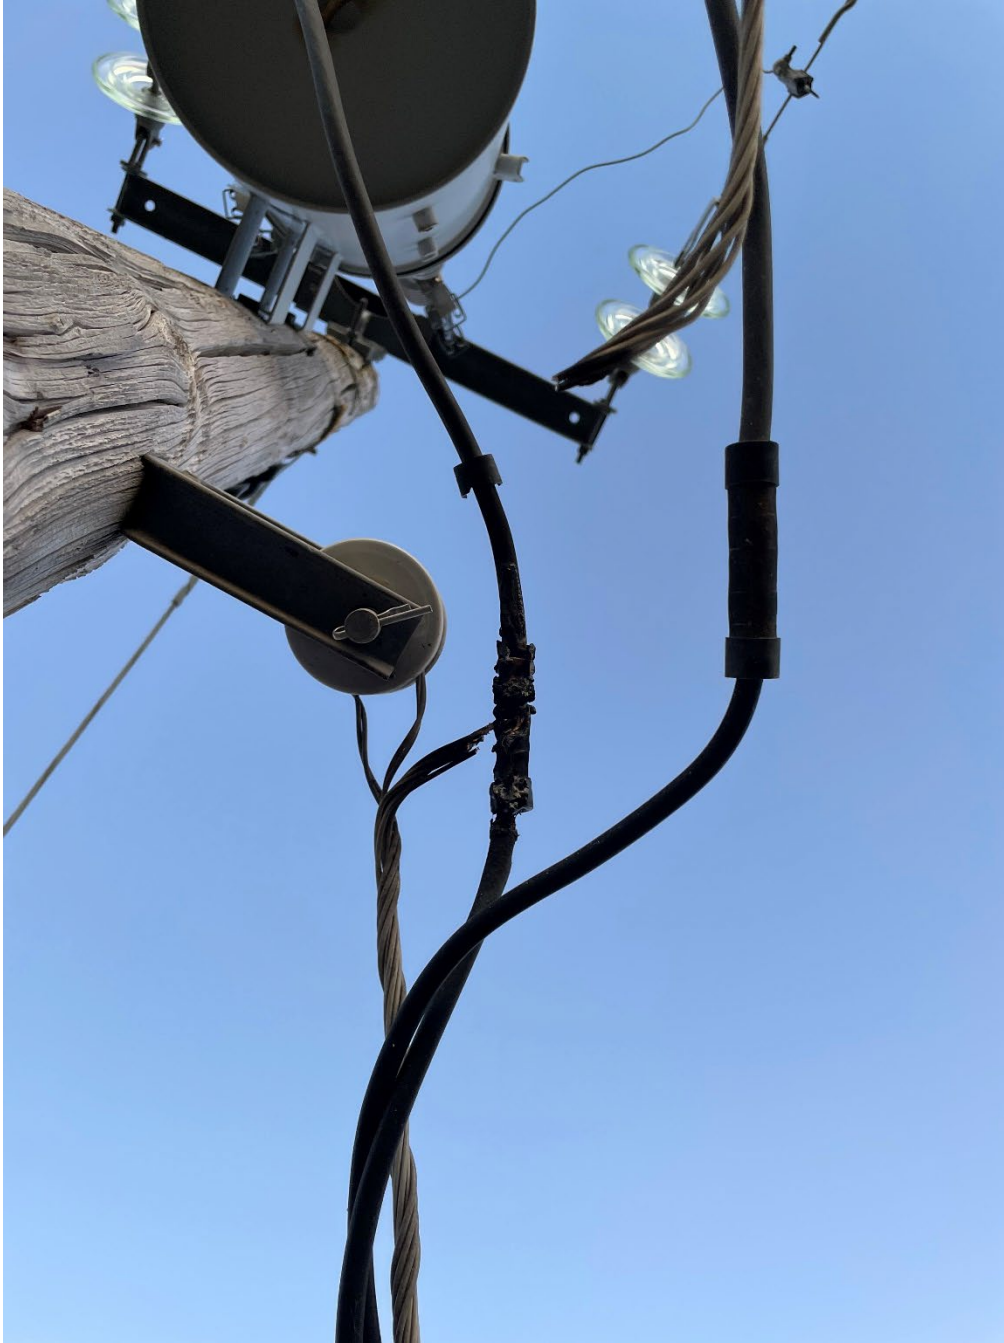
Figure 6 Photo looking up at damaged equipment on Pole #1. Photo taken by troubleshooter on June 20, 2024.

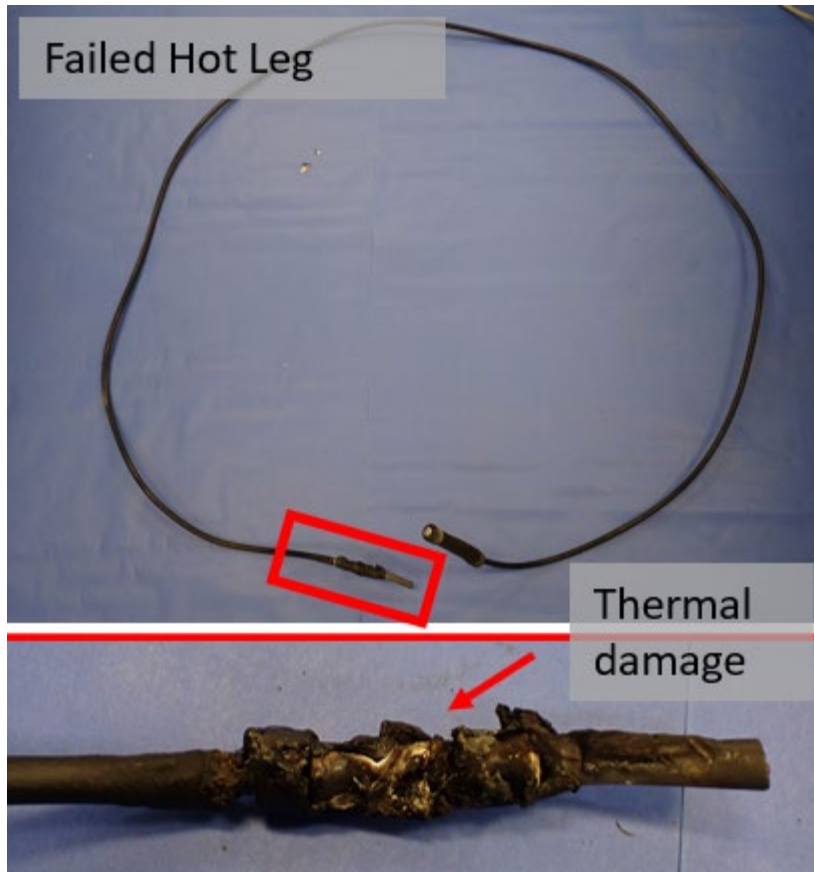
Figure 8 Failed hot leg. Photo taken at ATS by engineer who analyzed the incident.

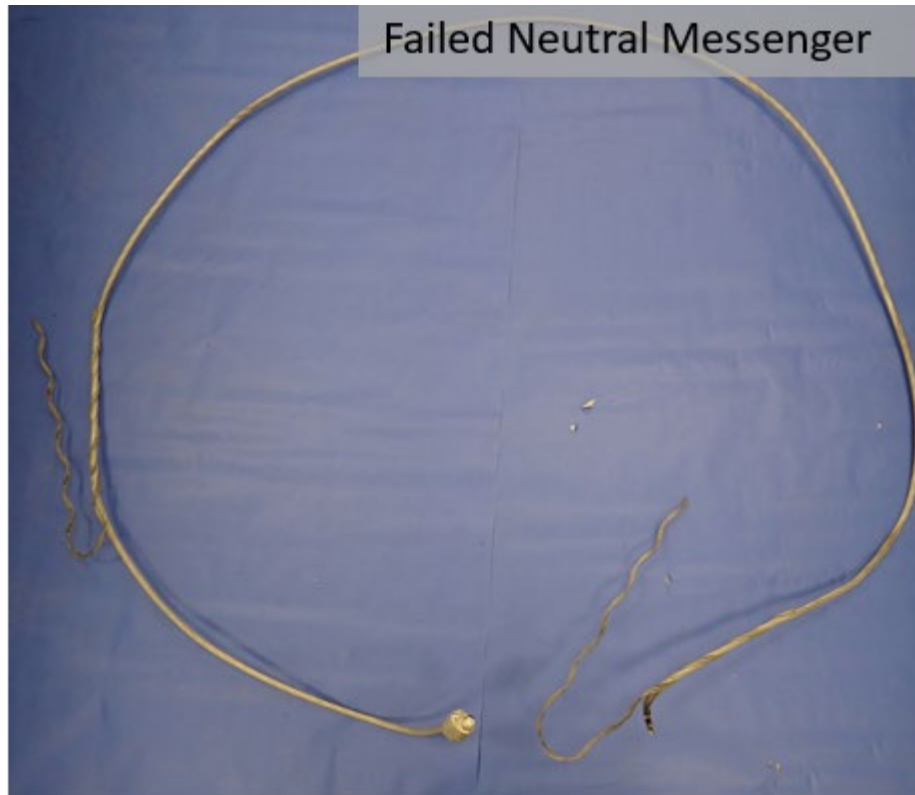
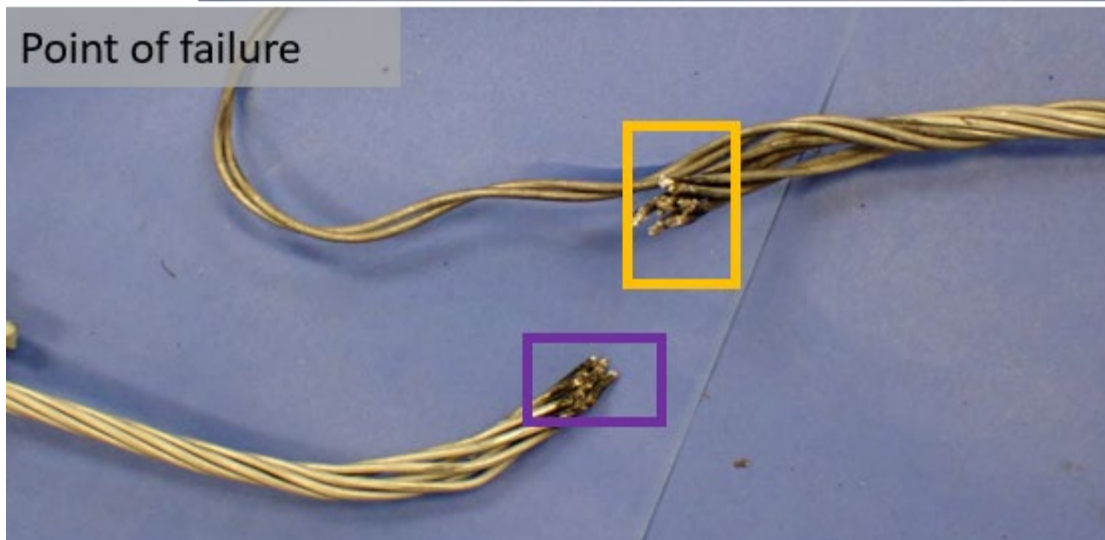
Figure 9 Failed neutral messenger. Photo taken at ATS by engineer who analyzed the incident.
