Preliminary Ignition Investigation Report

Ignition Database Index:	20240133N
Electric Incident Investigation (EII) Number:	N/A
Incident Name:	Highland - 27 Feb 2024
PG&E Facility Ignition?	Yes
CPUC Reportable Ignition?	Yes
Date & Time of Incident:	February 27, 2024 @ 1245 hours
Street Address:	Vicinity of Ridgecrest Place and Hillcrest Place
City:	Nipomo
County:	San Luis Obispo
Latitude/Longitude:	35.085381 -120.476268
State Responsibility Area (SRA) / Local Responsibility Area (LRA) / Federal Responsibility Area (FRA)	State Responsibility Area (SRA)
PG&E Division:	Los Padres
High Fire Threat District (HFTD):	Tier 2
High Fire Risk Area (HFRA):	Yes
EPSS Buffer:	No
Fire Index Area (FIA):	508
Fire Potential Index (FPI) Rating: FIA	R1
Fire Potential Index (FPI) Rating: Circuit	R1
Was there a PSPS event at the time of ignition?	No
Suspected Initiating Event:	Equipment - PG&E
Failure Driver:	All types of equipment / facility failure
Failure Sub-driver:	Conductor failure - all

Circuit:	Mesa 1101
Circuit Protection Zone:	Mesa 11016111
Nominal Voltage:	12kV
Pole SAP Equipment ID:	103405389
Subject to PRC 4292 Veg Pole Clearance:	No
PG&E Equipment associated with ignition:	Conductor - Prim

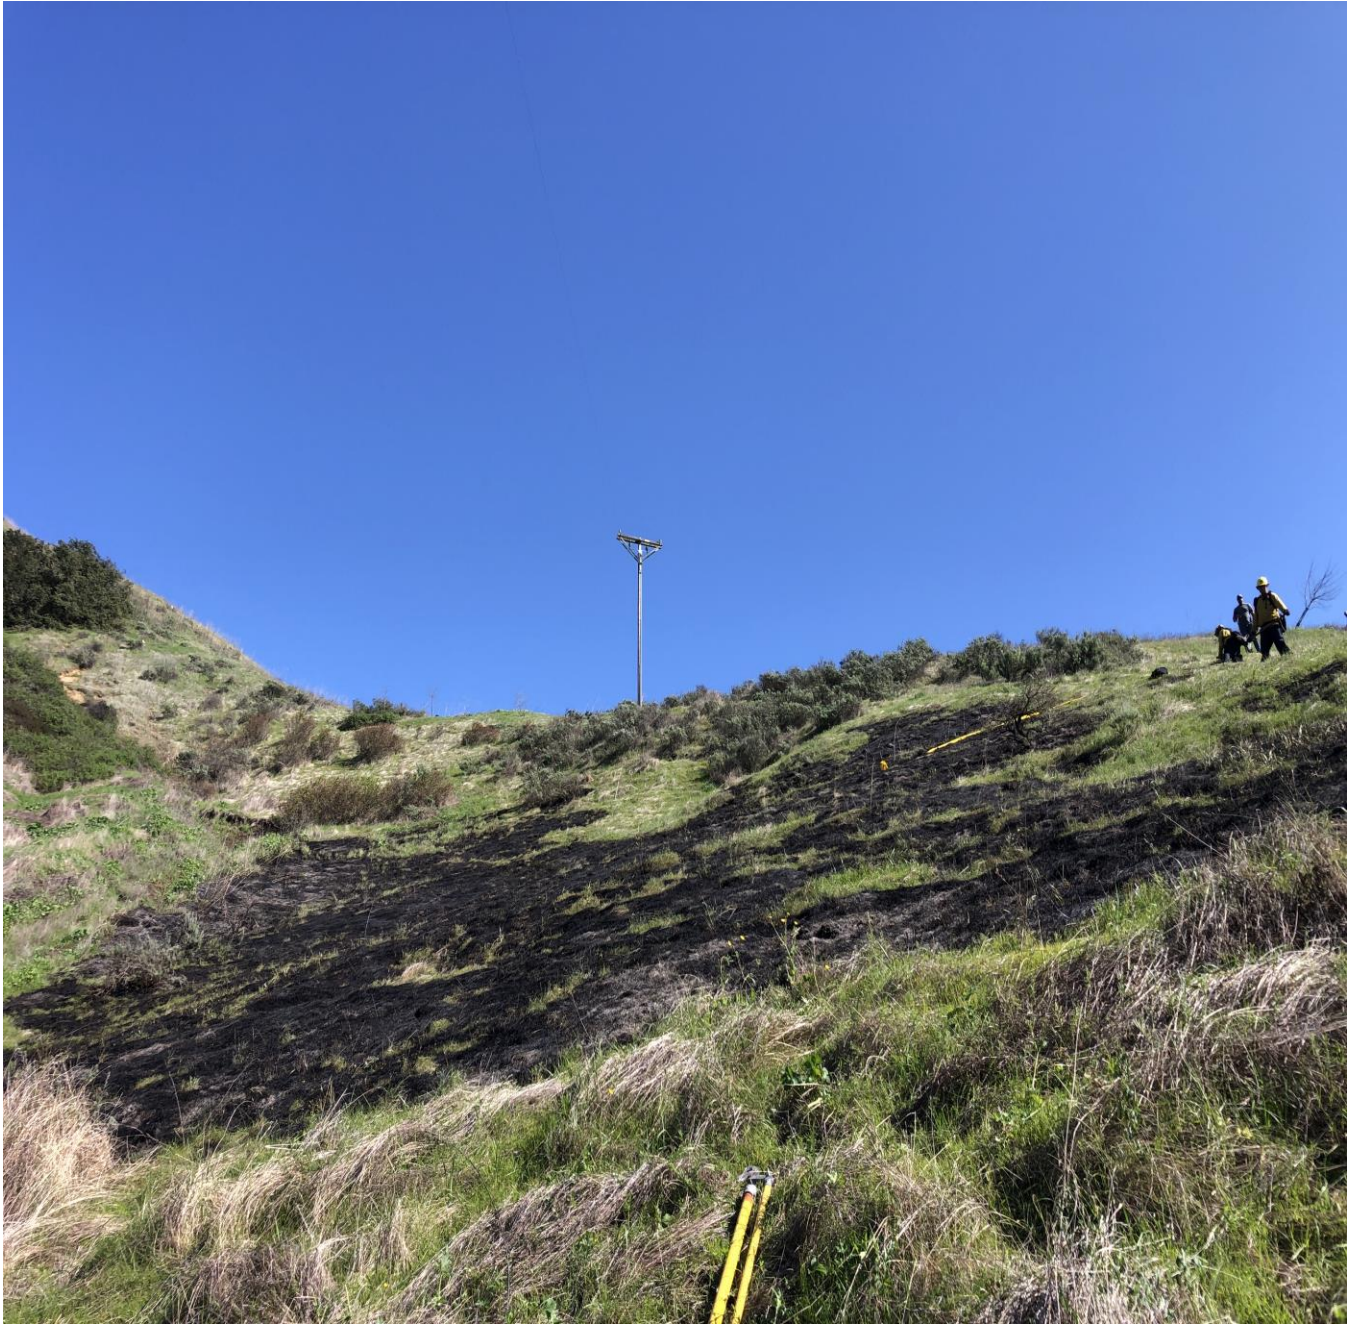
CAL FIRE responded to and extinguished the mostly self-extinguished approximately one-quarter acre fire known as the "Highland Fire" (See figures 2, 3, and 7).

Figure 2 - SAP Pole ID: 103405389 and burn scar area. Picture taken by the troubleshooter on February 27, 2024.

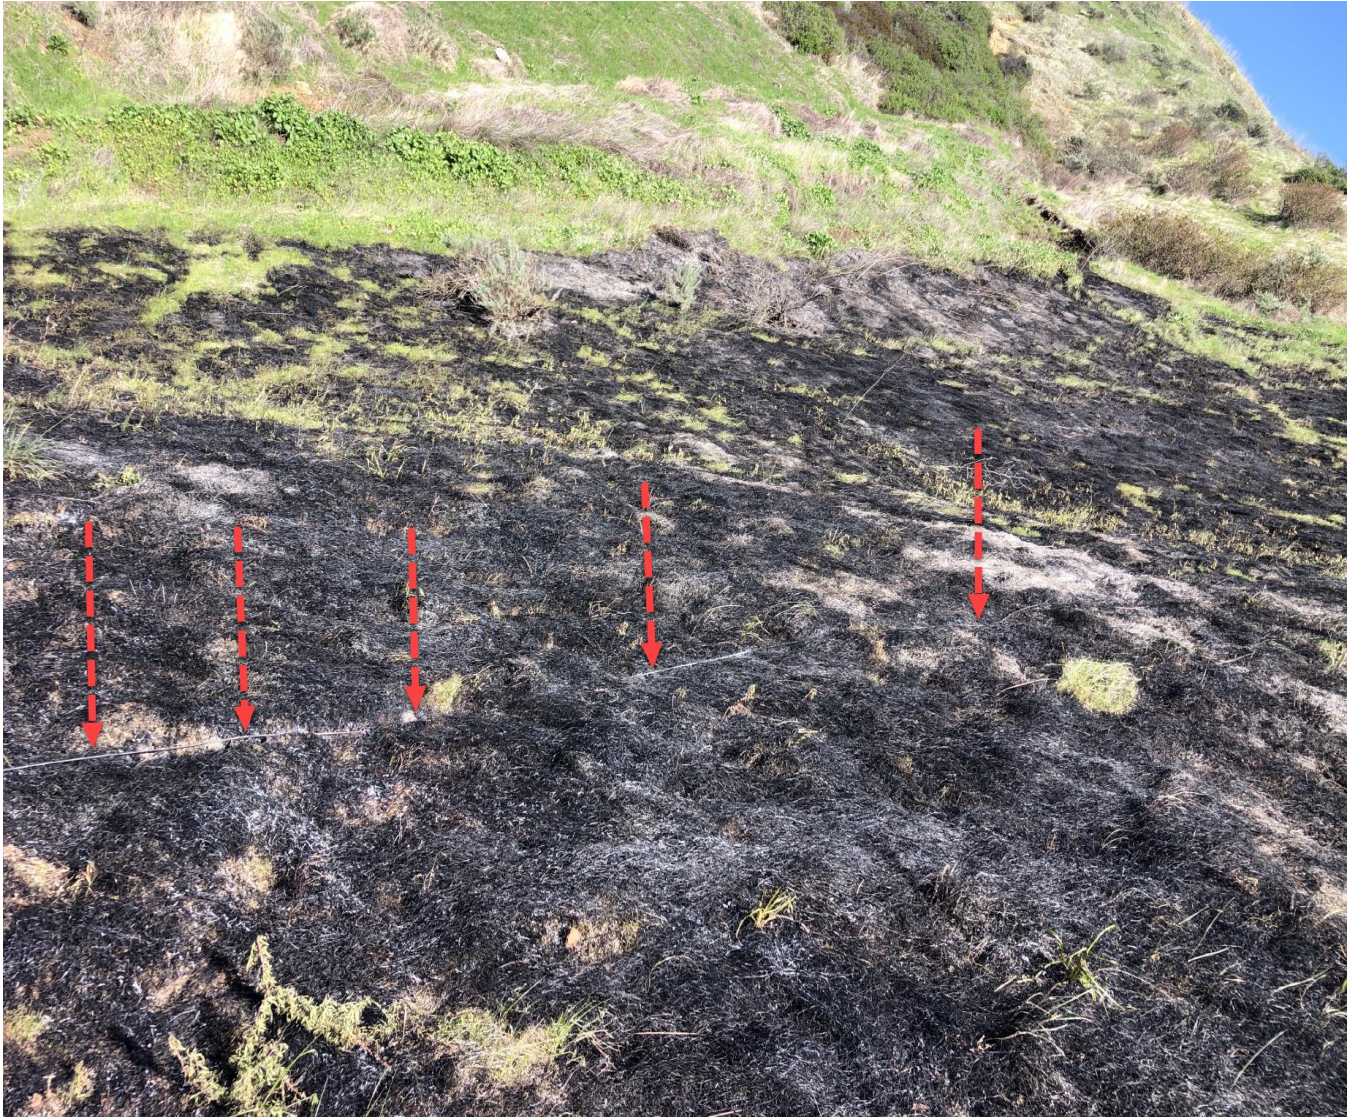
The troubleshooter traveled 0.55 miles to the west from the incident location and opened the jumpers at SAP Pole ID 101910542 to make the situation safe and isolate the trouble. The troubleshooter speculated that the ignition was caused by the number 6 copper overhead conductor that broke off at the automatic dead-end, which resulted in the still-hot conductor igniting the grass below (See figures 1, 3, and 4).

Figure 3 – Part of the burn scar area and one downed conductor phase of the Mesa 1101 12kV distribution circuit. Picture taken by the troubleshooter on February 27, 2024.

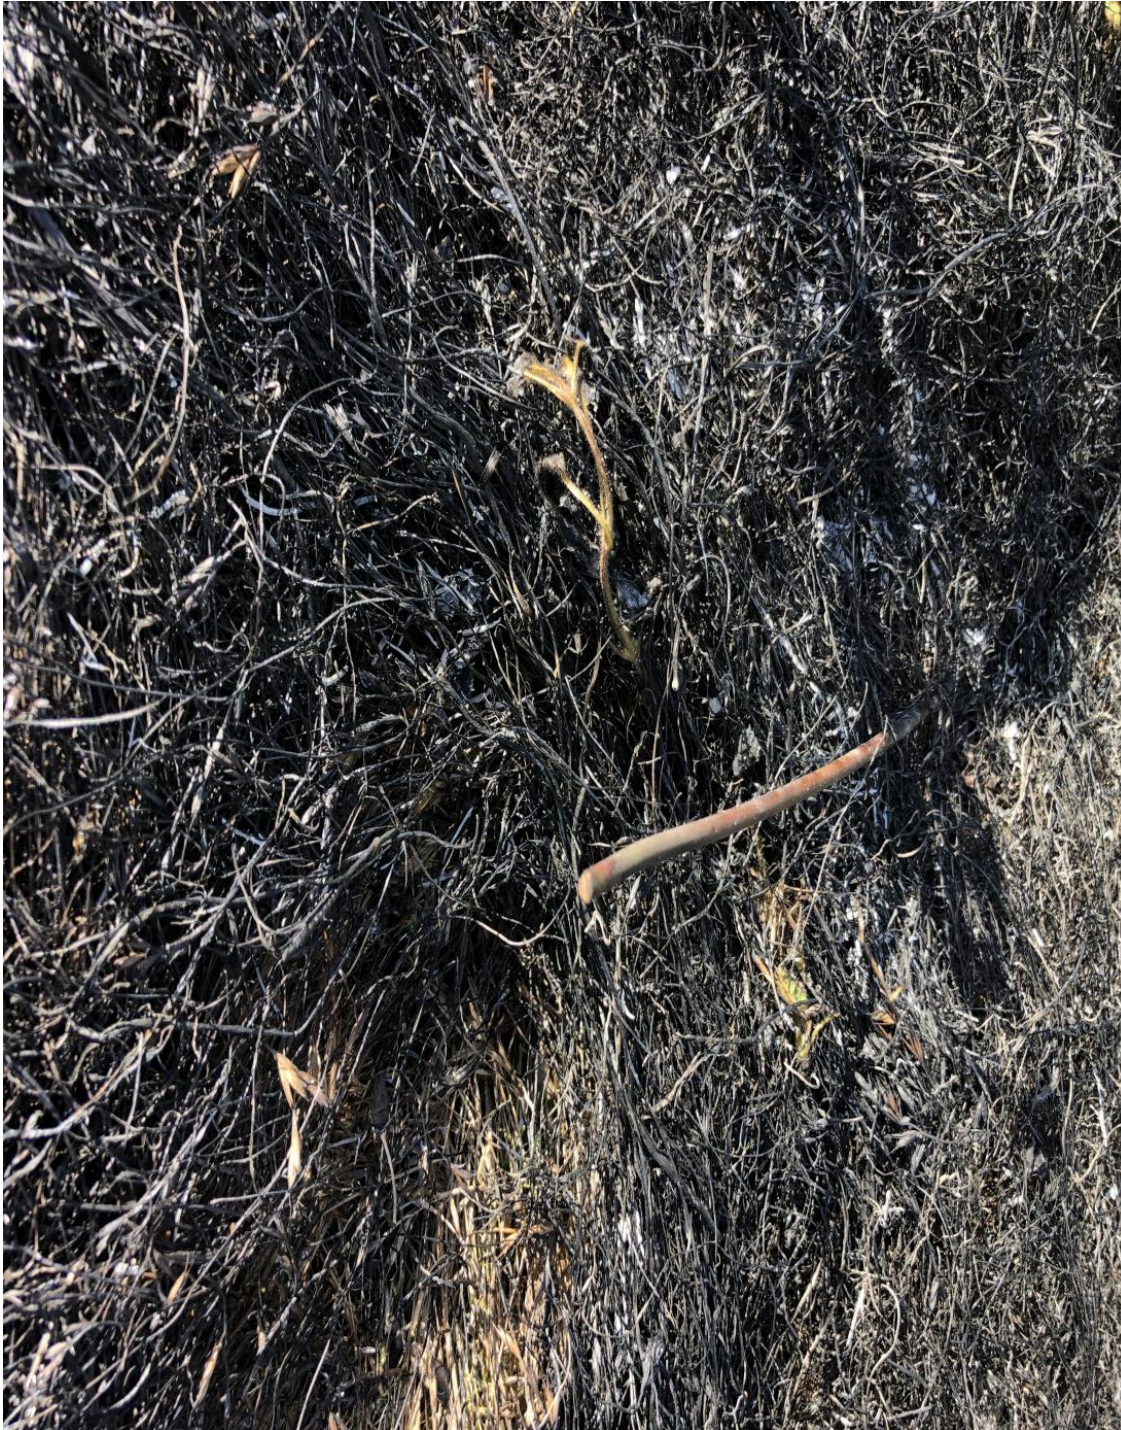
The PG&E troubleshooter arrived at the Incident Location (vicinity of Ridgecrest Place and Hillcrest Place) at approximately 1341 hours and observed a hot broken overhead number 6 copper conductor down on the ground source side of the automatic dead-end at SAP Pole ID 103405389, and a fire in the grass below (see figure 2). On the way to the Incident Location, he observed one (#2 position) of three phases blown open at the Trip Saver Recloser 6111 located about 1.6 miles to the southwest of the Incident Location.

Figure 4 – Source side downed conductor phase end of the Mesa 1101 12kV distribution circuit. Picture taken by the troubleshooter on February 27, 2024.

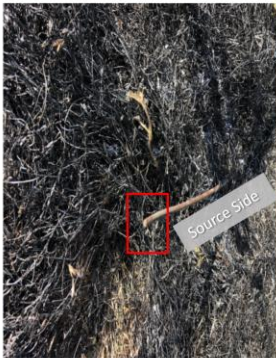
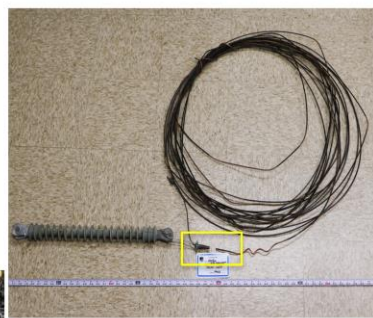
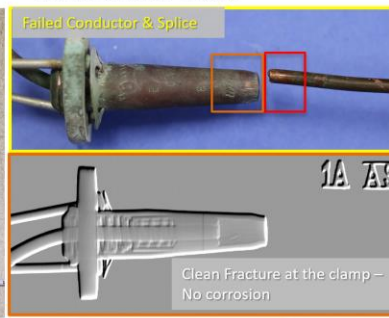
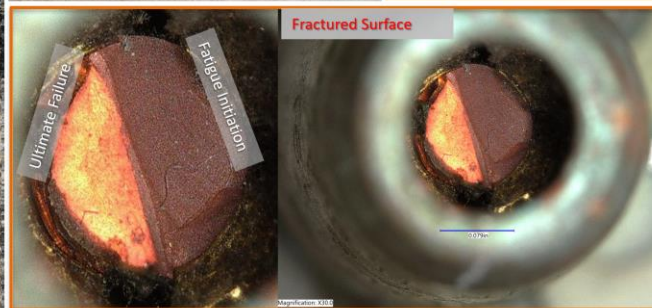
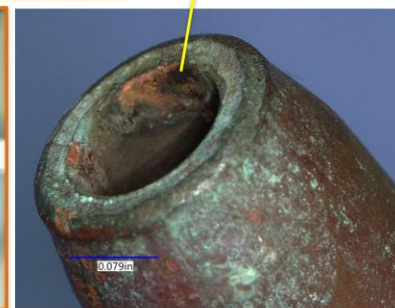
The Applied Technology Services (ATS) analysis determined that the failure of the number 6 copper conductor occurred at the automatic dead-end connector. The visual inspection of the damaged conductor shows a flat fracture consistent with mechanical fatigue (See figure 5).

The initial failure of the number 6 copper conductor occurred at the automatic dead-end connector. Examination of the damaged conductor revealed a flat fracture consistent with mechanical fatigue. Inside the conductor, patterns indicative of fatigue fracture development leading to ultimate failure were observed. X-ray imaging of the connector did not reveal substantial corrosion or material loss. Analysis of the historical span geometry suggests that the conductor was likely over-tensioned at the time of the incident, due to the need to achieve the correct sag over the long span length exceeding 1,300 feet. Additionally, the absence of vibration dampeners contributed to excessive line swaying, compounding the stress on the conductor. Tensile stress testing did not show material issues related to embrittlement.

Figure 5 - The failure of the #6 copper conductor occurred at the automatic dead-end connector. The visual inspection of the damaged conductor shows flat fracture consistent with mechanical fatigue. Slide taken from the ATS Summary-Mesa 1101 Conductor Analysis.

An Electric Corrective (EC) A-Tag (#128221361) was submitted for remediation, including the repair of approximately 1,000 feet of the number 6 copper conductor and the installation of a new number 6 copper dead-end clamp. The material was collected by the repair crew and retained for further analysis by ATS (See figure 5).

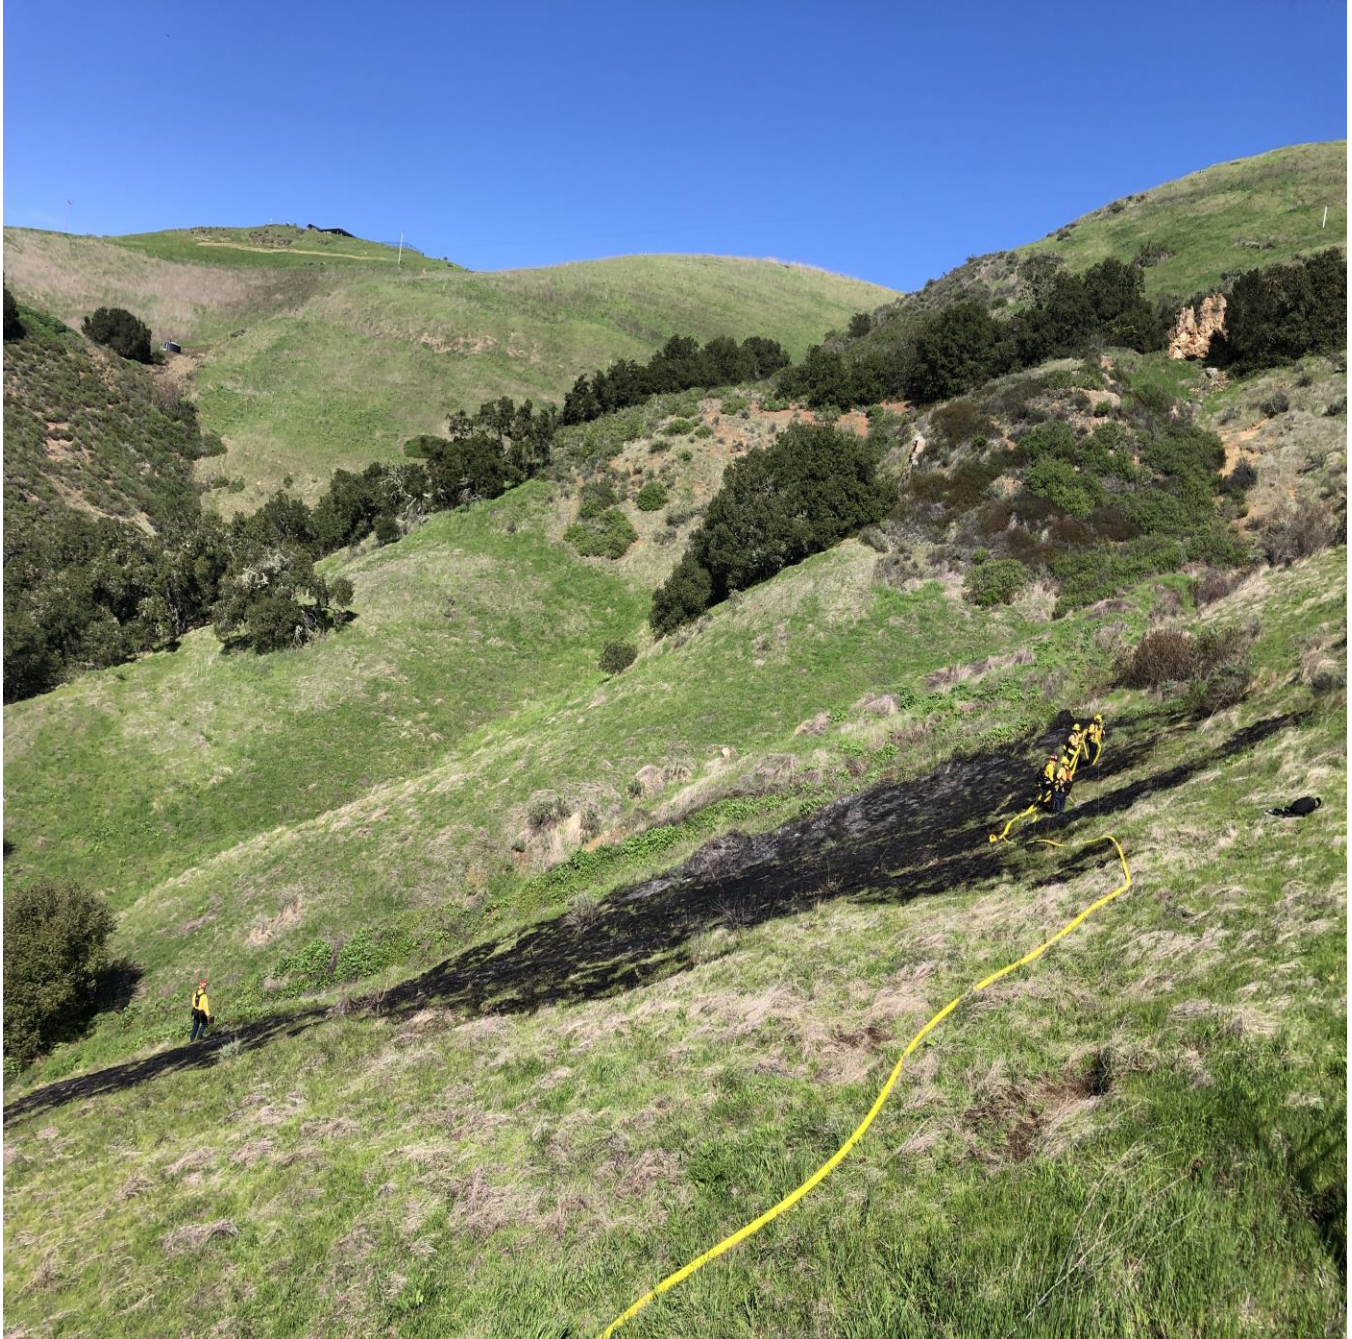
Figure 7 - CAL FIRE San Luis Obispo responded to and extinguished the mostly self-extinguished approximately one-quarter acre fire known as the "Highland Fire." Picture taken by the troubleshooter on February 27, 2024.

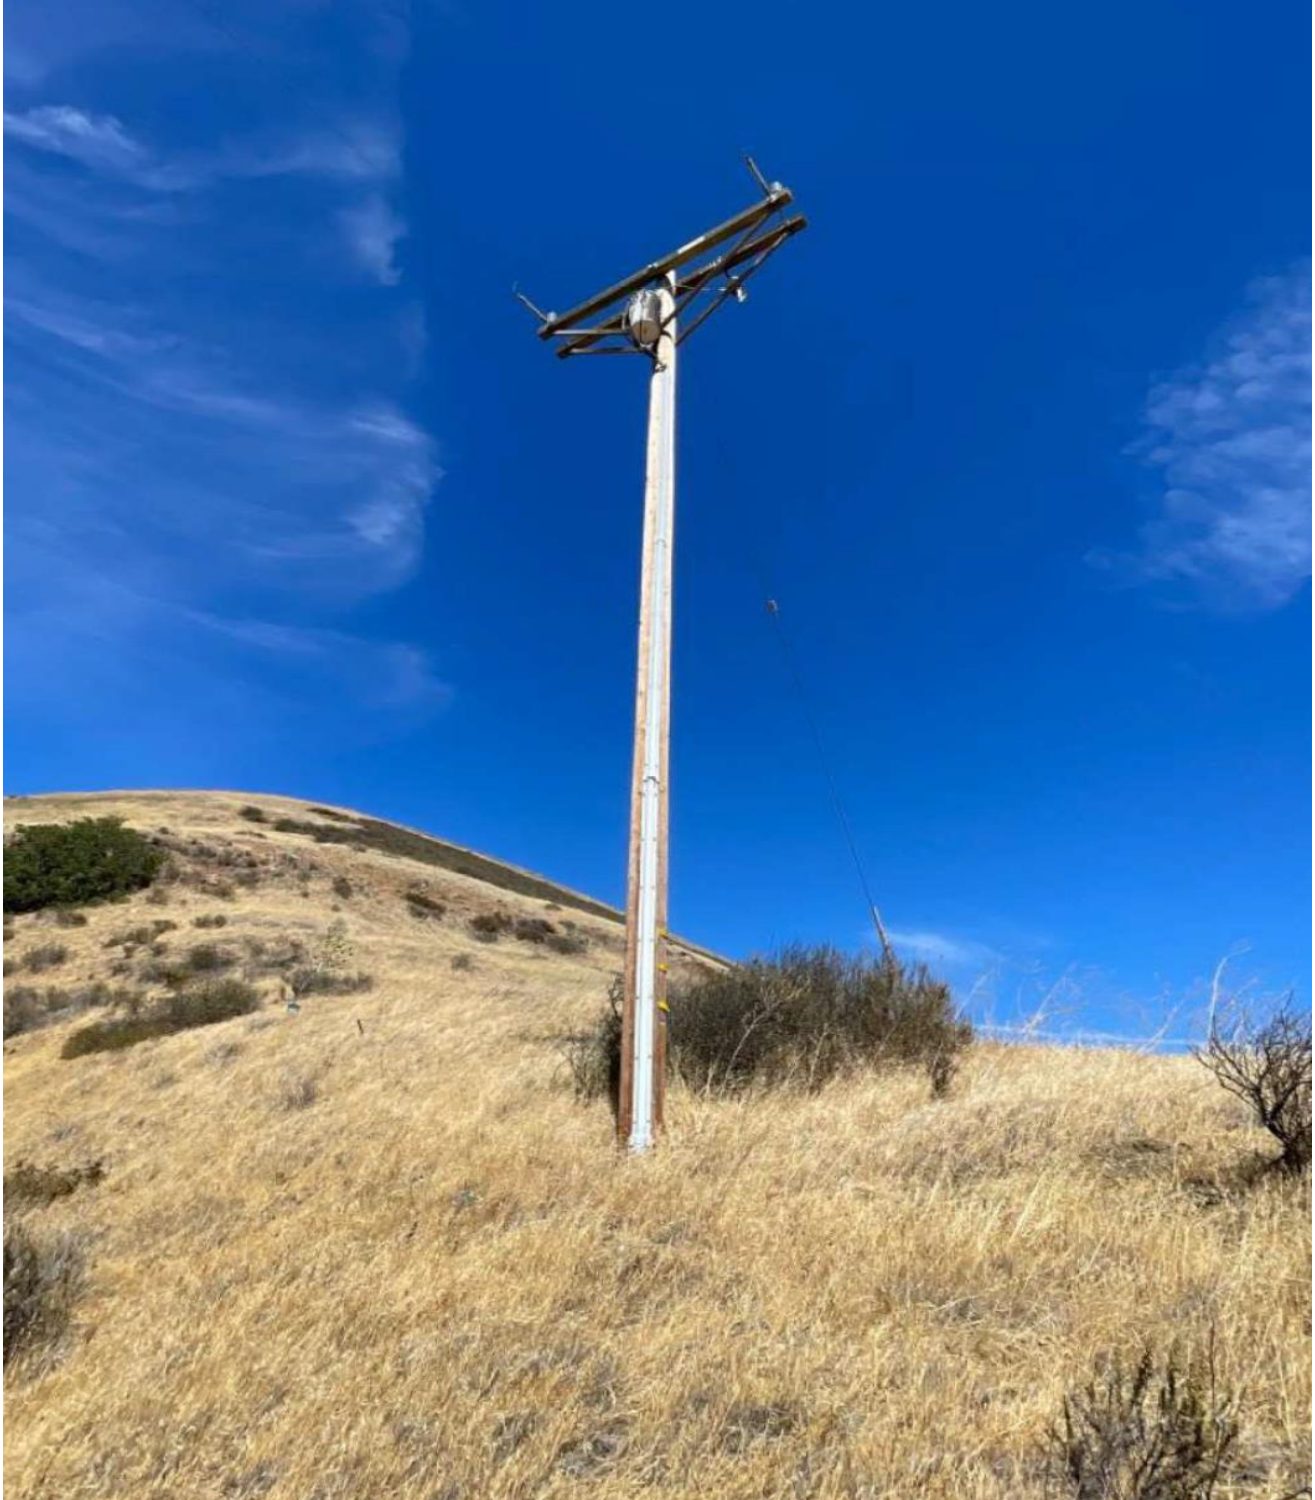
Source Side Structure SAP Pole ID: 103405389		
Info / Inspection	Most Recent Date	Findings
Install Date:	January 01, 1998	Douglas Fir, Class Unknown – 45-foot tall
Inspection:	June 15, 2021	GO165 Inspection identified one priority “E” EC tag that was created. EC tag (#121538856) was created for clearance/adjustment of the jumper. This work was completed on January 22, 2022.
	July 08, 2022	GO165 Inspection identified no compelling or abnormal conditions during this inspection. EC tag (#121538856) was still pending on this date (See figure 7).
Patrol:	N/A	
Corrective History:	February 27, 2024	A priority “A” EC tag was created. EC tag (#128221361) was created for a broken conductor repair. This work was completed on February 28, 2024.
Aerial Inspection Records:	May 01, 2019	Sharper Shape Aerial Imagery – identified no compelling or abnormal conditions of this pole and equipment (See figure 8).
VM Inspection:	N/A

Figure 8 - SAP Pole ID: 103405389 - Picture taken from the GO165 Inspection record that was completed on July 08, 2022.

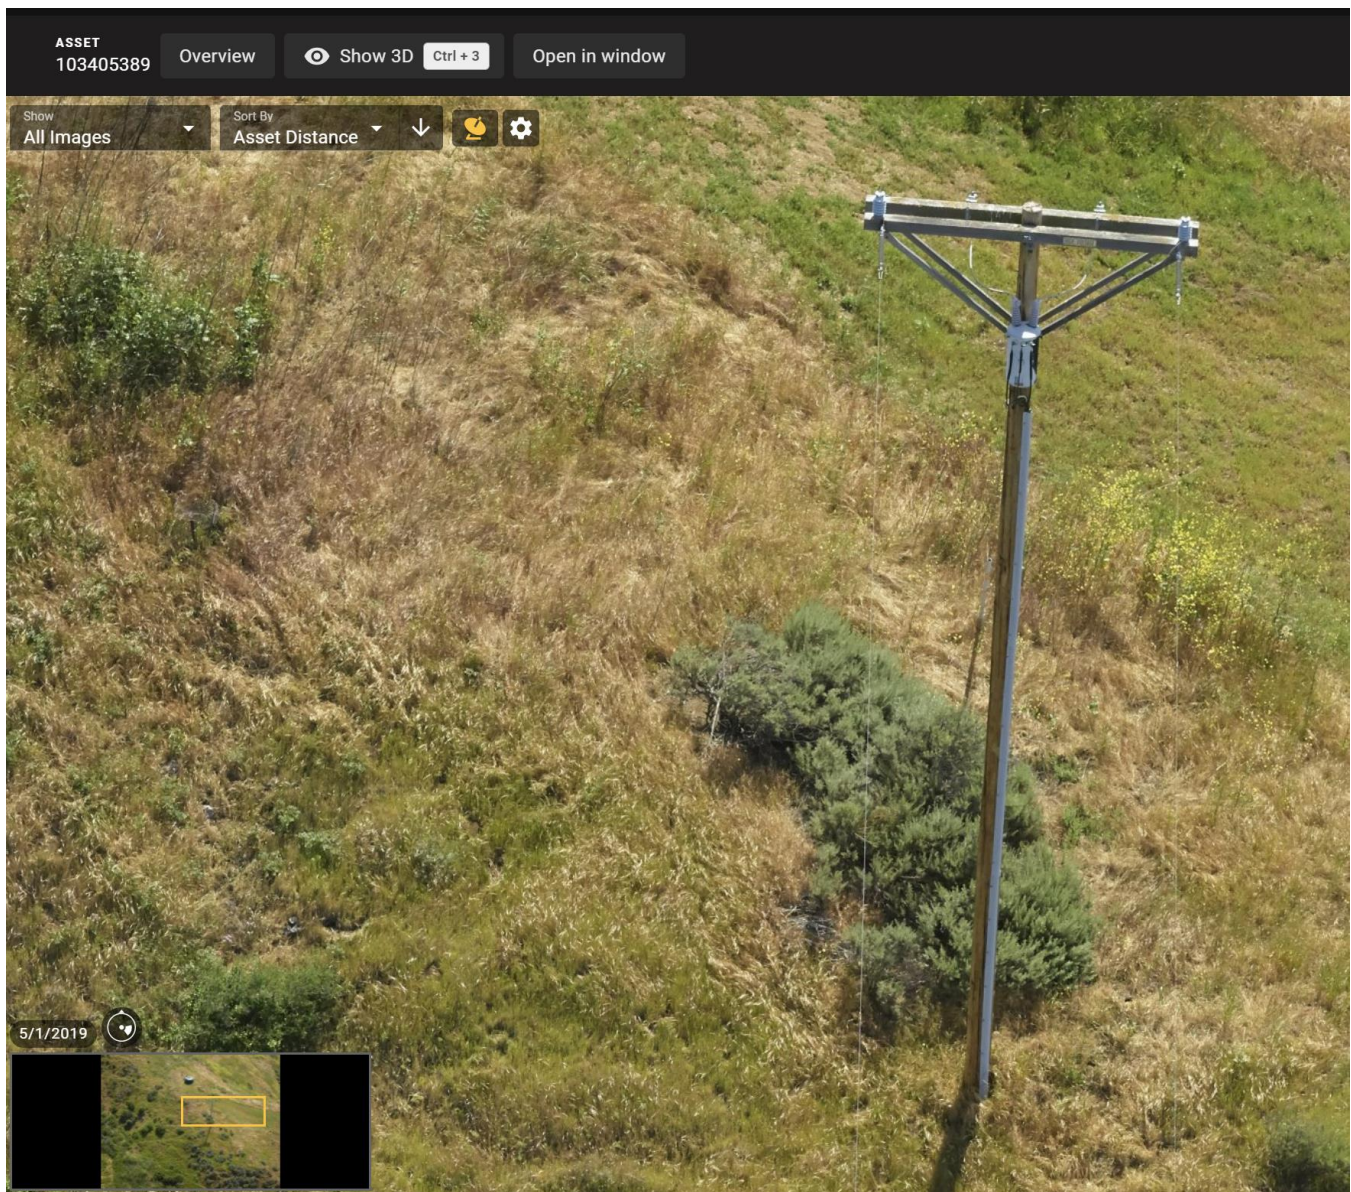
Figure 9 - SAP Pole ID: 103405389 (Incident pole), picture taken by Shaper Shape dated May 1, 2019.
