## Preliminary Ignition Investigation Report

<b>Ignition Database Index:</b>	20240223
<b>Electric Incident Investigation (EII) Number:</b>	N/A
<b>Incident Name:</b>	Garrison
<b>PG&amp;E Facility Ignition?</b>	Yes
<b>CPUC Reportable Ignition?</b>	Yes
<b>Date &amp; Time of Incident:</b>	March 26, 2024, 1953 hours
<b>Street Address:</b>	Highway 101 & Bradley Road
<b>City:</b>	Bradley
<b>County:</b>	Monterey
<b>Latitude/Longitude:</b>	35.8280186514, -120.7597621632
<b>State Responsibility Area (SRA) / Local Responsibility Area (LRA) / Federal Responsibility Area (FRA)</b>	Federal Responsibility Area
<b>PG&amp;E Division:</b>	Los Padres
<b>High Fire Threat District (HFTD):</b>	Tier 2
<b>High Fire Risk Area (HFRA):</b>	Yes
<b>EPSS Buffer:</b>	No
<b>Fire Index Area (FIA):</b>	570
<b>Fire Potential Index (FPI) Rating: FIA</b>	R1
<b>Fire Potential Index (FPI) Rating: Circuit</b>	R1
<b>Was there a PSPS event at the time of ignition?</b>	No
<b>Suspected Initiating Event:</b>	Equipment Failure

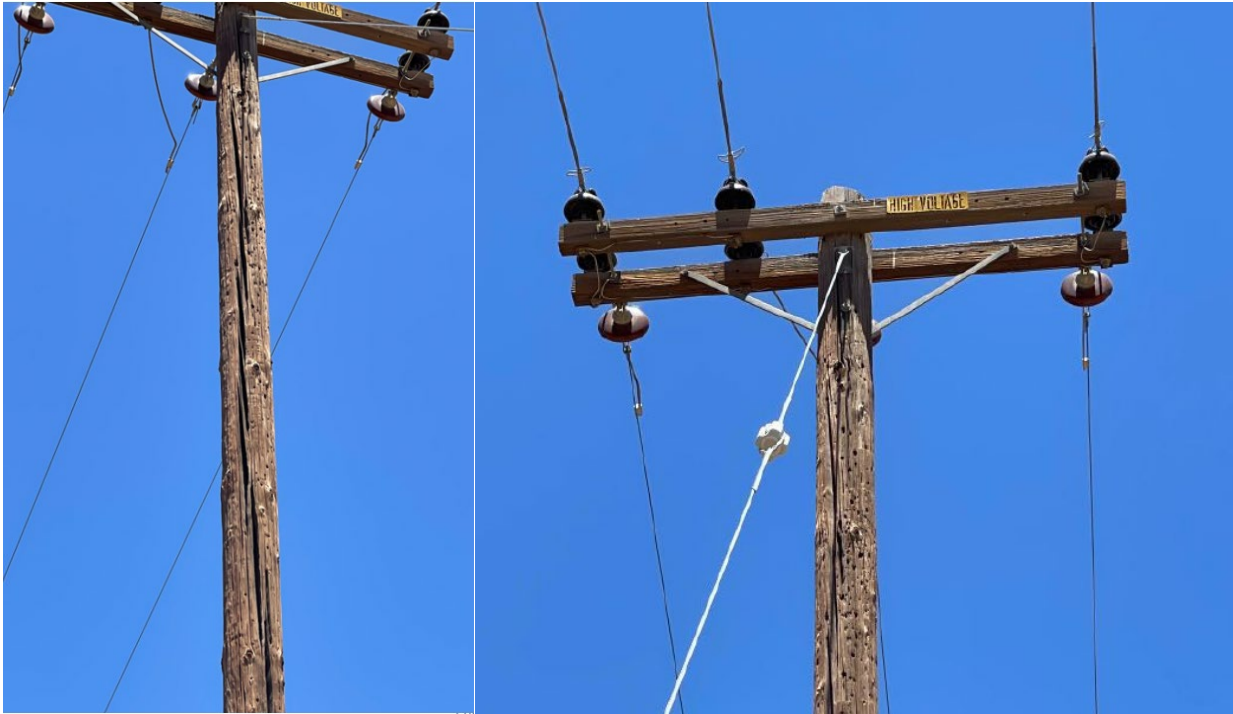
The pole had been flagged to be replaced in July of 2019 from a routine inspection. This work request was re-evaluated and placed on hold, with an updated due date of June 2023, which was not completed.

*Photo 2 - Photo taken 06/28/2022 from inspector showing pole is decayed/rotted and needs replacement.*

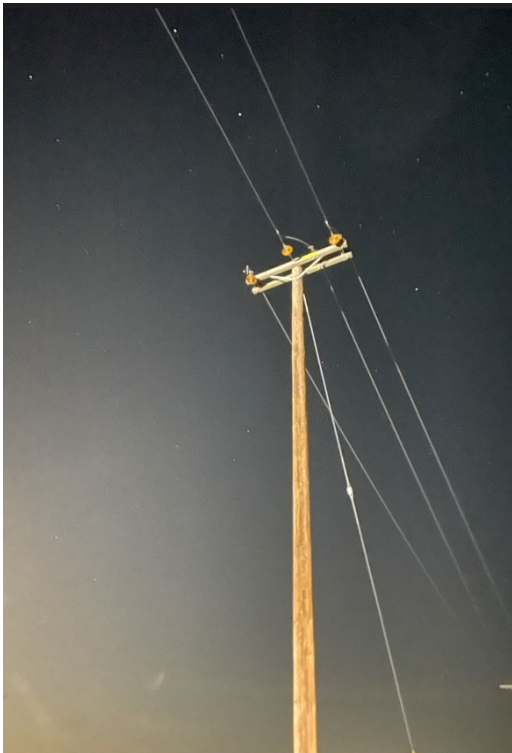
A section of #4 copper conductor failed load side at the dead-end attachment near the bell. The live conductor fell onto the grass fuel bed which retained moisture due to recent rains. The fire footprint was under three meters in size, which self-extinguished. This incident was named the Garrison Fire.

*Photo 3- Photo taken 03/26/24 by troubleshooter showing pole top, where conductor broke away.*

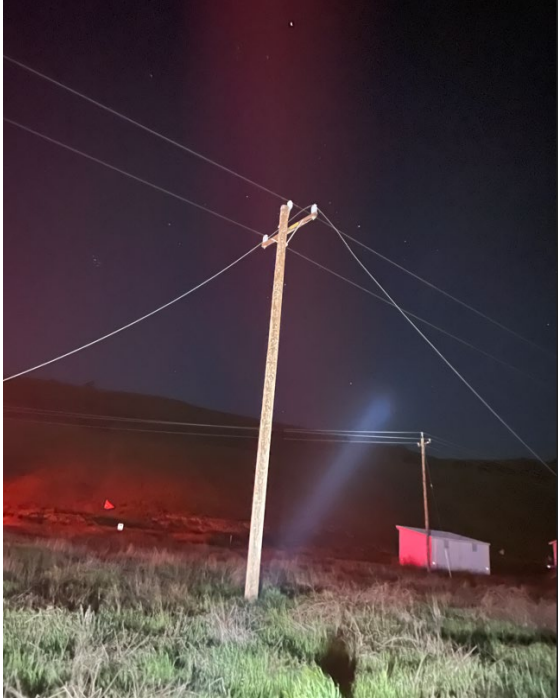
*Photo 4 - Photo taken 03/26/24 by troubleshooter showing downed conductor.*

Notification # 128373092 – A PG&E crew replaced conductor on March 27, 2024

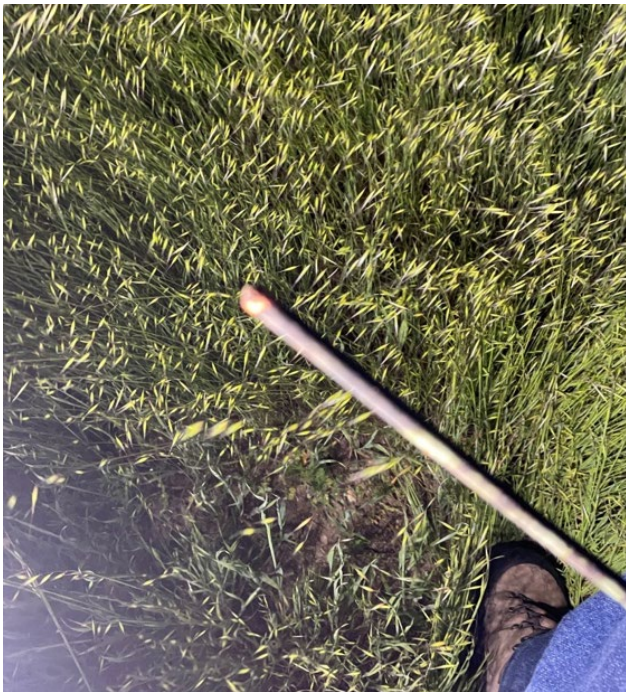
The overall cause of the failure is unknown as the section connected at the dead-end was not collected as evidence. ATS analysis suggests that the integrity of the copper conductor was likely compromised during the surges along with the age of the conductor, resulting in its failure. While the troubleshooter suggested that the copper conductor was corroded at the dead-end connector causing it to fail. Overall, the age, integrity and historical surge events are all contributing factors as to why the conductor failed.

*Photo 5 - Photo taken 03/26/24 by troubleshooter showing where it appears broken end of conductor has corrosion.*

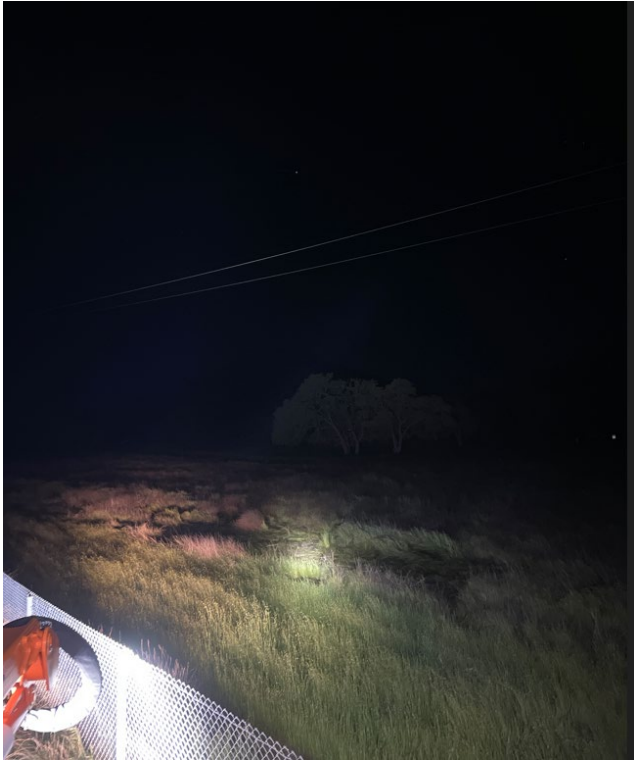
The failed conductor disengaged from the bell, causing the energized wire to fall to the ground. The topography consisted of a mixture of fresh and dried grasses. Due to the recent rains, the time of day and the cooler weather, the fire did not rapidly spread and burned less than three meters of ground vegetation.

*Photo 6 - Photo taken 03/26/24 by troubleshooter showing fire location.*
