## Preliminary Ignition Investigation Report

| <b>Incident Name:</b> | Tower – 18 May 2024 |
| <b>Circuit:</b> | Lamont 1104 |

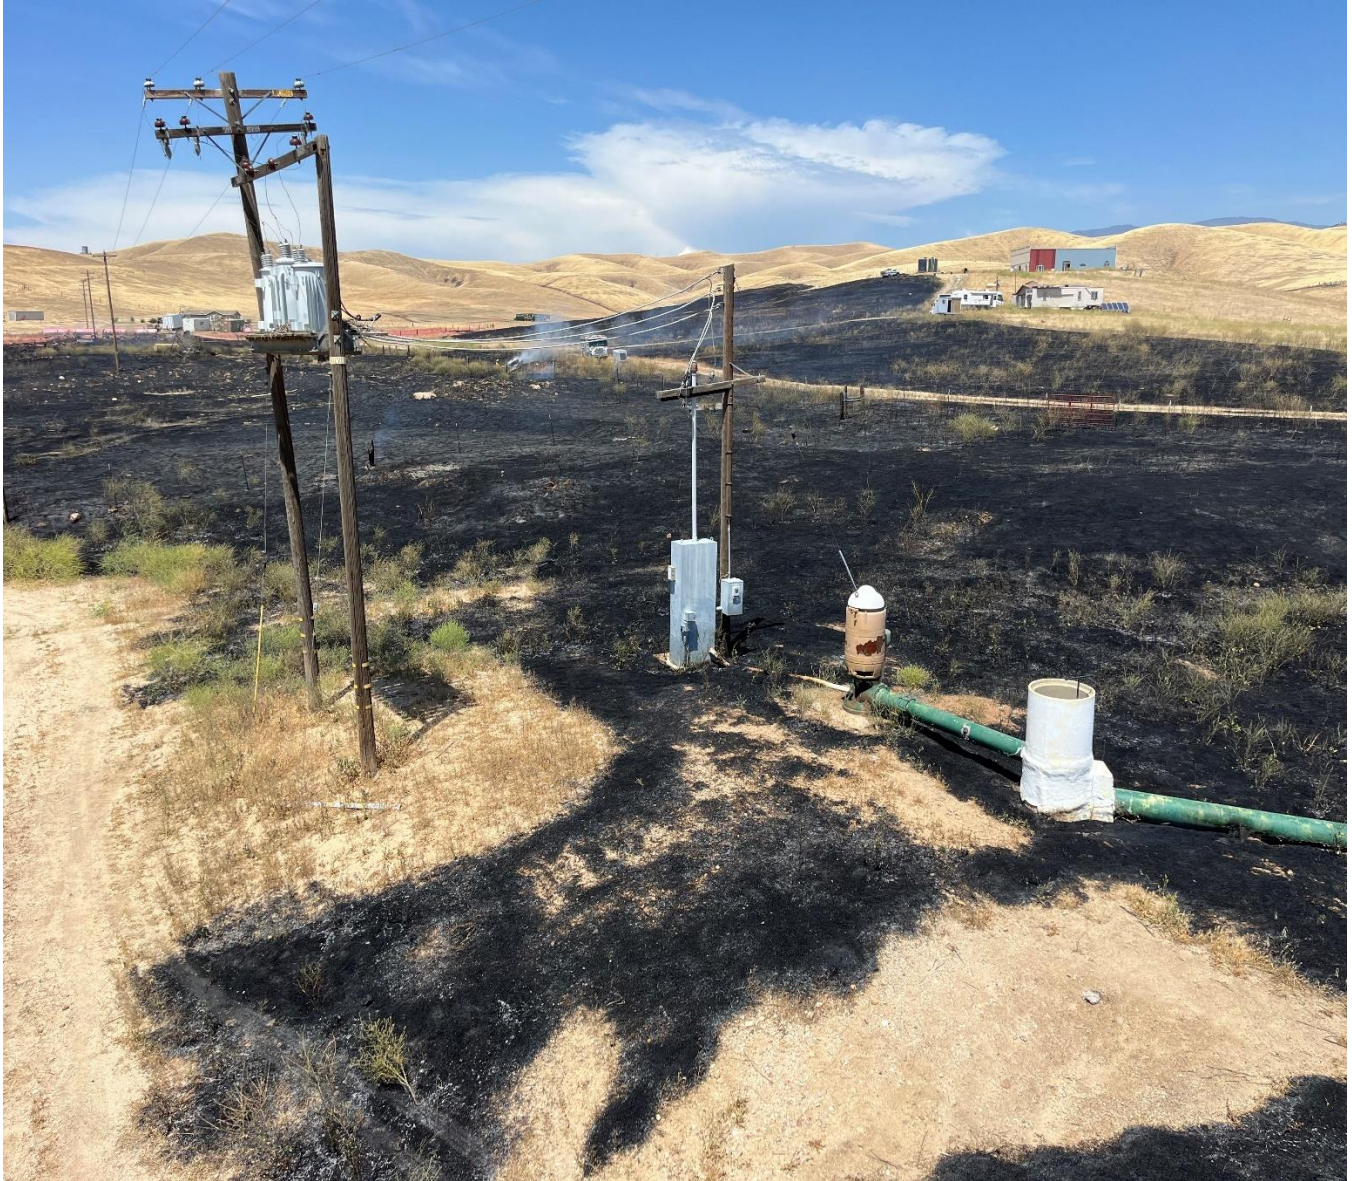
The PG&E troubleshooter arrived on scene at approximately 1221 hours and observed a fire. The troubleshooter indicated that a metallic balloon had contacted the conductor near distribution pole SAP Pole ID: 100188519. Remnants of the mylar balloon were still visible near the incident pole on the conductor (see Figures 3, 4 and 5). The remnants were not retained for further analysis.

| Pole Clearing Program | Expected Performance: Clear ground vegetation around certain poles to reduce fire spread potential; Observed Performance: Barrier performed as expected | N/A | Previous pole clearing at this location prevented the fire encroaching our asset SAP Pole ID: 100188521 [See Figure 3] |
| Utility Defensible Space | Expected Performance: Reduce the likelihood of rapid-fire development or impact in proximity to PG&E assets; Observed Performance: Barrier performed as expected | N/A | Pole clearing helped to reduce fire spread to PG&E assets [See Figure 3] |

*Figure 3 - Fire burn scar area with the mylar balloon remnants found in the conductor above this possible origin location. Please note, that previous pole clearing at this location prevented the fire encroaching our asset SAP Pole ID: 100188521. Picture taken by the troubleshooter on May 18, 2024*

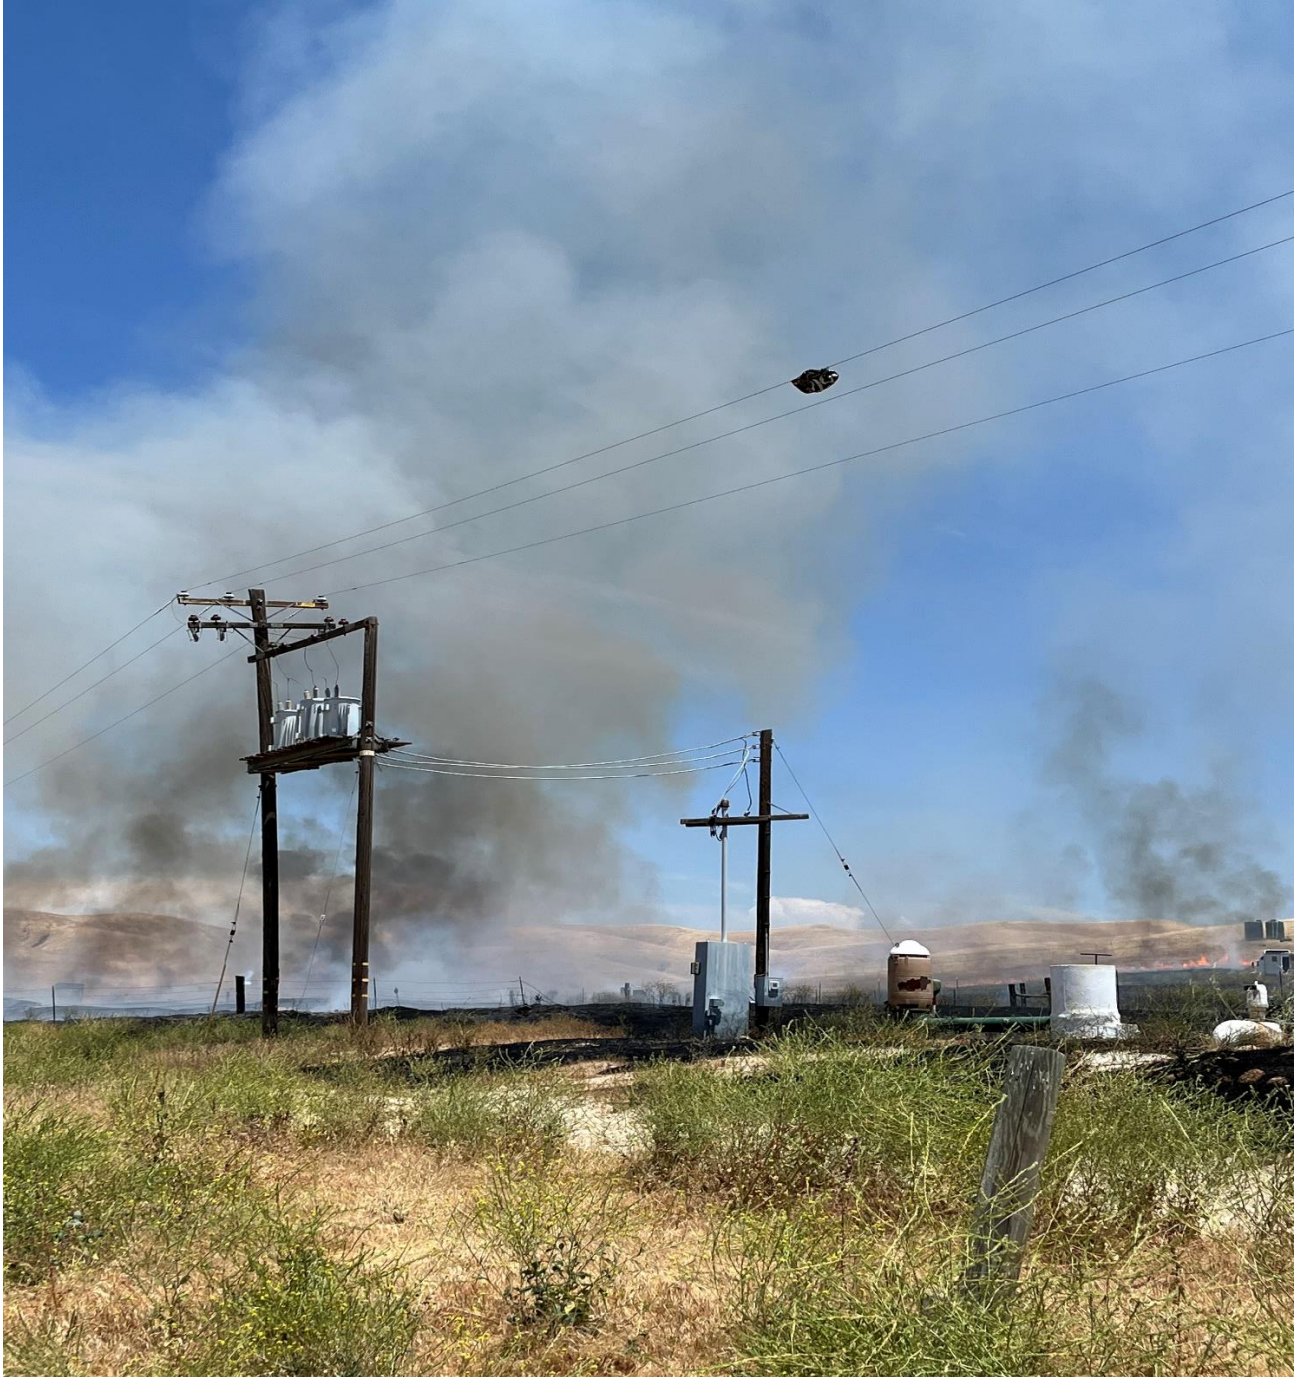
*Figure 4 – Ignition and Fire origin area with the mylar balloon remnants found in the conductor that led to the cause of ignition. Picture taken by the troubleshooter on May 18, 2024.*

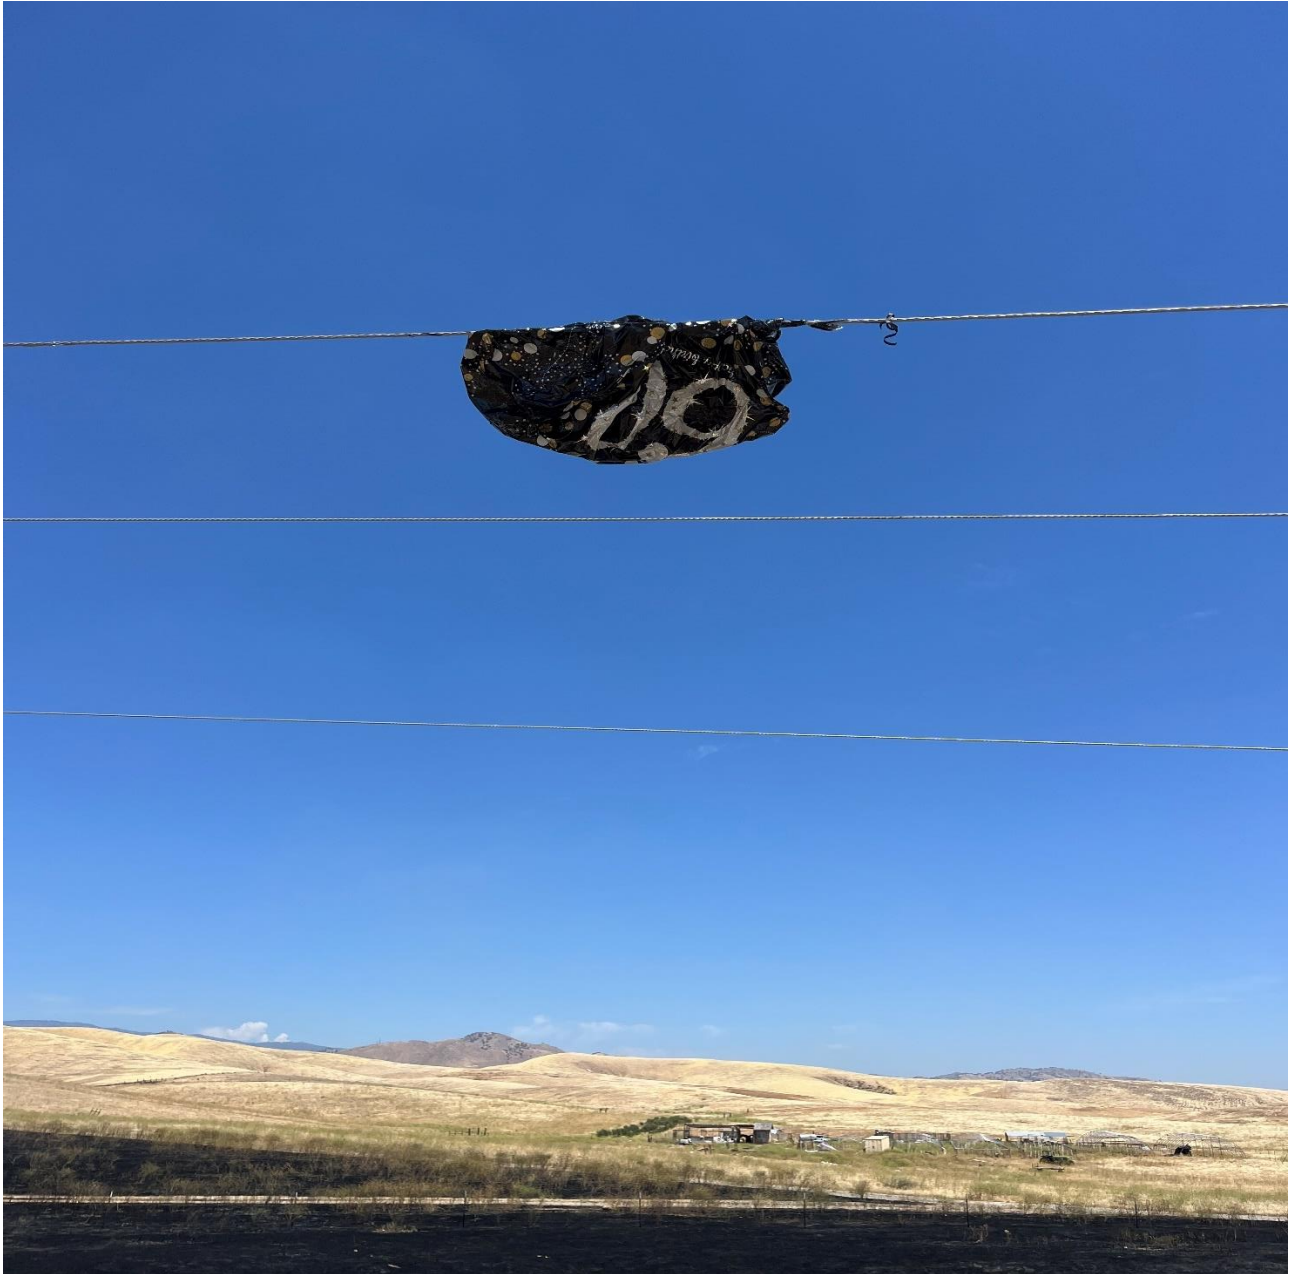
*Figure 5 - Mylar balloon remnants found that led to the cause of ignition. Picture taken by the troubleshooter on May 18, 2024.*

- California assembly Bill AB-847 Electrically Conductive Balloons ([Here](#)). Ongoing awareness is essential, and this topic should be consistently discussed at Town Hall public meetings and regularly on social media platforms.

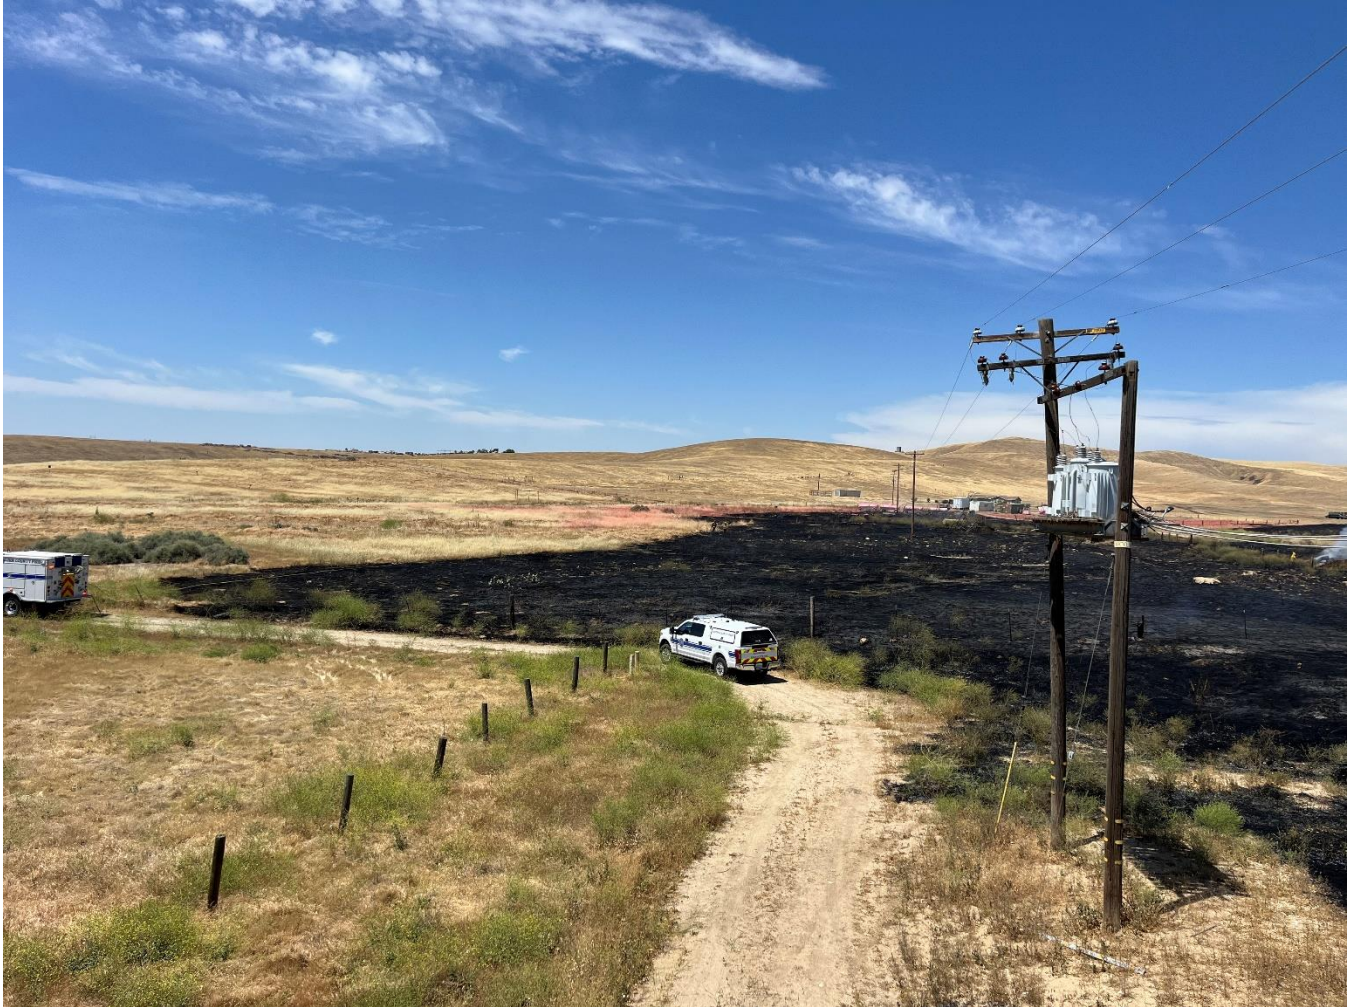
dispatch for vegetation fire was initiated, with units responding at 1236 hours. The fire had spread to about seven acres (based on HAWC summary) in size and was suppressed by Kern County Fire Department on May 18, 2024, (see Figure 6). There were no damages to PG&E equipment warranting repair.

*Figure 6 - Kern County Fire Department onsite to assist in controlling and suppressing the fire spread, picture taken by the troubleshooter on May 18, 2024.*
