## Preliminary Ignition Investigation Report

<b>Ignition Database Index:</b>	20240441N
<b>Electric Incident Investigation (EII) Number:</b>	N/A
<b>Incident Name:</b>	Jordan
<b>PG&amp;E Facility Ignition?</b>	Yes
<b>CPUC Reportable Ignition?</b>	Yes
<b>Date &amp; Time of Incident:</b>	May 20, 2024 at 1648 hours
<b>Street Address:</b>	NW Highway 101, East of Demonstration Forest Left
<b>City:</b>	Scotia
<b>County:</b>	Humboldt
<b>Latitude/Longitude:</b>	40.4417723235, -124.0202703923
<b>State Responsibility Area (SRA) / Local Responsibility Area (LRA) / Federal Responsibility Area (FRA)</b>	State Responsibility Area (SRA)
<b>PG&amp;E Division:</b>	Humboldt
<b>High Fire Threat District (HFTD):</b>	Tier 2
<b>High Fire Risk Area (HFRA):</b>	Yes
<b>EPSS Buffer:</b>	No
<b>Fire Index Area (FIA):</b>	105
<b>Fire Potential Index (FPI) Rating: FIA</b>	R1
<b>Fire Potential Index (FPI) Rating: Circuit</b>	R1
<b>Was there a PSPS event at the time of ignition?</b>	No

<b>Suspected Initiating Event:</b>	Vegetation
<b>Failure Driver:</b>	Contact from Object
<b>Failure Sub-driver:</b>	High Winds
<b>Circuit:</b>	Rio Dell 1101
<b>Circuit Protection Zone:</b>	LR 1504
<b>Nominal Voltage:</b>	12kV
<b>Po

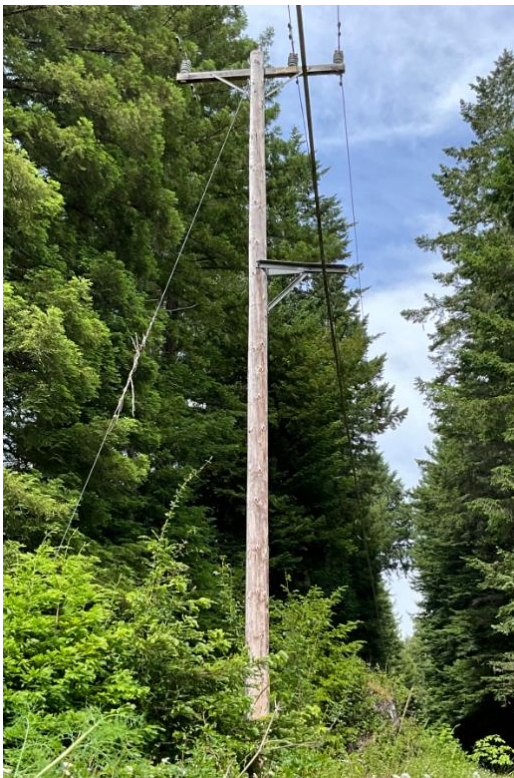
Load Side Structure		
Info / Inspection	Most Recent Date	Findings
Install Date:	2018	40' Class 3 wood pole
Inspection:	06/13/2023	Identified corroded anchor and guy. High sign faded and loose. GO165 enhanced inspection
	04/29/2021	No abnormal conditions noted in inspection

*Photo 3: Photo taken by inspector on June 13, 2023 inspection.*

Patrol:	N/A	
Corrective History:	06/13/2023	Replace corroded anchor and guy. Add high sign and trim overgrown vegetation on guy wire. Identified in GO165 inspection. EC #126364446, not worked
Aerial Inspection Records:	N/A	
VM Inspection:	2/29/2024	No work identified.
EVM Inspection:	5/18/2019	Tree not identified for EVM work
Equipment Test:	N/A	
Pole Intrusive Test:	N/A	
WSIP Inspection:	03/09/2019

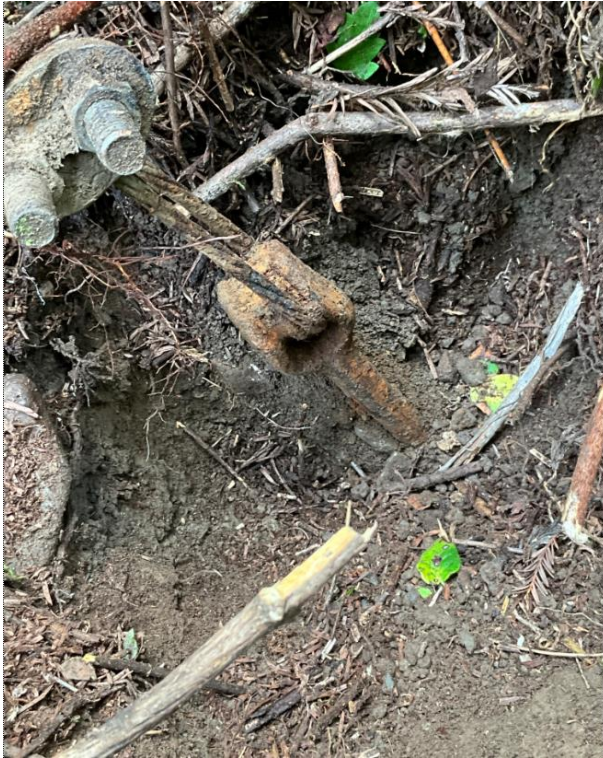
*Photo 4: Photo taken by inspector on June 13, 2023, inspection showing damaged anchor.*

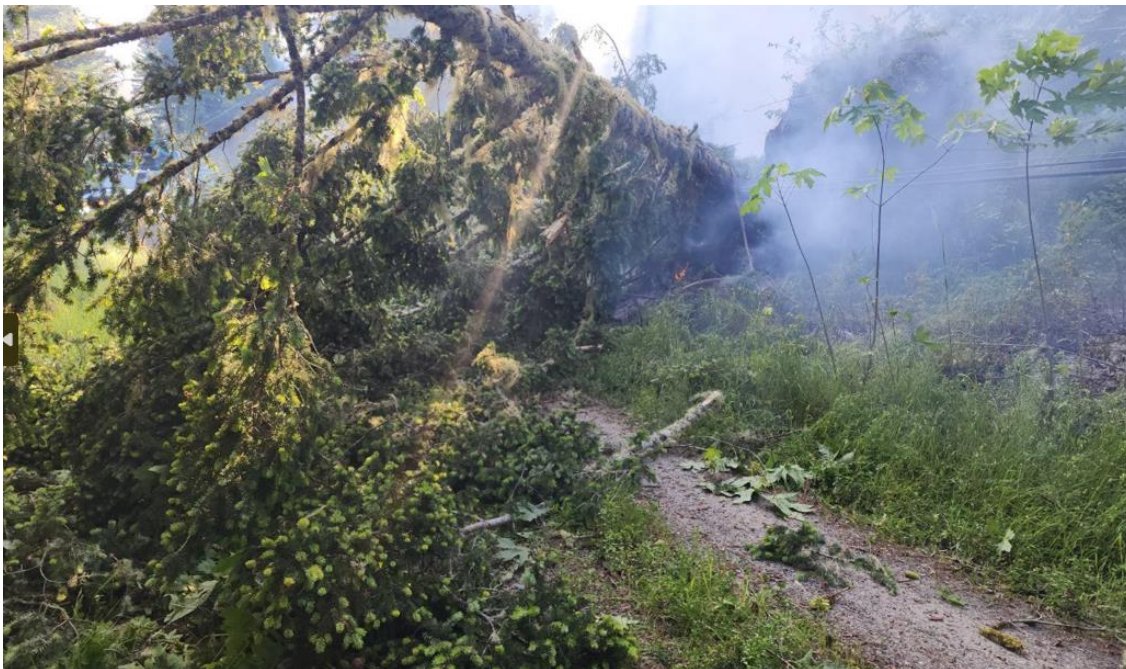
During the investigative patrol, the troubleshooter identified a Douglas fir tree with a failed stem approximately 27-feet above ground. The top portion of the tree fell onto the primary aluminum distribution conductors and communication lines. As the tree fell onto the energized overhead lines, four spans of primary conductor failed. This ignited two separate fires in the forest duff. Each incident occurred between one span of poles and resulted in ignitions totaling under one quarter acre in size.

*Photo 5: Photo taken by troubleshooter on May 20, 2024 of failed tree.*

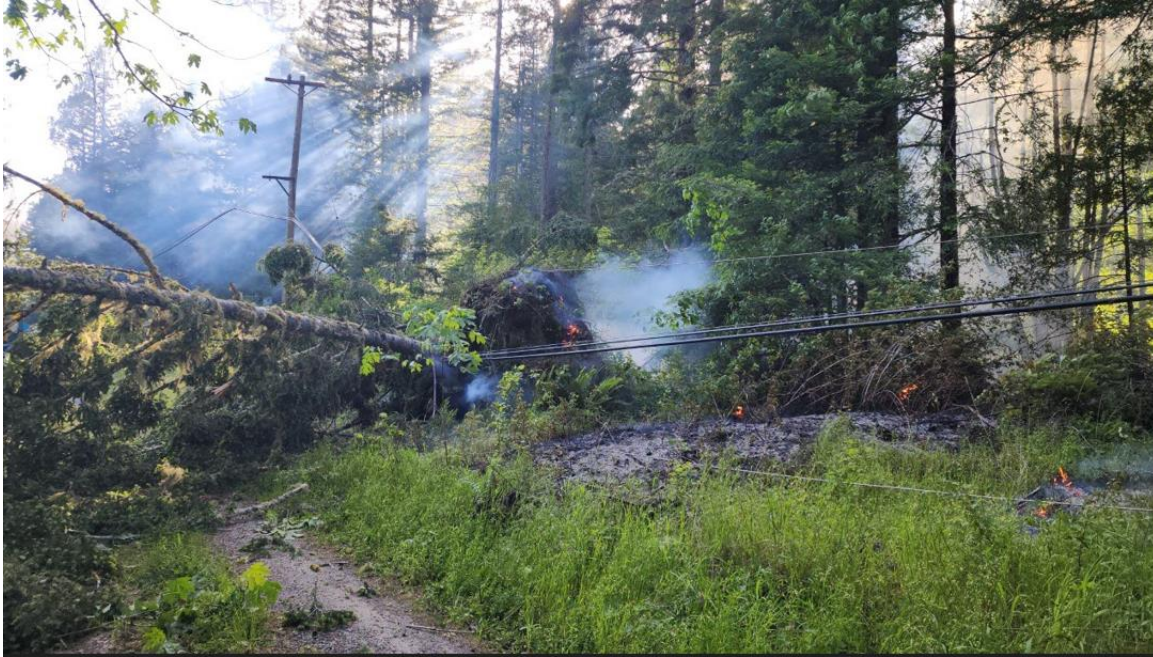
*Photo 6: Photo taken by troubleshooter on May 20, 2024 of failed tree taking utility lines down.*

A post incident corrective notification number, 128819567, was created as a priority A tag. A PG&E repair crew was onsite on May 20, 2024 where four spans of 3/0 aluminum were replaced totaling 40 feet along with one crossarm.

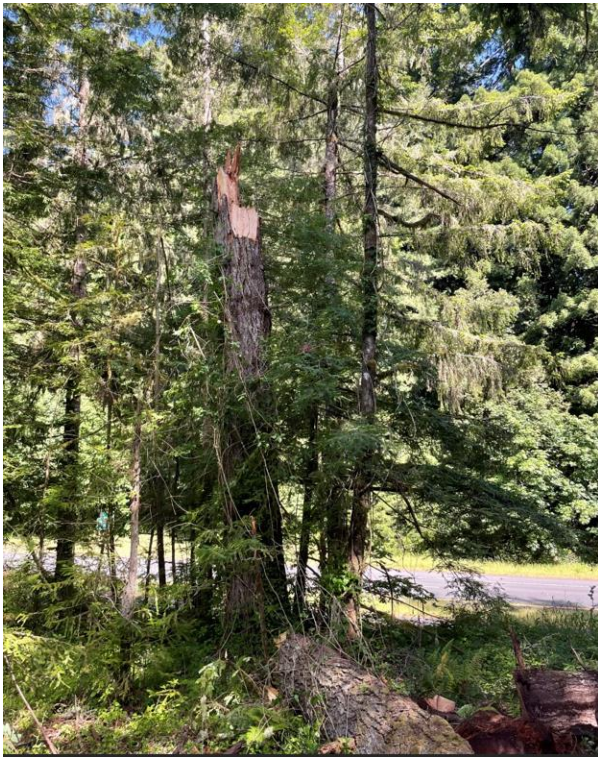
PG&E's Vegetation Management department performed a Vegetation Management Ignition Investigation (VMII) and Extent of Condition (XoC) patrol on May 21, 2024. The incident tree was determined to be a Douglas fir measuring 120-feet in height, 25-inches in diameter at breast height (DBH). The investigator confirmed that the tree was alive at the time of incident.

The Incident Location was inspected by Vegetation Management's Routine Maintenance program, Second Patrol Program, and a Vegetation Management Operational Mitigation patroller. Post ignition review of the Douglas fir tree by Vegetation Management personnel indicated that the tree had visible defects in the form of rot and decay which were facing away from conductors. A 'level 2' inspection involving a 360-degree review of the tree would have been required to identify the defects associated with the trunk failure. However, this location was not in scope for this type of inspection unless the inspector observed an issue that triggered a more detailed inspection. Unless that more-detailed inspection is triggered, Vegetation Management Inspectors observe most trees from the direction of the conductor they are patrolling.

*Photo 7: Photo taken by VM, May 21, 2024, post trunk failure.*

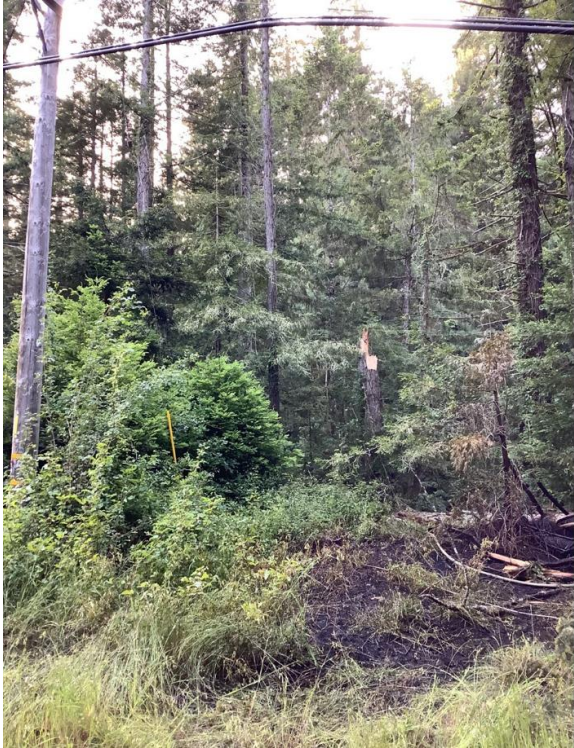
As a result of the tree failing onto the energized distribution facilities, this caused two separate ignition points. The combined fire footprint of these two locations was less than one quarter acre in size. An area outage occurred affecting 255 customers.

*Photo 8: Photo taken by troubleshooter May 20, 2024 of the fire footprint.*
