## Preliminary Ignition Investigation Report

Ignition Database Index:	20240489
Electric Incident Investigation (EII) Number:	N/A
Incident Name:	Benancio - 24 May 2024
PG&E Facility Ignition?	Yes
CPUC Reportable Ignition?	Yes
Date & Time of Incident:	May 24, 2024 @ 1252 hours
Street Address:	In the vicinity of [REDACTED] Road
City:	Salinas
County:	Monterey
Latitude/Longitude:	[REDACTED]
State Responsibility Area (SRA) / Local Responsibility Area (LRA) / Federal Responsibility Area (FRA)	State Responsibility Area (SRA)
PG&E Division:	Central Coast
High Fire Threat District (HFTD):	Tier 2
High Fire Risk Area (HFRA):	Yes
EPSS Buffer:	No
Fire Index Area (FIA):	505
Fire Potential Index (FPI) Rating: FIA	R1
Fire Potential Index (FPI) Rating: Circuit	R1
Was there a PSPS event at the time of ignition?	No
Suspected Initiating Event:	Vegetation
Failure Driver:	Contact from object
Failure Sub-driver:	Contact – Vegetation / Tree grew into Secondary
Circuit:	Reservation Road 1101

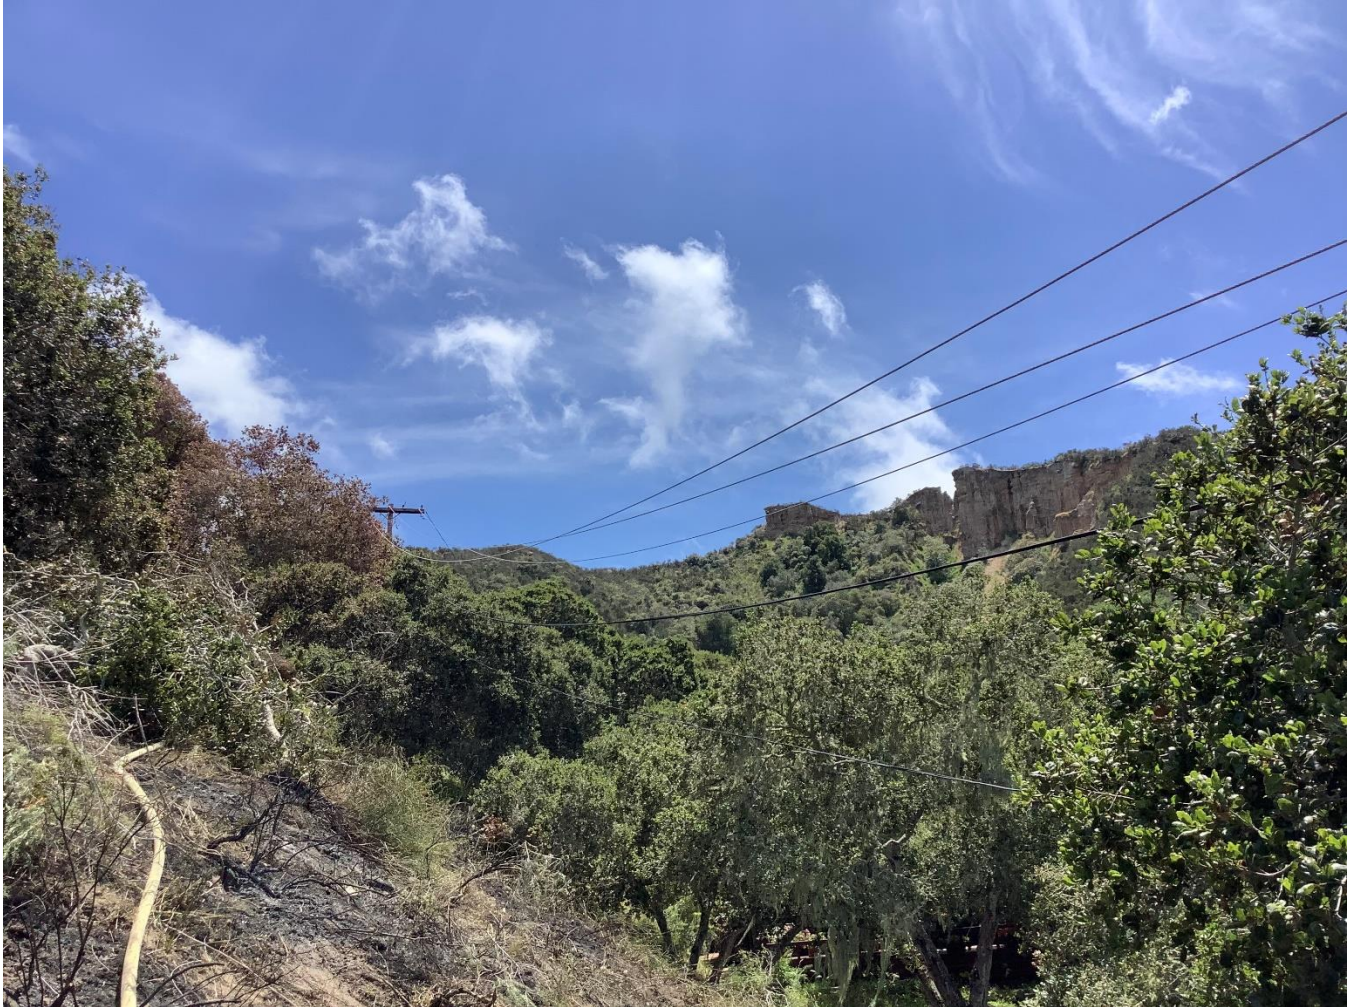
A post-incident investigation was performed by a Vegetation Management (VM) investigator on May 30, 2024, near the Incident Location. The VM investigator observed a small oak woodland area and estimated that approximately 0.5 acres was burned. The area directly below the secondary line did not appear to be burned. Numerous oak trees appeared to have been recently trimmed to clear the secondary line and fire retardant was dropped at the secondary end pole.

*Figure 3 - Fire burn scar area with the Secondary conductors above. Please note, that the tree crew began trimming the vines and branches away from the conductors. Picture taken by the troubleshooter on May 24, 2024*

An extent of condition (EOC) investigation was performed by another VM investigator on May 30, 2024, and they had noted that the wind caused the secondary line to strike against itself, generating a spark that ignited the grass/scrub on the hillside. Crews pruned trees growing near the secondary lines increasing clearances. The VM investigator patrolled five spans in each direction and noted that a residential oak scrub was performed only. No additional trees were identified or needed to be worked during the inspection.

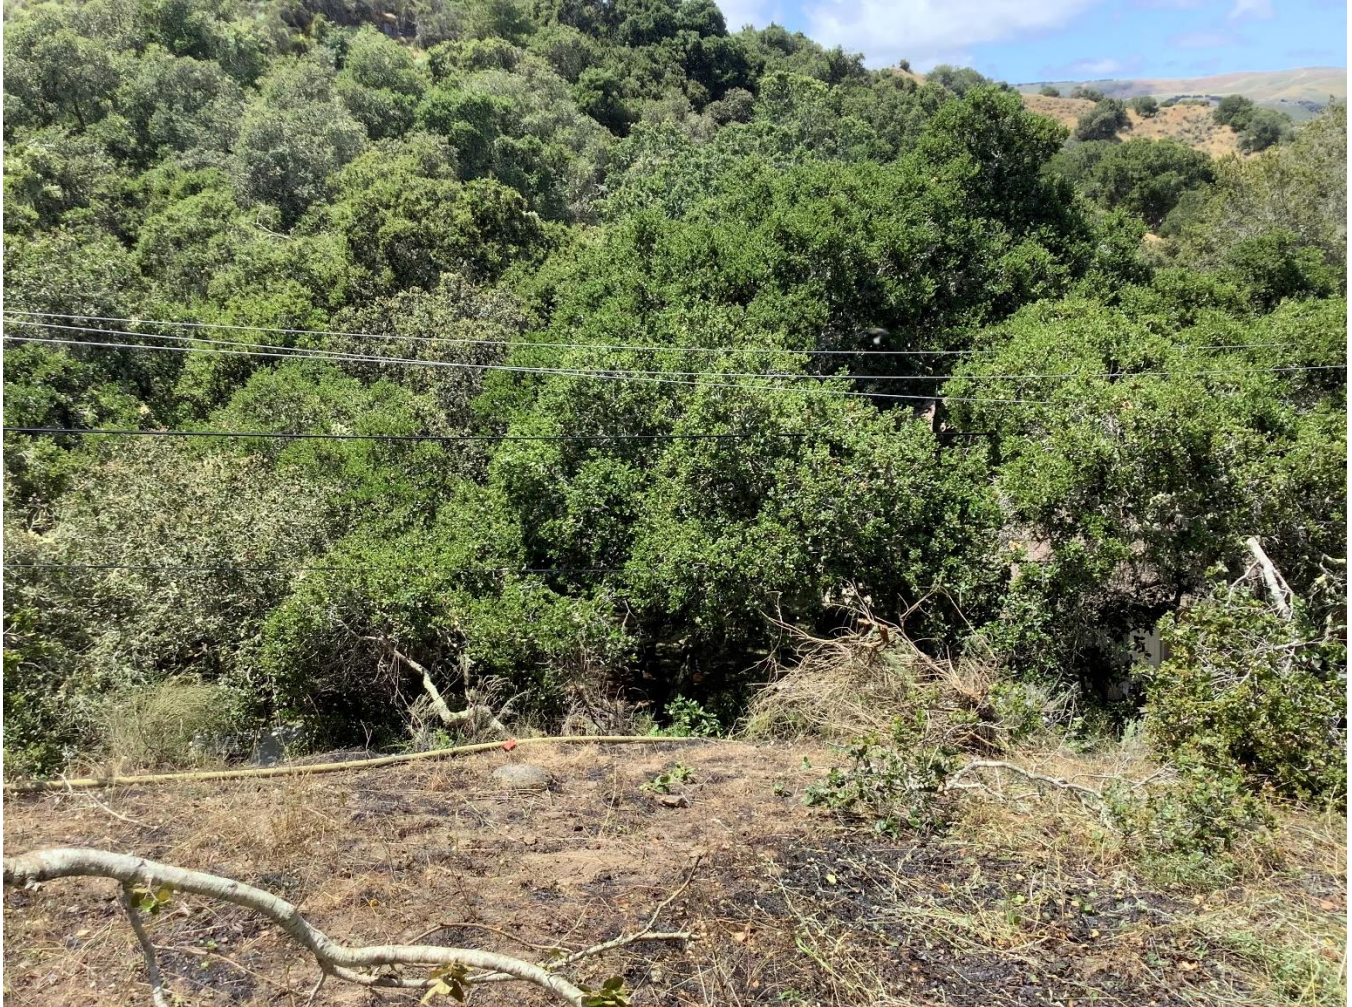
The Field Automation System (FAS) record stated that the PG&E troubleshooter arrived on the scene at approximately 1312 hours and observed a fire. The troubleshooter indicated that tree vines had grown into the secondary wires, and that high winds may have caused the secondary wires to slap together and arc resulting in sparks hitting the ground and starting the vegetation fire, (see Figures 3, 4, and 5) between distribution SAP Pole ID: 1001780037 (Load Side) and SAP Pole ID: 1001747581 (Source Side).

*Figure 4 – Ignition and fire origin area where the conductors slapped together leading to the cause of ignition. Picture taken by the troubleshooter on May 24, 2024.*

LC priority “A” Tag (#128888885) was created to replace a transformer and cutout on SAP Pole ID: 1001747581. The crew also adjusted and re-sagged the slack secondary conductors that slapped together between SAP Pole ID: 1001780037 (Load Side) and SAP Pole ID: 1001747581 (Source Side) resulting in the ignition of this incident. All repair work was completed by the PG&E Crew on May 24, 2024.

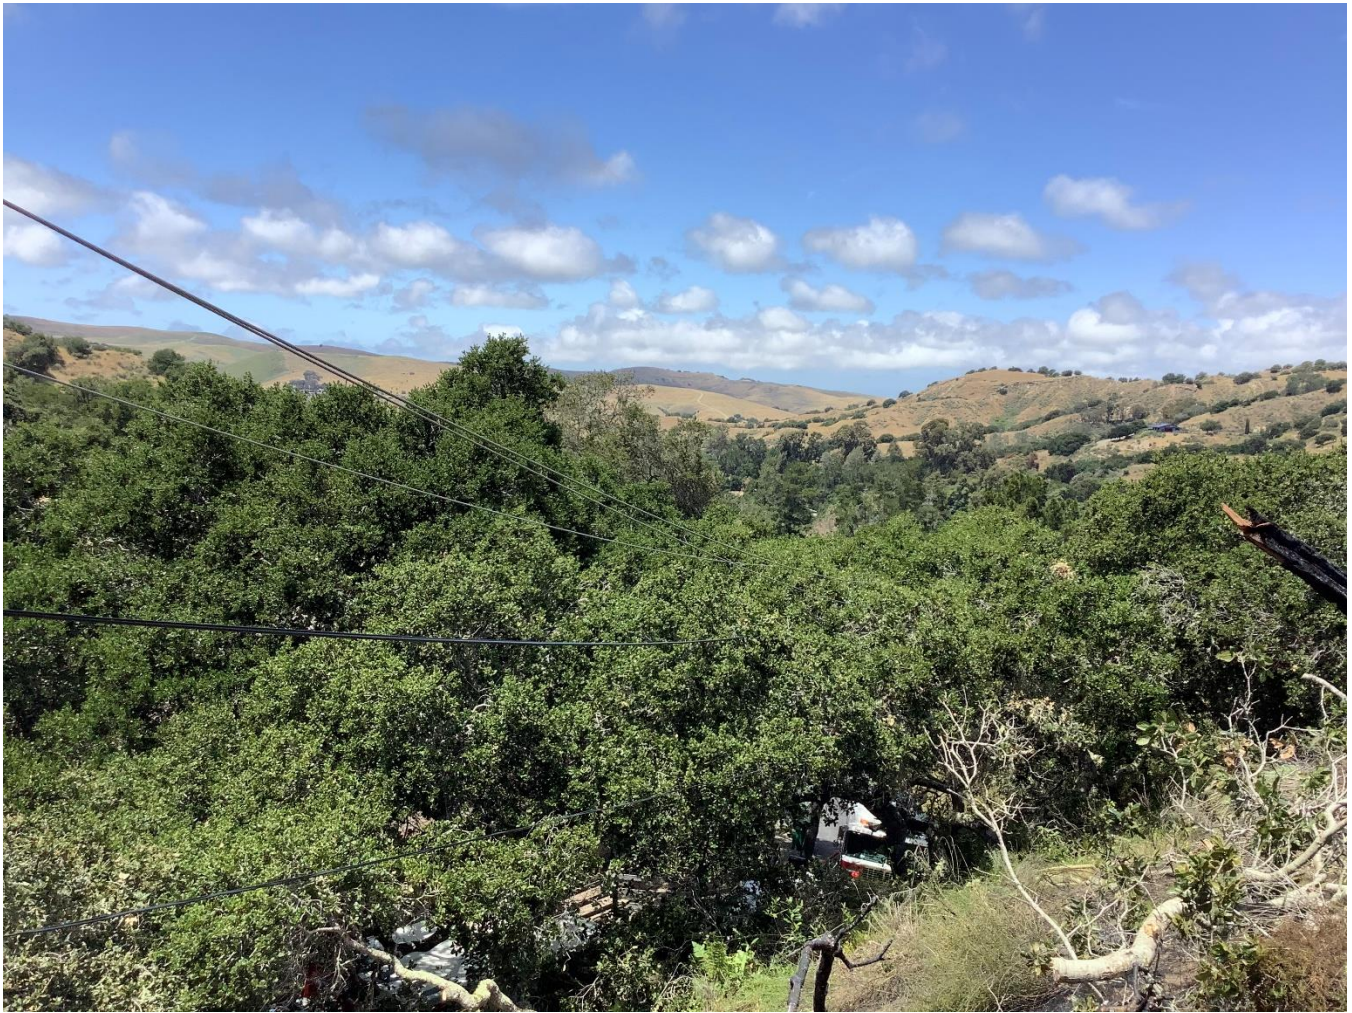
*Figure 5 - Secondary conductors going through the trees. Please note, that the tree crew planned on trimming the vines and branches away from the conductors after this picture was taken. Picture taken by the troubleshooter on May 24, 2024*

The PG&E repair crew arrived onsite at 1725 hours and adjusted (re-sagged) the slack secondary conductors. While onsite, the crew also replaced the transformer and cut-out on SAP Pole ID: 1001747581 due to deterioration and aging. This replaced equipment was not related to the ignition. Additionally, a tree crew was onsite to clear trees from the line while de-energized on May 24, 2024.

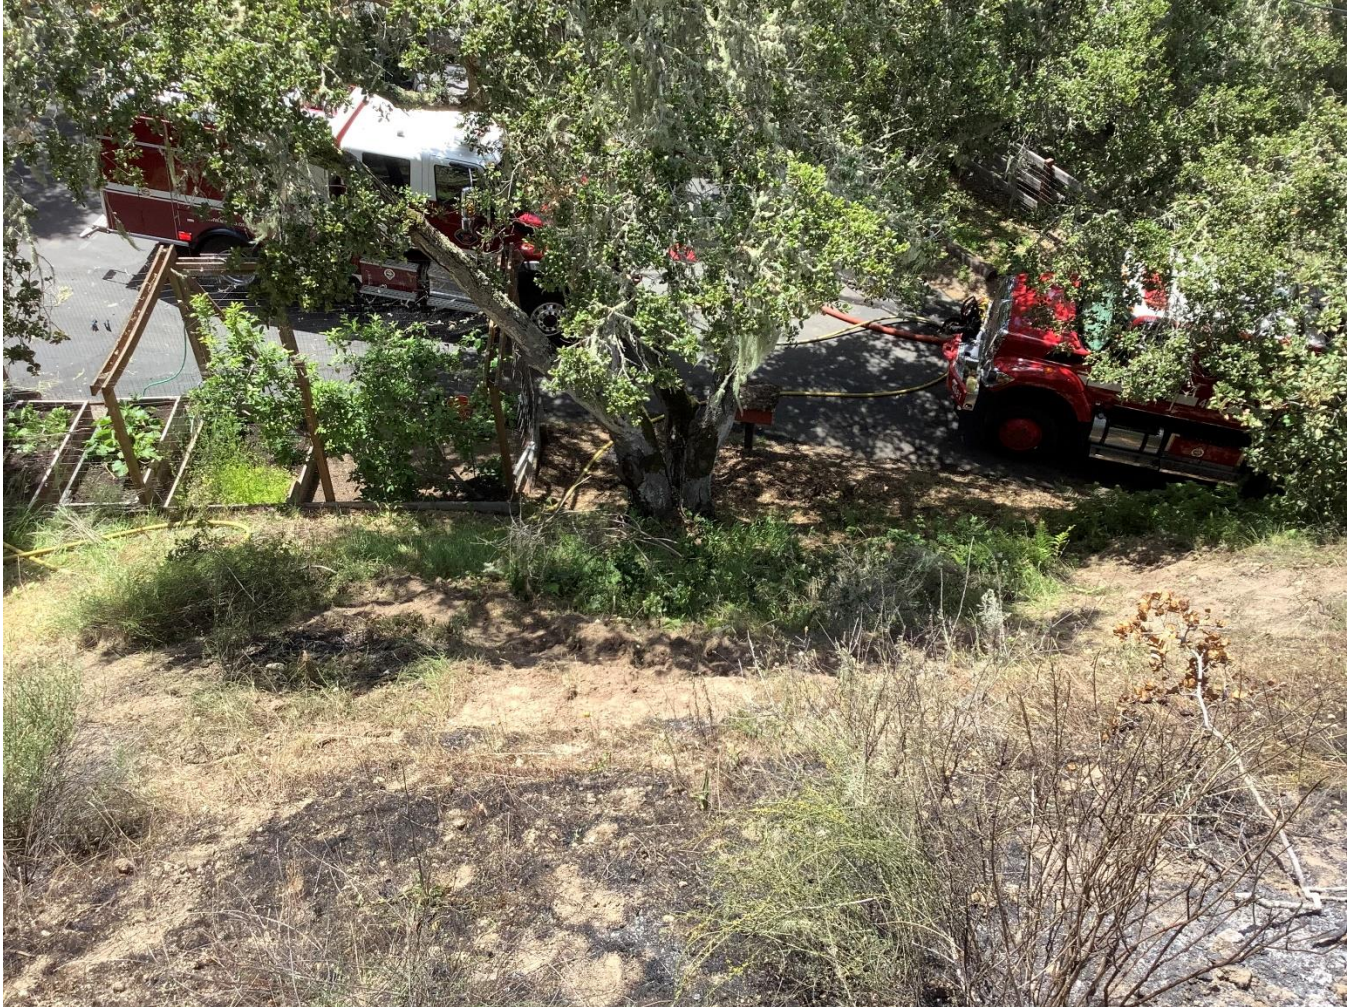
suppressed by two Monterey County CAL FIRE Departments (Gabilan and Carmel Hill) on May 24, 2024, (see Figure 6).

*Figure 6 – Monterey County CAL FIRE Department onsite to assist in controlling and suppressing the fire spread, picture taken by the troubleshooter on May 24, 2024.*

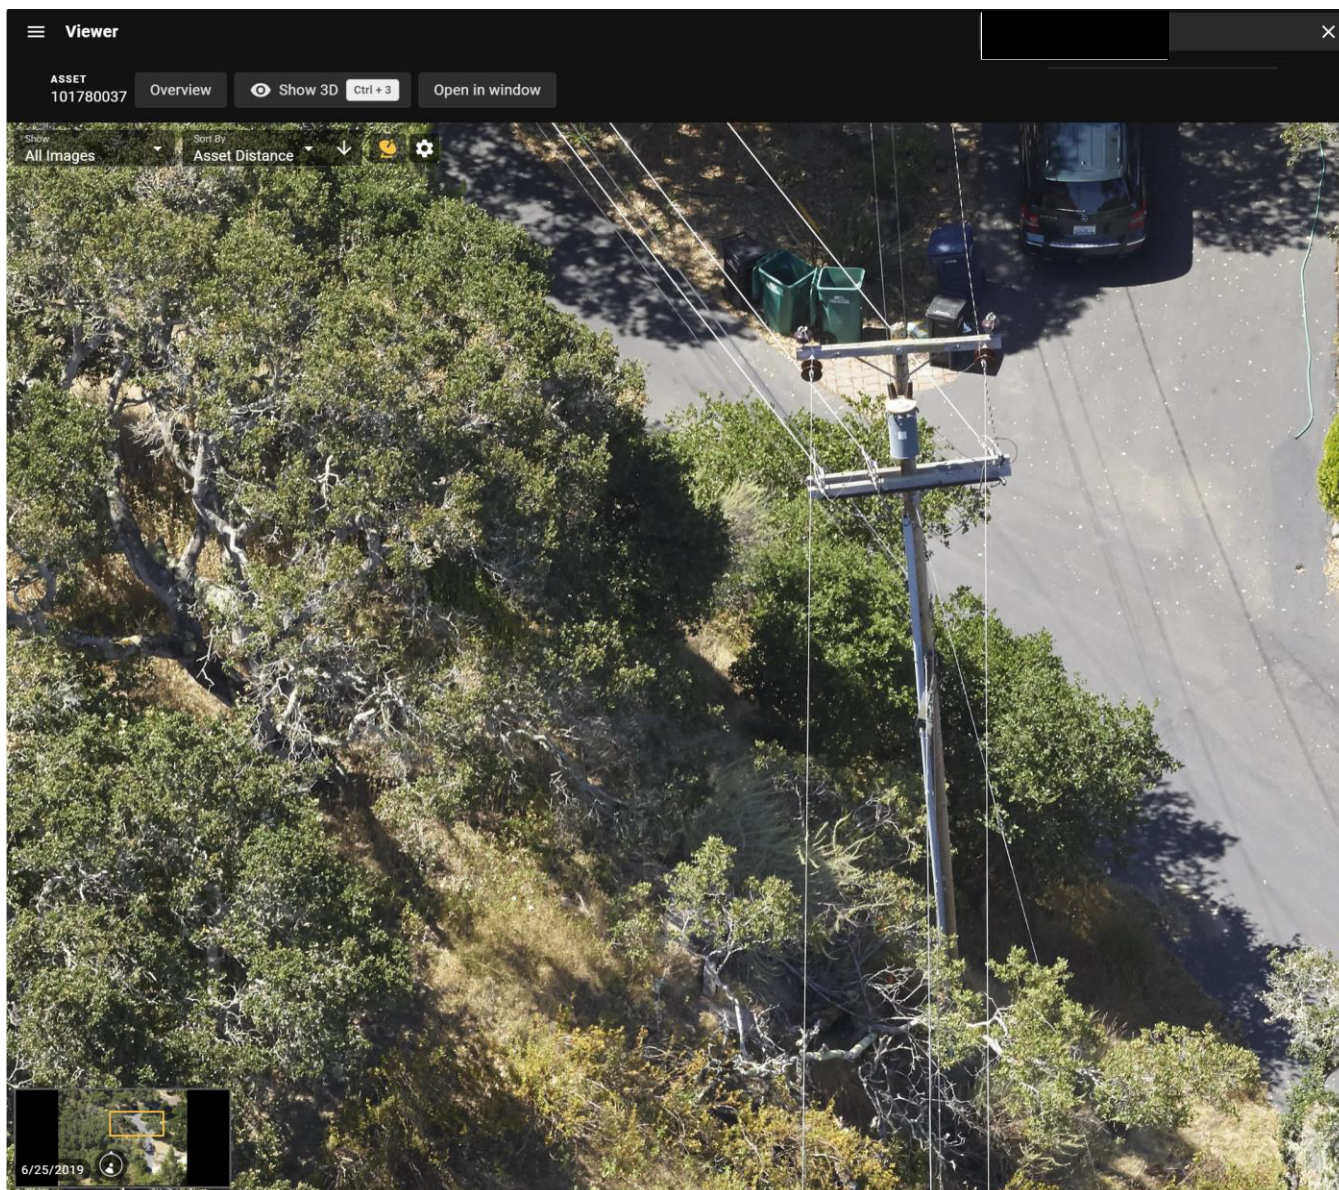
Figure 7 - SAP Pole ID: 101747581 (Source Side), picture taken from Shaper Shape dated June 25, 2019

Source Side Structure		
Info / Inspection	Most Recent Date	Findings
Install Date:	January 1, 1963	Douglas Fir – Class 6 – Height 40’
Inspection:	May 14, 2022	GO165 Inspection – No declaration items reported

N/A	
Patrol:	N/A	
	N/A	
Corrective History:	May 24, 2024	LC priority "A" Tag (#128888885) was created to replace a Transformer and Cutout on SAP Pole ID: 1001747581. The crew also adjusted and re-sagged the slack conductors
Aerial Inspection Records:	June 25, 2019	SAP Pole ID 101747581 (Source side) No abnormal conditions visible.
VM Inspection:	January 12, 2024 – March 5, 2024	Date Ranges for last completed Routine Pre-Inspection Patrols.
EVM Inspection:	N/A	A proximity search was performed in the Enhanced Vegetation Management (EVM) database and no trees were within a 1/8-mile radius of the coordinates provided for this incident.
Equipment Test:	N/A	
Pole Intrusive Test:	September 13, 2017	Passed with 92% wood strength
WSIP Inspection:	March 19, 2019	There were no compelling abnormal conditions reported

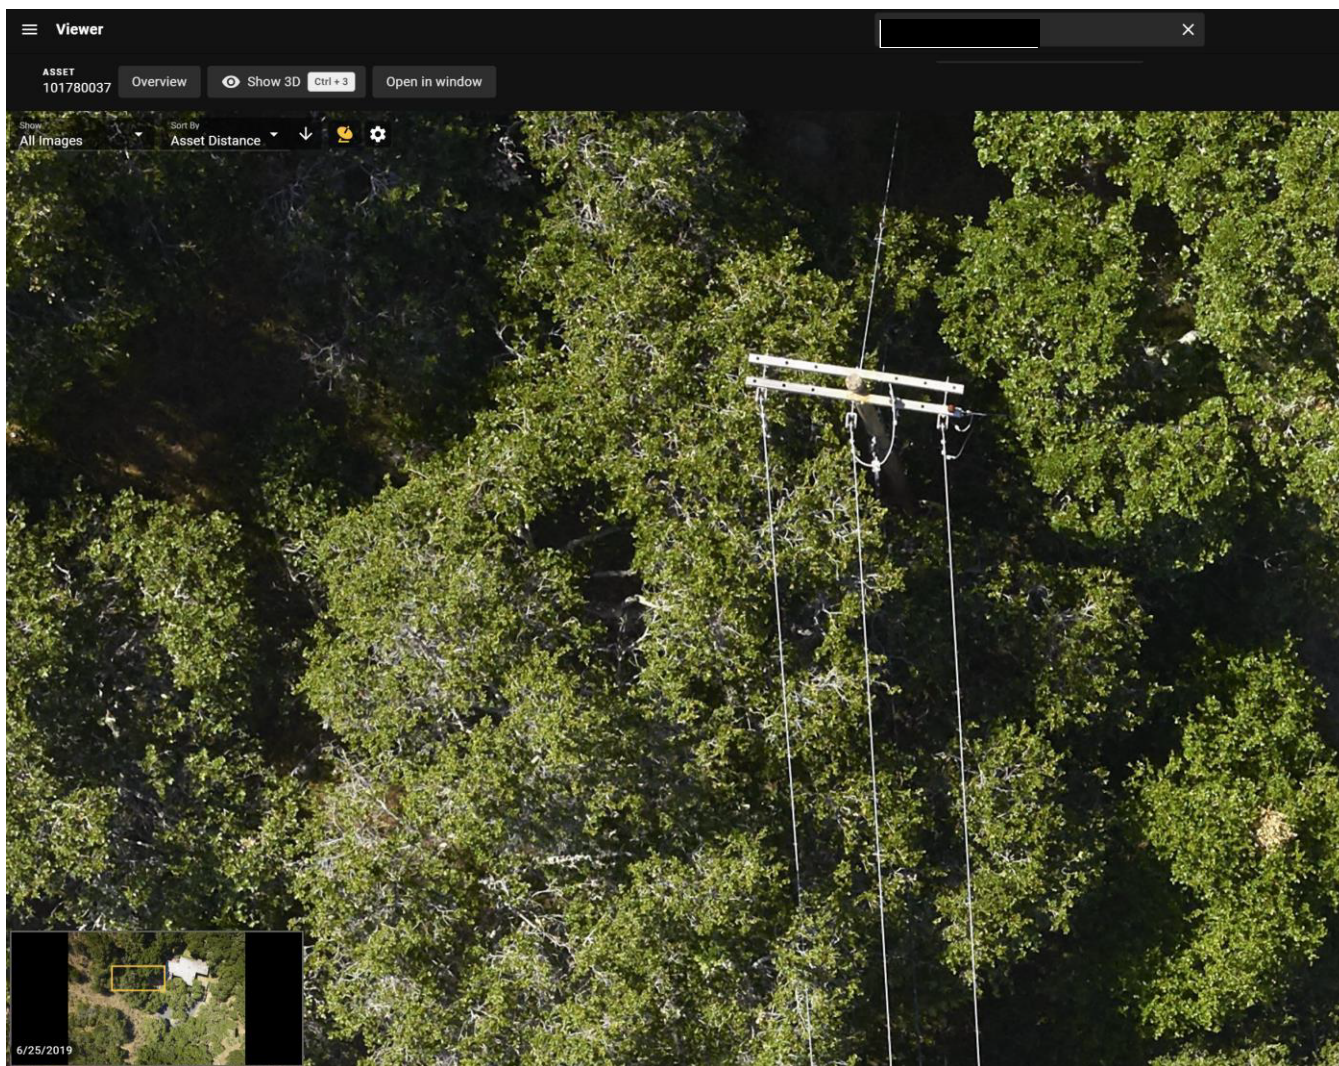
Figure 8 - SAP Pole ID: 101780037 (Load Side), picture taken from Shaper Shape dated June 25, 2019

Load Side Structure		
Info / Inspection	Most Recent Date	Findings
Install Date:	January 1, 1963	Douglas Fir – Class 5 – Height 35'
Inspection:	May 14, 2022	GO165 Inspection – No declaration items reported
	N/A	
Patrol:	N/A	
	N/A	
Corrective History:	N/A	No corrective history was found.
Aerial Inspection Records:	June 25, 2019	SAP Pole ID 101747581 (Load side) No abnormal conditions visible.
VM Inspection:	January 12, 2024 – March 5, 2024	Date Ranges for last completed Routine Pre-Inspection Patrols.
EVM Inspection:	N/A	A proximity search was performed in the Enhanced Vegetation Management (EVM) database and no trees were within a 1/8-mile radius of the coordinates provided for this incident.
Equipment Test:	N/A	
Pole Intrusive Test:	September 13, 2017	Passed with 91% wood strength
WSIP Inspection:	March 19, 2019	There were no compelling abnormal conditions reported
