## Preliminary Ignition Investigation Report

Ignition Database Index:	20240605
Electric Incident Investigation (EII) Number:	N/A
Incident Name:	Noteware
PG&E Facility Ignition?	Yes
CPUC Reportable Ignition?	Yes
Date & Time of Incident:	June 7, 2024, @approximately 1023 hours
Street Address:	745 Noteware Drive
City:	Ben Lomond
County:	Santa Cruz
Latitude/Longitude:	37.080271, -122.074213
State Responsibility Area (SRA) / Local Responsibility Area (LRA) / Federal Responsibility Area (FRA)	State Responsibility Area
PG&E Division:	Central Coast
High Fire Threat District (HFTD):	Tier 3
High Fire Risk Area (HFRA):	Yes
EPSS Buffer:	N/A
Fire Index Area (FIA):	520
Fire Potential Index (FPI) Rating: FIA	R1
Fire Potential Index (FPI) Rating: Circuit	R1
Was there a PSPS event at the time of ignition?	No
Suspected Initiating Event:	Contact – Animal – Bird
Failure Driver:	Contact from object
Failure Sub-driver:	Contact – Animal – Bird
Circuit:	Camp Evers 2105
Circuit Protection Zone:	LR 11004

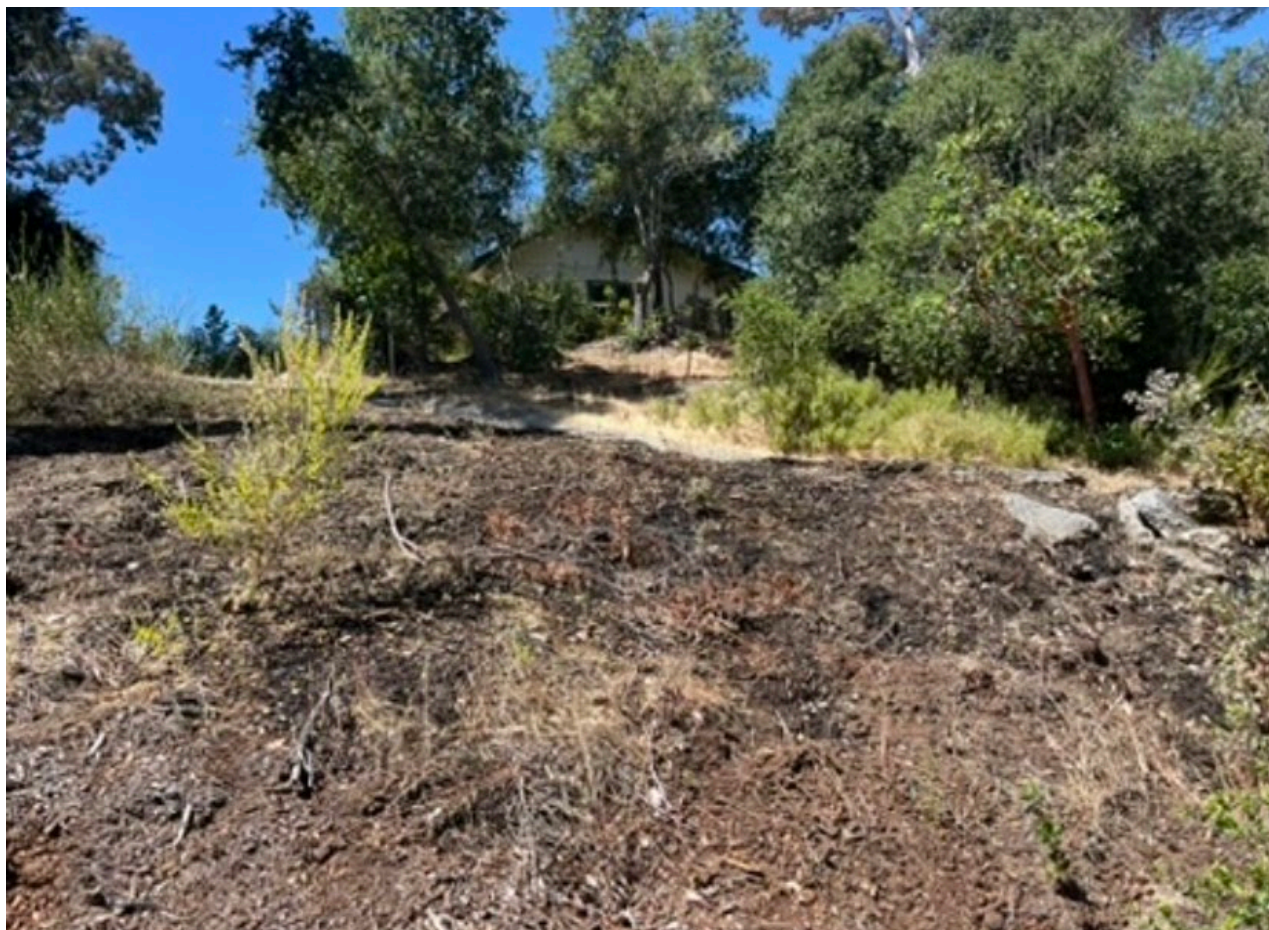
*Figure 2 Photo of burn scar. Photo taken by troubleshooter on June 7, 2024.*

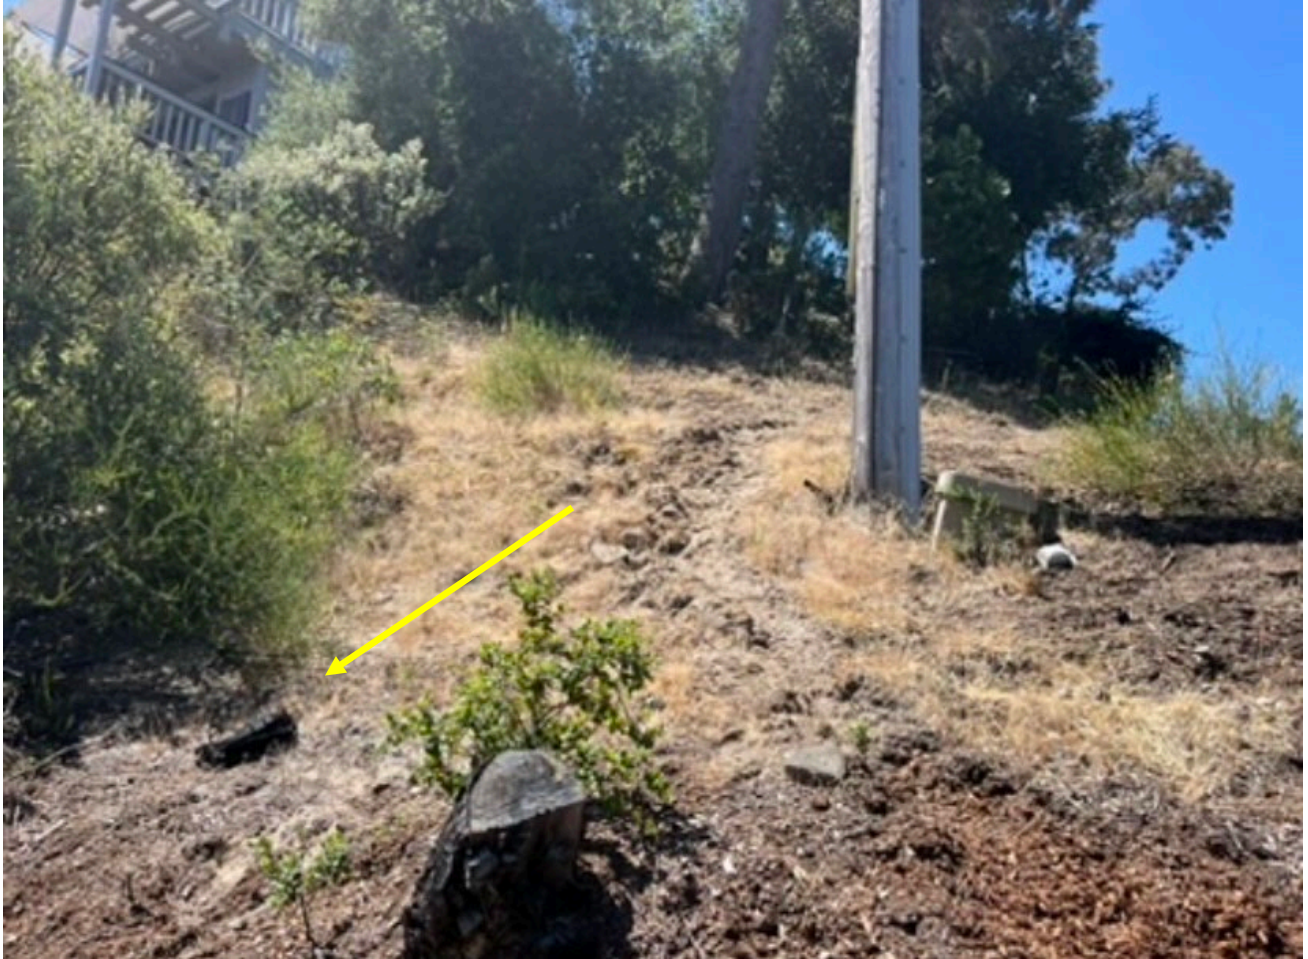
*Figure 3 Base of Pole #1, deceased crow on the left. Photo taken by troubleshooter on June 7, 2024.*

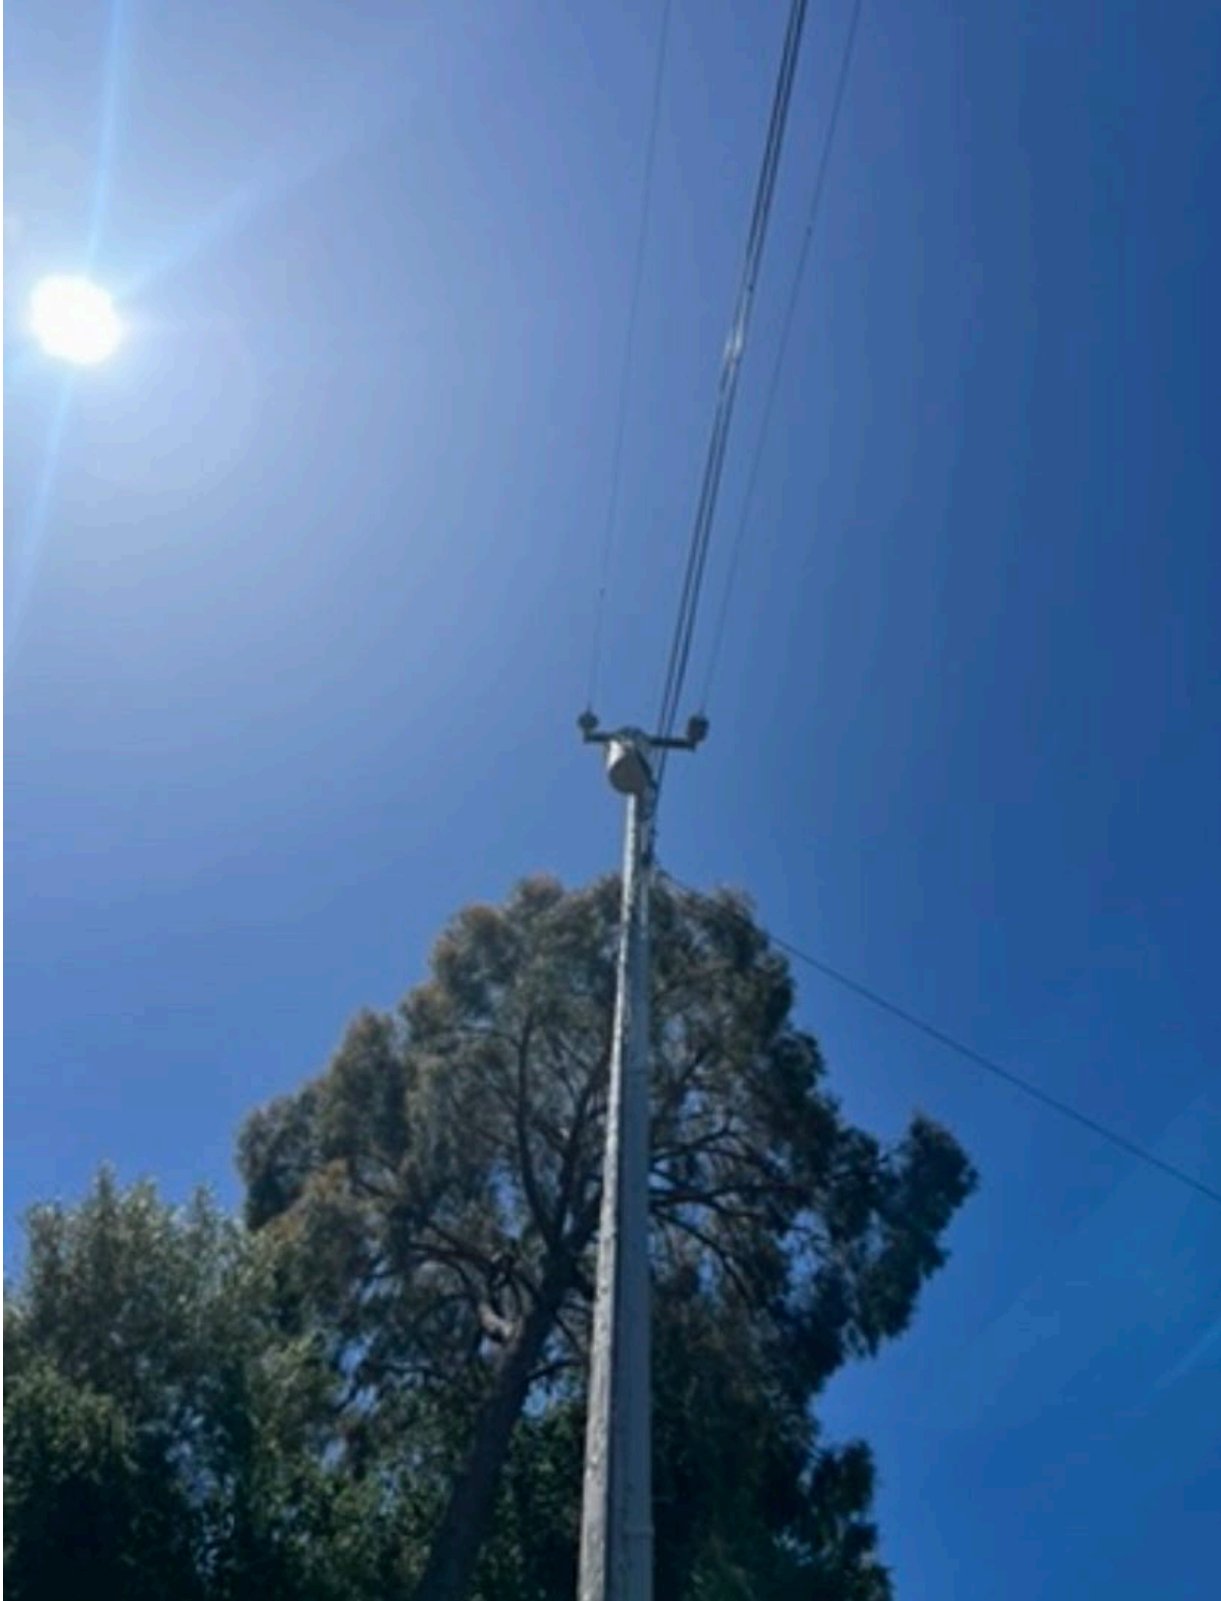
*Figure 4 Top of Pole #1. Photo taken by troubleshooter on June 7, 2024.*

- Create 90-day priority 'B' Tag to reframe and install fiberglass crossarm with arm-mounted cutouts, cutout covers, bushing covers, and insulated jumpers. Pending EC Tag (#129065323).

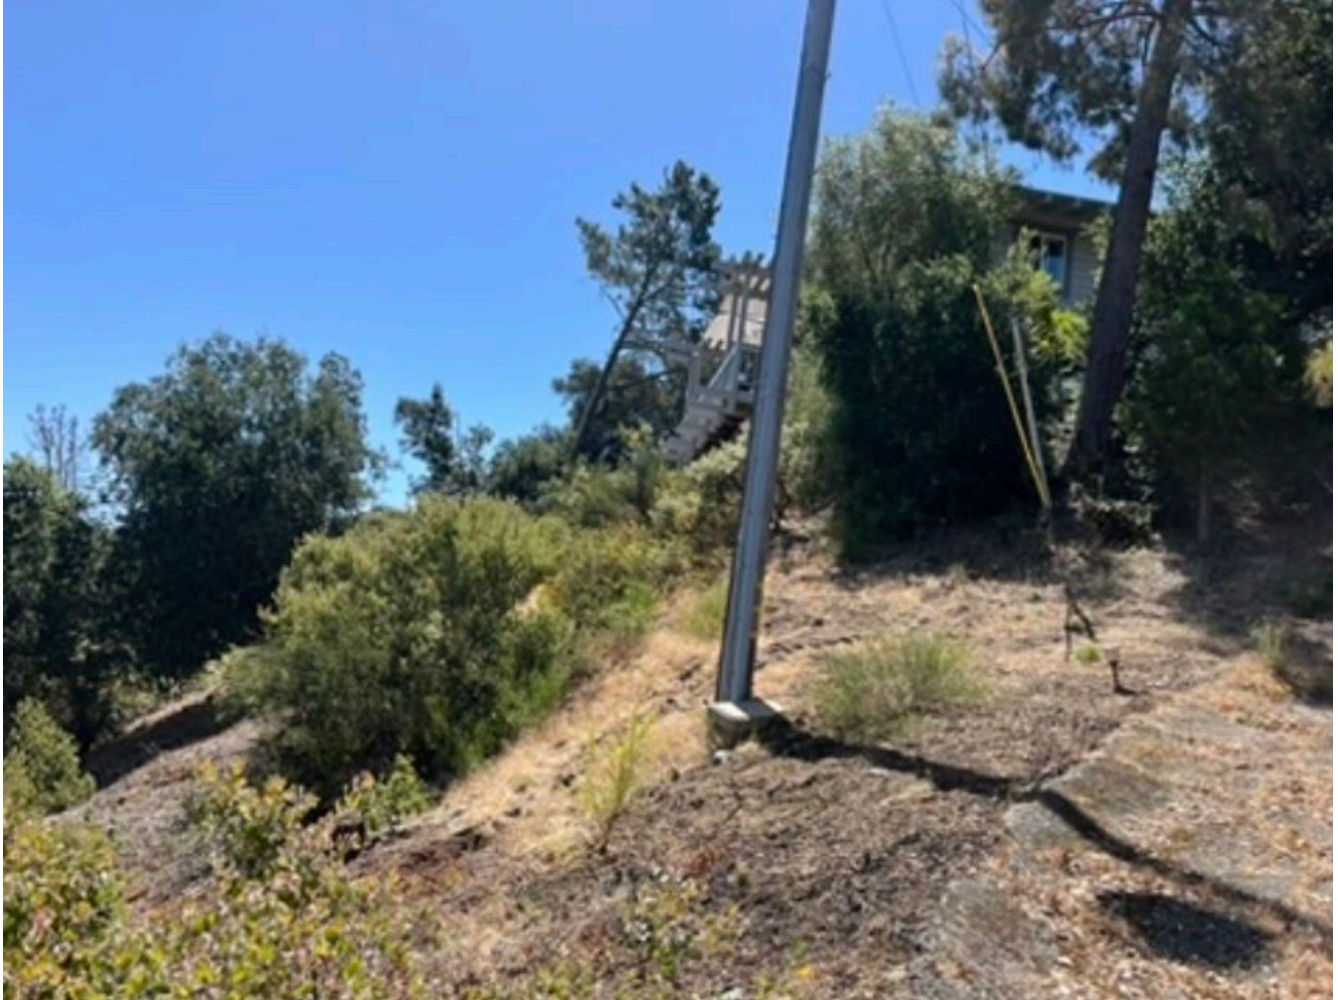
The ignition was isolated to the vegetation for a total space of 20 feet x 20 feet. There were no reports of injuries, fatalities, or property damage. The incident happened on a single-phase primary overhead (OH) distribution circuit, impacting 1,318 customers for a total of 43,072 minutes.

*Figure 5 Burn scar at the base of Pole #1. Photo taken by troubleshooter on June 7, 2024.*

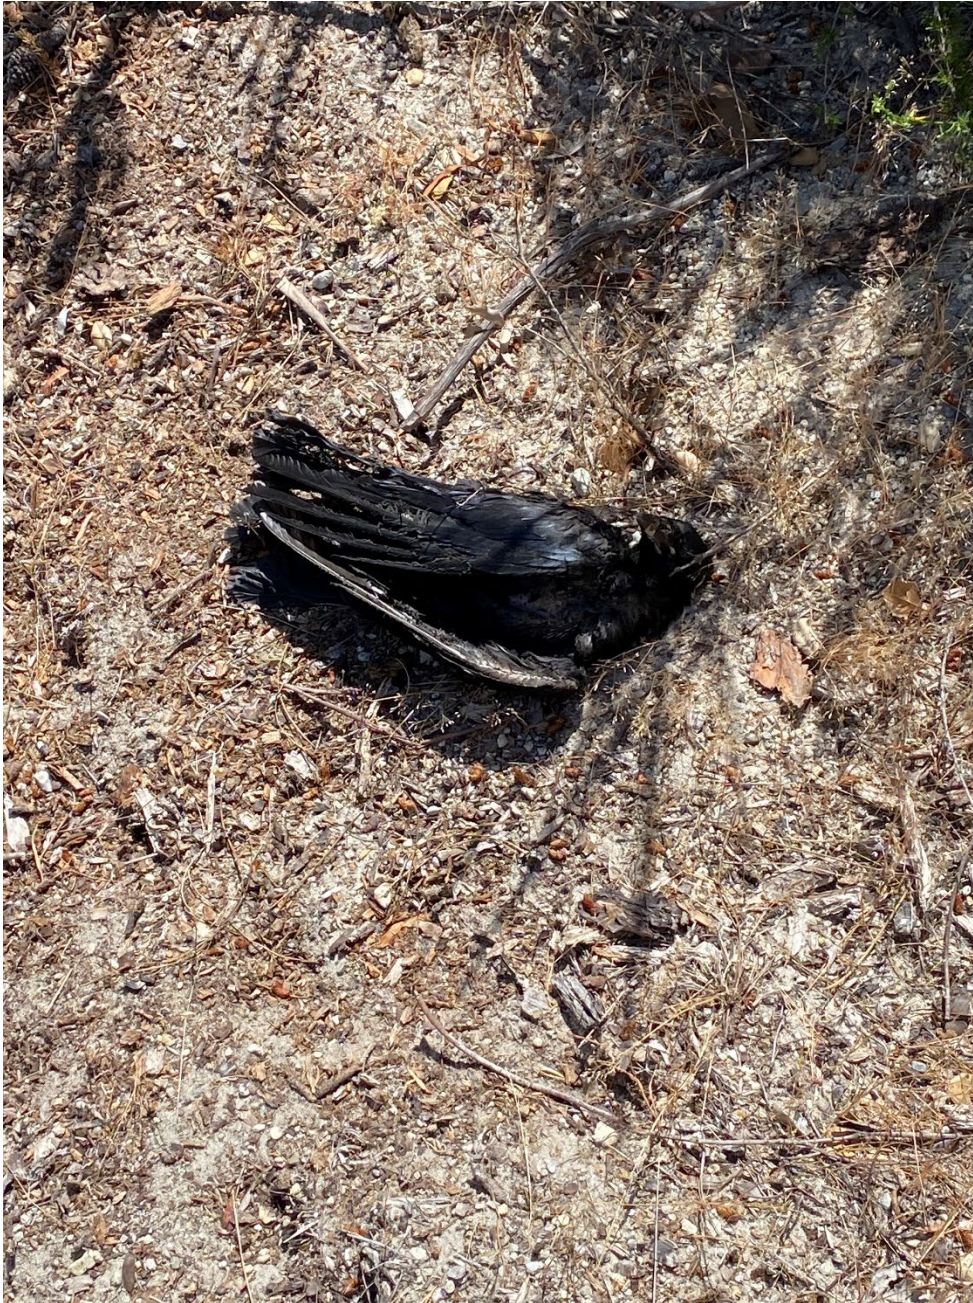
<b>FAS Field Remarks<sup>1</sup>:</b>	Crow found at base of pole below transformer. Patrolled and found no other cause. DO restored via scada.
<b>HAWC Summary<sup>2</sup>:</b>	Resources responded to a vegetation fire, the Noteware Incident. It was located at 745 NOTEWARE DR, ZAYANTE, CA in Santa Cruz County. This is a Tier 3 area. The fire was listed as extinguished. The fire size was listed as 20ft by 20ft. There was an outage associated with this incident. The outages were on the Camp Evers 2105 and the Ben Lomond 0401 circuit with 1187 customers impacted. The OIS number(s) was/were- 2479156, 2479137, 2479135. The closest circuit was the Camp Evers 2105, it was an EPSS circuit. An EPSS Text was sent. An E-page was not sent. A SIPT Engine did not respond to this incident. No notifications were made for this fire as it was reported as extinguished by the dispatch and confirmed by an on-scene report. The threat to PG&E assets had been mitigated. EPSS Text sent at 10:59am. Initial Irwin time: 10:19am. Closing this incident barring any changes.

*Figure 6 Deceased crow found at base of Pole #1. Photo taken by troubleshooter on June 7, 2024.*
