Preliminary Ignition Investigation Report

Ignition Database Index:	20240610
Electric Incident Investigation (EII) Number:	N/A
Incident Name:	N/A
PG&E Facility Ignition?	Yes
CPUC Reportable Ignition?	Yes
Date & Time of Incident:	June 08, 2024 @ 0728 hours
Street Address:	In the vicinity of [REDACTED]
City:	Magalia
County:	Butte
Latitude/Longitude:	[REDACTED]
State Responsibility Area (SRA) / Local Responsibility Area (LRA) / Federal Responsibility Area (FRA)	State Responsibility Area (SRA)
PG&E Division:	North Valley
High Fire Threat District (HFTD):	Tier 3
High Fire Risk Area (HFRA):	Yes
EPSS Buffer:	No
Fire Index Area (FIA):	248
Fire Potential Index (FPI) Rating: FIA	R1
Fire Potential Index (FPI) Rating: Circuit	R3
Was there a PSPS event at the time of ignition?	No
Suspected Initiating Event:	Equipment - Overloaded
Failure Driver:	All types of equipment/facility failure
Failure Sub-driver:	Riser failure
Circuit:	Oro Fino 1102
Circuit Protection Zone:	Oro Fino 1102787504

Executive Summary

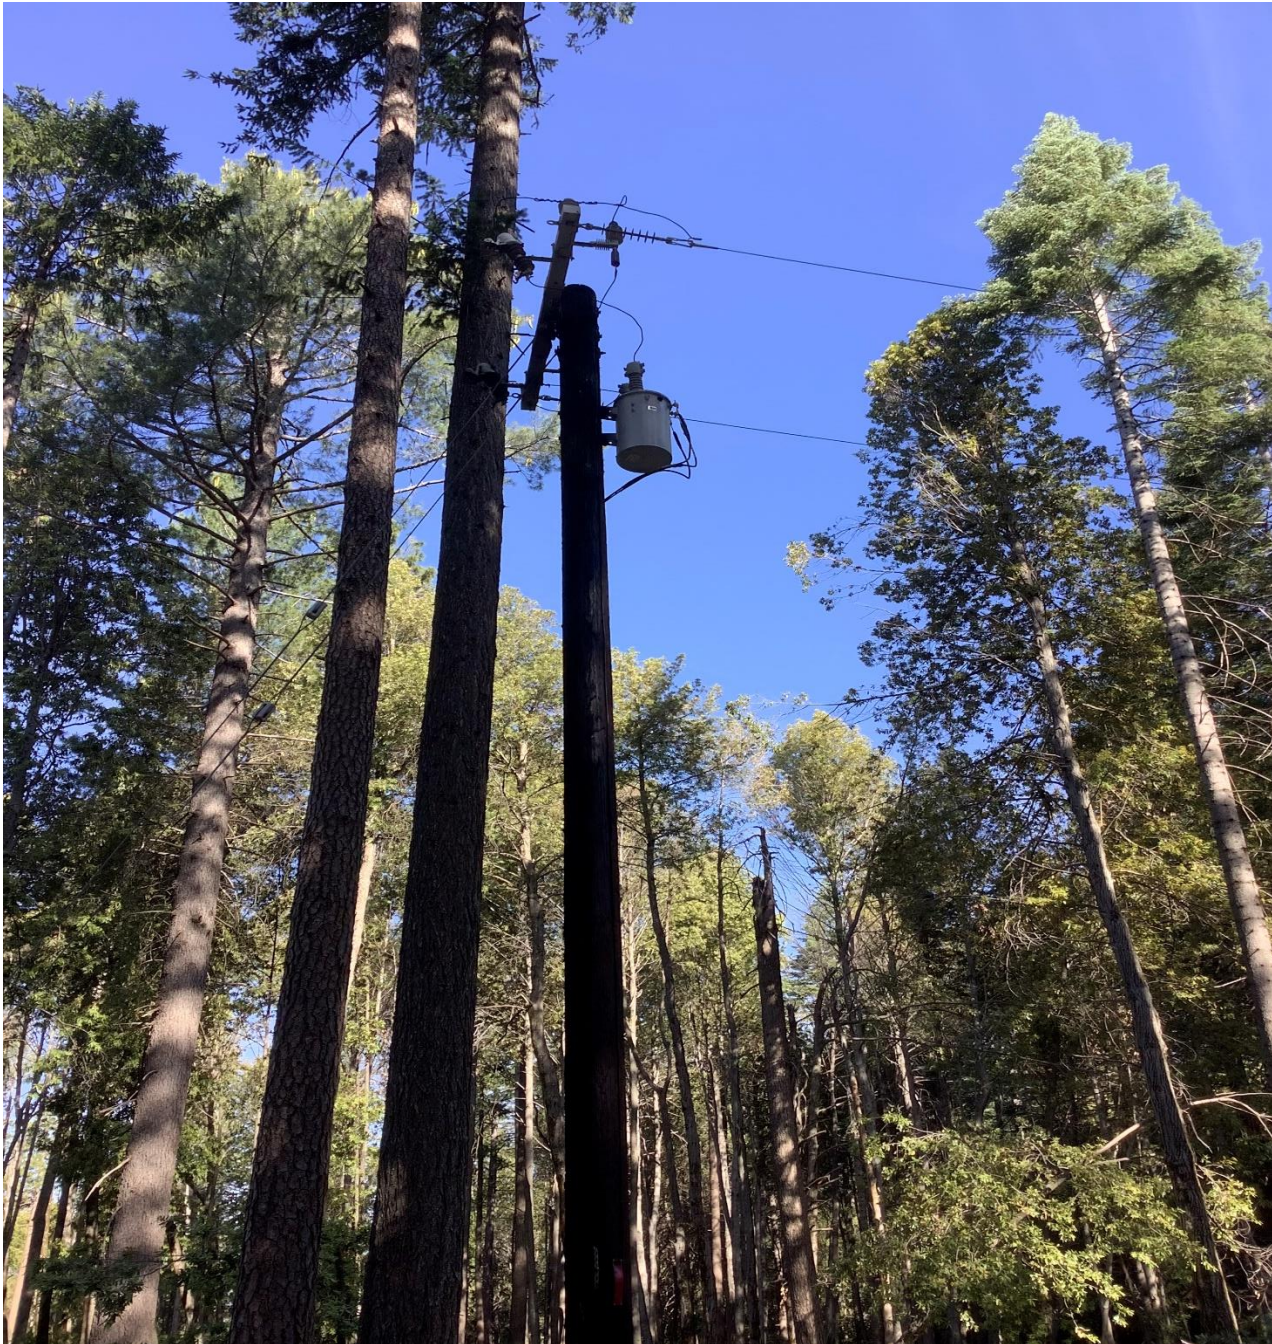
The PG&E troubleshooter arrived on the scene at approximately 0806 hours and observed a fire. The troubleshooter indicated that the secondary service was overloaded from a grow operation. This melted the splices on the secondary riser and bunt the molding and service conductor causing one fuse to blow on the transformer. This led to a vegetation fire on and around the base of SAP Pole ID # 104011327, (see Figures 3, 4, 5, and 6).

Figure 3 - SAP Pole ID: 104011327. Picture taken by the troubleshooter on June 8, 2024

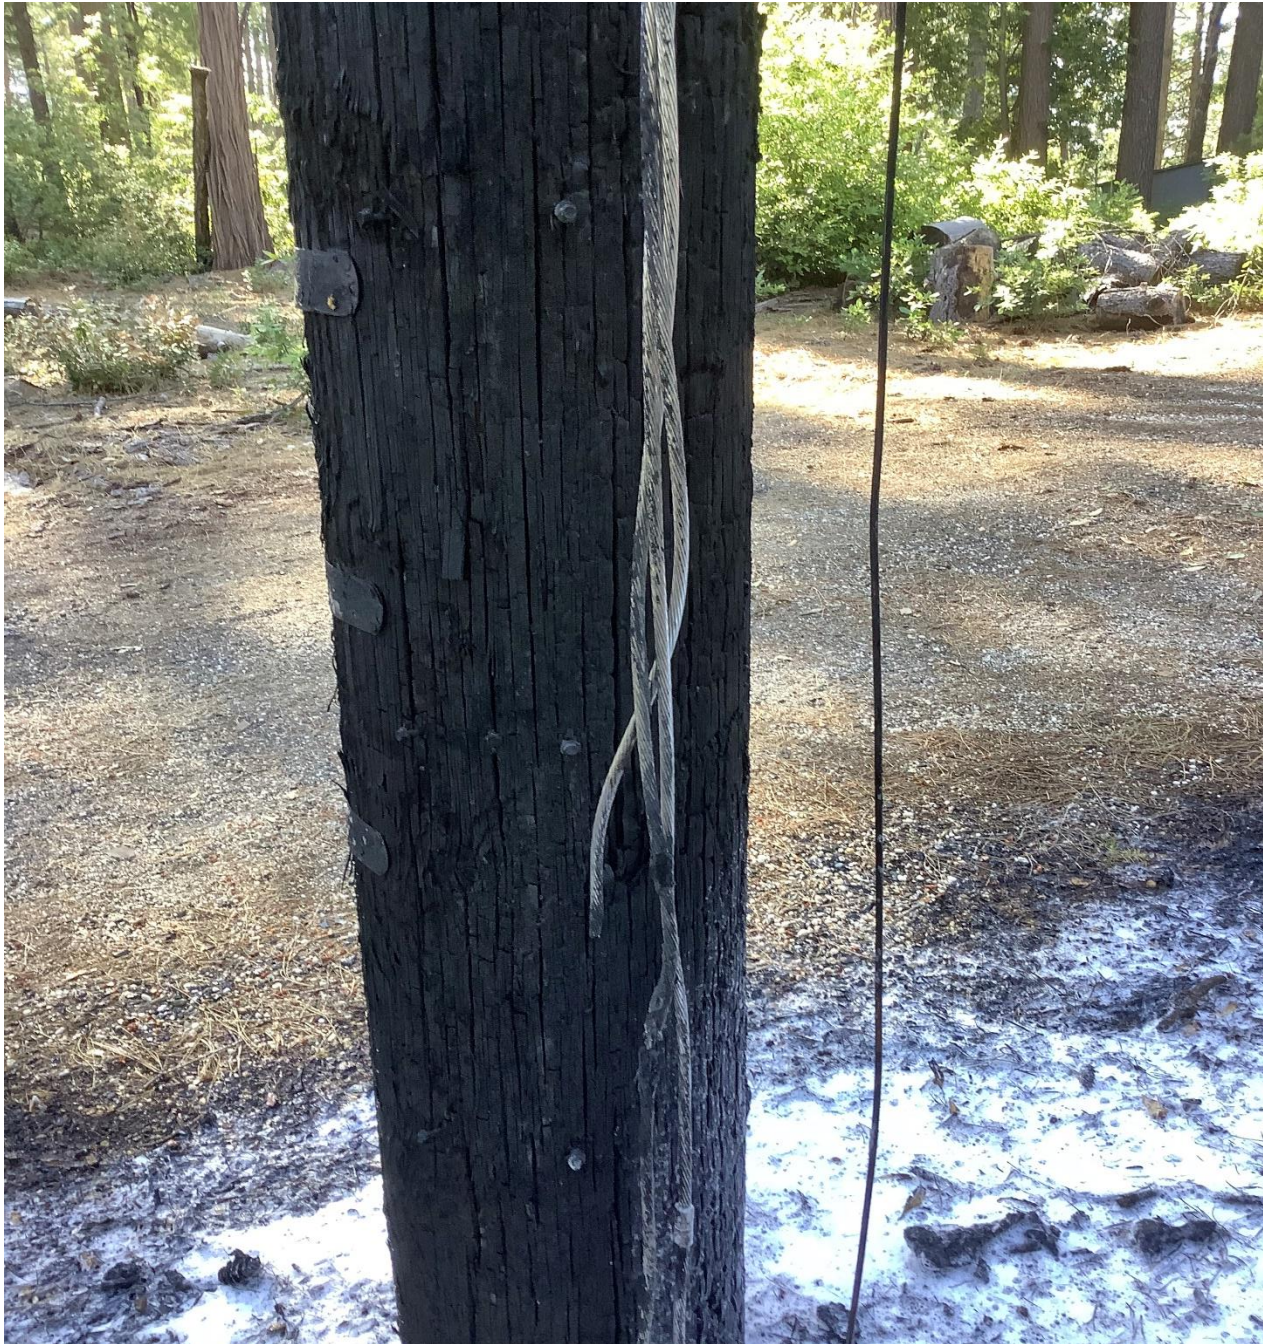
Figure 4 – Ignition and Fire origin area where the secondary riser burnt the molding and service conductor leading to the cause of ignition. Picture taken by the troubleshooter on June 8, 2024.

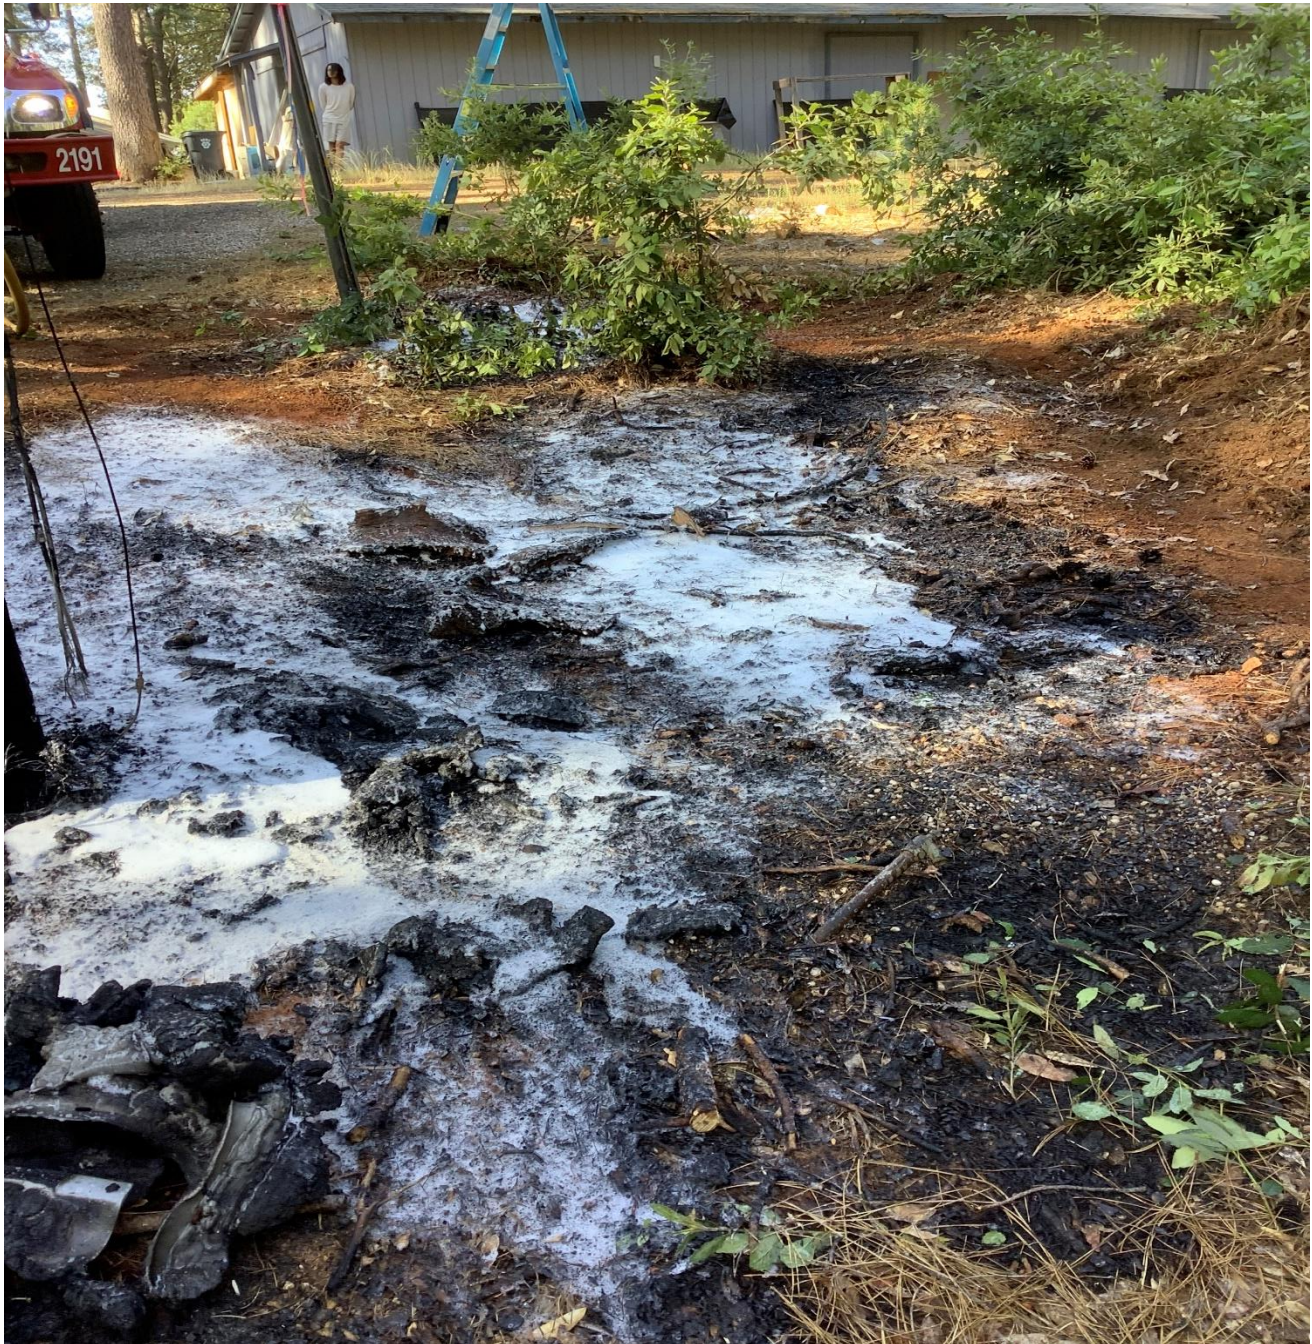
Figure 5 - Fire burn scar area. Picture taken by the troubleshooter on June 8, 2024

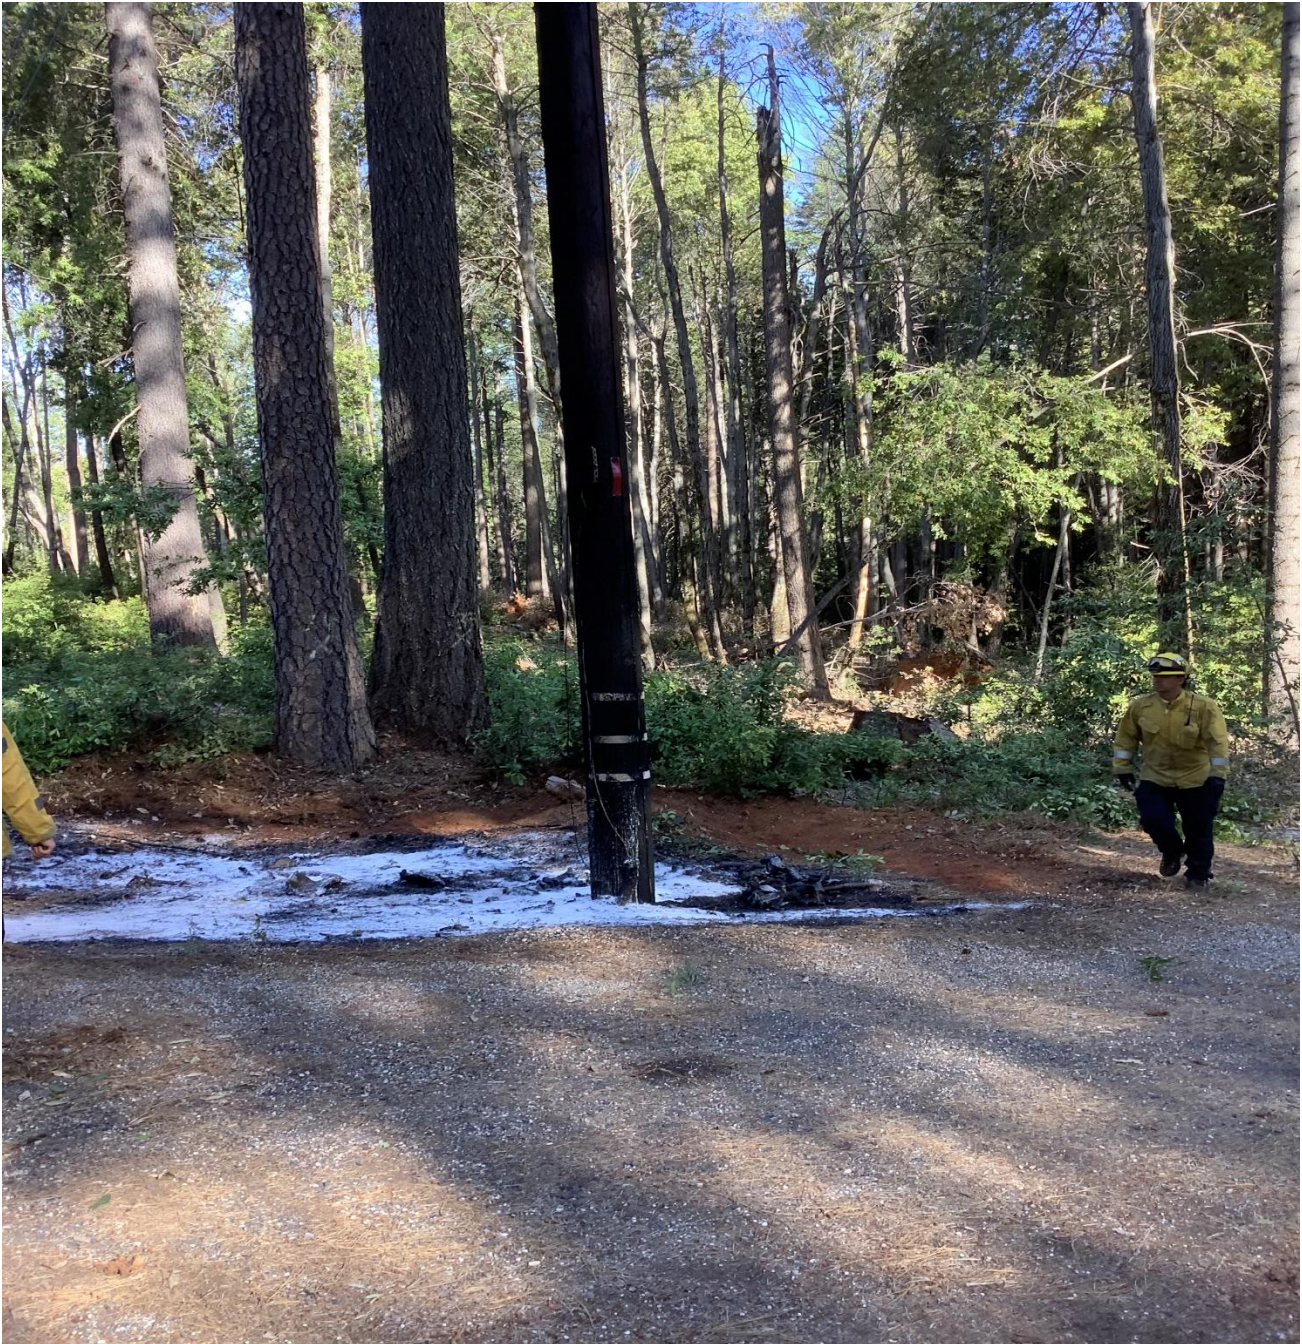
Figure 6 – Butte County CAL FIRE Department onsite to assist in controlling and suppressing the fire spread, picture taken by the troubleshooter on June 8, 2024.

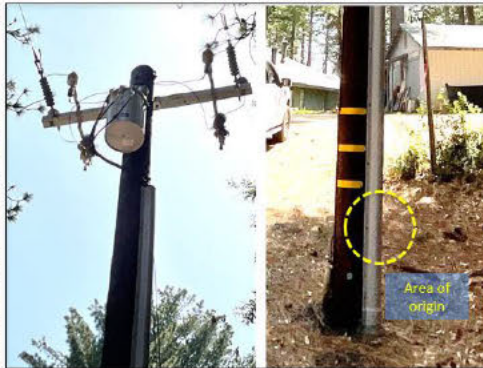
The pole ignition likely resulted from the failure of a secondary riser involving 1/0 aluminum conductors. A visual inspection of the conductor revealed melting patterns on two hot legs, leading to the breakage of aluminum strands near the ground line. Significant thermal damage was observed on a compression splice, which appears to be the initial failure point, (see Figures 7 and 8).

Figure 7 - The pole ignition likely resulted from the failure of a secondary riser involving 1/0 aluminum conductors. A visual inspection of the conductor revealed melting patterns on two hot legs, leading to the breakage of aluminum strands near the ground line.

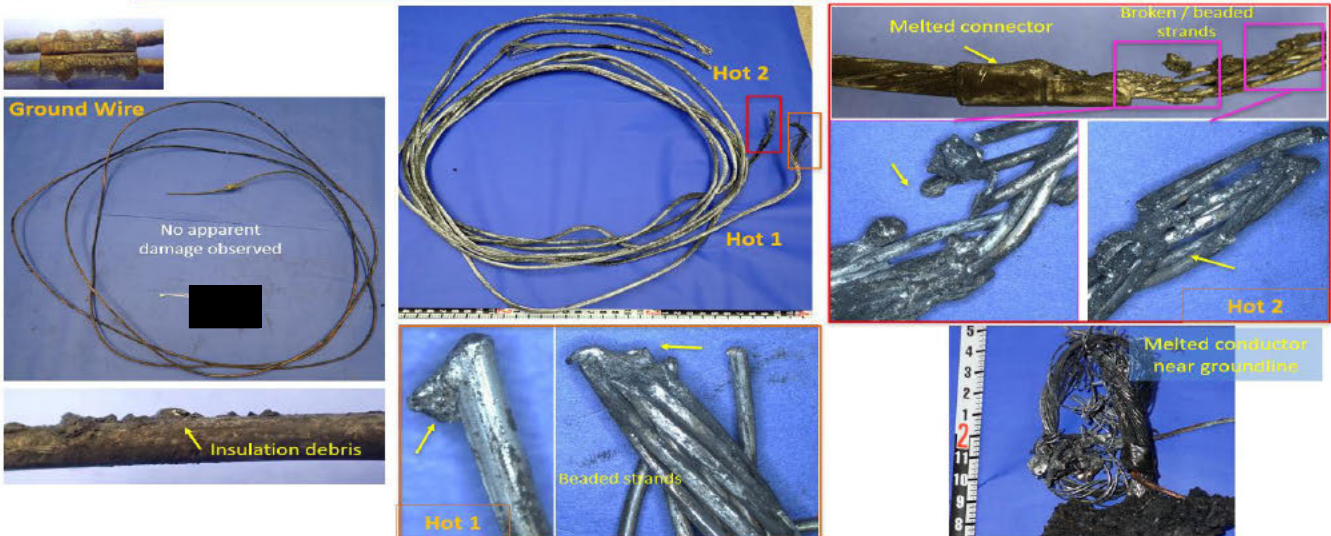
Figure 8 - Significant thermal damage was observed on a compression splice, which appears to be the initial failure point.

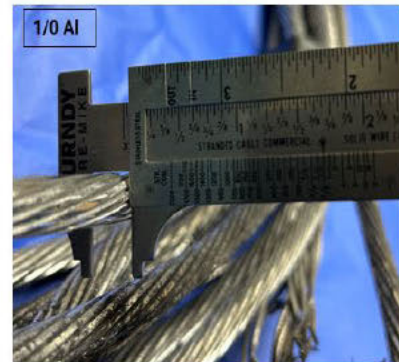
Historical data indicates that the transformer, with a nominal capacity of 15 kVA, has been consistently loaded beyond 30 kVA since 2021. This electrical overload may have caused a hotspot, leading to the deterioration of the connector, (see Figure 9).

Figure 9 - Historical data indicates that the transformer, with a nominal capacity of 15 kVA, has been consistently loaded beyond 30 kVA since 2021. This electrical overload may have caused a hotspot, leading to the deterioration of the connector.

ER Notification priority “G” Tag (#129228069) was created to disconnect service and replace the transformer that was overloaded from a grow operation and was serviced by an underground riser that led from SAP Pole ID: 104011327. Repair work has not been completed and power has not been reconnected as the date of this report being finalized.

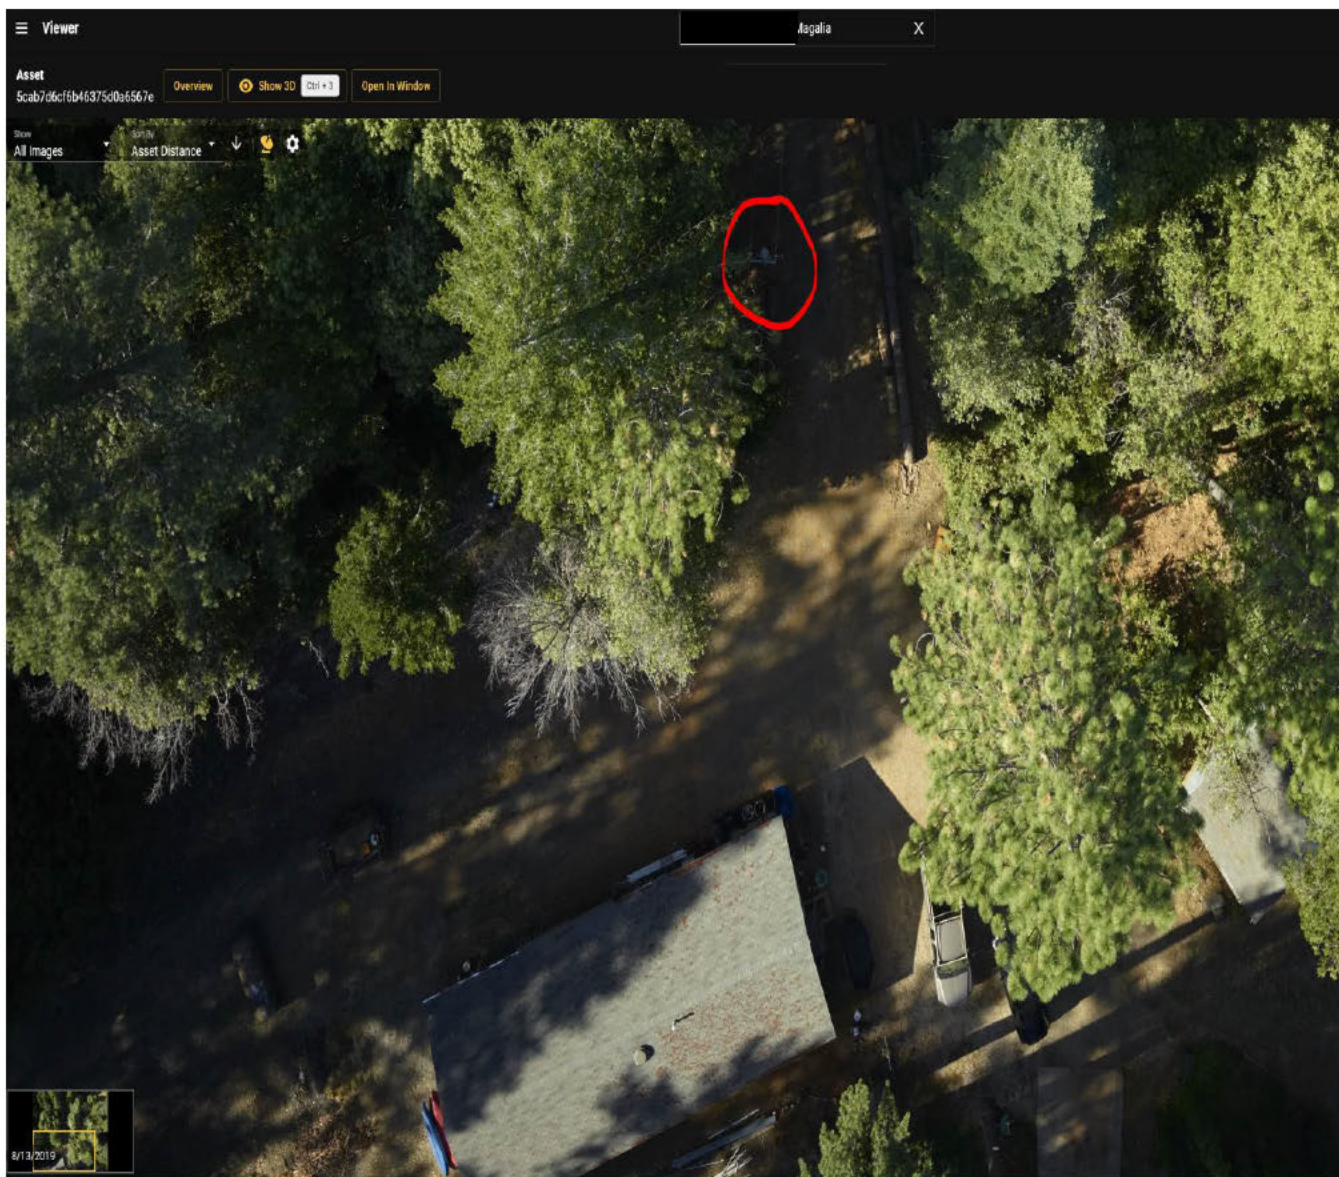
Source Side Structure	SAP Pole ID: 104011327 - Dead-End Pole	
Info / Inspection	Most Recent Date	Findings
Install Date:	January 1, 2021	Wood Pole – Class 1 – Height 45’
Inspection:	April 26, 2022	GO165 Inspection – No declaration items reported
	April 22, 2021	GO165 Inspection – No declaration items reported
Patrol:	N/A	
	N/A	
Corrective History:	June 12, 2024	ER Notification priority “G” Tag (#129228069) was created to disconnect service and Replace a Transformer that Overloaded from a grow operation that was serviced by an underground riser that led from SAP Pole ID: 104011327.
Aerial Inspection Records:	August 13, 2019	SAP Pole ID 104011327 (Shaper Shape) No abnormal conditions visible, (see Figure 10).
VM Inspection:	N/A	
EVM Inspection:	N/A	
Equipment Test:	N/A

Figure 10 - SAP Pole ID: 104011327 (Incident Pole), picture taken from Shaper Shape dated August 13, 2019
