Preliminary Ignition Investigation Report

Ignition Database Index:	20240916N
Electric Incident Investigation (EII) Number:	N/A
Incident Name:	Infrastructure In Calaveras
PG&E Facility Ignition?	Yes
CPUC Reportable Ignition?	Yes
Date & Time of Incident:	May 21, 2024 @ 1640 hours
Street Address:	Vallecito Road and Tyrone Road
City:	Angels Camp
County:	Calaveras
Latitude/Longitude:	38.067161, -120.537208
State Responsibility Area (SRA) / Local Responsibility Area (LRA) / Federal Responsibility Area (FRA)	LRA
PG&E Division:	Stockton
High Fire Threat District (HFTD):	Tier 2
High Fire Risk Area (HFRA):	Yes
EPSS Buffer:	No
Fire Index Area (FIA):	320
Fire Potential Index (FPI) Rating: FIA	R1
Fire Potential Index (FPI) Rating: Circuit	R1
Was there a PSPS event at the time of ignition?	No
Suspected Initiating Event:	Utility Work/Operation
Failure Driver:	Utility Work/Operation
Failure Sub-driver:	Utility Work/Operation
Circuit:	Frogtown 1701
Circuit Protection Zone:	Frogtown1701CB

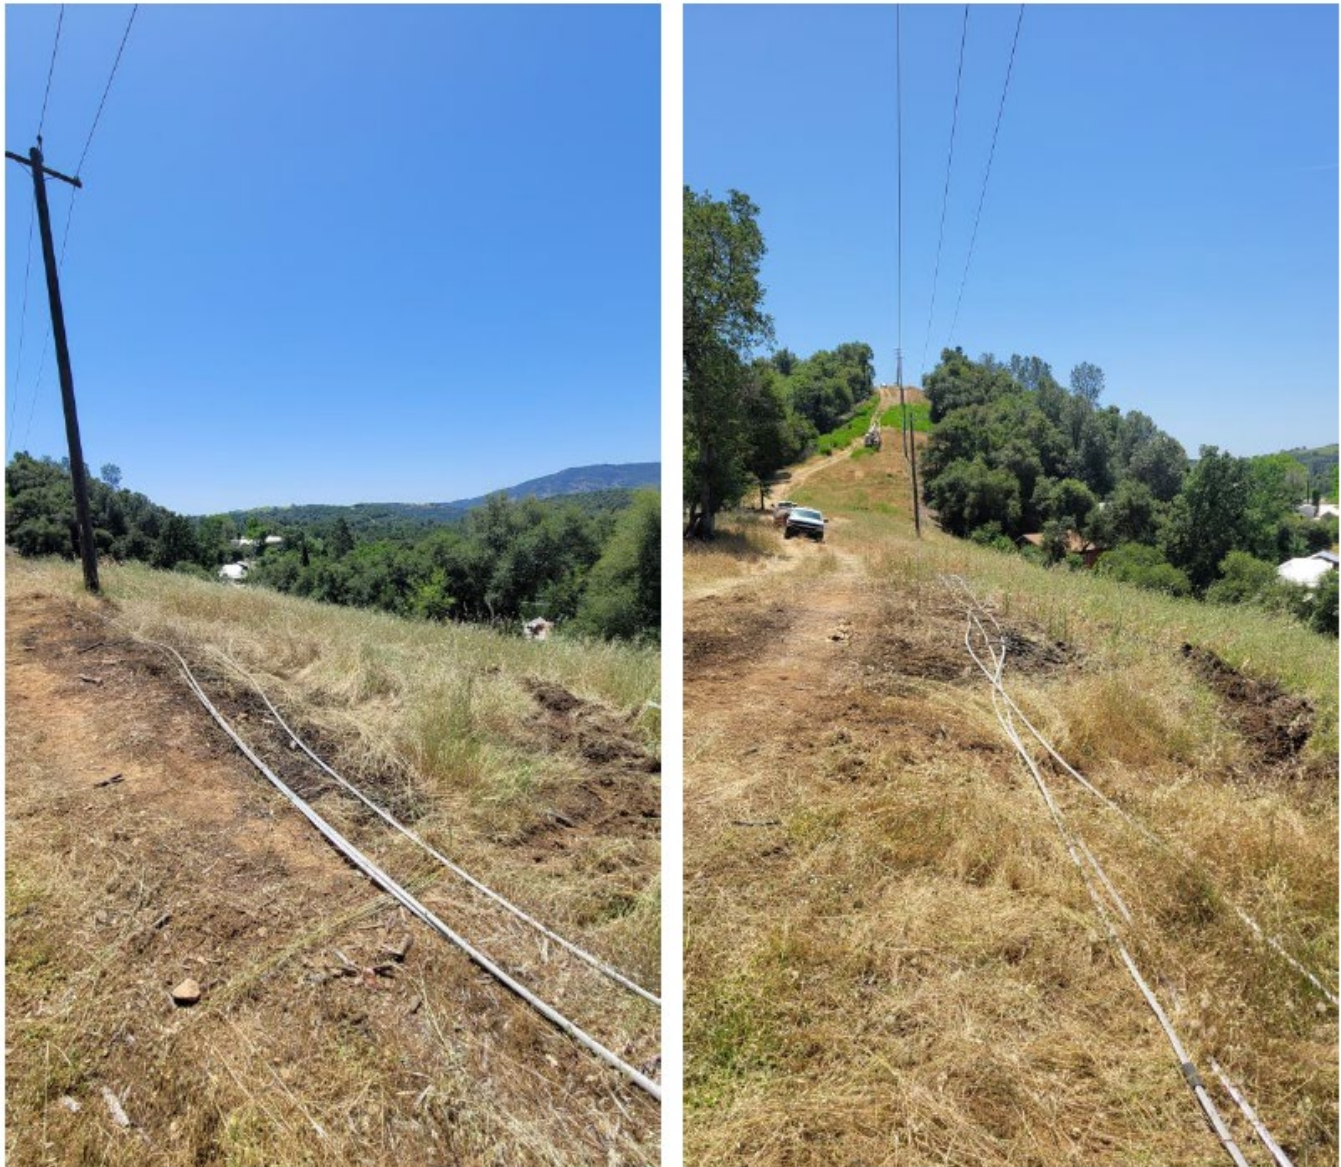
Figure 2: Pictures of the two fire footprints taken by the Crew.

The two ignitions were isolated to grassy vegetation, resulting in two burn scars approximately 20 x 25 feet and the 20 x 35 feet. There were no reports of injuries, fatalities, or property damage. There was no outage, and no customers were impacted.
