## Preliminary Ignition Investigation Report

Ignition Database Index:	20240922
Electric Incident Investigation (EII) Number:	N/A
Incident Name:	Irish Fire
PG&E Facility Ignition?	Yes
CPUC Reportable Ignition?	Yes
Date & Time of Incident:	July 11, 2024 @ 1316 hours
Street Address:	3980 Tunitas Creek Rd/10PSW
City:	Half Moon Bay
County:	San Mateo
Latitude/Longitude:	37.3960774596, -122.3651431923
State Responsibility Area (SRA) / Local Responsibility Area (LRA) / Federal Responsibility Area (FRA)	State Responsibility Area (SRA)
PG&E Division:	Peninsula
High Fire Threat District (HFTD):	Tier 3
High Fire Risk Area (HFRA):	Yes
EPSS Buffer:	No
Fire Index Area (FIA):	500
Fire Potential Index (FPI) Rating: FIA	R1
Fire Potential Index (FPI) Rating: Circuit	R1
Was there a PSPS event at the time of ignition?	No
Suspected Initiating Event:	Contact – 2nd Party (Davey Tree Surgery)
Failure Driver:	Contact from Object
Failure Sub-driver:	Contact – Vegetation
Circuit:	Half Moon Bay 1103

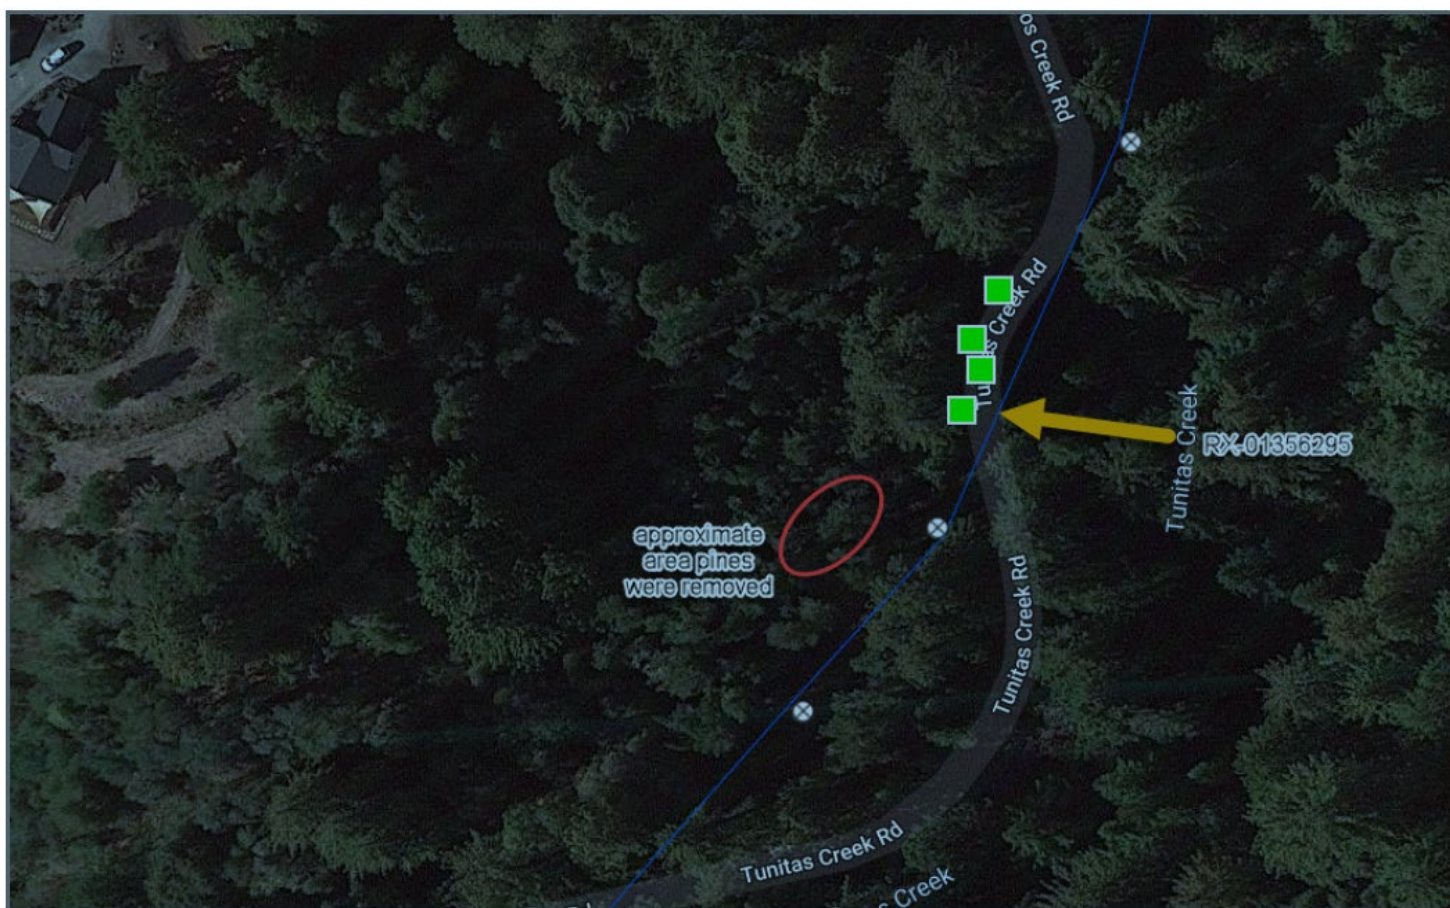
A Davey Tree Surgery investigation indicated a foreman instructed his team to remove multiple Monterey pine (*Pinus radiata*) trees blocking access to a prescribed removal of a 120-foot-tall coast redwood (*Sequoia sempervirens*). The removal of the trees blocking access to the redwood was unauthorized. In the process of removing one of the unauthorized trees, a limb from the Incident Tree removed crossed an adjacent tree restricting the intended path of fall causing the tree to spin and fall in an unintended direction. The tree fell into the primary conductors, causing a wire down and ignition.

A PG&E Vegetation Management inspector (VMI) performed a post-incident investigation on July 11, 2024. The (VMI) stated that a Davey Tree Surgery crew had cut three trees that were not on a work request to gain better access to a redwood tree prescribed for removal. In the process of removing a 14-inch DBH, 85-foot-tall Monterey pine (*Pinus radiata*), the tree twisted and made contact with the lines, bringing them down and started a fire.

Figure 3: Vegetation Management exhibit showing location of prescribed trees for removal (green) and location of unauthorized fell location of incident tree.

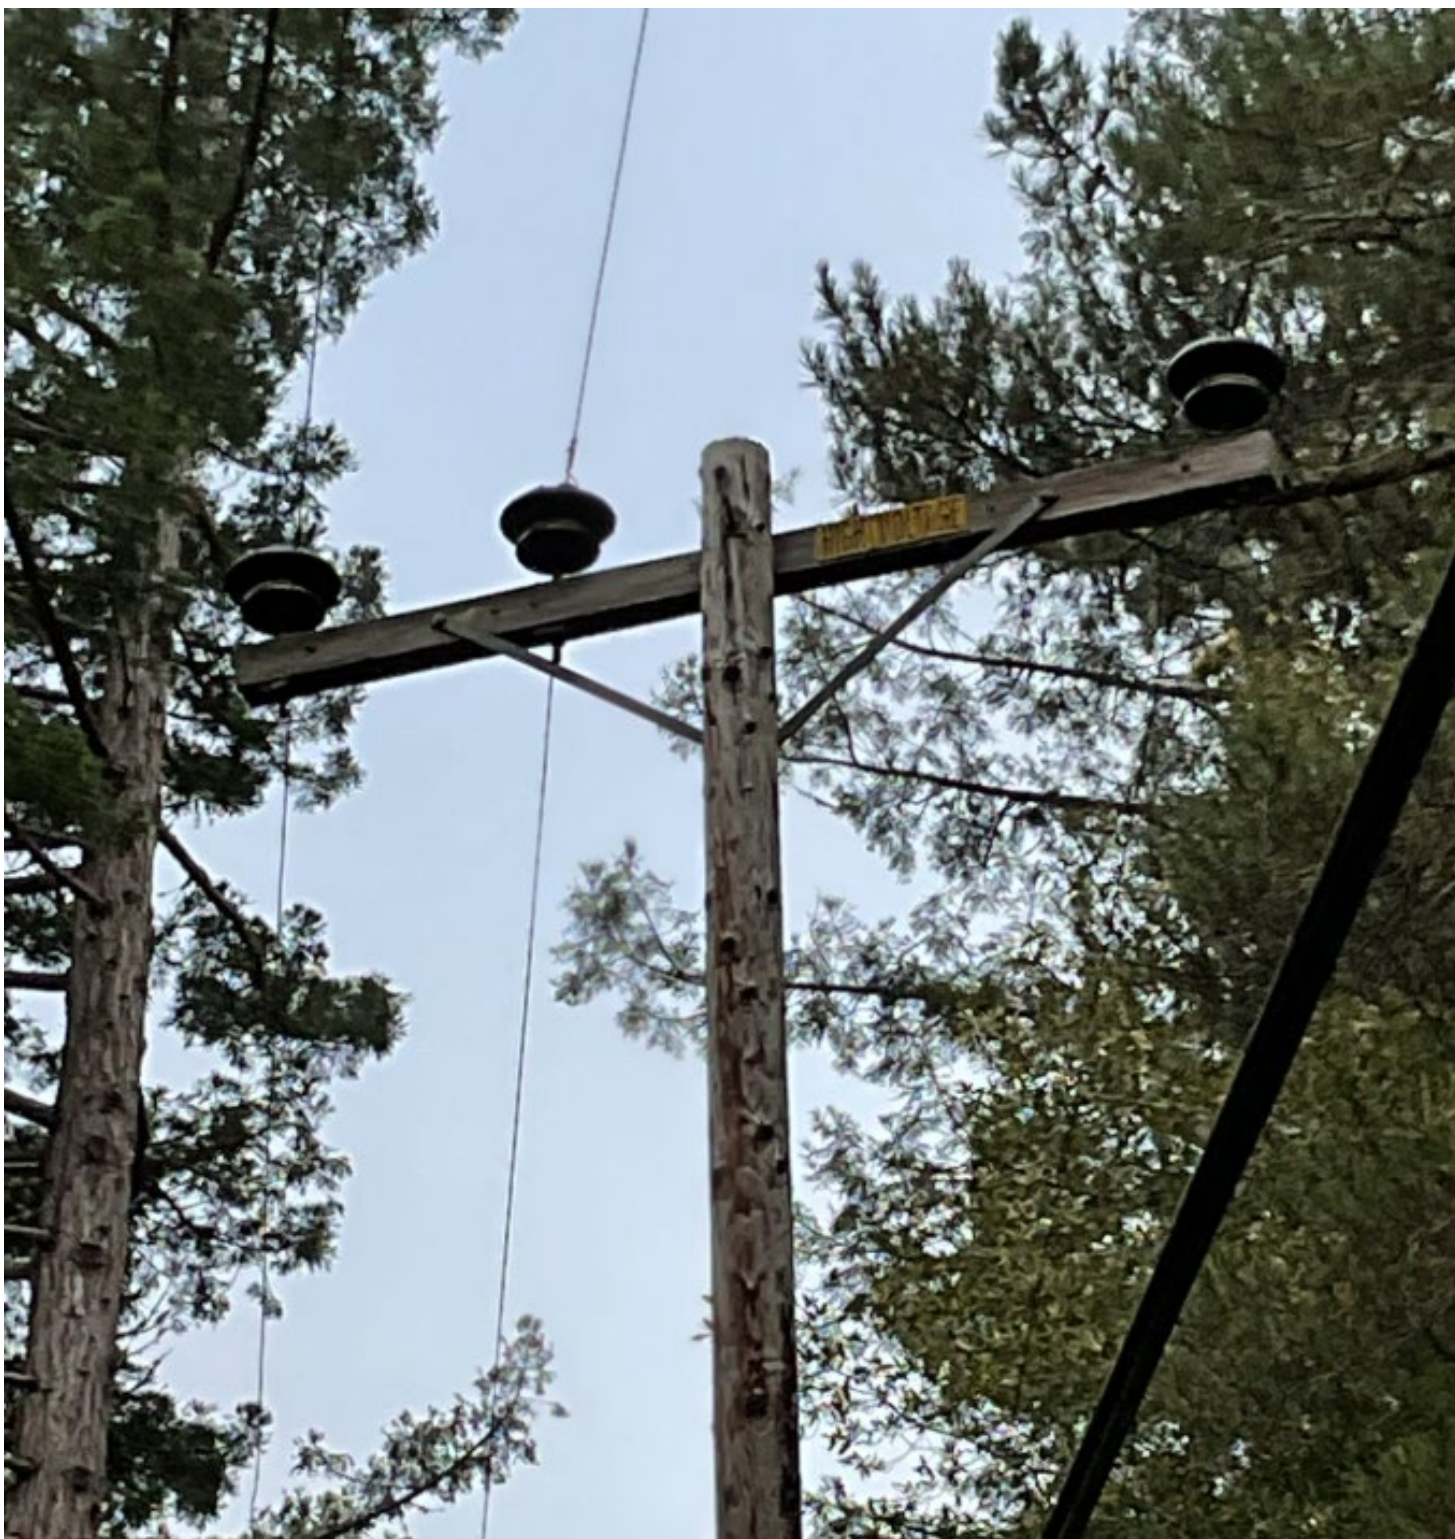
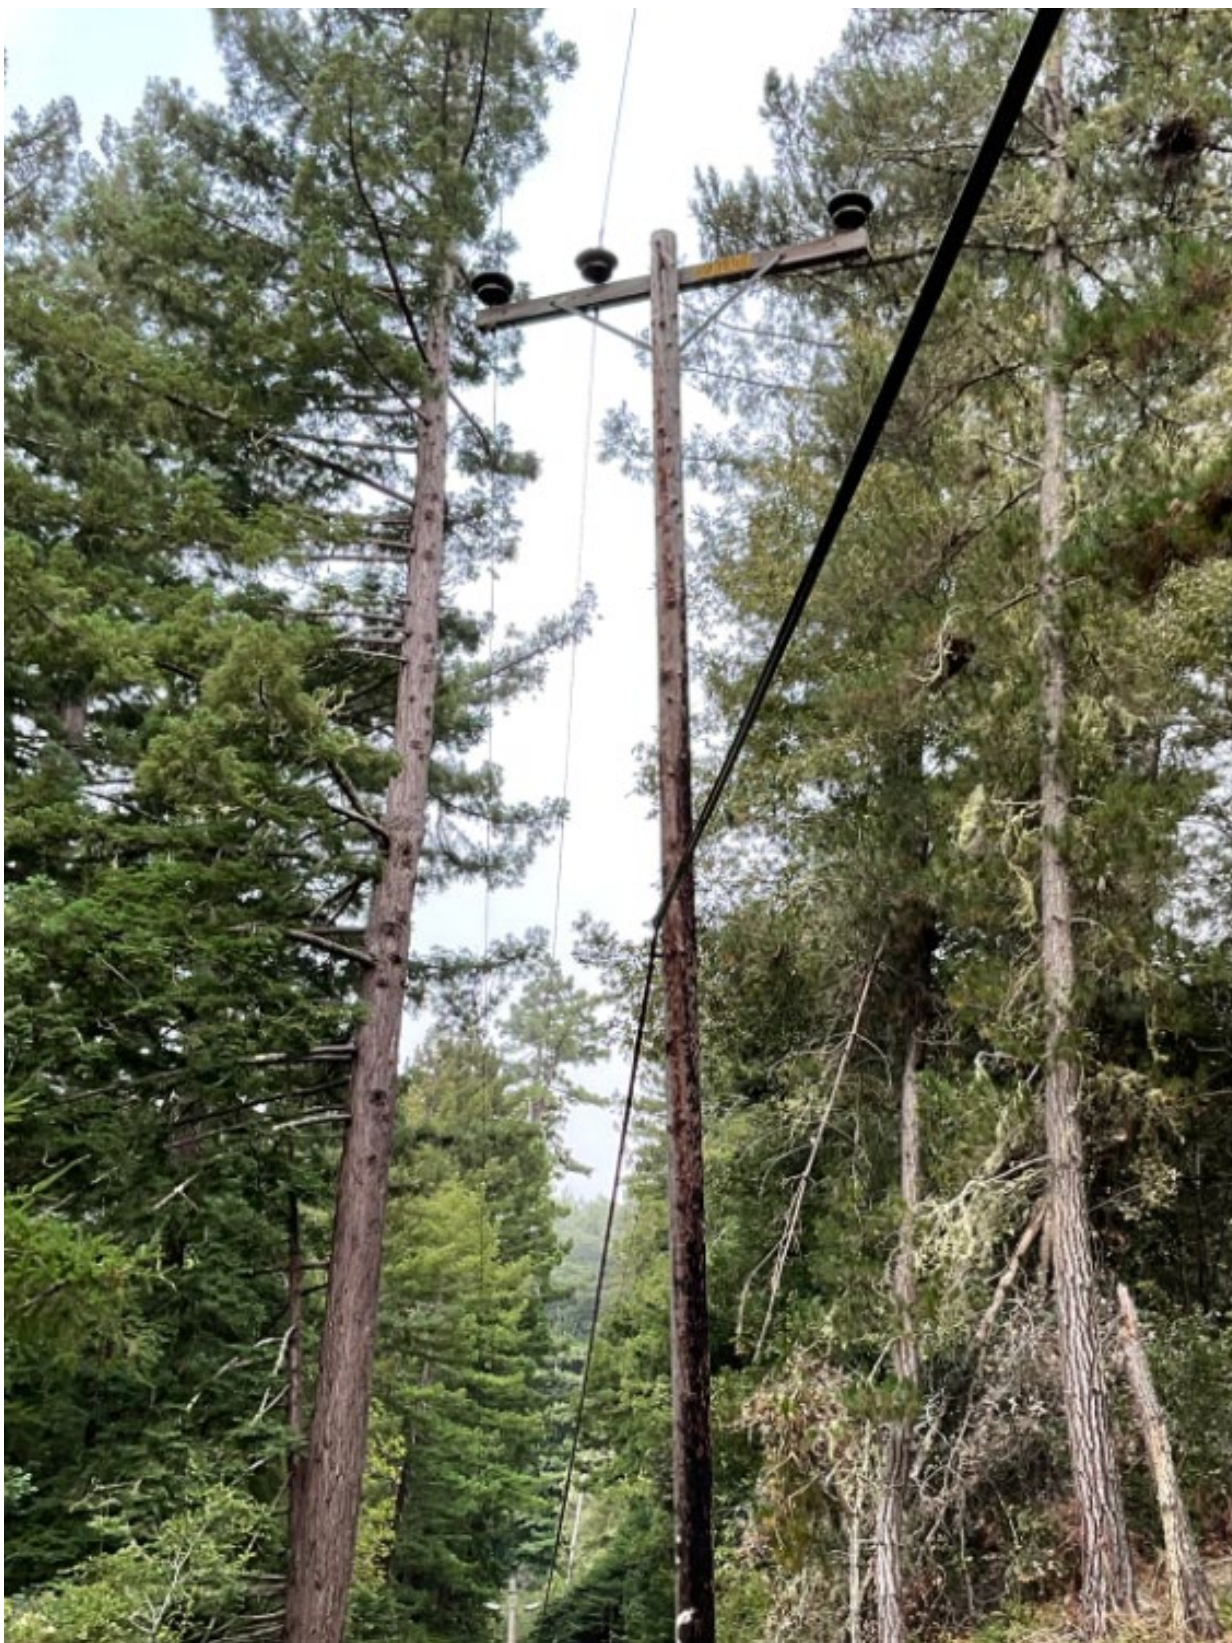
close proximity to insulator, adjust.			
EC Notification (SAP ID 100270326)	124099876	Hand ties have come loose, and insulators turned sideways. Wire is no longer lying in the groove of the insulator.	E	7/17/2022	01/17/2023
COE Notification		N/A			
LC Notification		N/A			
Veg Work Order	RX-01356295	Removal of 120' Redwood tree	Routine	2/2/2024	2/2/2025

Load Side Structure	Pole #1: SAP Pole ID: 100270325 (	
Info / Inspection	Most Recent Date	Findings
Install Date:	01/01/1964	Lodgepole Pine – Class 6 – Height 35'
Inspection:	07/17/2022	Hand or preform tie wire broken, damaged, burnt, loose, showing signs of wearing, missing, or missing armor rod. EC Notification: Tie Wire, Broken/Damaged, Replace.

05/27/2021	Pole leaning or out of plumb by more than 10% of its height above the ground. Necessary guys missing or loose. Anchor rod broken, damaged, corroded, covered by vegetation/overgrown, soil-eroded, graded, or buried. Pending EC tag 117214192
Patrol:	10/01/2023	There were no compelling abnormal conditions reported
	08/09/2019	There were no compelling abnormal conditions reported
Corrective History:	N/A	
Aerial Inspection Records:	N/A	
VM Inspection:	2/2/2024	Prescribed trees identified for removal
EVM Inspection:	N/A	
Equipment Test:	N/A	
Pole Intrusive Test:	09/12/2016	Passed with 99% wood strength
WSIP Inspection:	05/11/2019	Pole leaning more than 10%. Create EC Notification

Figure 4: 2022 Inspection photo of upper 1/3 of SAP 100270326

Figure 5: Additional 2022 Inspection photo of SAP 100270326

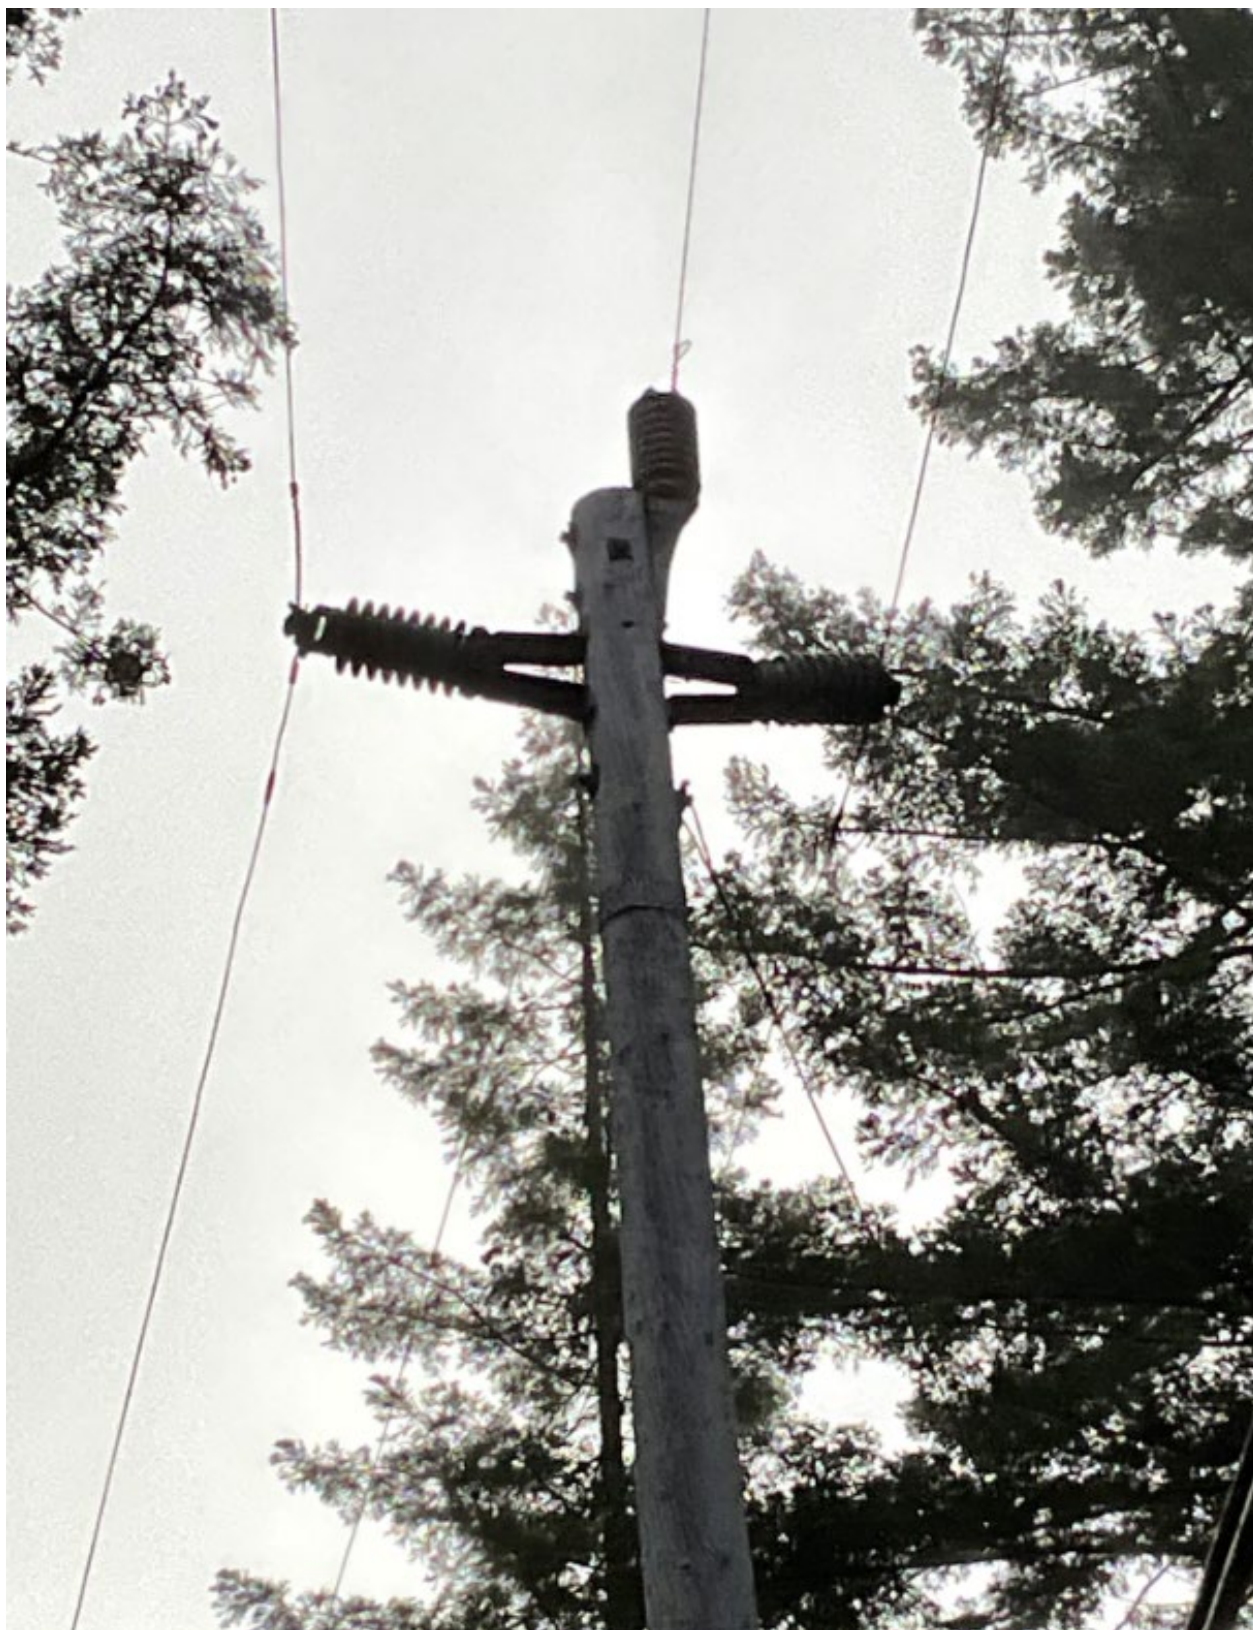
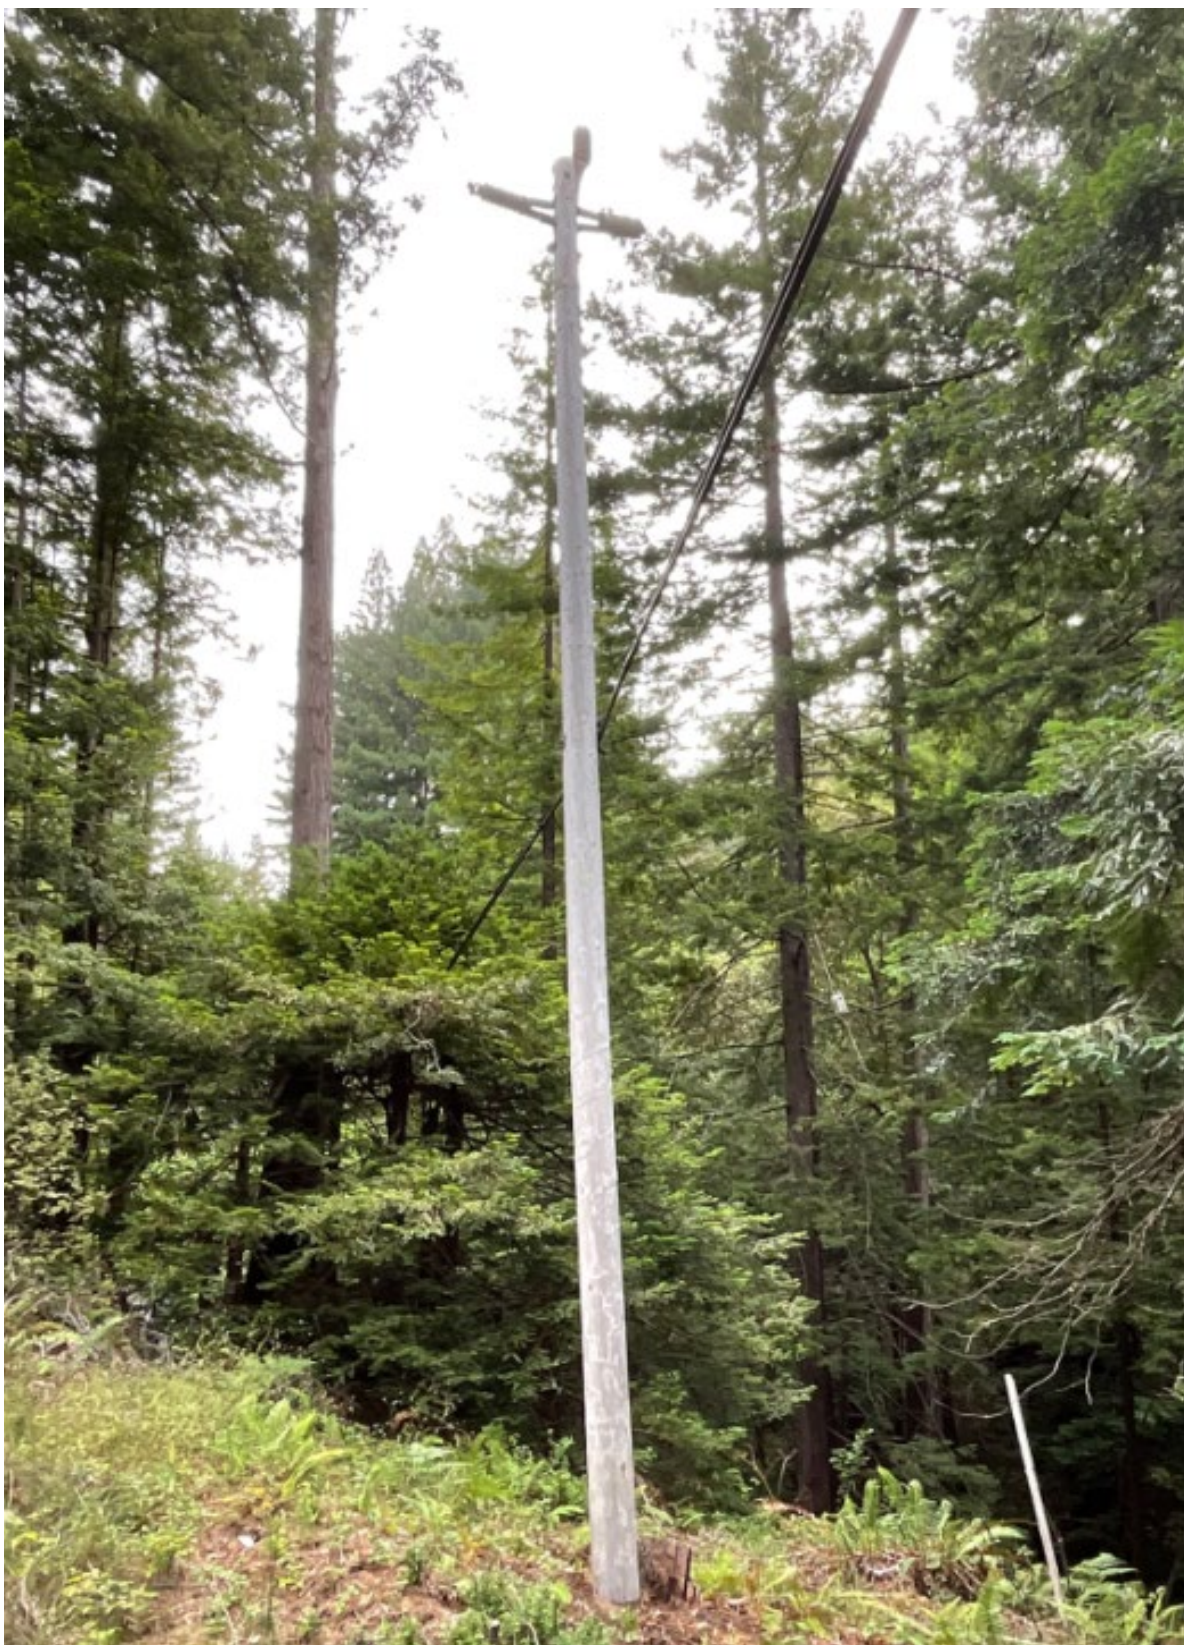
Type	Number	Description	Priority	Date Identified	Due Date
EC Notification	121430701	Guy loose at SAP pole ID 100270325, adjust. Splice in	E	5/27/2021	11/27/2021

Source Side Structure	Pole #2: SAP Pole ID 100270325	
Info / Inspection	Most Recent Date	Findings
Install Date:	01/01/1976	Lodgepole Pine – Class 6 – Height 35'
Inspection:	07/17/2022	Conductor has splices tied in proximity to insulator preventing free movement of splice with conductor.
	05/27/2021	Necessary guys missing or loose. Create EC tag for Guy, Loose, Adjust. Conductor, Clearance Impaired, Adjust
Patrol:	10/01/2023	No Findings
	08/09/2019	No Findings
Corrective History:	N/A	
Aerial Inspection Records:	N/A	
VM Inspection:	2/2/2024	
EVM Inspection:	N/A	
Equipment Test:	N/A	
Pole Intrusive Test:	7/8/2022	Inspection Result: Pass
WSIP Inspection:	04/15/2019	Unable to gain access to pole.

Figure 6: 2022 Inspection Photo of top 1/3 of SAP 100270325

Figure 7: Additional 2022 Inspection photo of SAP 100270325

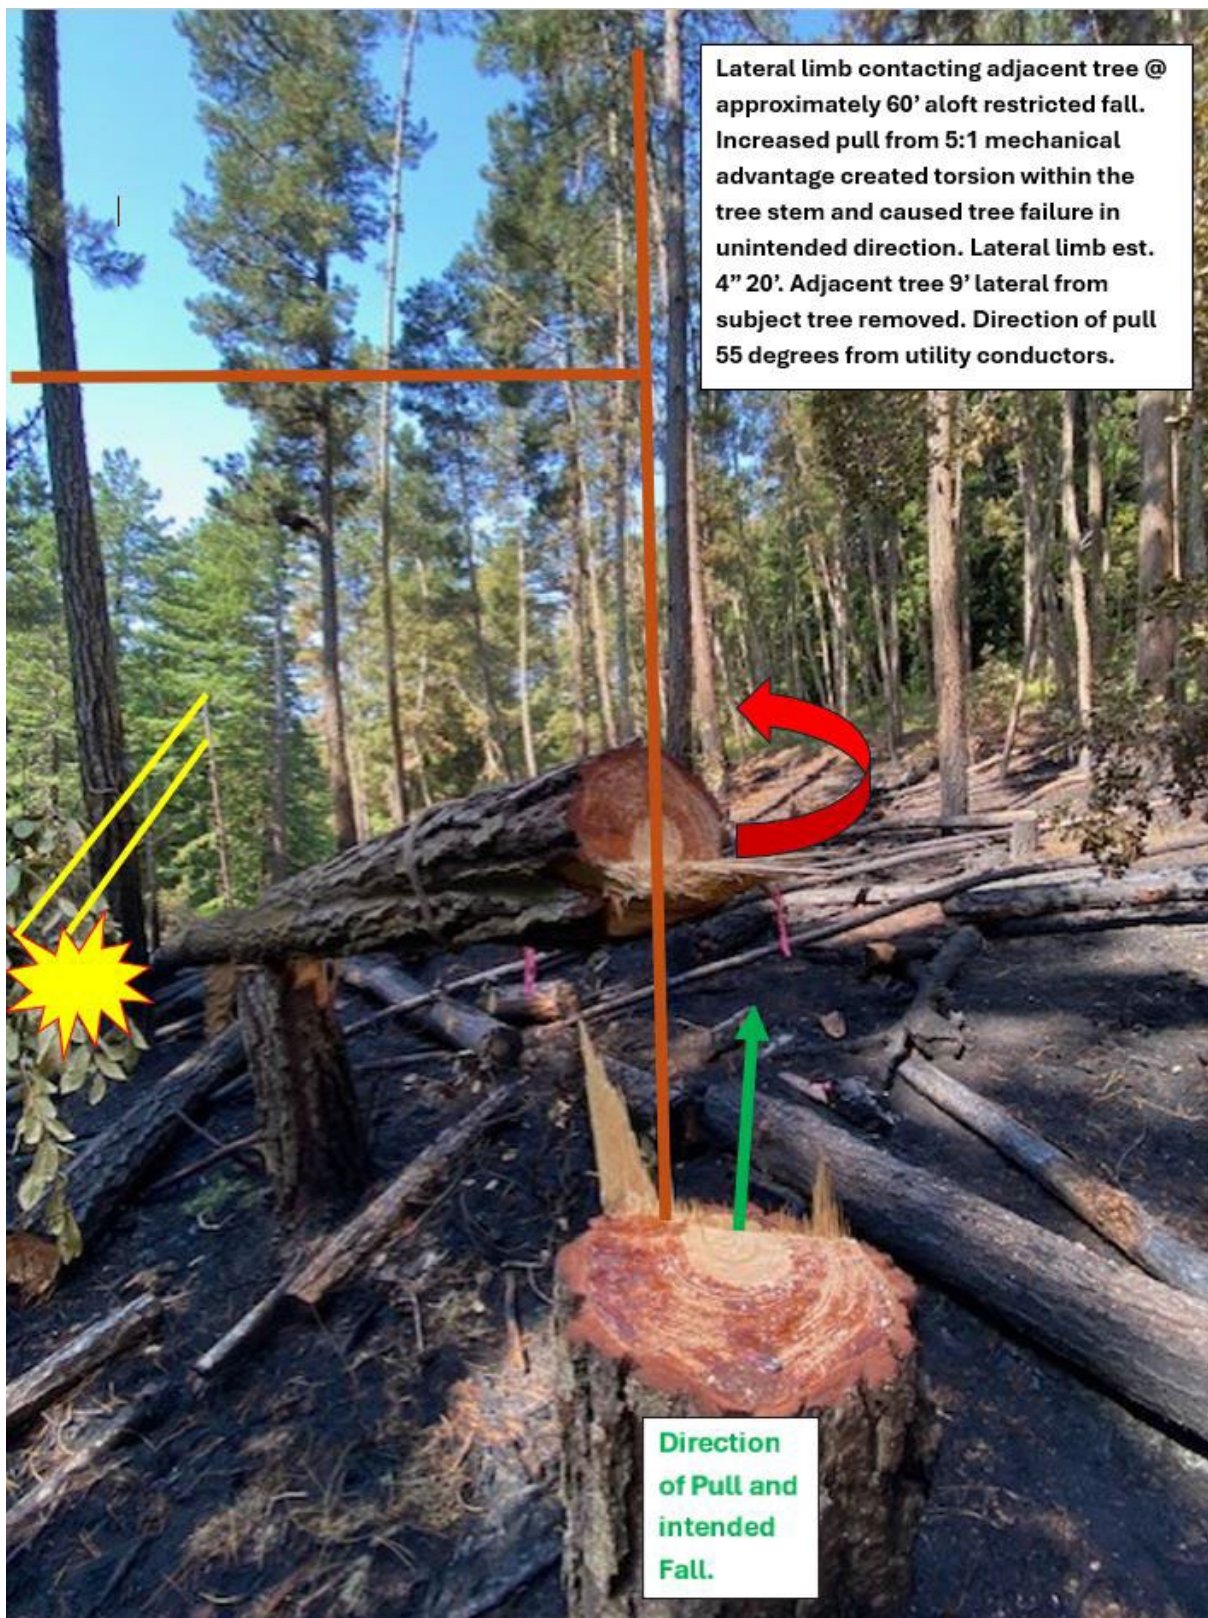
Hazard	Second-Party Contact	Sub-Hazard	Fallen Tree
Target	Fallen tree branch causing broken conductor		
Barrier	Expected vs. Observed Performance	Why did the barrier not prevent the ignition event? (See <a href="#">ICF Codes</a> )	Opportunity
Barriers that Negatively Affected Ignition			
Enhanced Powerline Safety Settings - Instantaneous Trip Settings	Expected Performance: EPSS Settings when enabled would reduce the likelihood of ignition from downed lines  Observed Performance: Barrier did not exist	A4B1C1D1 – Conditions did not meet EPSS enablement criteria	Weather conditions did not meet EPSS criteria for enablement
Vegetation Management Tree Pruning, Dismantling, and Felling Operations	Expected Performance: Mitigate hazards to avoid obstacles in the felling path.  Observed Performance: Barrier did not perform as expected	A3B1C2D3 – Work not performed in accordance to standard	Contractors failed to identify and remove potential snag branches that caused the tree to catch an adjacent tree and spin in an unintended direction into the lines. The worker performed unprescribed, unnecessary work outside of their scope.

Figure 8: Photo exhibit from Davey Tree Surgery Causal Evaluation showing incident tree's intended fall vs actual fall direction.

Davey Tree Surgery performed an independent investigation into this incident and took direct corrective action that they deemed necessary.

Davey Tree Surgery also conducted safety communication with their territory workforce regarding the incident identifying the causes and contributing causes with corrective actions focusing on the following specific information:

- PG&E Essential Control Training - Felling a Tree – landing zone and fall path clear.
- Incident Awareness Training – Cause Evaluation review of the incident with territory workforce.
- Risk Assessment (Site & Tree) – Identify hazards such as utility wires, trees or other obstacles that may be struck by the falling tree. All adjacent trees shall be considered to determine if there is risk of an obstructed fall path.
- Administrative Controls with trees located within M.A.D. – All trees prescribed to be worked located within M.A.D. Shall be identified and communicated with local management for work process approval. i.e., deenergize, aerial lift utilization, or alternative work method planning and confirmation.
