## Preliminary Ignition Investigation Report

Ignition Database Index:	20240949
Electric Incident Investigation (EII) Number:	N/A
Incident Name:	N/A
PG&E Facility Ignition?	Yes
CPUC Reportable Ignition?	Yes
Date & Time of Incident:	July 14, 2024 @ 0711 hours
Street Address:	Near 34 Millet Lane
City:	Oroville
County:	Butte
Latitude/Longitude:	39.5079880244, -121.4487940051
State Responsibility Area (SRA) / Local Responsibility Area (LRA) / Federal Responsibility Area (FRA)	State Responsibility Area (SRA)
PG&E Division:	North Valley
High Fire Threat District (HFTD):	Tier 2
High Fire Risk Area (HFRA):	Yes
EPSS Buffer:	No
Fire Index Area (FIA):	280
Fire Potential Index (FPI) Rating: FIA	R4
Fire Potential Index (FPI) Rating: Circuit	R4
Was there a PSPS event at the time of ignition?	No
Suspected Initiating Event:	Vegetation
Failure Driver:	Contact from object
Failure Sub-driver:	Vegetation Contact
Circuit:	Wyandotte 1103
Circuit Protection Zone:	Wyandotte 1103LR1508

Nominal Voltage:	12kV
Pole SAP Equipment ID:	100375645
Subject to PRC 4292 Veg Pole Clearance:	No
PG&E Equipment associated with ignition:	Yes
EPSS enabled at time of ignition?	Yes
Fault Type:	Line to Ground
Wire Down (Prim

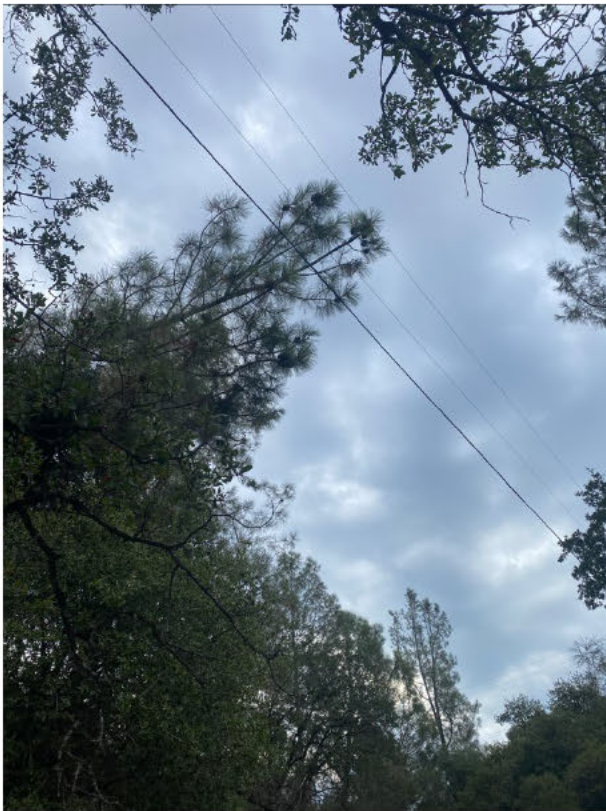
During the patrol, the troubleshooter located a failed tree lying over two phases of the distribution facilities. Pinecones from the tree fell to the ground combusting and igniting a fire on the ground vegetation. The troubleshooter observed burns on two of the three conductors, which shows arcing had occurred when the tree contacted the conductors.

The subject tree was identified as a gray pine during a Vegetation Management (VM) post incident investigation. The pine was 14 inches diameter at breast height with a partial failure. There were no indications that the tree was in a deceased or diseased condition. The tree maintained a 40-foot clearance from the conductor and was last inspected on February 29, 2024 by a contract company ACRT.

*Photo 3: Subject tree taken by troubleshooter.*

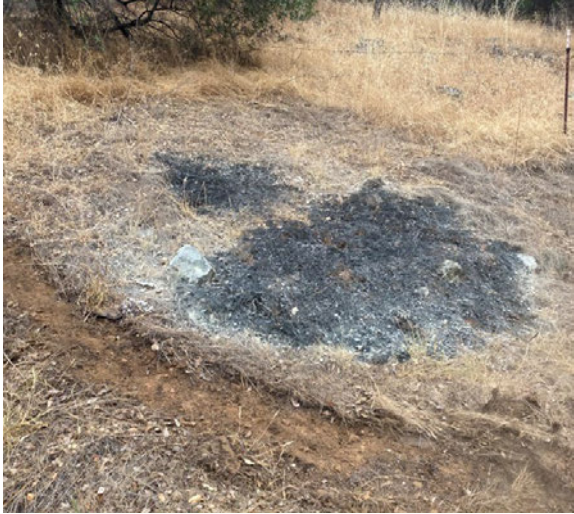
The ignition event on July 14, 2024 was caused by a single stem gray pine. The pine failed and fell onto the overhead three wire, 12kV distribution system. The contact between the tree and the conductor caused arcing. Pinecones from the tree fell to the ground combusting. Due to the dry fuel bed, a fire ensued under three meters in size. The fire footprint measured seven-foot-four-inches by four-foot 10-inches in size. Once the anomaly was detected in the system, LR 1508 opened causing a power outage affecting 564 customers. There were no injuries, fatalities or media associated with the incident.

*Photo 4: Ignition site, taken by troubleshooter.*

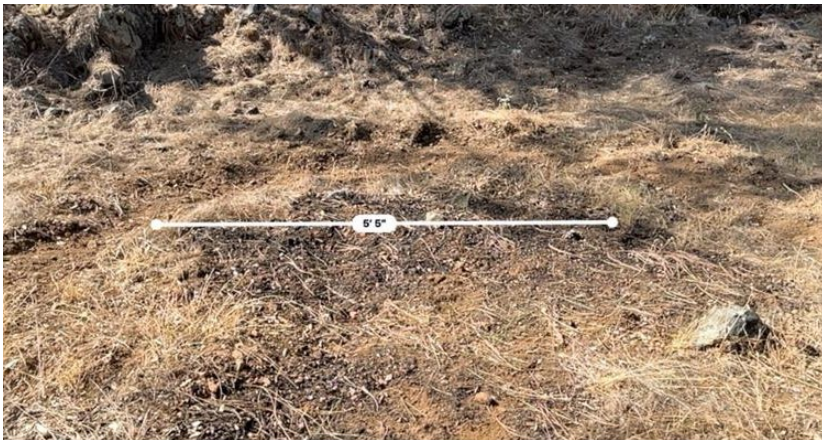
*Photo 5: ignition site, taken by vegetation management crew, post incident.*

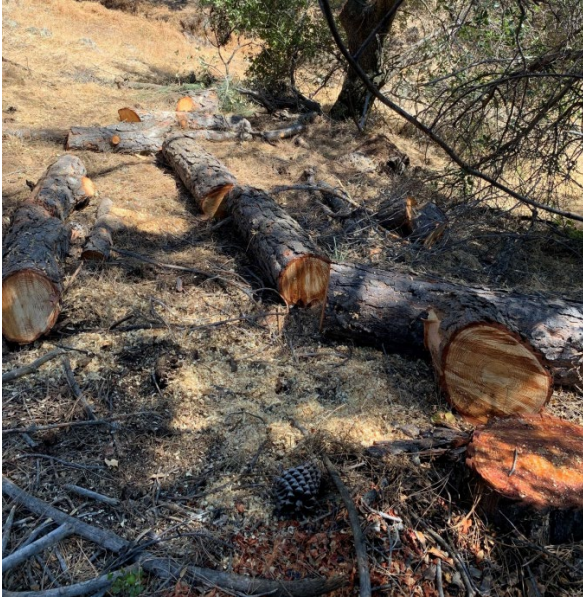
During the post incident inspection two days after the incident, the VM team observed the tree was cut into pieces with some portions of the tree missing from the site. Inspecting what remained of the tree the team was unable to determine the height of the tree, overall health, defects, root crown disturbance, or a point of failure. There was no marking on the trunk of the tree and no records associated with it through Vegetation Management records.

*Photo 6: taken by vegetation management crew, post incident of subject tree.*

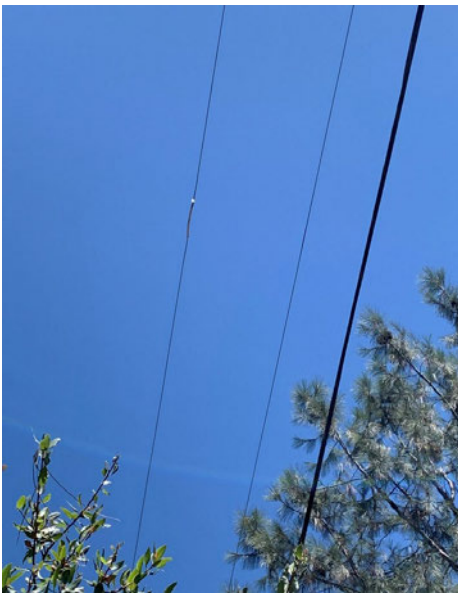
*Photo 7: taken by vegetation management crew, post incident, showing repair splice*

An “A” tag, EC Notification 129218803 was created to repair the damaged conductor. This tag was worked by a PG&E Crew on July 14, 2024 where a splice was placed where the vegetation made contact with the conductor.

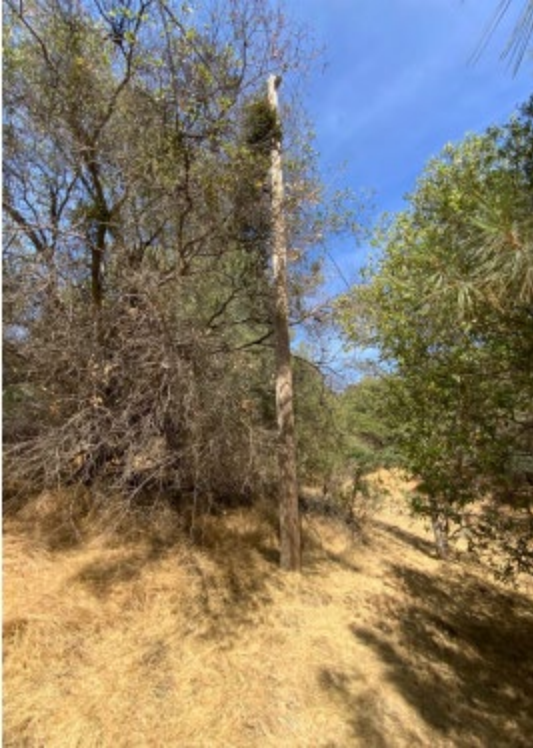
*Photo 8: taken during inspection in 2001, showing overgrown vegetation*
