Preliminary Ignition Investigation Report

Ignition Database Index:	20241105N
Electric Incident Investigation (EII) Number:	N/A
Incident Name:	Town
PG&E Facility Ignition?	Yes
CPUC Reportable Ignition?	Yes
Date & Time of Incident:	August 7, 2024 @approximately 1059 hours
Street Address:	Rural, approximately 1.6 miles north of Valley Springs (near Watertown Road)
City:	Valley Springs
County:	Calaveras
Latitude/Longitude:	38.218395, -120.835752
State Responsibility Area (SRA) / Local Responsibility Area (LRA) / Federal Responsibility Area (FRA)	State Responsibility Area
PG&E Division:	Stockton
High Fire Threat District (HFTD):	Tier 2
High Fire Risk Area (HFRA):	Yes
EPSS Buffer:	No
Fire Index Area (FIA):	345
Fire Potential Index (FPI) Rating: FIA	R5
Fire Potential Index (FPI) Rating: Circuit	NA
Was there a PSPS event at the time of ignition?	No
Suspected Initiating Event:	Contact – Animal – Bird
Failure Driver:	Contact from object
Failure Sub-driver:	Contact – Animal – Bird

Circuit:	Valley Springs #2 60kV (Pardee #1 Tap 60kV)
Circuit Protection Zone:	Circuit Breaker (CB) 6332 & CB 6322
Nominal Voltage:	60kV
Pole SAP Equipment ID:	40905035 Structure ID 006/092
Subject to PRC 4292 Veg

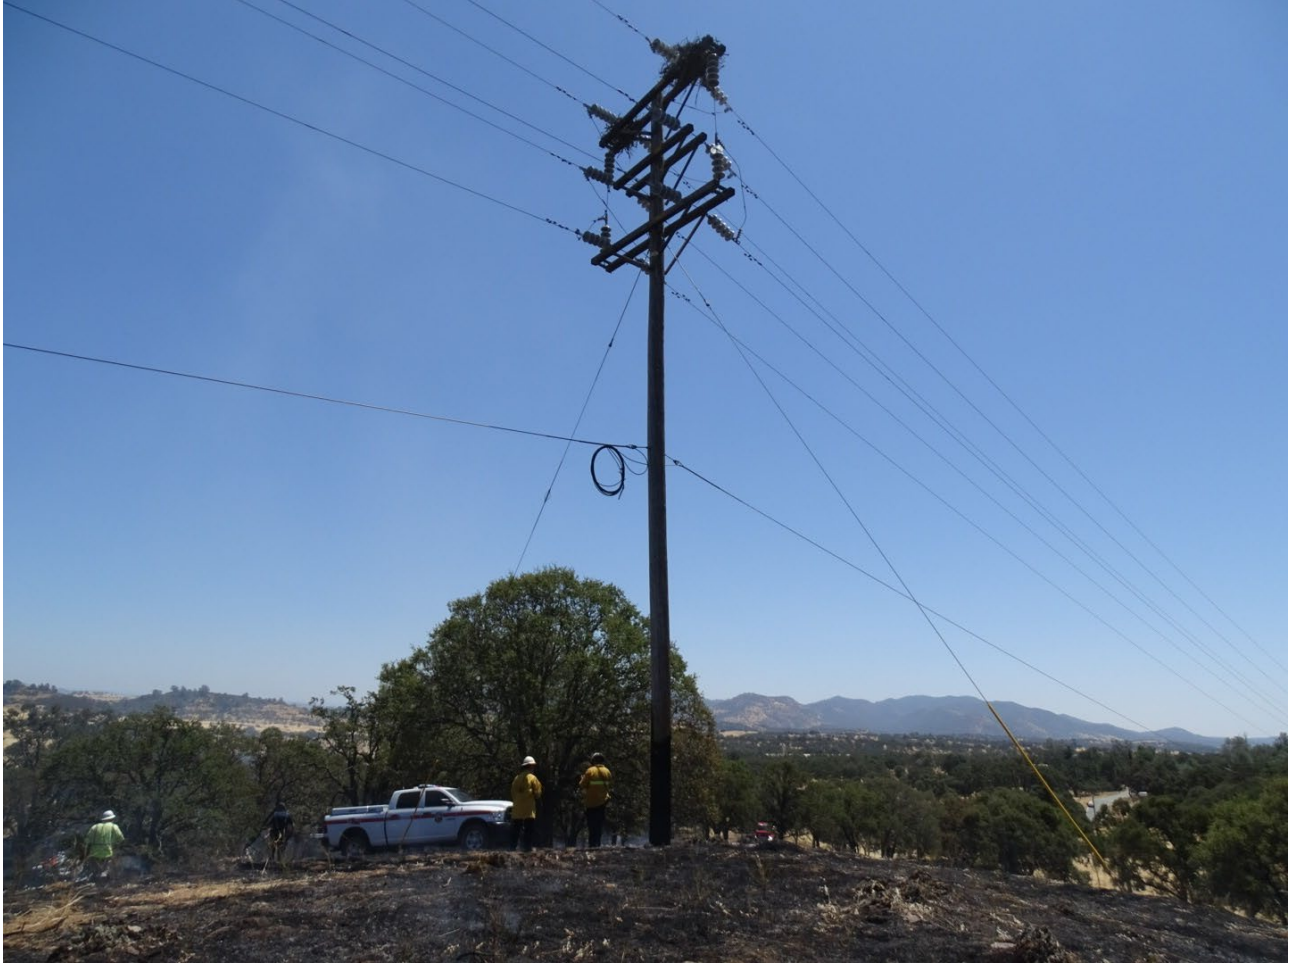
An electric program manager and PG&E’s avian subject matter expert (SME) analyzed the incident. They concurred that the baby Osprey chick likely exited the nest and came into contact with two OH phases of the Valley Springs #2 circuit at the same time, causing a fault and arc flash event. A Bird Incident Report⁴ was created on August 7, 2024, for the incident. The remaining, surviving baby Osprey chick was left undisturbed and it was reported by operations that the parents returned to the nest. Due to wildlife conservation efforts, the nest was left undisturbed until the entire family vacated the nest. On September 17, 2024, the empty nest was completely removed from PG&E assets.

Figure 2 Pole #1 - Incident Location - Bird nest on both sides of upper crossarm. Photo taken by troubleshooter on August 7, 2024.

- LC priority 'E' Tag (#129351590) was created on August 8, 2024, to request a two-pole structure to be designed due to bird nesting activity and ignition.
- CAP (#129628457) submitted October 3, 2024, for process improvement review of active nest removal.

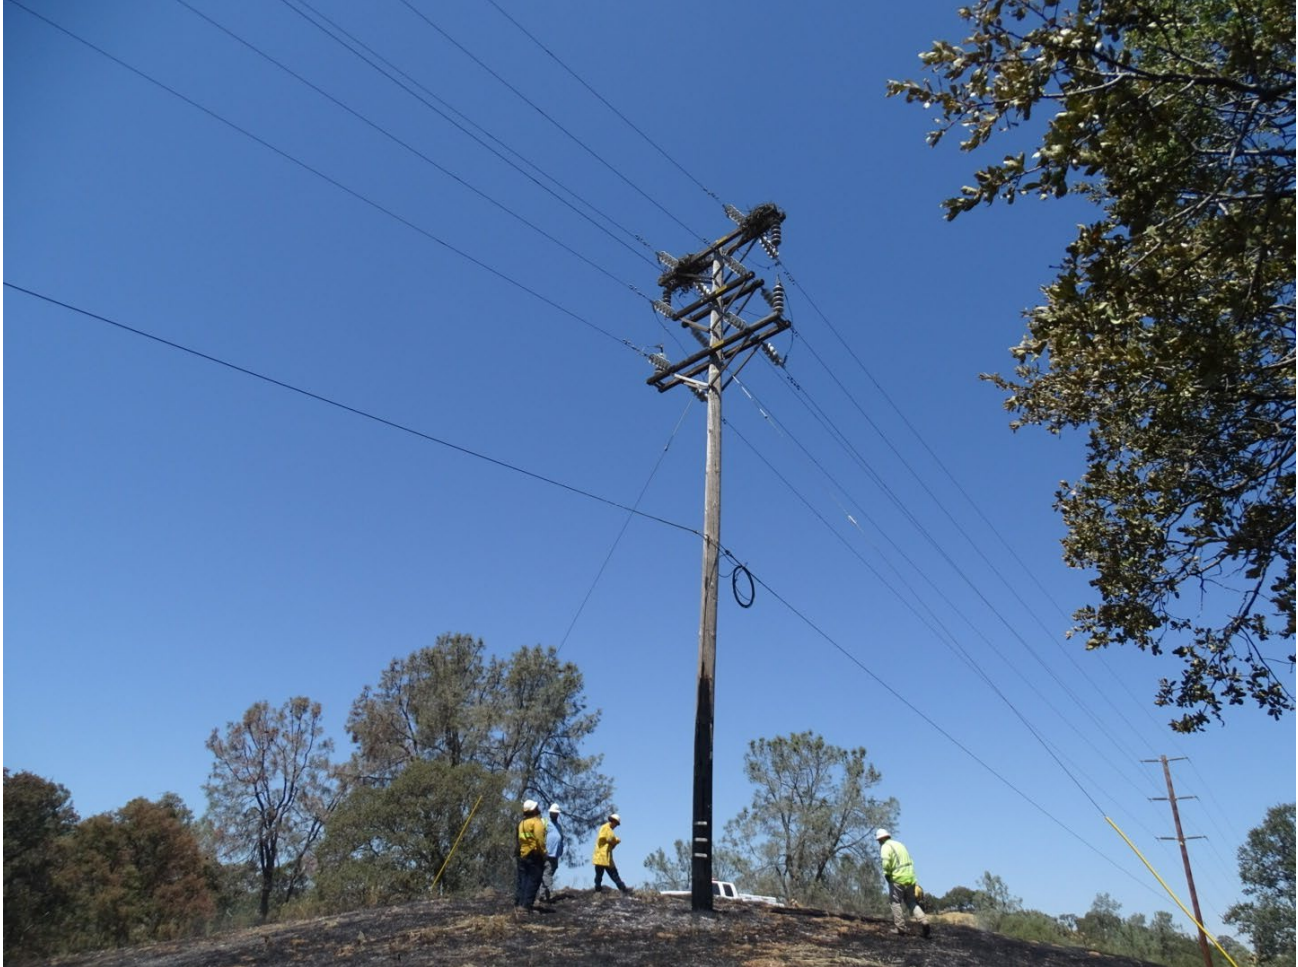
Figure 3 Pole #1 - Incident Location - Bird nest on both sides of upper crossarm. Photo taken by troubleshooter on August 7, 2024.

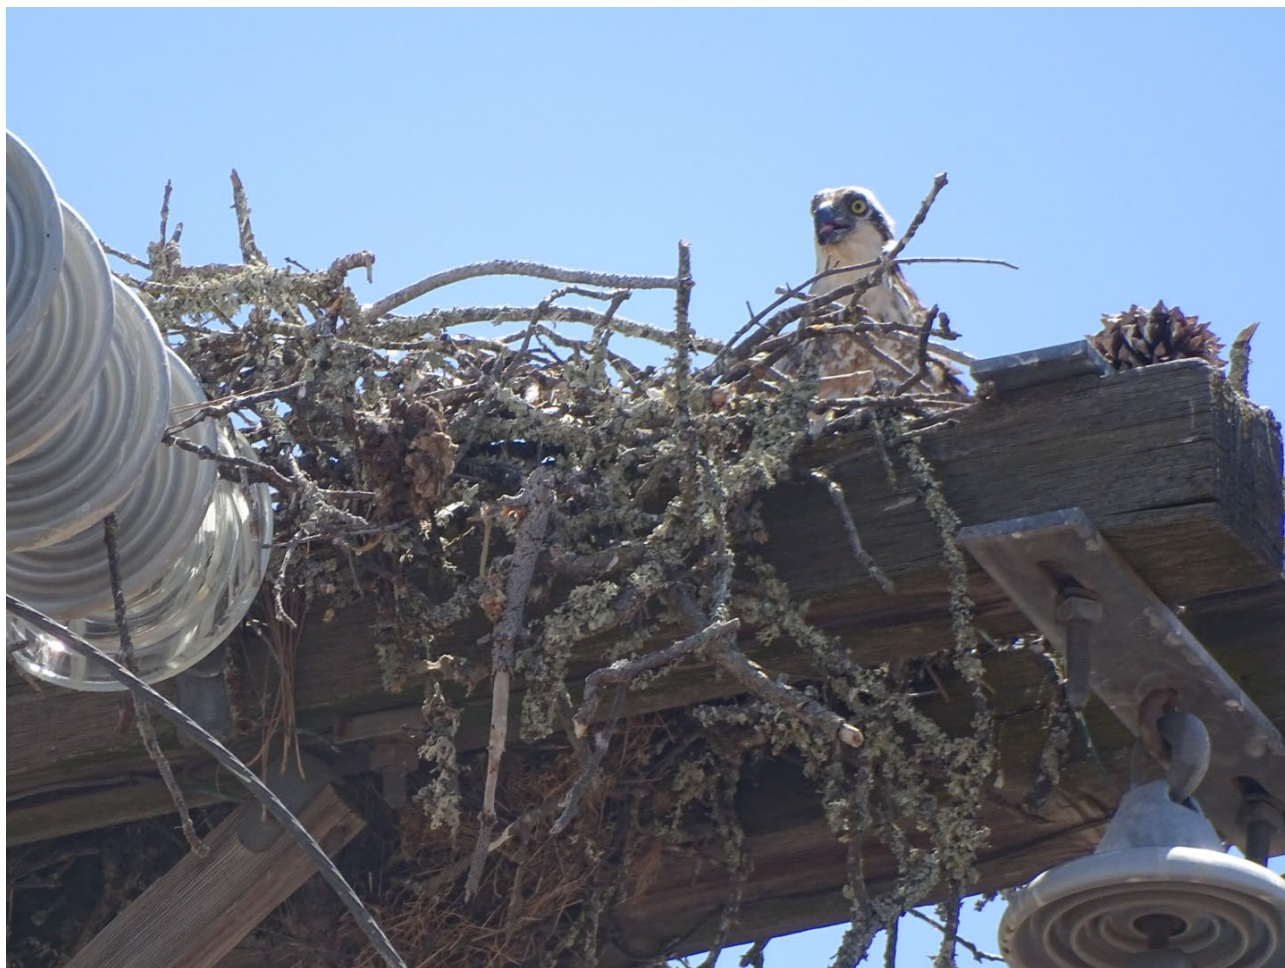
Figure 4 Surviving baby Osprey still in nest. Photo taken by troubleshooter on August 7, 2024.

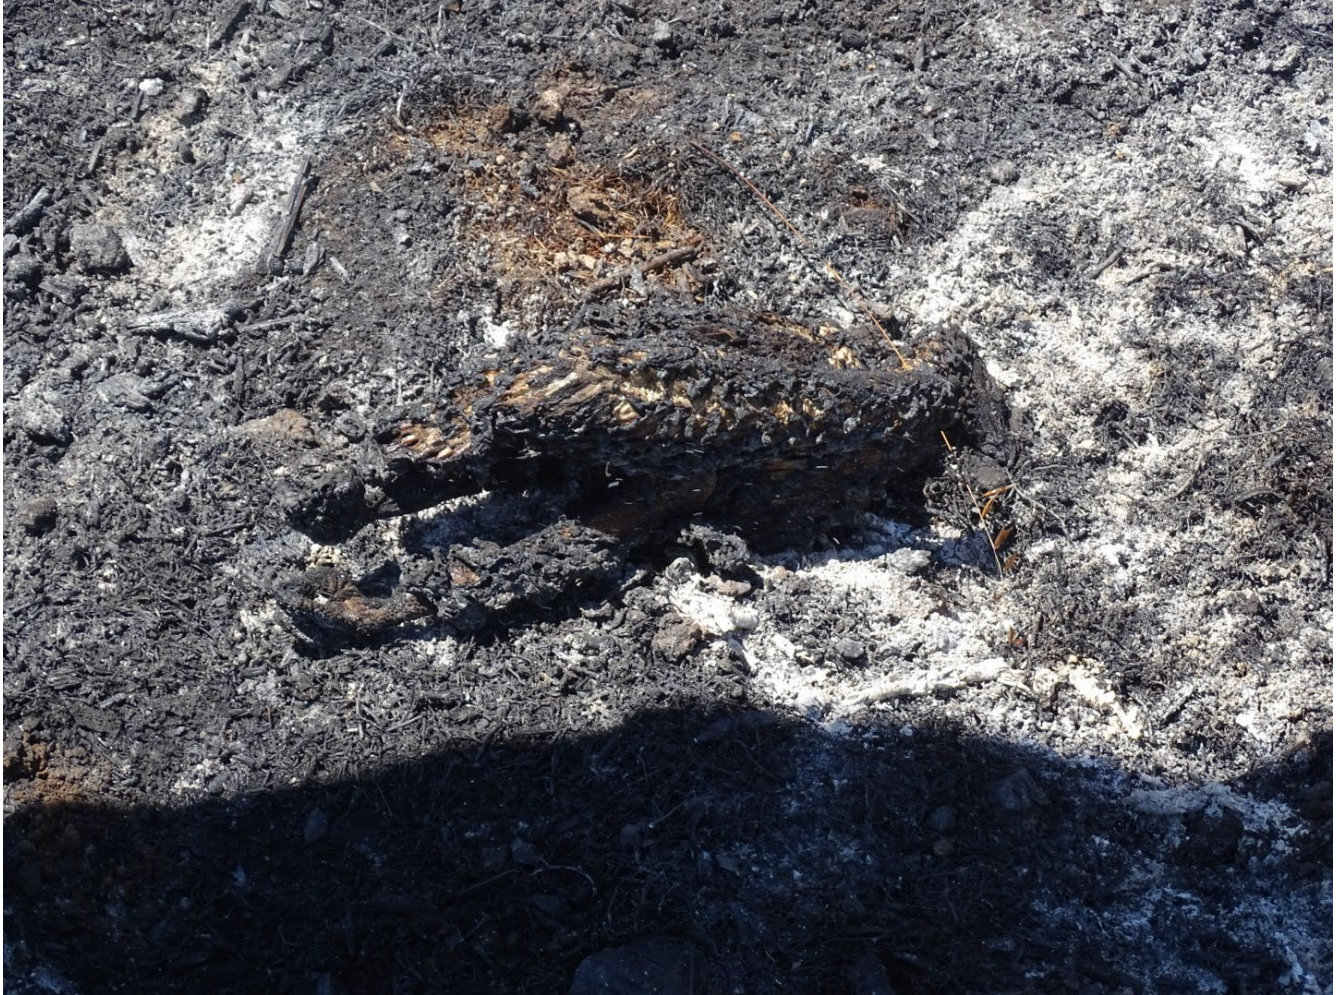
Figure 5 Baby Osprey that came into contact with the phases, found near the base of the pole. Photo taken by troubleshooter on August 7, 2024.
