## Preliminary Ignition Investigation Report

| HAWC Incident Name: | Far – 23 August 2024 |
| Circuit: | LINCOLN 1104 |

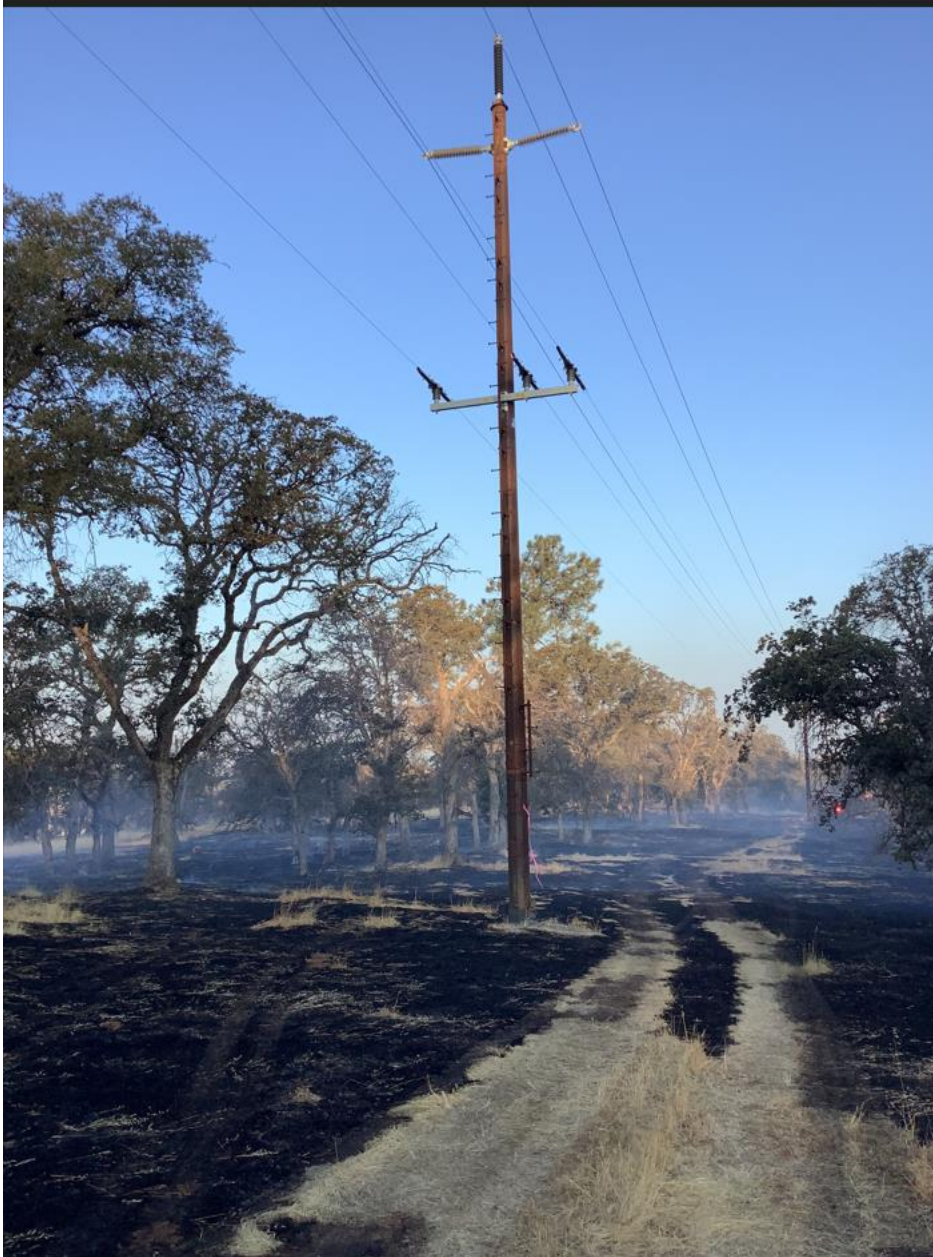
*Photo 2: Photo taken by troubleshooter from SAP 104192102 on ignition date.*

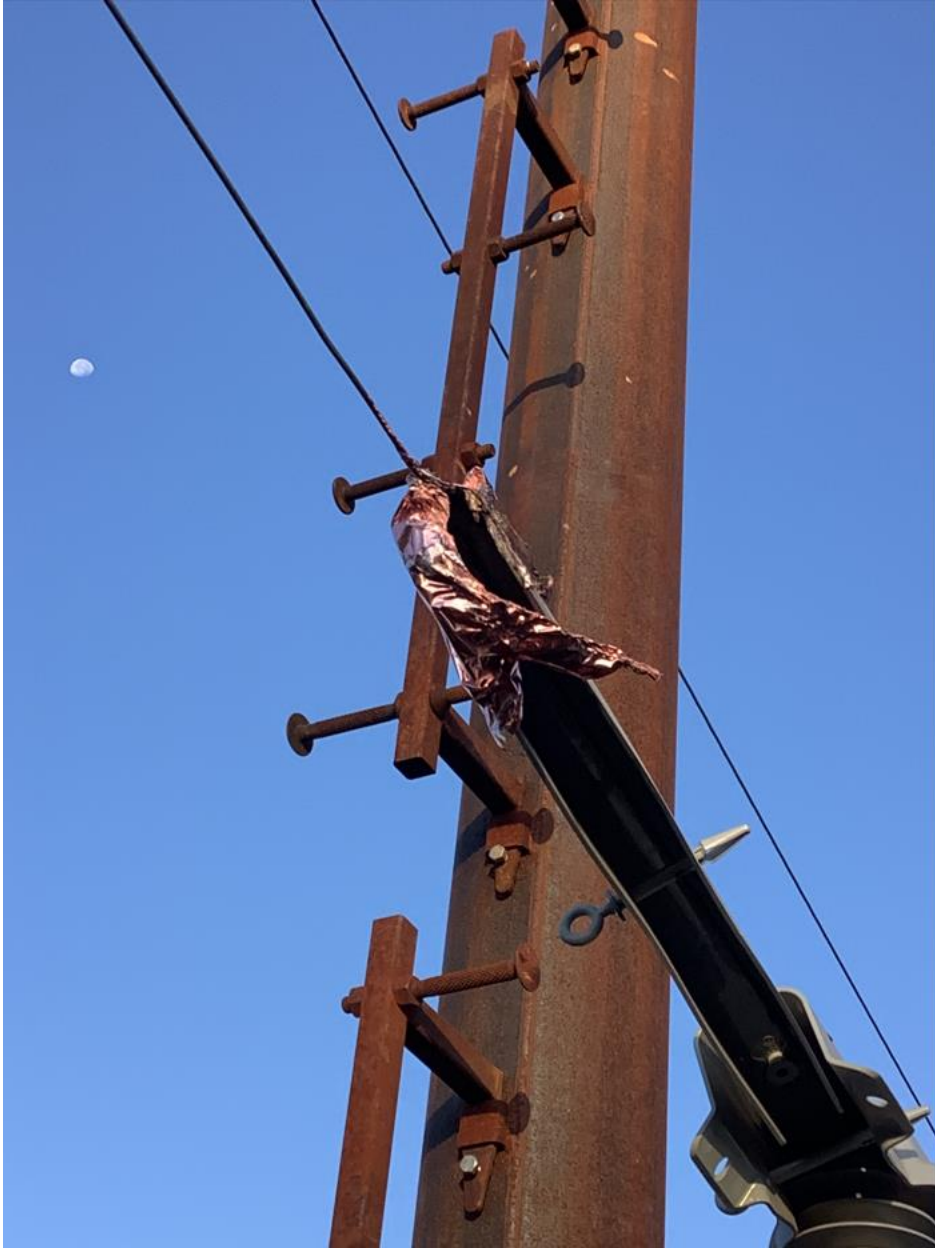
A Distribution troubleshooter was dispatched to inspect the line, but due to the nighttime darkness and the similarity in color between the rose gold balloon and the steel pole hindered the immediate identification of the cause. Following standard procedures, the control center disabled the Hot Line Tag (HLT) mode on LR 997576 and ALT#3 mode on LR 51756. The line was re-energized manually by the control center at 0353 hours on August 23<sup>rd</sup>. However, a similar fault occurred shortly after on both LRs. A fault was detected at 0356 hours, and self-cleared without requiring any action. Based on EPSS data, the ignition was caused by this test-in procedure.

*Photo 3: Photo of balloon taken by troubleshooter on ignition date.*

A priority “B” EC tag (#129428182) was created to inspect the condition of the #6 copper conductor where the mylar balloon came into contact with the power line. The tag is currently pending completion with a due date of November 23, 2024.

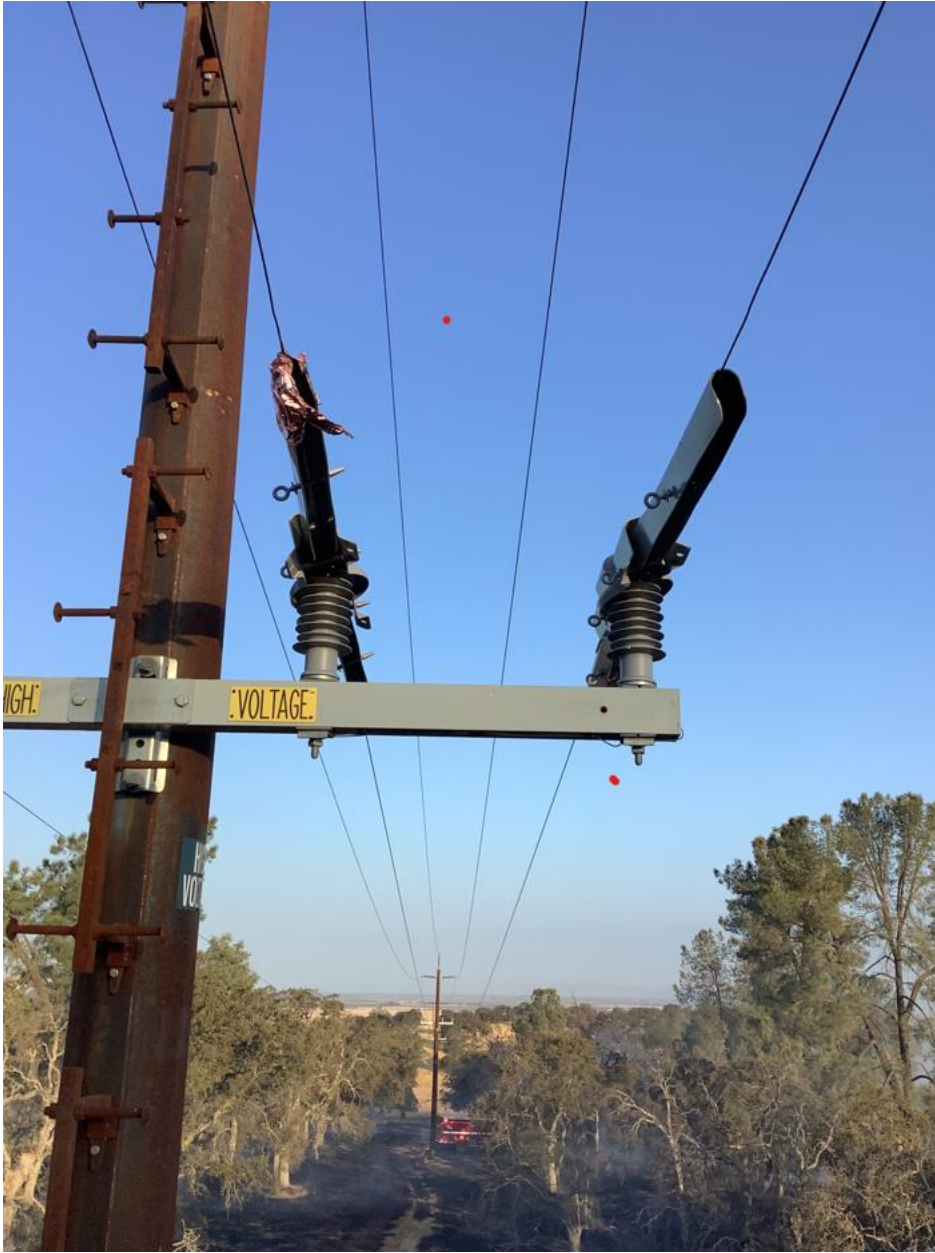
*Photo 4: Photo of balloon taken by troubleshooter on ignition date.*
