## Preliminary Ignition Investigation Report

Ignition Database Index:	20241233N
Electric Incident Investigation (EII) Number:	N/A
Incident Name:	Wildcat
PG&E Facility Ignition?	Yes
CPUC Reportable Ignition?	Yes
Date & Time of Incident:	August 27, 2024 @approximately 1332 hours
Street Address:	Rural (east of Berkeley approximately ½ mile)
City:	Rural (east of Berkeley approximately ½ mile)
County:	Contra Costa
Latitude/Longitude:	37.909929, -122.247505
State Responsibility Area (SRA) / Local Responsibility Area (LRA) / Federal Responsibility Area (FRA)	State Responsibility Area
PG&E Division:	East Bay
High Fire Threat District (HFTD):	Tier 3
High Fire Risk Area (HFRA):	Yes
EPSS Buffer:	No
Fire Index Area (FIA):	530
Fire Potential Index (FPI) Rating: FIA	R4
Fire Potential Index (FPI) Rating: Circuit	N/A
Was there a PSPS event at the time of ignition?	No
Suspected Initiating Event:	Contact – Animal – Bird
Failure Driver:	Contact from object
Failure Sub-driver:	Contact – Animal – Bird

Circuit:	Sobrante-R #2 115kV
Circuit Protection Zone:	Circuit Breaker (CB) 362 and CB 182
Nominal Voltage:	115kV
Pole SAP Equipment ID:	40764498 – Structure 002/015
Subject to PRC 4292 Veg Pole Clearanc

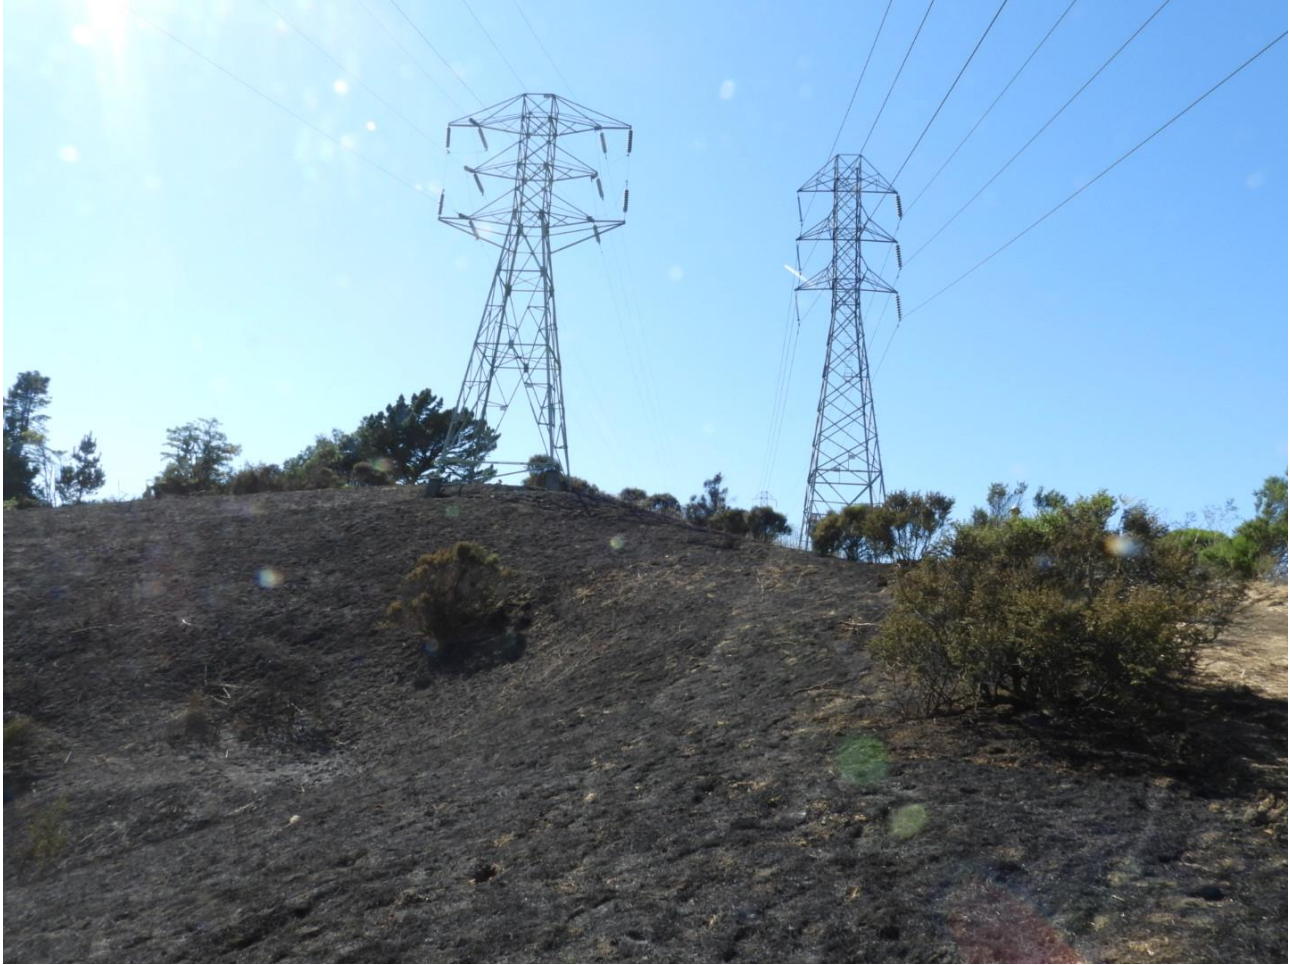
*Figure 2 SAP Tower ID 40764498 - Structure ID 002/015. Photo taken by troubleshooter on August 27, 2024.*

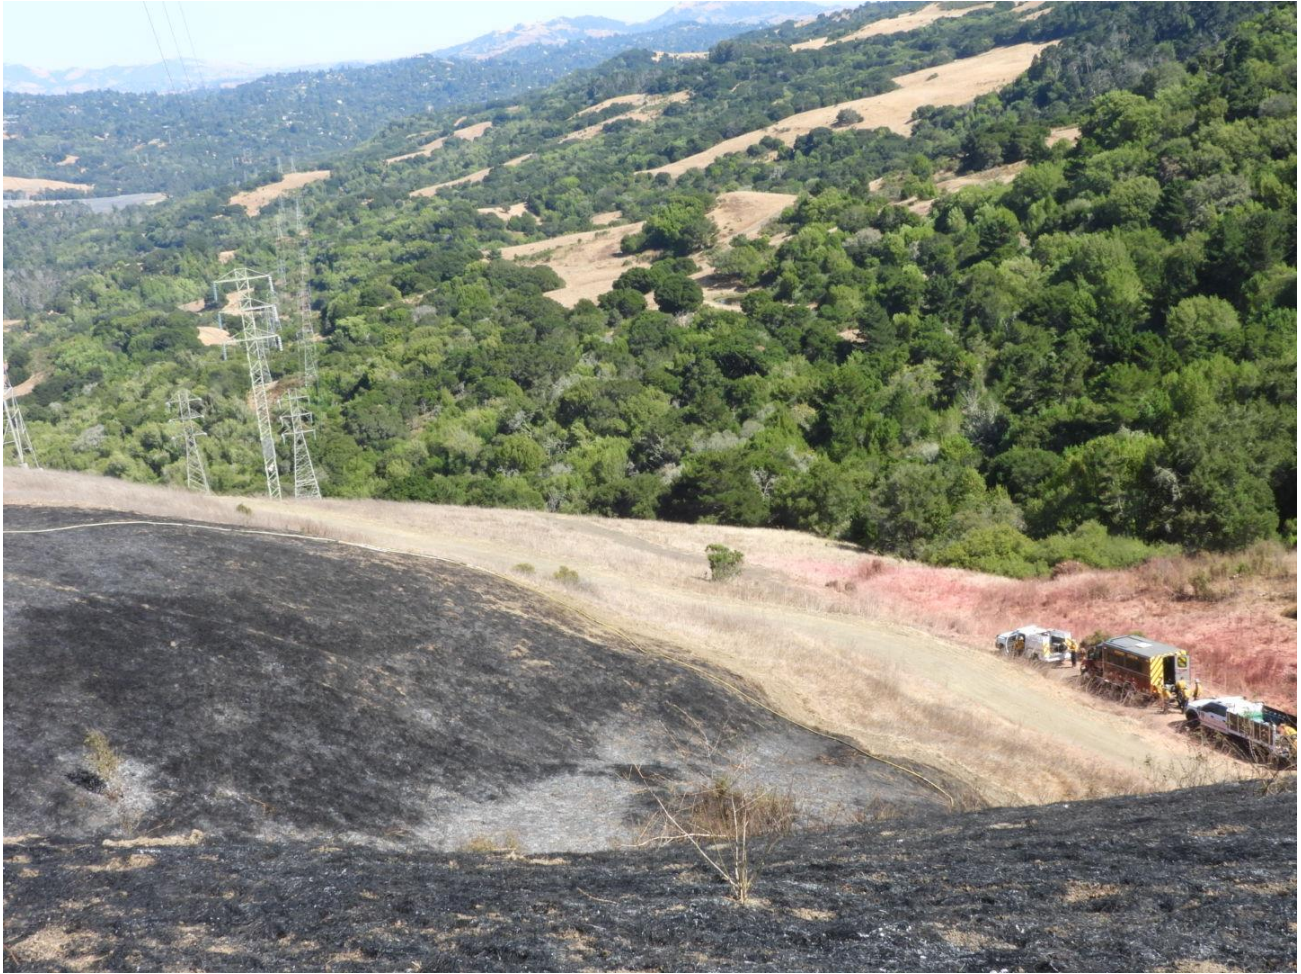
The ignition resulted in a burn scar that was approximately three acres in size, burning native shrubs and grasses. There were no reports of injuries, fatalities, or property damage. There was media interest from a reporter of the Berkeley Scanner<sup>5</sup>, requesting information about the cause of the ‘Berkeley hill’ fire that occurred around 1330 hours on August 27, 2024. The reporter heard it was related to a PG&E transformer explosion. There were no customers impacted by this event.

*Figure 3 Burn scar, photo facing south. Photo taken by troubleshooter on August 27, 2024.*

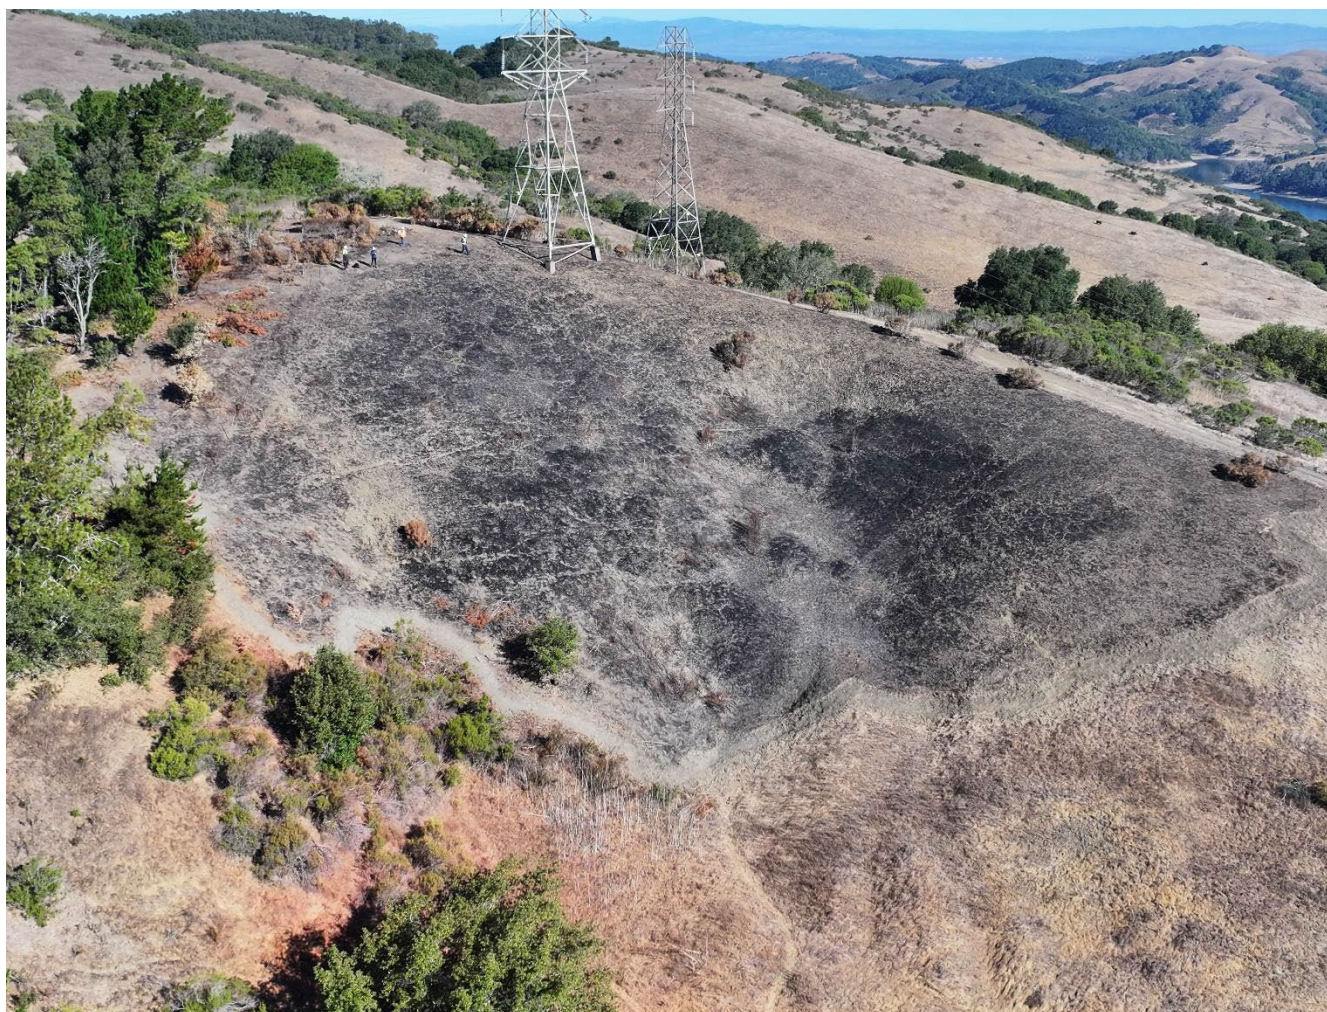
*Figure 4 Burn scar (approximately three acres), drone photo. Photo taken September 12, 2024, by Ignition Investigator.*

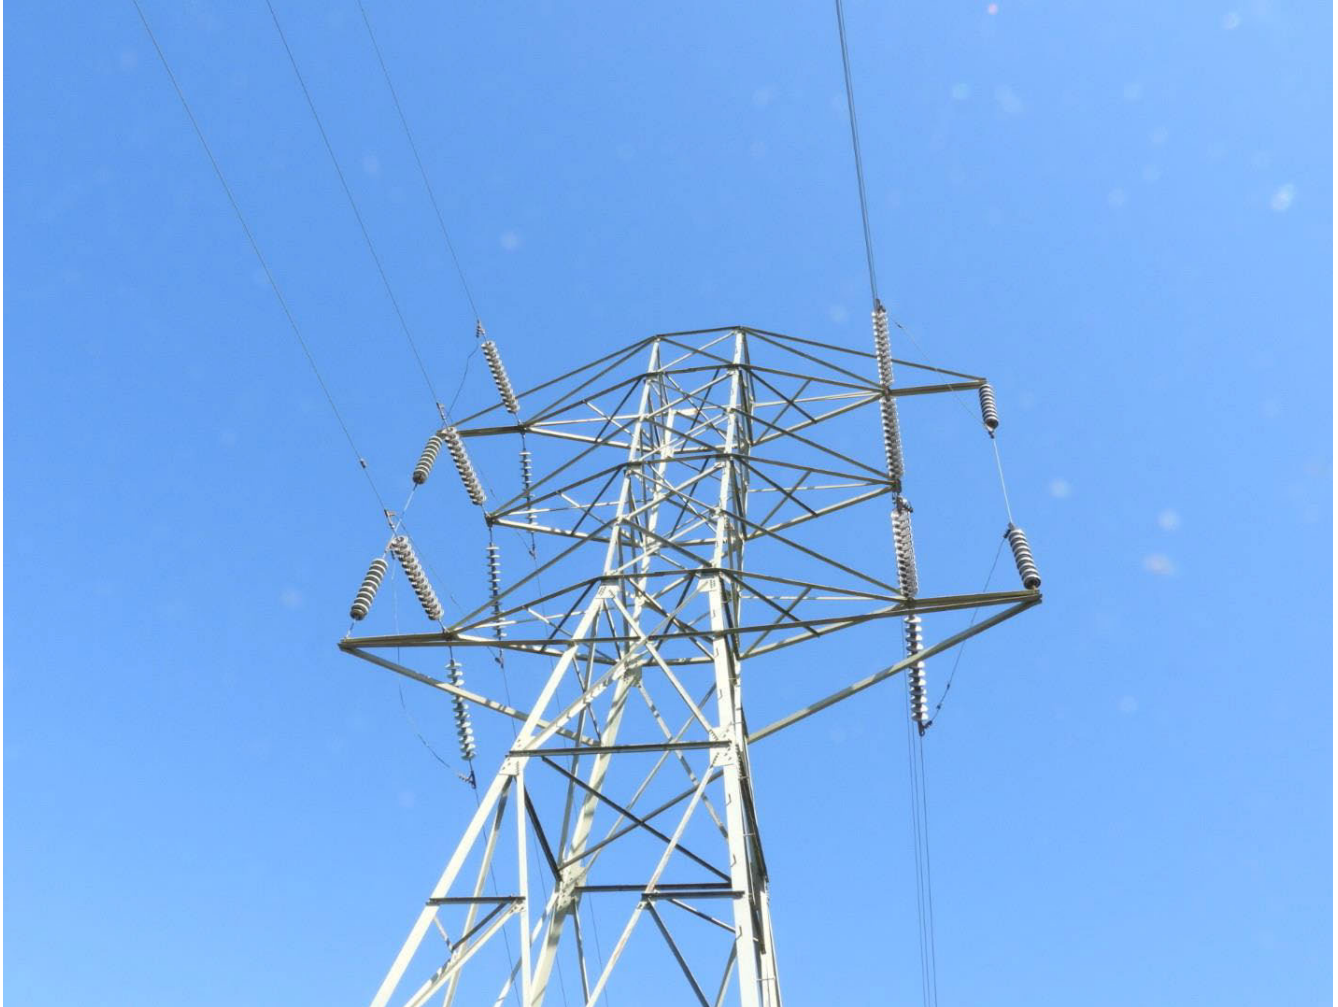
*Figure 5 SAP Tower ID 40764498 - Structure ID 002/015, photo taken by troubleshooter on August 27, 2024.*

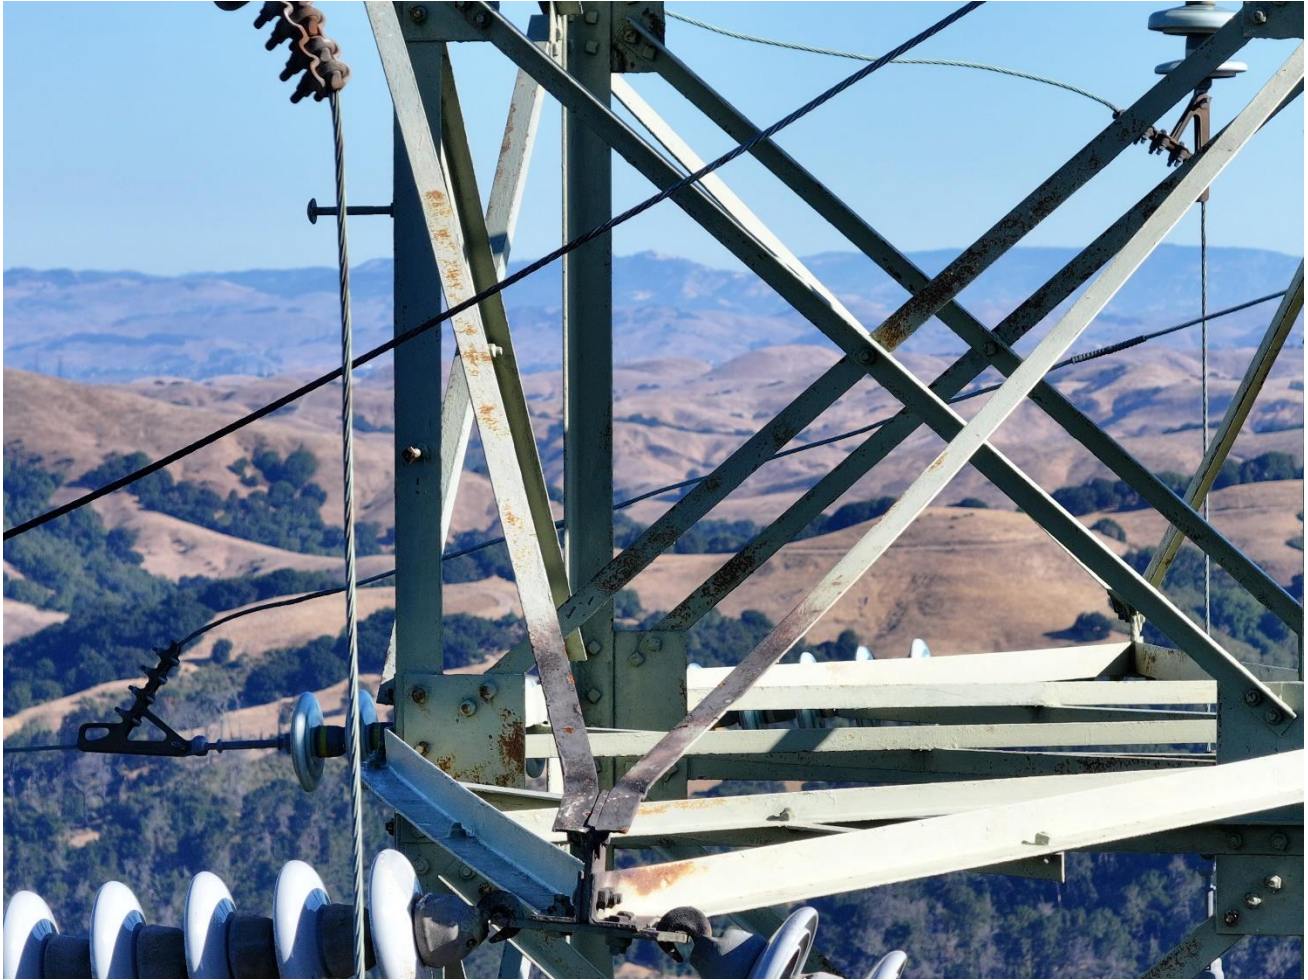
An electric program manager and PG&E's avian subject matter expert (SME) analyzed the incident. They concurred that the turkey vulture made contact with the jumper above the steel crossarm while either landing or taking flight from the crossarm. The arc flash marks (See Figure 6) observed are indicative of where the turkey vulture was landing or taking flight from. The proposed mitigation for this location is to install four custom-made crossarm covers to create a buffer between energized components and steel components. As of publication of this report, this effort is still under review as the best possible mitigation option at this location. A Bird Incident Report<sup>4</sup> was created on August 28, 2024.

*Figure 6 Arc marks on the corner of the steel crossarm (bottom center of photo). Drone photo taken by Ignition Investigator on September 12, 2024.*

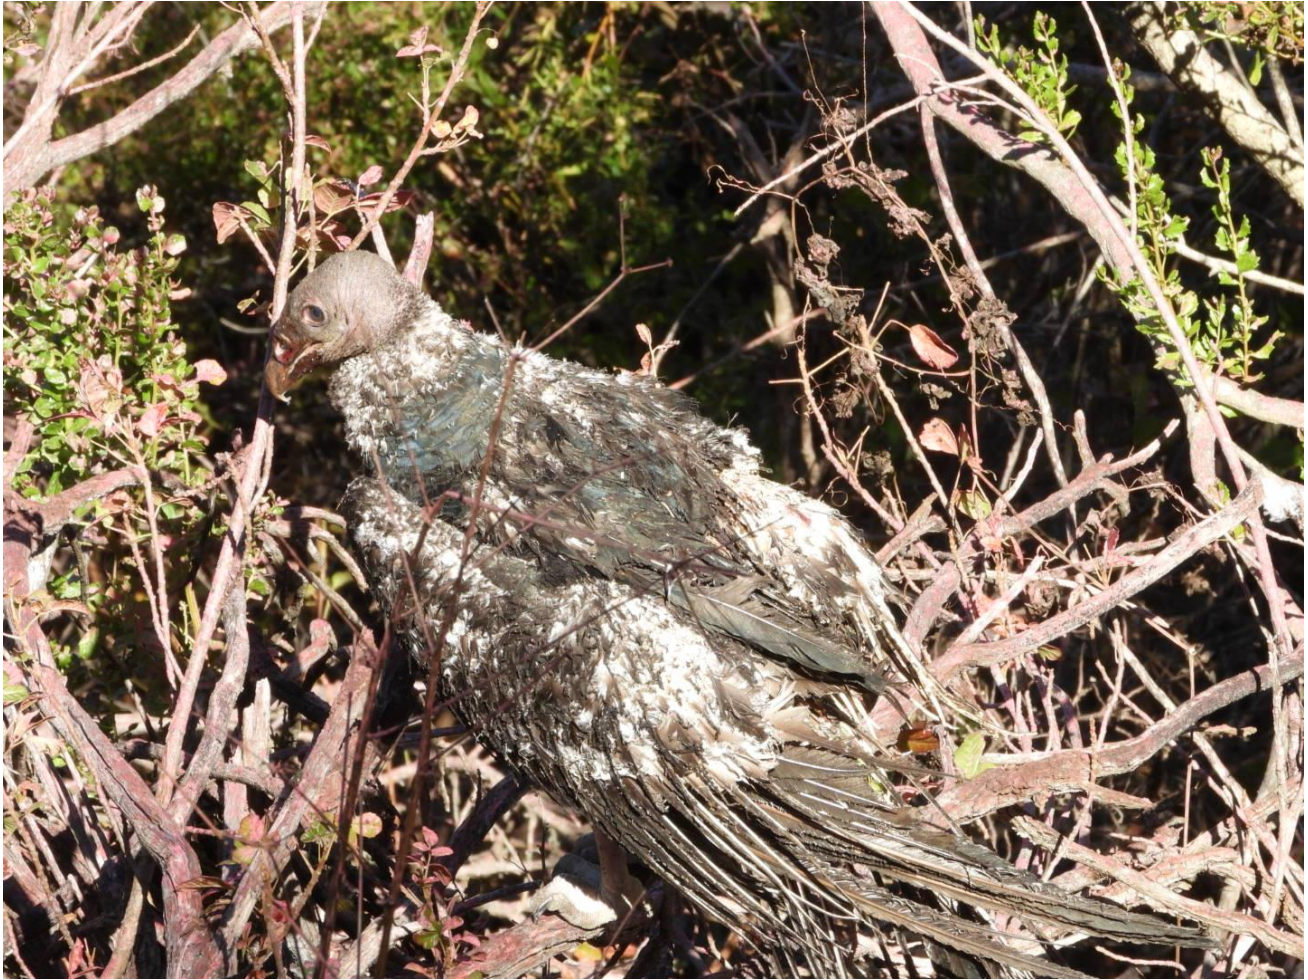
*Figure 7 Turkey vulture that came into contact with the energized components on Tower #1.*
