Preliminary Ignition Investigation Report

Ignition Database Index:	20241272
Electric Incident Investigation (EII) Number:	N/A
Incident Name:	Brook
PG&E Facility Ignition?	Yes
CPUC Reportable Ignition?	Yes
Date & Time of Incident:	September 03, 2024, @ 1653 hours
Street Address:	In the vicinity of [REDACTED]
City:	Shingletown
County:	Shasta
Latitude/Longitude:	[REDACTED]
State Responsibility Area (SRA) / Local Responsibility Area (LRA) / Federal Responsibility Area (FRA)	State Responsibility Area (SRA)
PG&E Division:	North Valley
High Fire Threat District (HFTD):	Tier 2
High Fire Risk Area (HFRA):	Yes
EPSS Buffer:	No
Fire Index Area (FIA):	247
Fire Potential Index (FPI) Rating: FIA	R4
Fire Potential Index (FPI) Rating: Circuit	R4
Was there a PSPS event at the time of ignition?	No
Suspected Initiating Event:	Equipment – Overloaded
Failure Driver:	All types of equipment/facility failure
Failure Sub-driver:	Splice/Clamp/Connector
Circuit:	Deschutes 1101
Circuit Protection Zone:	Deschutes 11011652

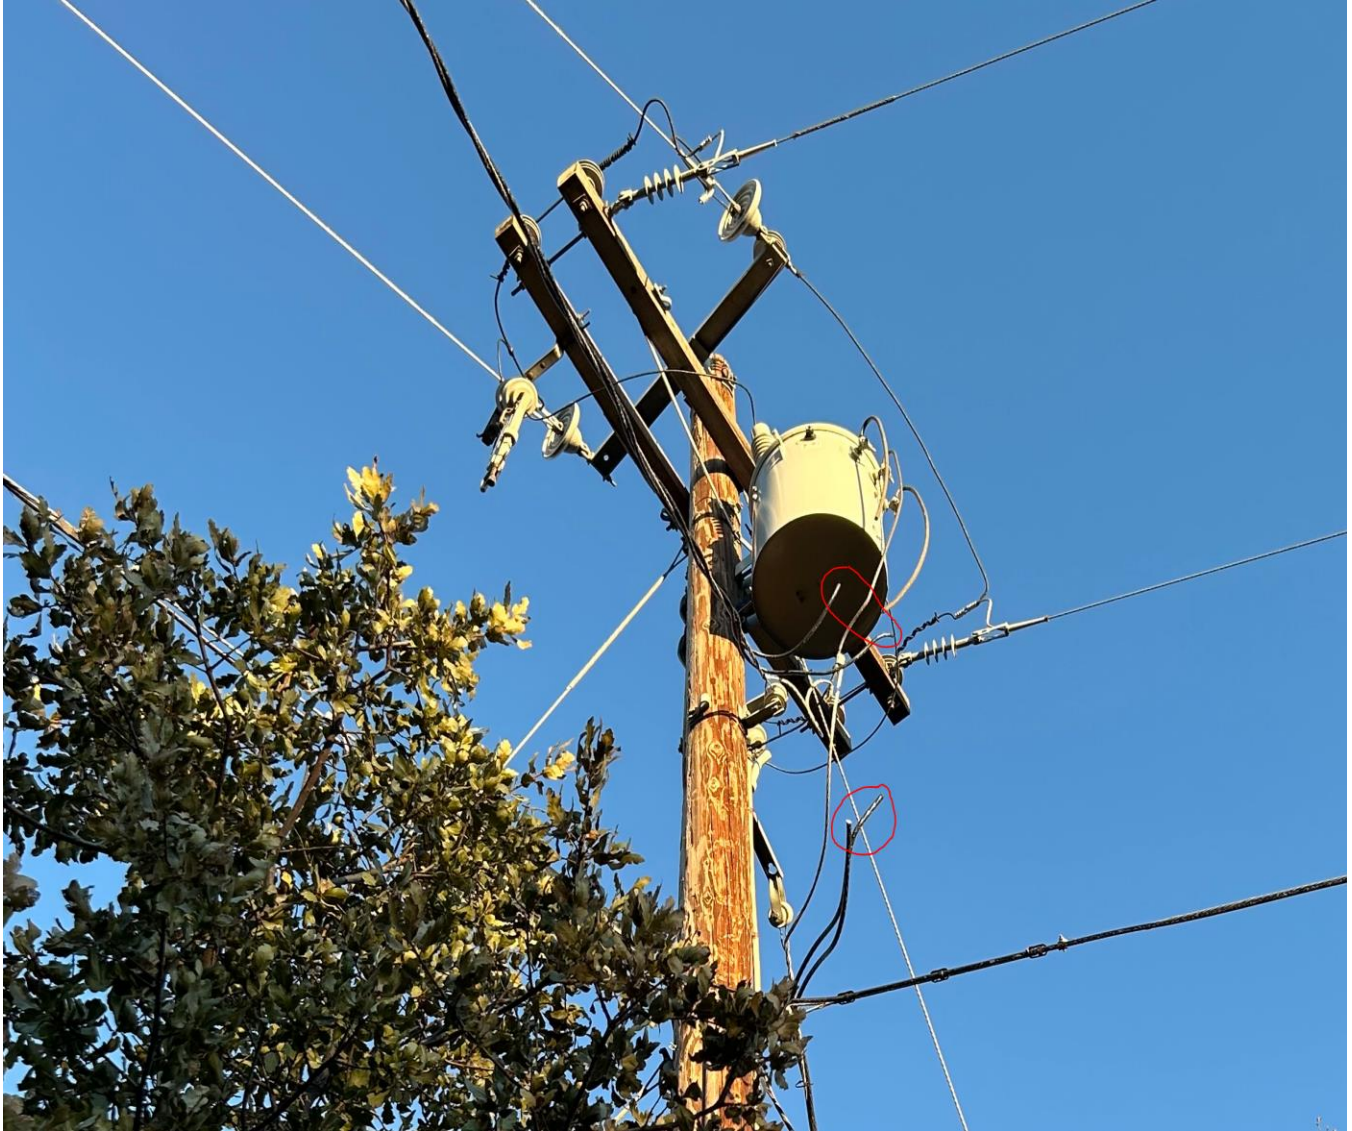
Figure 4 – Troubleshooter #1 removed the two connectors from the transformer jumpers and made the area safe. Picture taken by the troubleshooter on September 3, 2024.

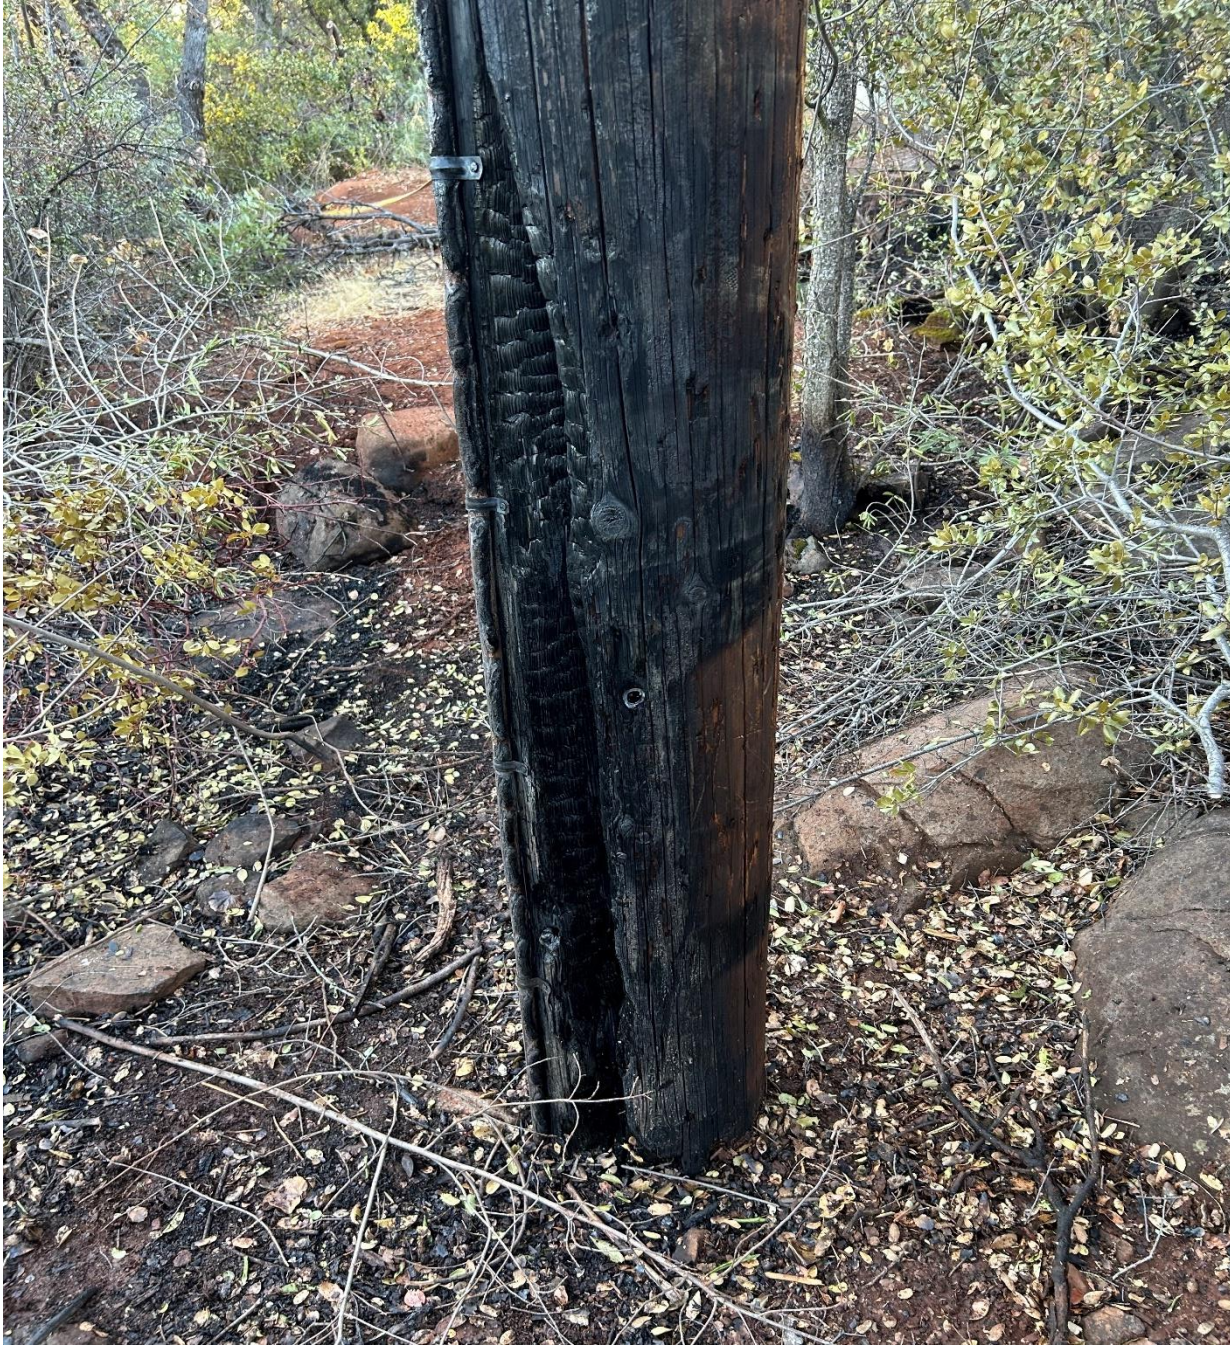
The PG&E Troubleshooter #1 arrived on the scene at approximately 1759 hours and observed a fire. Troubleshooter #1 confirmed that the transformer overheat sticker indicated overloading which resulted in the secondary service hot-leg connector failing on the service which caused arcing that burnt vegetation below at the base of SAP Pole ID # 101485155 (see Figures 3, 4, 5, and 6). Troubleshooter #1 removed the two connectors from the transformer jumpers and made the area safe. The ensuing fire was contained at one acre in size based on the Hazard Awareness Warning Center (HAWC) summary and the fire was suppressed quickly by CAL FIRE. CAL FIRE retained the failed connectors as evidence.

Figure 5 The secondary service hot-leg connector failed from overloading on the service which caused arcing and burned vegetation below at the base of SAP Pole ID # 101485155. Picture taken by the troubleshooter on September 3, 2024.

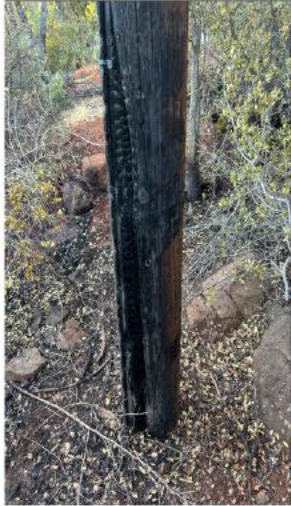
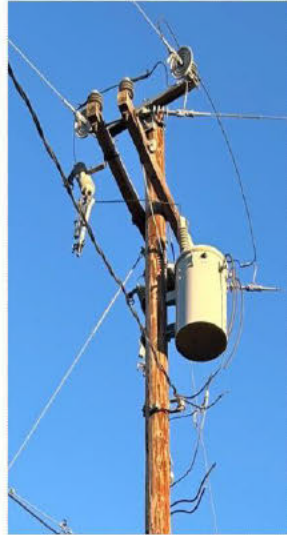
Troubleshooter #1 indicated a secondary service hot-leg connector burned/flushed from overloading on the service which caused arcing and burned the pole and vegetation below. The Troubleshooter removed the two connectors from the transformer jumpers and made the area safe. The incident service conductor has now been upgraded to a 397.5 aluminum conductor, which was completed under the Electric Corrective (EC) priority “A” Tag (#129470070) which now meets the required ampacity for the 400-amp meter panel (see Figures 7 and 8).

Figure 7 - Secondary service hot-leg connector burned/flushed from overloading on the service which caused arcing and burned the pole and vegetation below.

Pole burnt and replaced.
PM 35578674
