Preliminary Ignition Investigation Report

Ignition Database Index:	20241296
Electric Incident Investigation (EII) Number:	N/A
Incident Name:	Pearl
PG&E Facility Ignition?	Yes
CPUC Reportable Ignition?	Yes
Date & Time of Incident:	September 6, 2024 @approximately 0648 hours
Street Address:	(rural) 0.12 miles east of Camp 9 Road
City:	Angels Camp
County:	Calaveras
Latitude/Longitude:	38.11233, -120.41017
State Responsibility Area (SRA) / Local Responsibility Area (LRA) / Federal Responsibility Area (FRA)	State Responsibility Area
PG&E Division:	Stockton
High Fire Threat District (HFTD):	Tier 2
High Fire Risk Area (HFRA):	Yes
EPSS Buffer:	No
Fire Index Area (FIA):	320
Fire Potential Index (FPI) Rating: FIA	R5
Fire Potential Index (FPI) Rating: Circuit	R5
Was there a PSPS event at the time of ignition?	No
Suspected Initiating Event:	Equipment – PG&E
Failure Driver:	All types of equipment/facility failure
Failure Sub-driver:	Splice/Clamp/Connector
Circuit:	Stanislaus 1701

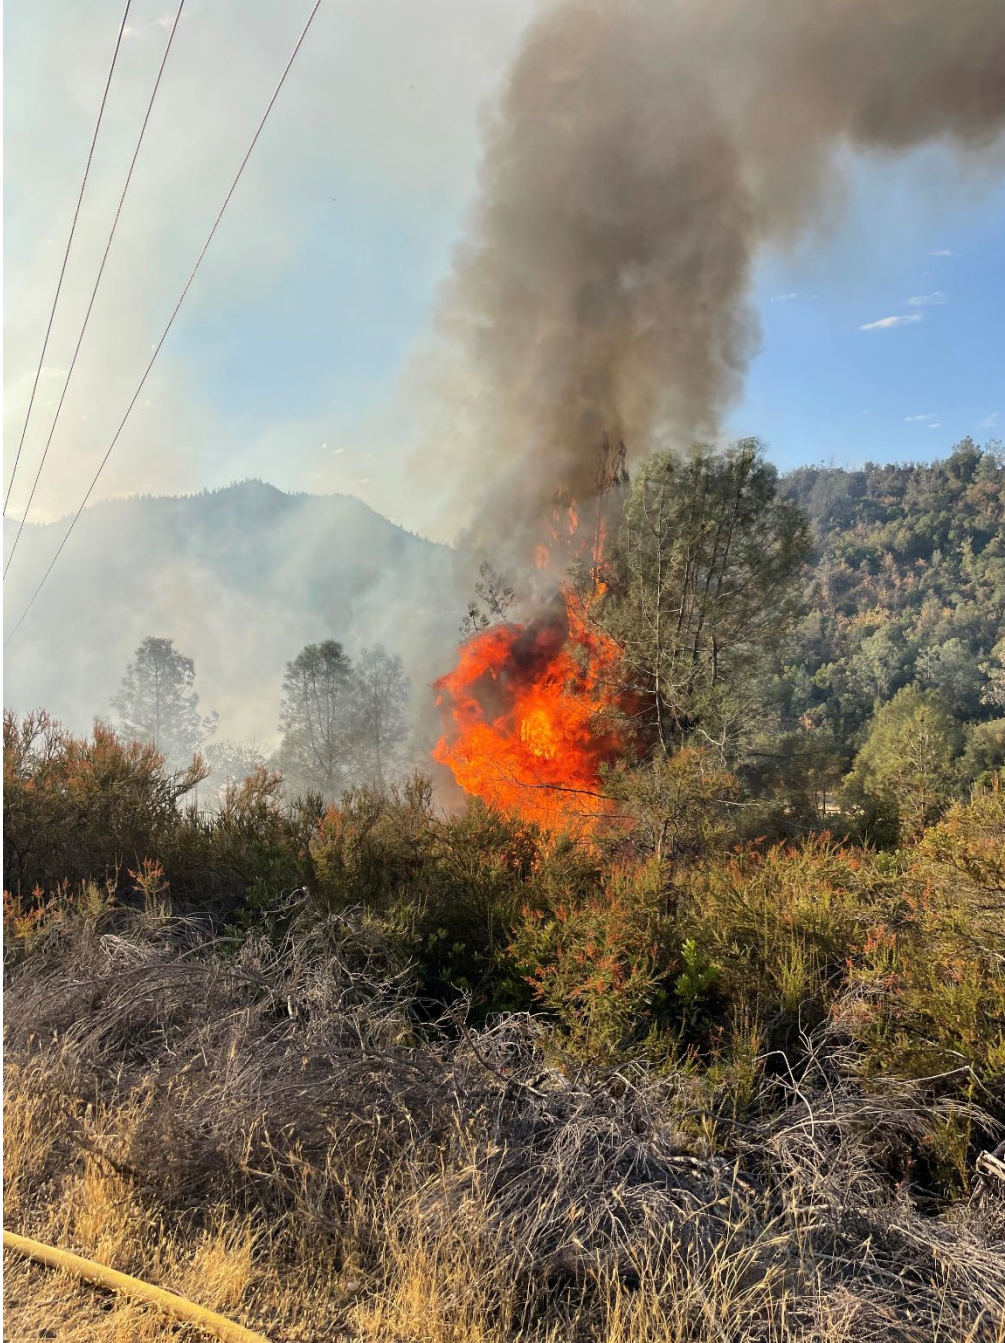
Figure 2 Active ignition at the Incident Location. Photo taken by responding troubleshooter on September 6, 2024.

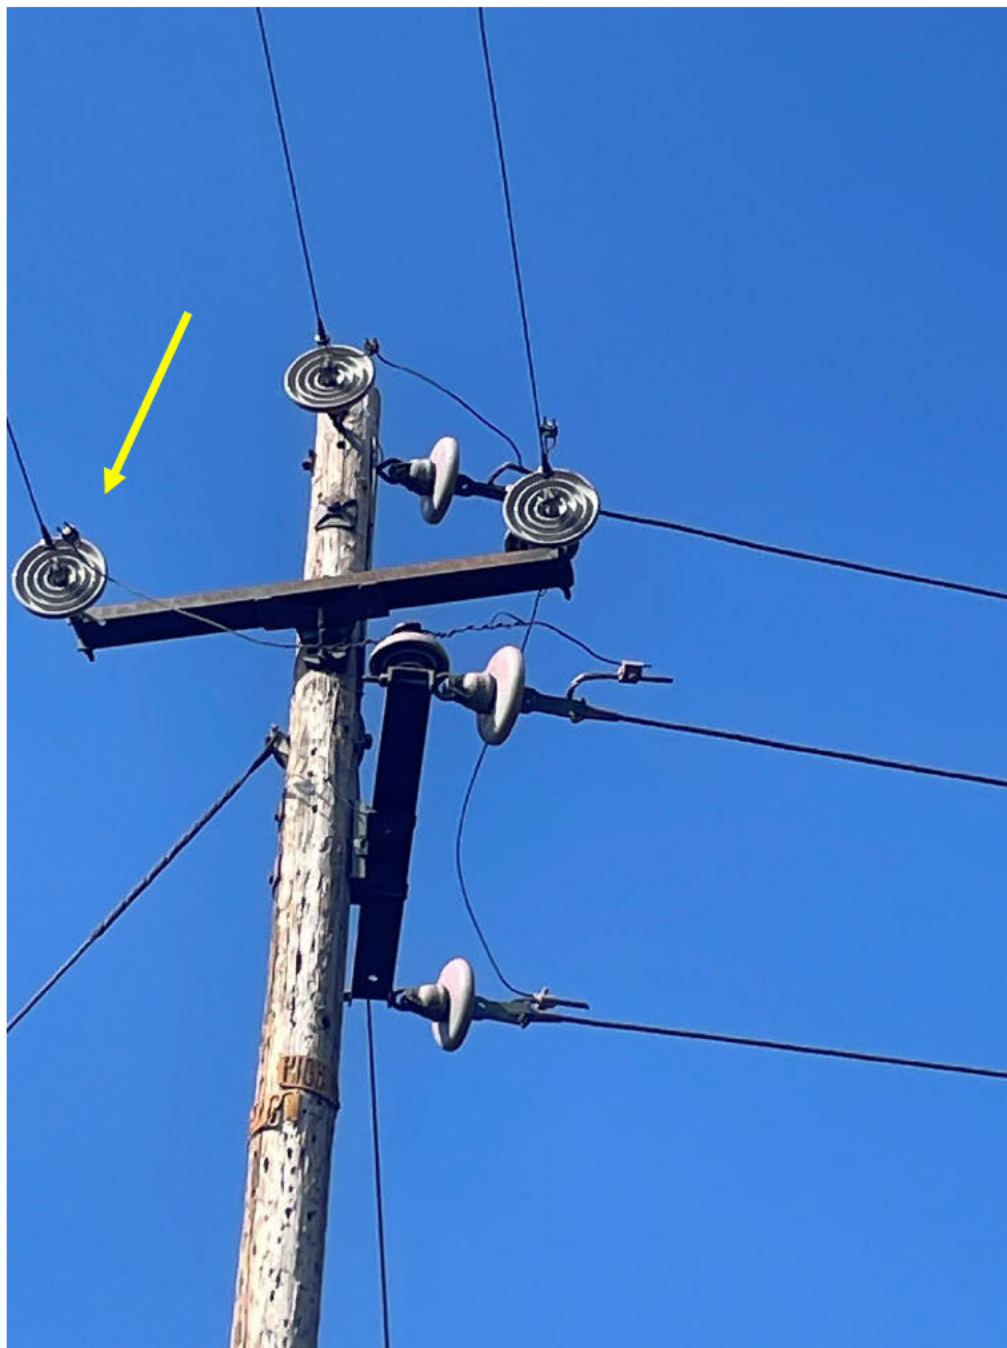
Troubleshooter #1 inspected the Incident Location with a CAL FIRE investigator. The CAL FIRE investigator suspected the ignition originated at the base of Pole #1. While inspecting Pole #1, Troubleshooter #1 saw no obvious signs of failure. The troubleshooter created EC Priority 'A' Tag (#129483126) to replace three jumpers on Pole #1 as well as to clean the insulators. While Troubleshooter #1 and the PG&E crew were replacing the jumpers, they found a loose connector on the 'A' phase, running from cutout to cutout. The loose connector (bolted connector) was retained for further analysis. Troubleshooter #1 created two more priority 'A' tags (#129485390) for Pole #2 and (#129485308) for Pole #3, to clean/wash the fire retardant from the assets.

Figure 3 SAP Pole ID 101285874 (Pole #1). Photo taken by troubleshooter on September 6, 2024. The bolted connector that was collected for analysis is identified in the photo.

- EC Priority 'A' Tag (#129483126) was created to clean the insulators and replace three jumpers on Pole #1 (SAP Pole ID 101285874). This tag was completed on September 6, 2024, by a PG&E crew.
- EC Priority 'A' Tags (#129485390 and #129485308) were created to wash/clean fire retardant from the insulators.
 - EC 'A' Tag (#129485390) → SAP Pole ID 104206160 – Pole #2
 - EC 'A' Tag (#129485308) → SAP Pole ID 104179457 – Pole #3

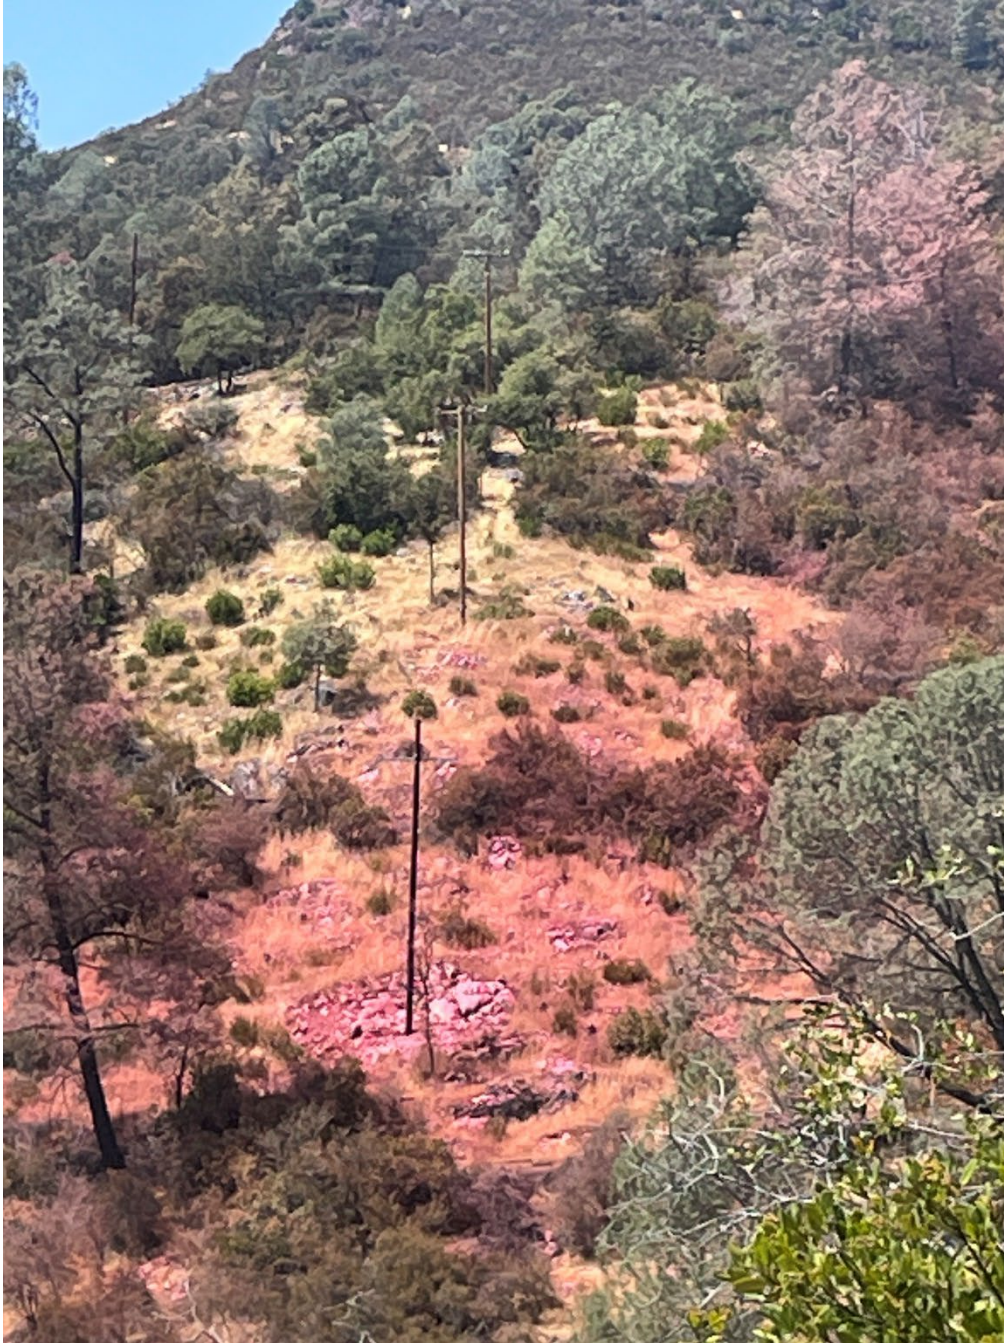
Figure 4 Poles that were treated with aerial fire retardant by CAL FIRE. Photo taken by troubleshooter on September 6, 2024.

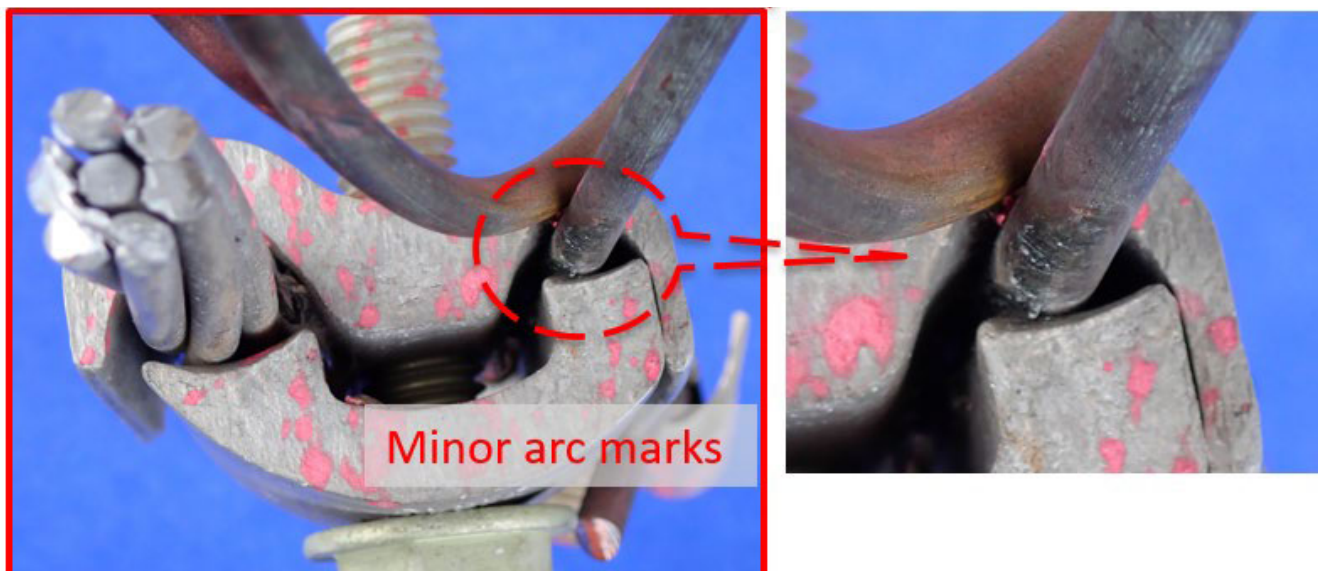
The failed bolted connector was collected and sent to Applied Technology Services (ATS) to be further analyzed by an engineer. Visual inspection of the bolted connector indicates minor arcing damage on the copper side of the parallel groove (PG) connector that attaches to the main line to the jumper (See Figure 5). There was a line-to-line fault a few minutes prior to the incident in the circuit protection zone of the ignition location. The engineer hypothesized that a surge caused arcing across a likely imperfection within the PG connector. The hot arcing products from the PG connector fell into the light, one-hour fuels on the ground, combusting.

The incident was reviewed by an Asset Failure Analysis (AFA) engineer, who concluded that the direct cause is still unknown. A loose connection can cause high resistance and voltage drops, which can heat up the joints on the connector. During a high magnitude fault, energy was dissipated at the loose connection rather than the other two phases.

Figure 5 ATS photo of bolted connector with the arc marks identified in the photo. Photo taken by ATS engineer.
