Preliminary Ignition Investigation Report

Ignition Database Index:	20241325
Electric Incident Investigation (EII) Number:	N/A
Incident Name:	N/A
PG&E Facility Ignition?	Yes
CPUC Reportable Ignition?	Yes
Date & Time of Incident:	September 12, 2024 @ 1200 hours
Street Address:	Alpine Road north of Alpine Oaks Road
City:	La Honda
County:	San Mateo
Latitude/Longitude:	37.2933948469, -122.2342660728
State Responsibility Area (SRA) / Local Responsibility Area (LRA) / Federal Responsibility Area (FRA)	State Responsibility Area
PG&E Division:	Peninsula
High Fire Threat District (HFTD):	Tier 2
High Fire Risk Area (HFRA):	Yes
EPSS Buffer:	No
Fire Index Area (FIA):	520
Fire Potential Index (FPI) Rating: FIA	R3
Fire Potential Index (FPI) Rating: Circuit	R3
Was there a PSPS event at the time of ignition?	No
Suspected Initiating Event:	Vegetation
Failure Driver:	Contact from Object
Failure Sub-driver:	Contact -Vegetation
Circuit:	Menlo 1103
Circuit Protection Zone:	Menlo 1103 LR8512

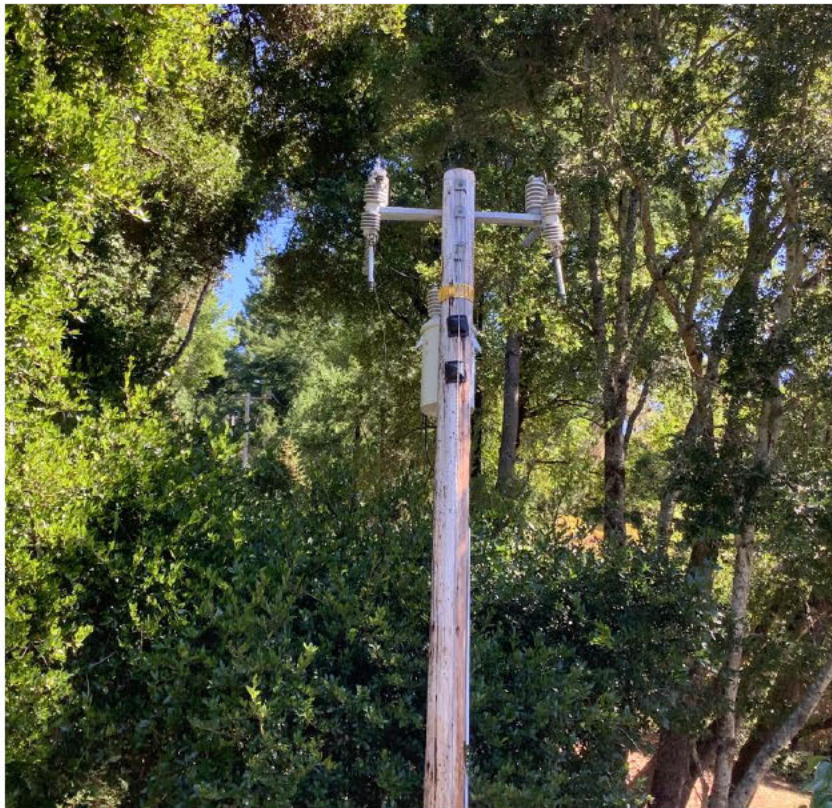
Figure 3 – Troubleshooter photo of Incident Pole taken 08/16/24

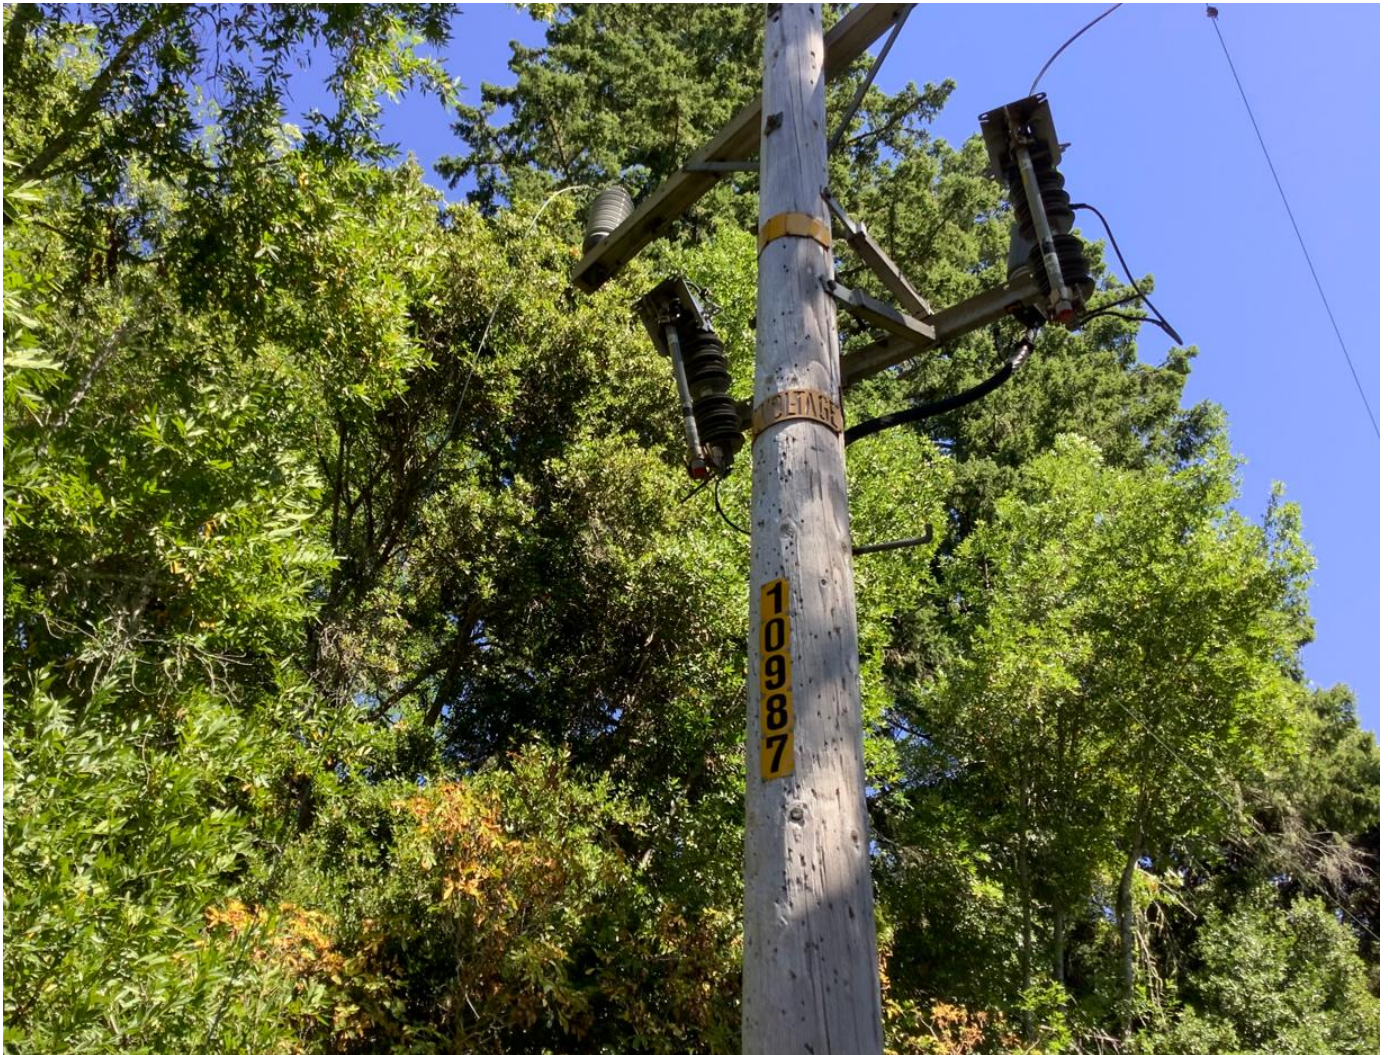
Figure 4 – Troubleshooter photo of adjacent pole, taken 08/16/24.

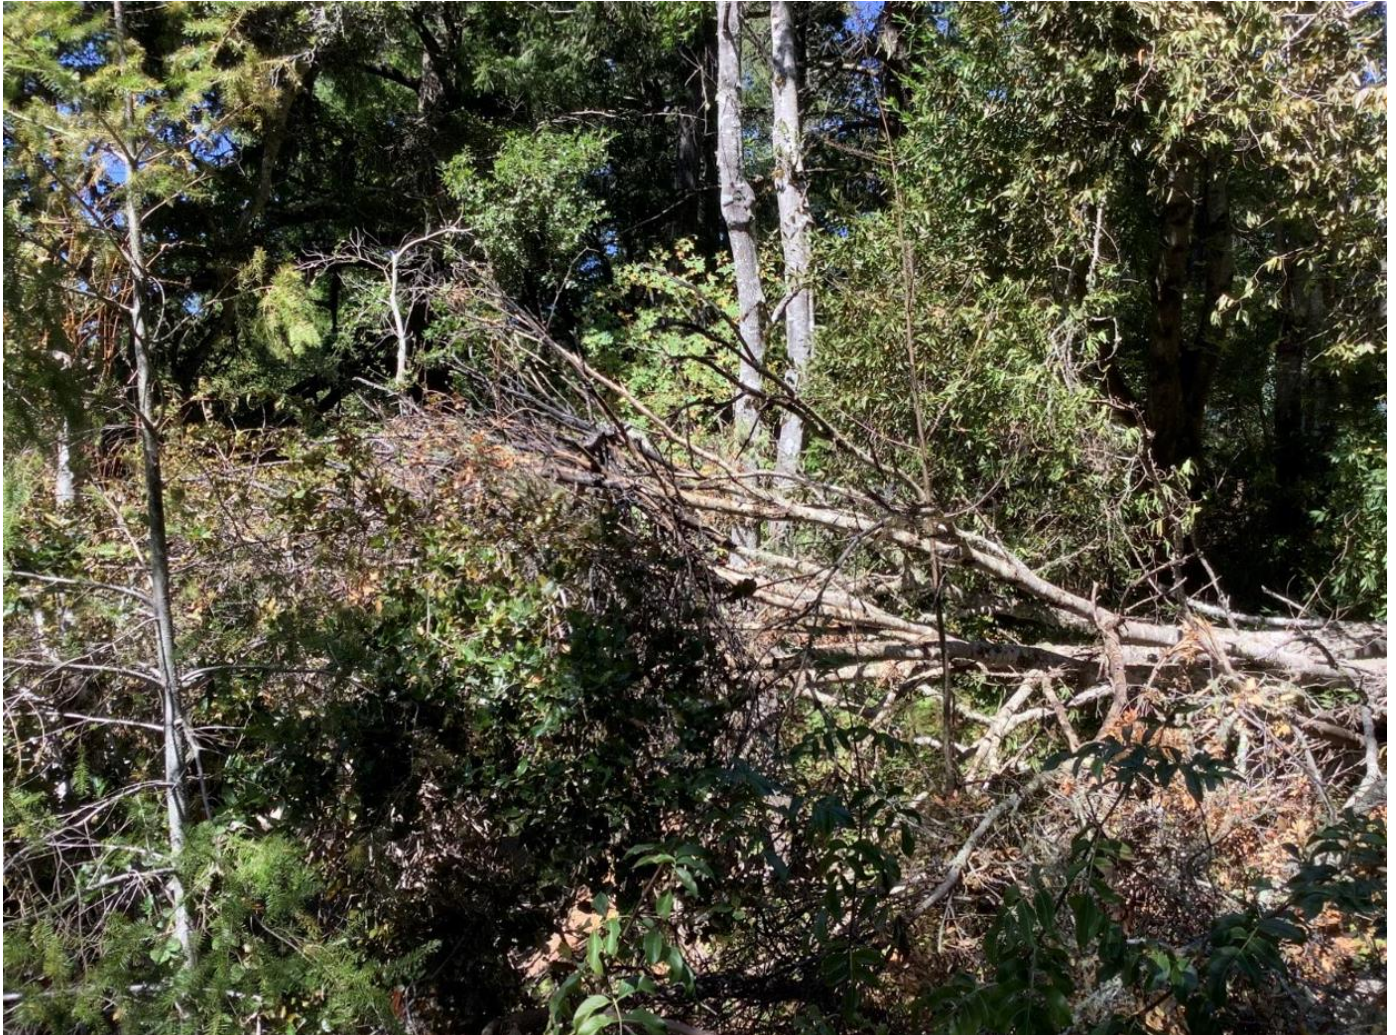
The troubleshooter arrived on Alpine Road, west of Alpine Oaks Road in La Honda at 1236 hours. Upon arrival the troubleshooter identified a failed tree branch that had fallen onto the conductor causing the one span of energized conductor to break. The energized conductor fell to the ground igniting a vegetation fire. CAL FIRE provided suppression efforts to a fire under 0.25 acres in size.

A California bay tree failed and fell onto the 12kV conductor causing a fire under 0.25 acres in size. Due to the weight of the tree, the conductors broke upon impact causing power lines to fall to the ground. CAL FIRE responded to the incident and extinguished a vegetation fire. An outage occurred affecting one customer for 636 minutes. Six additional customers were impacted by an area outage due to repair work. These six customers were without power for 534 minutes.

Figure 5 – Troubleshooter photo of downed tree branch on 08/16/24.

A priority “A” tag, EC Notification 129525337 was created to replace one span of #6 copper because of a tree branch falling and breaking the existing conductor. A PG&E repair crew was onsite on September 12, 2024 and repaired one span of #6 copper conductor to the impacted location.

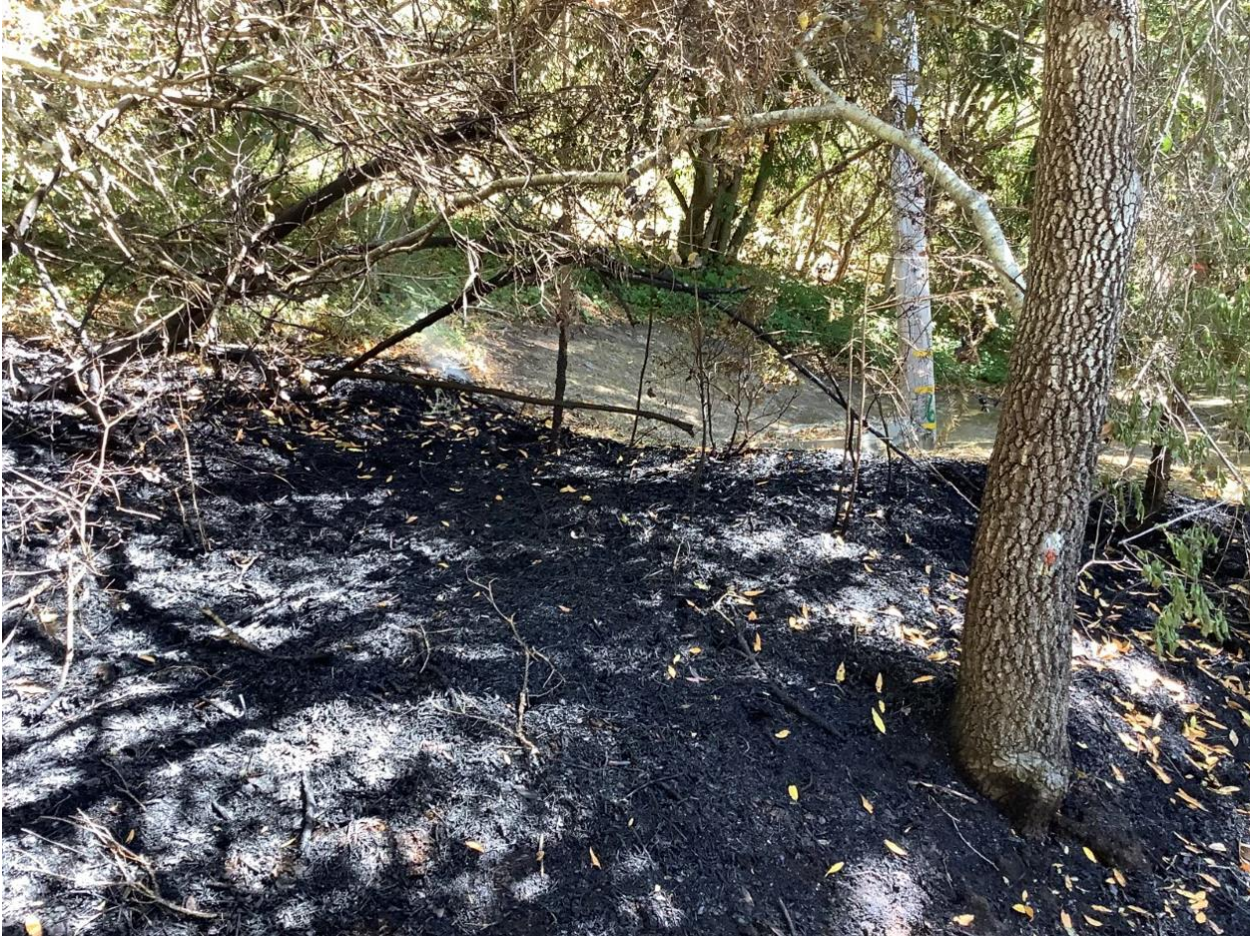
Figure 6 – Troubleshooter photo of fire footprint, taken 08/16/24

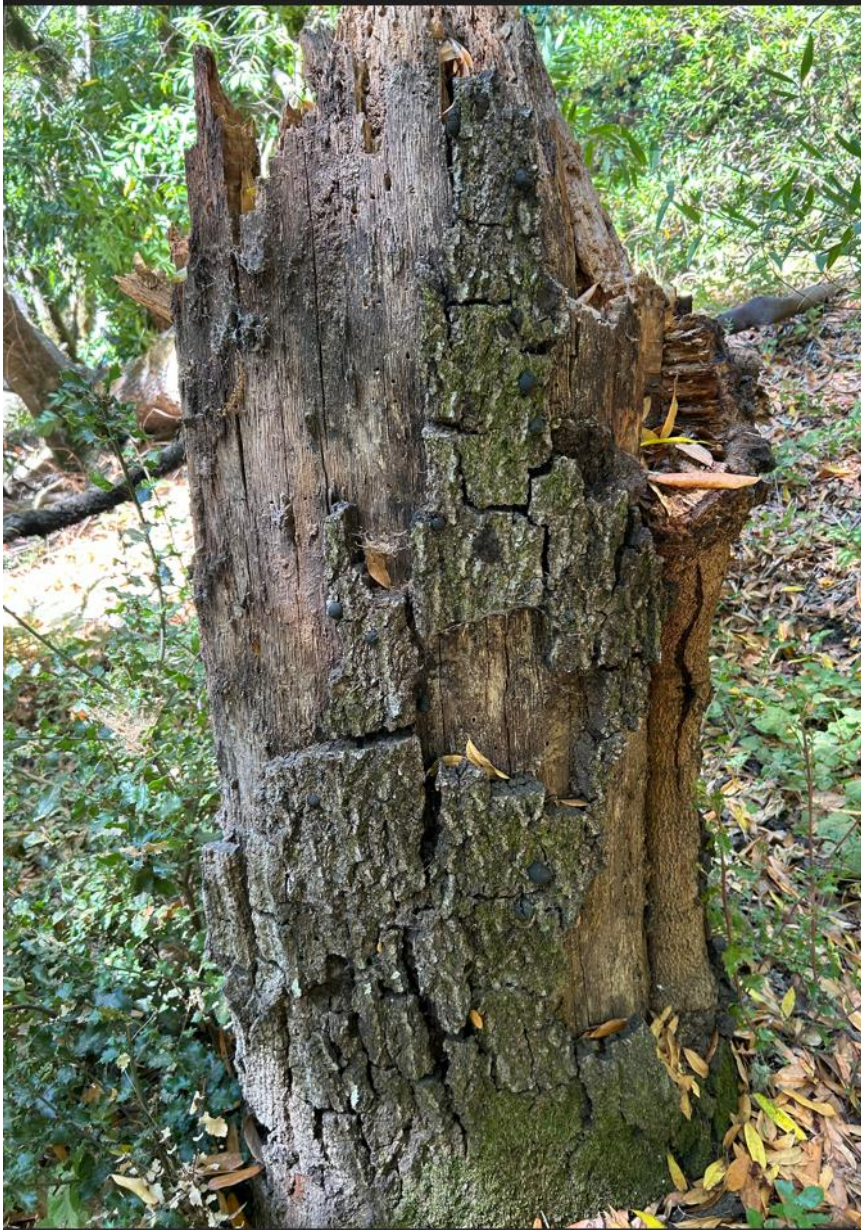
On September 13, 2024 a Vegetation Management (VM) fire incident investigation and extent of conditions (XoC) patrol were performed. The subject tree was identified as a California bay laurel (*Umbellularia californica*) that measured 23 inches diameter in breast height (DBH) and 65 feet in height. The partial failure was identified occurring 4.5 feet above ground level. The inspector identified the tree as dead or dying due to signs of decay along with black pustules, sloughing bark, termite/beetle frass in the trunk, a dead crown and a large old wound at the base of the tree.

The tree was last inspected by VM's routine maintenance program on August 16, 2024 and identified as dead at that time. The tree was prescribed for major dismantling work with a routine priority; however, the pending tag was descope after this failure occurred.

Figure 7 – Post incident photo taken by VM team, 09/13/24 showing hypoxylon cankers, missing bark, an old wound and termite damage

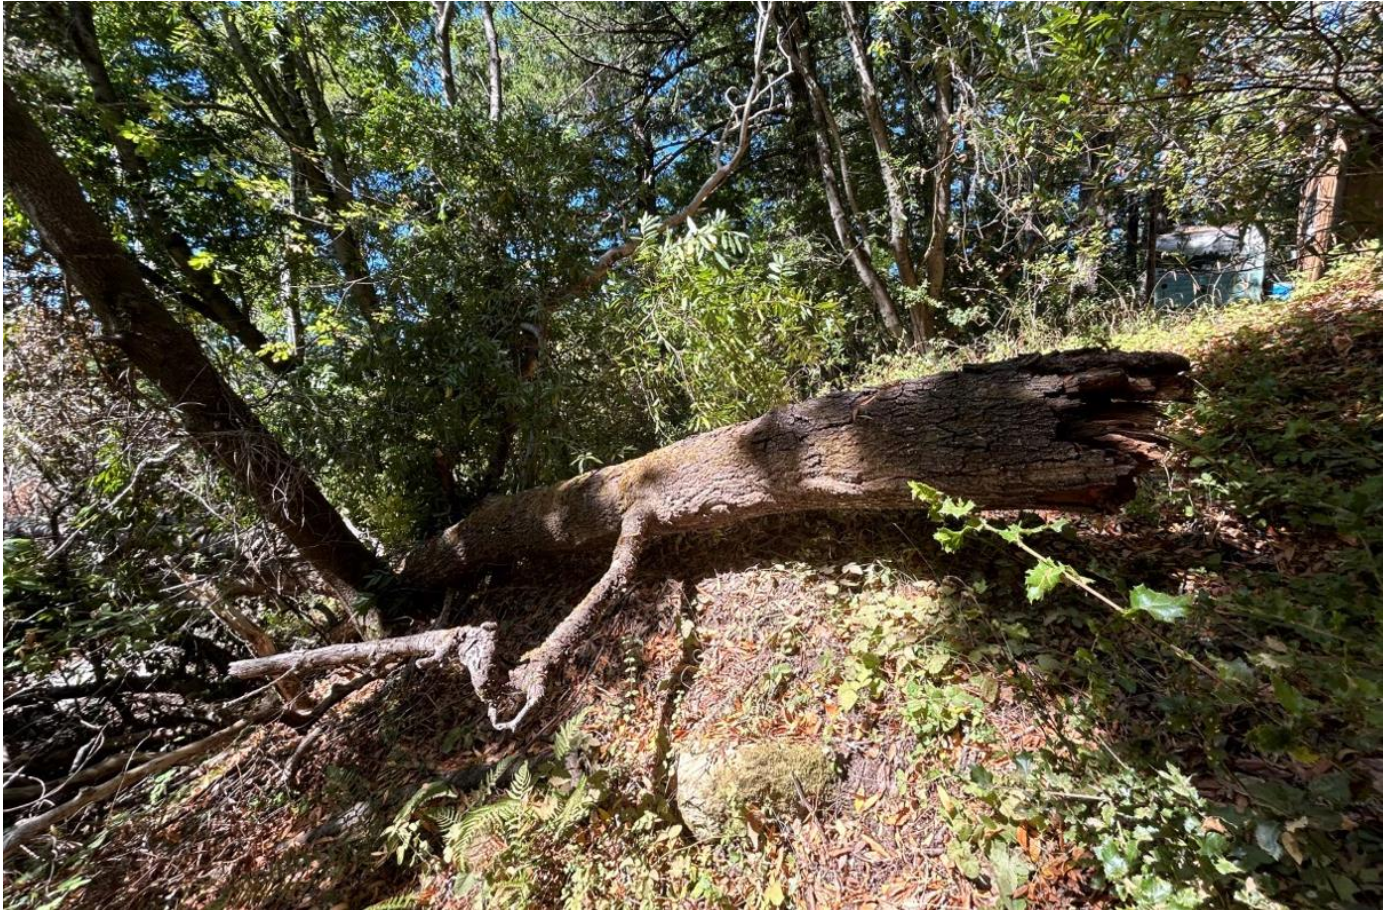
Figure 8 – Post incident photo taken by VM team, 09/13/2024 showing failed portion of tree. The break point is hollow indicating rot.

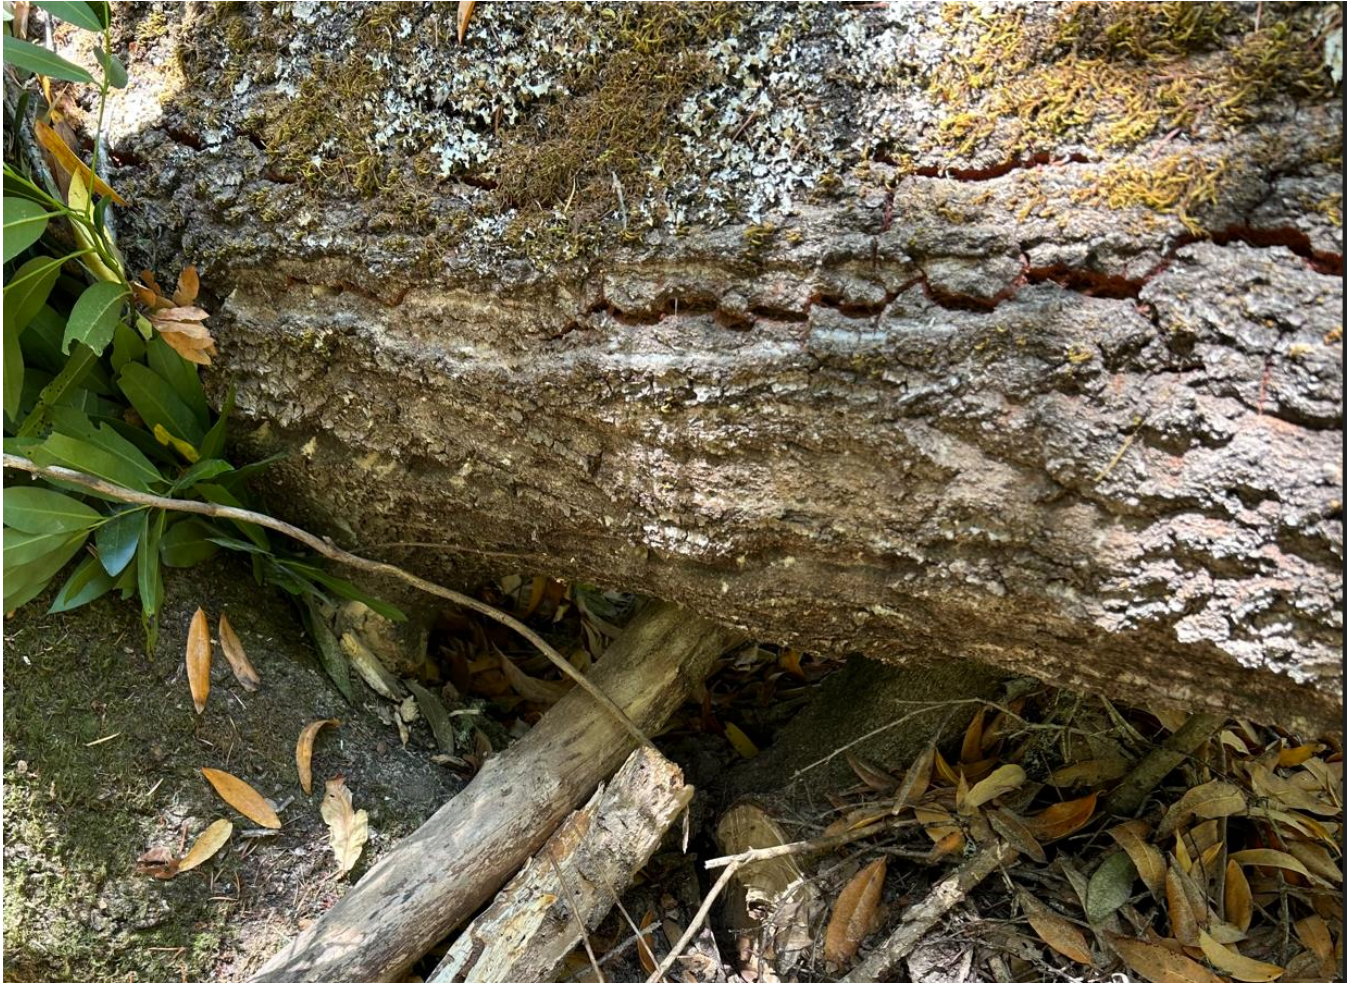
Figure 8 – Post incident photo taken by VM team 09/13/2024, showing linear cracks and fungus on bark.
