## Preliminary Ignition Investigation Report

Ignition Database Index:	20241335
Electric Incident Investigation (EII) Number:	N/A
Incident Name:	Holmes - 14 Sep 2024
PG&E Facility Ignition?	Yes
CPUC Reportable Ignition?	Yes
Date & Time of Incident:	September 14, 2024 @ 0323 hours
Street Address:	In the vicinity of [REDACTED]
City:	Philo
County:	Mendocino
Latitude/Longitude:	[REDACTED]°
State Responsibility Area (SRA) / Local Responsibility Area (LRA) / Federal Responsibility Area (FRA)	State Responsibility Area (SRA)
PG&E Division:	Humboldt
High Fire Threat District (HFTD):	Tier 2
High Fire Risk Area (HFRA):	Yes
EPSS Buffer:	No
Fire Index Area (FIA):	154
Fire Potential Index (FPI) Rating: FIA	R3
Fire Potential Index (FPI) Rating: Circuit	R3
Was there a PSPS event at the time of ignition?	No
Suspected Initiating Event:	Vegetation
Failure Driver:	Contact from object
Failure Sub-driver:	Contact – Vegetation
Circuit:	Philo 1102
Circuit Protection Zone:	Philo 1102920

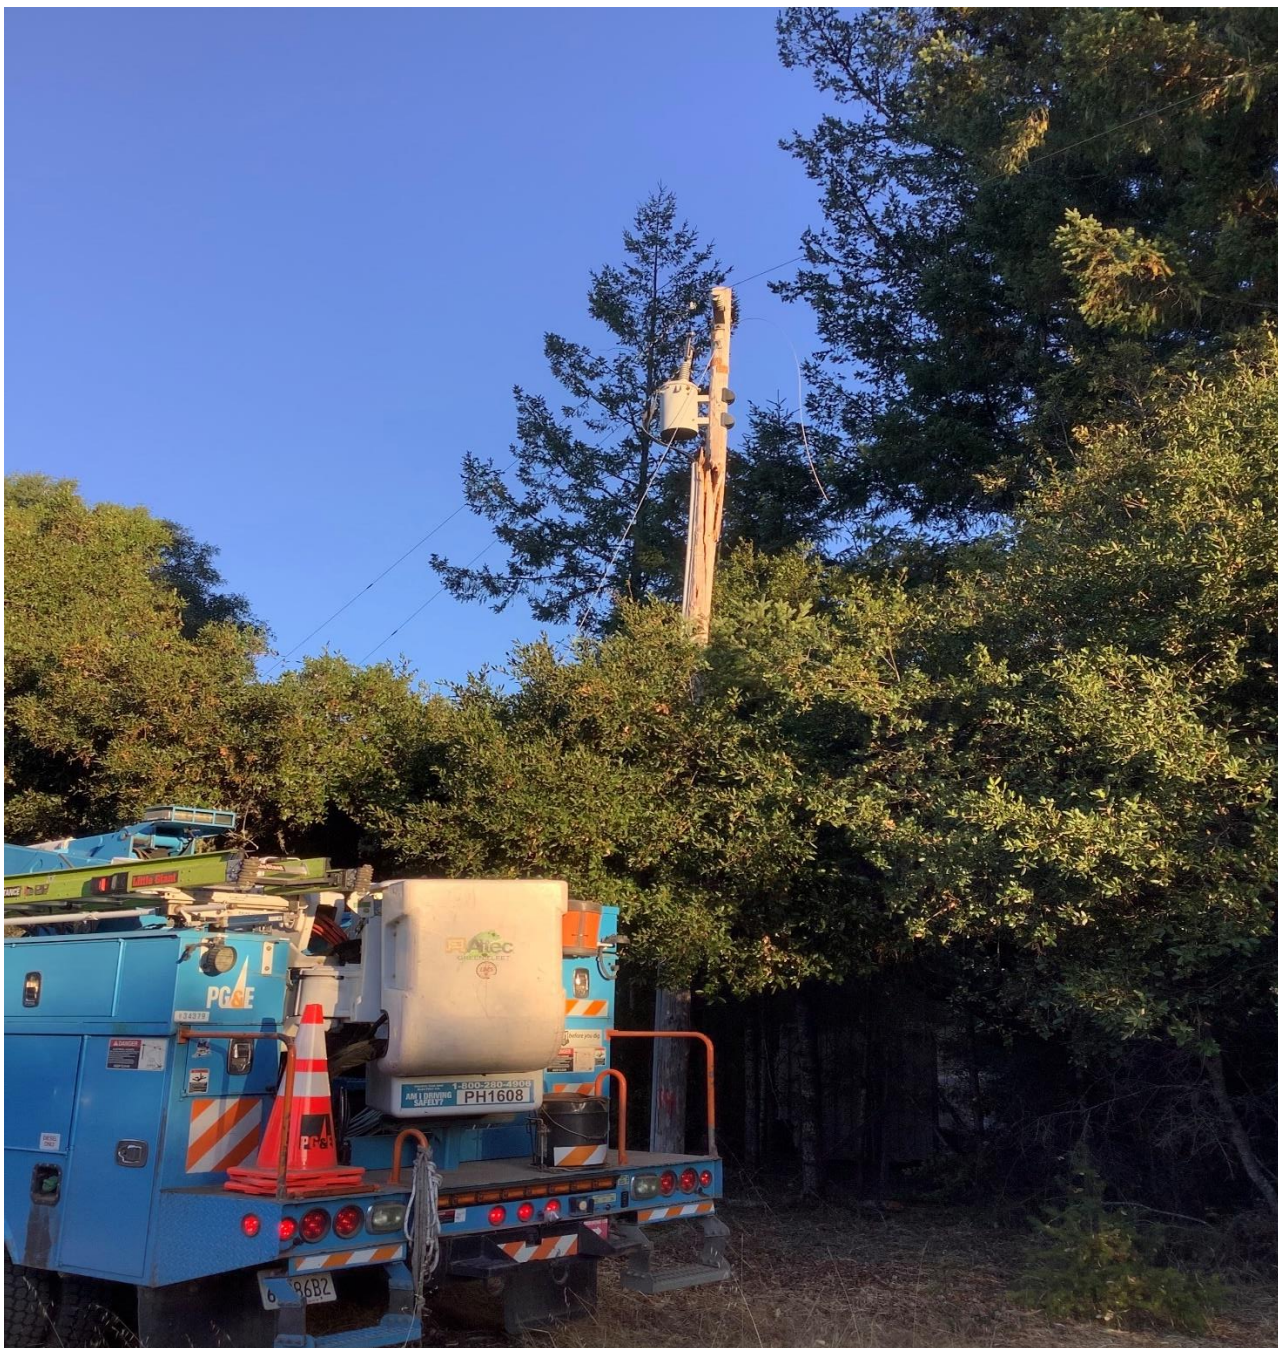
The Field Automation System (FAS) record states that the PG&E troubleshooter arrived on scene at approximately 0419 hours and observed a fire. The troubleshooter indicated that a tree branch fell onto the primary line conductor causing arcing and burned vegetation below. The troubleshooter also observed that one of two four-strand aluminum conductor steel reinforced (4 ACSR) came down causing a nearby SAP pole ID 102170053 to break mid-to-top of the pole with the impact (see Figures 3, 4, 5, 6, and 7).

Figure 3 – Broken pole by the impact of the failed tree branch, SAP Pole ID: 102170053 (Load Side). Picture taken by the troubleshooter on September 14, 2024

The PG&E repair crew arrived onsite at 1104 hours to replace a broken pole, transformer, and secondary riser on SAP Pole ID 102170053 (load side), which was part of the electric corrective (EC) priority "A"-tag # 129533214. The crew also replaced a single phase of 4-ACSR and the angle cross-arm on SAP Pole ID 102170048 (source side), which was part of the EC- priority "A"-tag # 129533214. All work was completed by the repair crew by 1453 hours, on September 14, 2024.

EC priority A Tag 129533214 was created to replace a broken pole, transformer, and secondary riser on SAP Pole ID 102170053 (load side). EC priority A Tag 129533214 was also created to replace a single phase of 4-ACSR and angle cross-arm on SAP Pole ID 102170048 (source side). All work was completed by the repair crew by 1453 hours, on September 14, 2024.

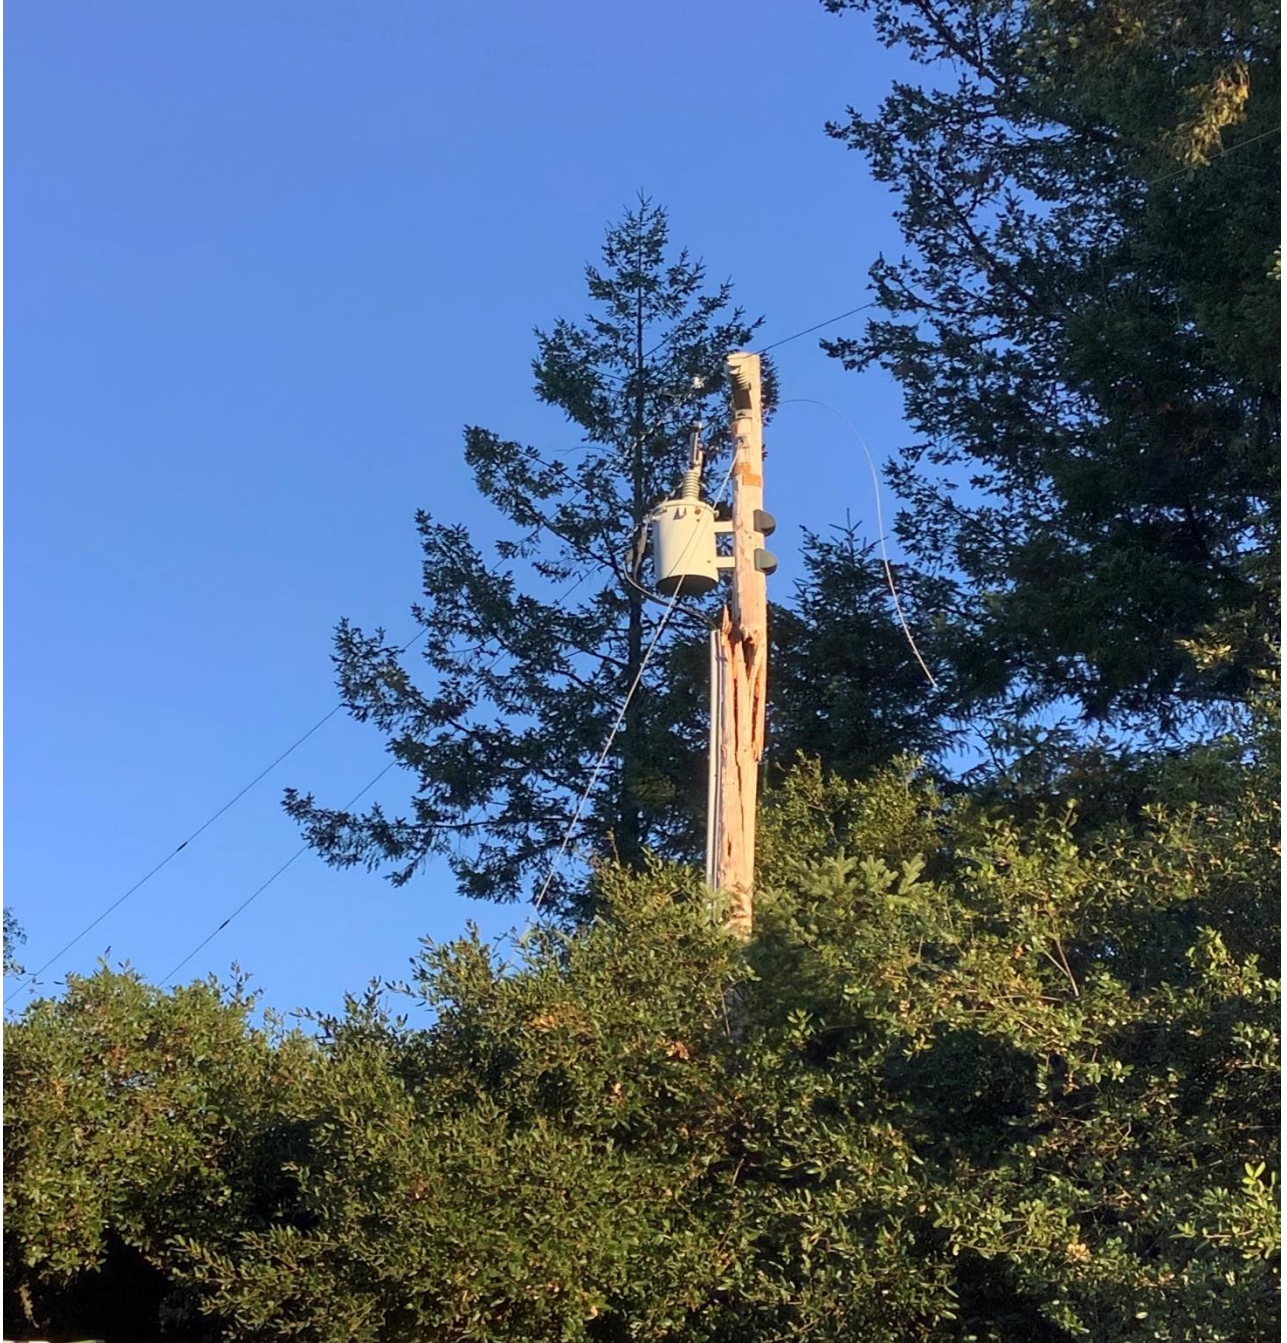
Figure 4 - - Close-up of the broken SAP Pole ID: 102170053 (Load Side). Picture taken by the troubleshooter on September 14, 2024

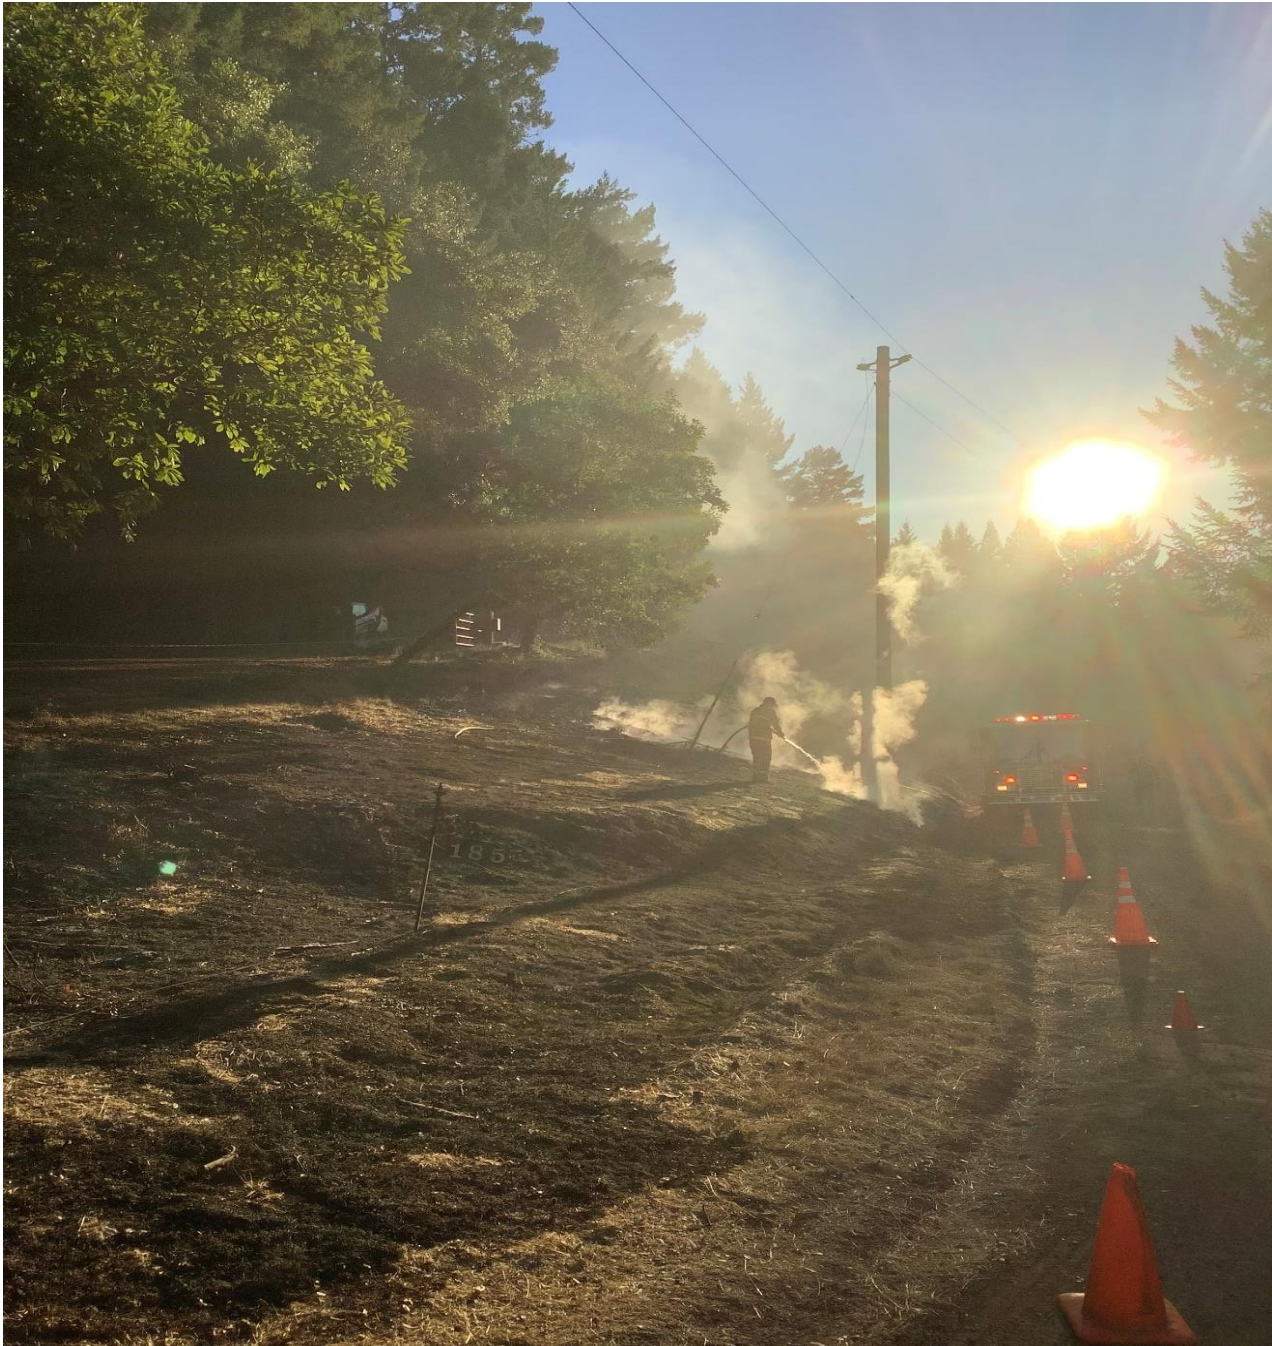
Figure 5 - Fire burn scar area and SAP Pole ID: 102170048 (Source Side). Picture taken by the troubleshooter on September 14, 2024.

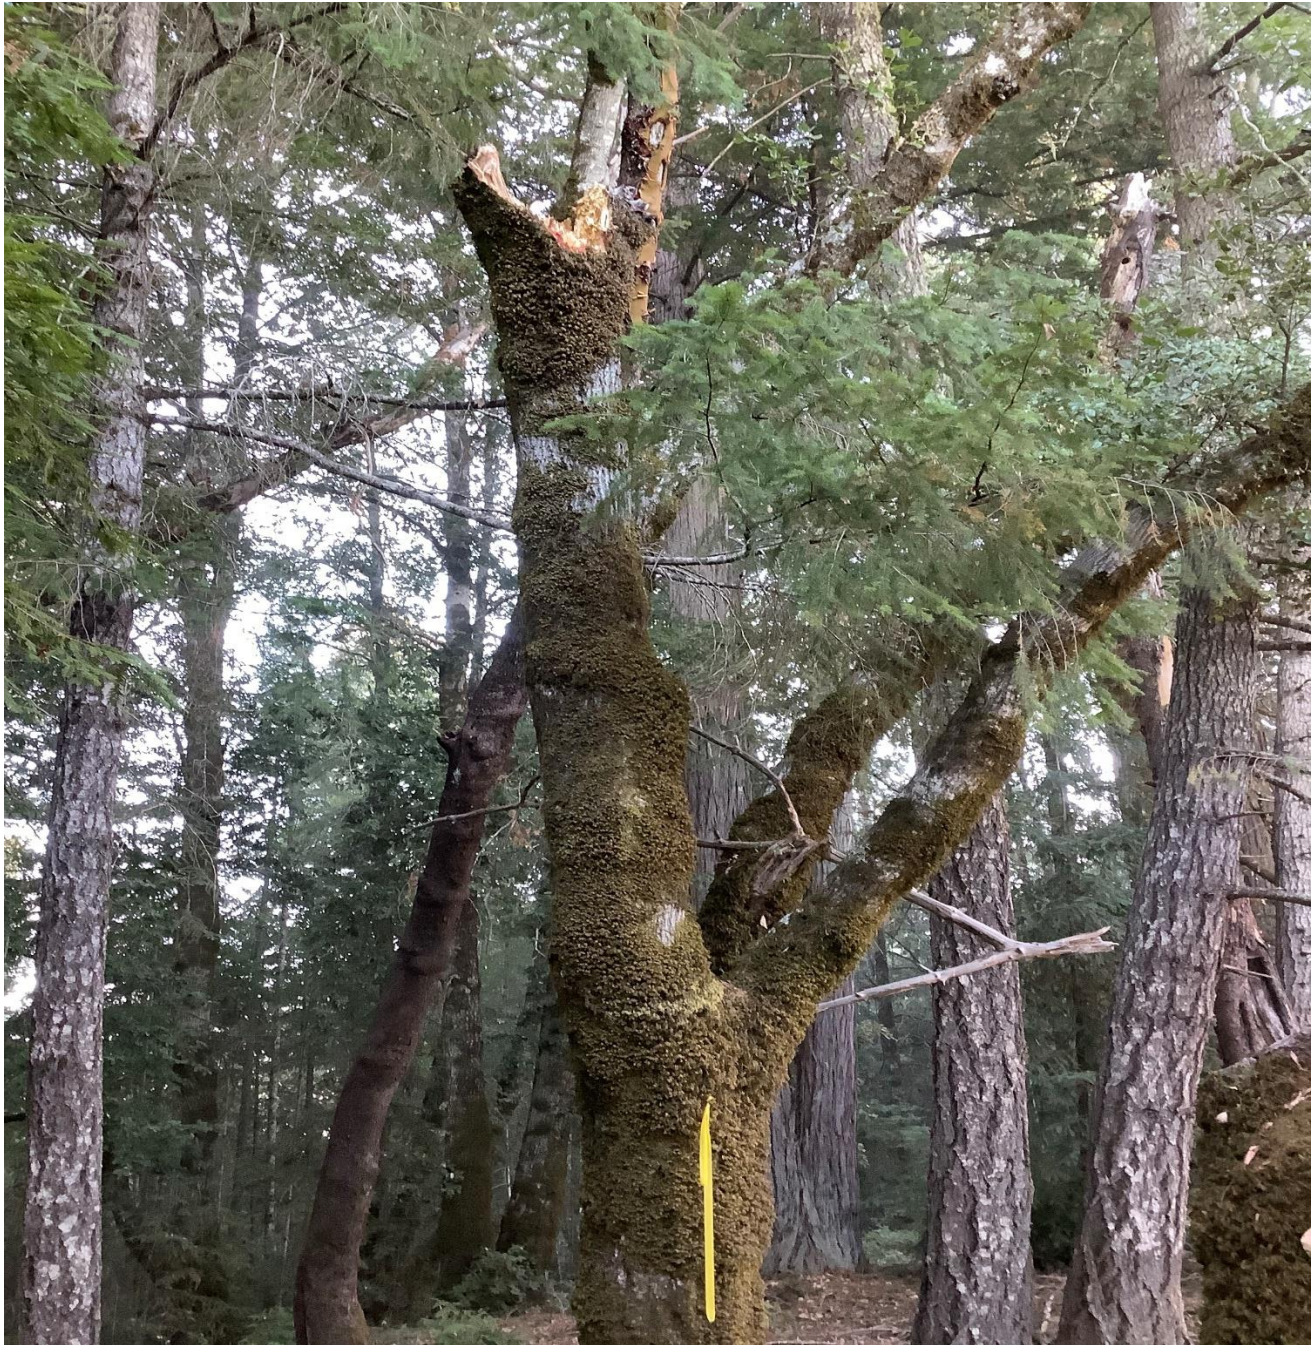
A post-incident investigation was performed by a PG&E Vegetation Management Inspector (VMI) on September 16, 2024, near the incident location. The VMI observed a large coast live oak (*Quercus agrifolia*) multi-stem tree with a diameter breast height (DBH) of 44 inches and a height of 54 feet. The subject tree had a large 13-inch diameter limb fail and fall through a primary line conductor causing arcing and burned vegetation below. In effect, this also broke the pole SAP Pole ID: 102170053 due to the impact. The inspector also observed that the failed live oak tree limb had a wound near the point of failure with signs of internal rot that would not have been visible from the ground prior to the failure occurring.

*Figure 6 – Incident Live Oak tree, where the branch/limb failed and fell onto the conductor which caused arcing and burned vegetation below. Picture taken by the troubleshooter on September 14, 2024.*

On September 16, 2024, RX-02393223 was delisted, and prescription RX-03314002 was created to remove the entire tree.

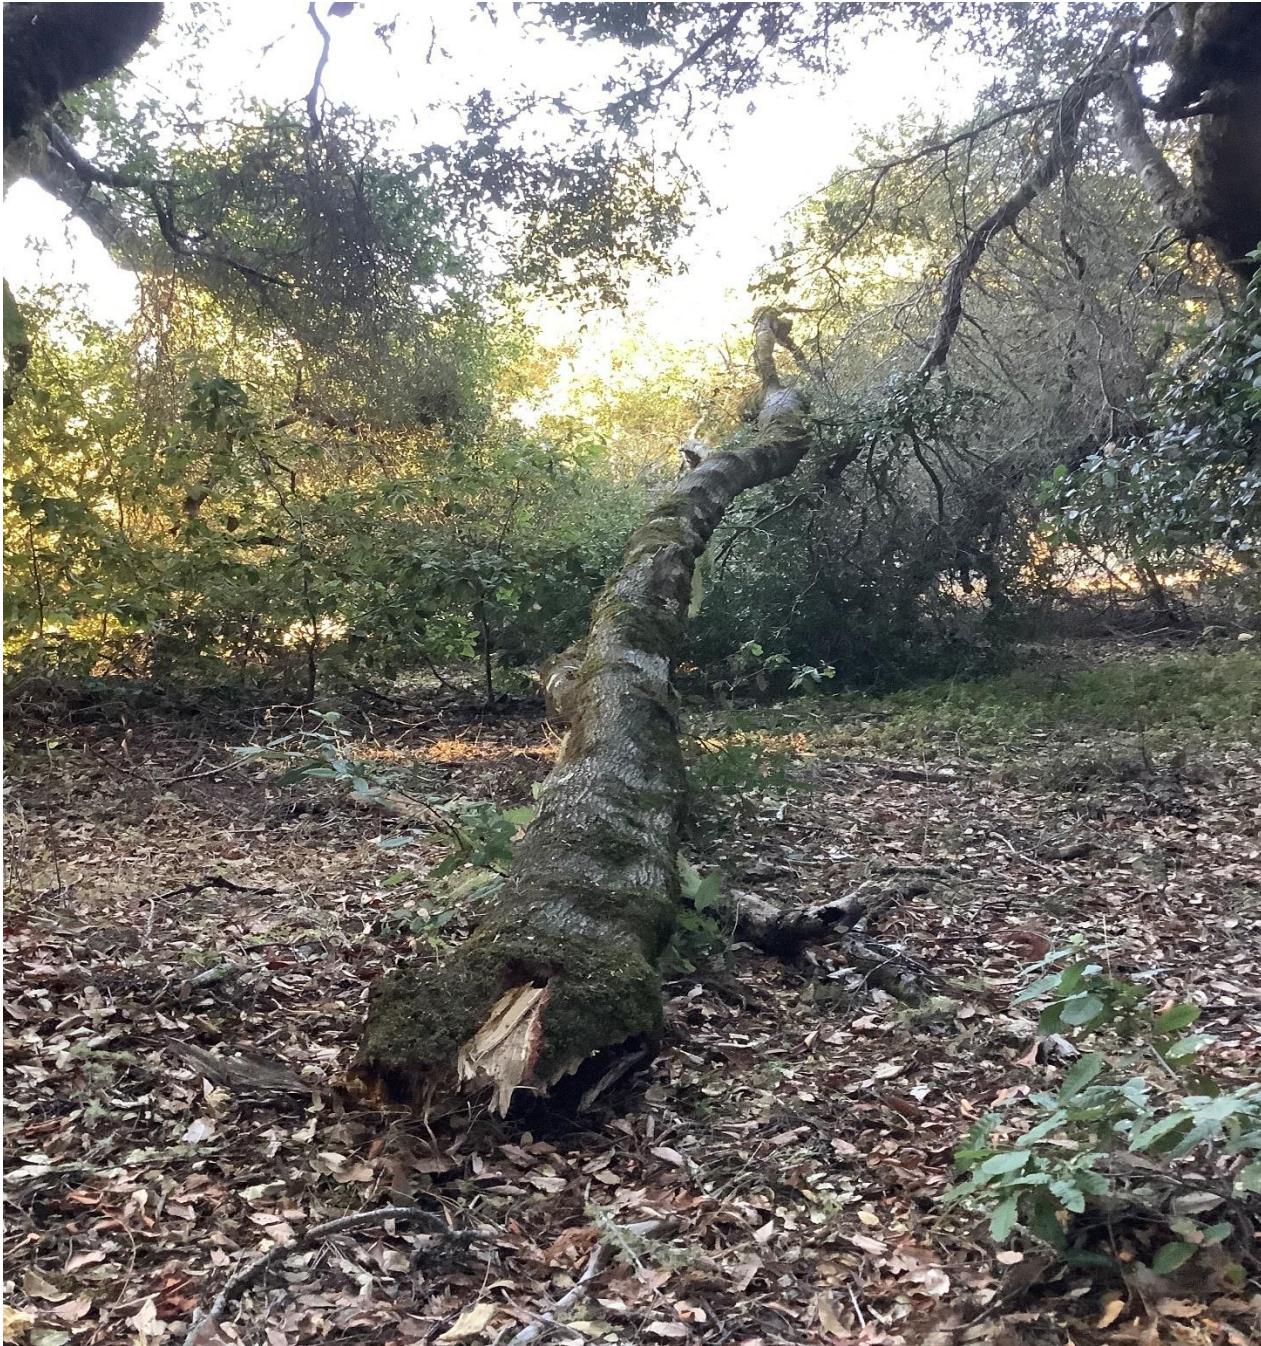
Additionally, it was noted that the subject tree stem was prescribed for a target prune during the last mid-cycle inspection that occurred on July 11, 2024. This inspection resulted in work prescription RX-02393223, which identified a large western stem with a visible wound to be removed. The work was to be completed by July 10, 2025. Per Vegetation Management (VM) work management standards, this was an acceptable time frame for the subject tree to be worked. Although, had this prescribed work been completed by the due date, this ignition could have been prevented.

*Figure 7 – Close-up of the large Live Oak branch/limb that failed and fell onto the conductor. Picture taken by the troubleshooter on September 14, 2024.*

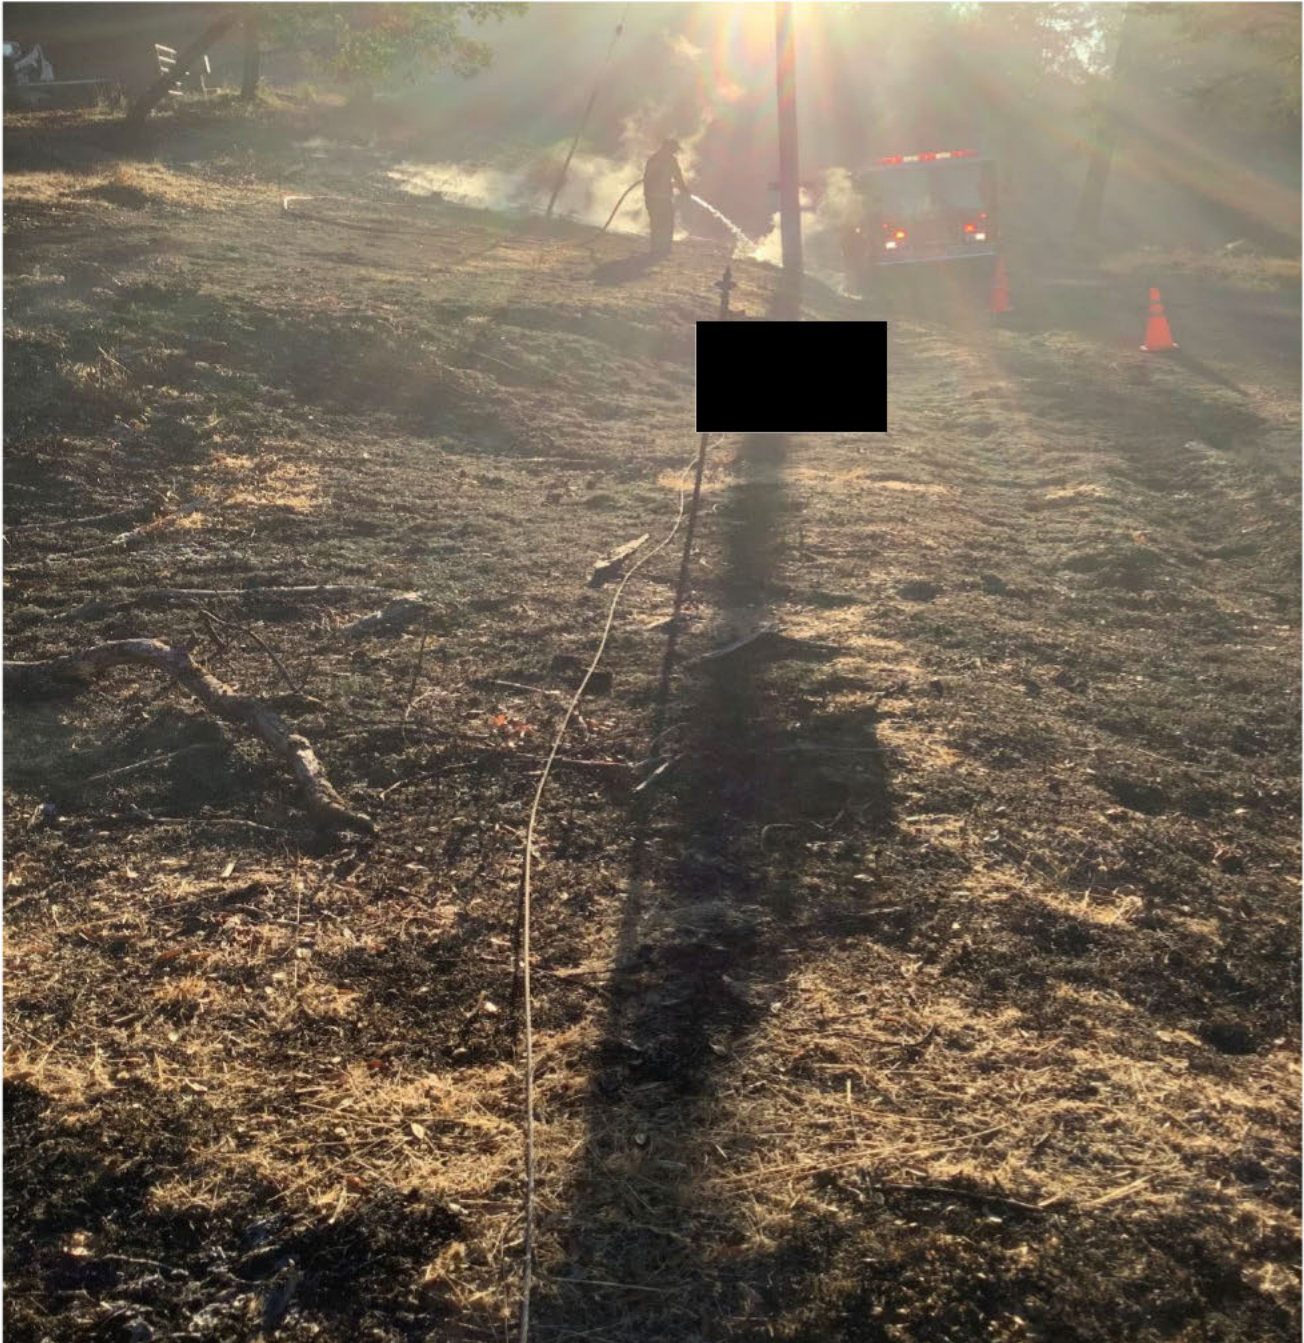
The fire is listed as the "Holmes" fire in the Hazard Awareness Wildfire Command (HAWC) fire activity report. The ensuing fire had spread to about 0.5 acres (based on the HAWC summary) in size and was suppressed by CAL FIRE on September 14, 2024, (see Figure 8).

*Figure 8 – CAL FIRE onsite to assist in controlling and suppressing the fire spread, picture taken by the troubleshooter on September 14, 2024.*

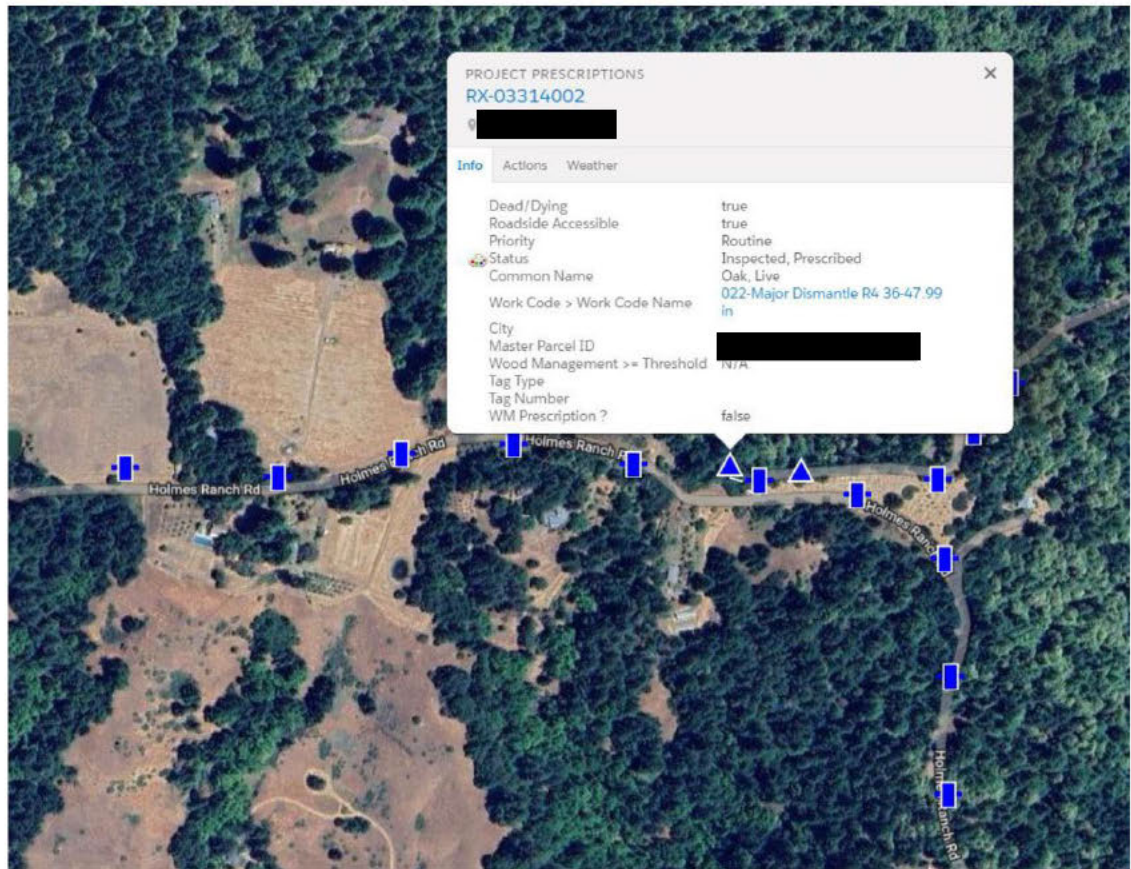
An extent of condition (XoC) investigation was performed by the same VMI on September 16, 2024, and noted the same details as the post-incident investigation above. The VMI patrolled five spans in each direction and identified two additional priority two (P2) for removal (see Figures 9, 10, and 11). The first tree identified was a 50-foot tall, 32-inch DBH interior live oak (*Quercus wislizeni*), and the second tree was a 51-foot tall, 10-inch DBH Douglas fir. Both trees were prescribed with a due date of October 10, 2024. All work related to the work request UCNC1006709 was completed on September 25, 2024, and the request was closed on September 30, 2024.

Figure 9 - Five-span patrol completed by the VM inspector on September 16, 2024.

Type	Number	Description	Priority	Date Identified	Due Date
EC Notification	N/A				
COE Notification	N/A				
LC Notification	N/A				
Veg Work Order	UCNC1006 709	Interior Live Oak, 50 ft, 32 in DBH (Major R3 Removal)  Douglas Fir, 51 ft, 10 in DBH (Major R1 Removal)	P2	September 16, 2024	October 10, 2024

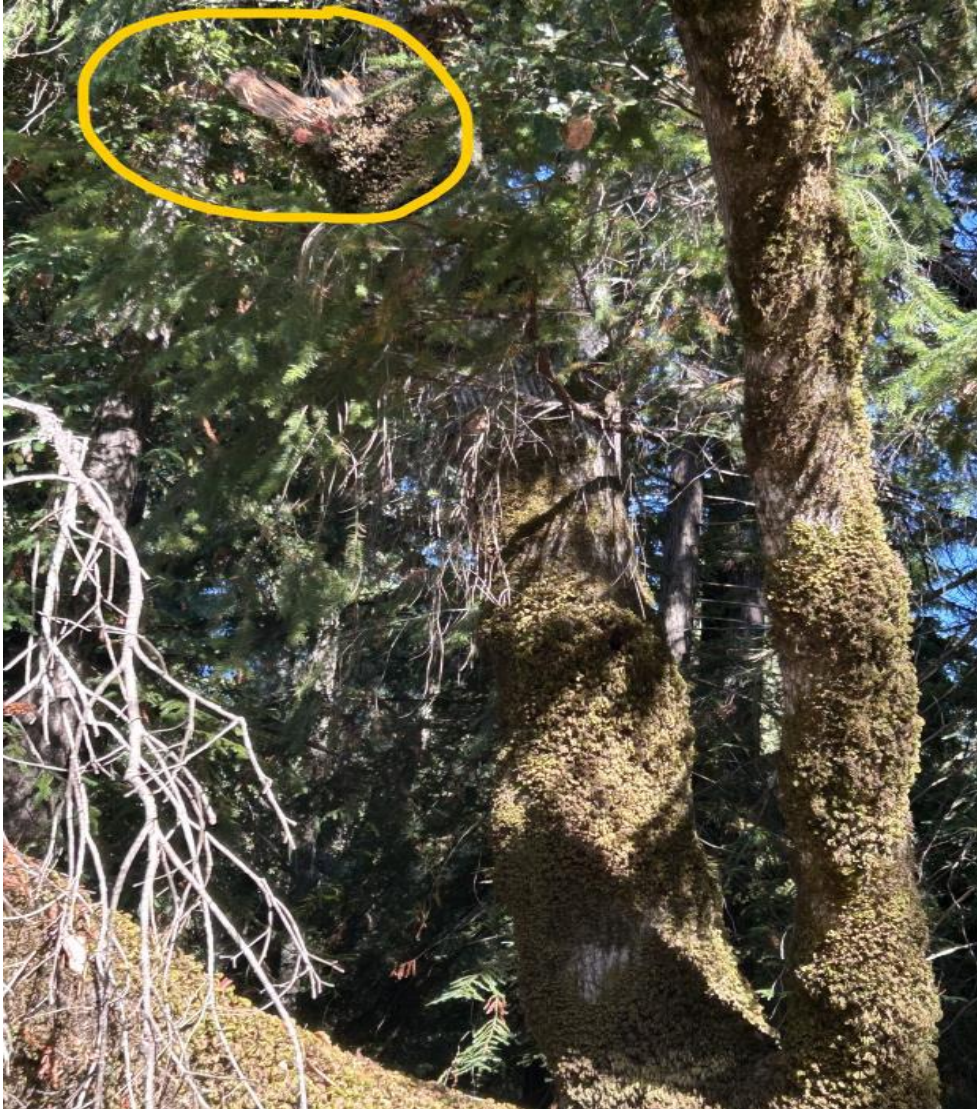
*Figure 10 – Point of partial tree failure (circled) picture taken by the VM inspector on September 16, 2024.*

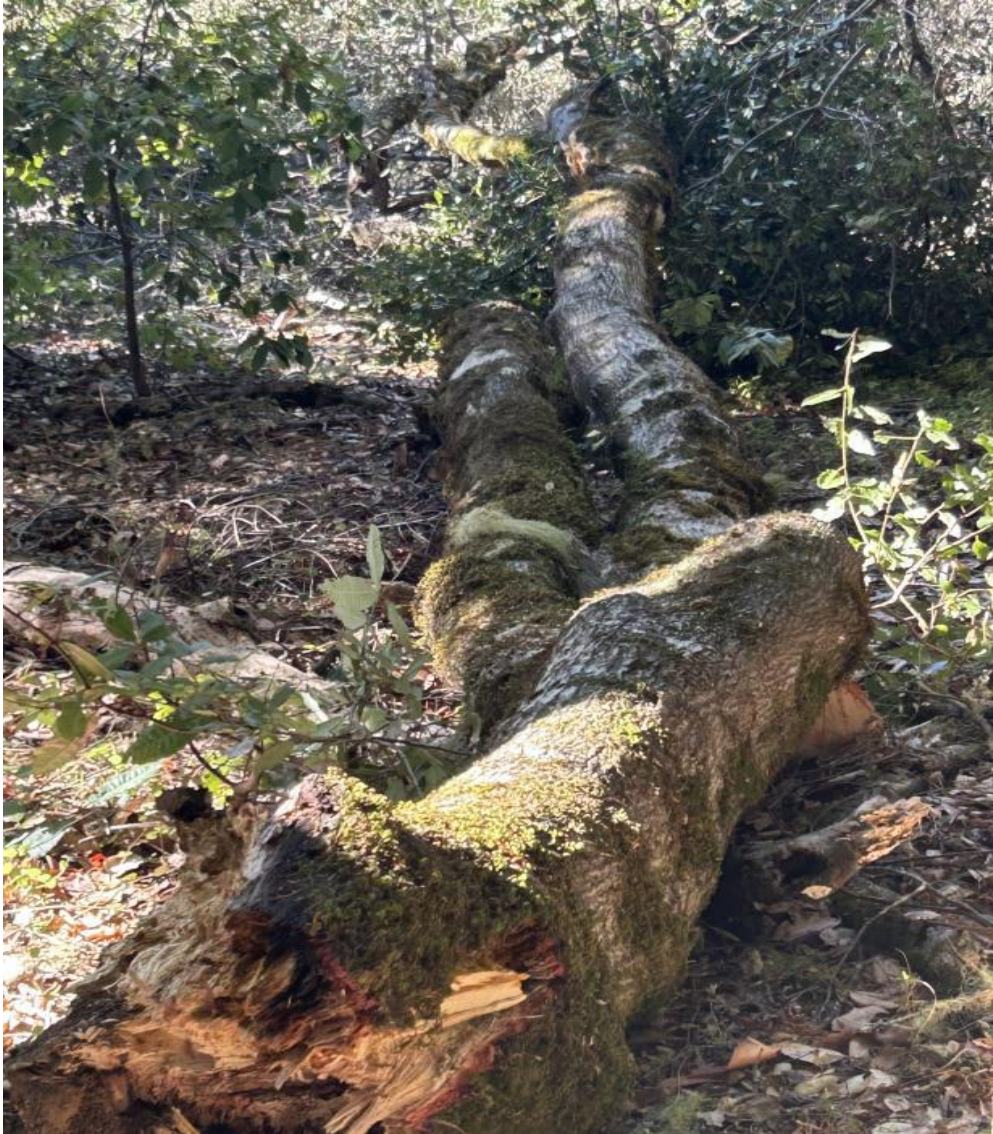
*Figure 11 – Failed limb on the ground, picture taken by the VM inspector on September 16, 2024.*
