Preliminary Ignition Investigation Report

Ignition Database Index:	20241353
Electric Incident Investigation (EII) Number:	NR240916A
Incident Name:	Rosa
PG&E Facility Ignition?	Yes
CPUC Reportable Ignition?	Yes
Date & Time of Incident:	September 16, 2024 @ 1100 hours
Street Address:	3780 Santa Rosa Road
City:	Lompoc
County:	Santa Barbara
Latitude/Longitude:	34.5949093115, -120.3616852881
State Responsibility Area (SRA) / Local Responsibility Area (LRA) / Federal Responsibility Area (FRA)	State Responsibility Area
PG&E Division:	Los Padres
High Fire Threat District (HFTD):	Tier 2
High Fire Risk Area (HFRA):	Yes
EPSS Buffer:	No
Fire Index Area (FIA):	512
Fire Potential Index (FPI) Rating: FIA	R2
Fire Potential Index (FPI) Rating: Circuit	R2
Was there a PSPS event at the time of ignition?	No
Suspected Initiating Event:	PG&E Equipment
Failure Driver:	All types of equipment/facility failure
Failure Sub-driver:	Splice/Clamp/Connector
Circuit:	Cabrillo 1103
Circuit Protection Zone:	Cabrillo1103 LR Y46

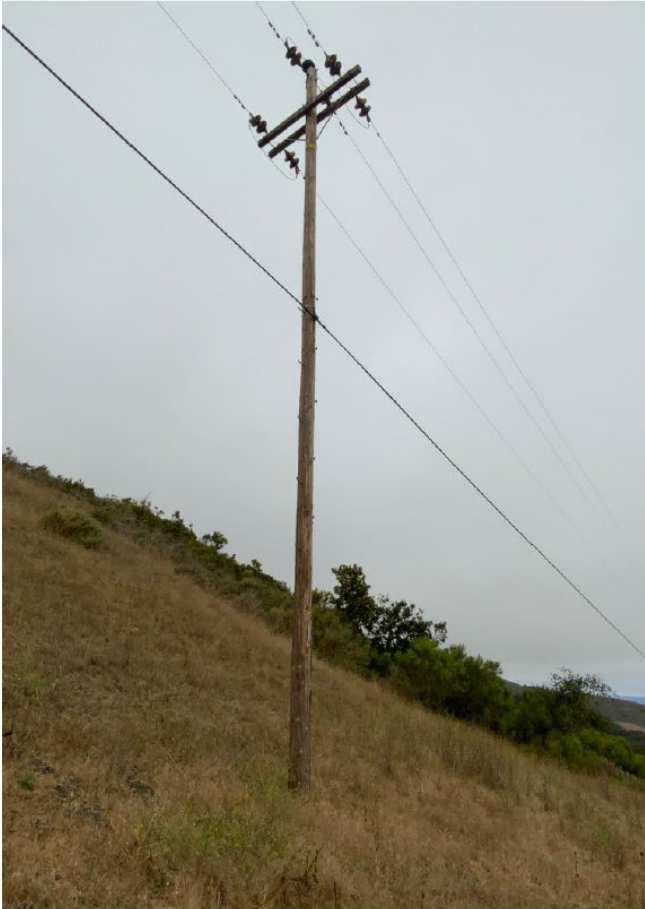
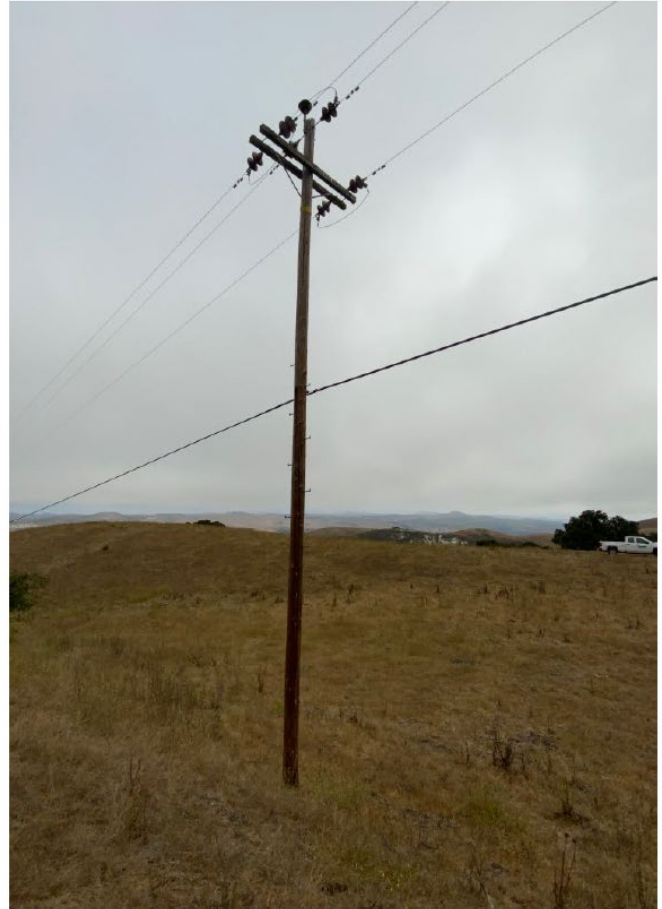
Photo 2 - Photo taken by inspector during 07/30/2021 GO 165 inspection SAP ID 101909085.

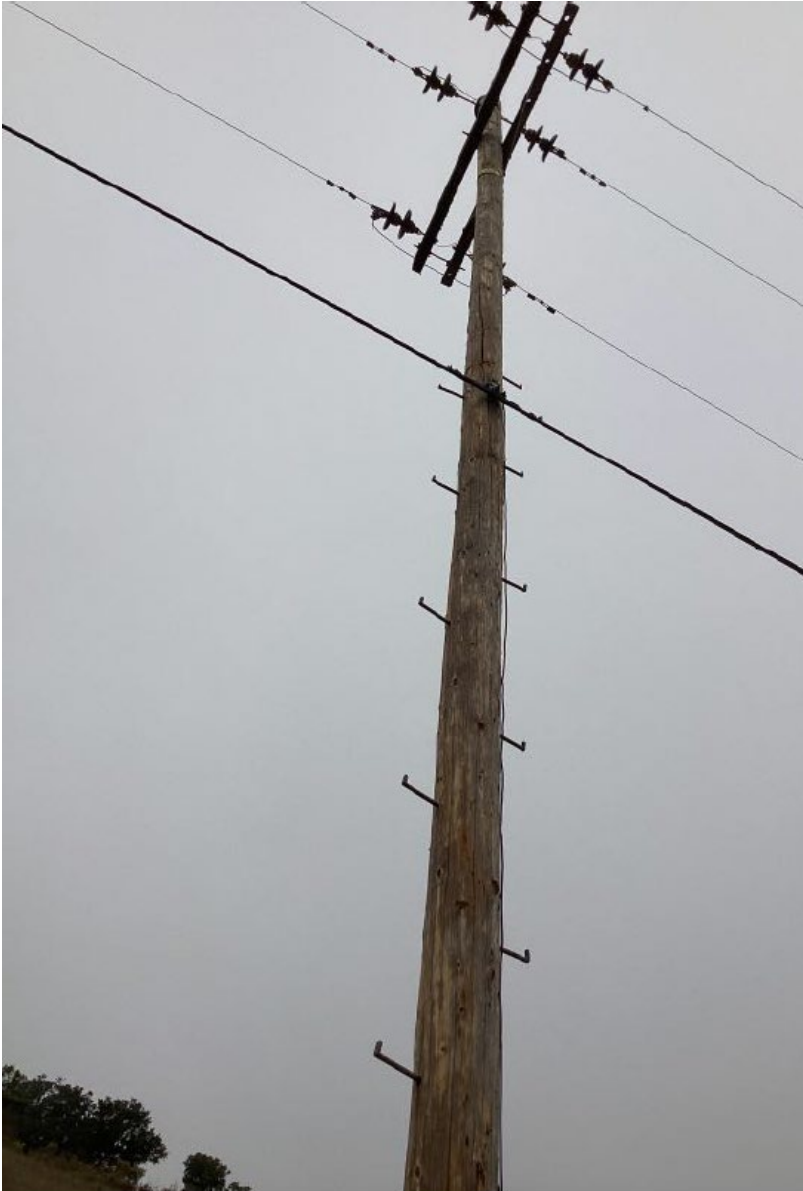
Pole Intrusive Test:	08/23/2022	Rot/Decayed
WSIP Inspection:	N/A

Figure 3 - Photo taken on 08/23/2022 during PTT inspection, SAP ID 101909085

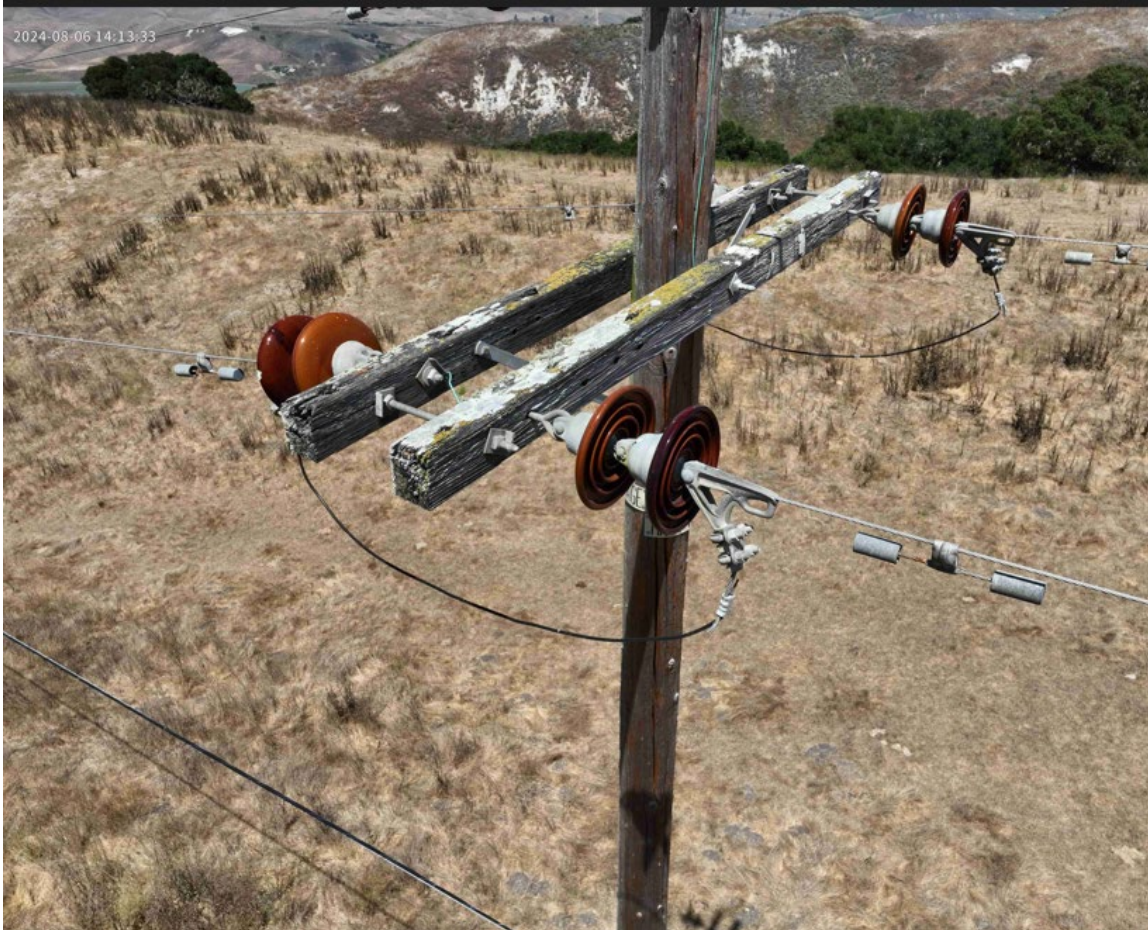
Figure 5 - Photo taken on 08/06/2024 during inspection, showing pole is decayed

A PG&E repair crew addressed the work orders for the decayed pole. On October 21, 2024 the wooden crossarms were removed and replaced with a 9'-foot light composite crossarm. In addition, all of the woodpecker holes were filled.

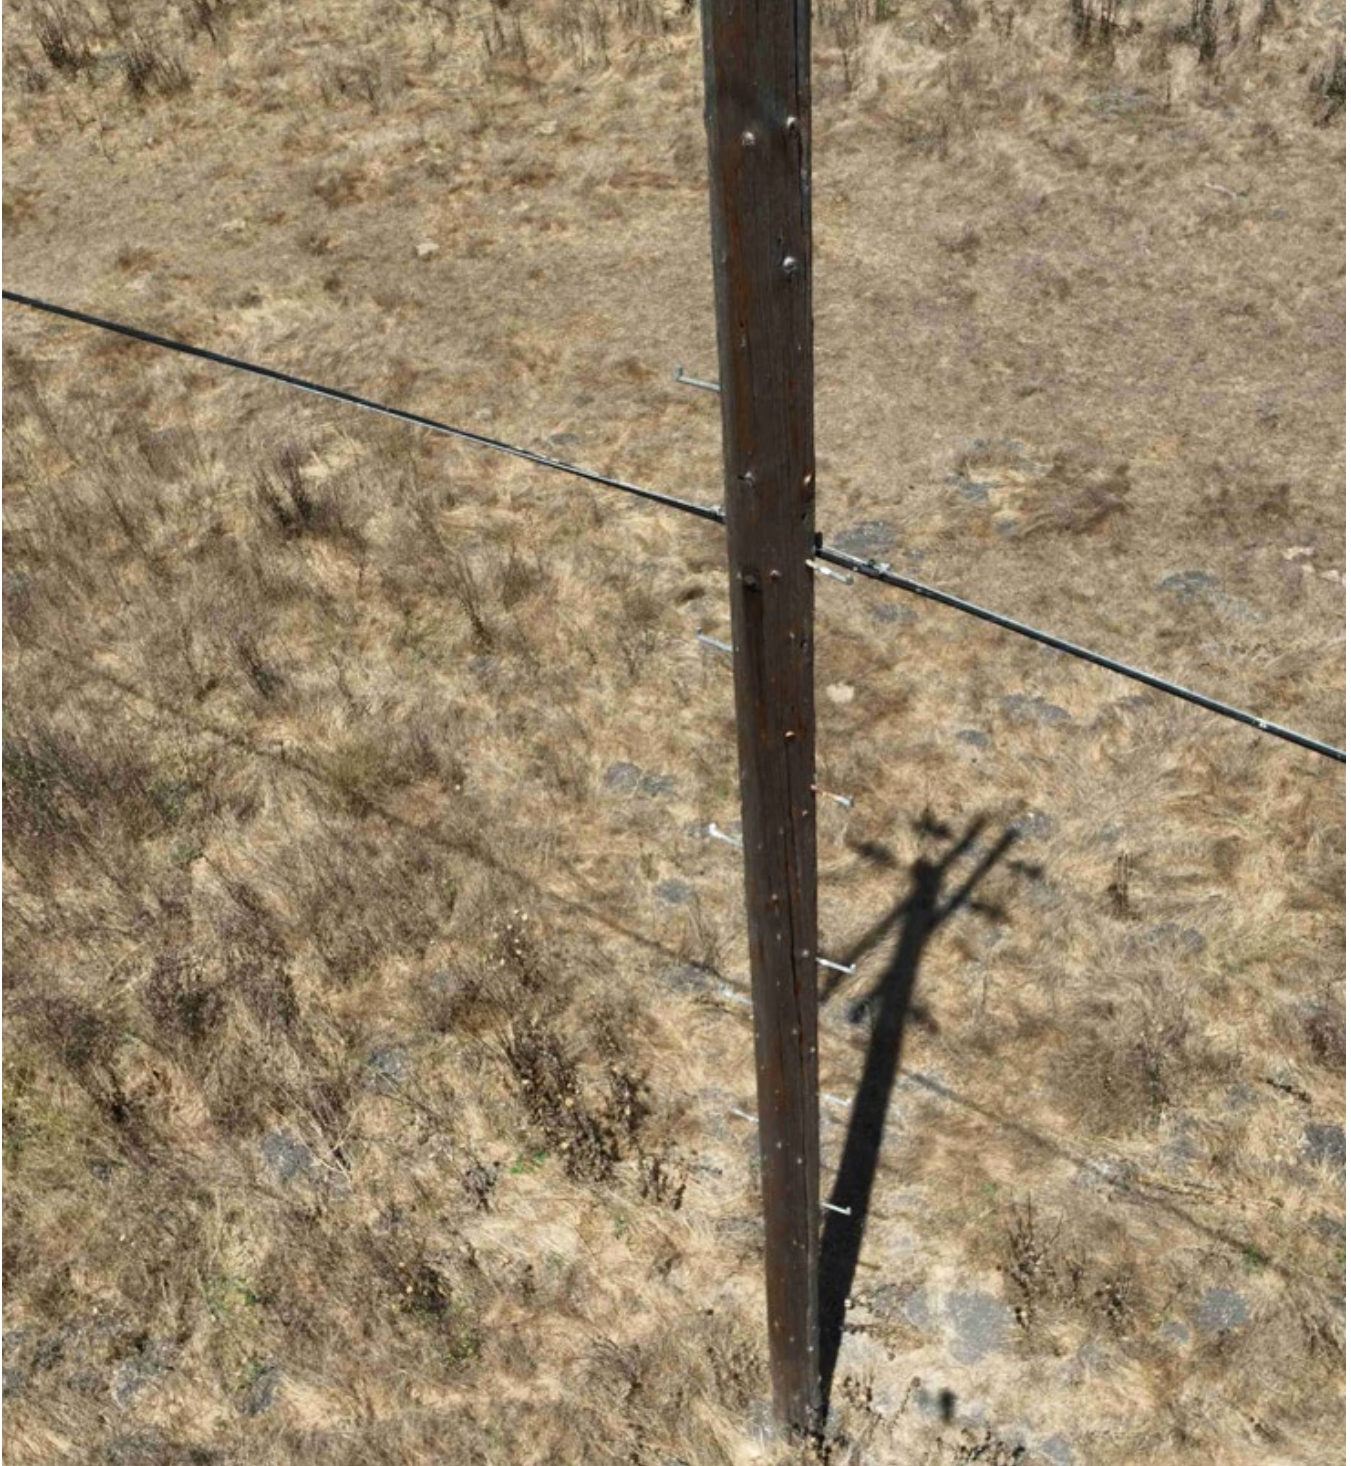
Figure 6 - Photo taken on 08/06/2024 during inspection, showing pole is decayed, base has woodpecker damage

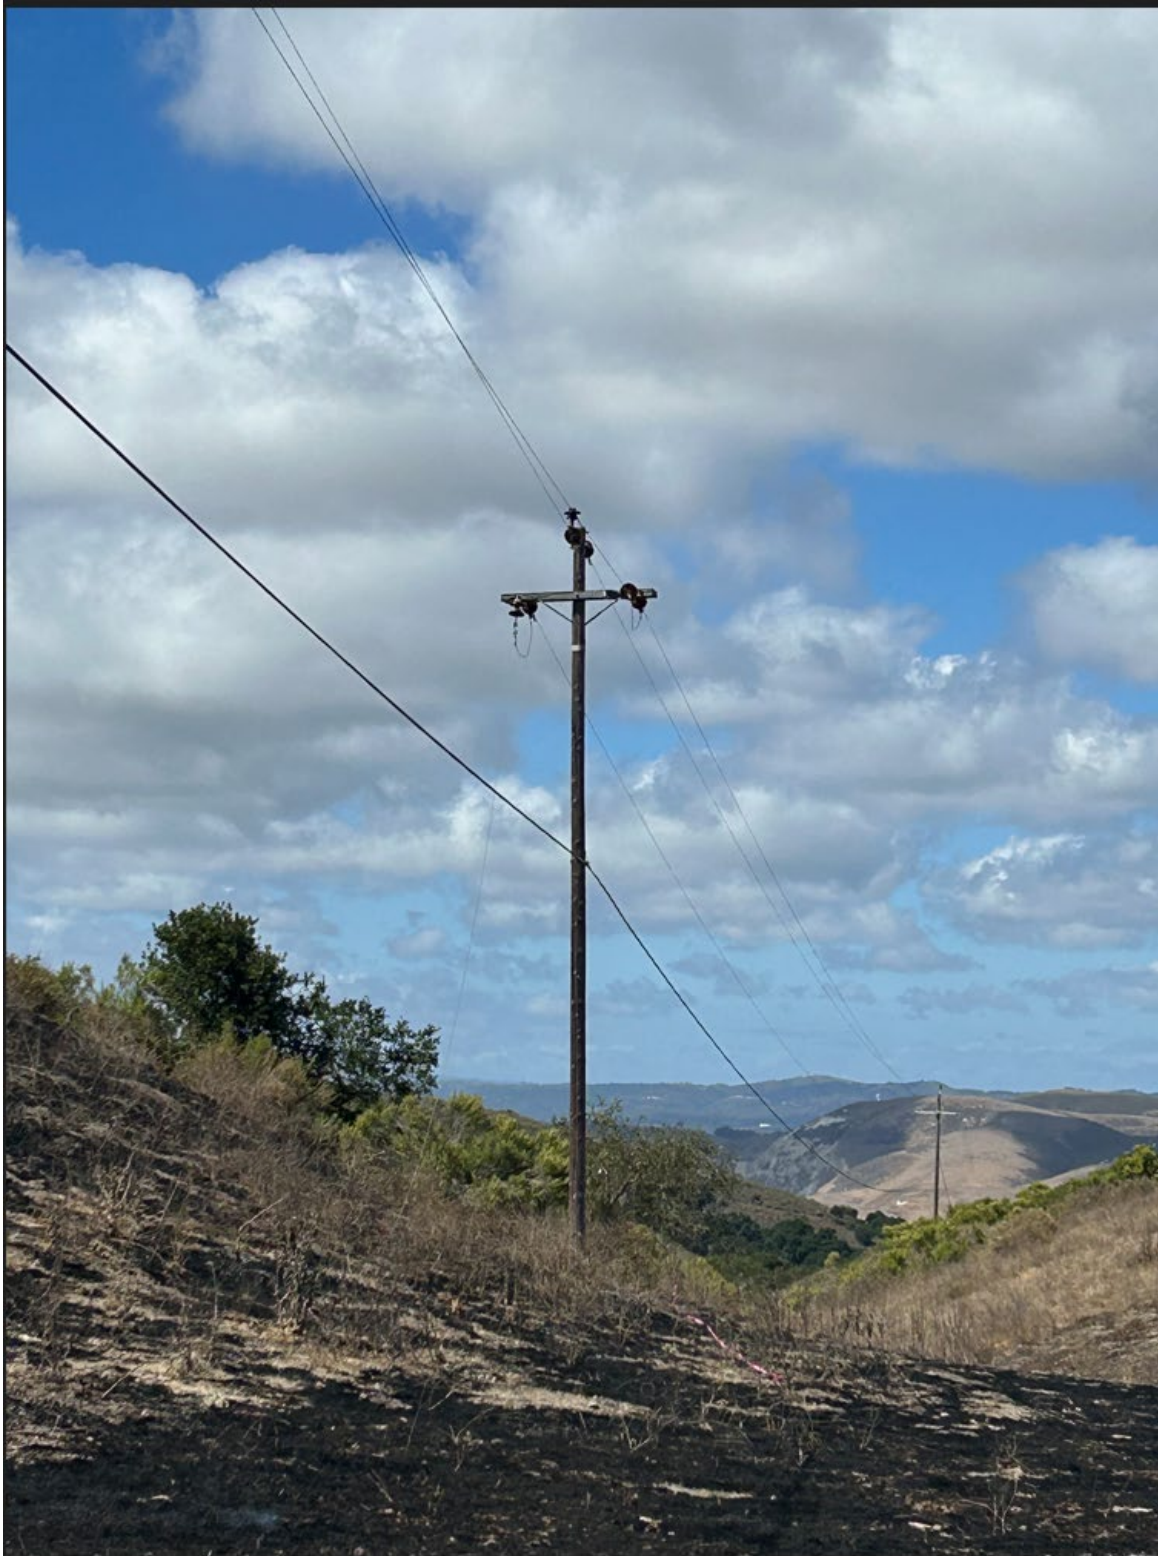
The troubleshooter located one of three spans downed along the hillside due to a failed automatic splice. The conductor still hot from being energized just moments before, fell onto a dried grassy hillside causing the heat to ignite the dried grass where the conductor made contact with the dried vegetation.

Figure 7 - Photo taken on 09/16/2024 by troubleshooter, SAP ID 101909085.

Two corrective notifications were created to address post incident repairs. An “A” tag was created under EC Notification #129539020, which was to repair the downed conductor. This tag was completed on September 16, 2024 which consisted of repairing 500 feet of #4 ACSR conductor.

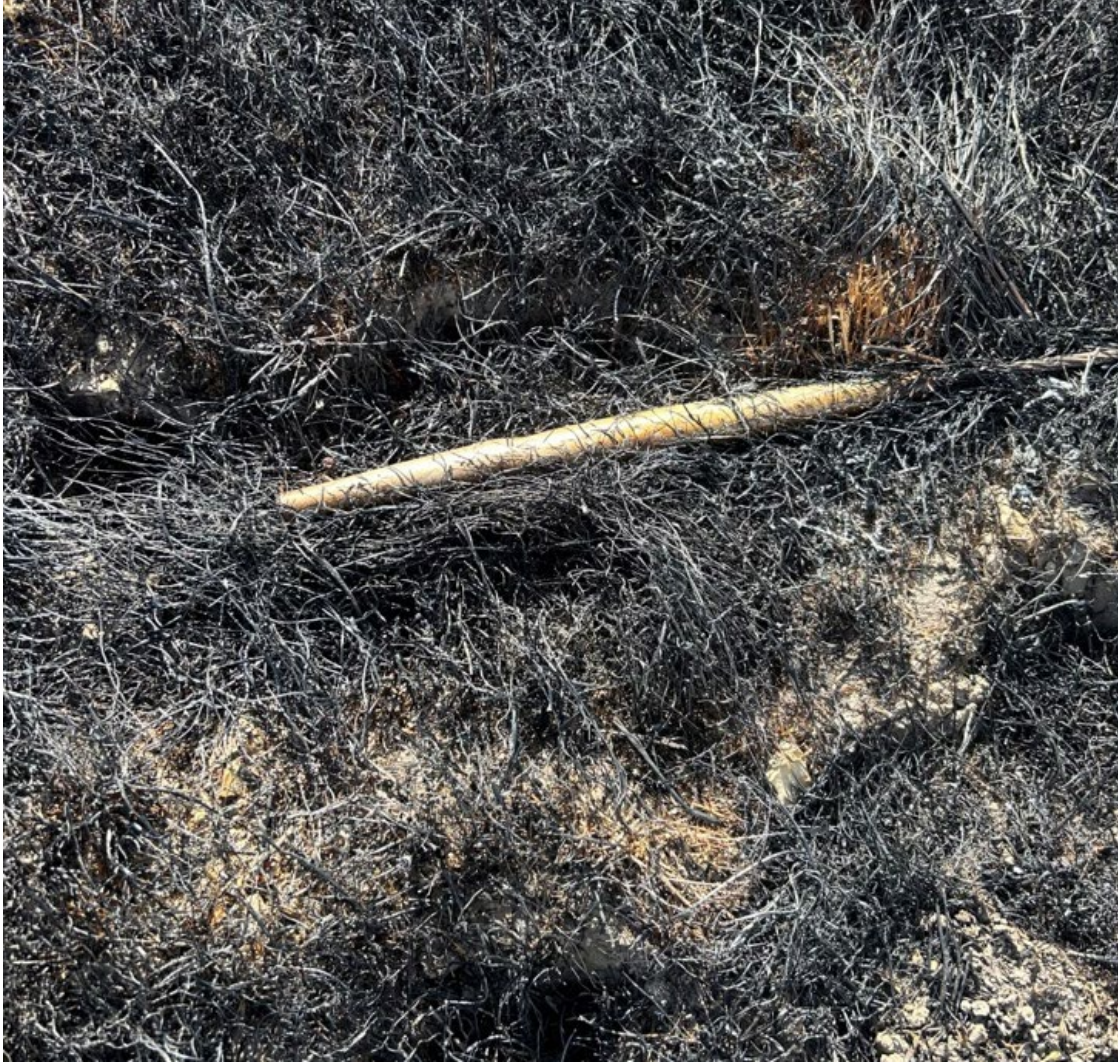
The failed automatic splice was removed from the scene and taken to Applied Technology Services (ATS), a PG&E facility where further analysis and destructive testing was performed on the material to determine a failure cause. General observations by the naked eye found the splice had deep cracks along with pitting, signs of heavy corrosion and missing funnel guides.

The splice underwent radiographic imaging to identify damage not visible to the naked eye. The results concluded that the springs inside were damaged, most likely from internal corrosion. Additionally, the failure point shows significant material loss that contributed to corrosion and believed to be the cause of the failure.

Figure 8 – Photo of failed connector/splice taken by troubleshooter 09/16/2024.

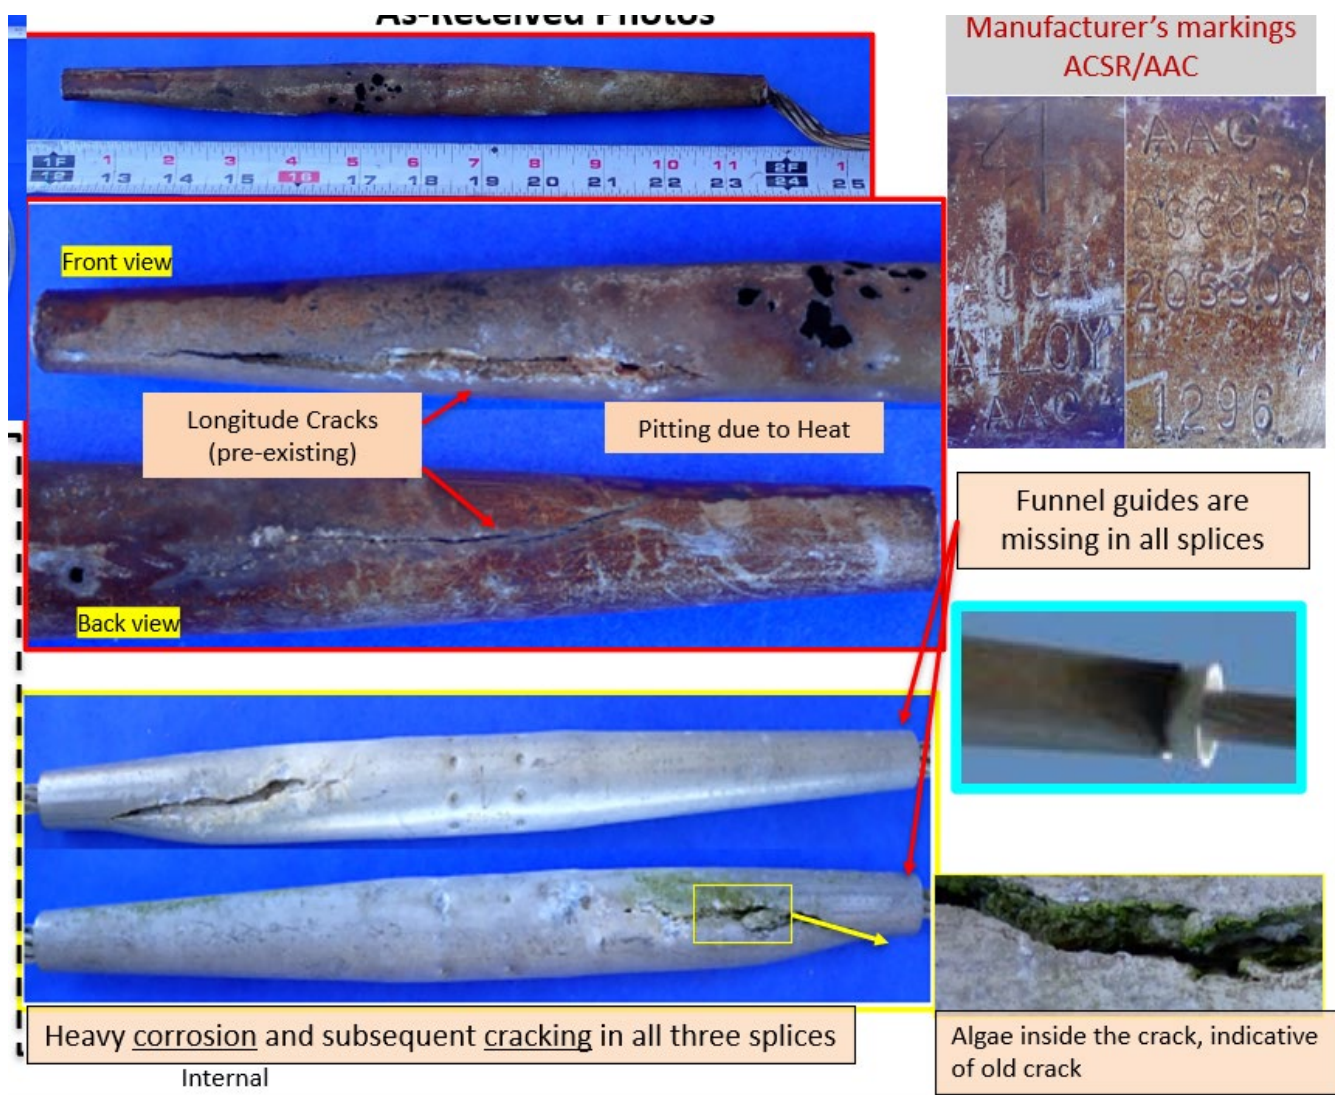
As the incident splice was analyzed, two other auto splices were removed from the Incident Location and sent into ATS for further analysis. These "sister" splices also showed indications of heavy corrosion, and cracking along the body. One of the splices had a crack that had grown algae inside, indicating the crack had been present for some time.

Figure 10 - Photo supplied by ATS 10/8/24, showing condition of failed splice and sister splices

A second notification, EC Notification #129579462 was created on September 24 to remove three remaining automatic splices that were left near the Incident Location. These splices were collected and sent into ATS for further destructive testing. The three automatic splices that were removed were replaced with three high tension press on sleeves.
