## Preliminary Ignition Investigation Report

Ignition Database Index:	20241371N
Electric Incident Investigation (EII) Number:	N/A
HAWC Incident Name:	Vegetation in Mariposa
PG&E Facility Ignition?	Yes
CPUC Reportable Ignition?	Yes
Date & Time of Incident:	September 18, 2024, at 1300 hours
Street Address:	7531 Hunter Valley Road
City:	Mariposa
County:	Mariposa
Latitude/Longitude:	37.602596, -120.192546
State Responsibility Area (SRA) / Local Responsibility Area (LRA) / Federal Responsibility Area (FRA)	State Responsibility Area
PG&E Division:	Yosemite
High Fire Threat District (HFTD):	Tier 2
High Fire Risk Area (HFRA):	Yes
EPSS Buffer:	No
Fire Index Area (FIA):	420
Fire Potential Index (FPI) Rating: FIA	R3
Fire Potential Index (FPI) Rating: Circuit	R3
Was there a PSPS event at the time of ignition?	No
Suspected Initiating Event:	Utility work/Operation
Failure Driver:	Utility work/Operation
Failure Sub-driver:	Utility work/Operation
Circuit:	Bear Valley 2101

## Executive Summary

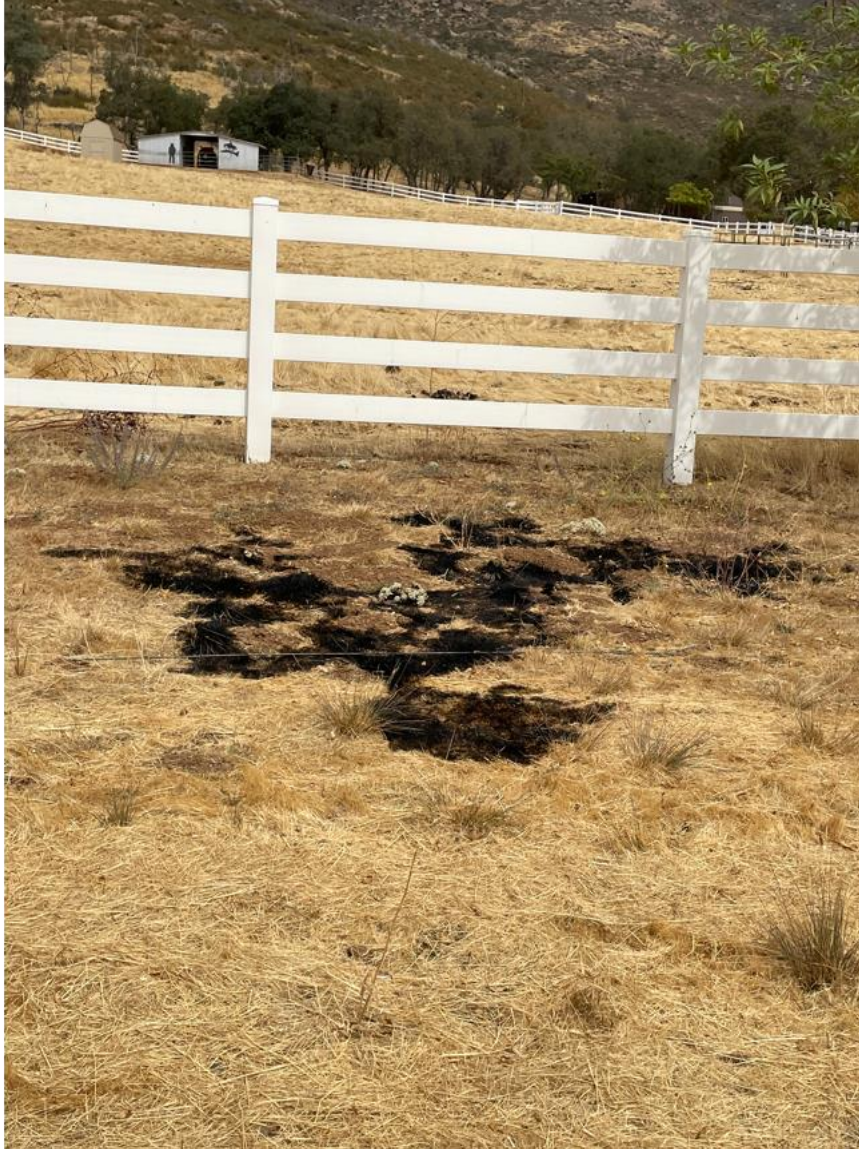
The conductor failure occurred as the crew utilized a make-and-break tool to secure permanent connections with a hydraulic press, the load side of a 4-cu conductor broke and fell to the ground. Despite the conductor failure, the line remained energized, igniting three small grass fires. Two fires measured approximately two feet by three feet, while the third was approximately four feet by four feet. These ignitions resulted from the energized conductor contacting the ground. The contractor crew successfully extinguished the three small grass fires before the arrival of first responders. A 911 call was placed to report the incident.

*Photo 3: Photo of one of the three impact sites taken by the contractor crew on the date of the ignition.*

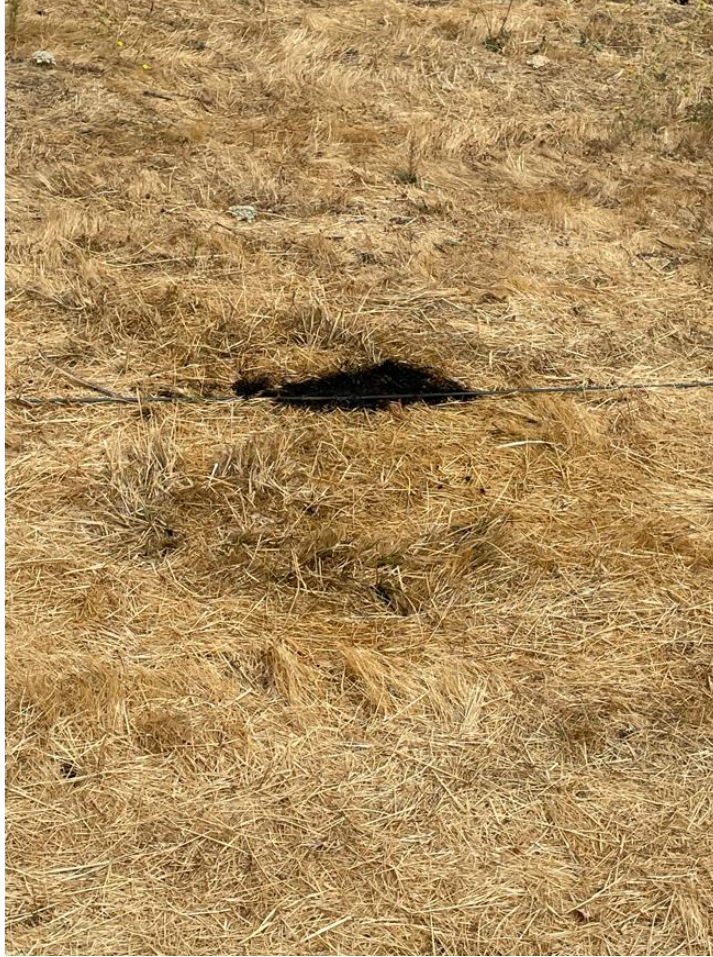
*Photo 4: Photo of additional impact site taken by the contractor crew on the date of the ignition.*

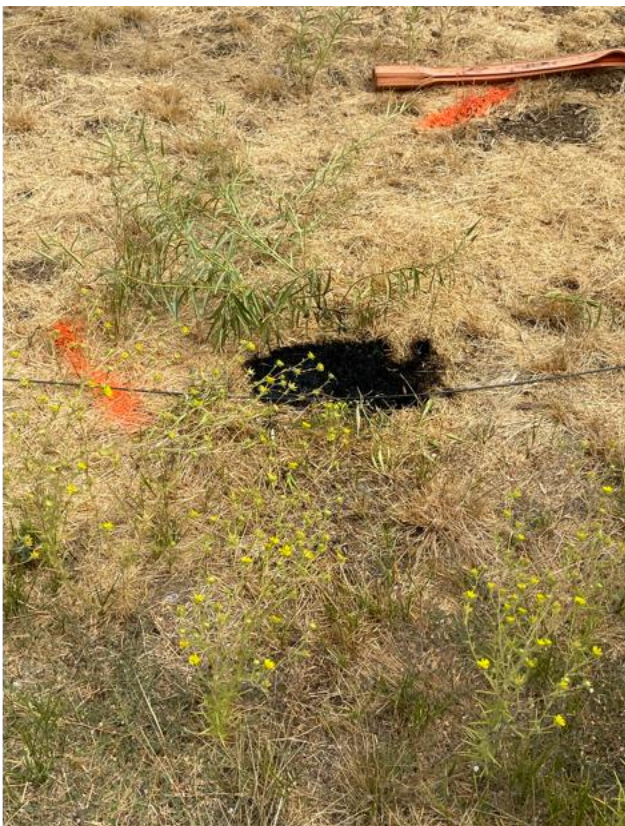
*Photo 5: photo of the third area affected by the conductor failure taken by the contractor crew on the date of the ignition.*
