## Preliminary Ignition Investigation Report

Ignition Database Index:	20241397
Electric Incident Investigation (EII) Number:	N/A
Incident Name:	Pinnacles - 27 Sep 2024
PG&E Facility Ignition?	Yes
CPUC Reportable Ignition?	Yes
Date & Time of Incident:	September 27, 2024 @ 1407 hours
Street Address:	In the vicinity of 31100 Pinnacles Road Highway 146
City:	Paicines
County:	San Benito
Latitude/Longitude:	36.4982968028, -121.1405433831
State Responsibility Area (SRA) / Local Responsibility Area (LRA) / Federal Responsibility Area (FRA)	Federal Responsibility Area (FRA)
PG&E Division:	Central Coast
High Fire Threat District (HFTD):	Tier 2
High Fire Risk Area (HFRA):	Yes
EPSS Buffer:	No
Fire Index Area (FIA):	545
Fire Potential Index (FPI) Rating: FIA	R3
Fire Potential Index (FPI) Rating: Circuit	R3
Was there a PSPS event at the time of ignition?	No
Suspected Initiating Event:	Vegetation
Failure Driver:	Contact from object
Failure Sub-driver:	Contact – Vegetation

Circuit:	Hollister 2105
Circuit Protection Zone:	Hollister 210515486
Nominal Voltage:	12kV
Pole SAP Equipment ID:	SAP pole ID: 101690175 (load side) replaced with new pole SAP ID: 104228225. SAP pole ID: 101690176 (source side

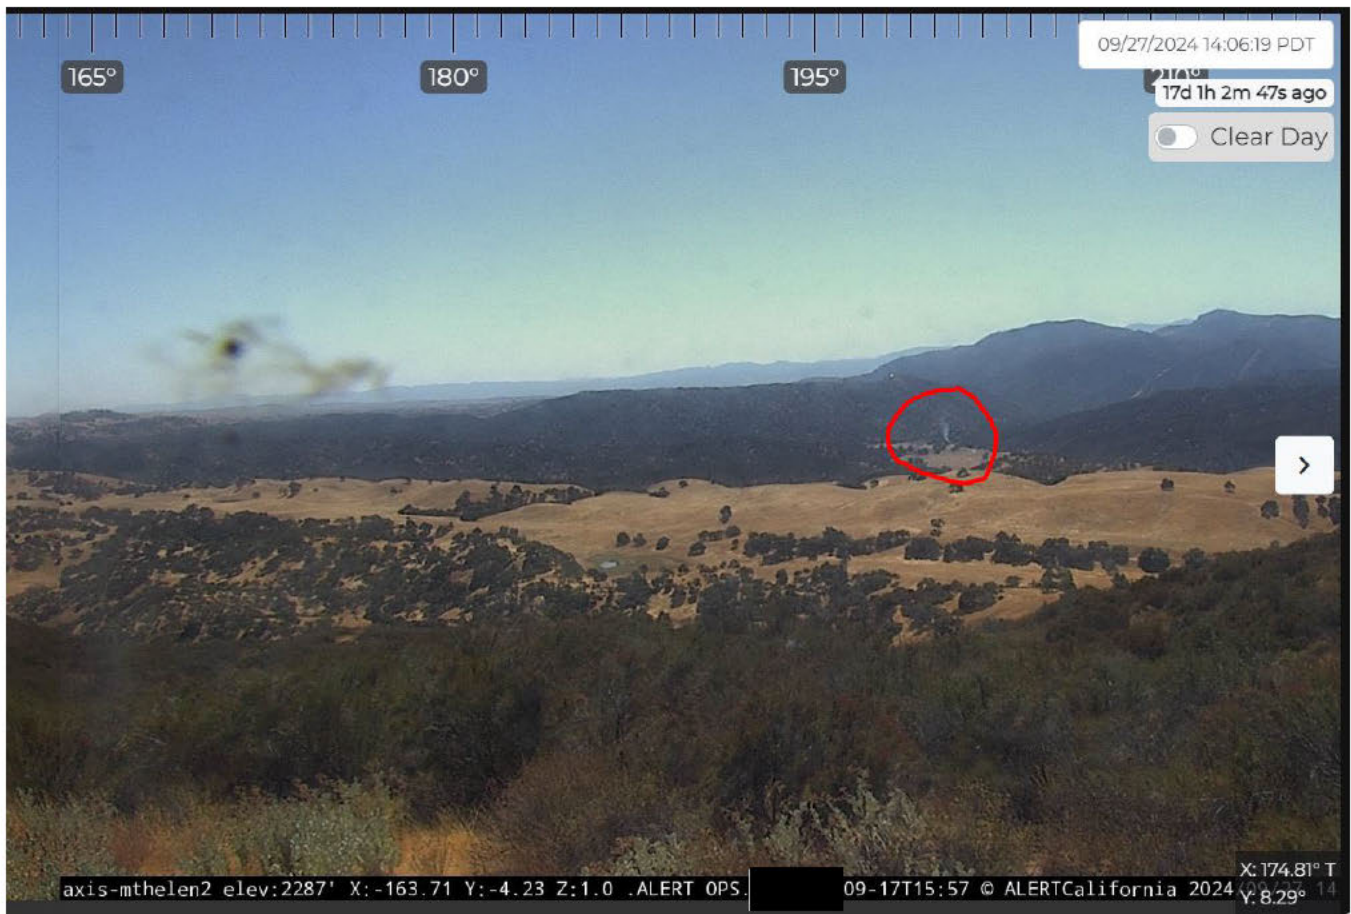
Figure 3 - First detection of smoke on the Mount Helen 2 wildfire camera @ 1406 hours on September 27, 2024.

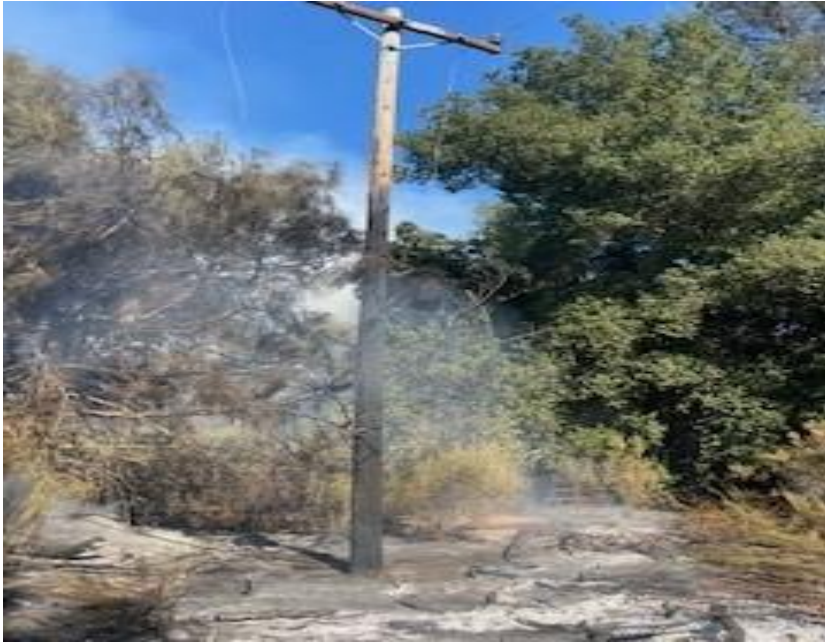
The Field Automation System (FAS) record states that the PG&E troubleshooter arrived on scene at approximately 1454 hours and observed a fire. The troubleshooter indicated that a treetop fell onto the primary line conductor causing arcing and burned vegetation below. The troubleshooter also observed that one of two, Aluminum Conductor Steel Reinforced (ACSR) phases came down causing a nearby SAP pole ID 101690175 to get burnt, needing replacement. The first detection of smoke came through on the Alert California Mount Helen 2 wildfire camera [here](#) at 1406 hours on September 27, 2024, (see Figures 3, 4, 5, and 6).

Figure 4 – Brunt and damaged pole SAP pole ID 101690175 (load side). Picture taken by the troubleshooter on September 27, 2024

The PG&E repair crew arrived onsite at 1349 hours on September 28, 2024, to replace a burnt pole, and one span of broken conductor on SAP Pole ID 101690175 (load side), which was part of the electric corrective (EC)-Priority A-Tag # 129599989. All work was completed by the repair crew by 1817 hours (per the ILIS record), on September 28, 2024.

EC priority A tag 129599989 was created to replace the pole and one span (400 feet) of 2-ACSR Conductor on SAP pole ID 101690175 (load side). All repair work was completed by the PG&E repair crew by 0545 hours, on September 29, 2024.

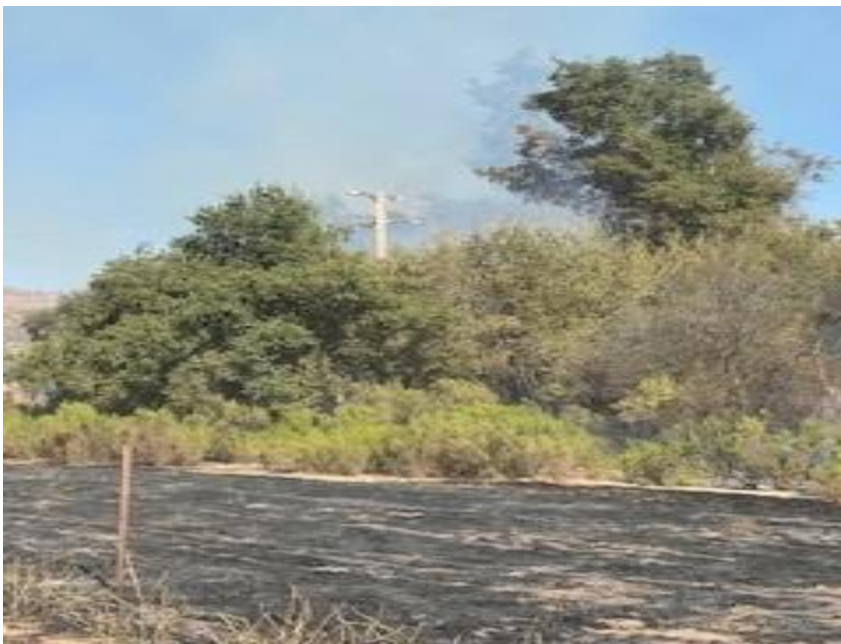
Figure 5 – Close-up of the broken SAP pole ID 101690176 (source side). Picture taken by the troubleshooter on September 27, 2024

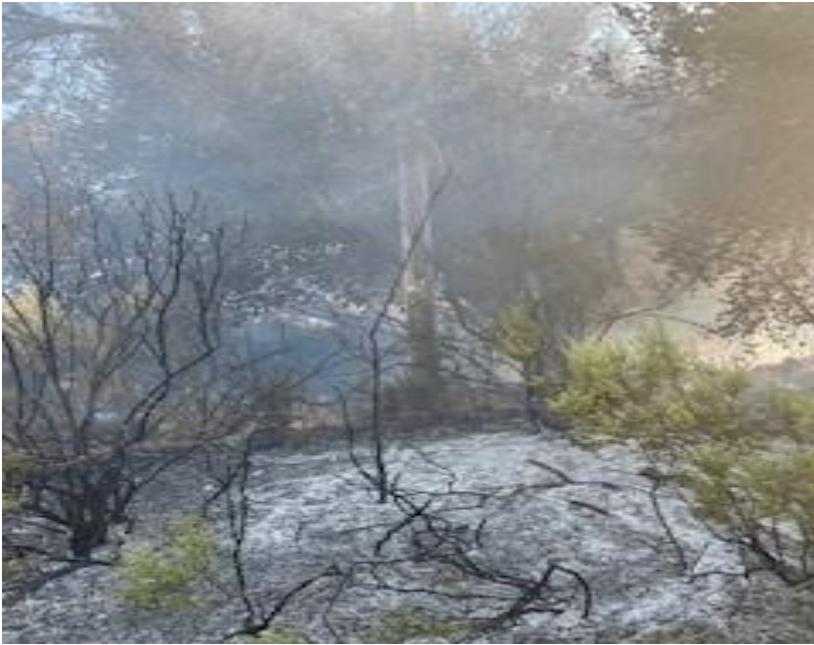
Figure 6 - Fire burn scar area around SAP pole ID 101690176 (source side). Picture taken by the troubleshooter on September 27, 2024.

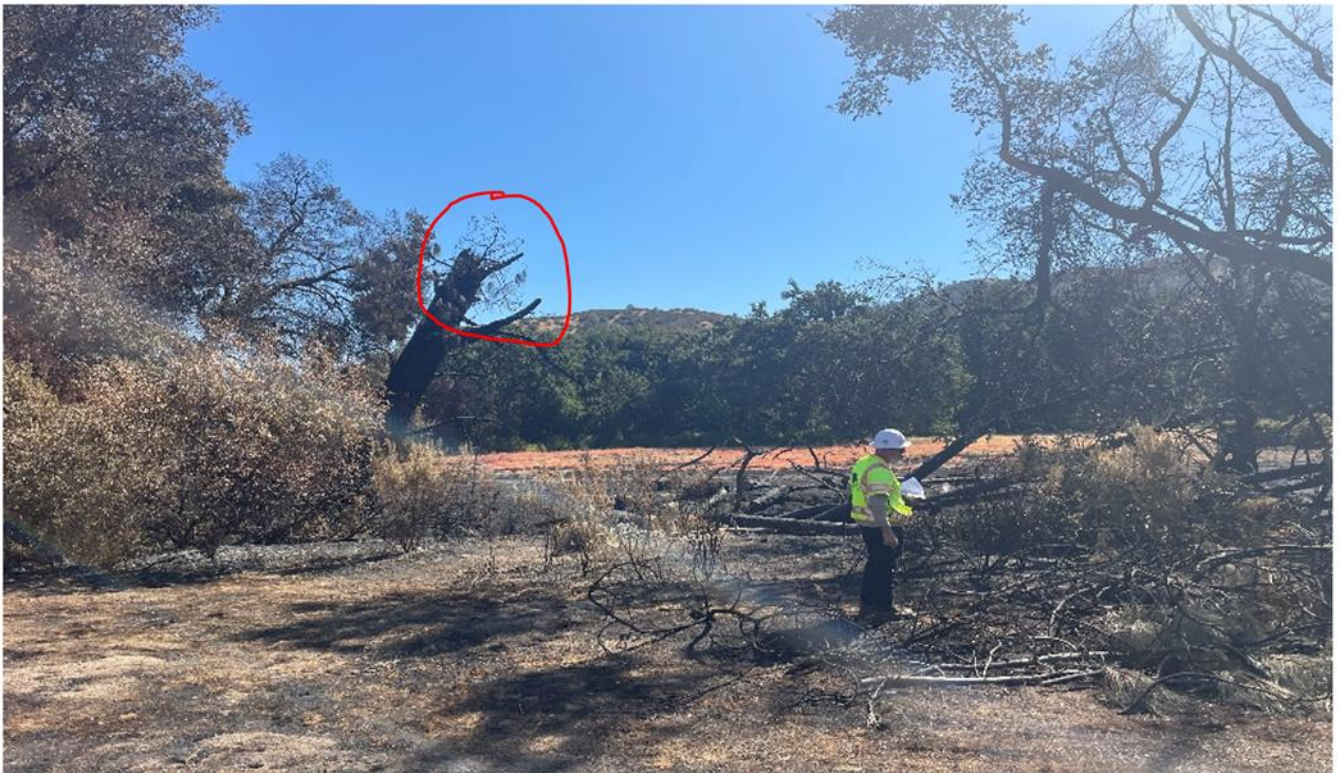
A post-incident investigation was performed by a vegetation management inspector (VMI) on October 1, 2024, near the Incident Location. The VMI observed a live gray pine (*Pinus sabiniana*) tree with a diameter at breast height (DBH) of 45 inches and a height of 97 feet, located 45 feet southeast of the conductors that had failed, (see figures 7 and 8). The Incident Tree was still standing with a lean parallel to the lines. The gray pine tree had a codominant top, with signs of multiple failed stems 24 feet above ground level. One major codominant top stem failed near the union and fell in the direction of the conductors, the other stems fell away in another direction. The VMI noted that no cavities or additional defects were found.

Figure 7 - Incident tree, failure at 24 feet above ground level, picture taken by the VMI inspector on October 1, 2024

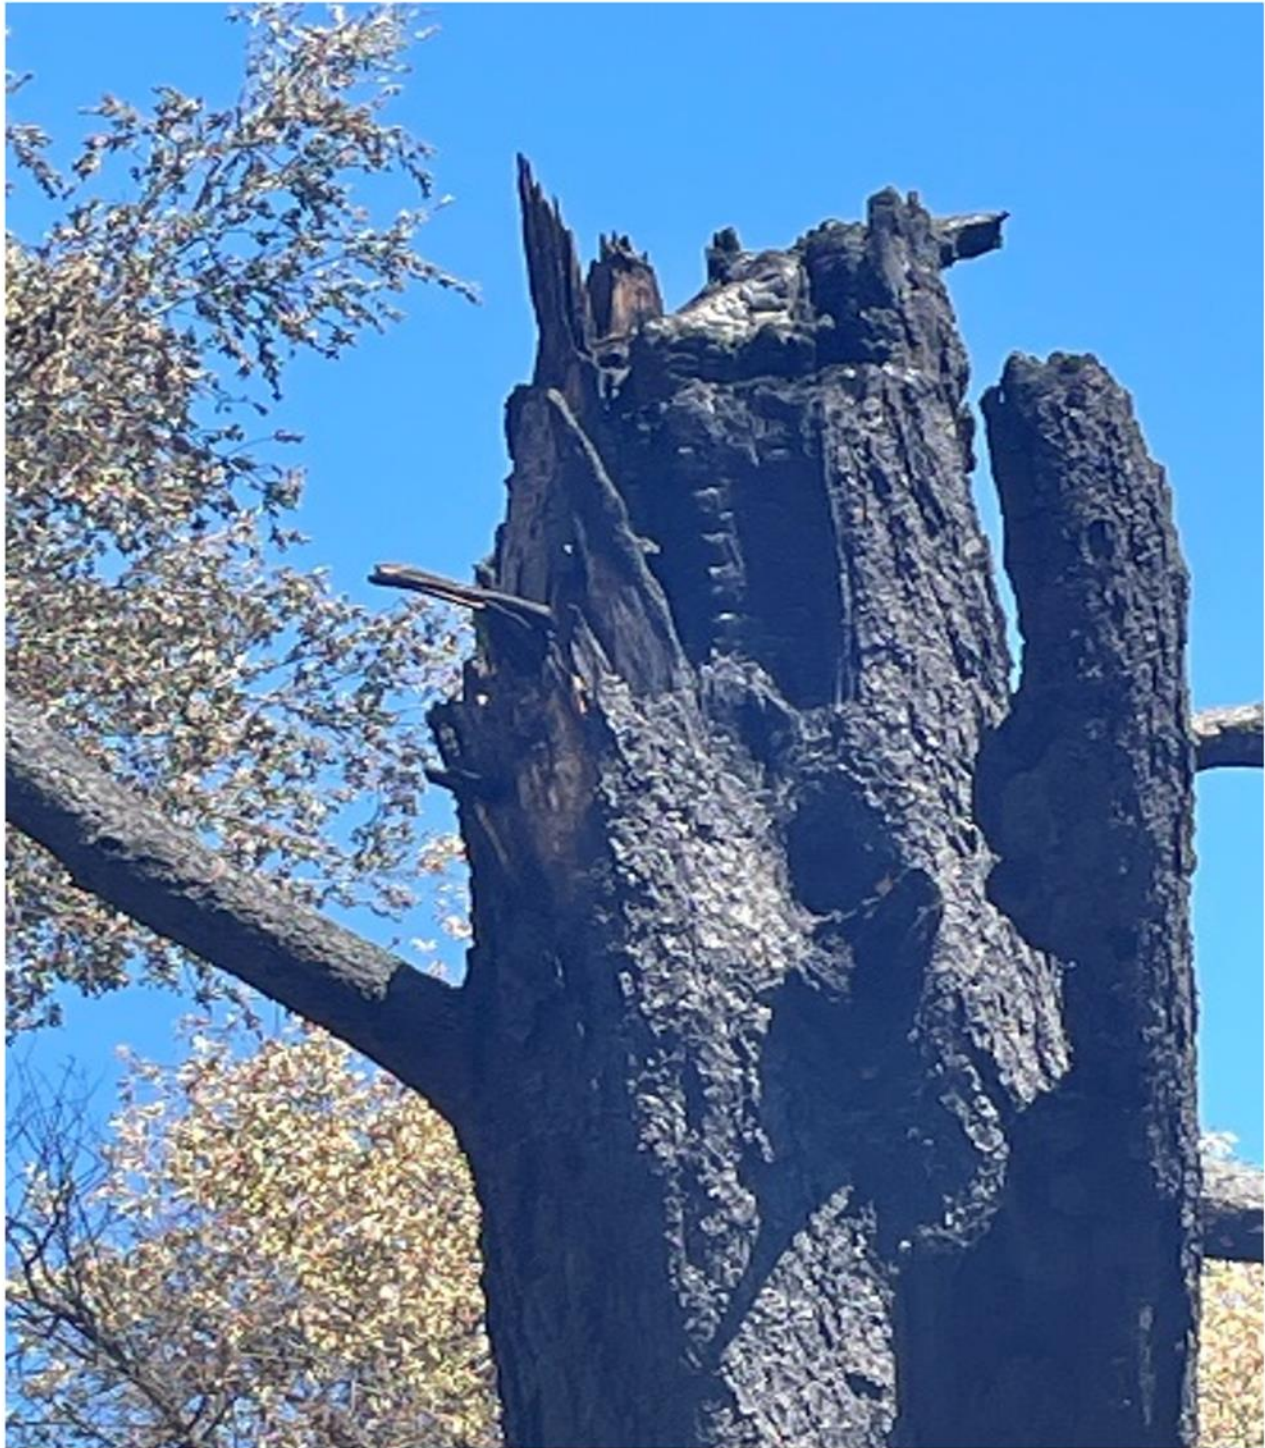
*Figure 8 - Incident tree at break point, picture taken by the VMI inspector on October 1, 2024.*

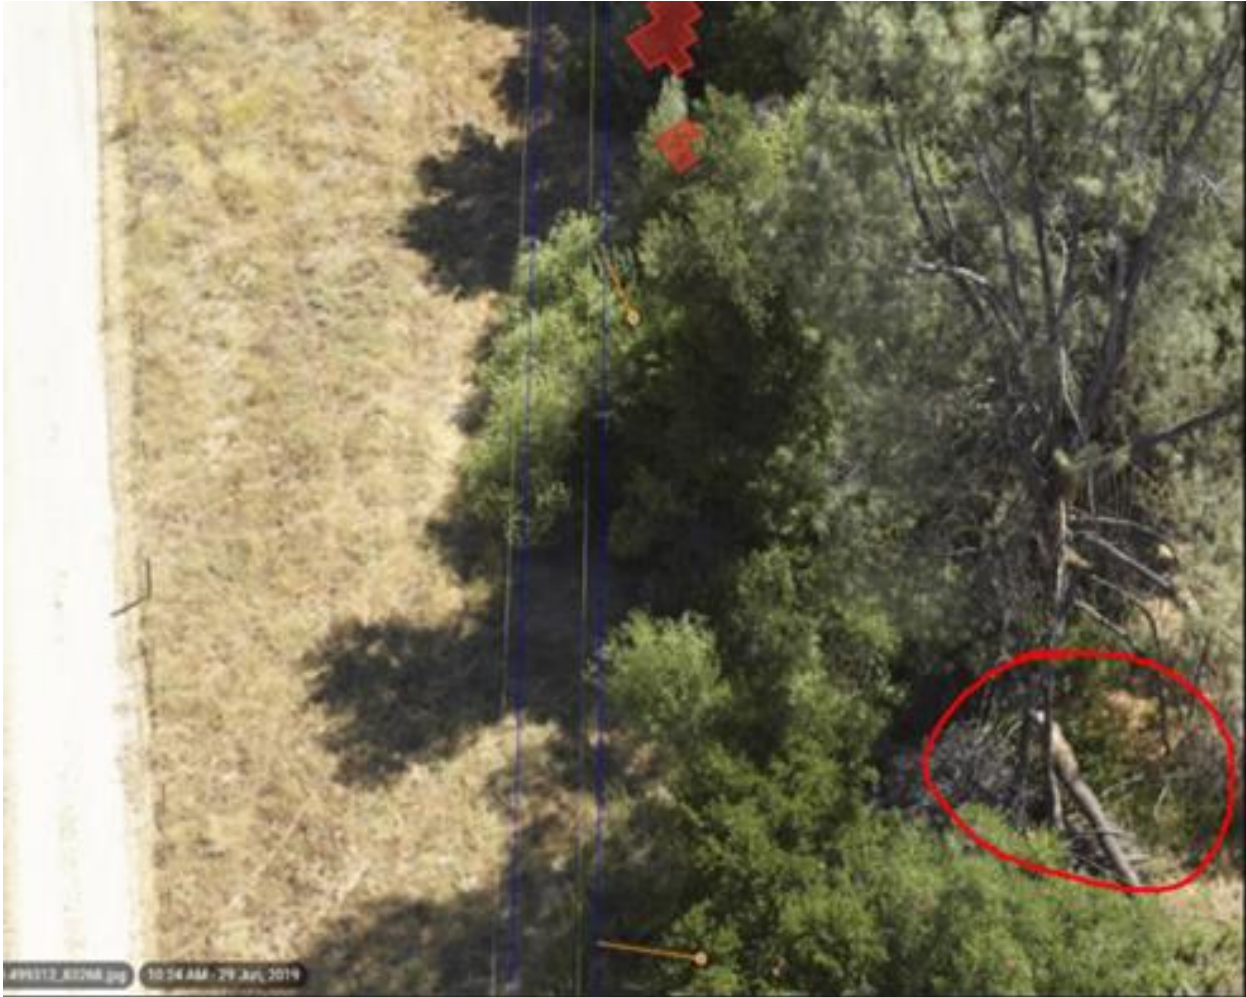
During this investigation, a search of the incident tree on Sharper Shape identified inspection photos from June 29, 2019, showing a prior limb failure with a visible wound on the main stem (see Figures 11, 12, and 13).

*Figure 11 - Incident tree, with a large gray pine limb laying down on the ground against the incident tree, picture taken from Sharper Shape dated June 29, 2019.*

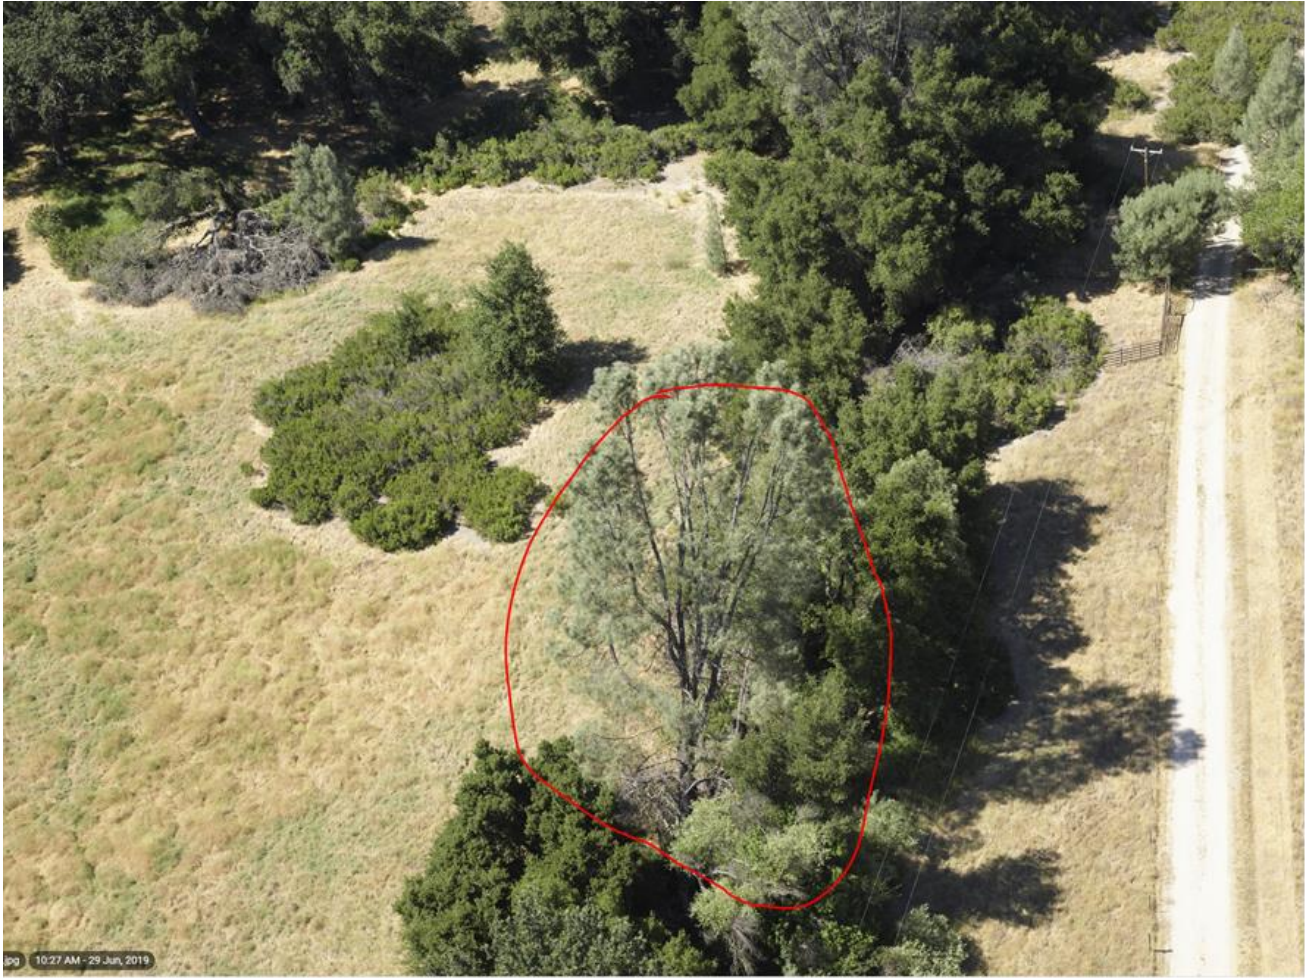
Figure 12 - Incident tree, picture taken from Sharper Shape dated June 29, 2019.

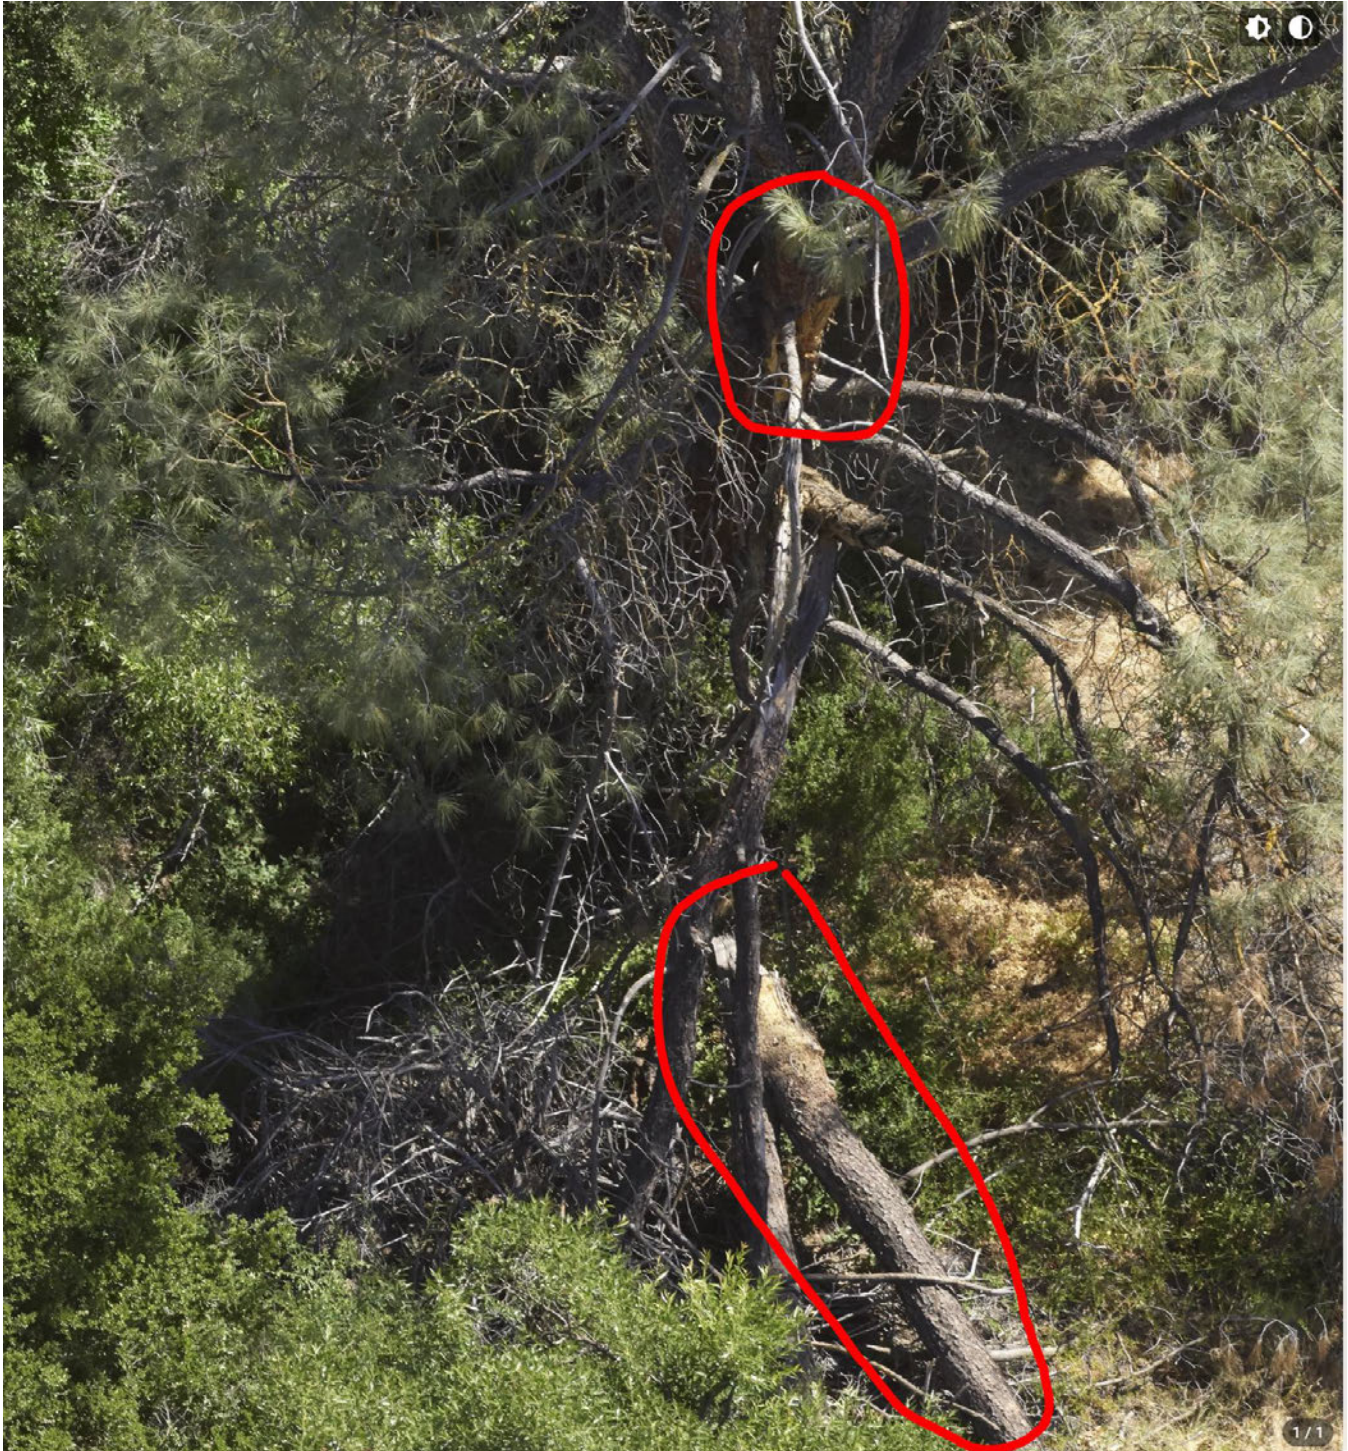
Figure 13 - The incident tree on Sharper Shape discovered a prior limb failure with a visible fresh wound on the codominant top, dated June 29, 2019. This limb failure was never identified in past VM inspections.

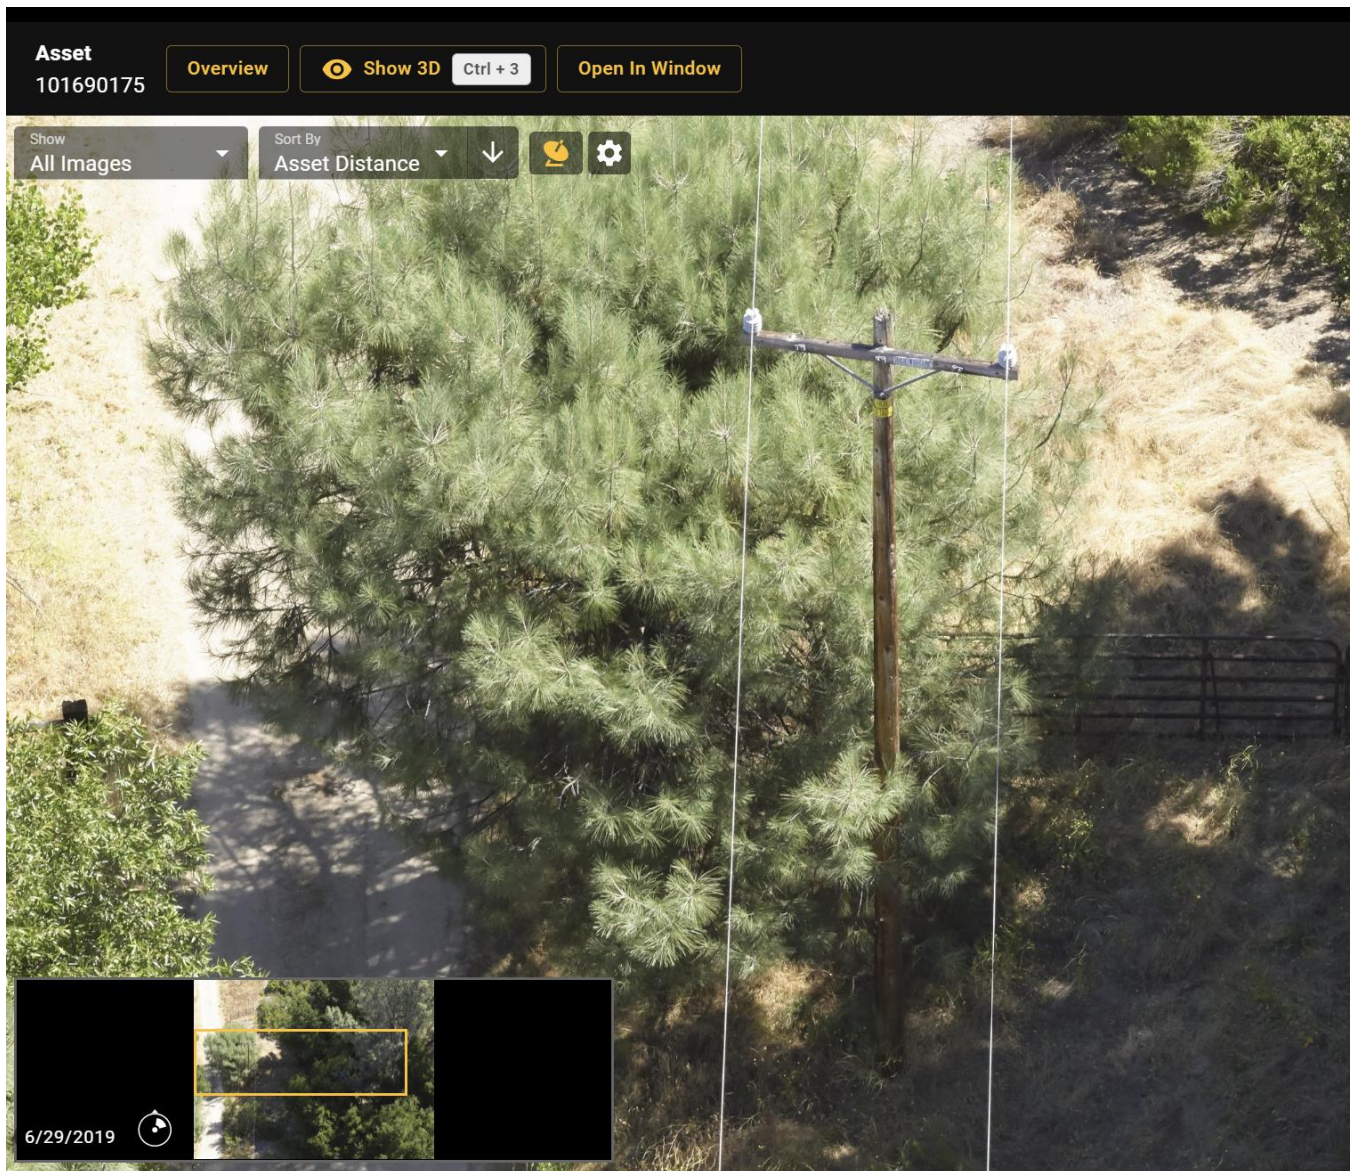
EVM Inspection:	N/A	
Equipment Test:	N/A	
Pole Intrusive Test:	N/A	New pole was installed on September 27, 2024, (incident date).
WSIP Inspection:	May 16, 2019	EC priority “E” Tag (#117250285) was created to replace the pole due to rotten pole top, splitting and cracks throughout,

woodpecker damage, and Lapp Insulators with a due date of May 16, 2020. EC priority "E" Tag (#117250285) was still open and not worked as of the incident date.
--	--	---

Figure 14 - SAP Pole ID: 101690175 (Load Side), picture taken from Shaper Shape dated June 29, 2019

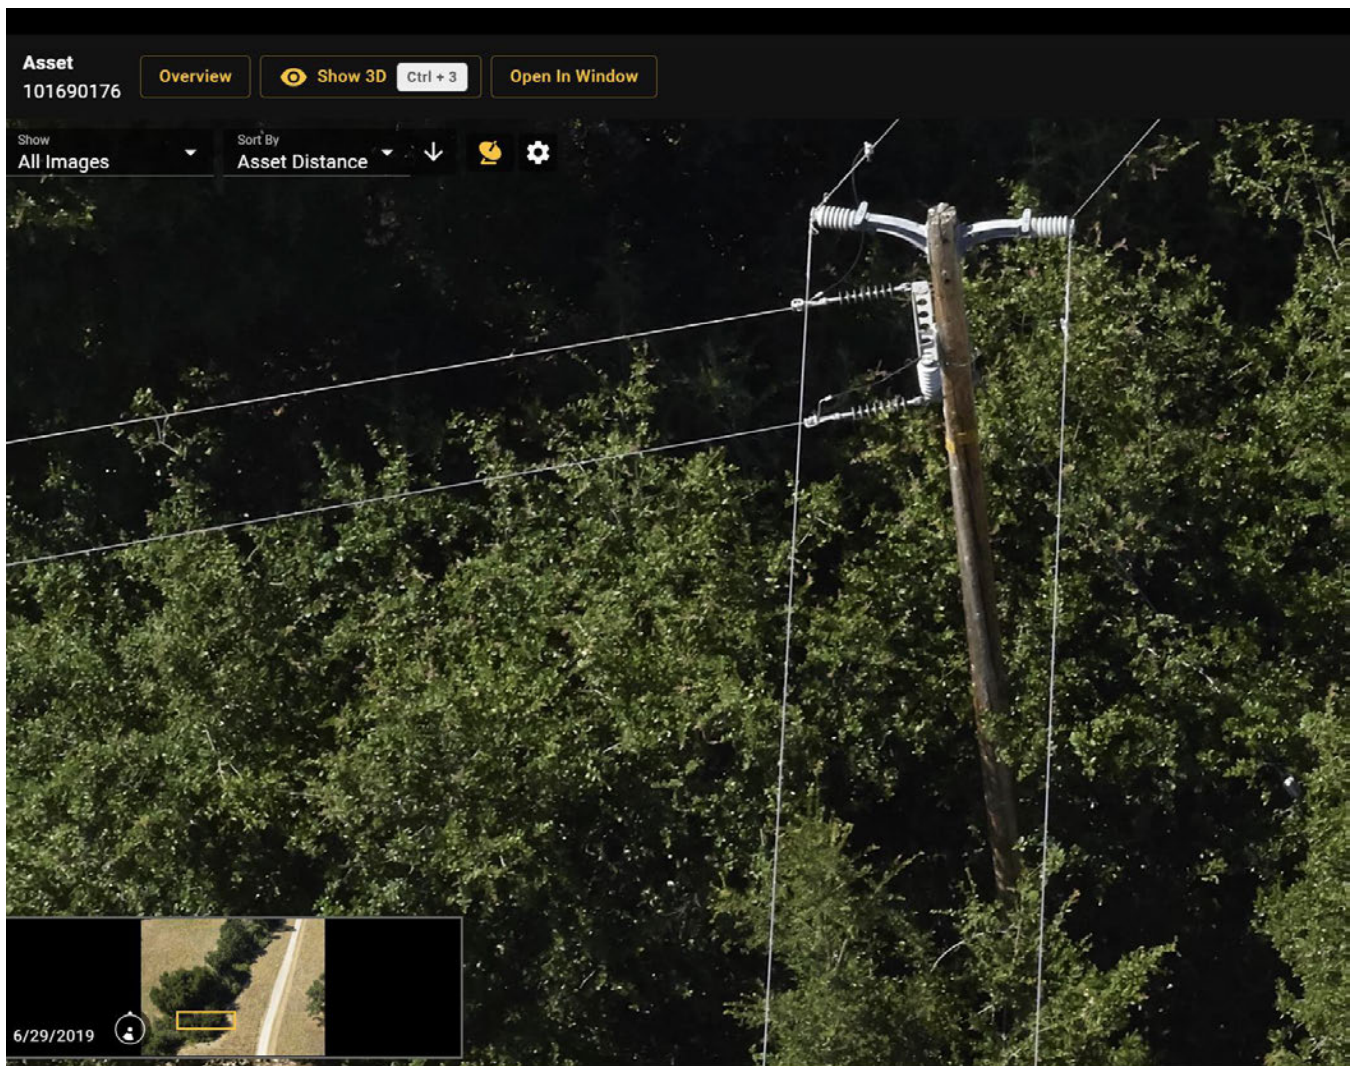
VM Inspection:	April 29, 2024	No work was identified.
EVM Inspection:	N/A	
Equipment Test:	N/A	
Pole Intrusive Test:	December 7, 2021	Passed with 99% wood strength remaining
WSIP Inspection:	May 16, 2019	EC priority "E" Tag (#117250279) was created to replace the pole due to large deep cracks throughout, woodpecker damage, and decaying wood with a due date of May 16, 2020. EC priority "E" Tag (#117250279) was still open and not worked as of the incident date.

Figure 15 - SAP Pole ID: 101690176 (Source Side), picture taken from Shaper Shape dated June 29, 2019
