## Preliminary Ignition Investigation Report

Ignition Database Index:	20241460
Electric Incident Investigation (EII) Number:	NR241008B
Incident Name:	Lake
PG&E Facility Ignition?	Yes
CPUC Reportable Ignition?	Yes
Date & Time of Incident:	October 8, 2024 @approximately 1841 hours
Street Address:	Behind 104 Lake Drive
City:	San Bruno
County:	San Mateo
Latitude/Longitude:	37.6183, -122.4499
State Responsibility Area (SRA) / Local Responsibility Area (LRA) / Federal Responsibility Area (FRA)	Local Responsibility Area
PG&E Division:	Peninsula
High Fire Threat District (HFTD):	Tier 2
High Fire Risk Area (HFRA):	Yes
EPSS Buffer:	No
Fire Index Area (FIA):	518
Fire Potential Index (FPI) Rating: FIA	R3
Fire Potential Index (FPI) Rating: Circuit	R1
Was there a PSPS event at the time of ignition?	No
Suspected Initiating Event:	Equipment – PG&E
Failure Driver:	All types of equipment/facility failure
Failure Sub-driver:	Other
Circuit:	Sneath Lane – Pacifica 60kV transmission

## Executive Summary

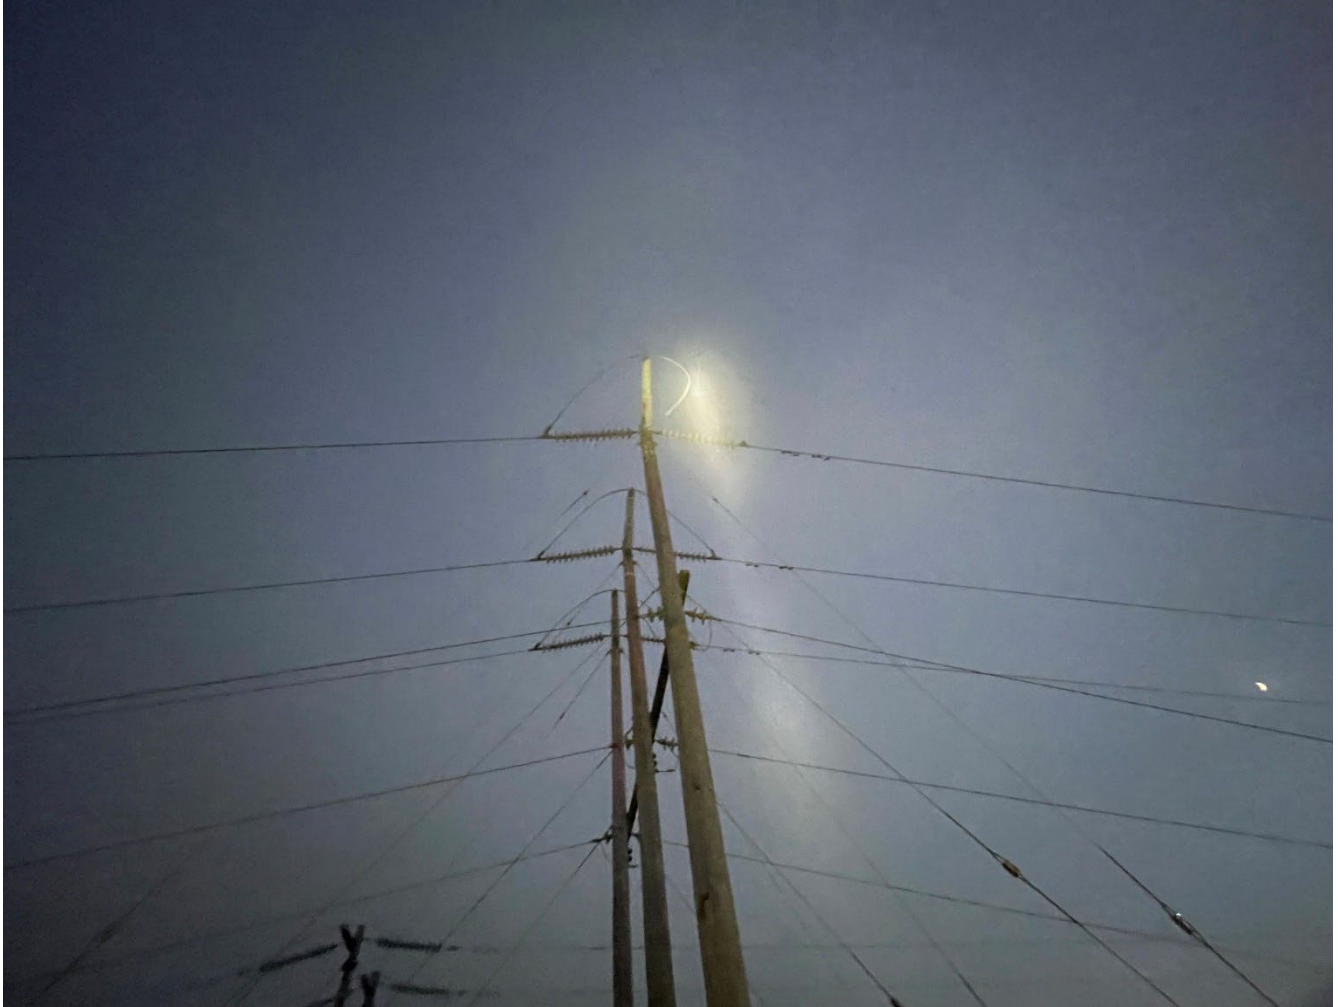
*Figure 2 SAP Pole ID 42560786/Structure 004/049 on the Sneath Lane – Pacifica 60kV transmission line. Jumper failure from pole top to south shoe (farthest west phase). Photo taken by troubleshooter on October 8, 2024.*

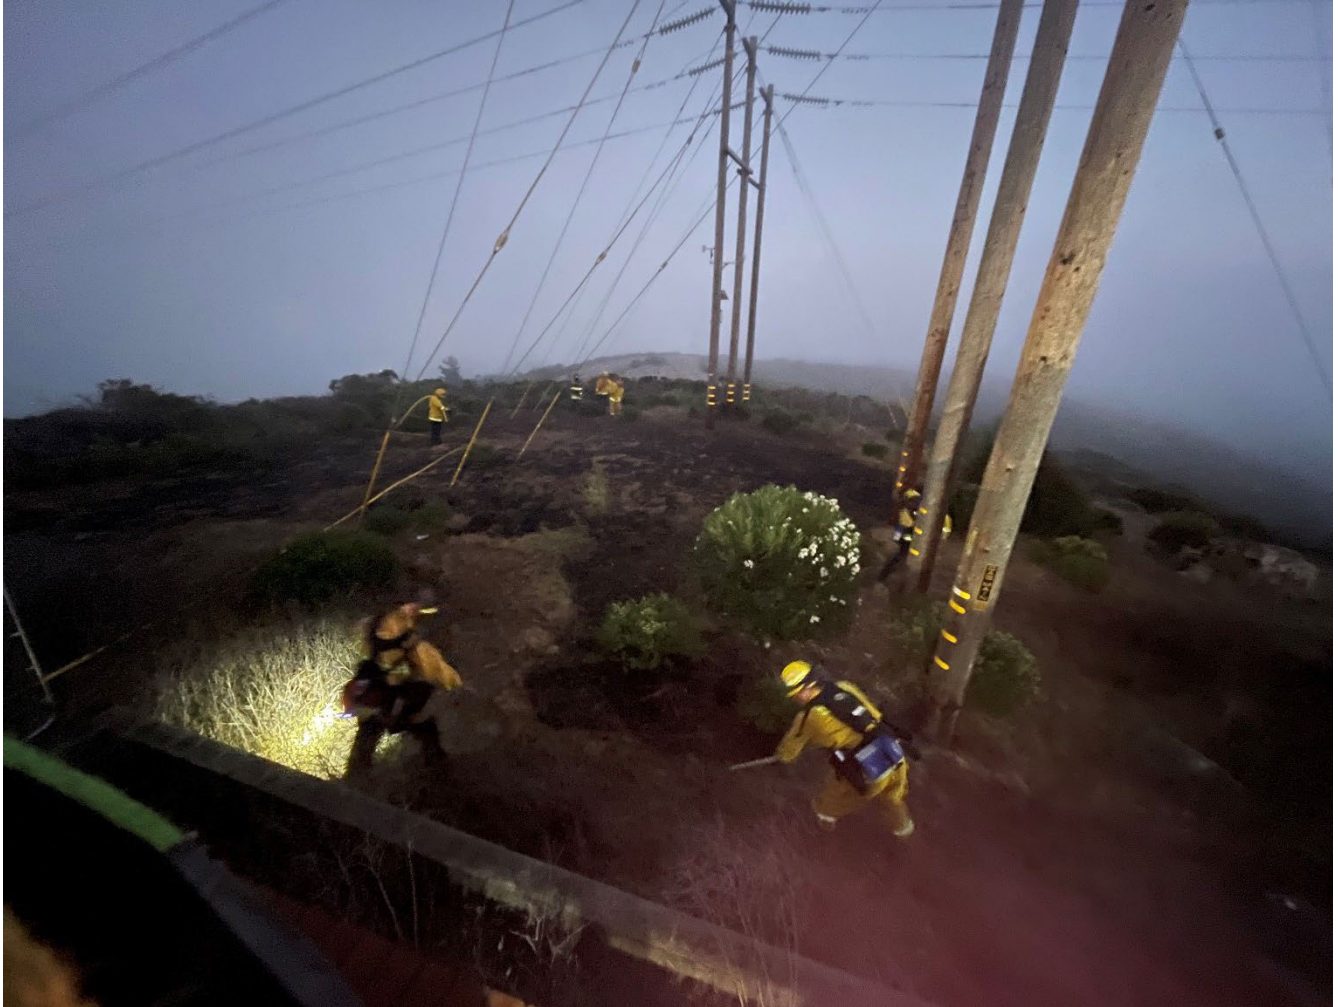
*Figure 3 Suppression/mop up activities by local fire agency personnel. Photo taken by troubleshooter on October 8, 2024.*

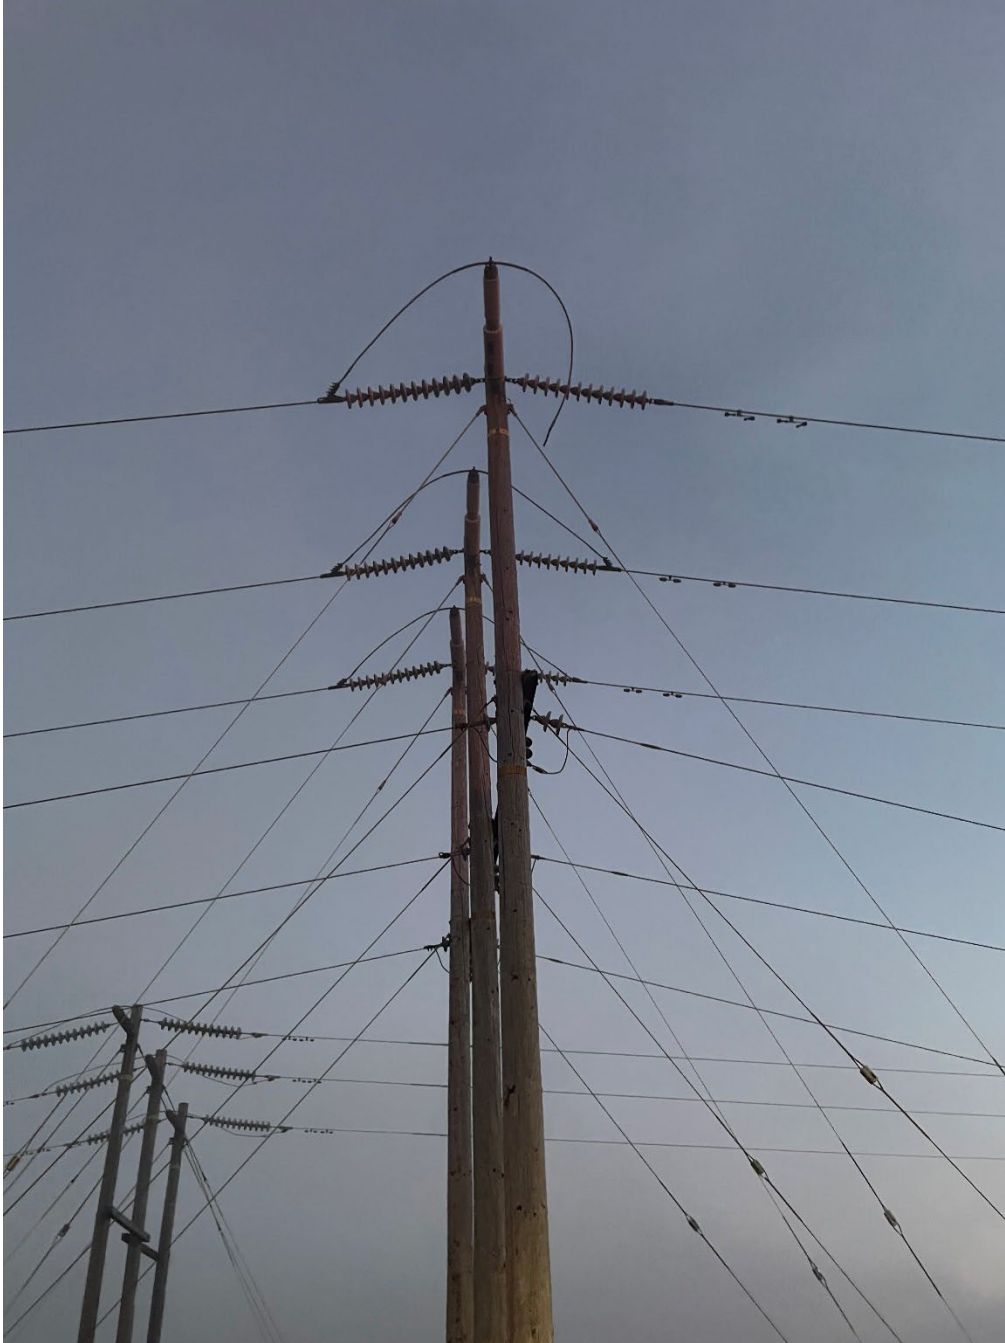
*Figure 4 SAP Pole ID 42560786/Structure 004/049 on the Sneath Lane – Pacifica 60kV transmission line, post-ignition. Failed jumper on the southside of pole top. Photo taken by troubleshooter on October 8, 2024.*

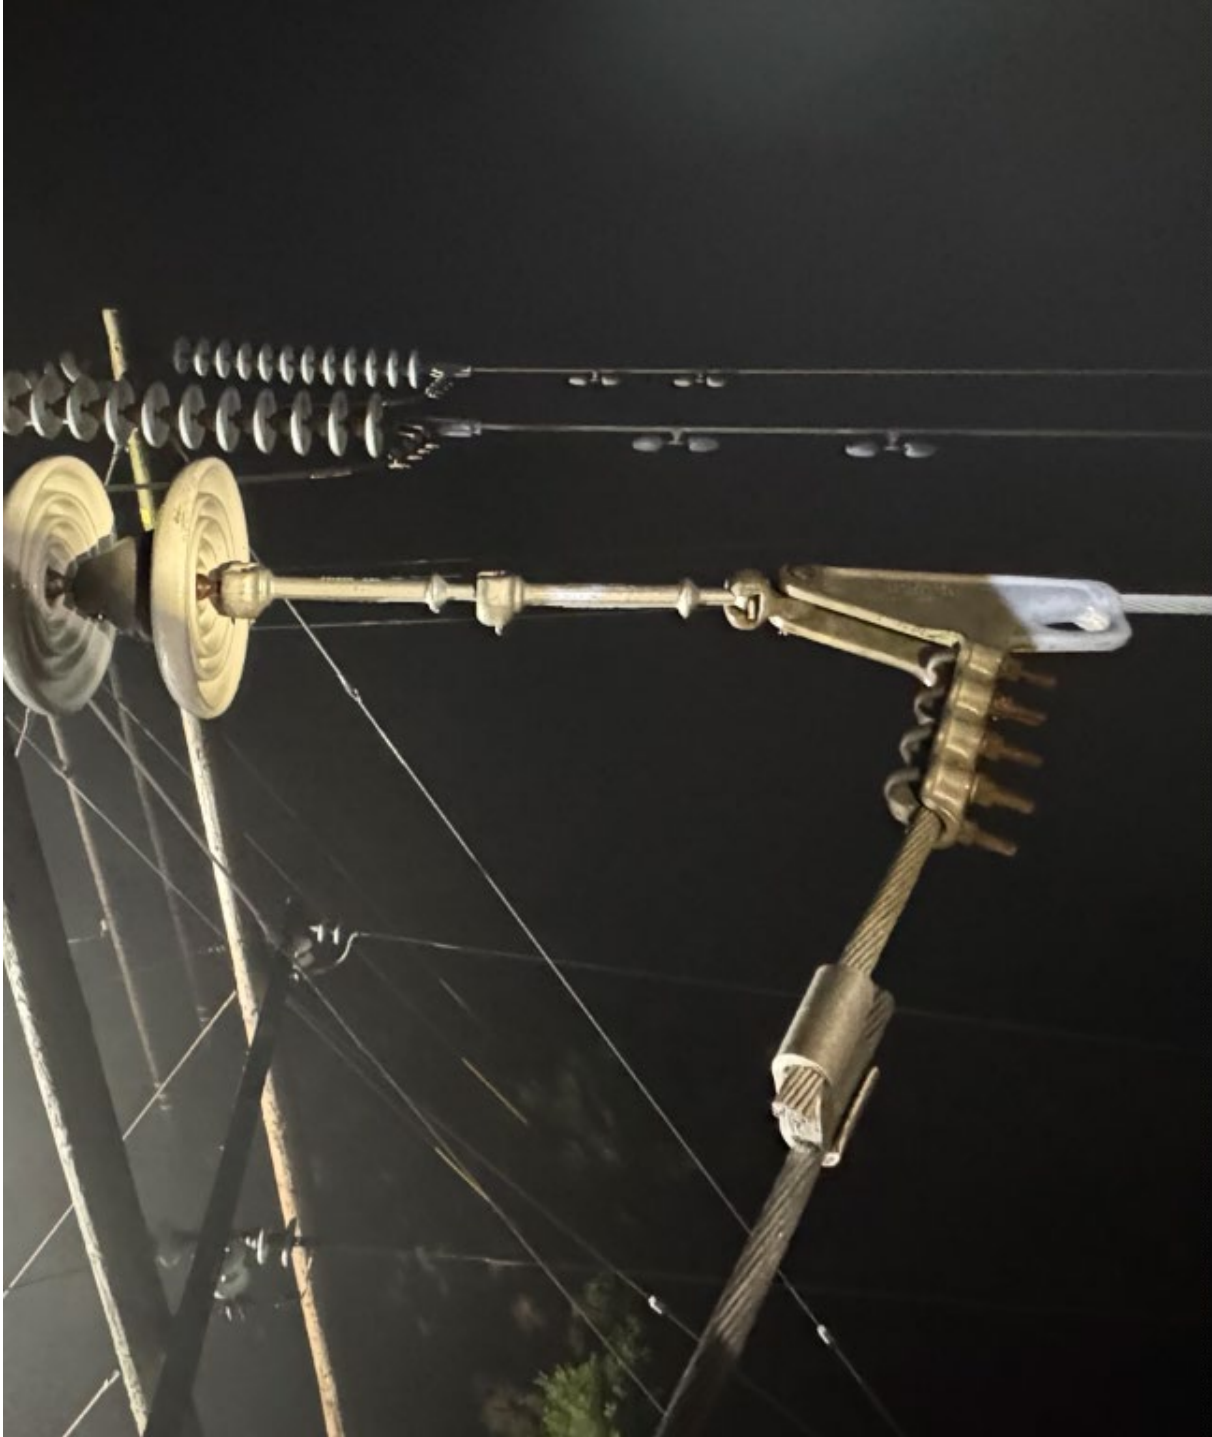
*Figure 5 Post-construction photos of shoe repairs. Photo taken by PG&E crew on October 9, 2024.*

The troubleshooter wrote an LC Priority 'A' Tag (#129657510) to replace the burnt, open jumper. The repair was completed by a PG&E crew the following morning, October 9, 2024.

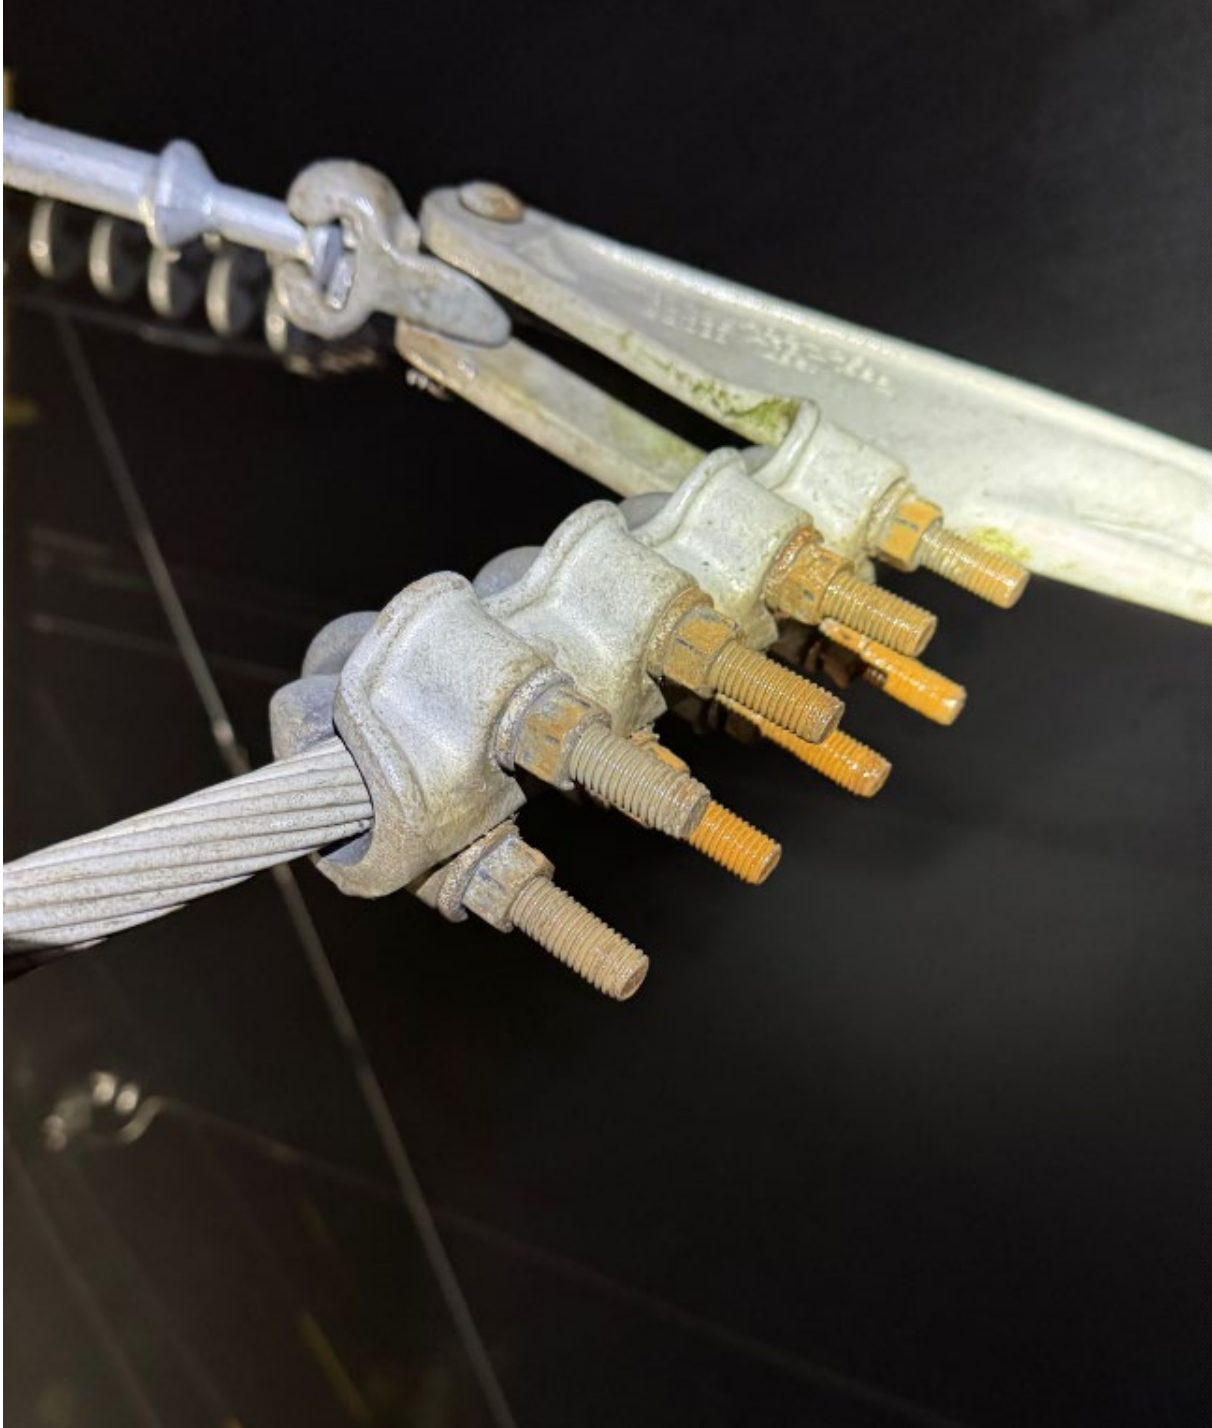
*Figure 6 Re-used shoe, post-construction photos taken on October 9, 2024.*

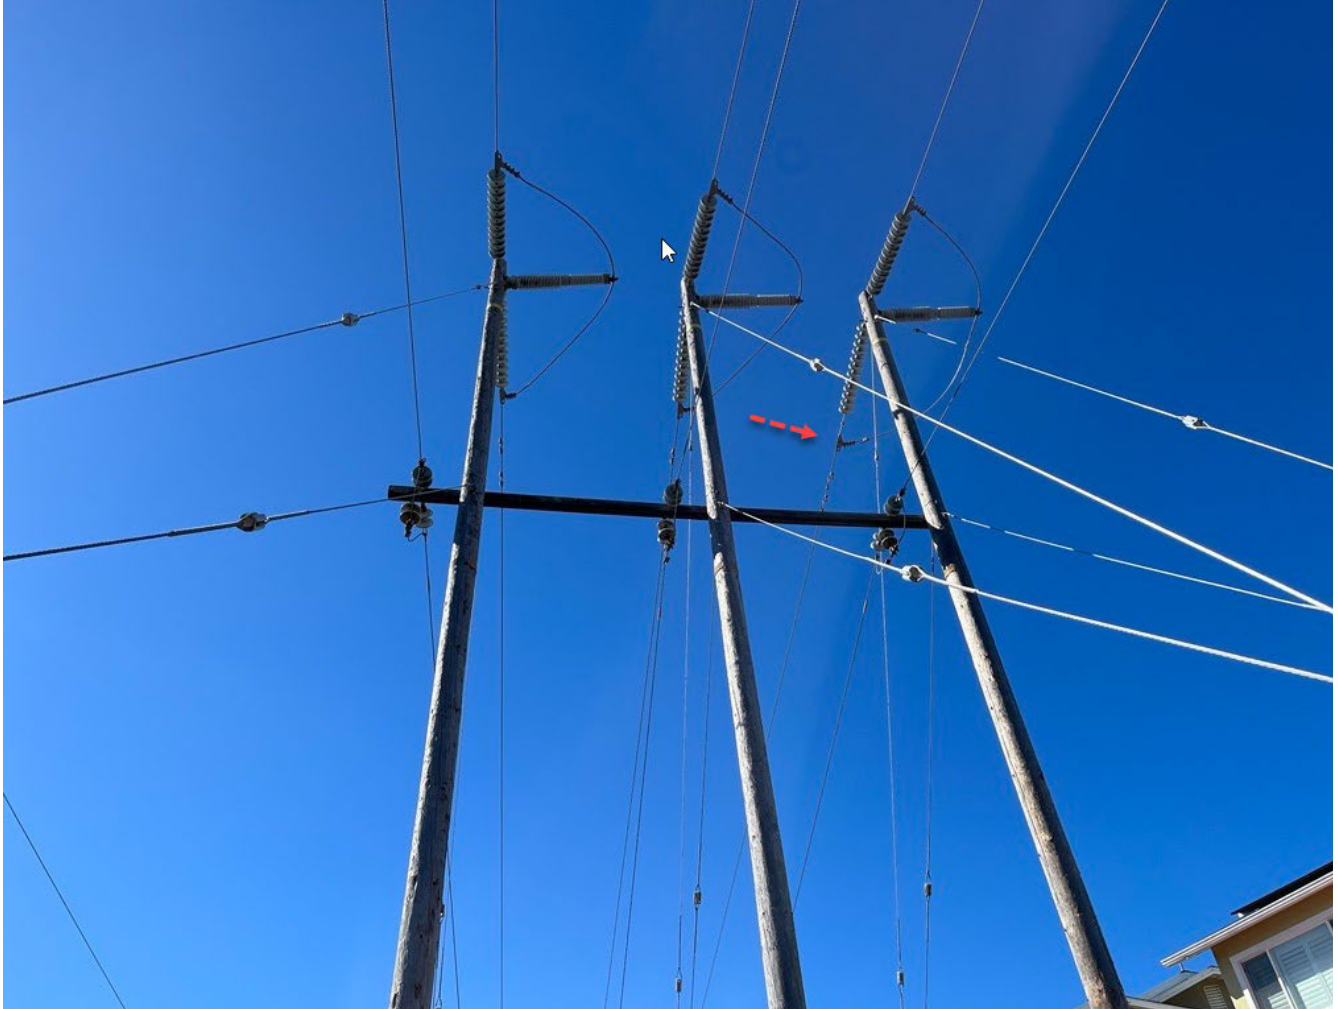
*Figure 7 Post-construction photo of asset. The impacted shoe/jumper is identified in the photo. Photo taken by Ignitions Investigator during site visit on October 23, 2024.*

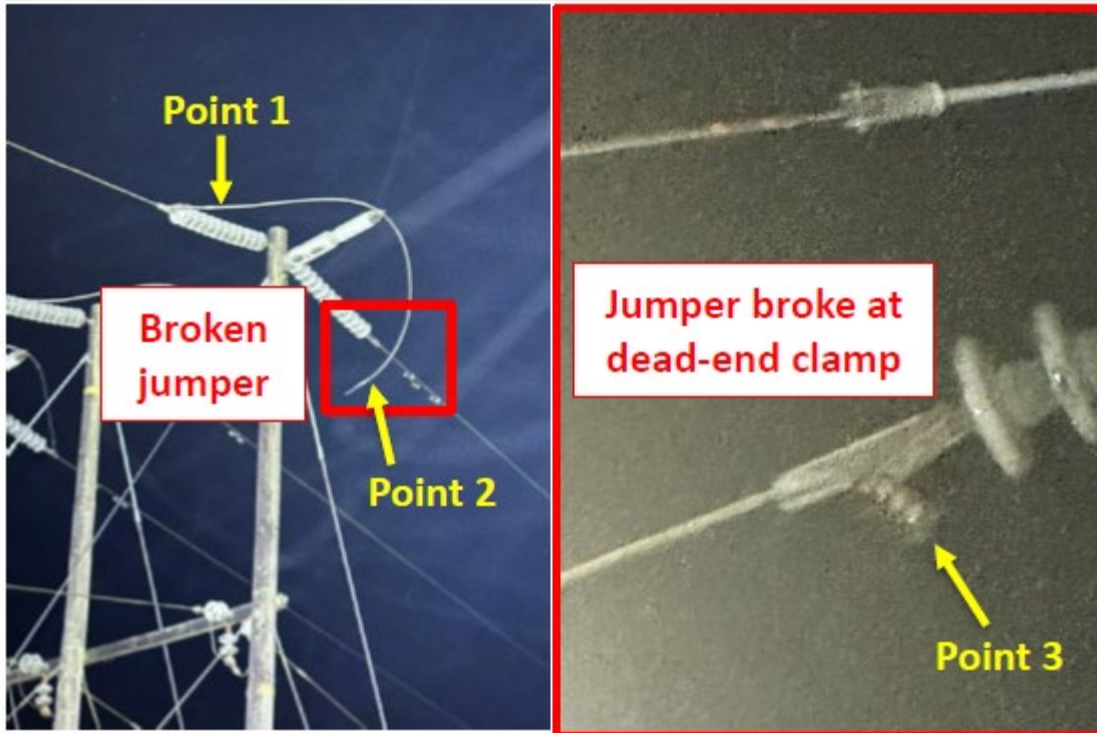
Figure 8 The failed jumper, as photographed by troubleshooter prior to removal, October 8, 2024.

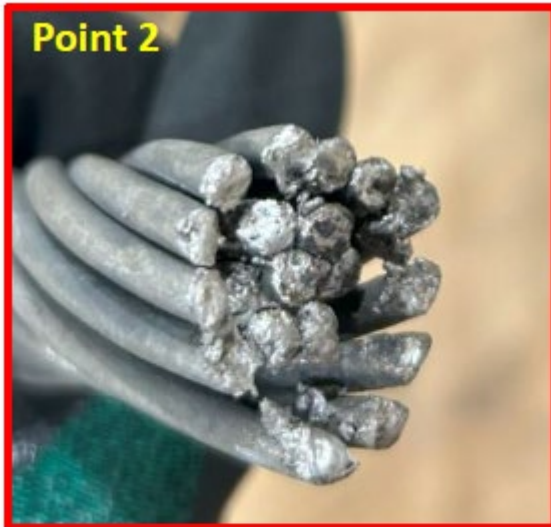
**Point 2**

The failed jumper was sent to Applied Technology Services (ATS) to be further analyzed by an engineer. A visual inspection was conducted of the jumper, with a focus on the failed ends. Point #1 is where it was cut in the clear from the north shoe and Point #2 (source side of fracture) is where the jumper failed approximately ½ inch above the south shoe (See Figure 8). Point #2 has signs of arc flash damage (See Figure 9), that likely took place after the fracture. Point #3 is the section of jumper that was still inside the dead-end clamp/shoe and has signs of low cycle fatigue (See Figure 10). The jumper appears to have failed from low cycle fatigue (LCF<sup>7</sup>) at the dead-end clamp attributed to cumulative wind gusts.

Source side of fracture, arc damage likely after the fracture

*Figure 9 ATS photos of the source side of the failed jumper.*

Dark color in vicinity of fracture surfaces suspected to be fretting wear debris

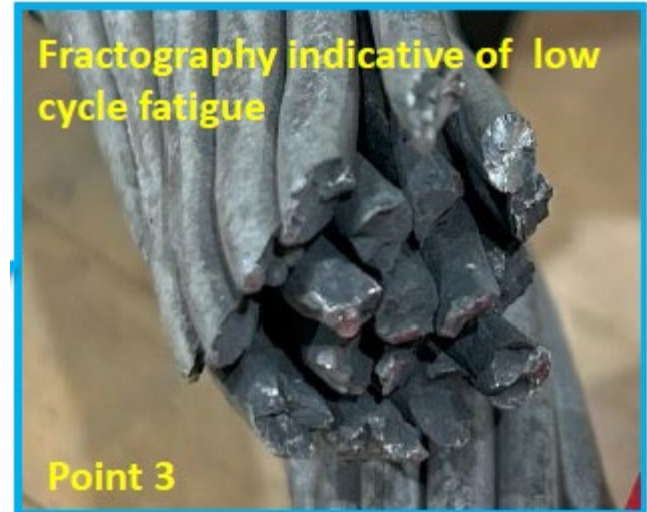
**Point 3**

The incident was analyzed by an Asset Failure Analysis (AFA) engineer. AFA agrees with the ATS results that conclude that the jumper ultimately failed from a low cycle fatigue (LCF) at the dead-end clamp attributed to cumulative wind gusts. Age is also a major contribution as the jumper conductor may be well over its end of life potentially over 100 years old (possibly 126). There have been two outages on this line, March 13, 2018, and October 24, 2021, with similar jumper failures (See Figure 11). The Sneath Lane jumper and the Pacifica circuit switcher (CSW) interrupter are related only in that when attempting to switch to alternate sources AFTER the jumper failure the CSW failed to operate. The jumper failure did NOT impact the CSW at the time of the relay. *"After an outage on the Sneath Lane-Pacifica line due to a burnt/open jumper. Operations tried to use Pacifica's alternate source from Half Moon Bay. Pacifica switch (SW) 25 C phase would not latch and stay closed. We forced SW 25 out of service."*<sup>8</sup>

**Fractography indicative of low cycle fatigue**

*Figure 10 ATS photo of the section of jumper that remained in the dead-end clamp/shoe.*

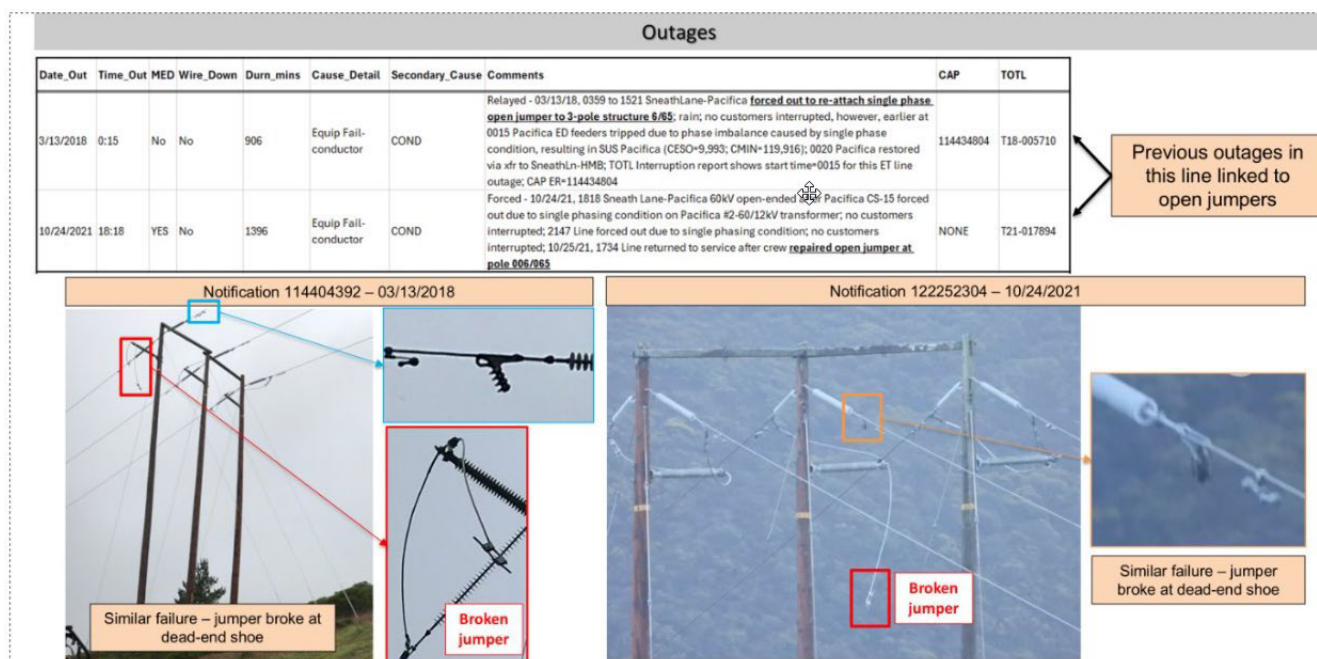
Figure 11 Historical outage data (compiled for reference) due to open jumpers on the Sneath Lane – Pacifica 60kV by AFA.
