## Preliminary Ignition Investigation Report

Ignition Database Index:	20241489
Electric Incident Investigation (EII) Number:	N/A
Incident Name:	Roberts
PG&E Facility Ignition?	Yes
CPUC Reportable Ignition?	Yes
Date & Time of Incident:	October 14, 2024 @ approximately 1403 hours
Street Address:	Near 4334 Lichau Road
City:	Penngrove
County:	Sonoma
Latitude/Longitude:	38.3312, -122.6273
State Responsibility Area (SRA) / Local Responsibility Area (LRA) / Federal Responsibility Area (FRA)	State Responsibility Area
PG&E Division:	Sonoma
High Fire Threat District (HFTD):	Tier 2
High Fire Risk Area (HFRA):	Yes
EPSS Buffer:	No
Fire Index Area (FIA):	180
Fire Potential Index (FPI) Rating: FIA	R2
Fire Potential Index (FPI) Rating: Circuit	R1
Was there a PSPS event at the time of ignition?	No
Suspected Initiating Event:	Contact - 3 <sup>rd</sup> Party
Failure Driver:	Contact from Object
Failure Sub-driver:	Contact – Balloon
Circuit:	Penngrove 1101
Circuit Protection Zone:	Penngrove 1101 LR 950828

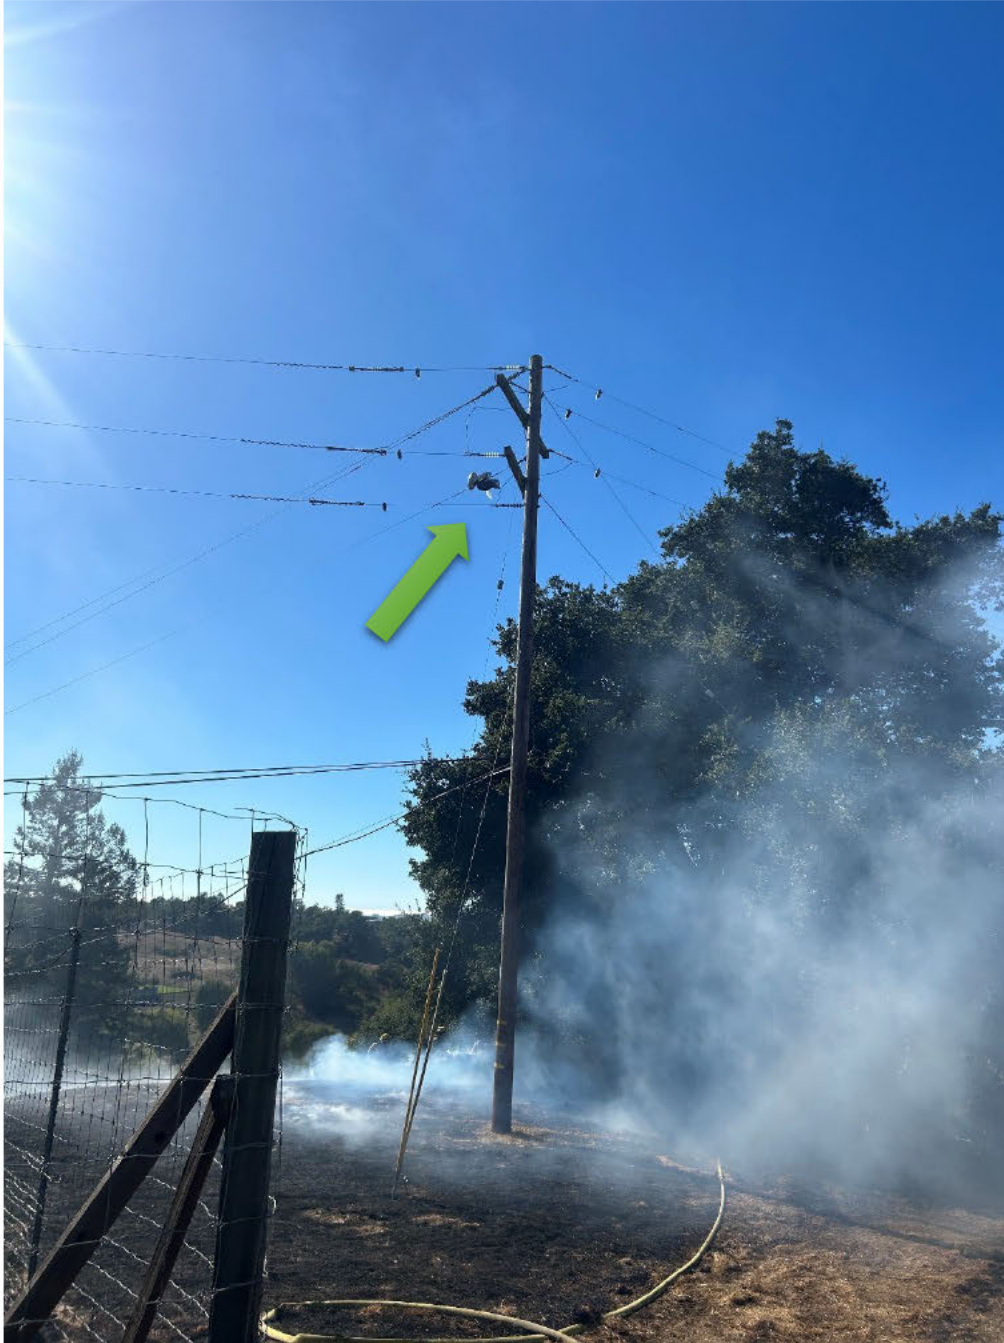
Troubleshooter #1 removed the balloons from the line and CAL FIRE retained the balloons as evidence. The ensuing fire was approximately four acres in size and the fire was suppressed by CAL FIRE. The incident occurred within a Tier 2 HFTD and HFRA during R1 conditions. There were small arc marks on one of the conductors. No corrective tags were created in response to the outage.

Figure 2 - Photo of the contained fire and burn scar with the balloon contact on the line. Photo taken by troubleshooter on October 142024. SAP Pole ID 103886356

No corrective notifications were created as a result of this incident. The troubleshooter removed the balloons from the overhead lines working off the FAS tag (#T006525869).

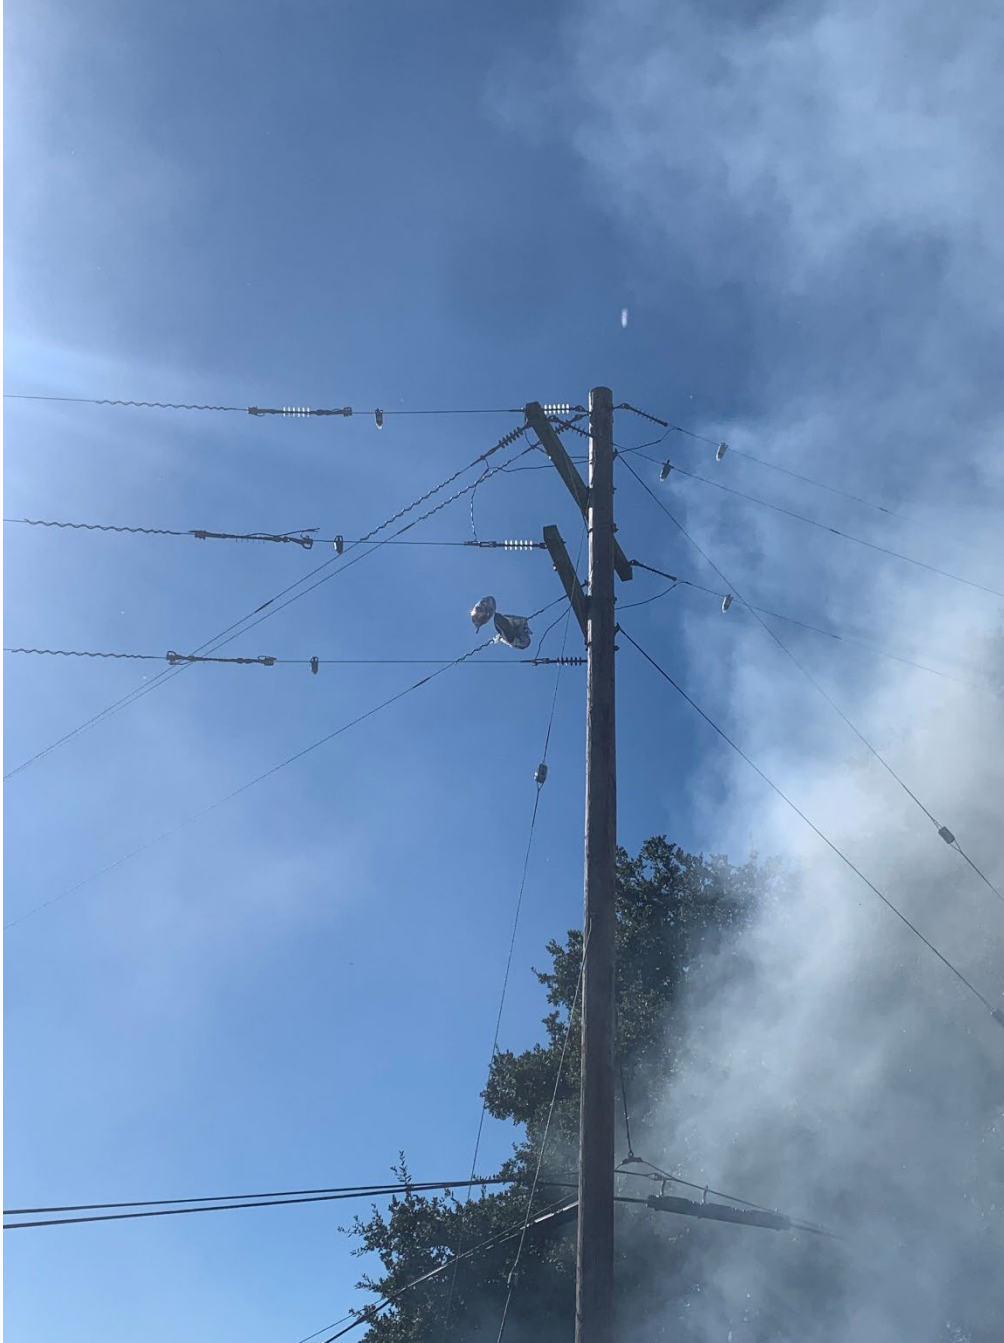
*Figure 3- Contained fire and Mylar balloon remnants found that led to the cause of the ignition. Photo taken by troubleshooter on October 14, 2024. SAP Pole ID # 103886356*

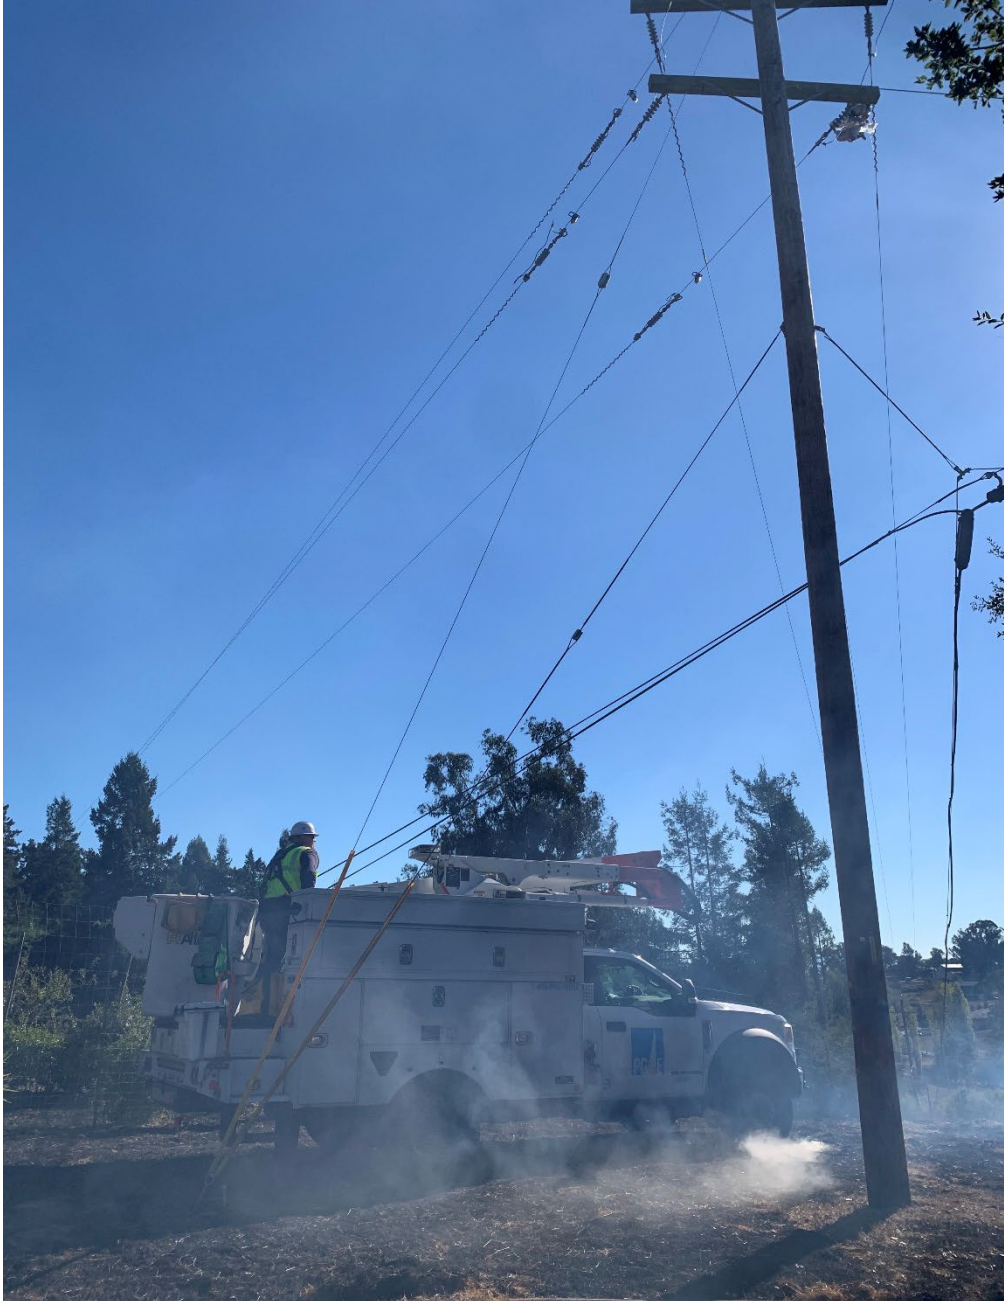
Figure 4- Suppressed fire and PG&E troubleshooter identifying the Mylar balloon prior to removal. Photo provided by troubleshooter on October 14, 2024. SAP Pole ID3103886356

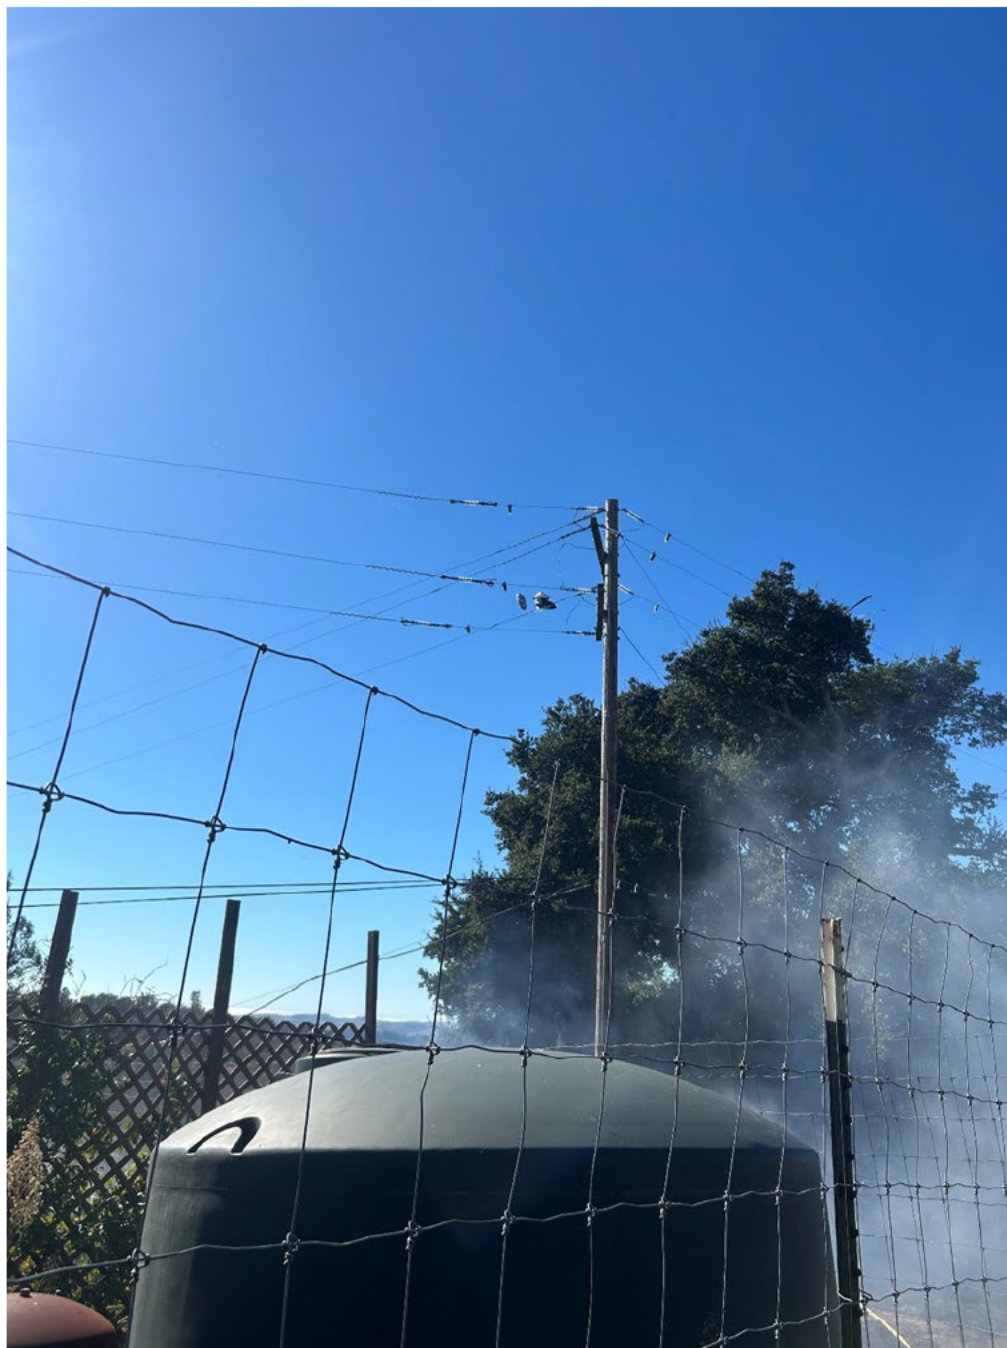
*Figure 5 Photo of the Mylar balloon and the suppressed fire. Photo provided by the Troubleshooter on October 14, 2024. SAP Pole ID #103886356*
