Preliminary Ignition Investigation Report

Ignition Database Index:	20240309 (Index 309) 20240309N (Index 309N)
Electric Incident Investigation (EII) Number:	NR240420A – 309 N/A – 309N
Incident Name:	Blackberry – 309 N/A – 309N
PG&E Facility Ignition?	Yes – 309 and 309N
CPUC Reportable Ignition?	Yes - 309 and 309N
Date & Time of Incident:	April 20, 2024 @ approximately 1416 hours
Street Address:	Deer Creek Hwy (HWY 32) & Blackberry Road – 309 Deer Creek Hwy (HWY 32) & Eagle Ridge Drive – 309N
City:	Forest Ranch
County:	Butte
Latitude/Longitude:	39.83563, -121.69607 – 309 39.84403, -121.694526 – 309N
State Responsibility Area (SRA) / Local Responsibility Area (LRA) / Federal Responsibility Area (FRA)	State Responsibility Area – 309 and 309N
PG&E Division:	North Valley – 309 and 309N
High Fire Threat District (HFTD):	Tier 3 – 309 and 309N
High Fire Risk Area (HFRA):	Yes – 309 and 309N
EPSS Buffer:	N/A
Fire Index Area (FIA):	280 – 309 and 309N
Fire Potential Index (FPI) Rating: FIA	280

Fire Potential Index (FPI) Rating: Circuit	R1
Was there a PSPS event at the time of ignition?	No – 309 and 309N
Suspected Initiating Event:	Contact – 3 rd party – 309 Equipment – PG&E – 309N
Failure Dr

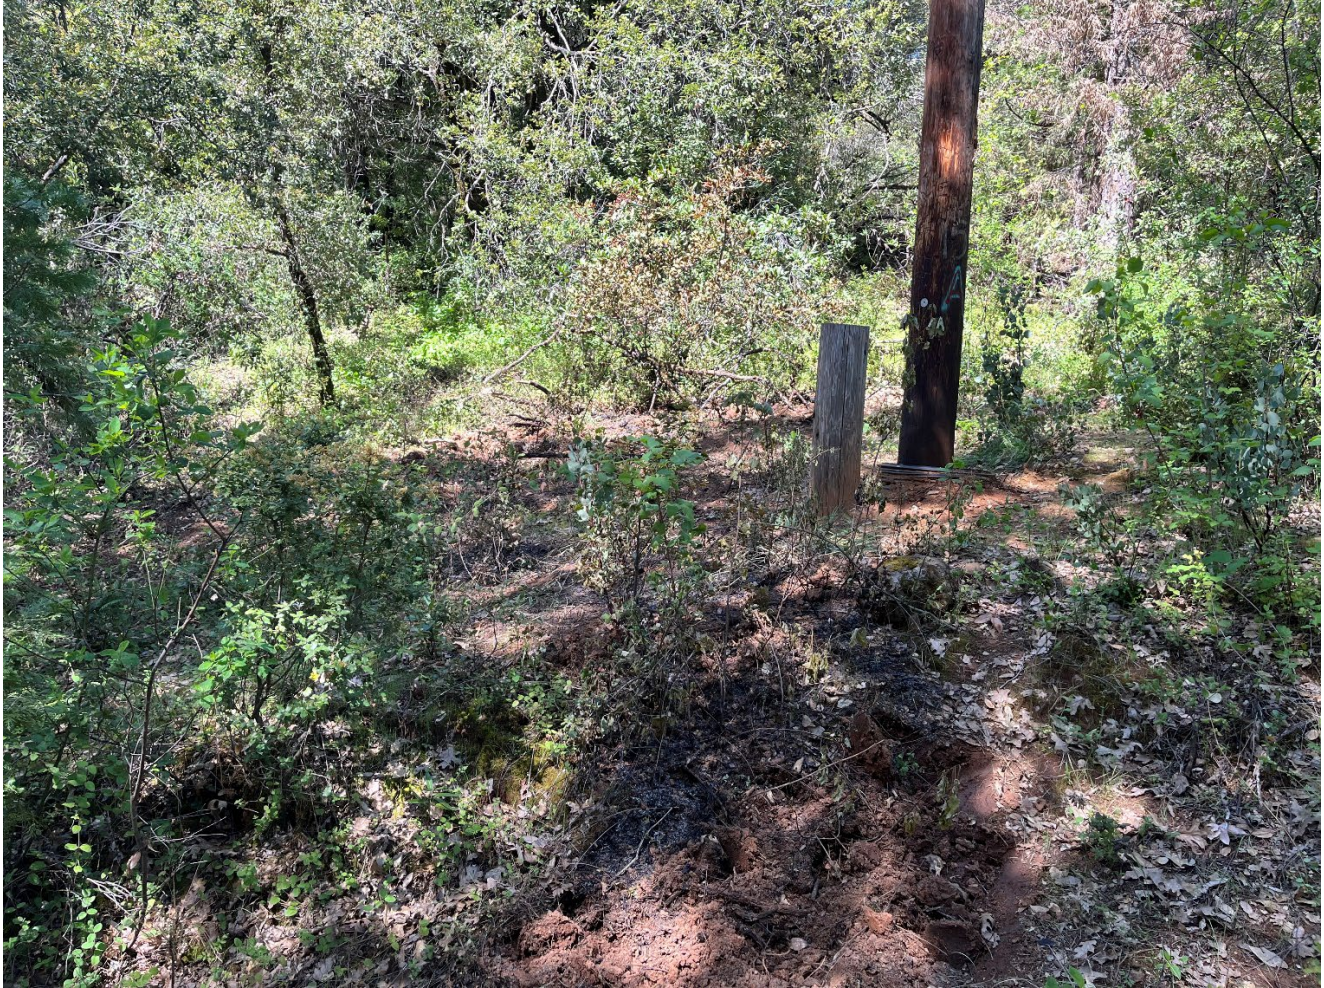
The ensuing fires burned at two separate locations approximately .58 miles apart and were reported as two separate incidents. For Index 309, the burn scar was approximately 12-feet x 18-feet in size, burning shrubs and vegetation around the base of Pole #2 (SAP Pole ID 103320076).

Figure 2 Base of SAP Pole 103320076 - Pole #2 – Incident Location #2. Burn scar was approximately 18' x 12' in size near the base of the pole. Photo taken by ignition investigator on April 22, 2024.

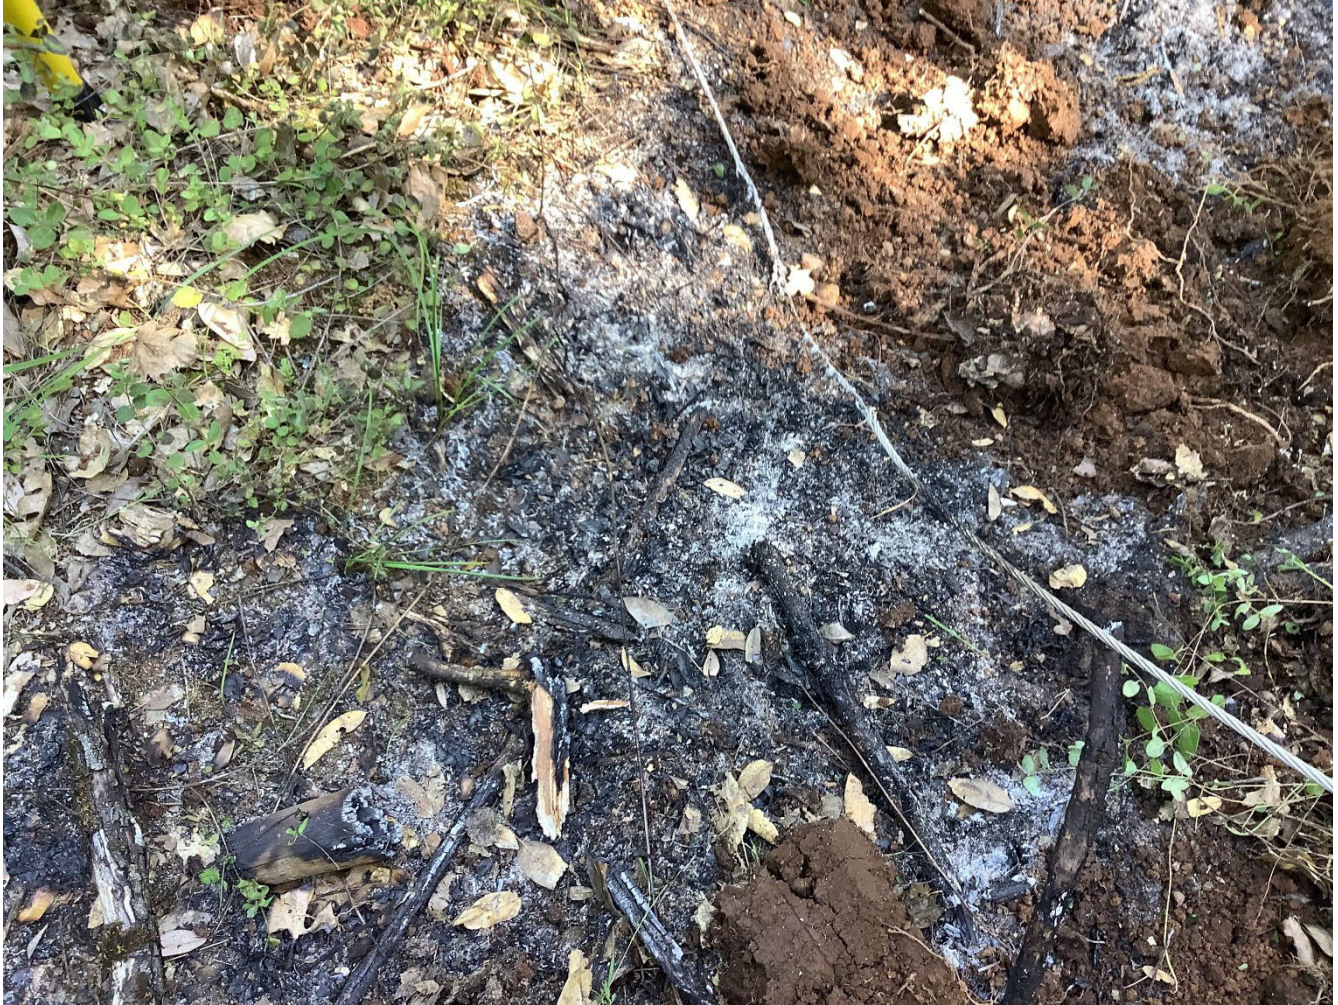
Figure 3 A small section of conductor (footage unknown) still suspended from Pole #2 (behind, to the right in photo). The conductor had melted where it came into contact with the ground. Photo taken by troubleshooter on April 20, 2024.

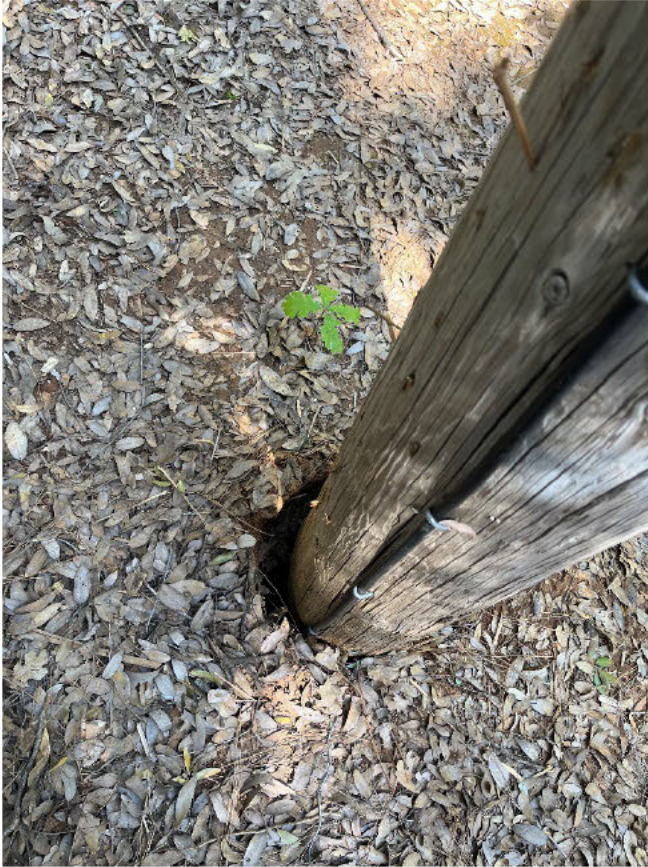
Figure 4 Base of Pole #3 showing the gap created from the forceful movement of the pole when the dozer snagged the guy wire. Photo taken by ignition investigator on April 22, 2024.

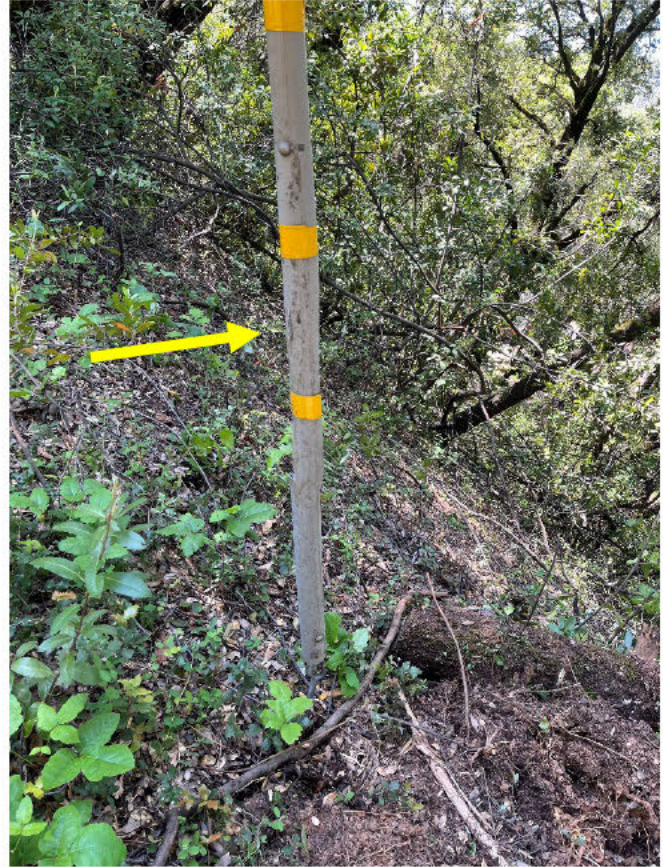
Figure 5 Guy wire from Pole #3 with visible damage and breakage on the plastic shell. Photo taken by ignition investigator on April 22, 2024.

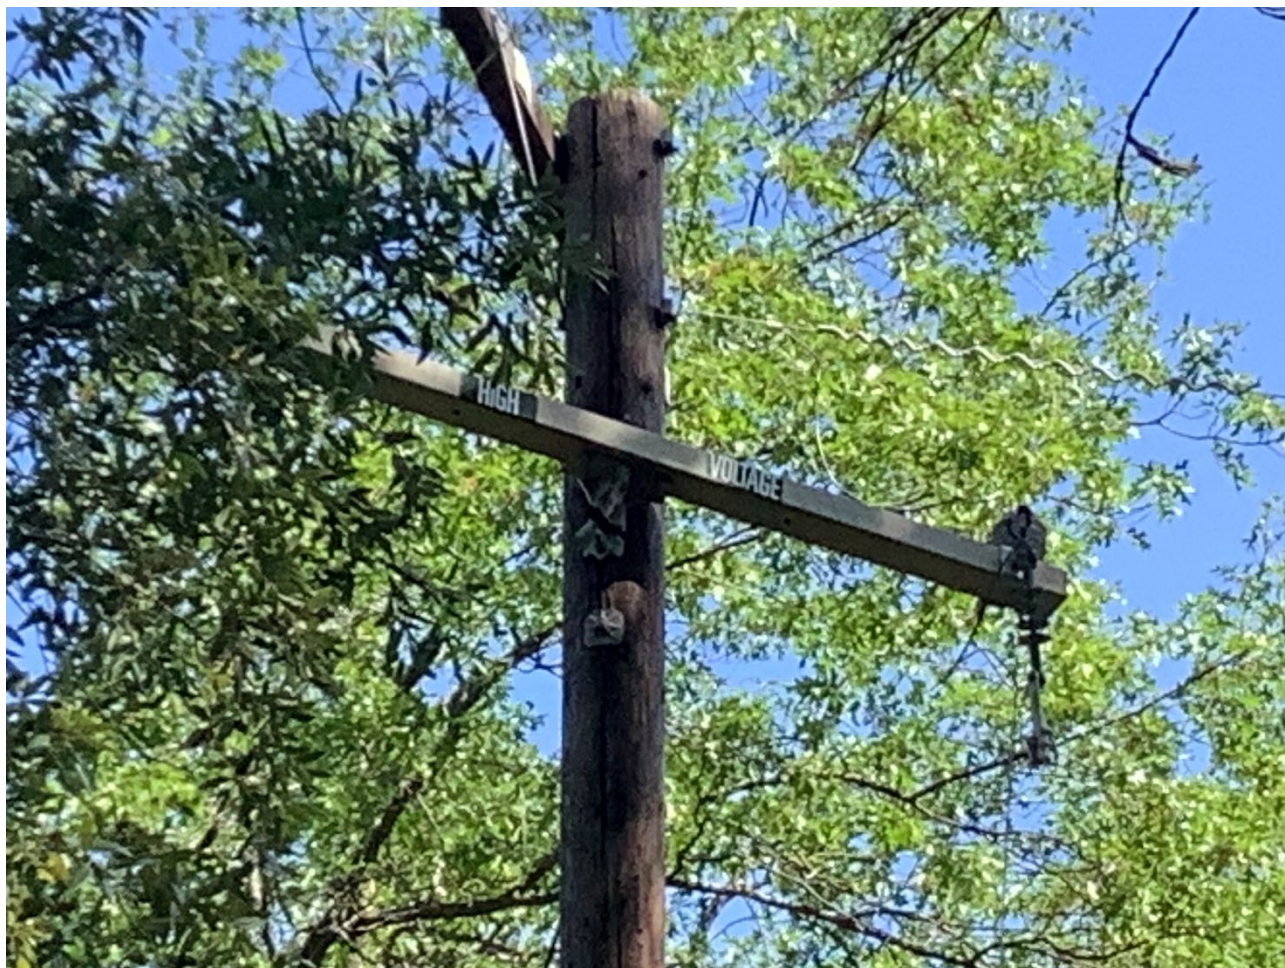
Figure 6 Pole #2 (SAP Pole ID 103320076) - Incident Location #2. Crossarm was damaged when guy wire had been contacted by the dozer, the force pulling the conductor forcibly before it failed. Photo taken by troubleshooter on April 20, 2024.

EC Priority 'A' Tag (#128609398) to replace crossarm and conductor at Incident Location #2, which was completed the same day by a PG&E crew. The fuses were also replaced at Incident Location #1 and closed back in for re-energization of all impacted customers by 2233 hours on April 20, 2024.

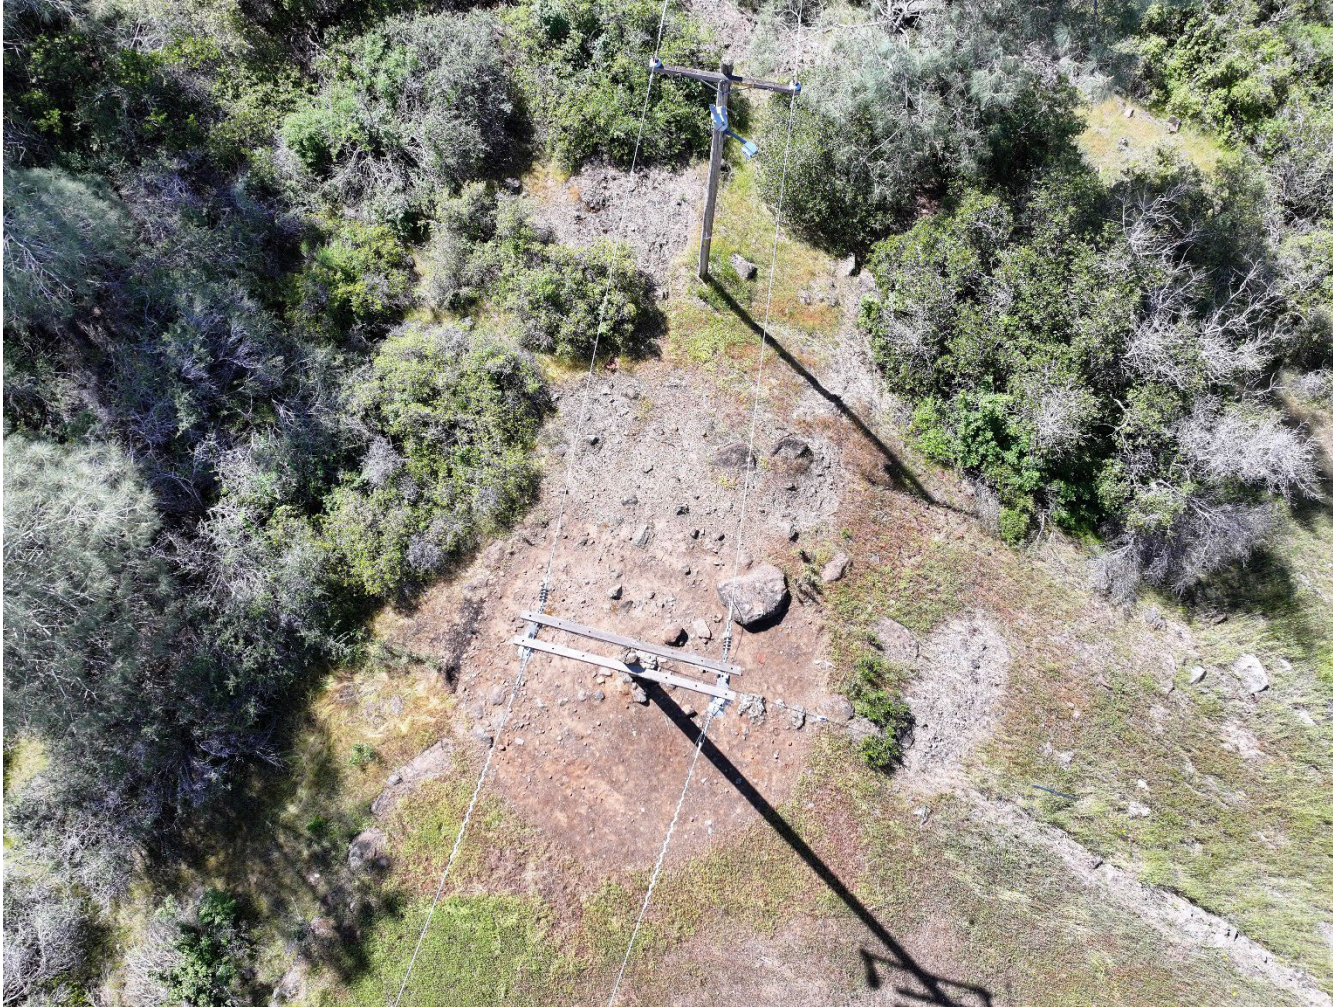
For index 309N, the burn scar was approximately 6.5-feet x 1foot in size just outside the defensible space of Pole #1 (SAP ID 100331947), burning dry grassy vegetation just outside the 10-foot defensible space circumference.

Figure 7 Aerial view of Incident Location #1 - Pole #1 (SAP Pole ID 100331947, with Fuse 26501), showing the defensible space and burn scar just outside of it. Aerial drone photo taken by Ignition Investigator on April 22, 2024.

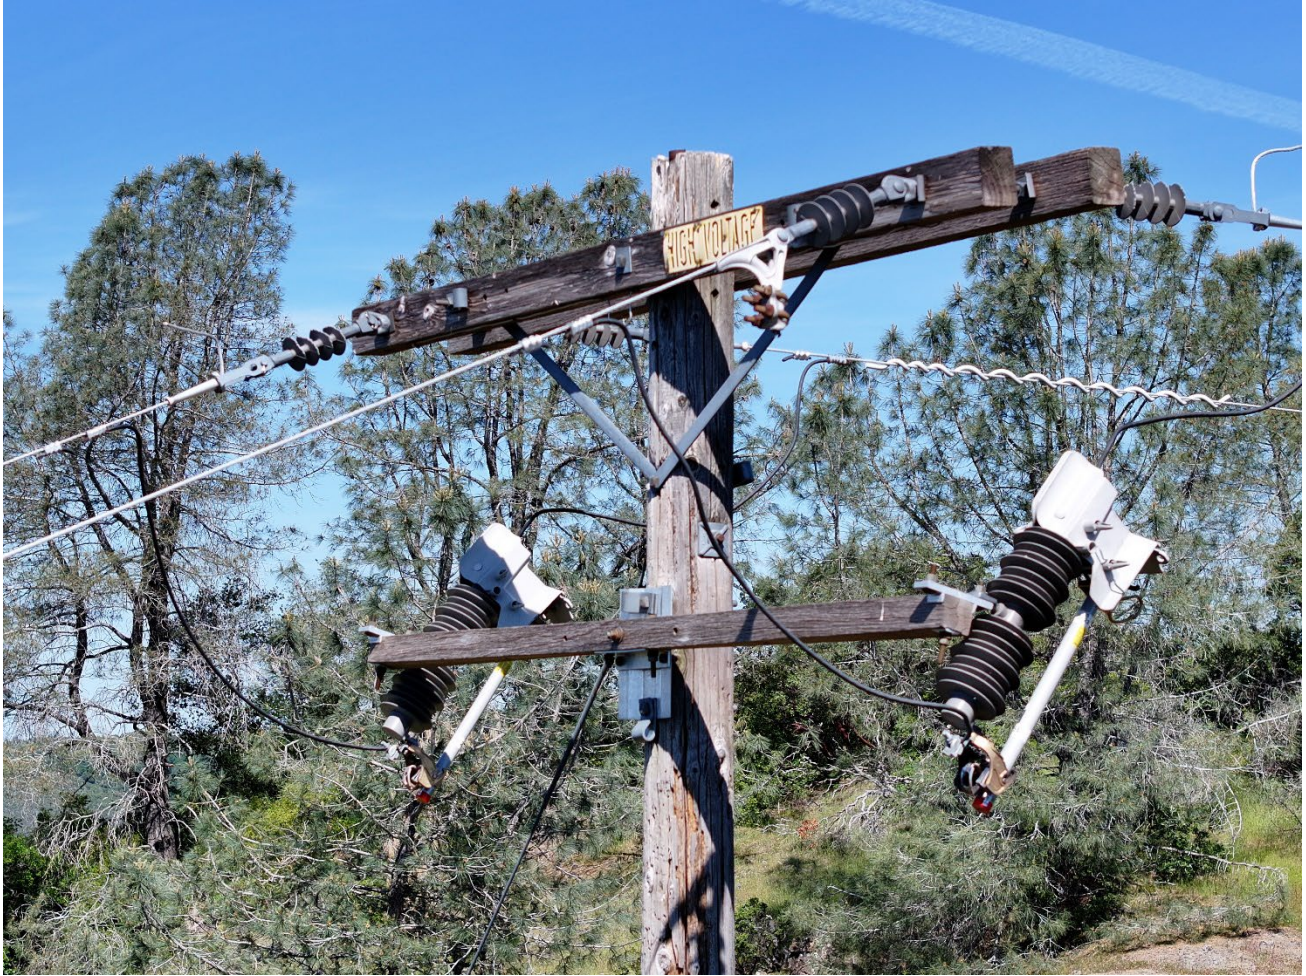
Figure 8 Incident Location #1 - Pole #1 with new fuses. Photo taken by Ignition Investigator on April 22, 2024.

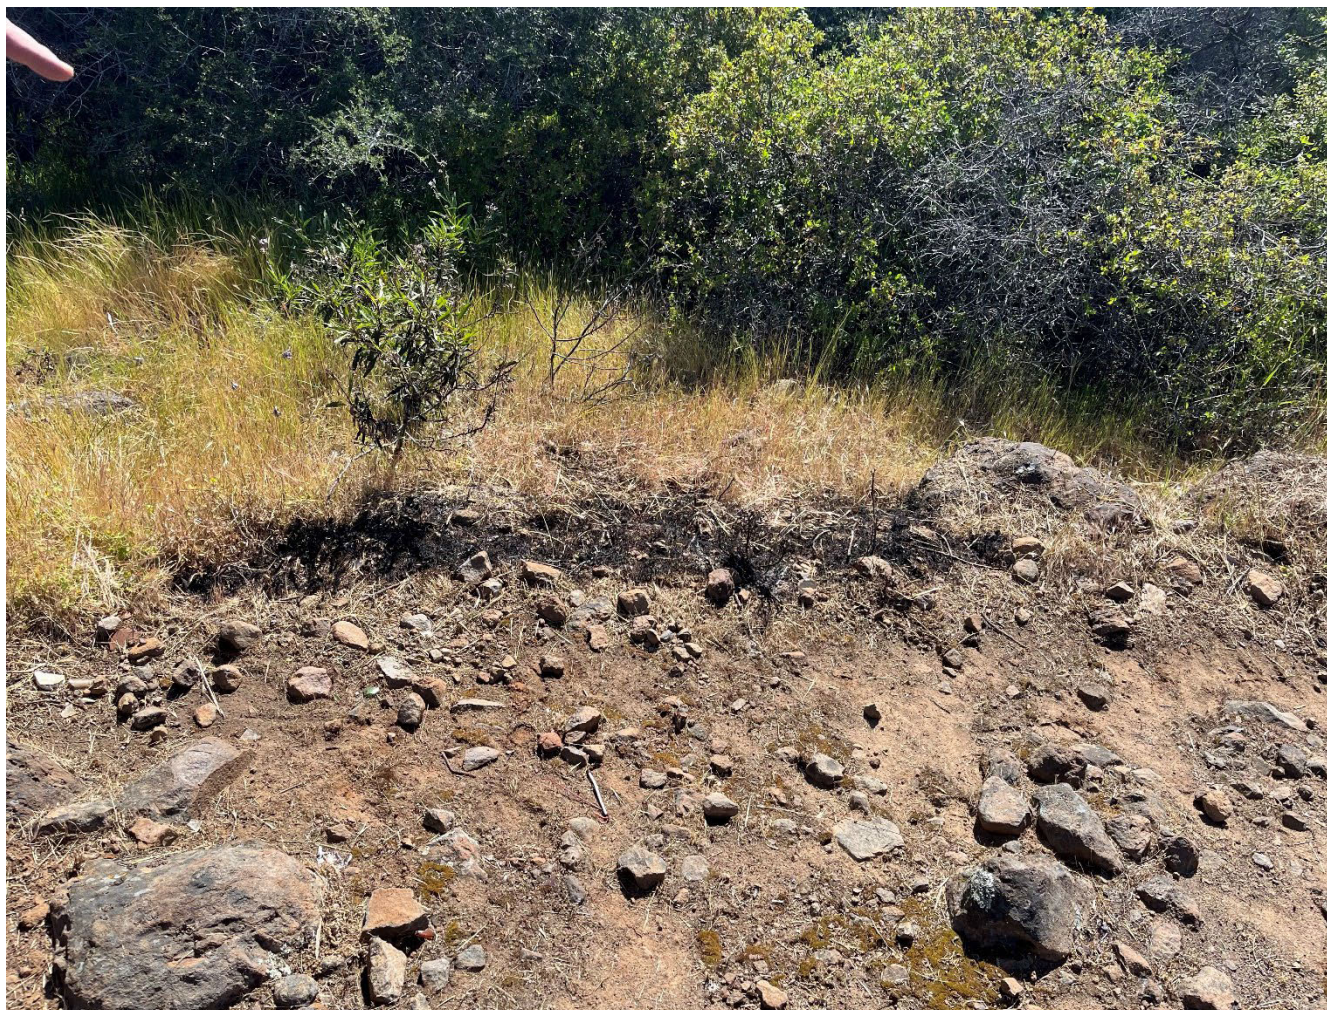
Figure 9 Burn scar at Incident Location #1 - Pole #1. Burn scar was approximately 6.5' x 1' in size. Photo taken by Ignition Investigator on April 22, 2024.

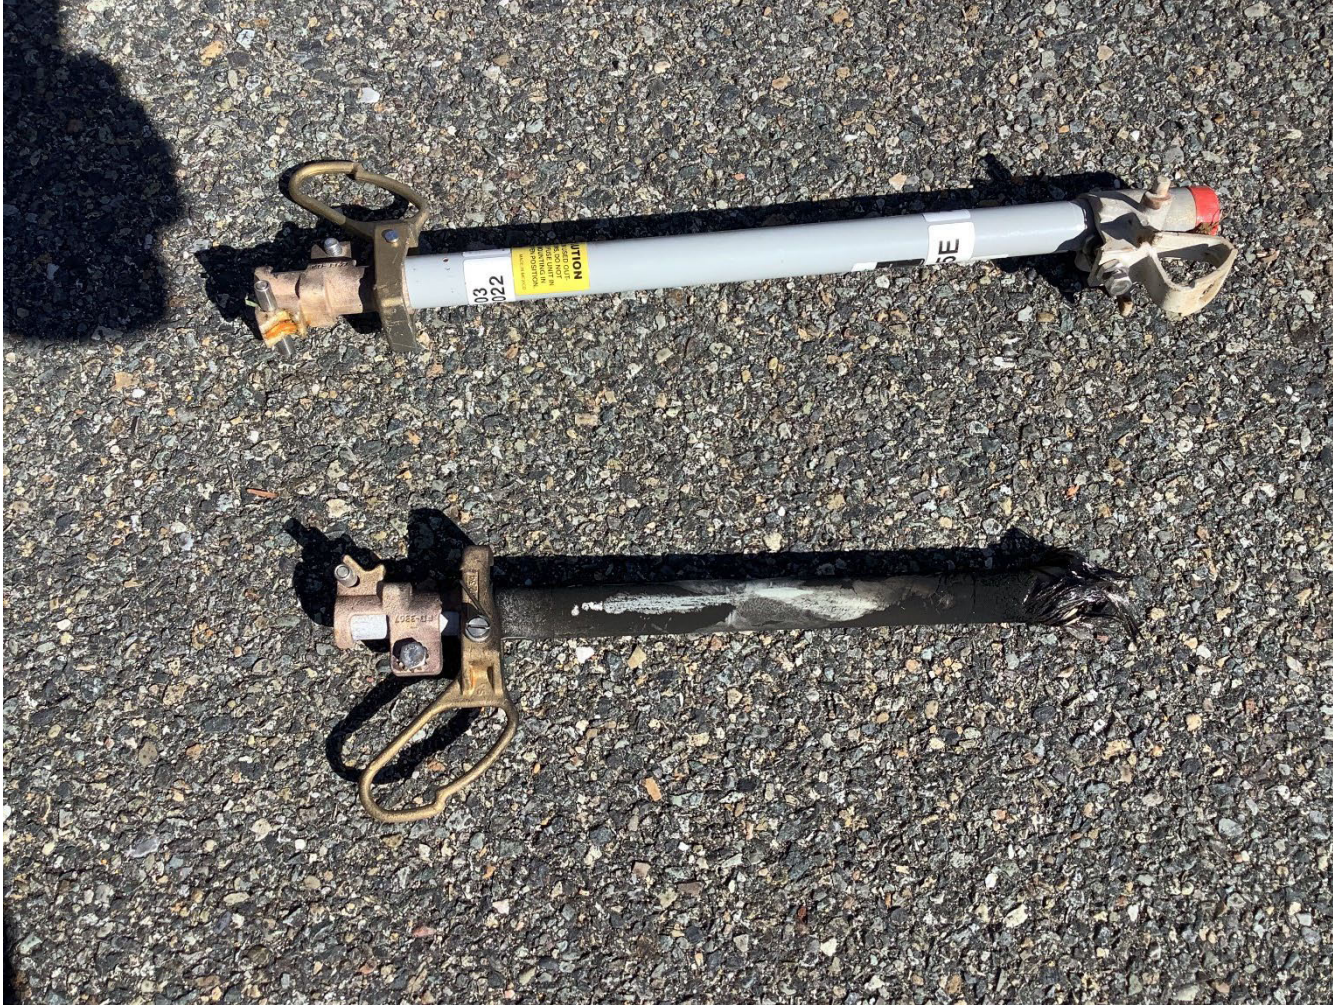
The failed fuses from Pole #1 were collected and sent to Applied Technology Services (ATS) to be further analyzed. The failed connector from Pole #3 was also collected and sent to ATS. The visual and computed tomography (CT) examination of the failed fuse show evidence consistent with boric acid closedown, which likely caused uninterrupted arcing within the fuse. The fuse failure is likely instigated by a reported vehicle contact collision a few spans downstream near Pole #3, which caused a 4-ACSR conductor to fail at the crimp connector. The failed connector showed signs of plastic deformation of aluminum conductor spans.

The incident was reviewed by an Asset Failure Analysis (AFA) engineer, who also concurred that the E-Fuse failed likely due to boric closedown, which is a common failure mode for this fuse.

Both Incident Locations were protected by fuse 26501 (E-Fuse), which did not operate as designed. It is designed to open at 124amps in 0.3 seconds, however, the fuse mis-operated and burnt up while staying secure in the cutout. The next upstream protective device after the fuse 26501 is recloser device 2028 (LR 2028), which was set in profile 1 (non-EPSS settings) with an operating time of 36 seconds at 90 amps. For operation, it would have needed to stay at the peak amperage (124amps) for at least 3 seconds, which it did not.

Figure 10 E-fuses that were retrieved from Pole #1 - Incident Location #1. The partially burnt fuse and the sister fuse were sent to ATS for further analysis. Photo taken by troubleshooter on April 20, 2024.

- AFA is conducting an E-Fuse Root Cause Evaluation, which includes a ‘fuse task force’ that is addressing the following issues:
 - Evaluate moisture ingress and boric acid close-down
 - Handling/storage issues such as removing from the packaging.
 - Open the fuses and hanging them upside down for an extended period of time.
