## Preliminary Ignition Investigation Report

Ignition Database Index:	20240559
Electric Incident Investigation (EII) Number:	N/A
Incident Name:	Little
PG&E Facility Ignition?	Yes
CPUC Reportable Ignition?	Yes
Date & Time of Incident:	June 1, 2024 @approximately 1932 hours
Street Address:	East side of Little Morro Creek Road, approximately 715 feet north of Main Street
City:	Morro Bay
County:	San Luis Obispo
Latitude/Longitude:	35.376281, -120.850962
State Responsibility Area (SRA) / Local Responsibility Area (LRA) / Federal Responsibility Area (FRA)	Local Responsibility Area
PG&E Division:	Los Padres
High Fire Threat District (HFTD):	Tier 2
High Fire Risk Area (HFRA):	Yes
EPSS Buffer:	No
Fire Index Area (FIA):	508
Fire Potential Index (FPI) Rating: FIA	R1
Fire Potential Index (FPI) Rating: Circuit	R1
Was there a PSPS event at the time of ignition?	No
Suspected Initiating Event:	Utility Work/Operation
Failure Driver:	Utility Work/Operation
Failure Sub-driver:	Improper Construction

Circuit:	Morro Bay 1101
Circuit Protection Zone:	LRV66
Nominal Voltage:	12kV
Pole SAP Equipment ID:	101929764
Subject to PRC 4292 Veg Pole Clearance:	No
PG&E Equipment associated with ignition:	Chance Cl

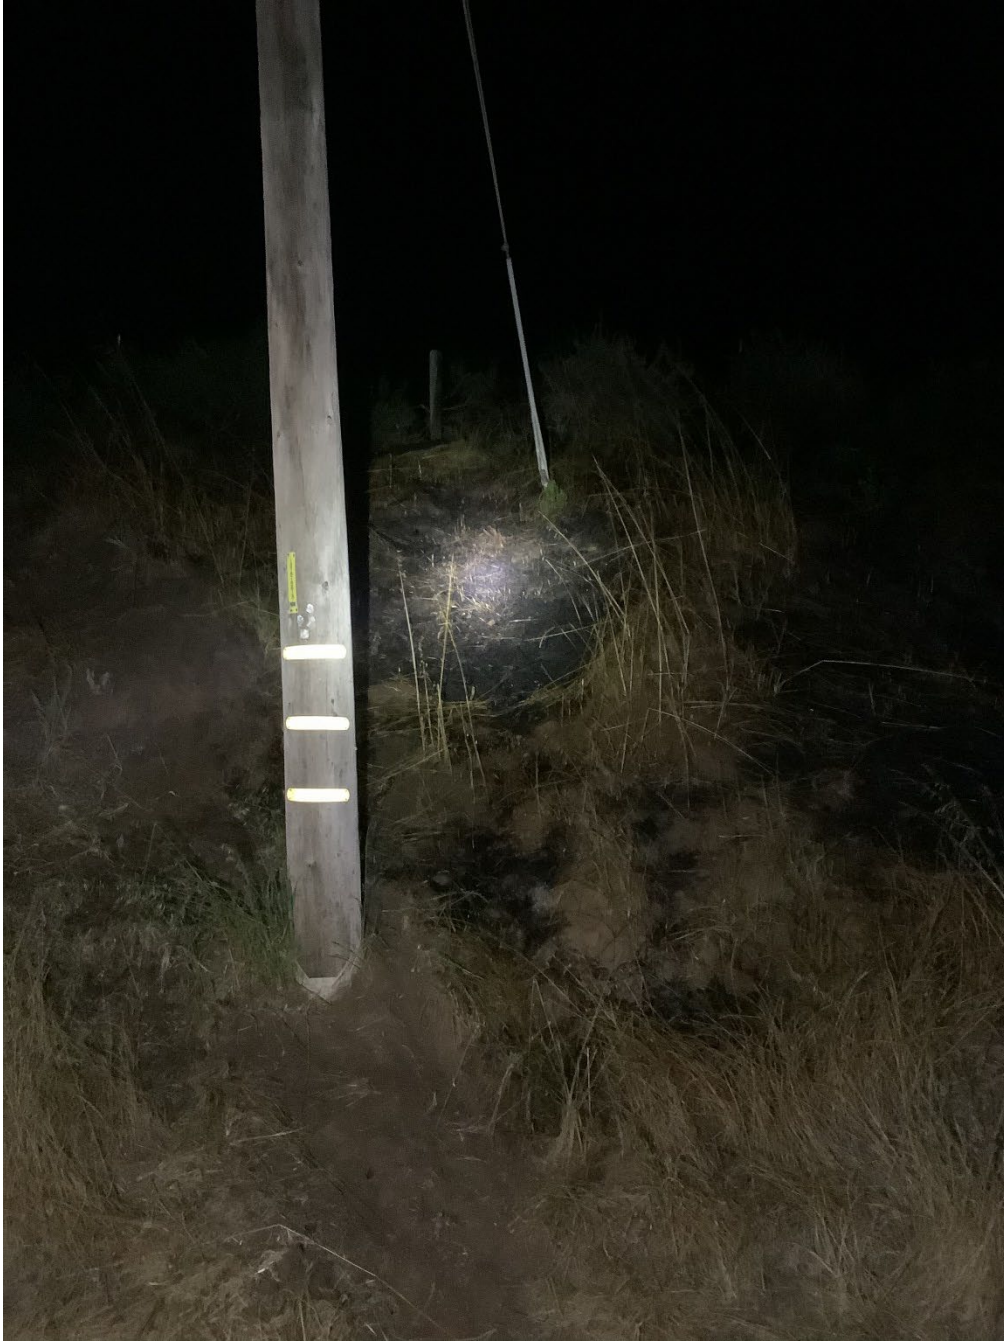
The troubleshooter (Troubleshooter #1) observed evidence of arcing from a chance clamp on one of three phases connected to Pole #1. The arcing had ignited the light, grassy fuels at the base of Pole #1, leaving a burn scar approximately 20-feet x 40-feet in size. The nearest protective device (located two spans to the west of the Incident Location), Line Recloser V66 (LRV66) had operated, de-energizing the location. The troubleshooters worked off FAS Tag (#T006407927) to make temporary repairs on the chance clamp in an effort to restore impacted customers.

*Figure 2 Burn scar at base of SAP Pole ID 101929764 (Pole #1). Photo taken by troubleshooter on June 1, 2024.*

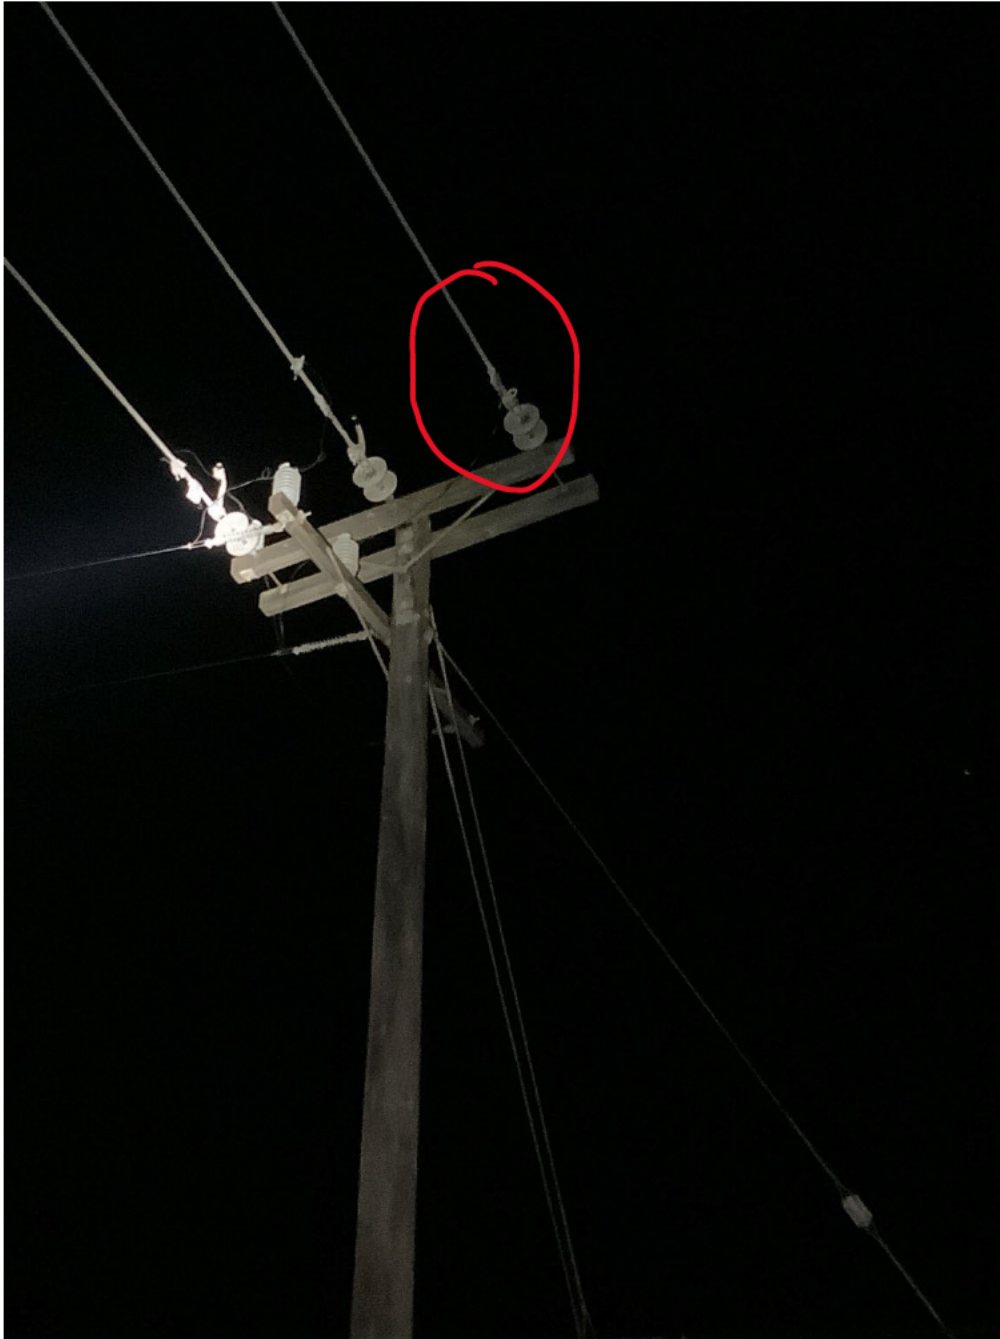
*Figure 3 Pole #1 – Arcing chance clamp on far-right phase, circled. Photo taken by troubleshooter on June 1, 2024.*

<b>FAS Field Remarks<sup>1</sup>:</b>	CREW TO REPLACE JUMPERS ON LINE AND BUCK POLE 715 ALUM TO #6 CU. CHANCE CLAMP WAS ARCHING AND STARTED SMALL VEG FIRE AT BASE OF POLE. ALSO FOUND LEANING POLE THAT NEEDS TO BE STRAIGHTENED. WE MADE TEMP REPAIR ON JUMPER AND THE LINE TESTED GOOD. WE MADE 2 TAGS FOR CREW.
<b>HAWC Summary<sup>2</sup>:</b>	Units responded to an incident at 1847 ATASCADERO RD, MORRO BAY. Fire is being reported as forward progress stopped with a current size of .25 acre. OMT showing 2 outages (OIS# 2472837, 2472836) on the Morro Bay 1101 , 183011101 with 333 customers impacted, Non EPSS enabled. Clamp was arching and started a small vegetation fire at base of pole. Notifications have been made to: PSS HAWC Ops
<b>Injuries / Fatalities / Property Damage / Media Attention:</b>	No/No/No/No
<b>Weather Conditions<sup>3</sup>:</b>	At 1940 hours near the Incident Location: Temperature: 54.6°F Relative Humidity: 88% Wind Speed: 4.1 MPH from the north-northwest Wind Gust: 7.4 MPH

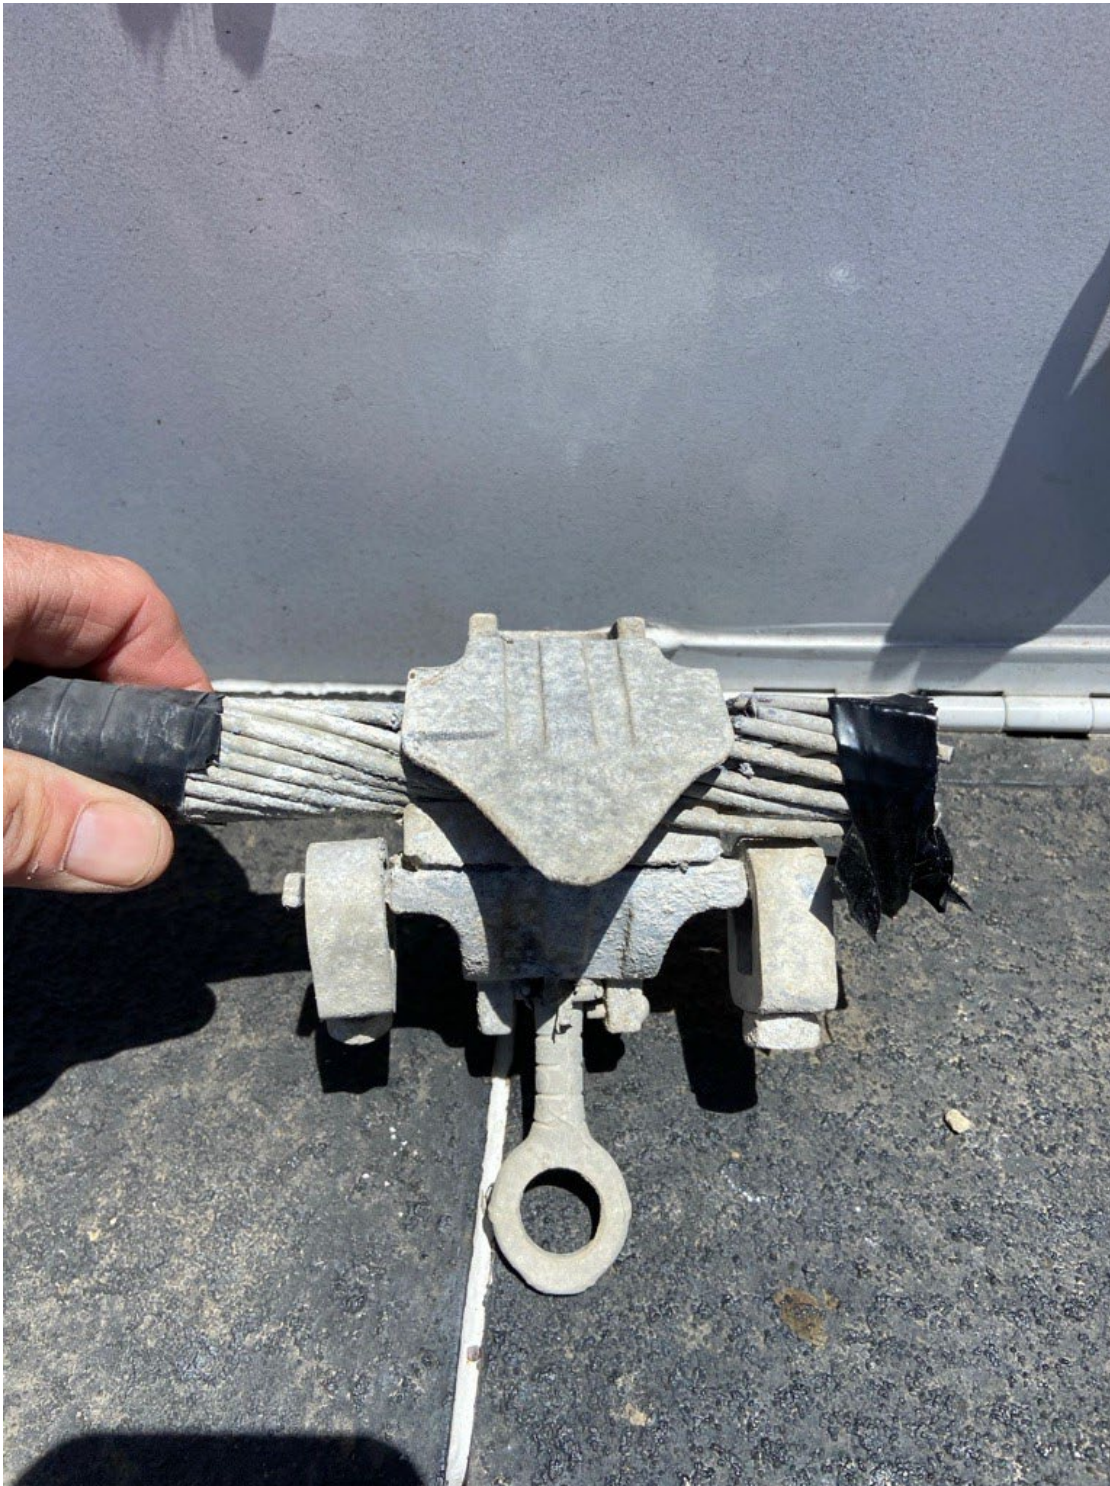
*Figure 4 Chance clamp that was removed, side one. Photo taken by troubleshooter on June 2, 2024.*

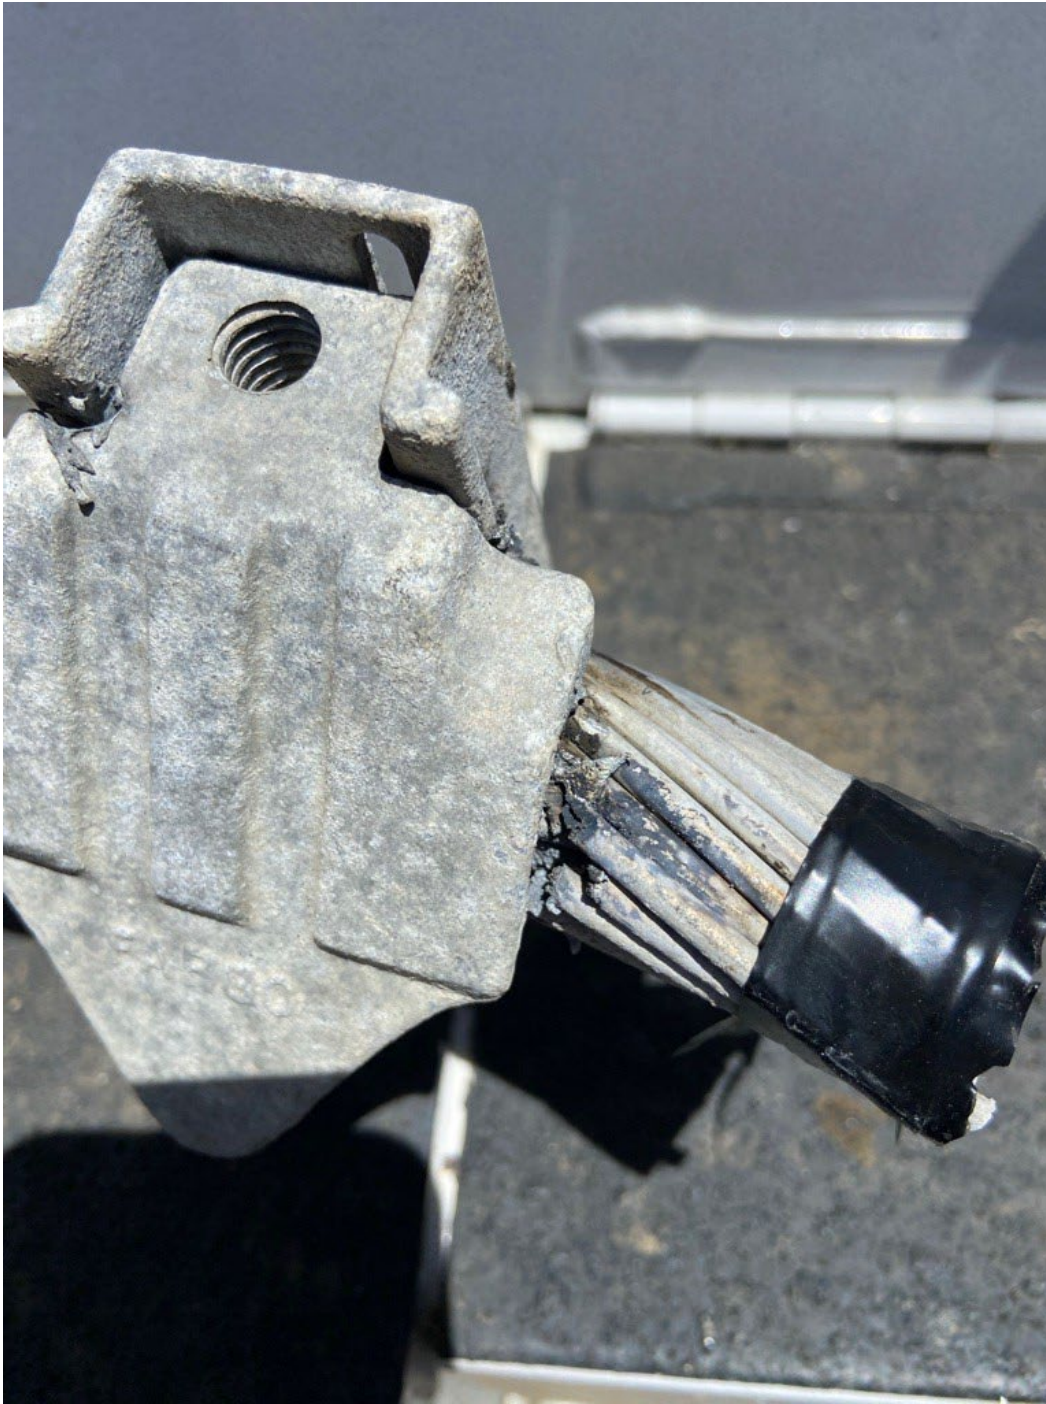
*Figure 5 Chance clamp that was removed, side two. Photo taken by troubleshooter on June 2, 2024.*

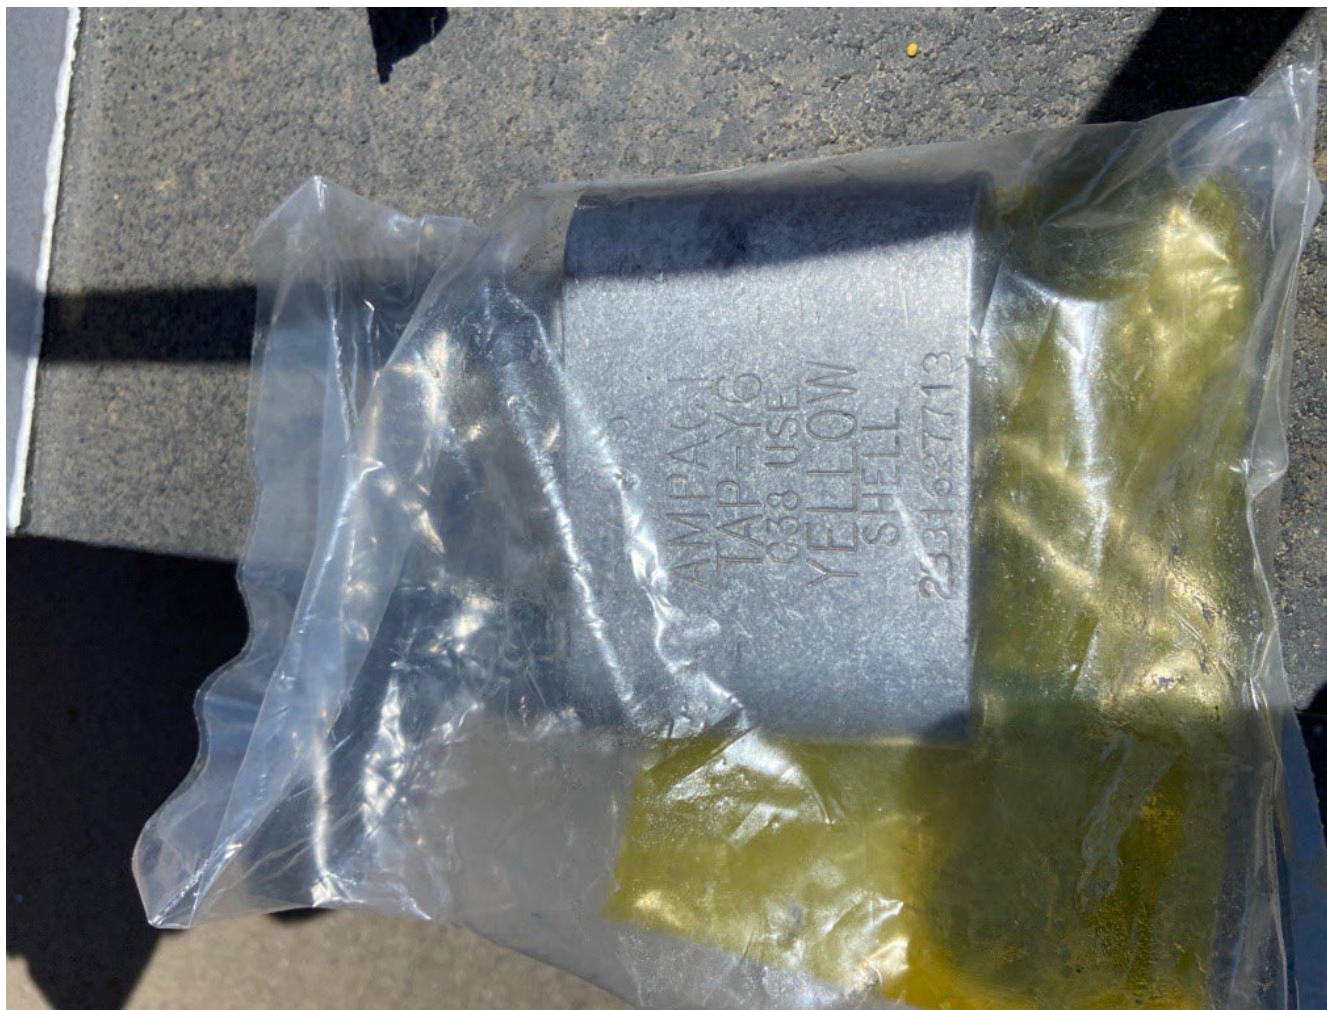
*Figure 6 Ampac connector that was installed by the crew the following day, June 2, 2024. Photo taken by troubleshooter on June 2, 2024.*

Troubleshooter #1 wrote EC priority ‘A’ Tag (#128966121) to replace the chance clamp with an ampac connector (See Figure 6). That tag was completed by a PG&E crew the following day, June 2, 2024, with the help of troubleshooter #1.

The troubleshooter wrote EC Priority 'A' Tag (#128966121) to replace burnt jumper connections (715 to 6 Cu) and to install an ampac (See Figure 6) connection. The tag was completed the following day, June 2, 2024, by a PG&E crew. The troubleshooter also created a second EC Priority 'A' Tag (#128966101) for a leaning pole on the

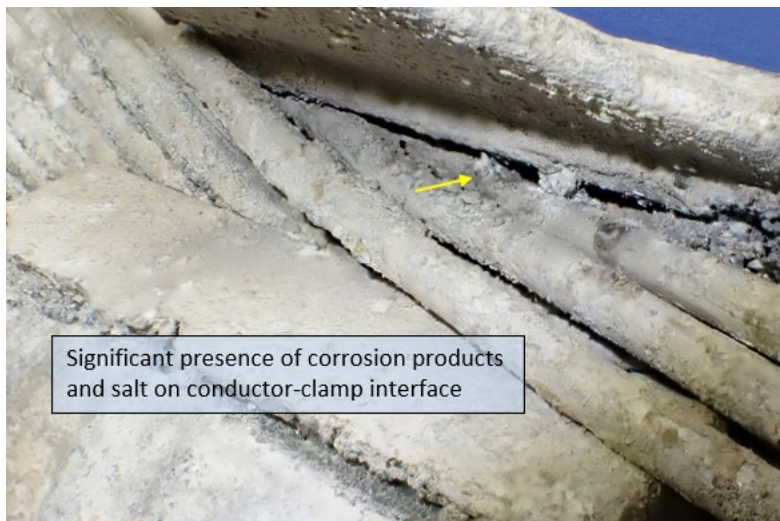
The failed chance clamp was collected and sent to Applied Technology Services (ATS) to be further analyzed. Visual inspection of the tap guard shows significant melting and loss of material at the conductor-clamp interface. There were signs of arc markings between the clamp and all-aluminum conductor (AAC) strands (patina looks new)(See Figures 7-8). There was evidence of previous arcing damage near the top of the chance clamp (bolt area) that appeared to be weathered and old (See Figure 9). The chance clamp and encased conductor shows substantial corrosion products and salt deposits (See Figure 7) that likely contaminated the electrical interface and caused the internal arcing. Prior to the failure, there was an outage reported due to an unknown three-phase fault downstream of the Incident Location. This fault could have likely accelerated the thermal damage to the corroded connector. It is noteworthy that the failed equipment was located in a ‘severe’ corrosion environment.

The incident was reviewed by an Asset Failure Analysis (AFA) engineer, who concluded an improperly installed arcing tap clamp/connector (poor workmanship) caused the ignition. There was evidence of lack of conductor preparation (not enough inhibitor), it was installed in a severe corrosion zone, and was located where the load exceeded four times greater than the limit (~20Amps) it was designed for. It was noted that tap clamps are not to be used in severe corrosion areas<sup>4</sup>.

*Figure 7 Significant presence of corrosion products and salt on conductor - clamp interface. Photo taken at ATS by analyzing engineer.*

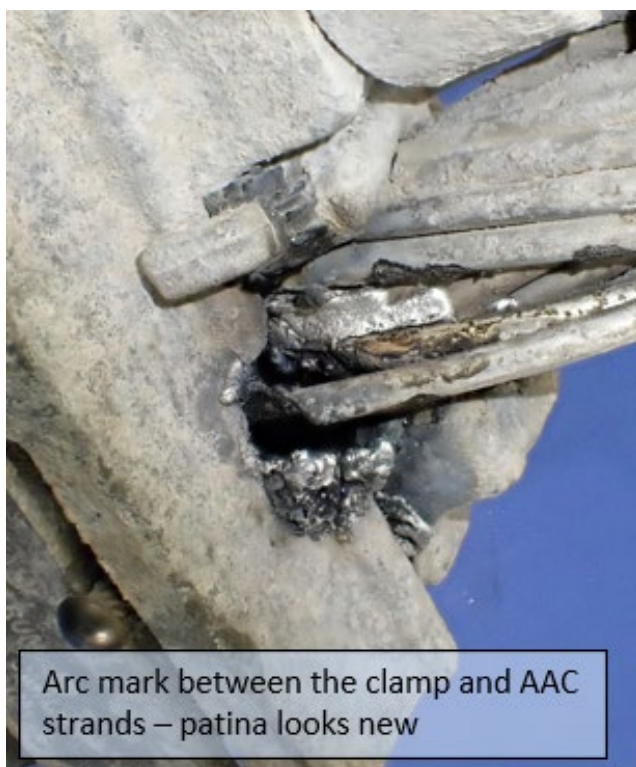
*Figure 8 Arc mark between the clamp and AAC strands - patina looks new. Photo taken at ATS by analyzing engineer.*

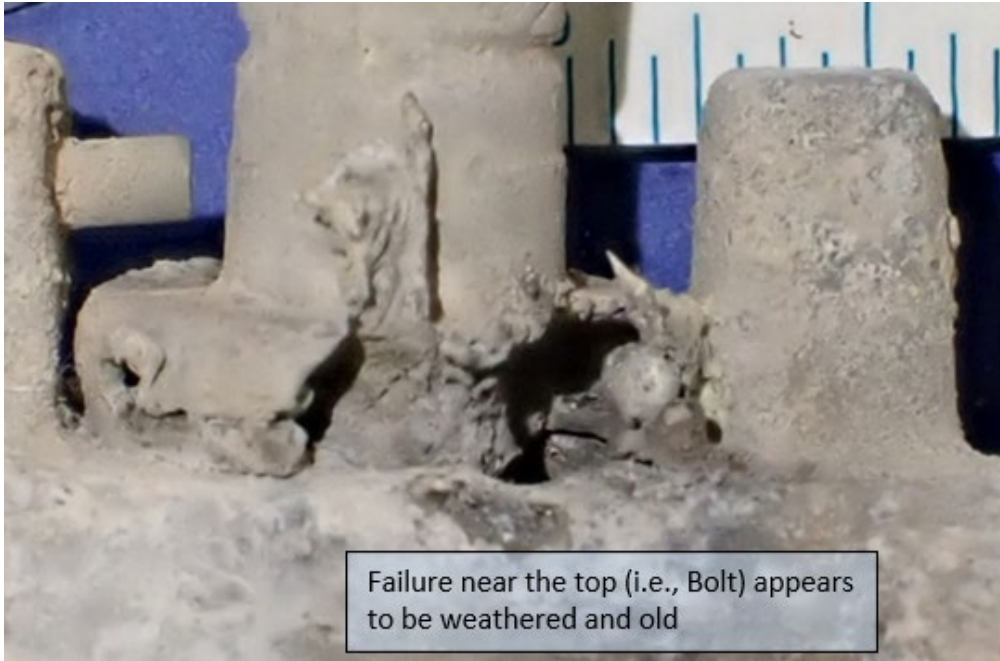
*Figure 9 Failure near the top (i.e. bolt) appears to be weathered and old. Photo taken at ATS by analyzing engineer.*

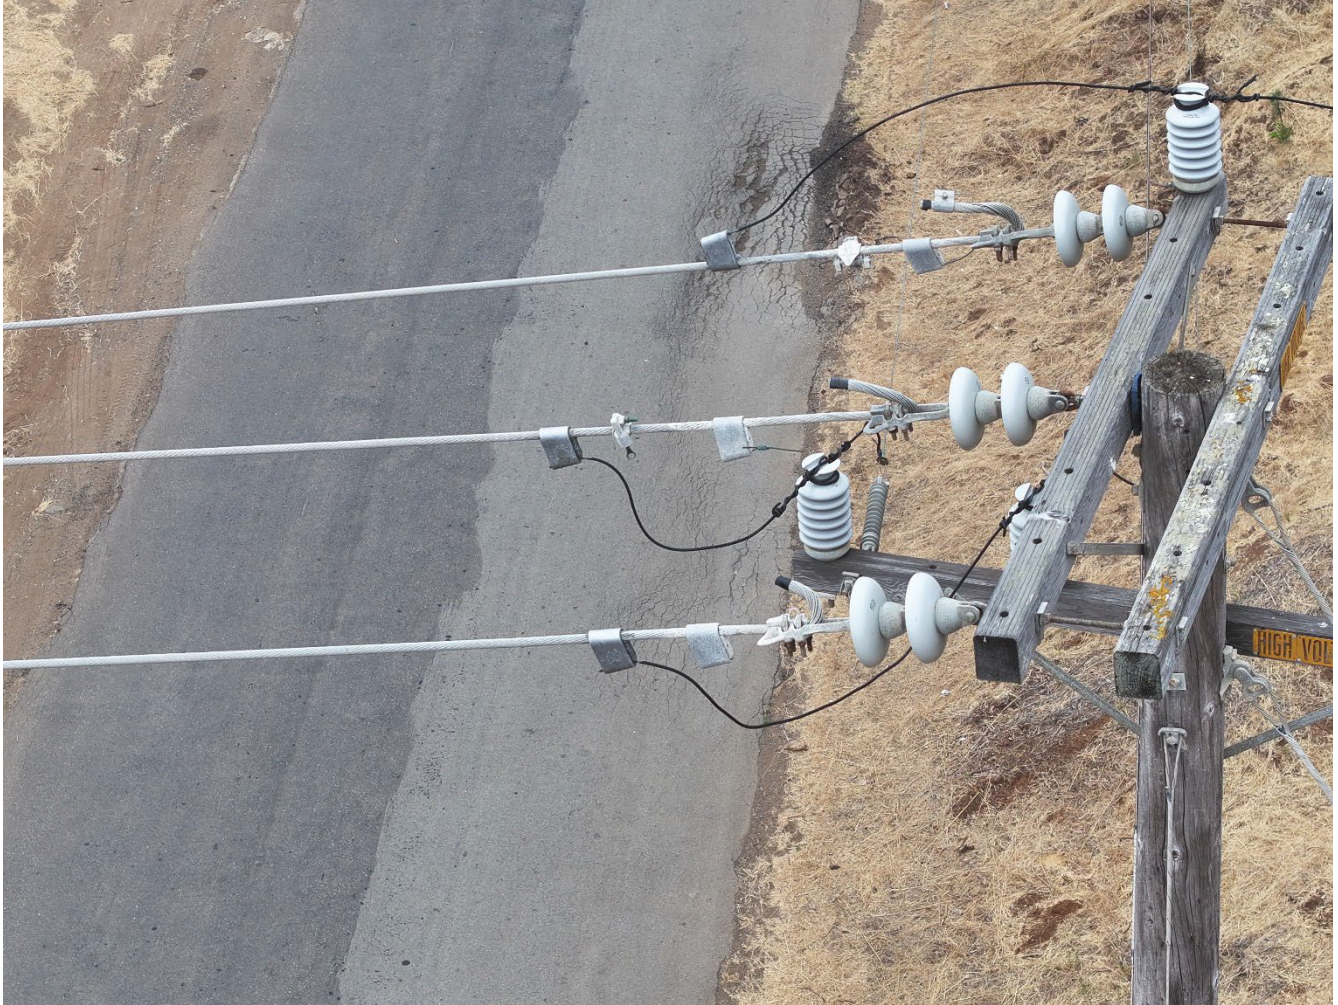
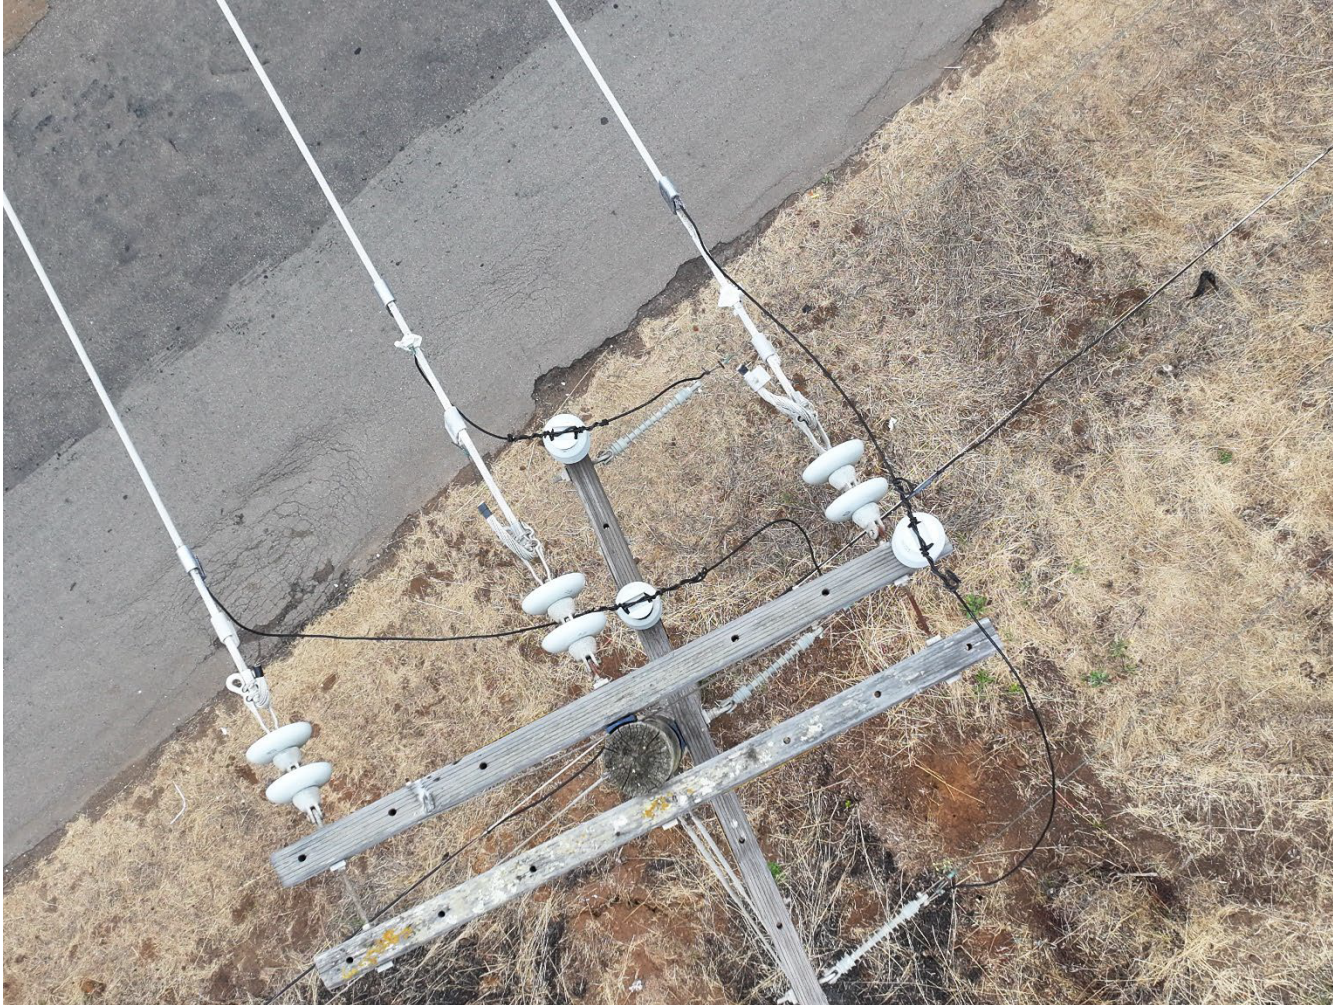
*Figure 10 Post-ignition/post-construction photos of Pole #1. Drone photo taken by Ignition Investigator on July 9, 2024.*

*Figure 11 Post-ignition/post-construction photo of Pole #1. Drone photo taken by Ignition Investigator on July 9, 2024.*
