Preliminary Ignition Investigation Report

Ignition Database Index:	20230613
Electric Incident Investigation (EII) Number:	N/A
Incident Name:	N/A
PG&E Facility Ignition?	Yes
CPUC Reportable Ignition?	Yes
Date & Time of Incident:	June 30, 2023, at approximately 1441 hours
Street Address:	Encinal Place and Valle Vista
City:	Pittsburg
County:	Contra Costa
Latitude/Longitude:	37.994617436308, - 121.899106865404
State Responsibility Area (SRA) / Local Responsibility Area (LRA) / Federal Responsibility Area (FRA)	Local Responsibility Area
PG&E Division:	Diablo
High Fire Threat District (HFTD):	No
High Fire Risk Area (HFRA):	No
EPSS Buffer:	No
Fire Index Area (FIA):	N/A
Fire Potential Index (FPI) Rating: FIA	N/A
Fire Potential Index (FPI) Rating: Circuit	R4
Was there a PSPS event at the time of ignition?	No
Suspected Initiating Event:	Equipment – PG&E
Failure Driver:	All types of equipment / facility failure
Failure Sub-driver:	Transformer failure
Circuit:	Kirker 2104

Executive Summary

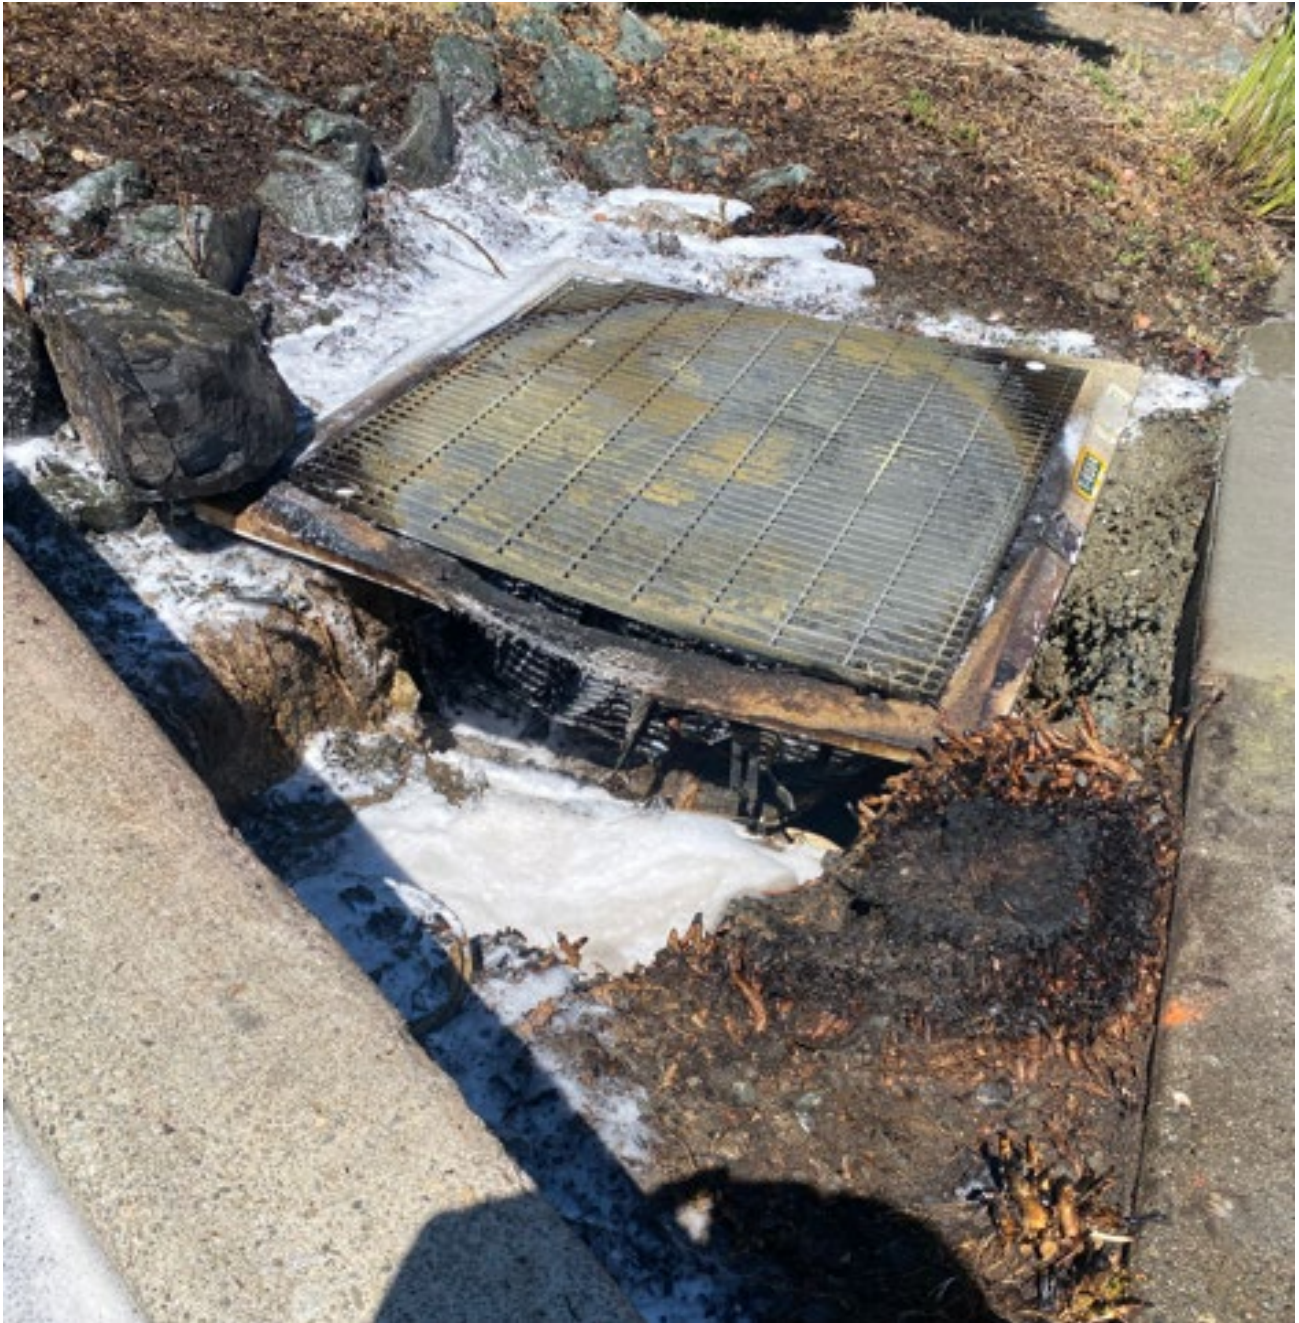
An underground transformer connection failed causing a flashover and flame to come out of the underground vault. The Contra Costa Fire Department responded to the incident and supported suppression efforts to the incident. The subsequent fire finalized at under three meters in size and caused damage to the utility enclosure as well as charring on the landscaping near the utility enclosure.

Photo 3 – Post incident photo taken by troubleshooter.

After the failure, the responding troubleshooter created an emergency “A” tag to replace the transformer along with the primary and secondary enclosure. Repair of the primary and secondary cable was also required due to the cable melting during the incident. A PG&E repair crew was onsite and removed the damaged 75kVA transformer and installed a new 100kVA transformer on July 1, 2023.

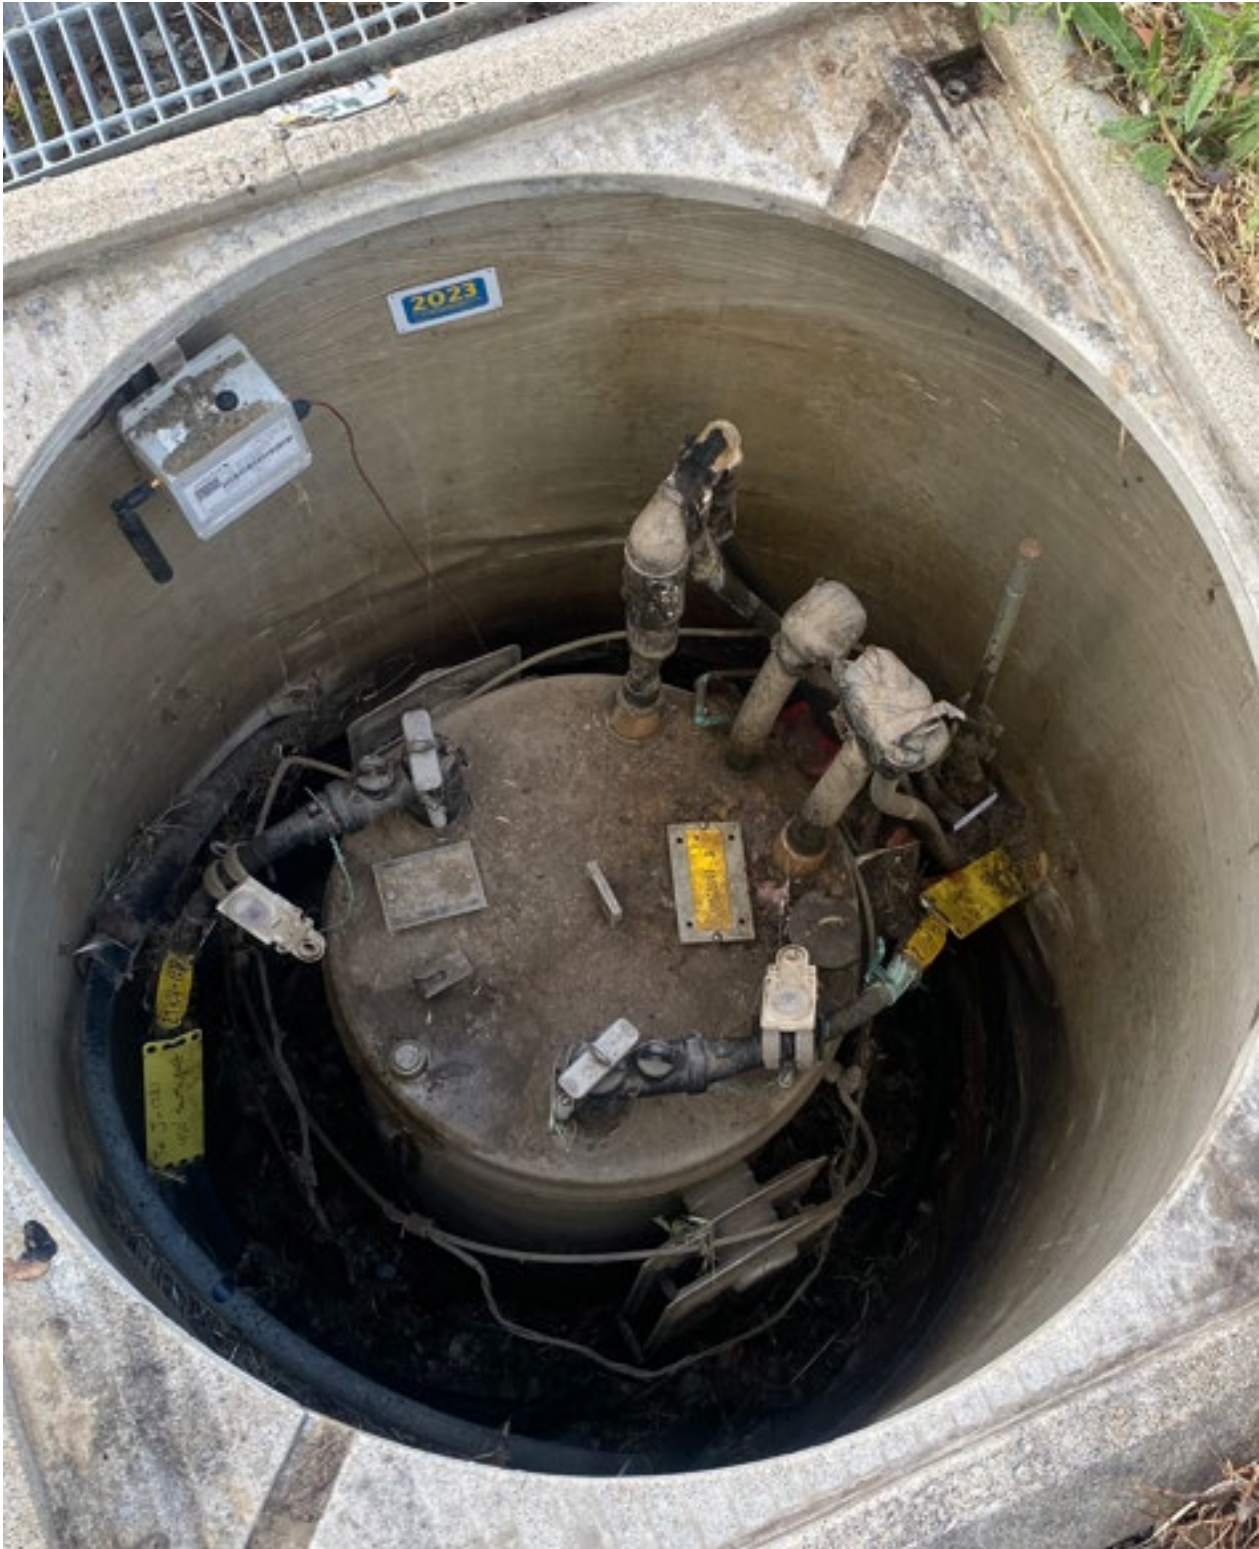
This transformer was inspected 21 days prior to this incident occurring. The inspector noted the secondary SweetHeart™ connectors were, “bad, burning” and the top cap was, “broken and difficult to secure.” The inspection results prompted the creation of a “B” Tag, however the 90-day period a “B” tag holds were not sufficient to eliminate this facility from failing.

Photo 4 – June 9, 2023, inspection photo showing full view of facilities in enclosure.

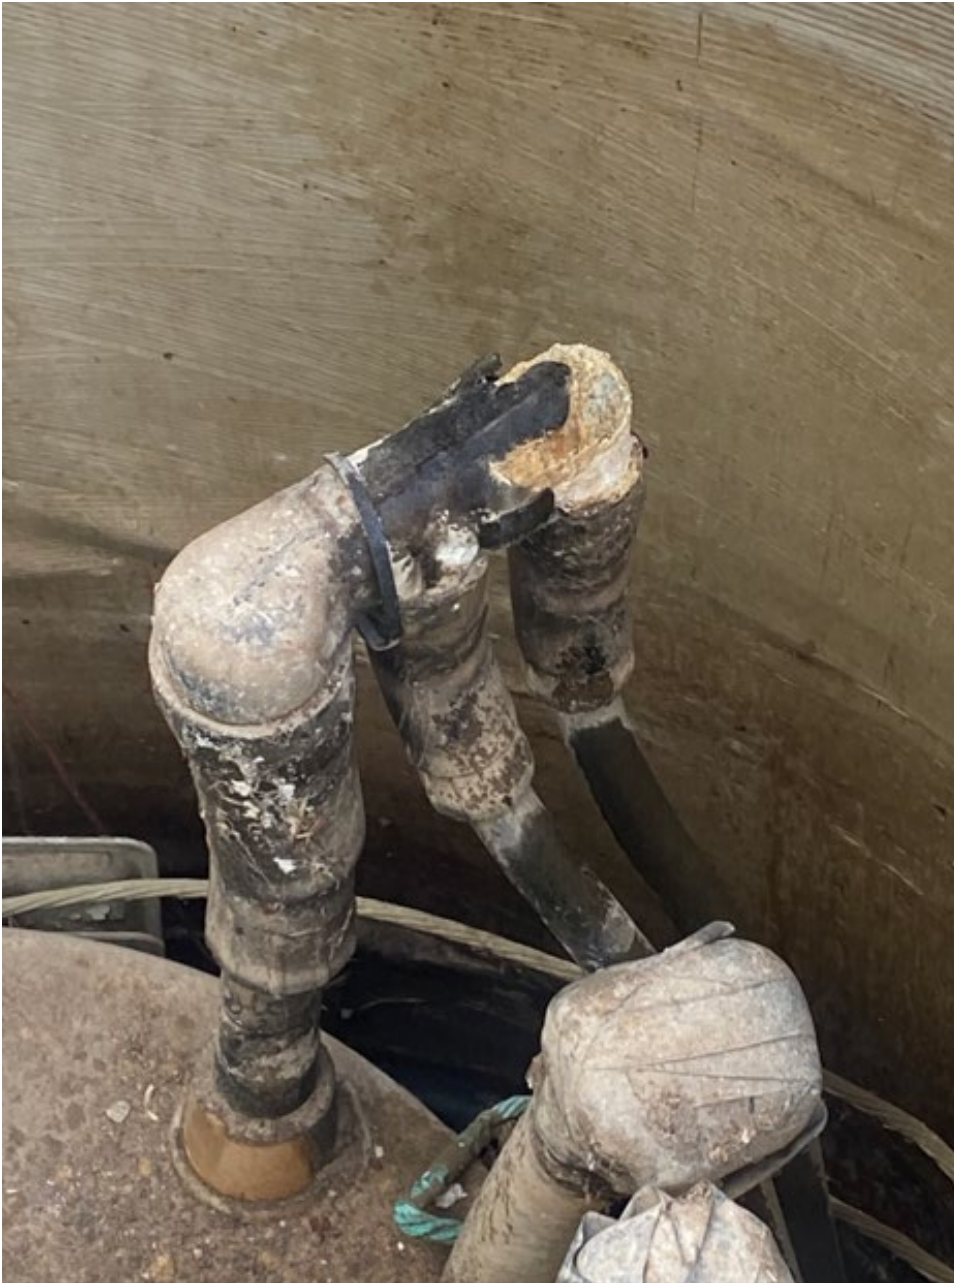
Info / Inspection	Most Recent Date	Findings
Install Date:	N/A	
Inspection:	06/09/2023	Secondary sweethearts going bad/burning. Top cap broken difficult to secure, replacement warranted
Patrol:	N/A	
Corrective History:	05/28/2020	Fault indicator damaged/broken

Photo 4 – June 9, 2023, inspection photo showing damage.
