## Preliminary Ignition Investigation Report

<b>Ignition Database Index:</b>	20230862
<b>Electric Incident Investigation (EII) Number:</b>	N/A
<b>Incident Name:</b>	N/A
<b>PG&amp;E Facility Ignition?</b>	Yes
<b>CPUC Reportable Ignition?</b>	Yes
<b>Date &amp; Time of Incident:</b>	August 8, 2023 at 1412 hours
<b>Street Address:</b>	8714 Terrace Drive
<b>City:</b>	El Cerrito
<b>County:</b>	Contra Costa
<b>Latitude/Longitude:</b>	37.919709, -122.285107
<b>State Responsibility Area (SRA) / Local Responsibility Area (LRA) / Federal Responsibility Area (FRA)</b>	Local Responsibility Area (LRA)
<b>PG&amp;E Division:</b>	Diablo
<b>High Fire Threat District (HFTD):</b>	Tier 2
<b>High Fire Risk Area (HFRA):</b>	No
<b>EPSS Buffer:</b>	Yes
<b>Fire Index Area (FIA):</b>	530
<b>Fire Potential Index (FPI) Rating: FIA</b>	R3
<b>Fire Potential Index (FPI) Rating: Circuit</b>	R1
<b>Was there a PSPS event at the time of ignition?</b>	No
<b>Suspected Initiating Event:</b>	Equipment – PG&E

<b>Failure Driver:</b>	All types of equipment / facility failure
<b>Failure Sub-driver:</b>	Splice/Clamp/Connector
<b>Circuit:</b>	EL CERRITO G 1105
<b>Circuit Protection Zone:</b>	EL CERRITO G 1105CB
<b>Nominal Vo

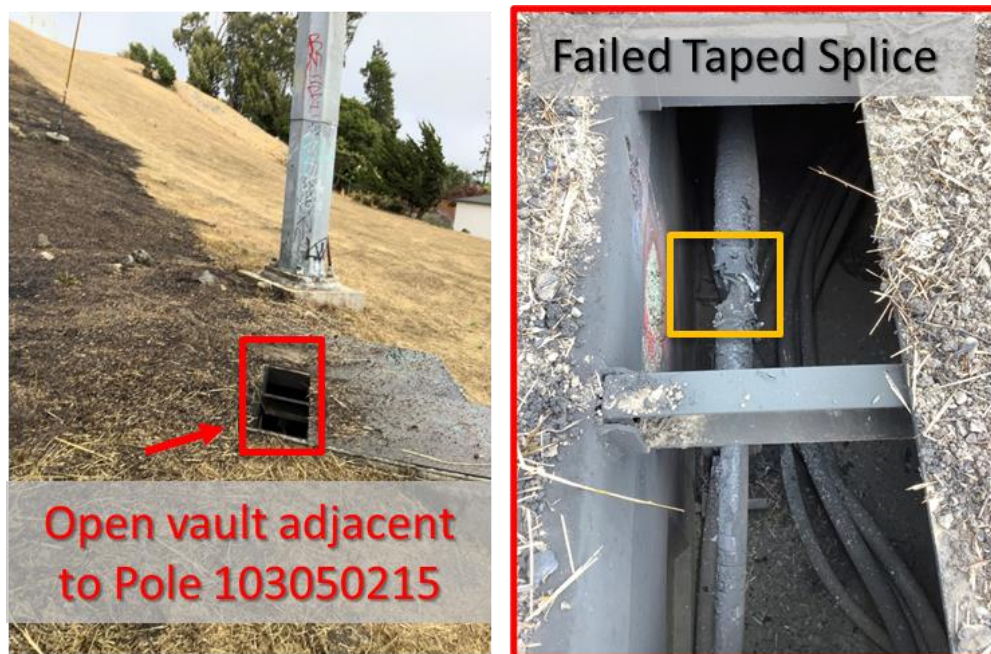
Upon arrival at the Incident Location at approximately 1455 hours, Troubleshooter 1 observed firefighters on scene who had extinguished the fire around an unmapped underground splice box. Troubleshooter 2 arrived on scene at approximately 1511 hours and the troubleshooters opened the splice box and observed a blown tape splice and a broken distribution pothead riser on pole SAP ID 103050215 on the source side of the splice (see Figure 2). The troubleshooters observed that the other two splices in the splice box are of newer vintage than the failed splice which they suspected were replaced at some point. The protective device that tripped (CB 1105/12) did not show abnormally high loading within a week before the incident. Based on the device history, CB 1105/12 had two vegetation-related outages in 2023 (ILIS #23-0006485 on January 4, 2023 and ILIS #23-0045685 on March 14, 2023).

Figure 2. Incident splice box and splice (taken 8/8/2023).

Troubleshooter 2 created EC Notification Tag #126777072 on August 8, 2023 to replace the broken riser at pole SAP ID 103050215 and replace the damaged splice in the splice box. This repair was completed on August 10, 2023.

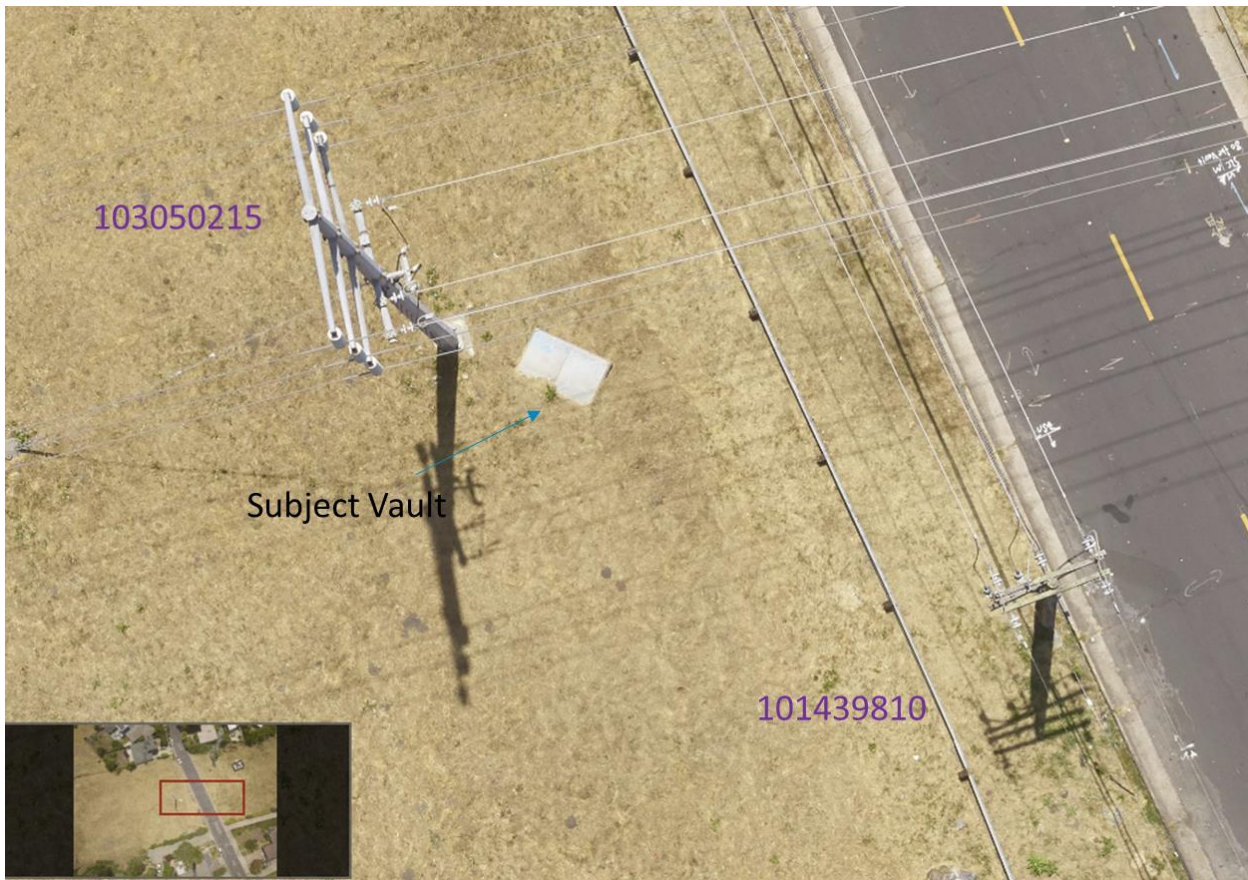
Figure 4. SharperShape Aerial Inspection imagery from 2018 showing splice box.

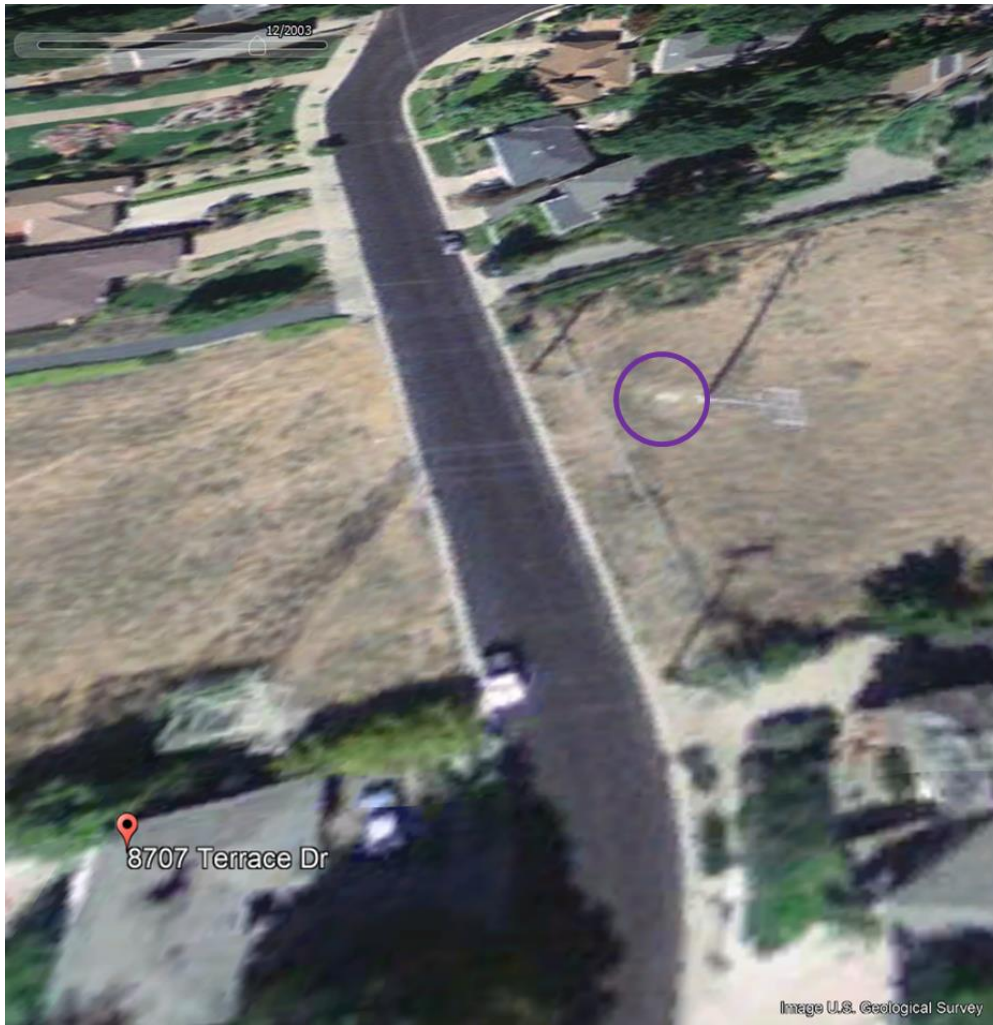
Figure 5. Google Maps satellite imagery dated December 2003 showing splice box.

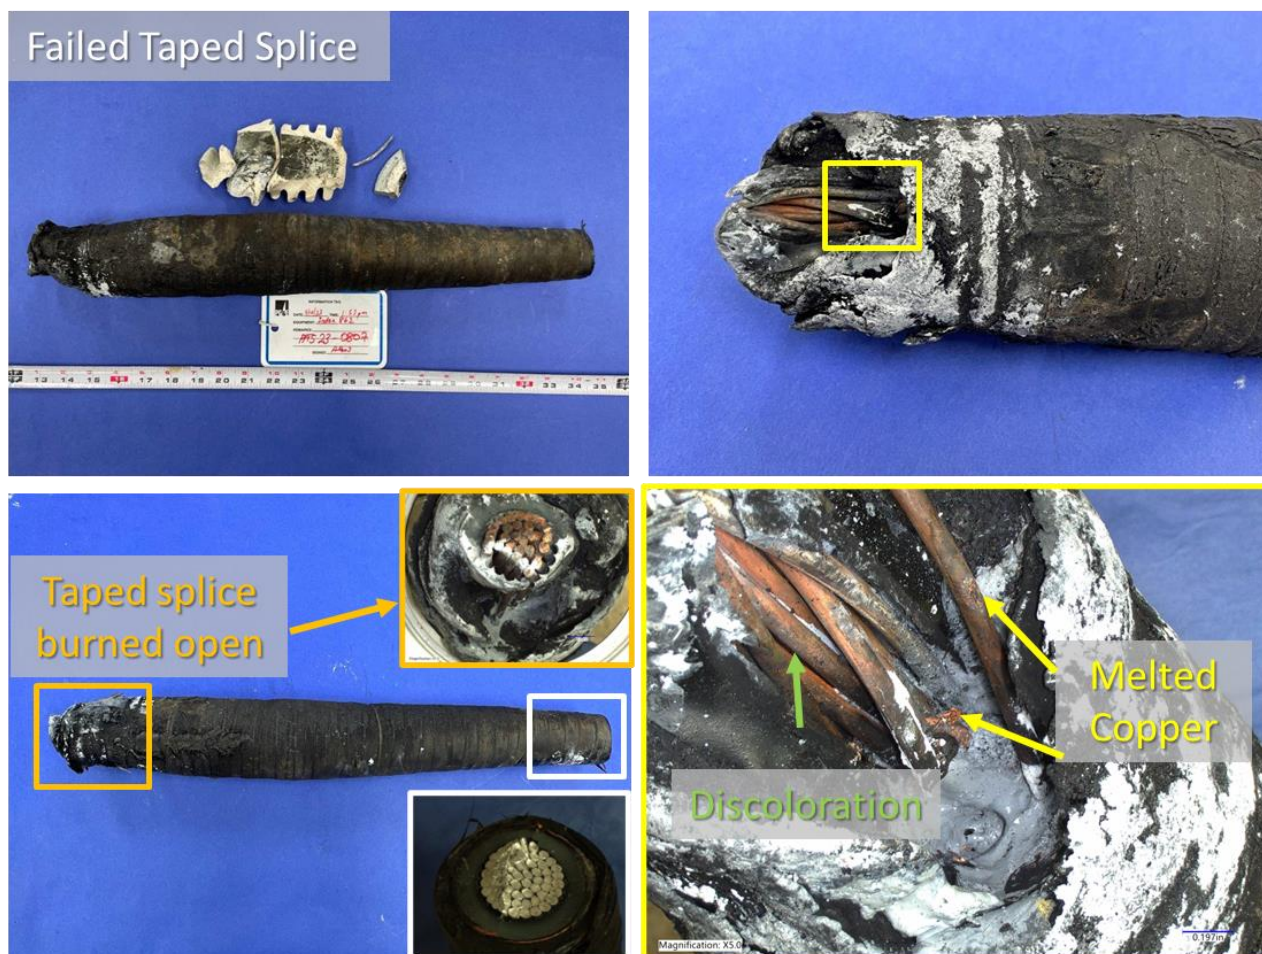
Advanced Technology Services (ATS) conducted an initial visual examination to document the failed component. ATS noted that the ignition appeared to be the result of an underground splice failure and observed melted copper at the splice failure location as well as discoloration of copper strands. This dissimilar metal splice is the junction of copper/aluminum conductors (see Figure 7). Additionally, ATS performed radiography imaging and dissected the splice to evaluate the internal condition. The failed splice appeared to be attributed to moisture ingress through the tape, causing corrosion within the splice. There were corrosion products observed on the splice and copper end of the connector. The increased resistance from the corrosion products led to localized arcing near the copper end, as confirmed by x-ray (see FiguresFigure 8 andFigure 9).

Figure 7. ATS as-received photos of incident splice.

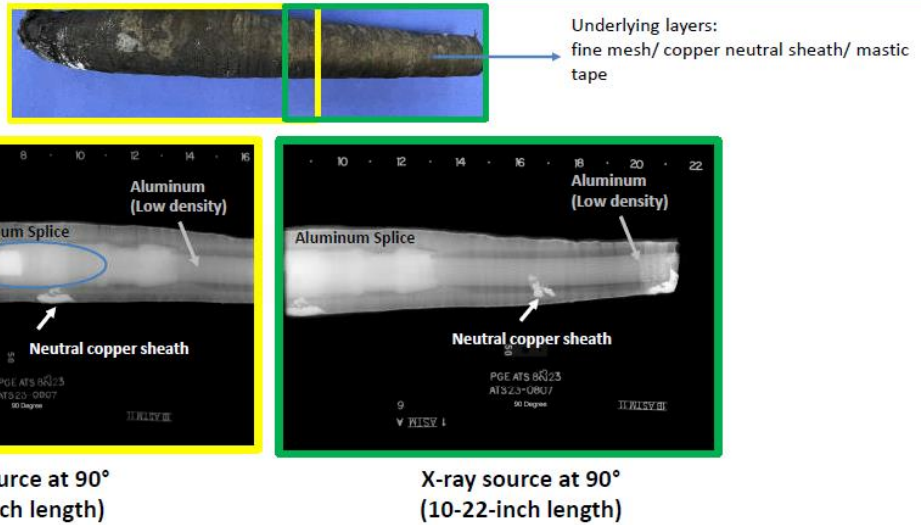
**Non-Intrusive Radiography:** 2D X-Ray was performed on the subject splice

Figure 8. ATS non-intrusive radiography of splice.

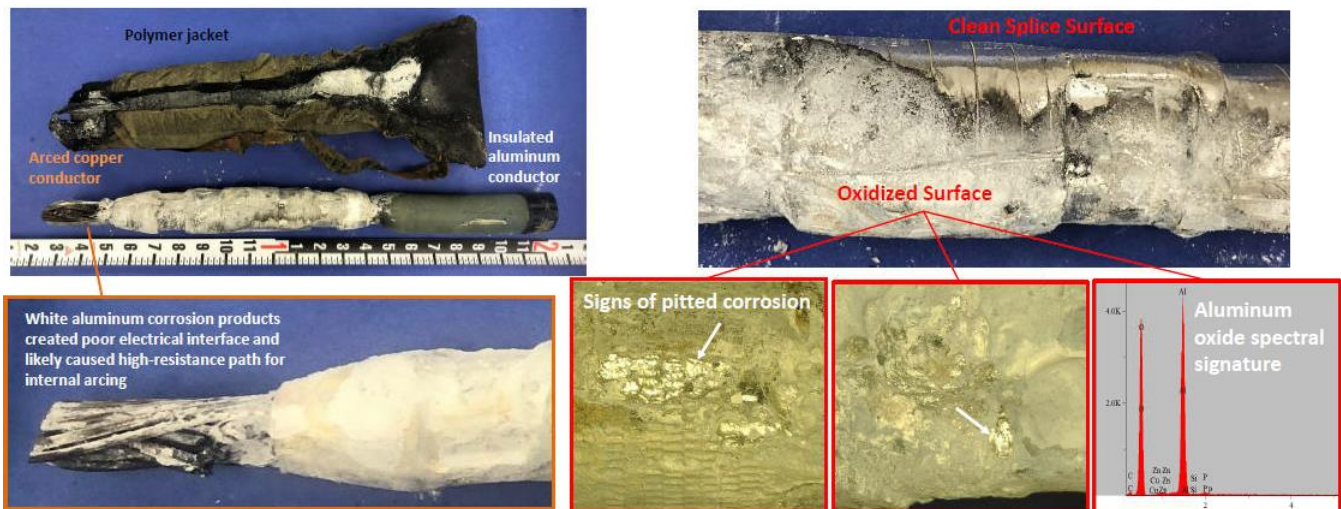
**Destructive Inspection:** The polymer jacket around the splice was sectioned longitudinally to get visual access to the splice.

The surface of the splice after sectioning revealed a thick layer of white corrosion biproduct that was covering the aluminum splice and copper conductor.

Figure 9. ATS destructive inspection of failed splice.
