This job aid provides the steps for consistent evaluation of overhead ground wire/fiber optic (OPGW) cable in transmission lines, and consistent decision-making.

# Evaluating Conditions of OPGW in Transmission Line

TD-1001M-JA11  
Publication Date: 08/03/2023  
Effective Date: 10/03/2023  
Rev: 4

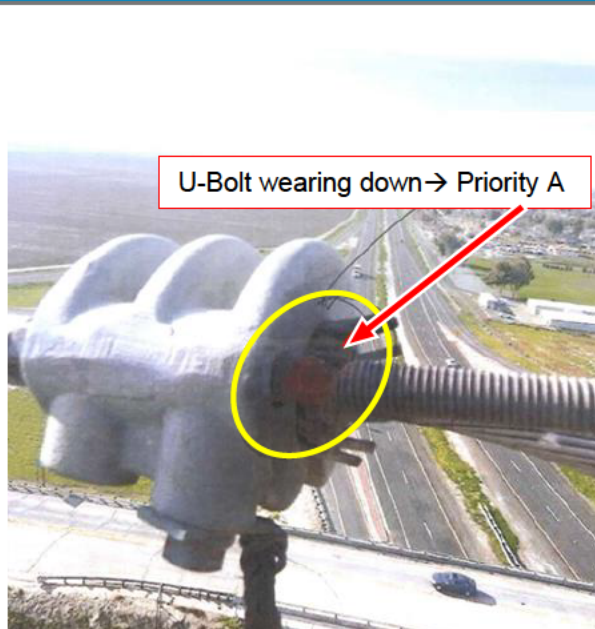
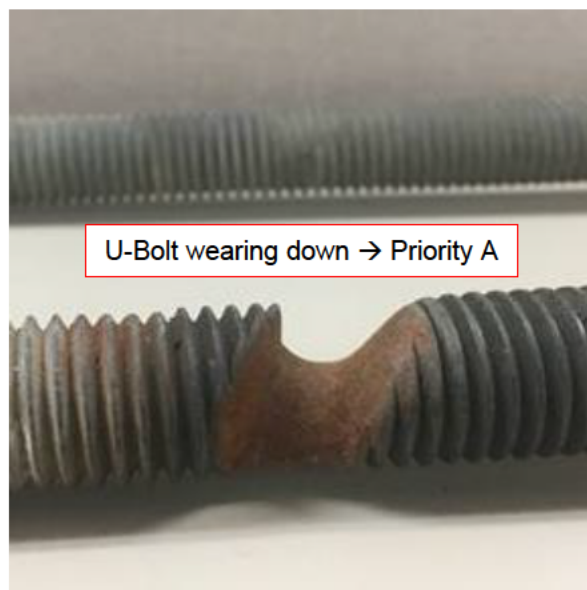
### Condition 5

**More than 50% material loss**, due to non-standard ground wire installation, with an **immediate** safety concern OR potential to impact operations.

1. Initiate SAP Notification; Priority Code A.
2. T-Line to make the situation safe by replacing hardware or by installing safety snubs or some alternative method.
  - IF the situation cannot be made safe and cable removal is the only option, THEN contact IT immediately, so that IT can notify the appropriate lines of business and 3rd party customers of the emergency outage.
3. Notify IT by calling the ENOC at [REDACTED].
  - Document the date, time, and the name of the person at the ENOC who took the call.
  - Capture this information in the Comments field of the SAP Notification.
3. Take close-up photos of the condition found.

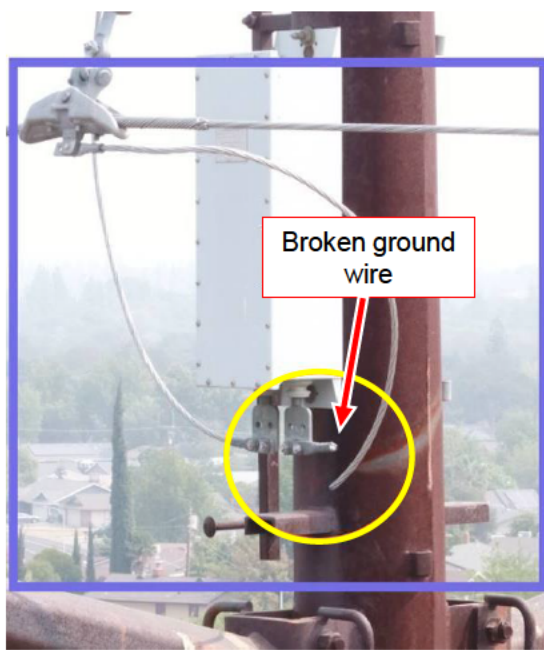
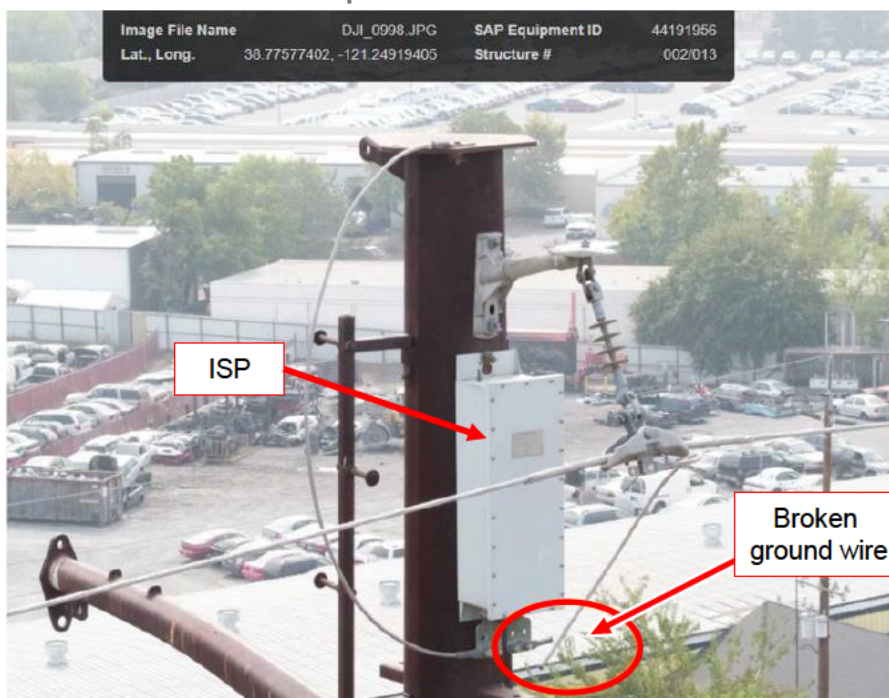
#### Broken ground wire to Isolator Surge Protector (ISP) with an immediate public safety concern.

The purpose of this scheme, is to prevent interference with the adjacent Union Pacific Railroad crossing arms. During a fault condition, the crossing arms could malfunction, if **either**:

1. The ground wire from the OPGW hardware to the ISP is broken, OR
2. The ground wire from the ISP to the structure is broken.

1. Initiate SAP Notification; Priority Code A.
2. Notify IT by calling the ENOC at [REDACTED].
  - Document the date, time, and the name of the person at the ENOC who took the call.
  - Capture this information in the Comments field of the SAP Notification.
3. Take close-up photos of the condition found.

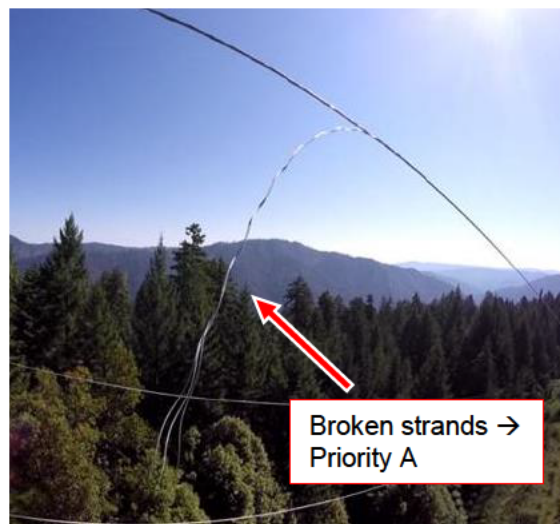
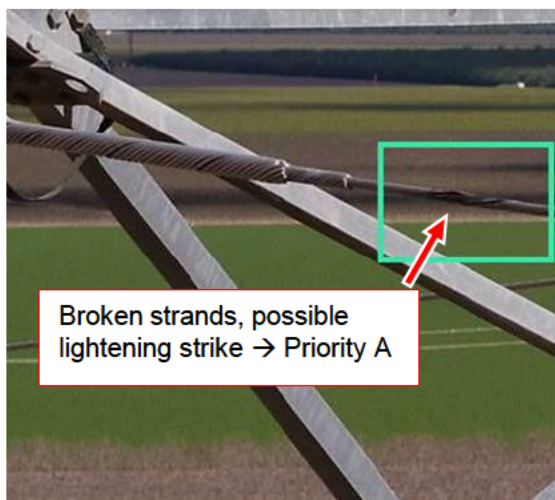
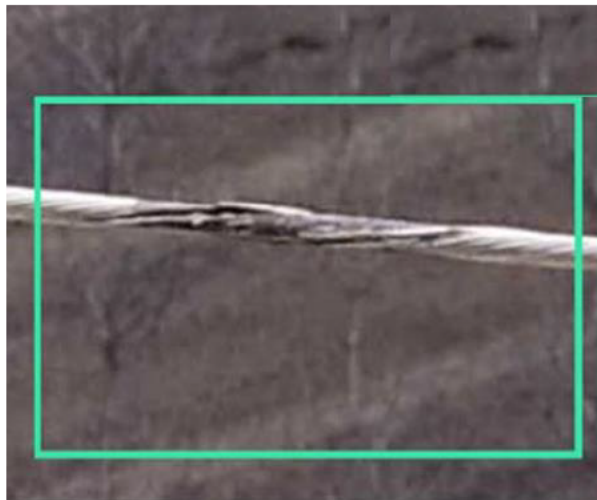
### Broken Strands (in the span/tension side)

Repair rods can restore the OPGW cable back to full rated breaking strength, if **three or fewer** strands are broken. If more than three strands are broken, repair rods provide **some** structural integrity back to the OPGW cable. For both scenarios, install repair rods.

Repair rods can be used to repair broken strands under the following conditions:

1. The loose strands can be wrapped back into place.

2. The damaged strands are within 8 inches of each other.

THEN install U-bolt or preform dead-ends out past damaged area, as a safety snub to make safe.

1. Initiate SAP Notification; Priority Code A.
2. T-Line crew to identify and document how many OPGW strands are broken. Report back to IT.
3. Take close-up photos of the damaged area.

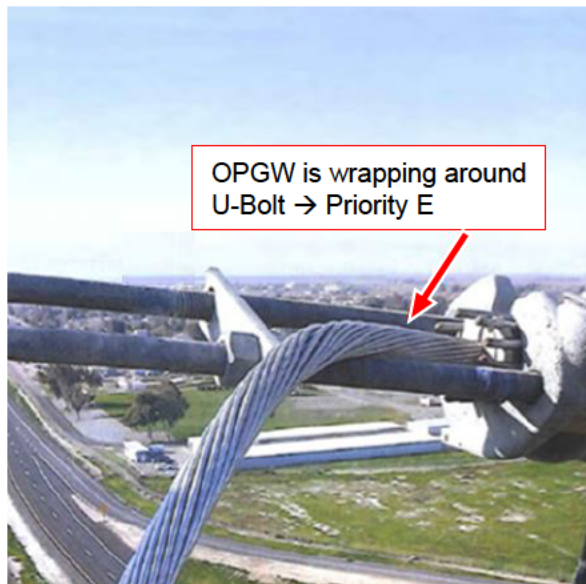
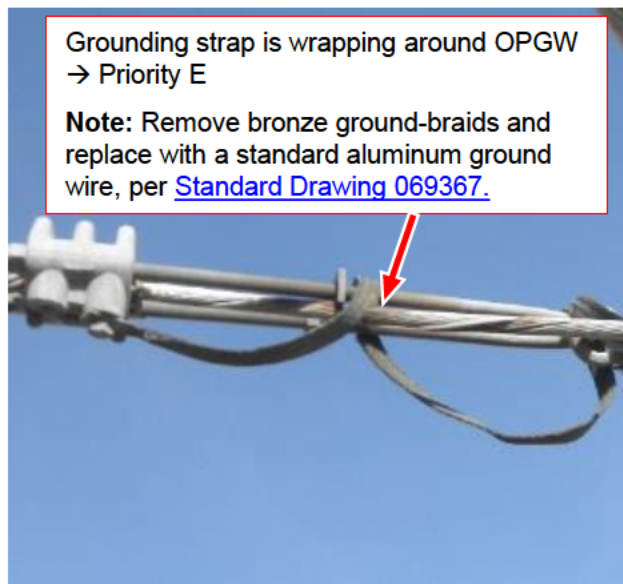
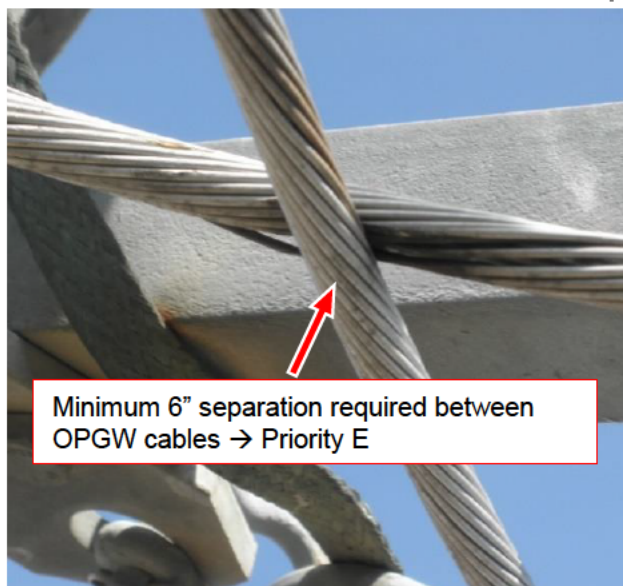
**External contact on the OPGW.**

1. Initiate SAP Notification; Priority Code E.
2. Fix not to exceed 3 months.
3. Take close-up photos of the condition found.

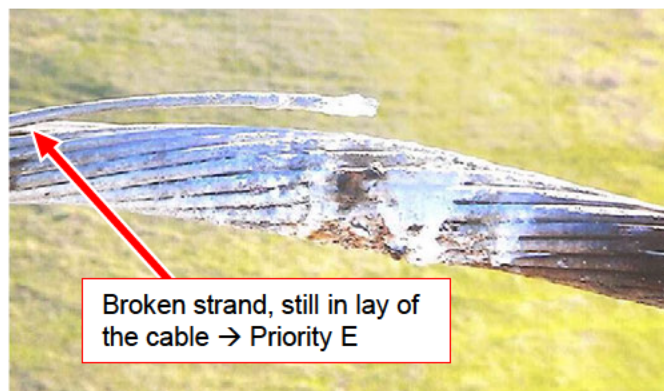
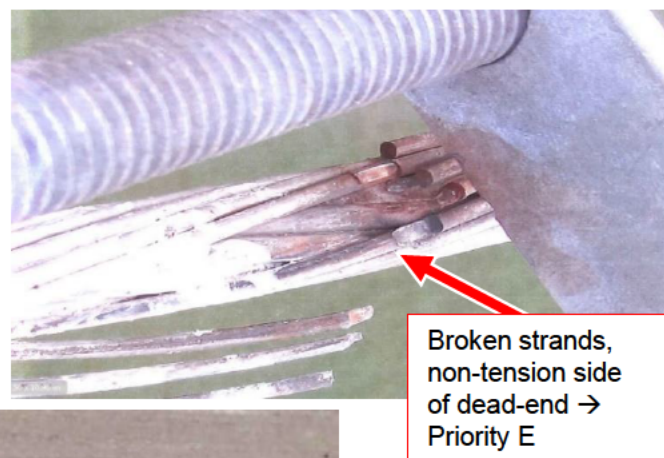
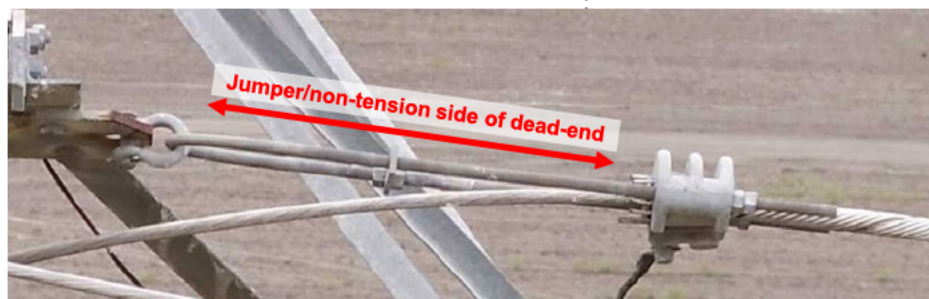
**Broken OPGW strands, not an emergency condition.**

Since the damage is between the dead-end and the structure, there is no threat of the OPGW cable falling to the ground, if it were to fail. Install repair rods.

If three or fewer strands are broken out on the span, but they have not unraveled out of their lay position on the cable, then this is not an immediate threat to drop into the conductors below. Install repair rods.

1. Initiate SAP Notification; Priority Code E.
2. Fix not to exceed 3 months.
3. T-Line crew to document how many OPGW strands are broken and if the steel tube containing the fiber strands has been damaged. Report back to IT.
4. Take close-up photos of the condition found.

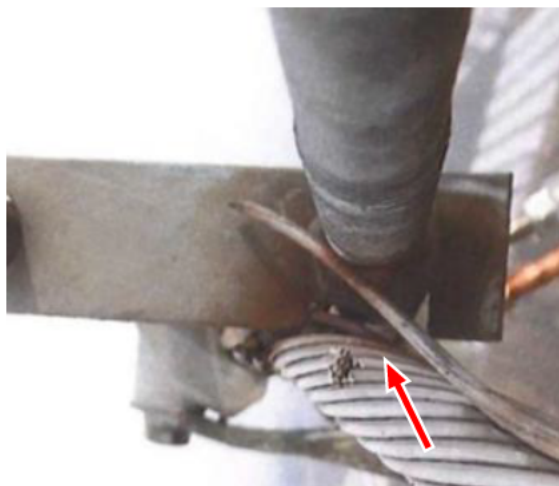
Spacer bar is cutting into OPGW → Priority E

1. Initiate SAP Notification; choose Priority Code E.
2. Fix not to exceed 3 months.
3. Take close-up photos of the condition found.

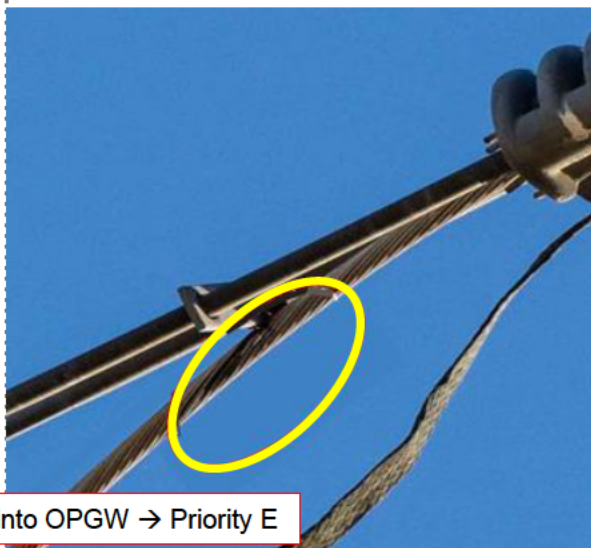
Spacer bar is out-of-position, contacting OPGW → Priority E

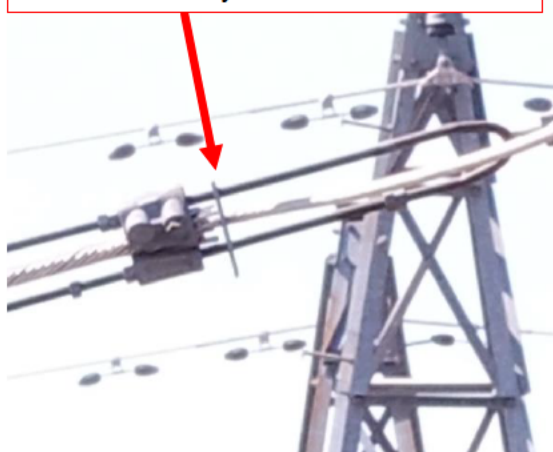
Loose spacer bar → Priority E

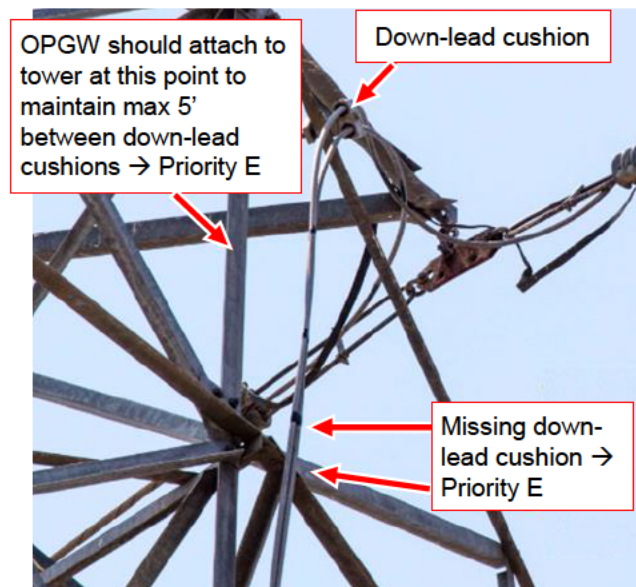
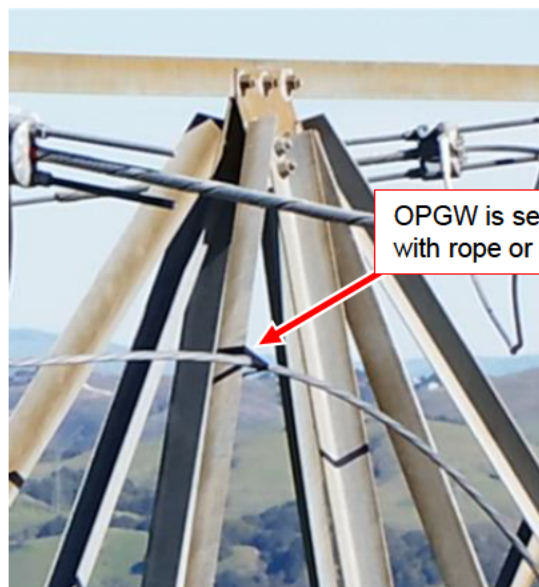
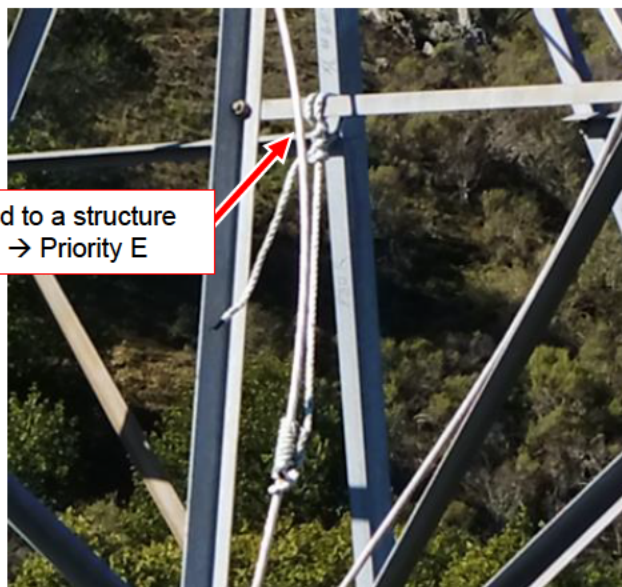
#### Missing down-lead cushion.

OPGW is improperly secured to a structure.

1. Initiate SAP Notification; Priority Code E.
2. Fix not to exceed 3 months.
3. Take close-up photos of the condition found.

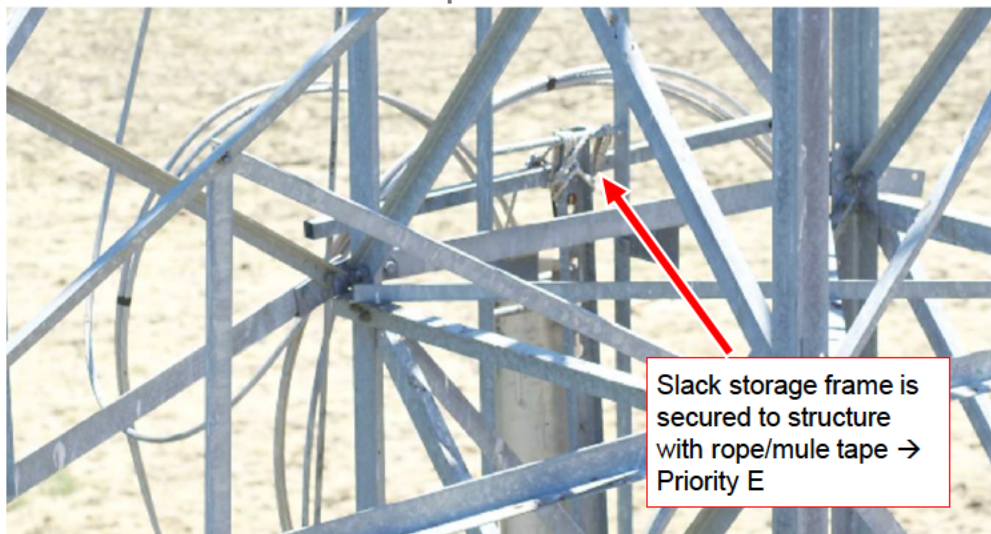
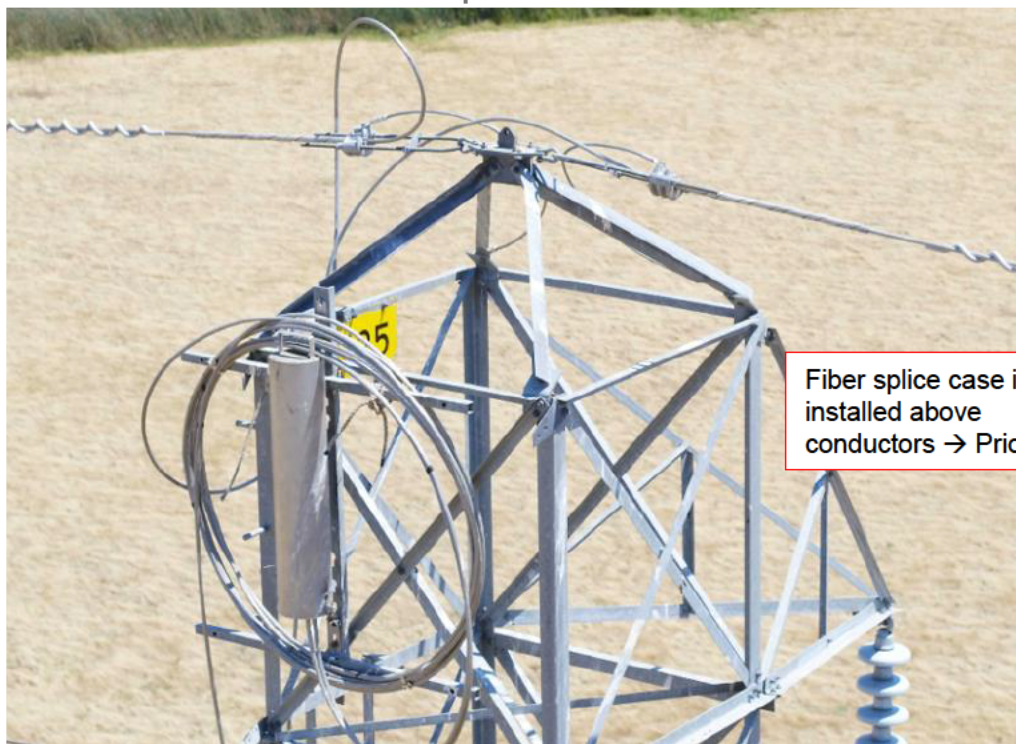
Splice case is installed **above** electric conductors.

Slack storage frame is **improperly** secured to a structure.

1. Initiate SAP Notification; Priority Code E
2. Fix not to exceed 3 months.
3. Take close-up photos of the condition found.

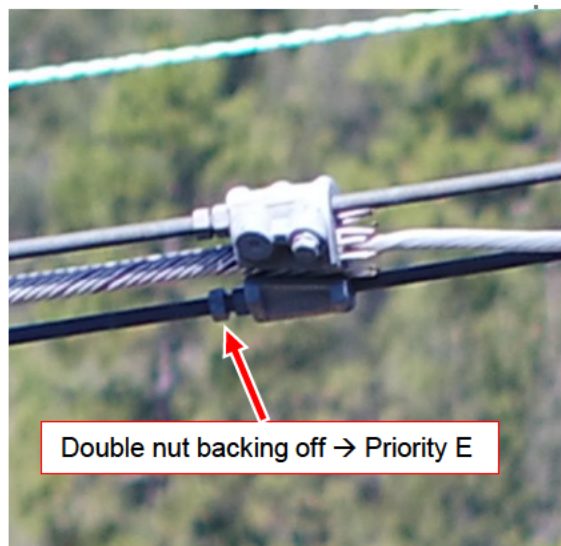
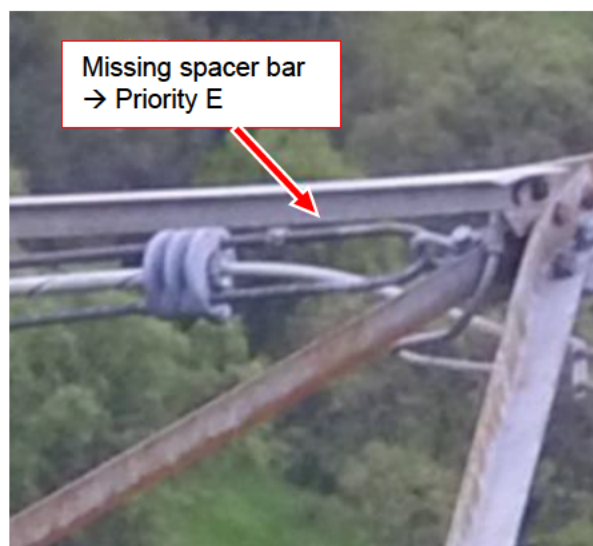
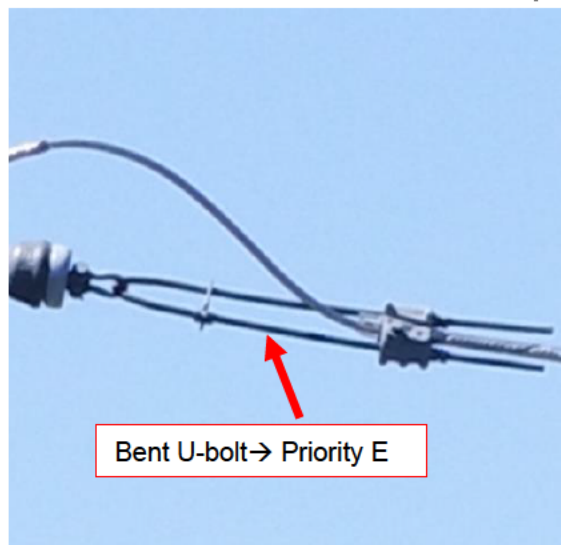
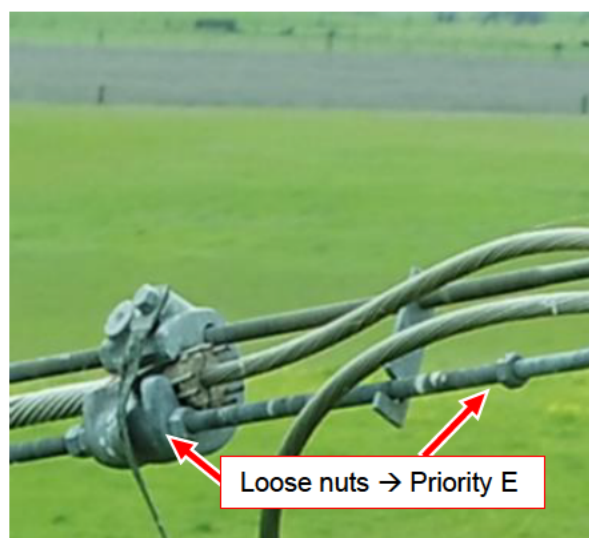
- Double nut backing off, loose nuts.
- Missing/out-of-position spacer bar.
- Bent U-bolt.

1. Initiate SAP Notification; choose Priority Code E.
2. Fix not to exceed 12 months.
3. Take close-up photos of the condition found.

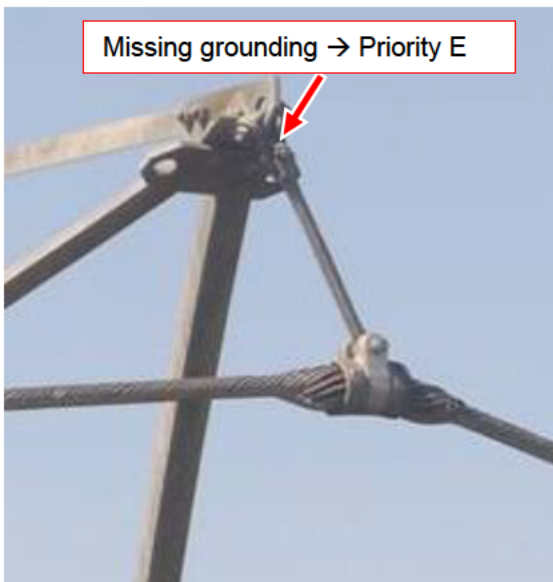
Missing grounding → Priority E

1. Initiate SAP Notification; Priority Code E.
2. Fix not to exceed 12 months.
3. Take close-up photos of the condition found.

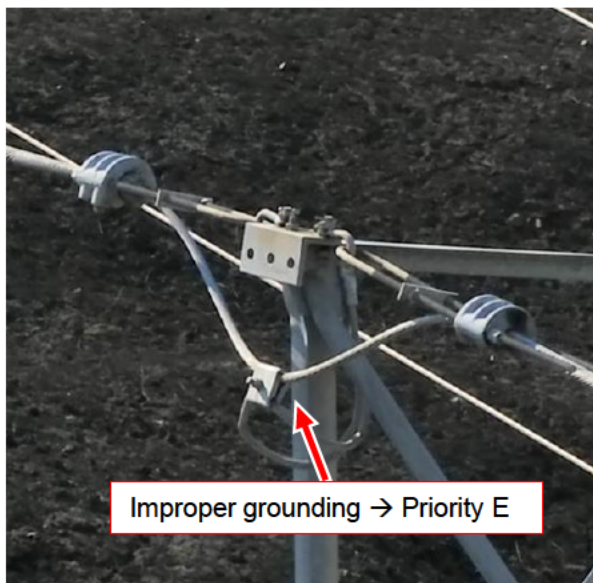
Improper grounding → Priority E

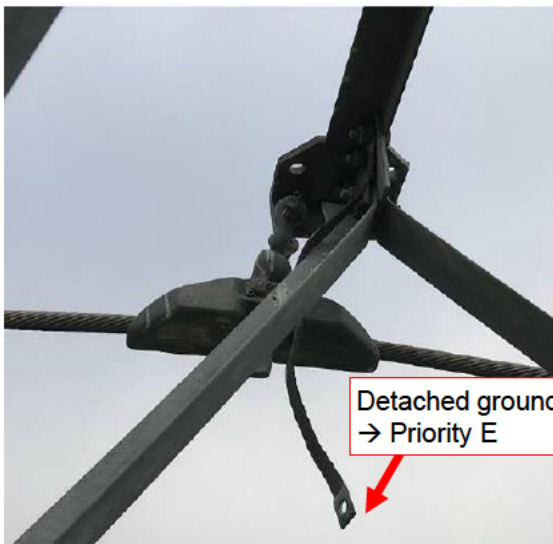
Detached grounding  
→ Priority E

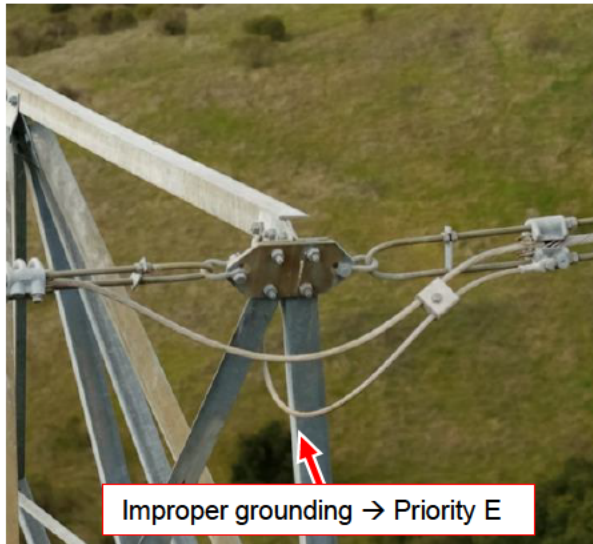
Improper grounding → Priority E

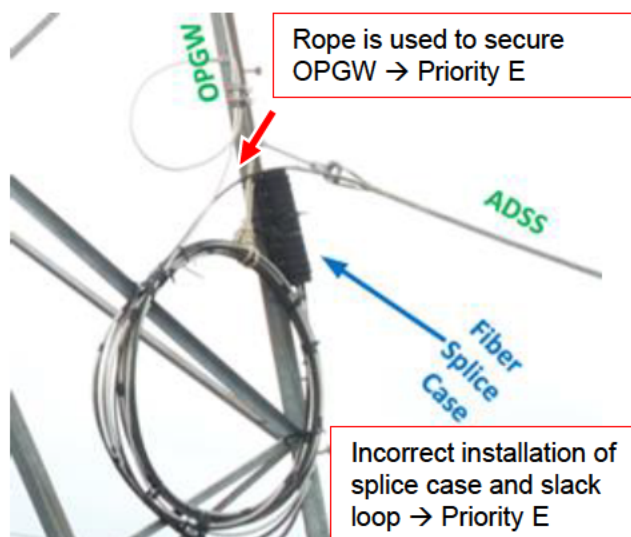
### OPGW coil is installed incorrectly.

1. Initiate SAP Notification; Priority Code E.
2. Fix not to exceed 12 months.
3. Take close-up photos of the condition found.

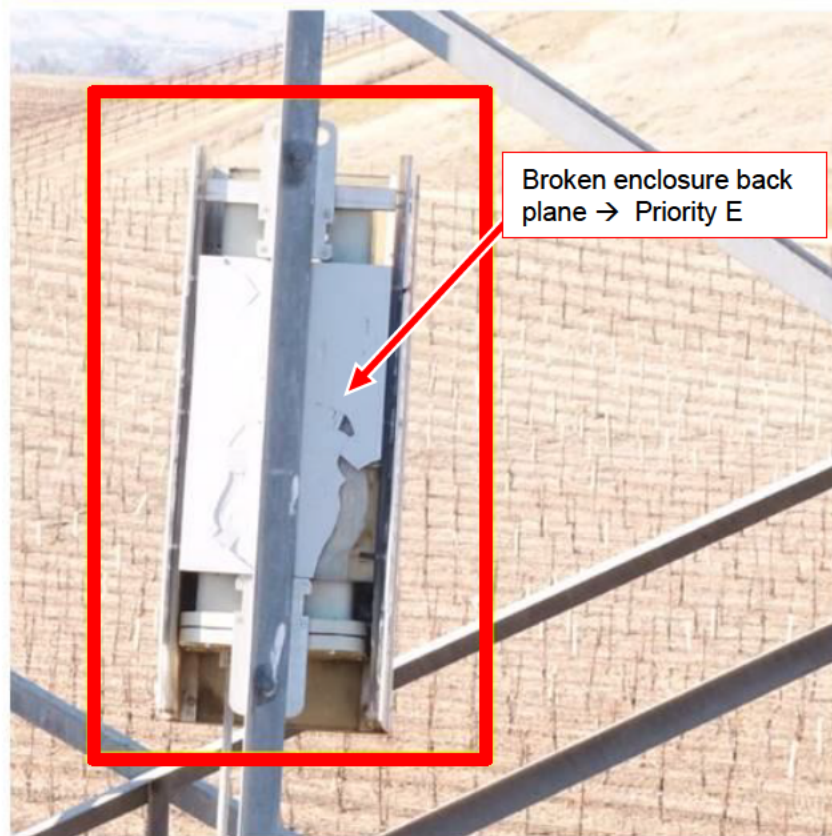
**Broken/cracked OPGW splice case**  
bullet-proof enclosure.

1. Initiate SAP Notification; choose Priority E.
2. Fix no later than 12 months.
3. Take close-up photos of the condition found.

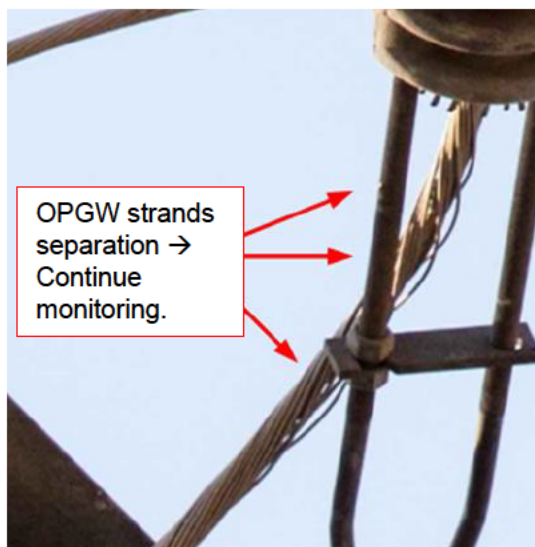
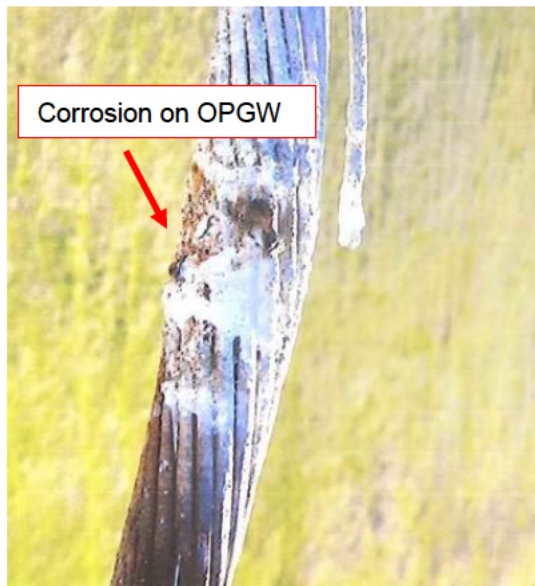
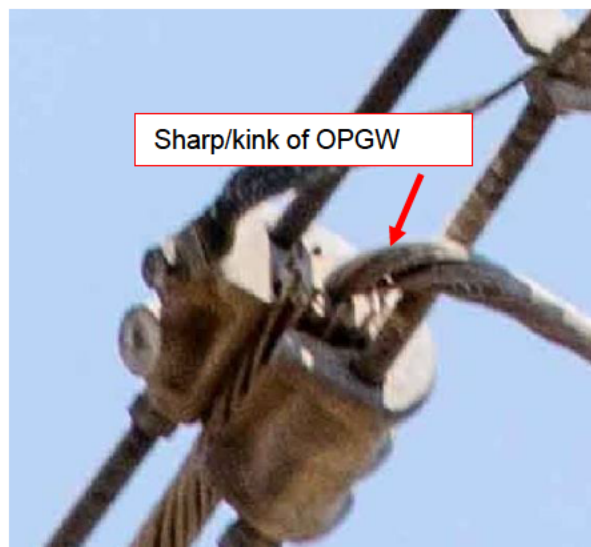
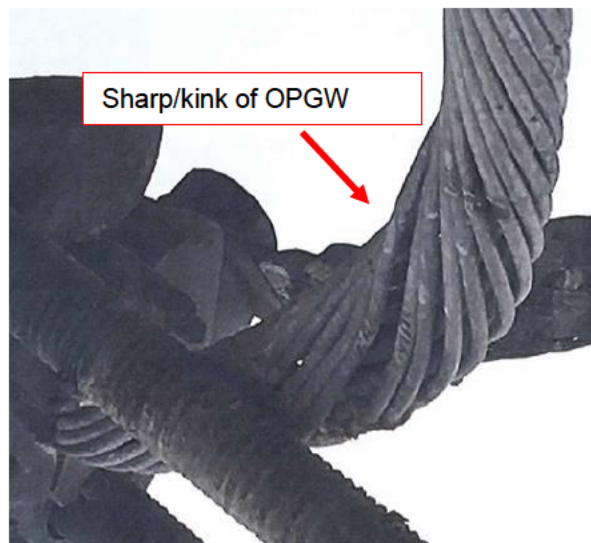
**Sharp angle/kink, strands separation of OPGW, or severe corrosion.**

1. Initiate SAP Notification; Priority Code E.
2. Take close-up photos of the condition found.

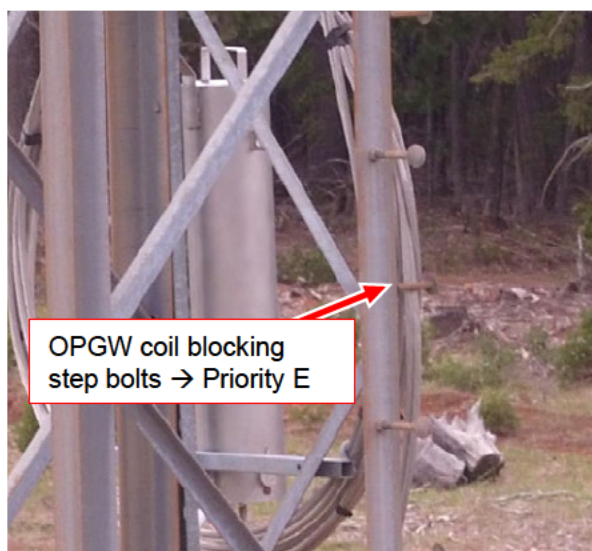
**OPGW coil is installed incorrectly/blocking step bolts.**

1. Initiate SAP Notification; Priority Code E.
2. Take close-up photos of the condition found.

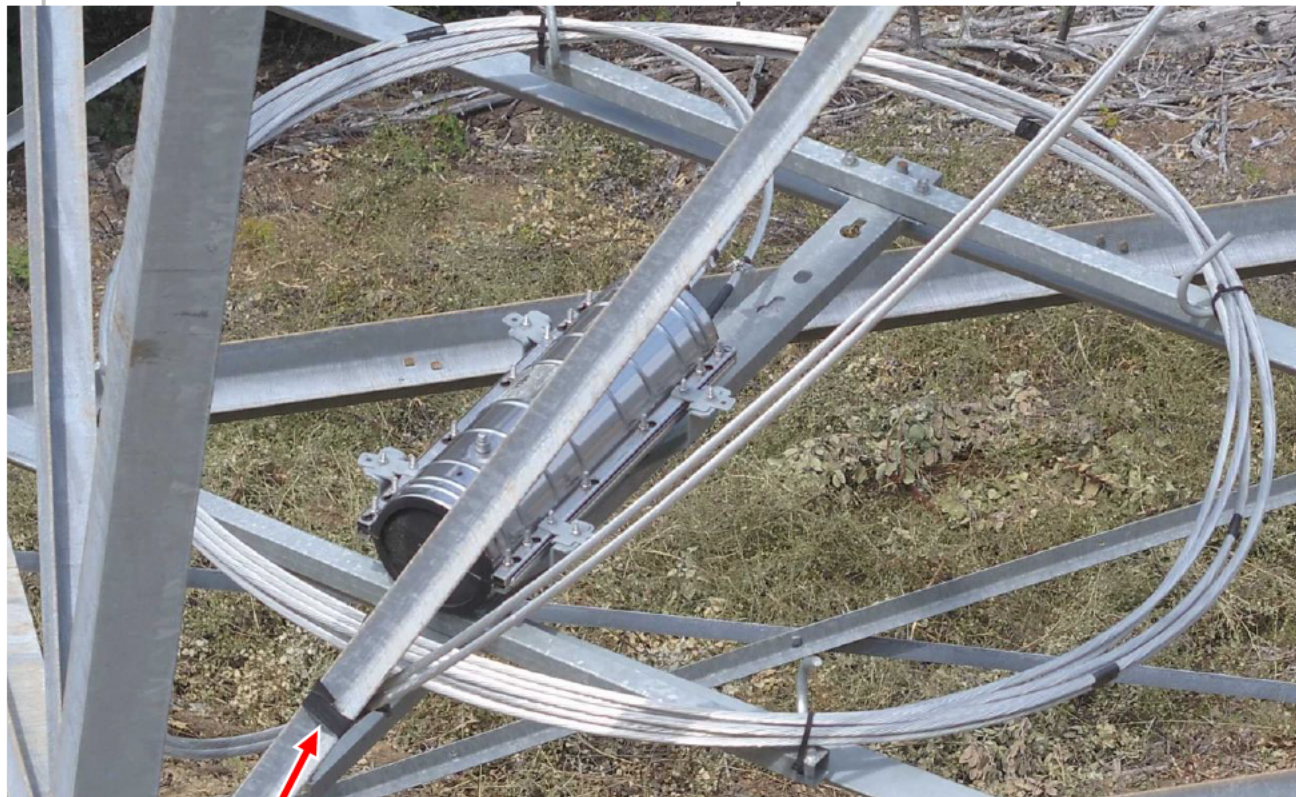
**OPGW is improperly secured to a structure with tape – within 10 feet of fiber slack coil.**

- Not a threat to fall onto the electric conductors or the general public.

Tape attaching OPGW  
to tower member

1. Initiate SAP Notification, Priority Code E.
2. Take close-up photos of the condition found.

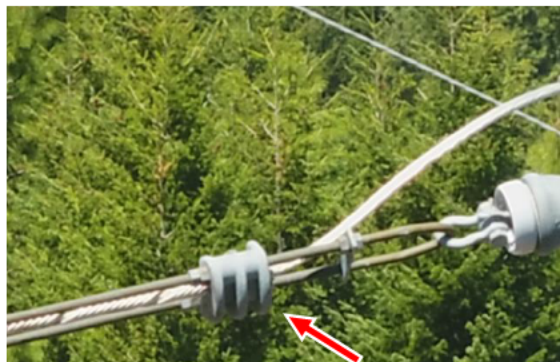
- Housing and spacer bar are in close proximity.
- From this angle, we are unable to determine if  $1.5"$  radial clearance is present.
- Other images are required to determine any potential action.

No work to be performed by T-Line M&C. IT to review, assess, and determine next steps, if needed.

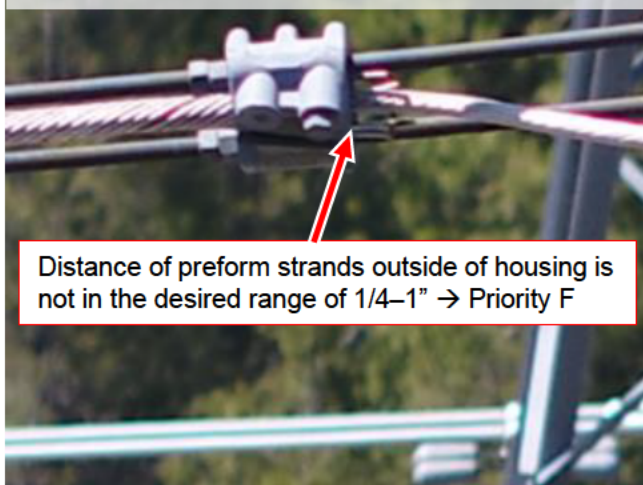
Distance of preform strands outside of housing is not in the desired range of  $1/4$ – $1"$  → Priority F

Location of housing is not as desired, but installation is OK, since  $1.5"$  separation is maintained between spacer bar and OPGW.

1. Initiate SAP Notification; Priority Code F.
2. Take close-up photos of the condition found.

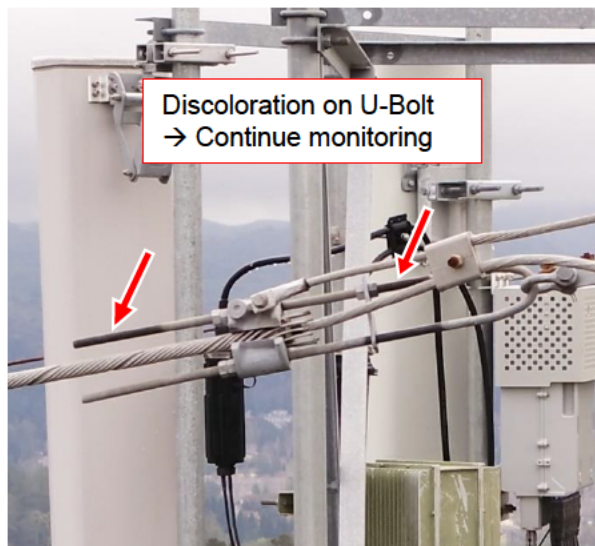
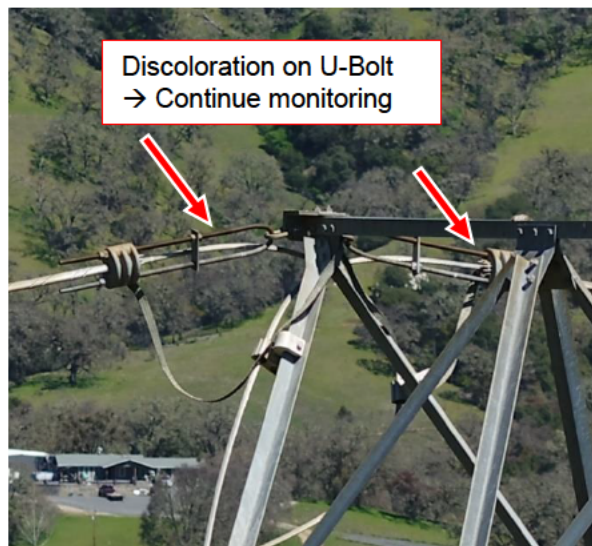
### Discoloration on U-bolt.

1. Initiate SAP Notification; Priority Code F.
2. Take close-up photos of the condition found.

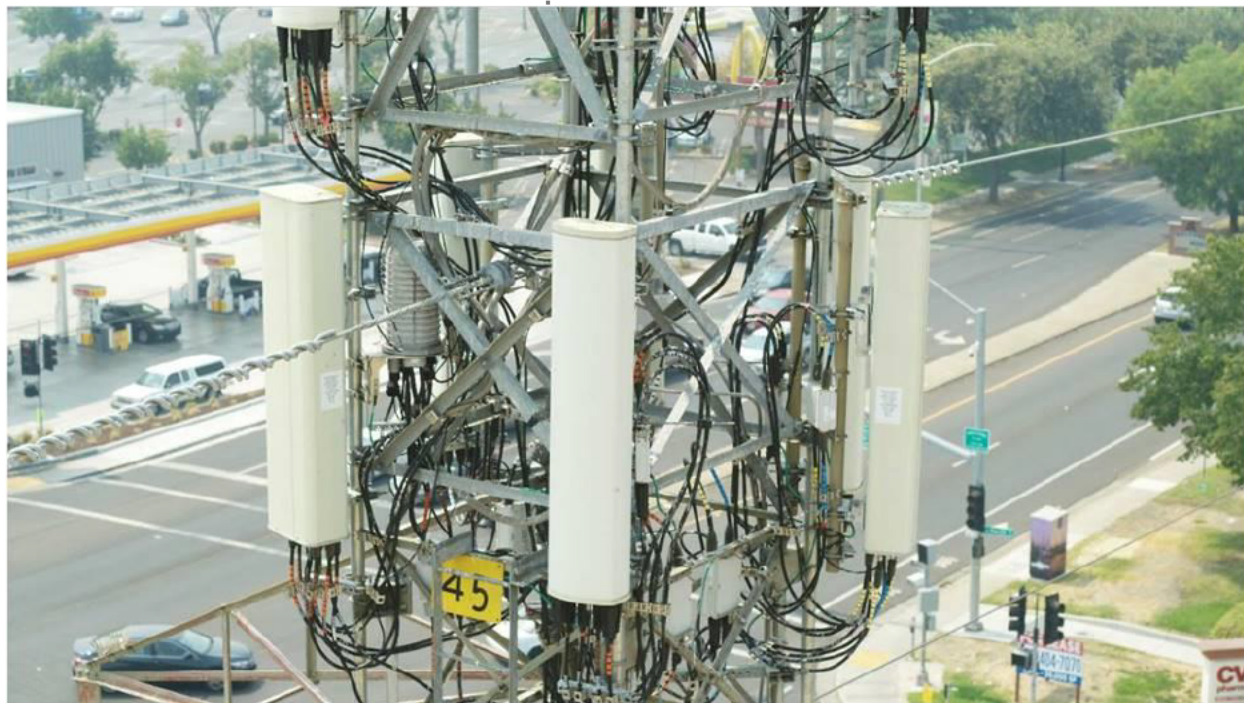
Cell/Antenna cabling installed within less than 10 inches of OPGW cable and cell antenna vertical clearance to OPGW is less than 24 inches.

OPGW installed through cell array to maintain 24-inch vertical clearance from all cell panels and 10-inch to associated cell/antenna cabling.

1. Follow [Utility Procedure TD-2014P-01, "Notification of Conditions to Third-Party Utility,"](#) to notify the 3<sup>rd</sup> Party of the Level 3 condition via [ElectricD3rdPartyNotificationsDesk@pge.com](mailto:ElectricD3rdPartyNotificationsDesk@pge.com).
2. Transfer the finding to the New Revenue Development (NRD) group at [NRDlineProjects@pge.com](mailto:NRDlineProjects@pge.com).
3. Take close-up photos of the condition found.

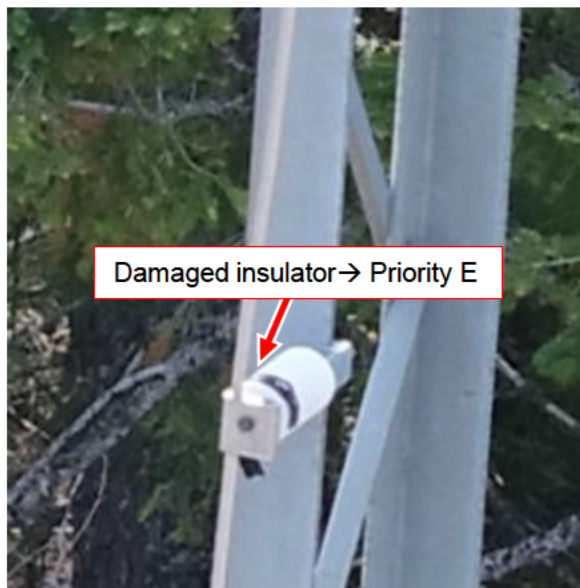
Damaged insulator → Priority E

1. Initiate SAP Notification; Priority Code E.
2. Fix not to exceed 3 months.
3. Take close-up photos of the condition found.

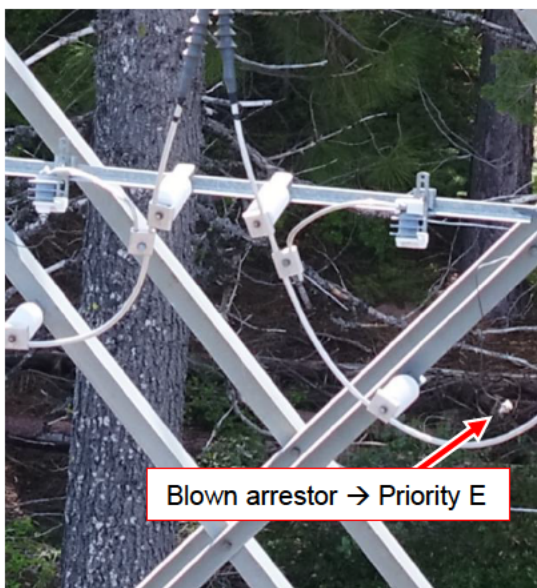
Blown arrester → Priority E

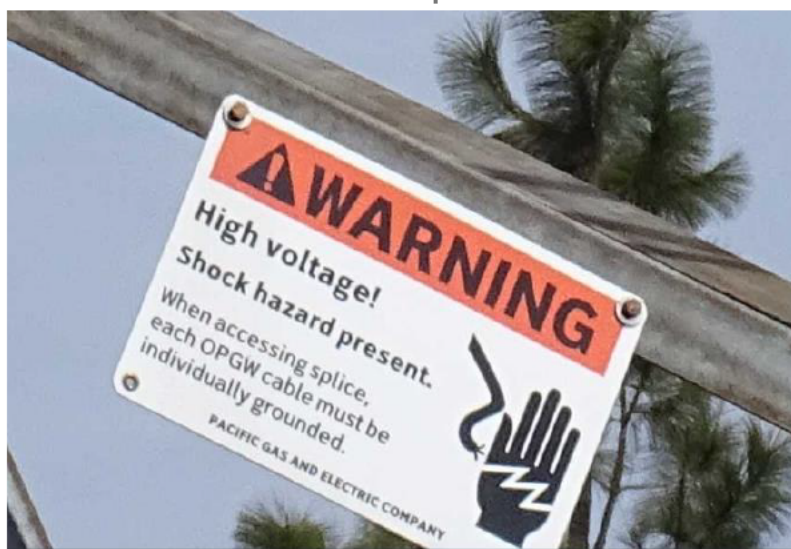
**Missing** “Ungrounded OPGW High Voltage” sign on 500-kV structures.

- Install the high voltage Warning sign at OPGW fiber splice locations where the OPGW cable(s) are not grounded (installed on insulators).
- If a singular OPGW cable or two are present AND each one is grounded to the structure, then the sign is not required.
- Install the sign in the vicinity of the fiber splice case.

1. Initiate SAP Notification; Priority Code E.
2. Fix not to exceed 12 months.

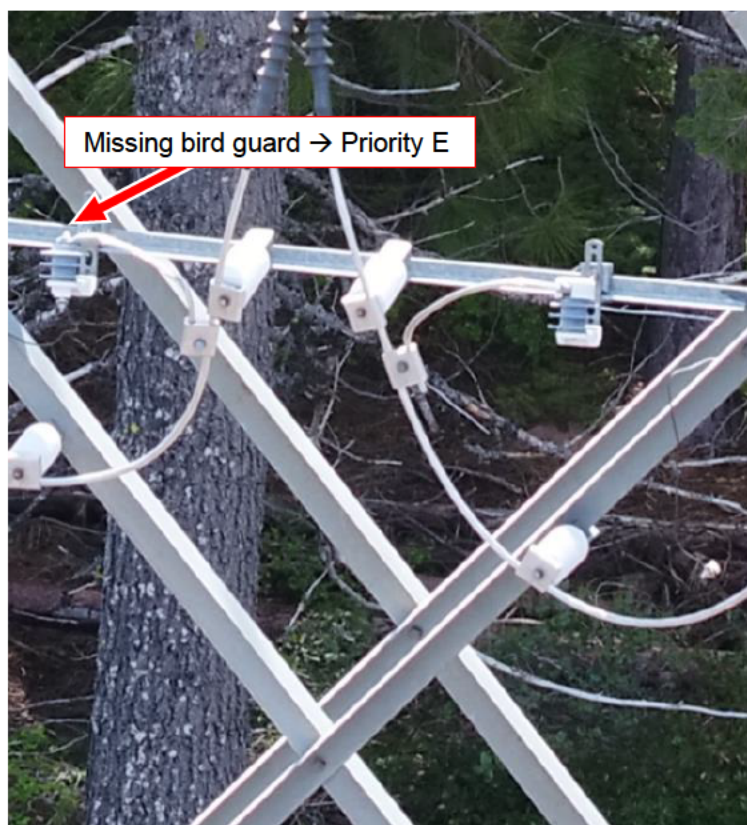
### Missing Bird Guard

1. Initiate SAP Notification; Priority Code E.
2. Take close-up photos of the condition found.

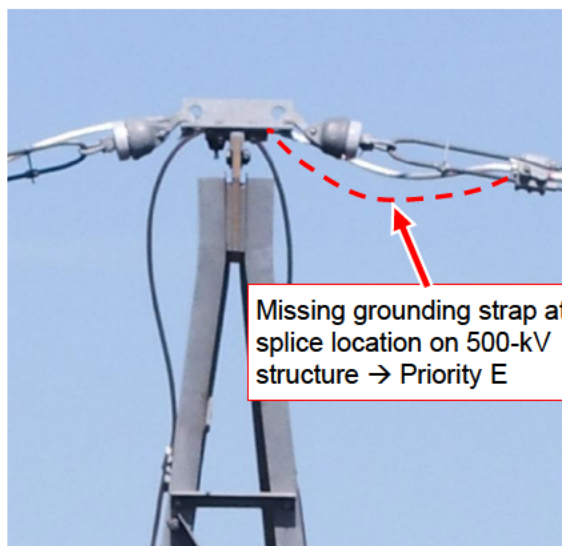
**Missing grounding strap at splice location on 500-kV structure.**

1. Initiate SAP Notification; Priority Code E.
2. Fix not to exceed 12 months.
3. Take close-up photos of the condition found.
