This job aid provides consistent evaluation of all dielectric self-supporting cable (ADSS) in transmission lines, and consistent decision-making.

## ADSS Inspections

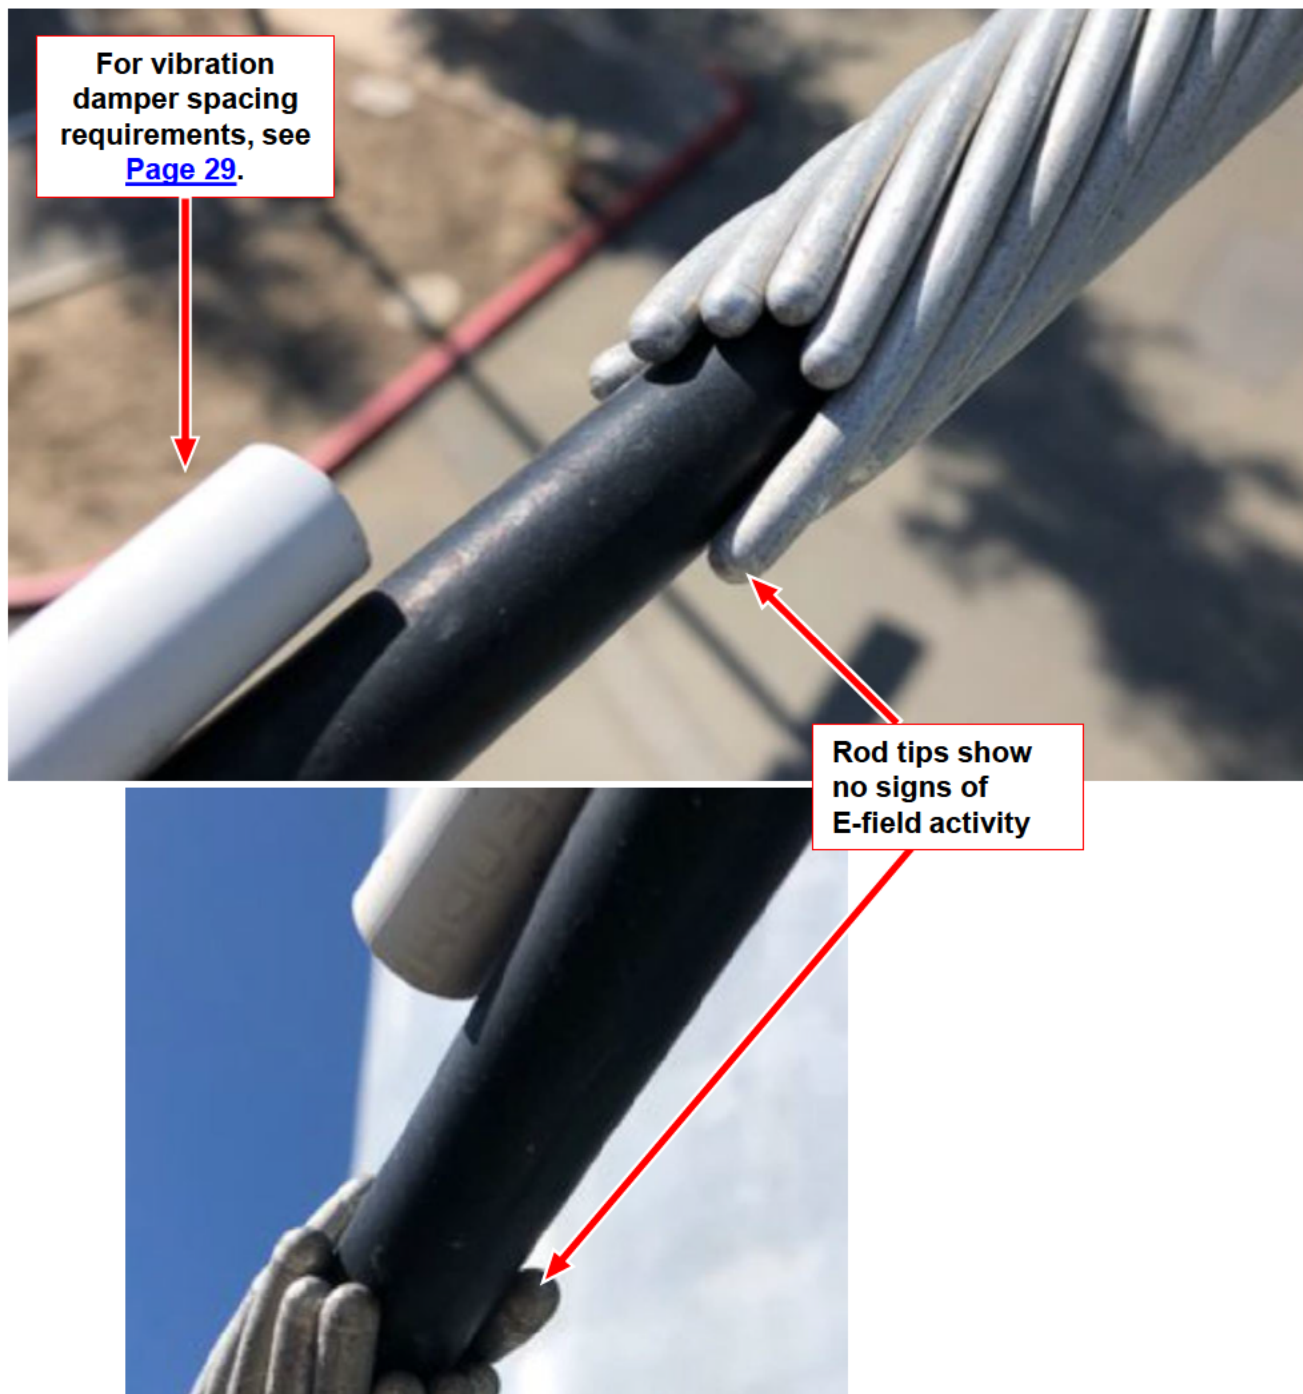
## ADSS Cable With No Signs Of E-Field Damage

In the image below, the ADSS cable shows no signs of corona discharge or tracking. The cable jacket is smooth. When E-field activity is present, the rod tips of the armor rods typically turn black from the arcing. In the image below, the rod tips are “clean,” and no black marks are present.

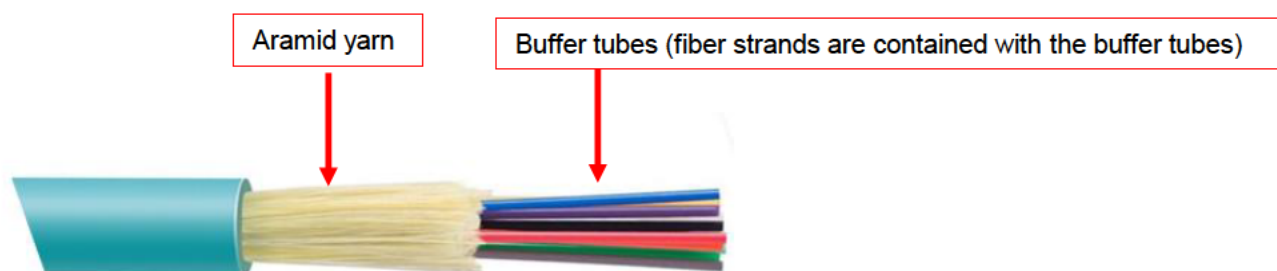
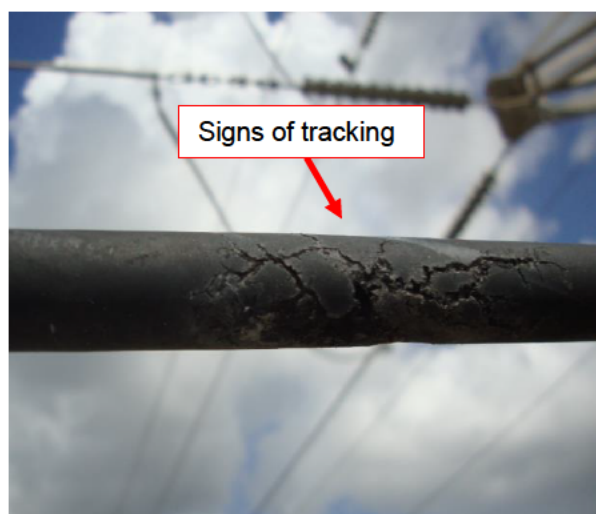
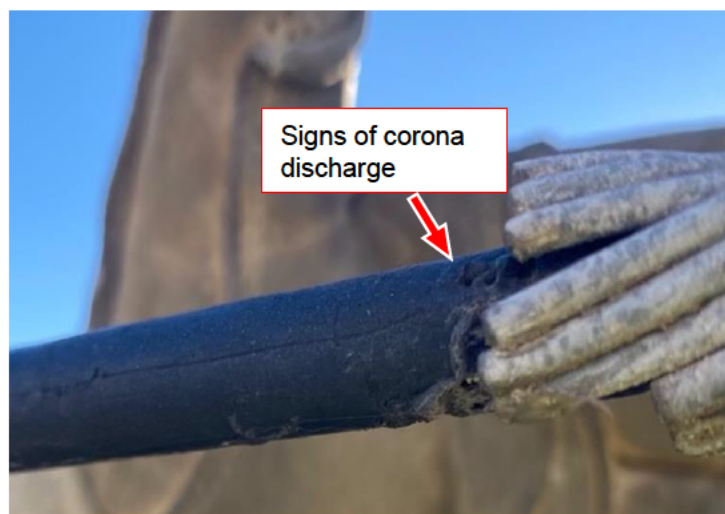
## ADSS Cable With E-Field Damage

Over time, the electric field burns through the cable jacket, causing a cable breach. Once the cable has been breached, there are two conditions that accelerate the degradation of the cable:

1. **Water Ingress:** Once water enters the cable, the tracking effect can start internally, where the cable will burn from the inside out. Once the aramid yarn is damaged/burnt through, the integrity of the cable is compromised, to the point where it will separate and eventually completely pull apart and fail.
2. **Aramid Yarn Degradation:** The part of the fiber cable that provides support, protection, and tensile strength is commonly referred to as Kevlar, which is a brand of aramid yarn. Aramid yarn is not UV-rated. Once exposed to the sun, it slowly degrades, changing from a yellow color to a white color. As it degrades, the cable loses its ability to self-support – eventually it will pull apart and fail.

Below are examples of tracking and corona discharge.

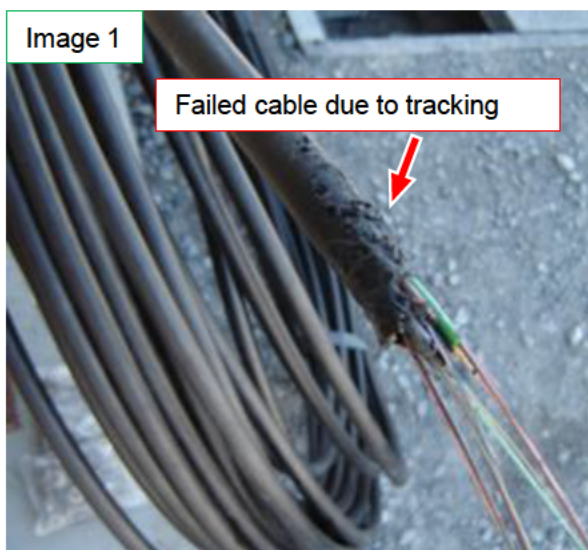
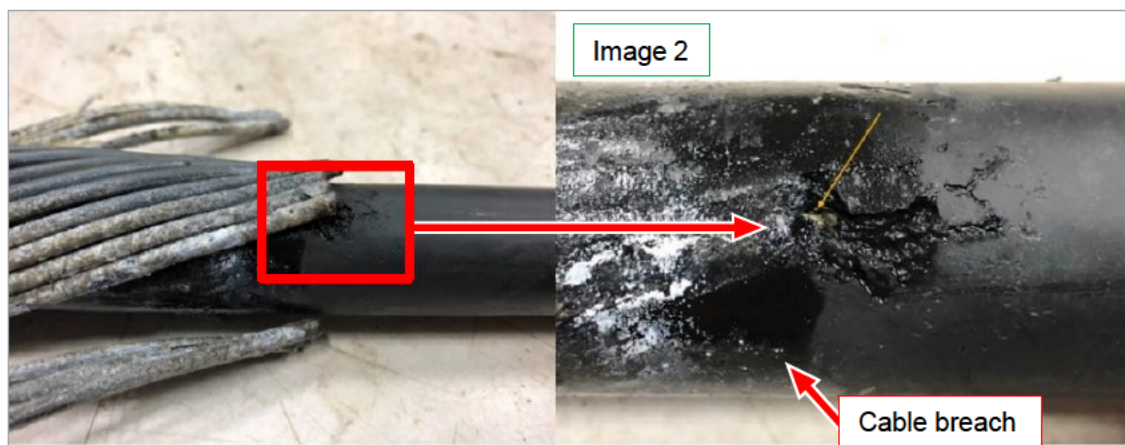
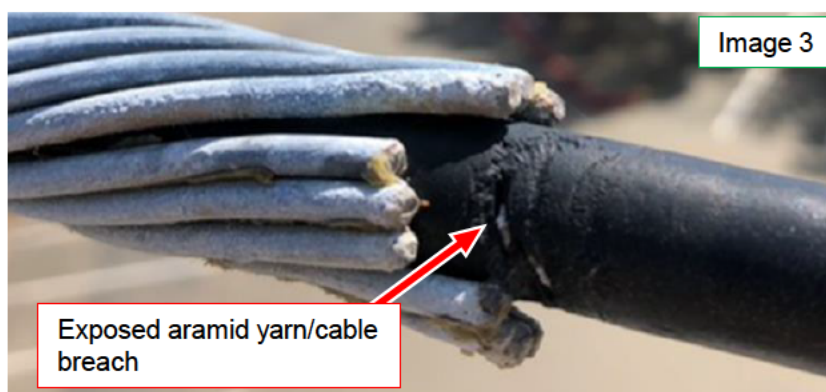
Damage caused by corona discharge can be difficult to see at times, as it can occur right underneath the armor rod tips, as shown below in the Image 2.

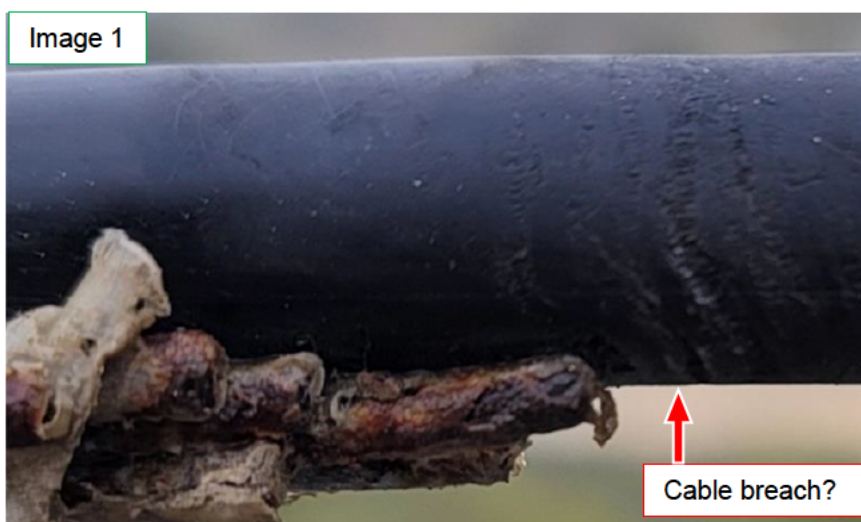
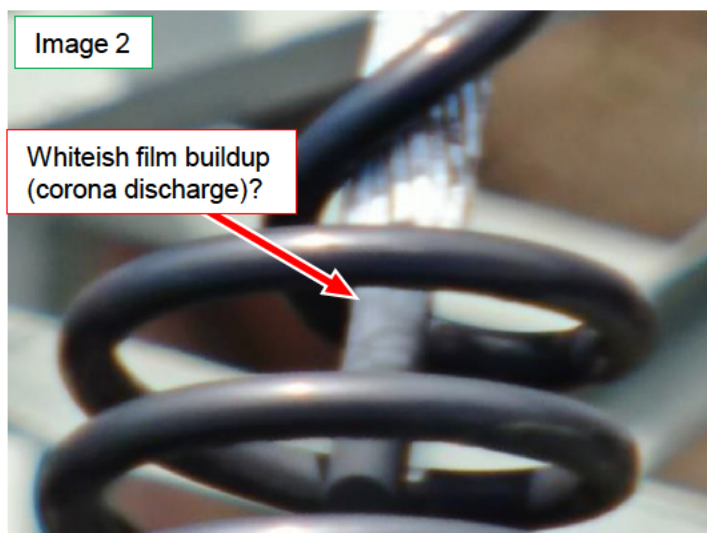
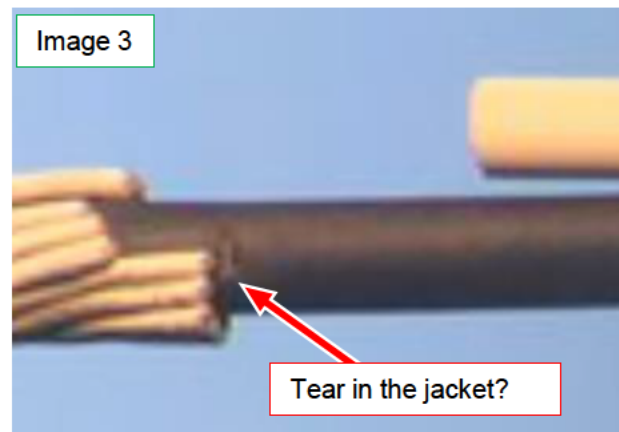
## Quality of Drone Imagery or Angle of Image

- E-field degradation typically occurs on top of the cable or on the sides, but it can occur anywhere on the surface of the cable. In Image 1, there are signs of degradation on the jacket, but it is hard to tell what is happening on the bottom of the cable.
- Sometimes the drone image becomes too blurry when zoomed in, making it hard to tell if the cable jacket is damaged or not, as shown in Images 2 and 3.
- It may be necessary to send a field crew out to perform an up-close inspection or to re-fly the drone to focus specifically on the fiber cable to gather clearer images.
- Re-flight follows existing Cannot Inspect (CNI) process.

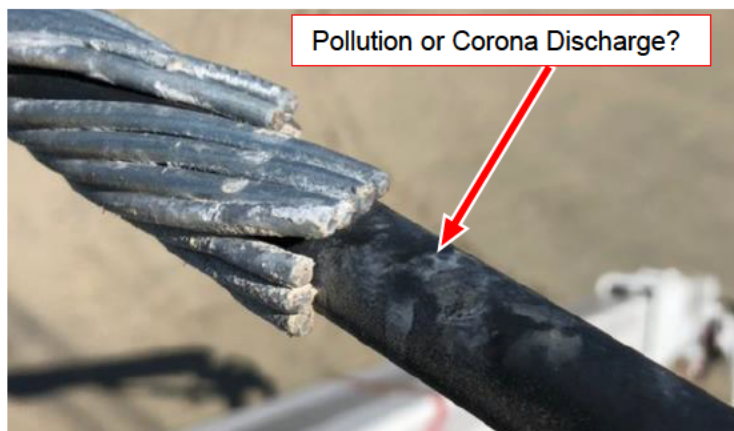
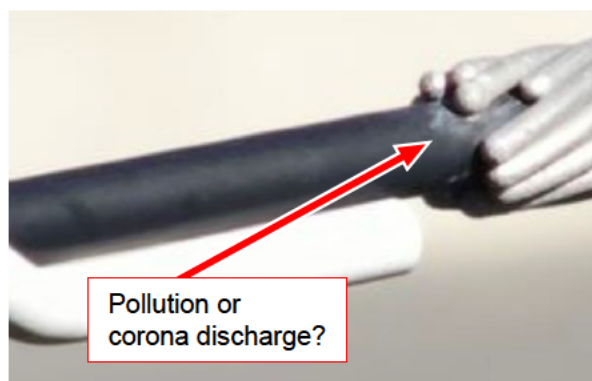
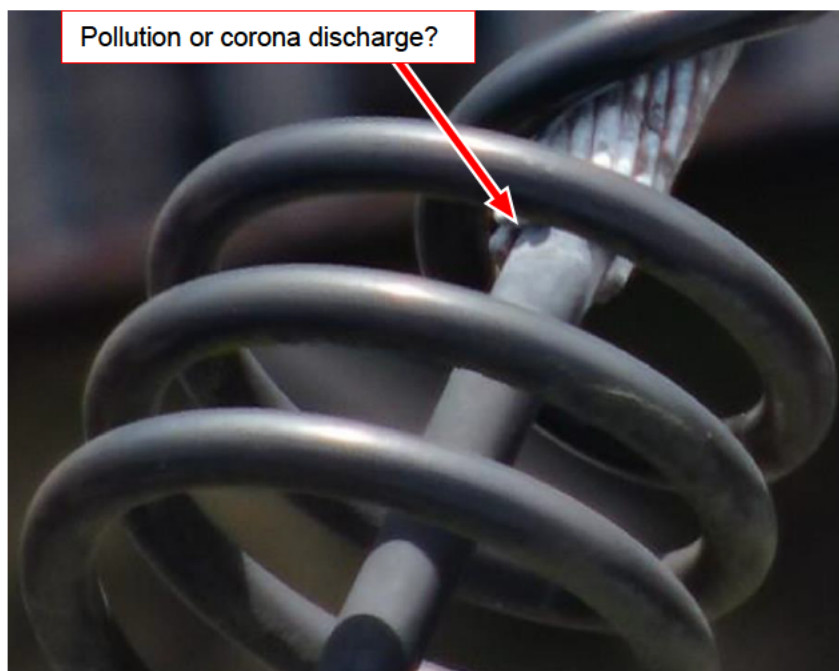
## Pollution/Sediment Build Up on Cable Jacket or Corona Discharge

- Early sign of corona discharge can be a whiteish film that builds up at the end of the armor rods. However, this can be confused with sediment build-up on the cable jacket or even bird droppings.
- Consistent rainfall helps to wash away sediment build-up, which is generically called “pollution.” It can be difficult to determine if any E-field damage is present, due to pollution buildup.
- It may be necessary to have a crew wipe the cable jacket down to remove any pollution buildup and then perform an up-close inspection to assess if any E-field damage is present. Take up-close photos for review by the EO and IT Inspection teams.

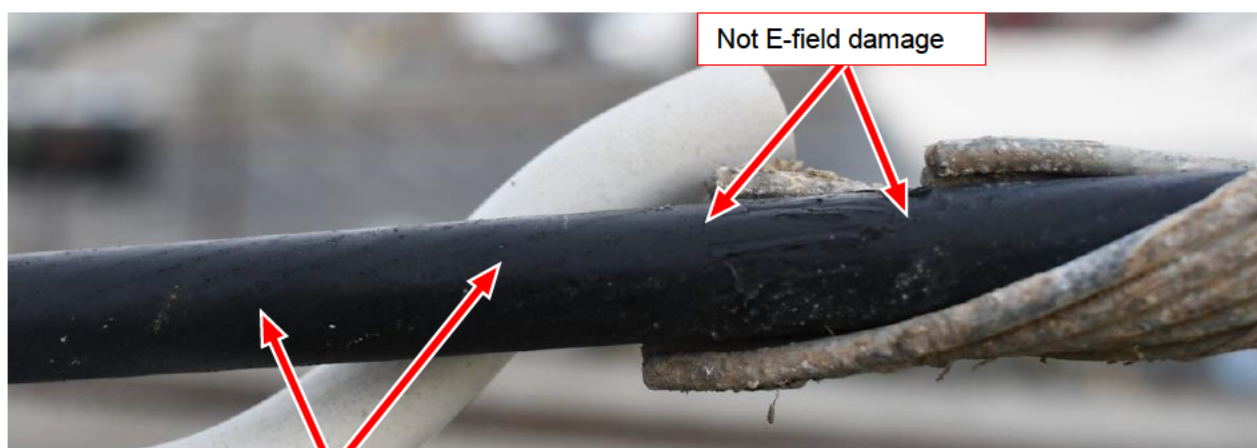
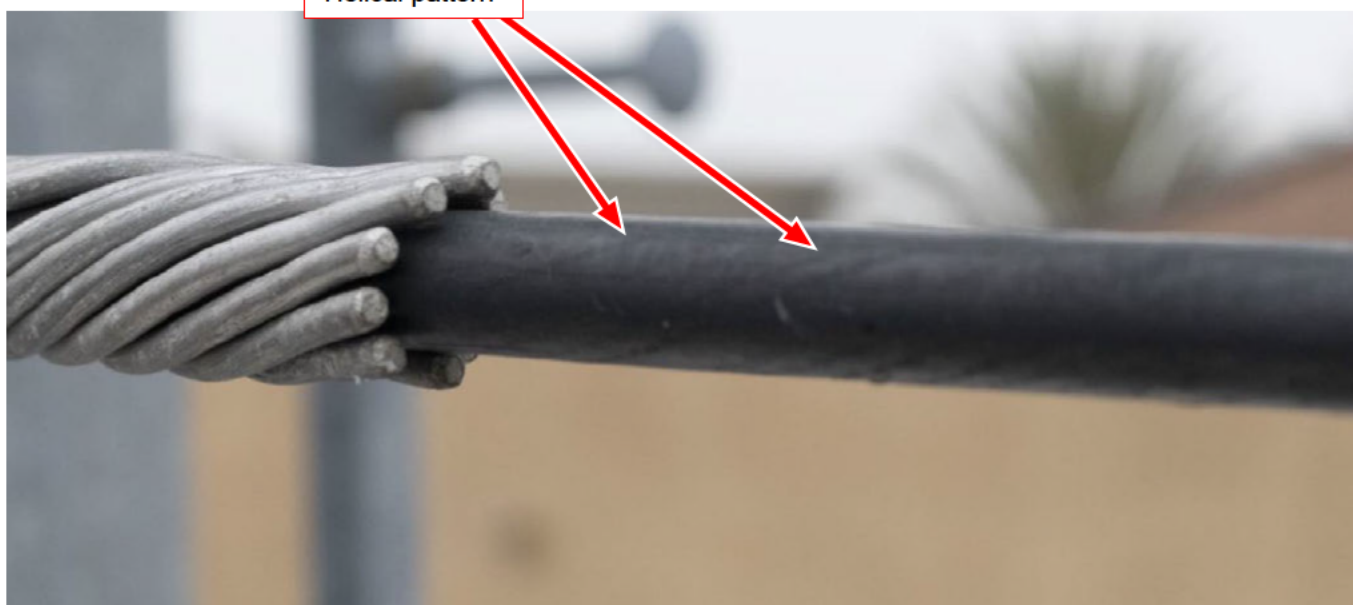
## Fiber Cable Jacket Irregularities That Are Not E-Field Damage

- In the two images below, there are helical “patterns” on the jacket, where the preform rods were originally installed, removed, and then repositioned. Do not confuse these with E-field degradation.
- On the right side of the first image, it appears that a sliver of the jacket has been removed/scrapped off somehow. It is not known what could have caused this. This is not E-field damage.

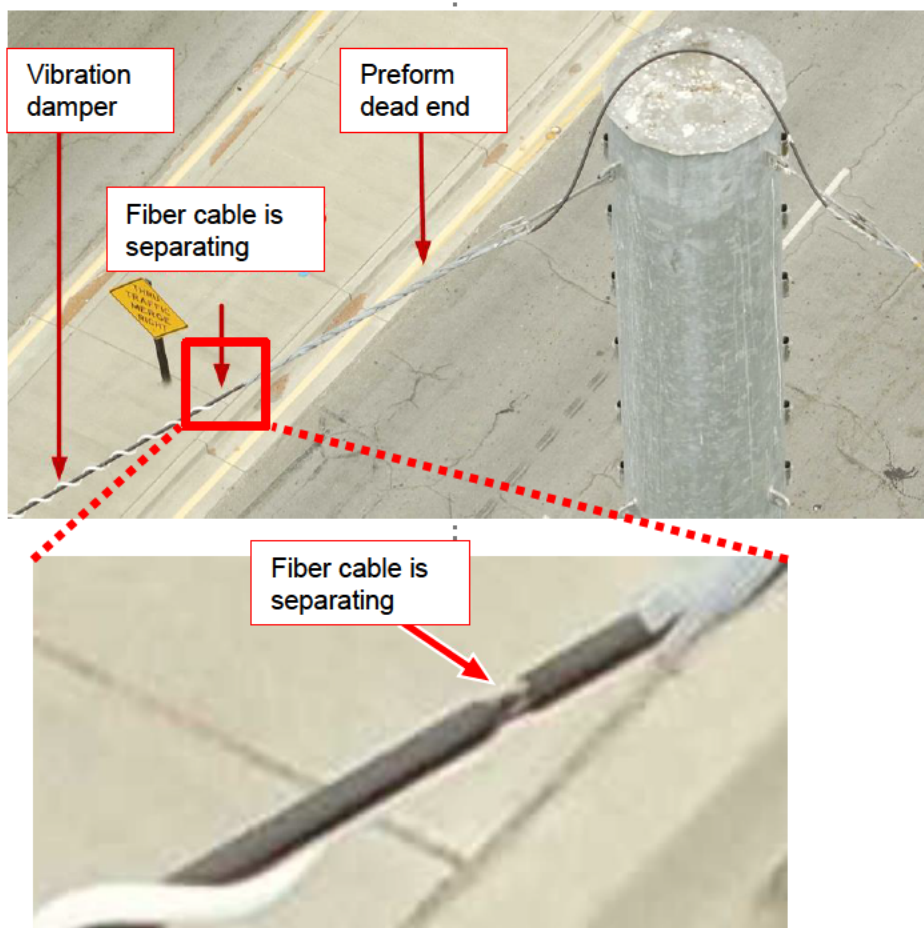
### Condition 5

#### Damaged/Separating/Cable Breach

ADSS cable (E-field damage, vandalism, vehicular contact)

1. Initiate SAP Notification, Priority Code A.
2. T-Line to make the situation safe with preform safety snubs.
  - If the situation cannot be made safe and cable removal is the only option, contact IT immediately, so that IT can notify the appropriate lines of business and 3rd party customers of the emergency outage.
3. Notify IT by calling the ENOC at [REDACTED].
  - Document the date, time, and the name of the person at the ENOC who took the call.
  - Capture this information in the comments field of the SAP notification.
4. Take close-up photos of the condition found.

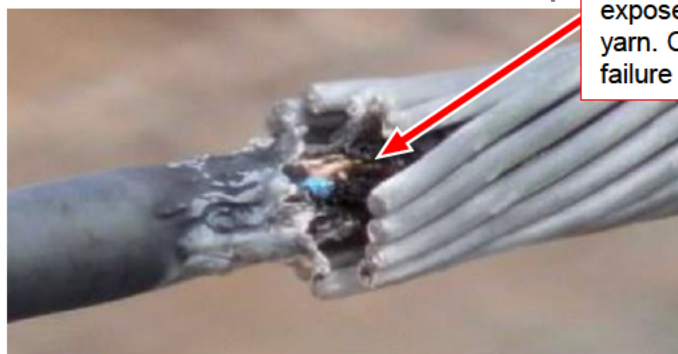
**E-field Damage:** Cable jacket has been breached; blue buffer tube is exposed, as well as the orange aramid yarn. Cable separation and complete failure will occur.

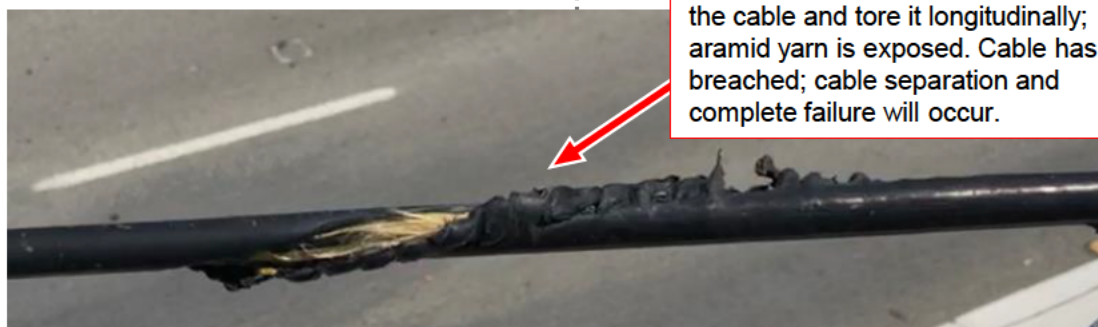
**Vehicular Contact:** It is believed that a vehicle carrying something tall "caught" the cable and tore it longitudinally; aramid yarn is exposed. Cable has been breached; cable separation and complete failure will occur.

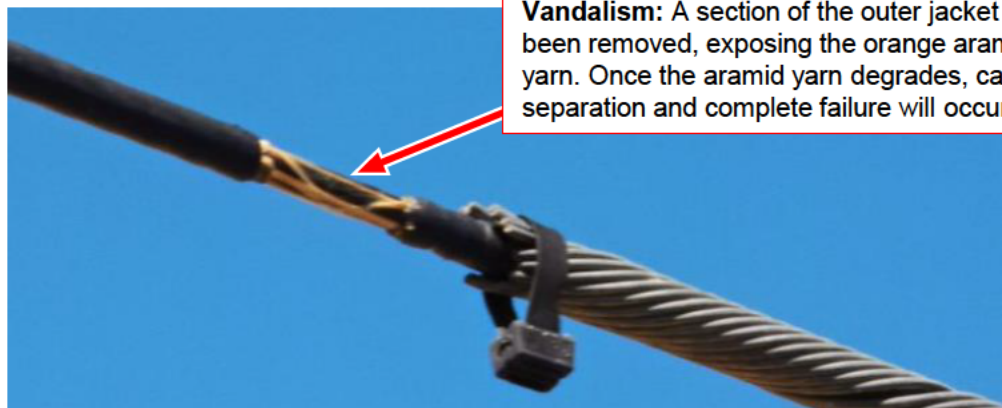
**Vandalism:** A section of the outer jacket has been removed, exposing the orange aramid yarn. Once the aramid yarn degrades, cable separation and complete failure will occur.

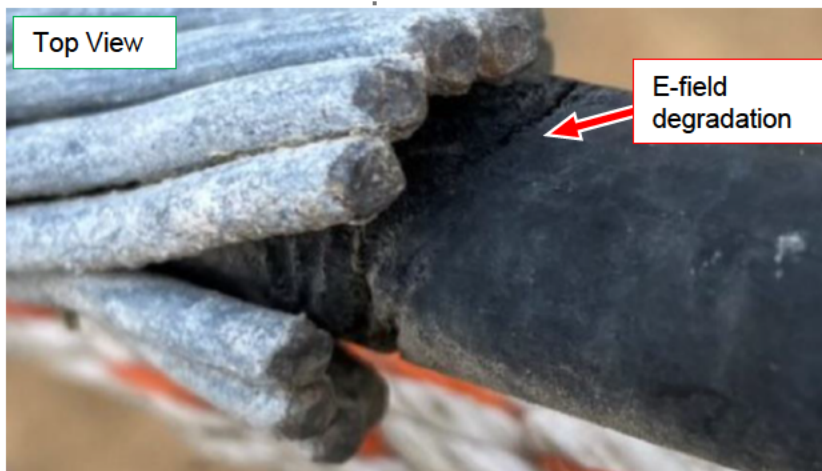
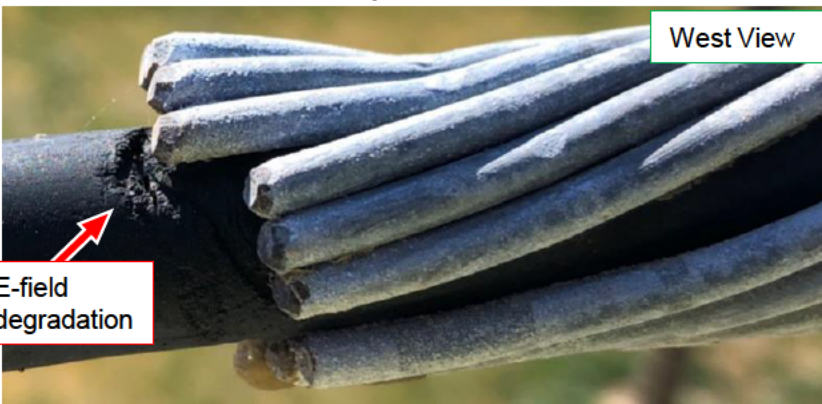
Sometimes one image is not good enough to show the severity of the damage to the cable. The side views below do not show the extent of the damage, as well as the top view does.

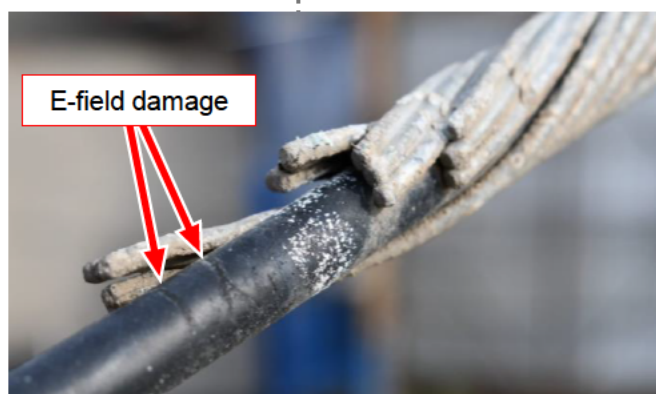
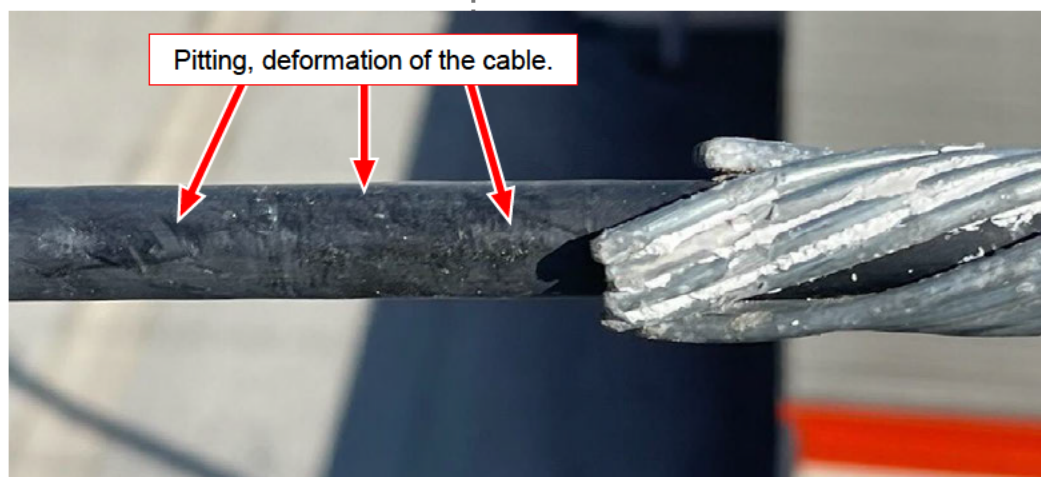
### Condition 4

#### Signs of E-Field Damage ADSS cable (Tracking or Corona Discharge).

No signs of a cable breach.

If signs of E-field damage are present, conduct an up-close inspection of the cable to determine the severity of the degradation and whether the cable has been breached.

1. Initiate SAP Notification, Priority Code E (3 months)
2. Install preform safety snub.
3. Take close-up photos of the condition found.

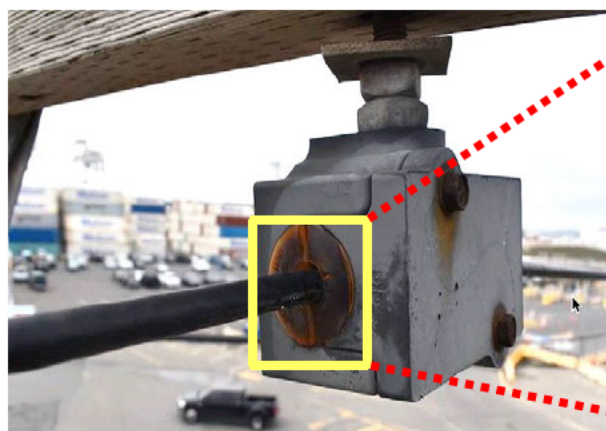
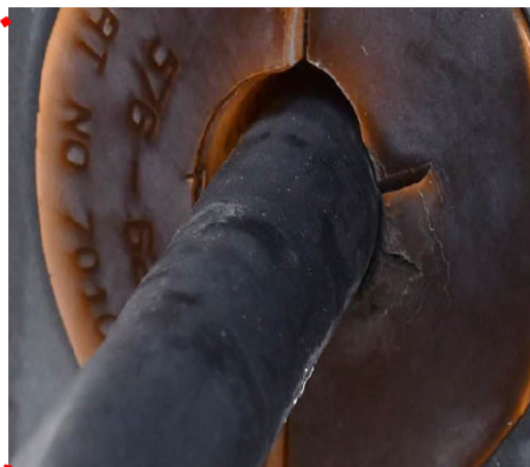
**Non-Standard Installation** of suspension/tangent support on structure with line voltage of 69 kV and above.

- Installation of the dielectric support and aluminum suspension without rods is not allowed on structures with a voltage greater than 60 kV.
- In the image below, it appears that there are signs of electric activity, burning of the dielectric insert. The manufacturer specifies that this type of suspension can burn if installed in high electric fields.
- It is possible that a fire burning right underneath this structure could have caused this damage.
- See Pages 6, 7, and 8 for reference and exception.

1. Initiate SAP Notification, Priority Code E (3 months).
2. ET assesses the condition of the fiber cable to determine if it has been damaged.
3. If the cable is damaged, send images to the IT Inspection team for review and assessment of next steps.
4. Install preform safety snubs, as required.
5. Take close-up photos of the condition found.

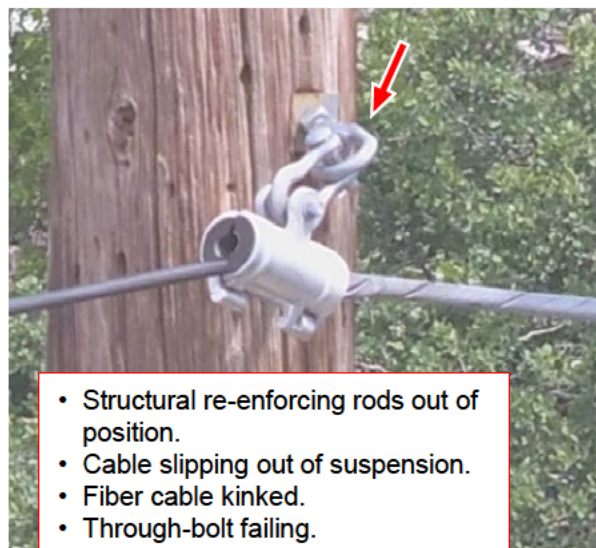
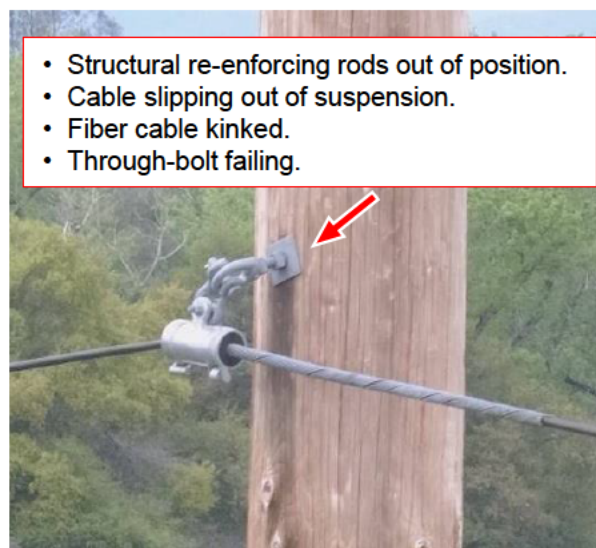
**Sharp angle/kink of ADSS cable and failing hardware.**

1. Initiate SAP Notification, Priority Code E (3 months).
2. Take close-up photos of the condition found.

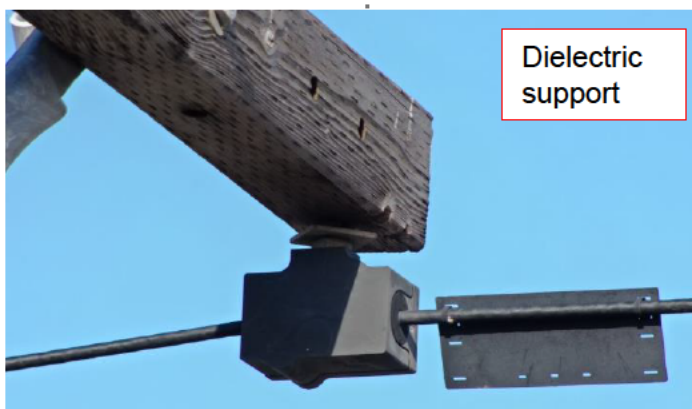
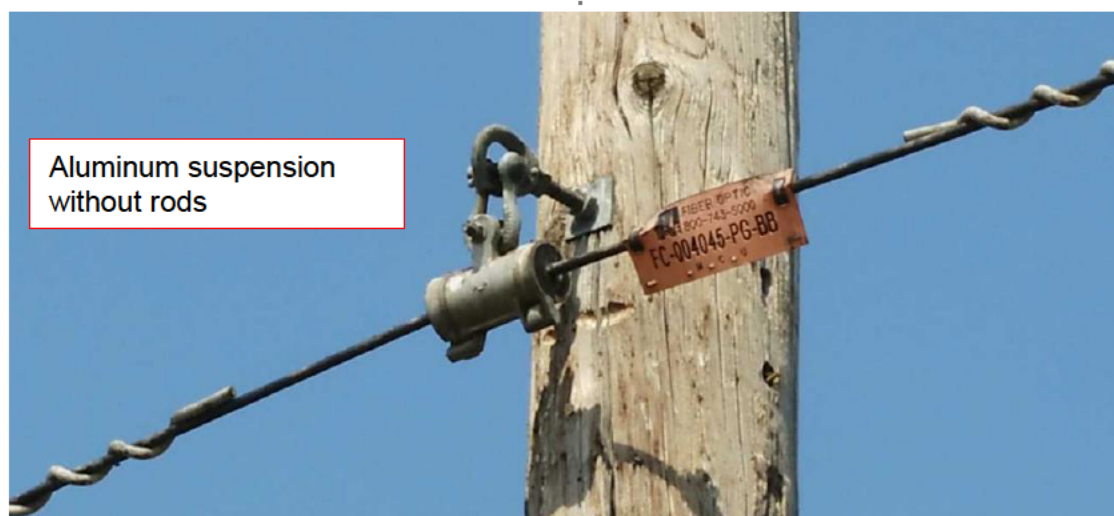
#### No Signs of E-Field Damage

**Non-Standard Installation** of suspension/tangent support on structure with line voltage of 69 kV and above.

- Installation of the dielectric support and aluminum suspension without rods is not allowed on structures with a voltage greater than 60 kV.
- See Pages 6, 7, and 8 for reference and exception.

1. Initiate SAP Notification, Priority Code E (12 months).
2. Take close-up photos of the condition found.

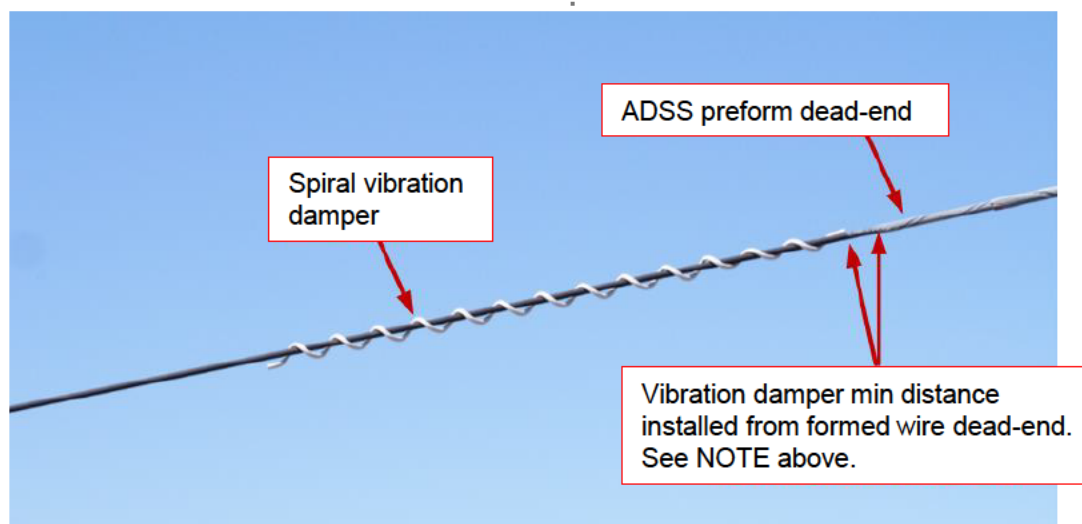
### Spiral Vibration damper installed incorrectly

- For all transmission voltage levels, ensure that the damper is not touching the armor rods or any part of the dead-end/ suspension hardware.
- For 69 kV and above, install the damper a minimum of 4 feet away from all hardware components.
- For 60 kV, there is no minimum distance requirement. The damper just cannot be touching any part of the hardware assembly.
- Check for signs of tracking between the damper and armor rods, as well as on the ends of the damper closest to the armor rods.

1. Initiate SAP Notification, Priority Code E (3 months).
2. Take close-up photos of the condition found.

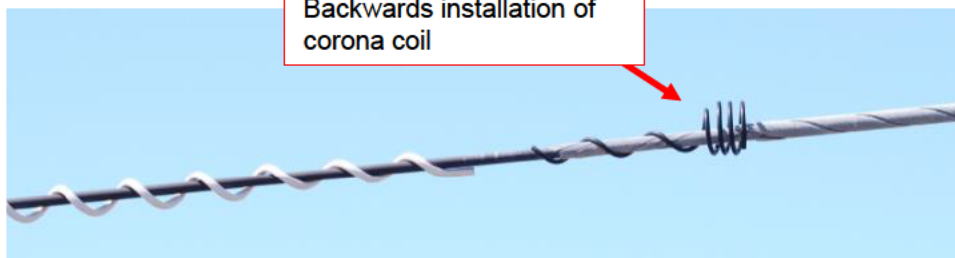
## Corona coil installed incorrectly

Backwards installation of  
corona coil

1. Initiate SAP Notification, Priority Code E (3 months).
2. Take close-up photos of the condition found.
3. The purpose of the corona coil is to eliminate the effects of corona discharge.
  - If the corona coil is not installed correctly, check for signs of corona discharge on the cable.

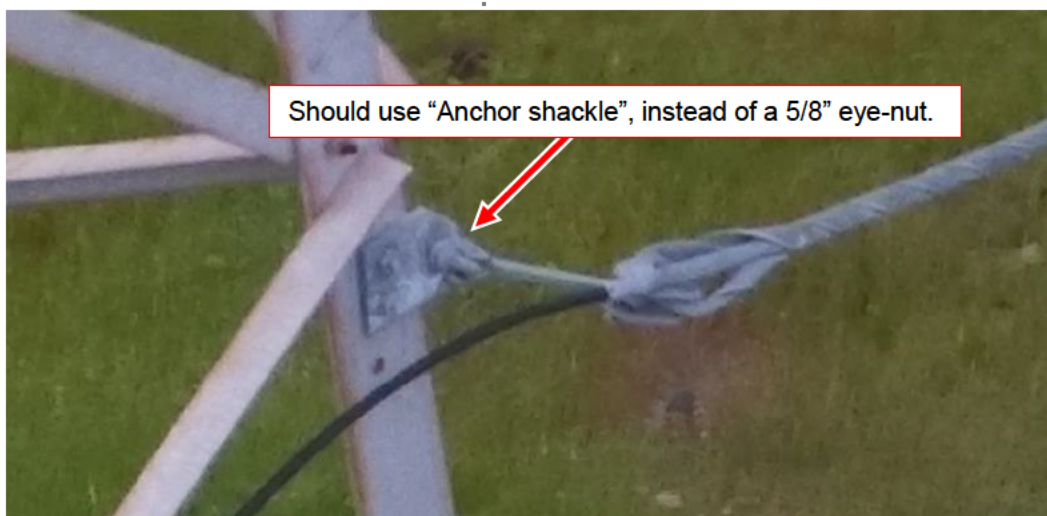
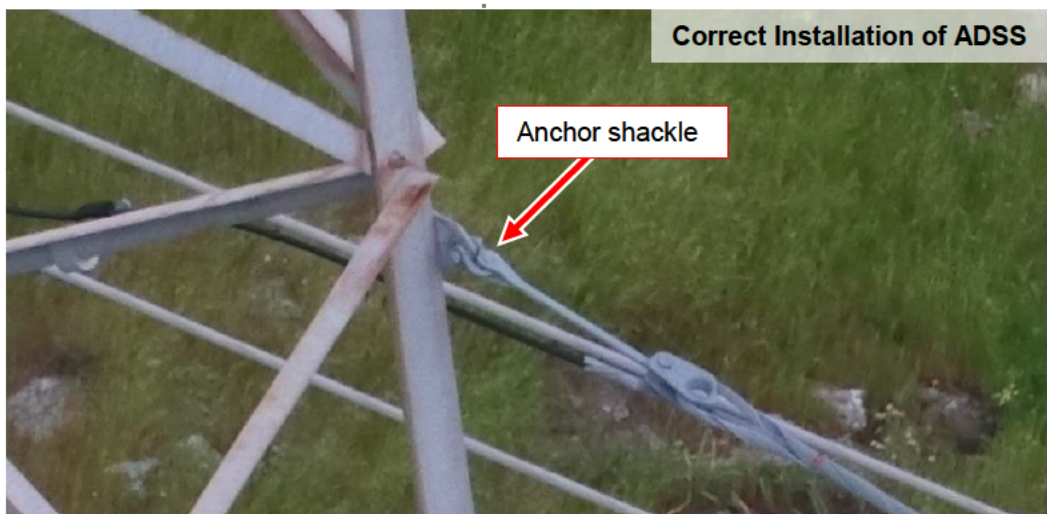
### Non-standard installation of ADSS.

1. Initiate SAP Notification, Priority Code E (12 months).
2. Take close-up photos of the condition found.

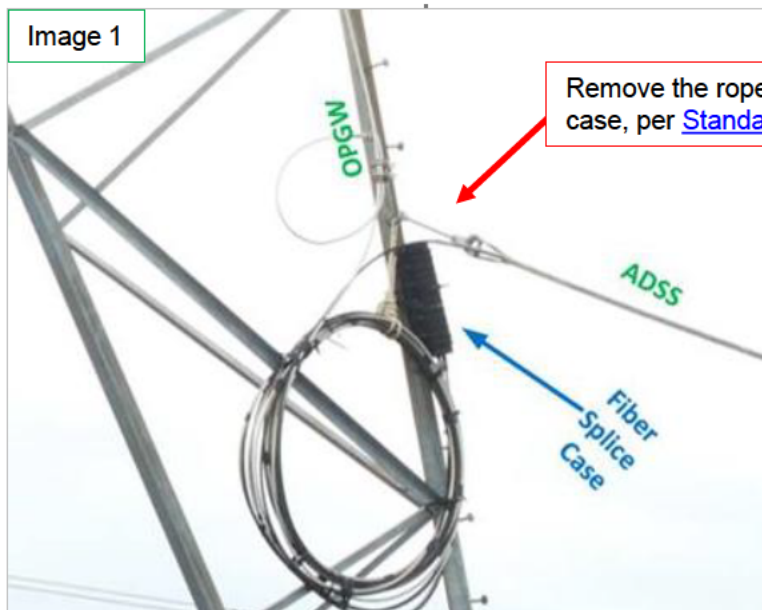
In Image 1 below, this was a temporary install, as a result of an emergency restoration, till the permanent installation could be engineered.

- If this type of condition is found, CIRT confirms with IT if the condition is a temporary installation and if there is a project in the works to remediate the situation to a standard installation.
- If there is a project in the works, the splice case and slack coil can be left in this configuration. Ensure that the rope is in good working order.

1. Initiate SAP Notification, Priority Code E (12 months).
2. Take close-up photos of the condition found.

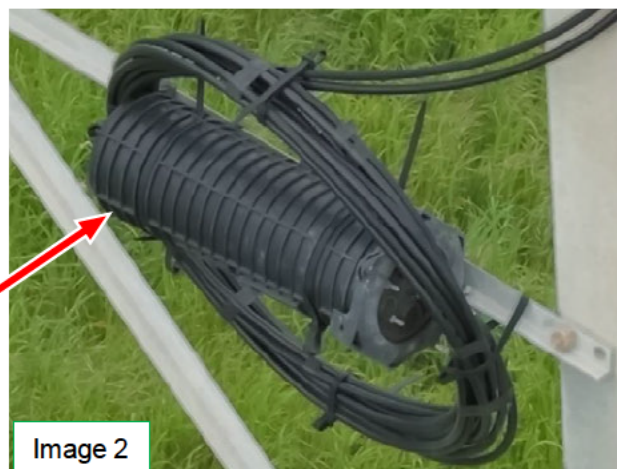
Splice case should not be tie-wrapped to the tower leg. Tie-wraps appear to be the standard UV-rated type. Non-UV-rated would fail quickly in the sun.

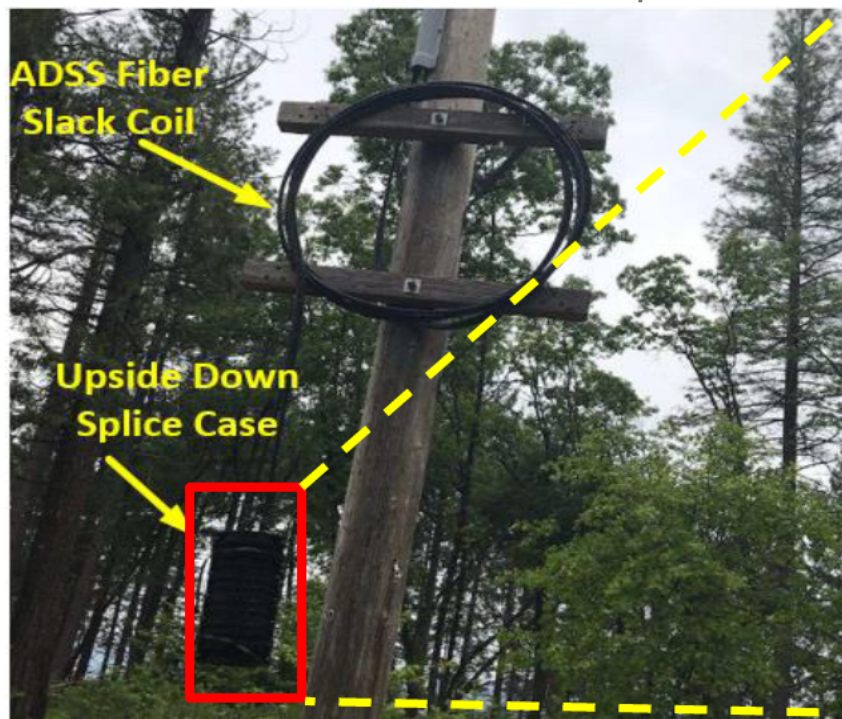
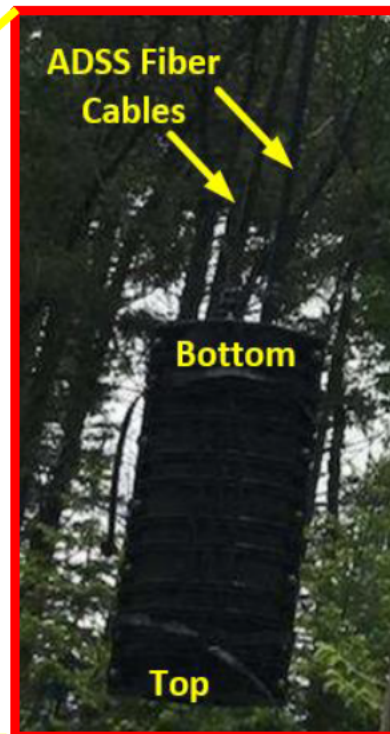
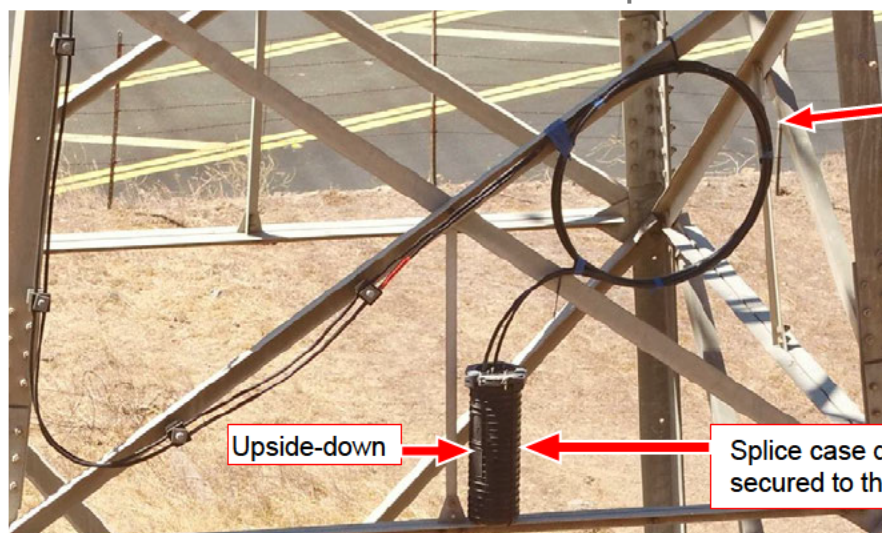
An upside-down splice case might fill up with water, which will damage the bare fiber strands. The bottom side of the splice case is the side where the fiber cables enter.

1. Initiate SAP Notification, Priority Code E (12 months).
2. Take close-up photos of the condition found.

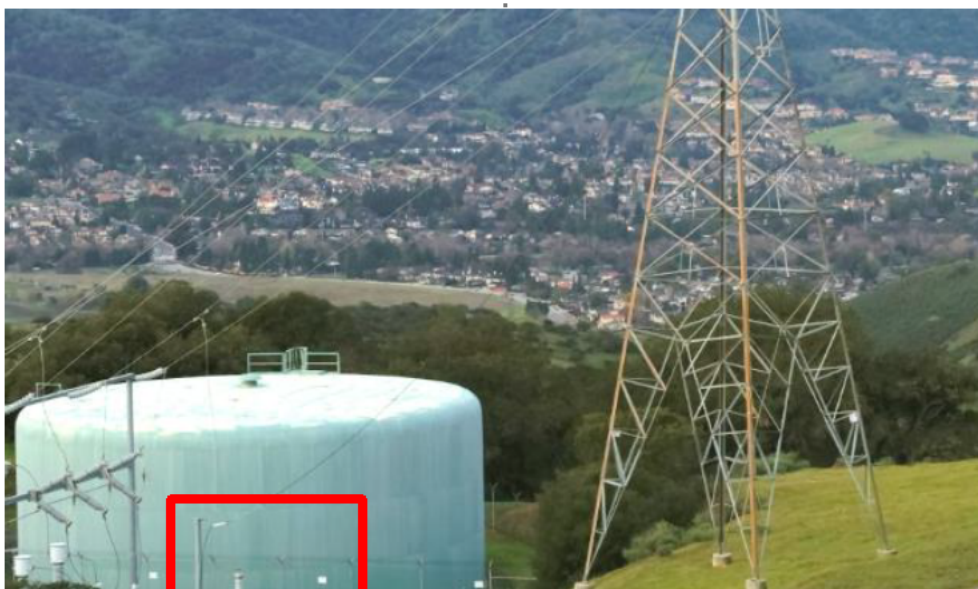
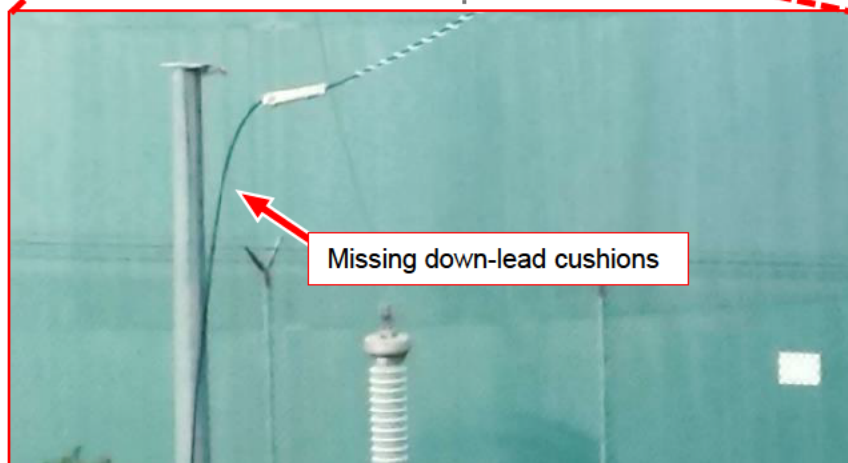
### Non-standard installation of ADSS.

Maximum spacing is 5 feet between down-lead cushions.

1. Initiate SAP Notification, Priority Code E (12 months).
2. Take close-up photos of the condition found.

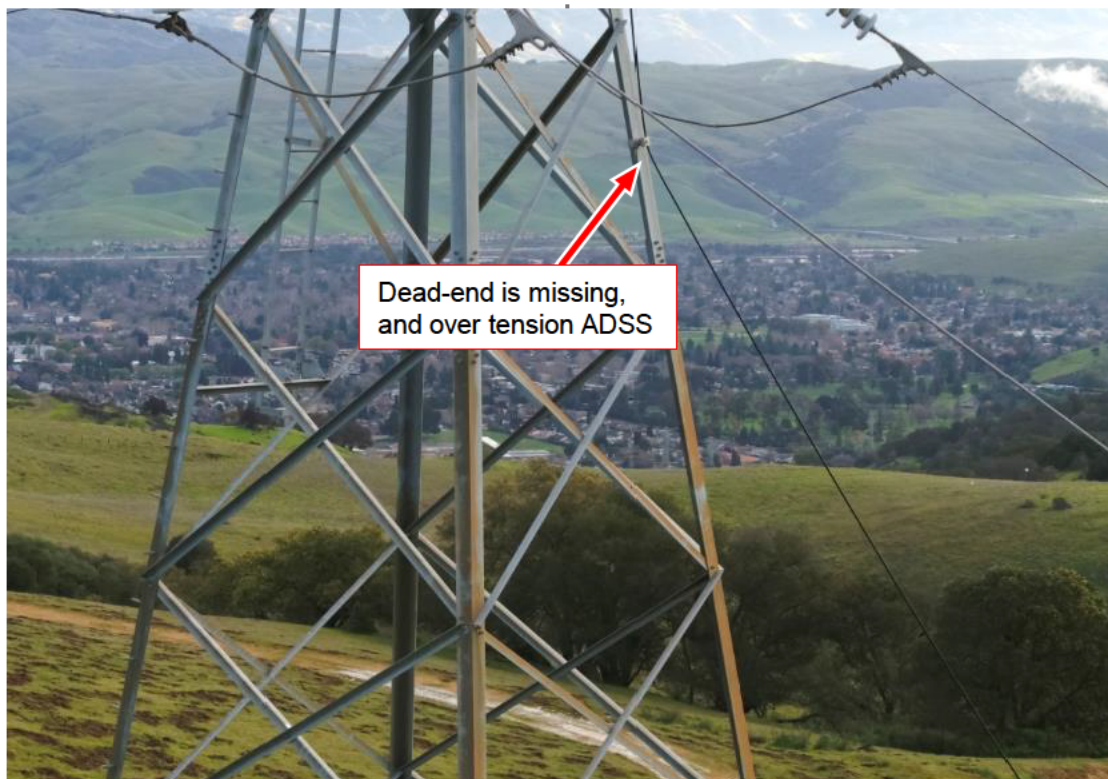
### Non-standard installation of ADSS.

1. Initiate SAP Notification, Priority Code E (12 months).
2. Take close-up photos of the condition found.

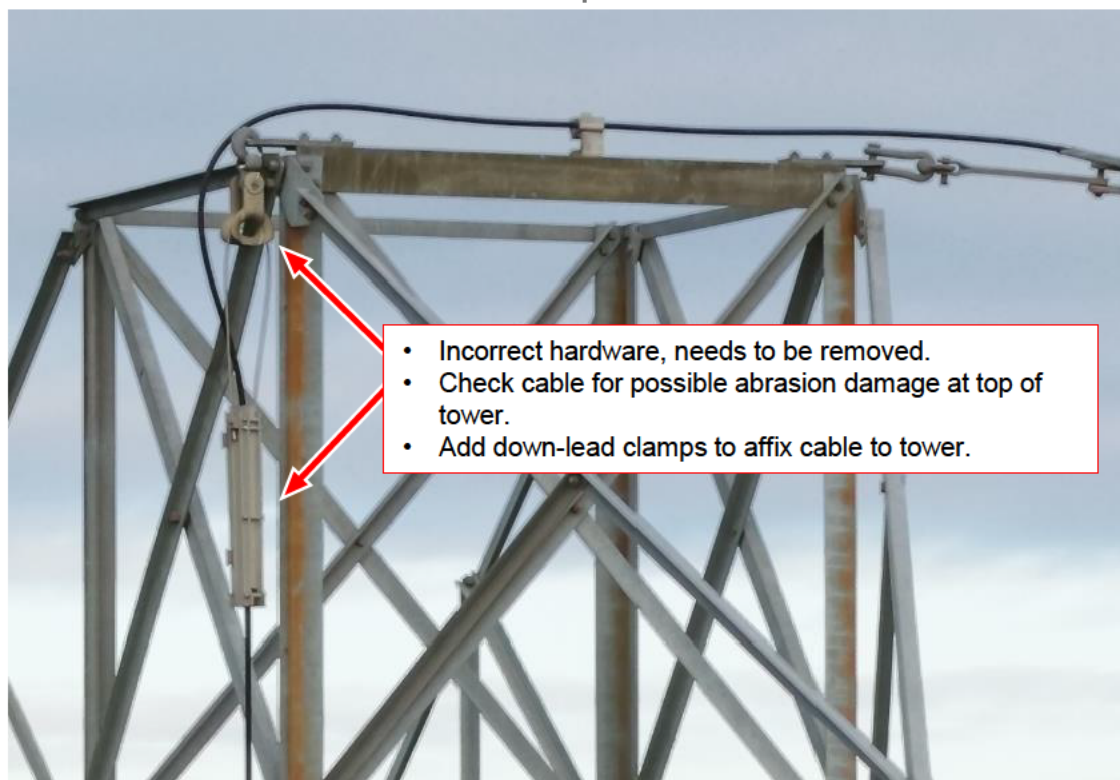
### Non-standard installation of ADSS.

1. Initiate SAP Notification, Priority Code E (12 months).
2. Take close-up photos of the condition found.
