This job aid provides consistent evaluation of all dielectric self-supporting cable (ADSS) in transmission lines, and consistent decision-making.

## ADSS Inspections

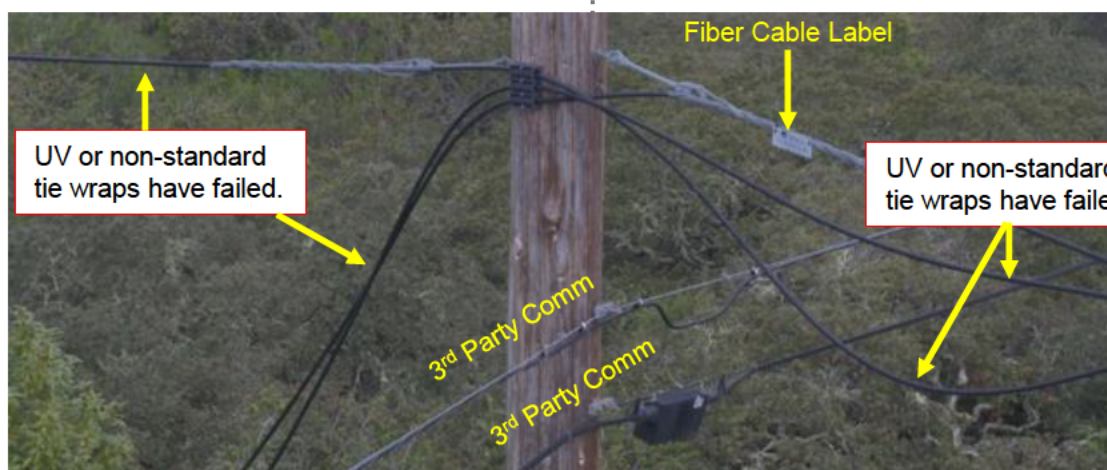
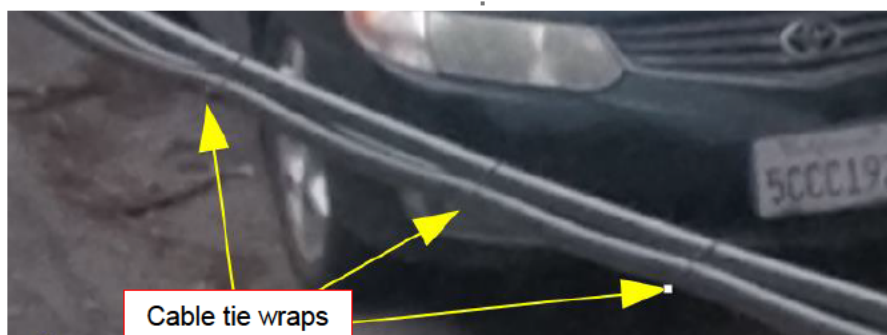
### Failed Tie-Wraps ADSS.

If a low hanging fiber cable presents a safety risk to the general public, discuss with the supervisor if this should be classified as a Priority Code A.

1. Initiate SAP Notification, Priority Code E (12 months).
2. Take close-up photos of the condition found.

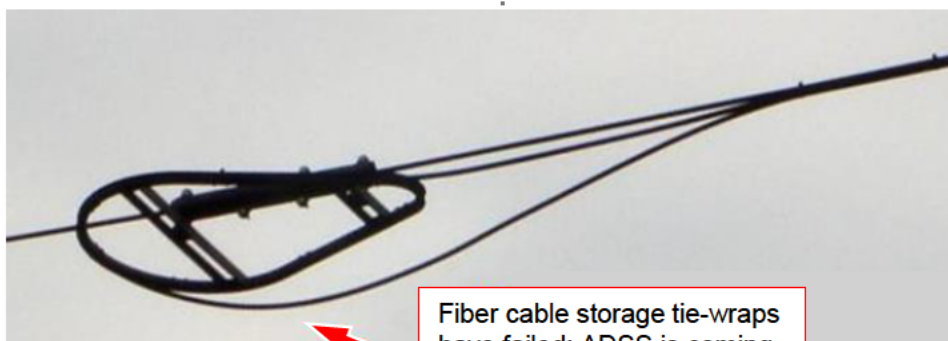
Fiber cable storage tie-wraps have failed; ADSS is coming loose from storage system.

1. Initiate SAP Notification, Priority Code E (12 months).
2. Take close-up photos of the condition found.

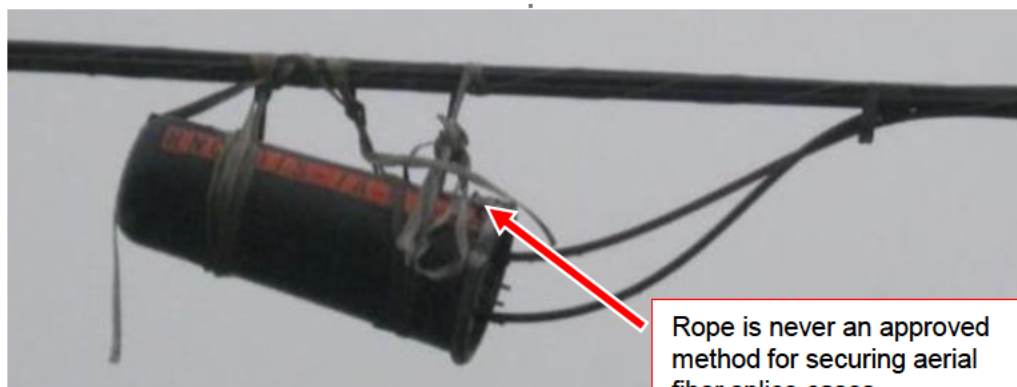
Rope is never an approved method for securing aerial fiber splice cases

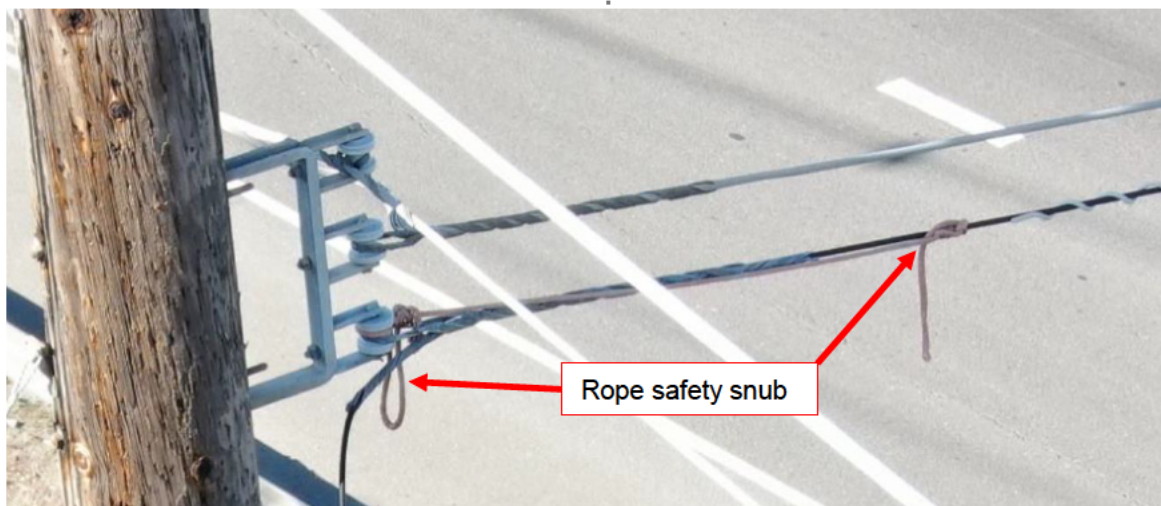
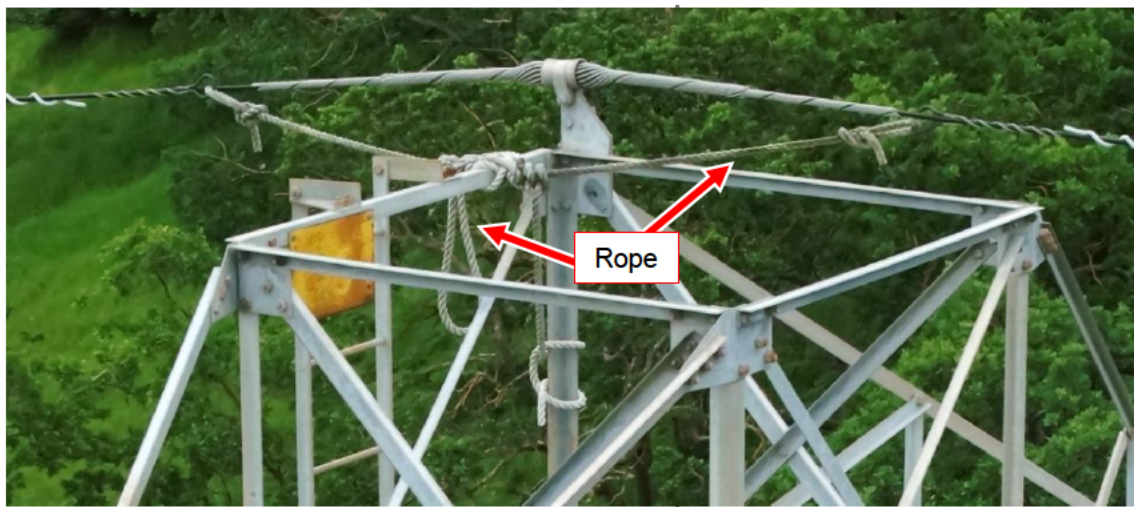
### Pre-Existing Rope Safety Snubs

Safety snubs are typically installed out past a damaged area on the ADSS cable, to provide a safety dead-end grip, in case the cable were to fail. The safety snub should be a preform snub and not rope.

IF rope is found in this scenario,  
THEN replace the rope with a fiber preform dead-end, with a corona coil installed on the end.

1. Initiate SAP Notification, Priority Code E (12 months).
2. Replace rope with a fiber dead-end assembly (dead-end, isolator, and corona coil).

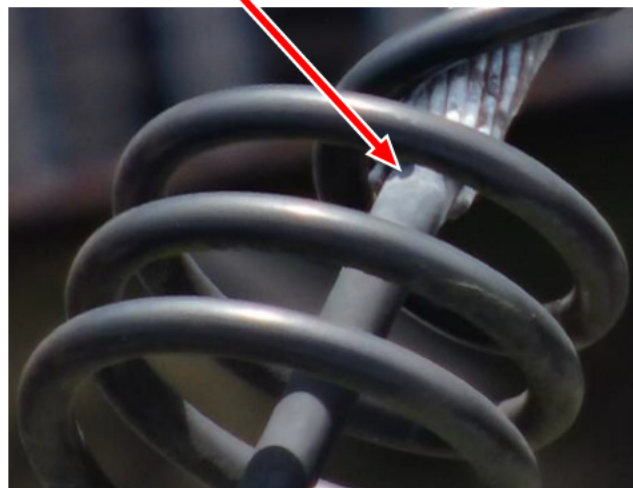
Sometimes, a whitish film is found on the cable jacket, which could be either Corona Discharge or sediment build up (pollution). This film can make it difficult to determine if there are any signs of E-Field damage. The whitish film can be removed by wiping the cable jacket down with a cloth. This provides better clarity as to whether E-Field damage is present. It is difficult to perform this action for Above Conductor installations and some Below Conductor installations. See Page 16 for reference.

Pollution or corona discharge?

- Inspector creates S5 SAP Notification F.
- CIRT reviews and confirms, and saves S5 with unique description (e.g., HOLD FILM ).
- CIRT emails IT Inspection team for review.
- IT Inspection team reports back to CIRT if an LC should be created or if the S5 notification is to be canceled.
  - The IT Inspection Team provides a priority recommendation, when responding to CIRT, for the fiber cable at the identified location.

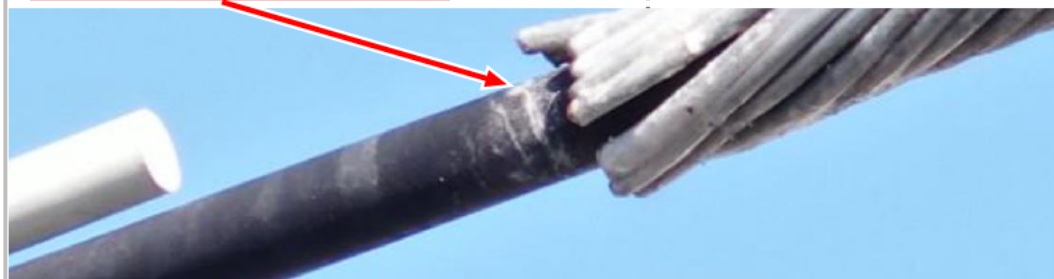
Pollution or Corona Discharge?

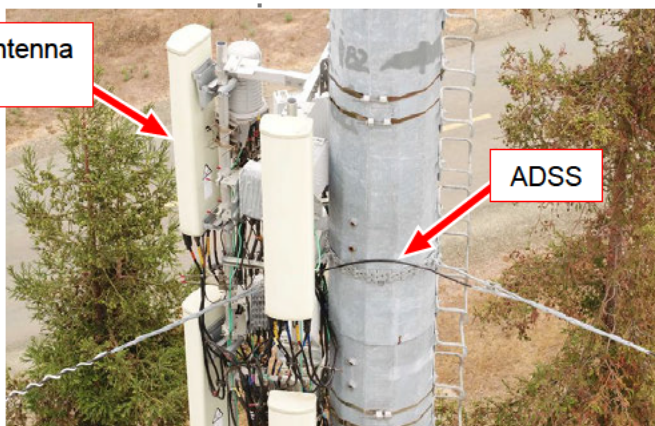
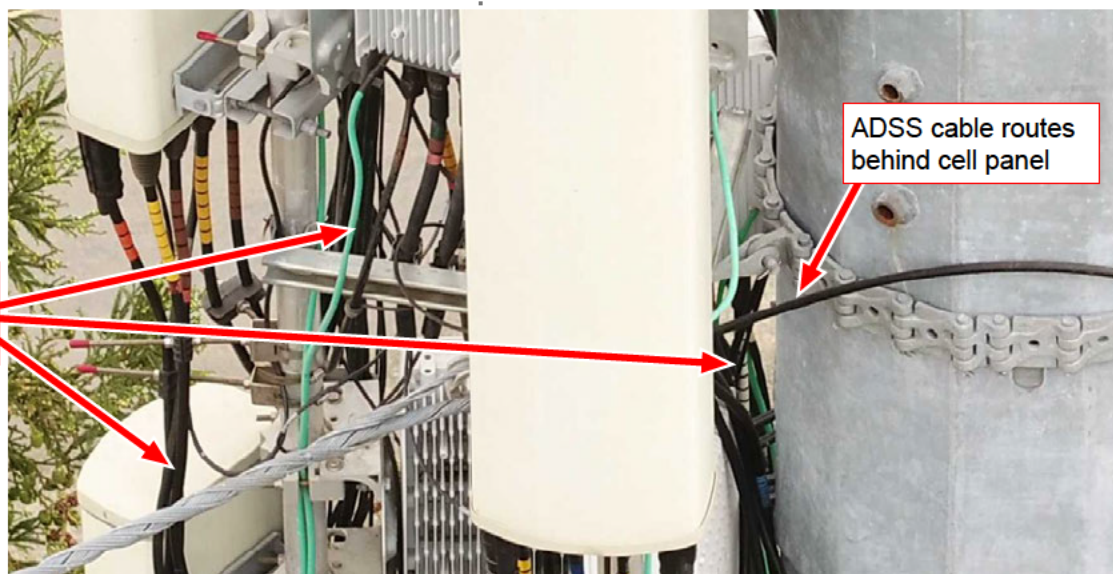
Cell/antenna cabling installed within less than 10 inches of ADSS cable and cell antenna vertical clearance to ADSS is less than 24 inches.

- 24-inch requirement is specified in G.O. 95, Rule 94.4C, which references Rule 38, Table 2, Case 21.
- 10-inch requirement is specified in G.O. 95, Table 2, Case 2, Column C note (ww).

ADSS cable routes  
behind cell panel

1. Follow [Utility Procedure TD-2014, "Notification of Conditions to Third-Party Utility,"](#) to notify the 3<sup>rd</sup> party of the Level 3 condition: [ThirdPartyNotice@pge.com](mailto:ThirdPartyNotice@pge.com).
2. Finding to be transferred to the New Revenue Development (NRD) group at [NRDLineProjects@pge.com](mailto:NRDLineProjects@pge.com).
3. Take close-up photos of the condition found.

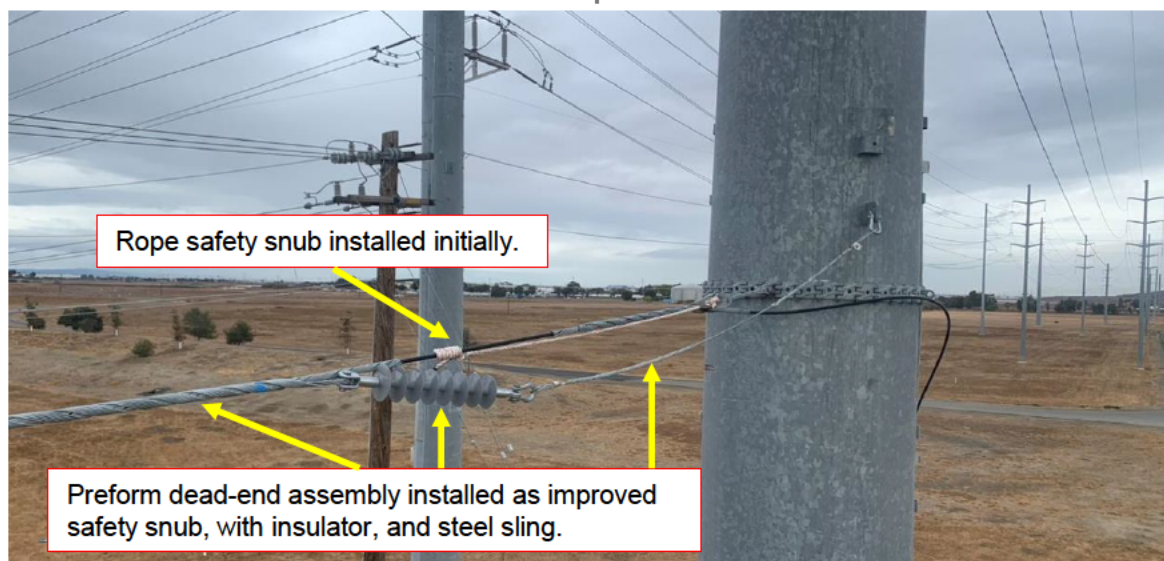
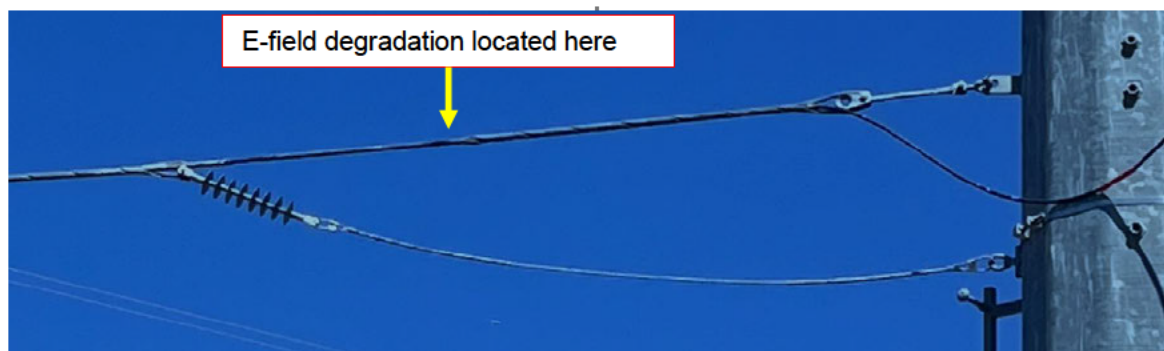
### Pre-Existing Fiber Dead-End Safety Snub

Safety snubs are typically installed out past a damaged area on the ADSS cable to provide a safety dead-end grip, in case the cable were to fail. The safety snub should be a preform dead-end – **not** rope.

1. Inspector creates S5 SAP Notification F.
2. CIRT reviews and confirms, and saves S5 with unique description (e.g., HOLD SNUB).
3. CIRT emails IT Inspection team for review.
4. IT Inspection team reports back to CIRT if an LC should be created or if the S5 notification is to be canceled.
  - The IT Inspection Team provides a priority recommendation when responding to CIRT, for the fiber cable at the identified location.
