Evaluating Conditions of Non-ADSS Lashed Fiber Cable in Transmission Line

This job aid provides steps for evaluation of non-all dielectric self-supporting (non-ADSS) lashed fiber cable in transmission lines and consistent decision-making process.

TD-1001M-JA22

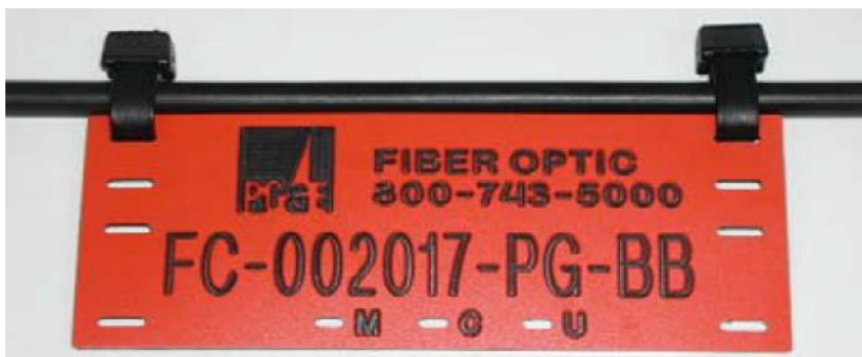
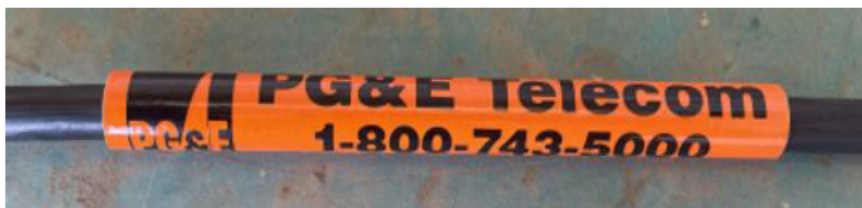
- Both IT fiber and copper cables are labeled with an orange Standard Cable label, as shown below. Fiber cables are identified by the leading prefix of “FC,” while copper cables are identified with the prefix of “CC.”

- The IT standard for labeling was implemented in 2004. Fiber and copper cables installed before 2004, may not be labeled.
- In accordance with California Public Utilities Commission (CPUC) General Order (G.O.) 95, PG&E fiber cables are to have a fiber label affixed to the cable at every wood pole, light duty steel pole, or tubular steel pole, when installed in the “below-conductor” position. Only one label is required at each structure; a label is not needed on each side of the structure. Below are examples of the two types of labels currently in use.

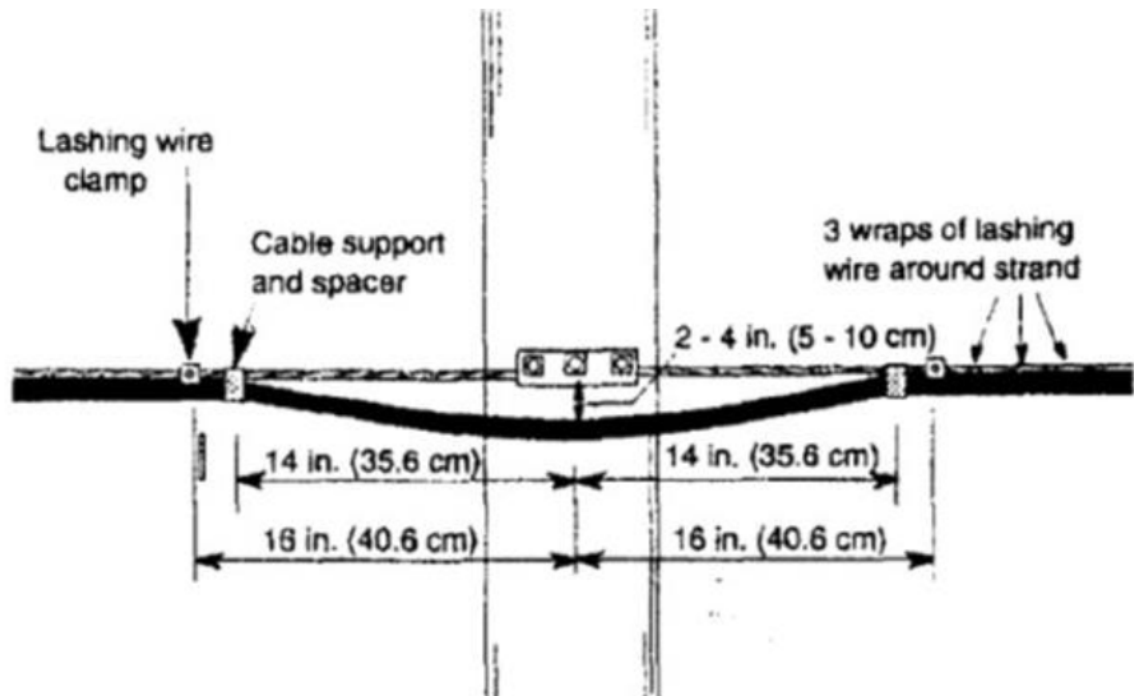
Aerial Cable Messenger Diagram

Non-Grounded Assembly

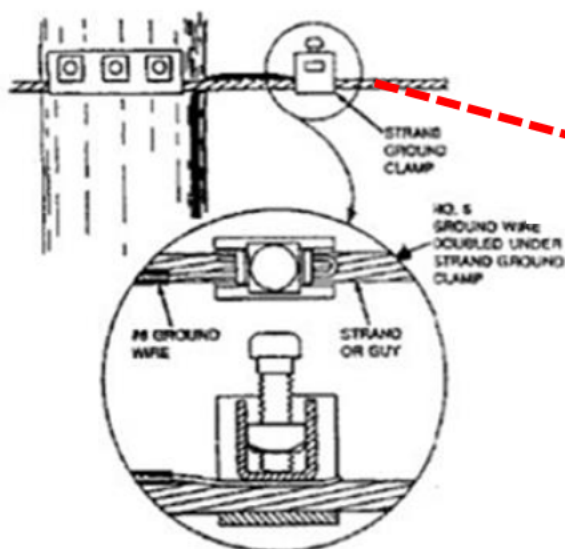
Maclean 438ALC Tap

- Minimum G.O. 95 requirements state that the messenger wire is grounded at each end of the run, and a minimum of intermediate points spaced not exceeding 800 feet apart.

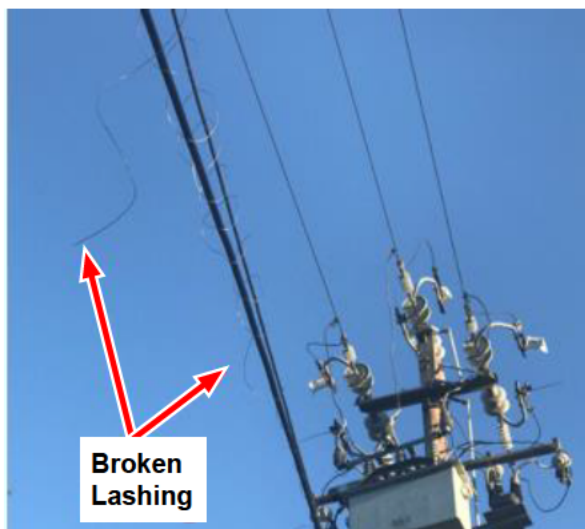
Condition 5

Broken Lashing Wire on Lashed Fiber/Aerial Duct.

- A crew will need to be dispatched to make safe, until the cable can be re-lashed.

Action:

1. Initiate SAP Notification, Priority Code A.
2. T-Line makes the situation safe by securing the broken lashing, so that it is no longer a threat to flip up into the conductors.
3. If cable removal is the only option to make safe, contact IT immediately, so that IT can notify the appropriate lines of business and 3rd party customers of the emergency outage.
 - Notify IT by calling the ENOC at [REDACTED].
 - Document the date, time, and the name of the person at the ENOC who took the call.
 - Capture this information in the comments field of the SAP Notification.
3. Take close-up photos of the condition found.

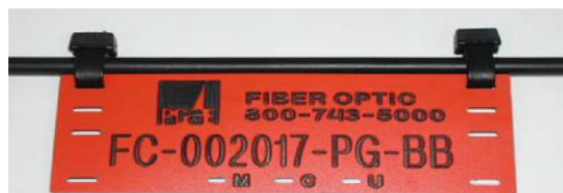
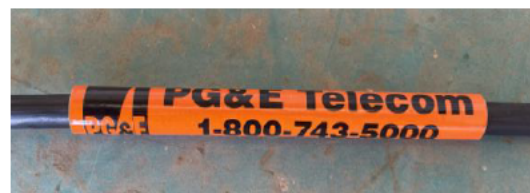
Condition 2

Missing Fiber Label

- In accordance with CPUC G.O. 95, the fiber cable is to have a label affixed to it at every structure location.
- Only one label is needed to be attached to the cable, on either side of the structure.
- The label must have "PG&E" and a phone number imprinted on it.
- Either of the two fiber labels shown below is acceptable.

Action:

1. Initiate SAP Notification, Priority Code F.
