Preliminary Ignition Investigation Report

Ignition Database Index:	20241189
Electric Incident Investigation (EII) Number:	N/A
Incident Name:	Amaral
PG&E Facility Ignition?	Yes
CPUC Reportable Ignition?	Yes
Date & Time of Incident:	August 21, 2024 @ approximately 1020 hours
Street Address:	Near Amaral Court and Rockville Road
City:	Suisun City
County:	Solano
Latitude/Longitude:	38.252714, -122.174453
State Responsibility Area (SRA) / Local Responsibility Area (LRA) / Federal Responsibility Area (FRA)	State Responsibility Area (SRA)
PG&E Division:	Sacramento
High Fire Threat District (HFTD):	Tier 2
High Fire Risk Area (HFRA):	Yes
EPSS Buffer:	No
Fire Index Area (FIA):	180
Fire Potential Index (FPI) Rating: FIA	R3
Fire Potential Index (FPI) Rating: Circuit	R3
Was there a PSPS event at the time of ignition?	No
Suspected Initiating Event:	Contact – Animal – Bird
Failure Driver:	Contact from object
Failure Sub-driver:	Contact – Animal – Bird
Circuit:	Cordelia #2 Tap

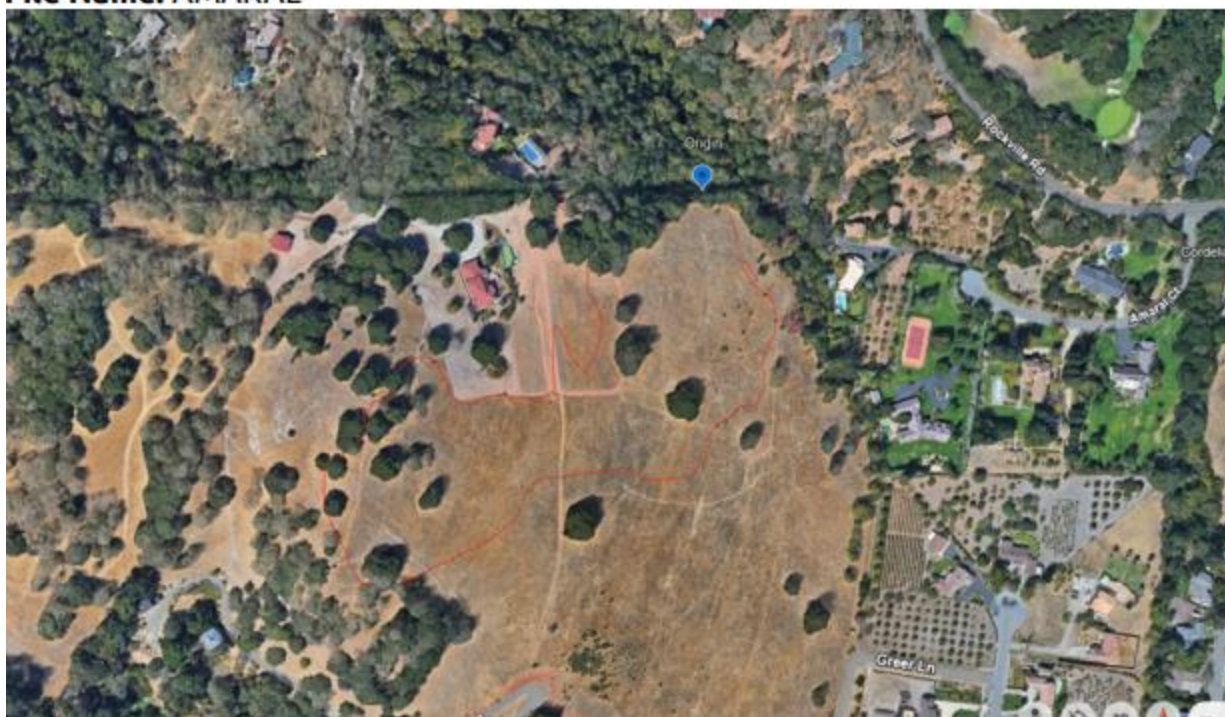
Figure 2 Image of Incident Location from CAL FIRE report. Blue dot indicates the location of the transmission Structure # 004/095.

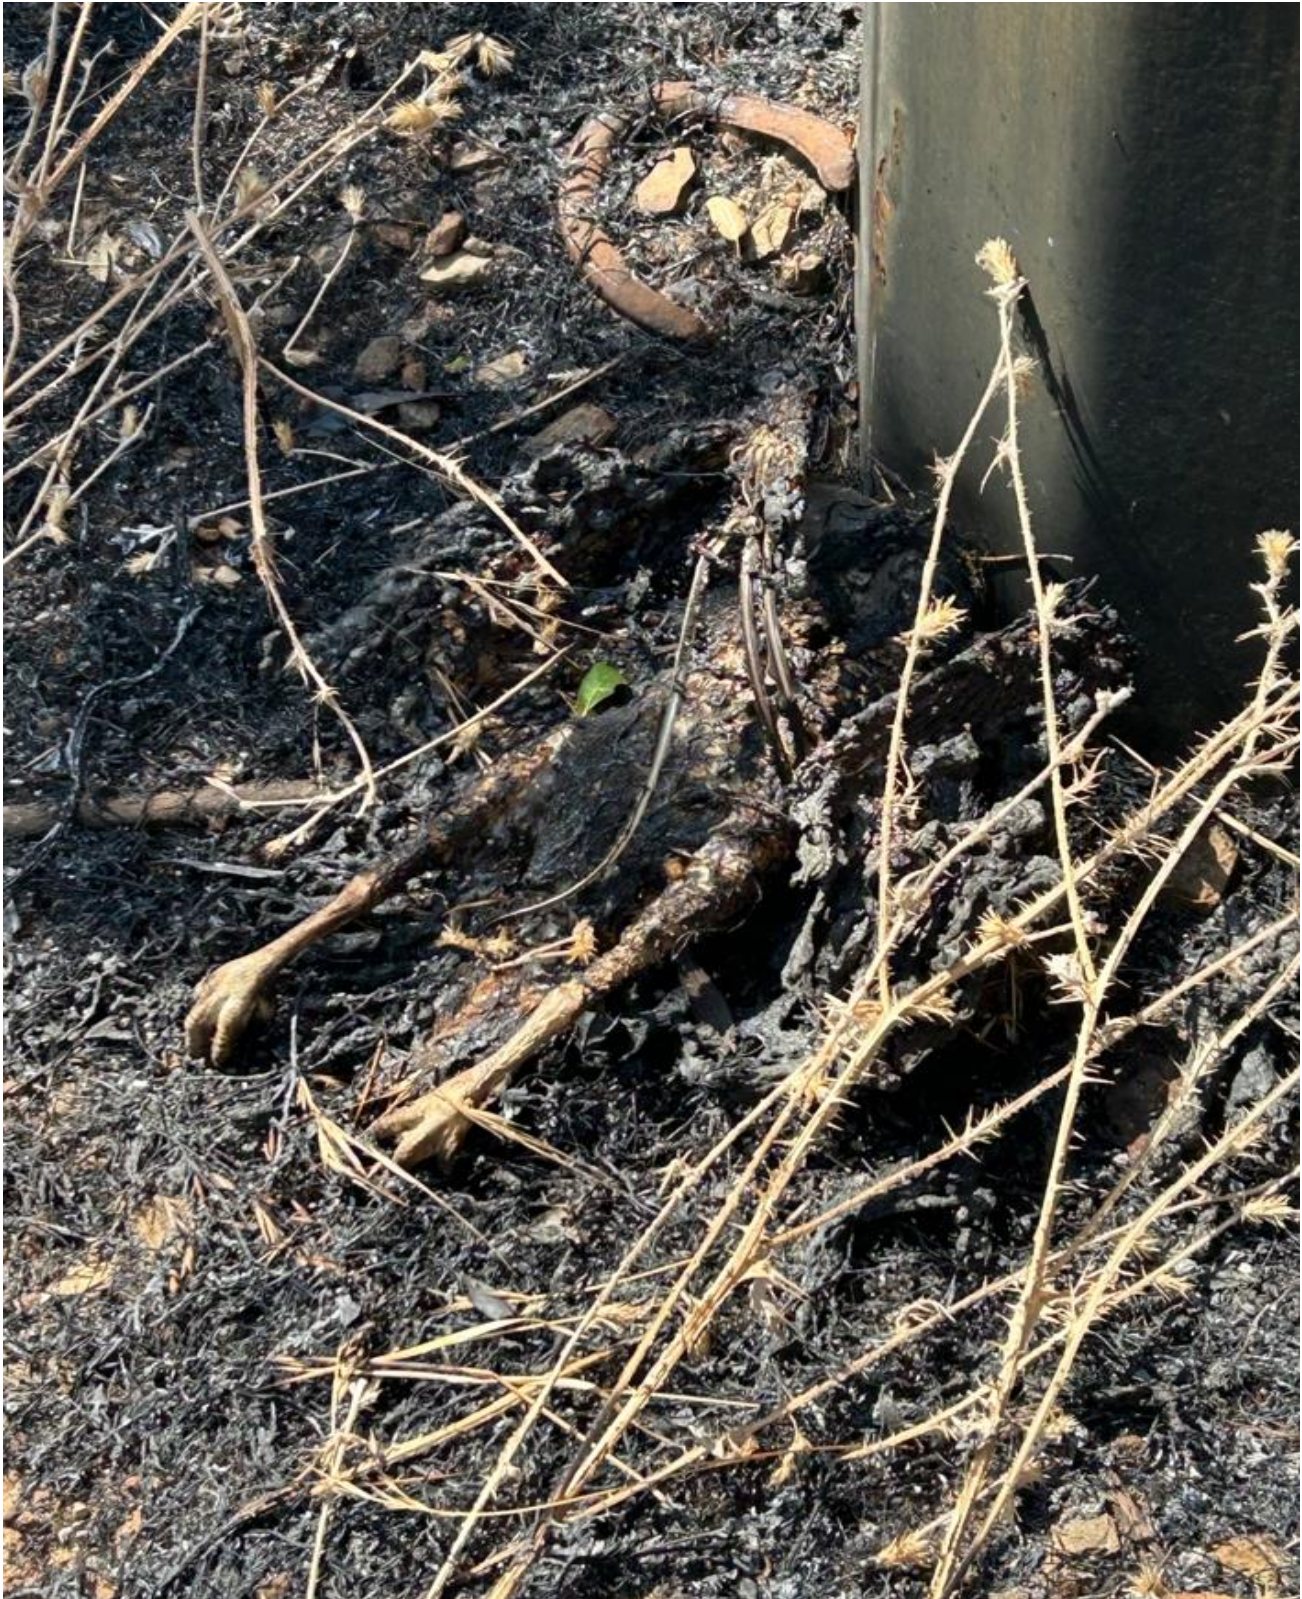
Figure 3 Photo of dead bird found at base of pole taken by troubleshooter on the date of incident.

The troubleshooter arrived on scene at approximately 1031 hours and observed a dead (burnt) bird at the base of the transmission pole SAP ID # 45138158 / Structure # 004/095, with distribution underbuild (Napa 1112). Initial analysis indicates a bird made contact with 60kV transmission line which resulted in a vegetation fire measuring 10.75 acres in size³. The troubleshooter completed a patrol of the fault location and found no damage to line or equipment. The transmission line was returned to service.

Analysis of the incident from PG&E Electric Program Manager and Avian Subject Matter Expert (SME) indicates a wild turkey appears to have made contact with the transmission's center phase while landing or taking flight from the crossarm. The turkey fell dead at the base of the pole and a fire ensued. A Bird Incident Report (Bird Incident Reporting Incident No. ETR0821240946) was created on August 22, 2024. The SME completed a historical review of the Cordelia #2 60kV transmission line. This incident was the only avian contact related ignition going back 10 years. The risk of this location and surrounding area sustaining a similar incident remains low. No additional mitigations were recommended as a result of the incident.

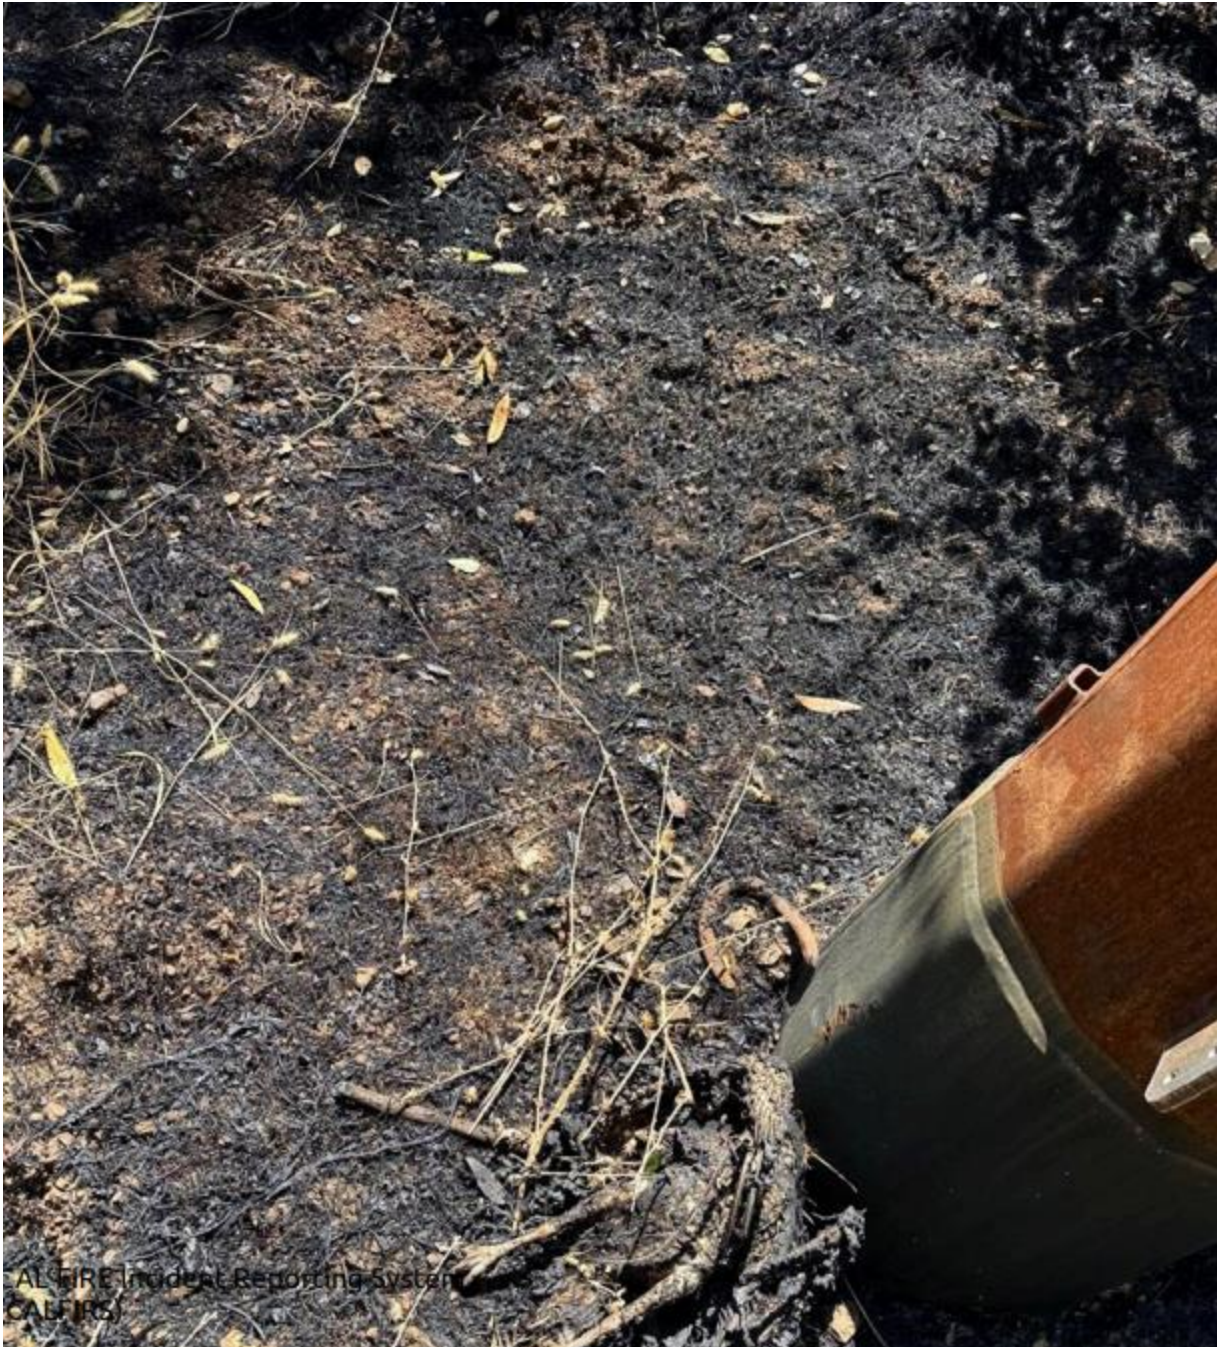
Figure 4 Photo of specific origin area taken from CAL FIRE report. Dead bird and transmission pole.

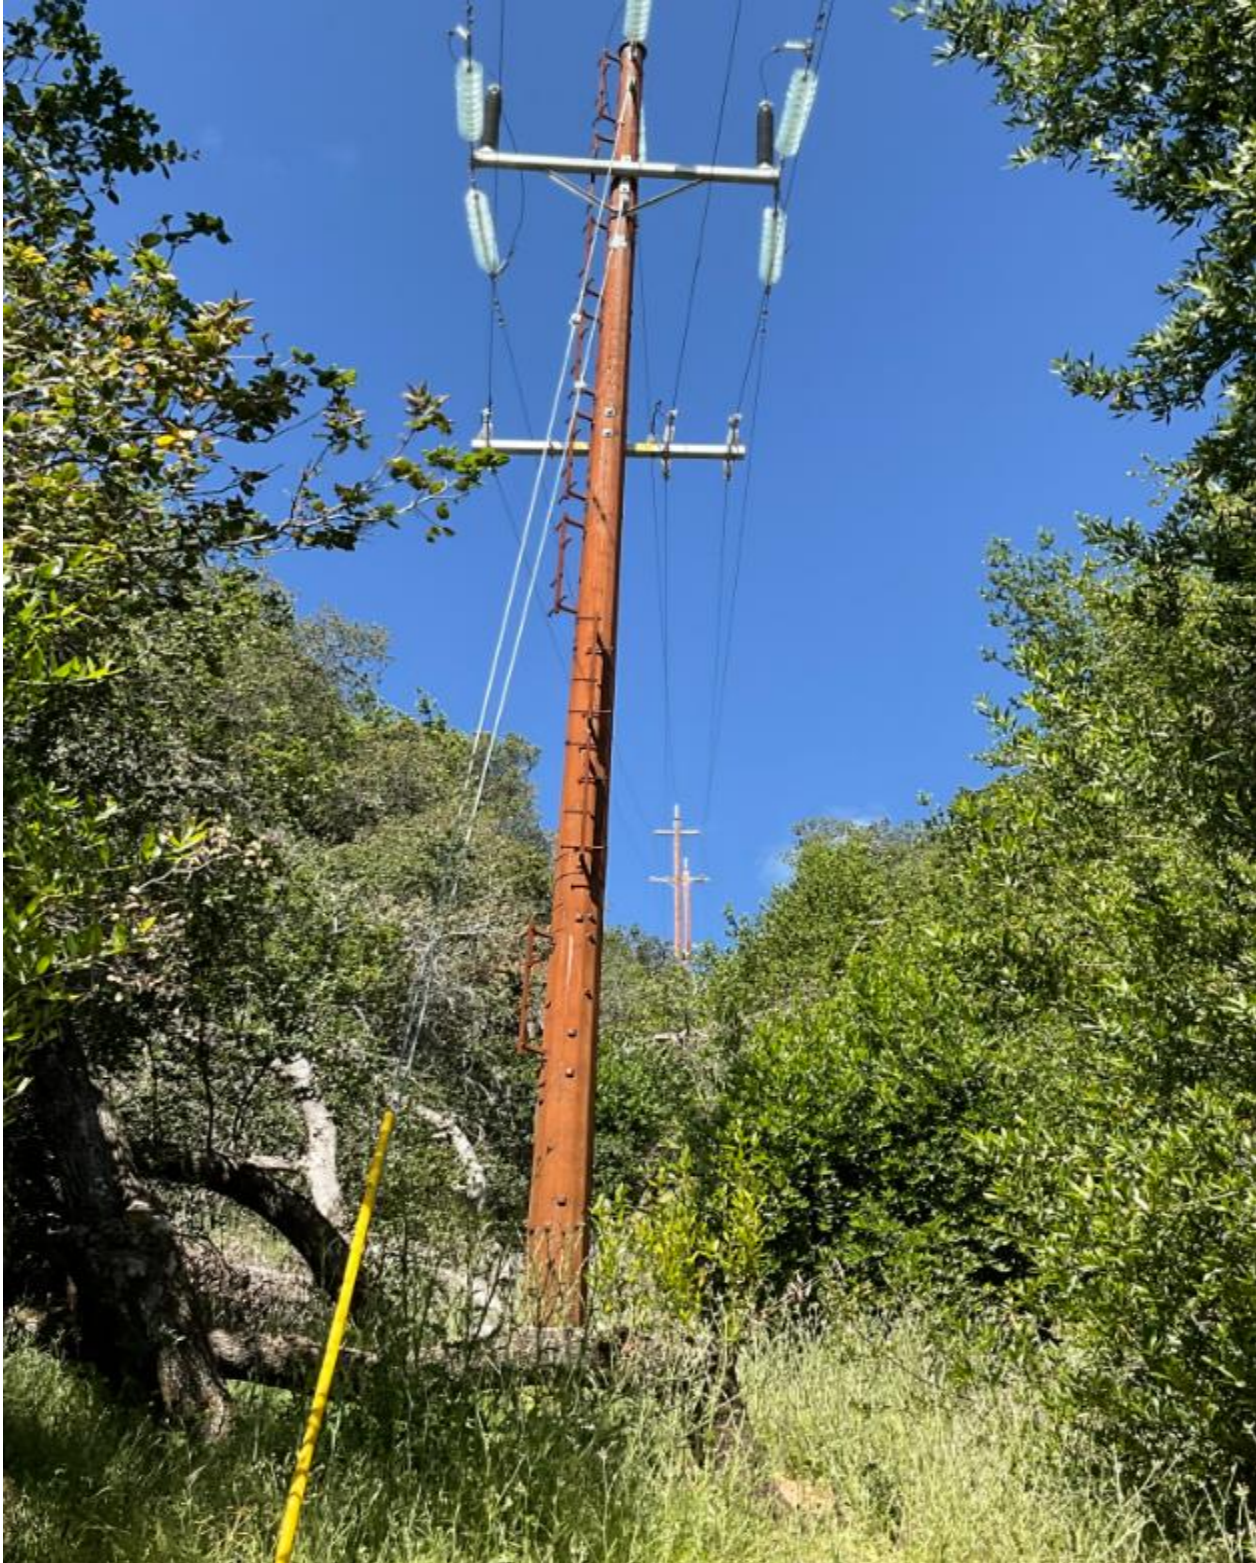
Figure 5 Photo taken during Compliance Inspection on May 10, 2022 (EC Notification # 123559383) for Distribution underbuilt (SAP Equipment ID # 104051394 - Distribution).

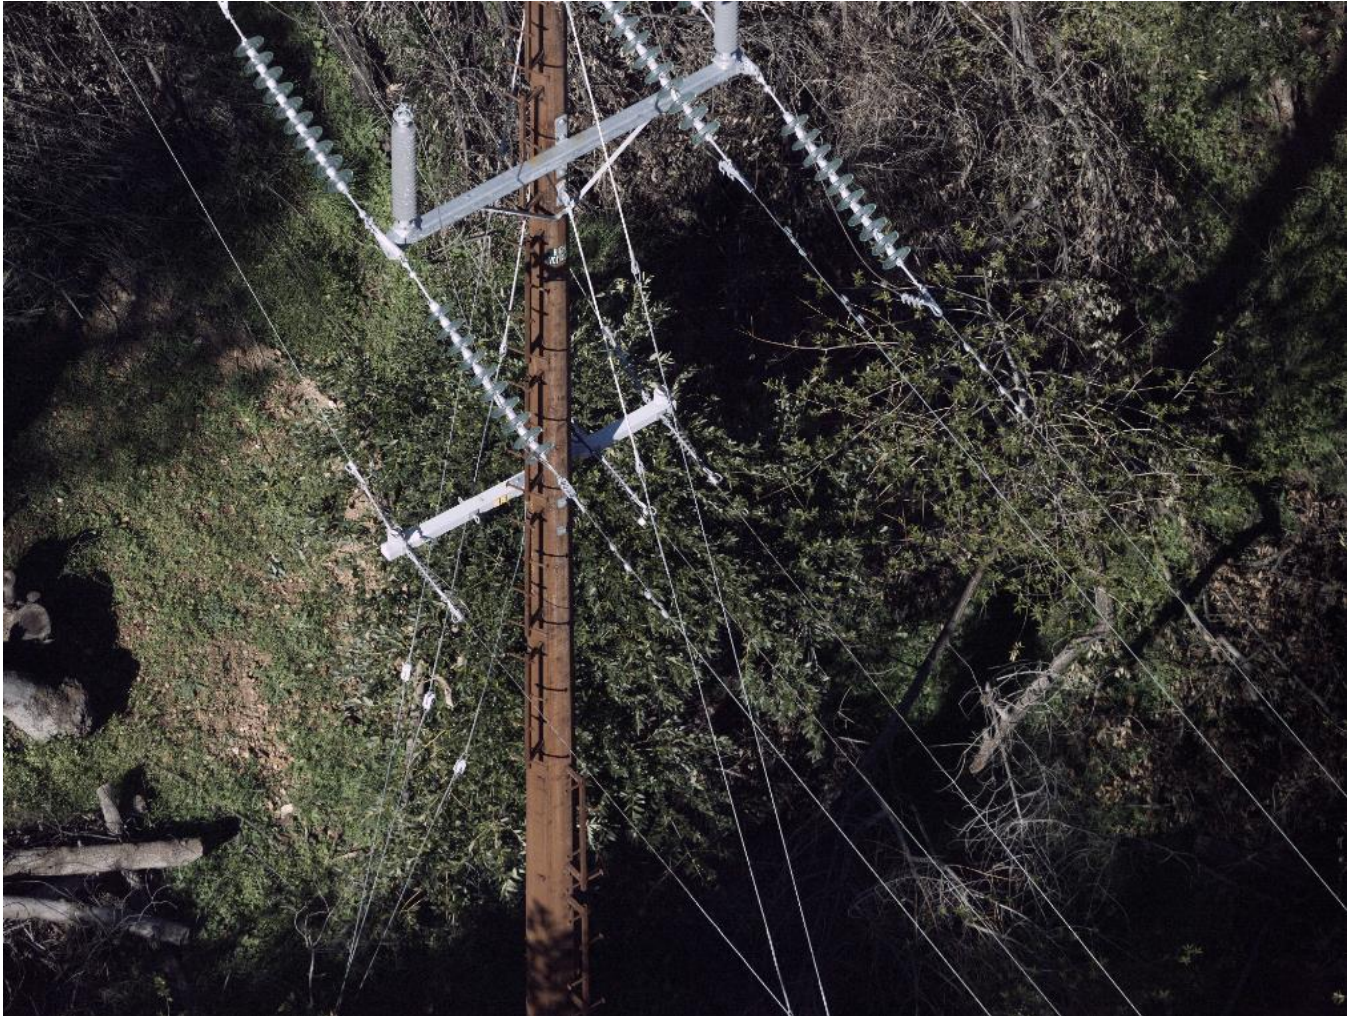
Figure 6 Aerial image taken on May 14, 2022 obtained from Sherlock database. No compelling abnormal conditions identified during inspection.
