Job Aid: Overhead Assessment

TD- 2305M-JA02
WMP-Discovery2023-2025 DR SPD 024-Q003Atch02
Publication: 01/06/2025 Effective: 01/14/2025

Rev: 14

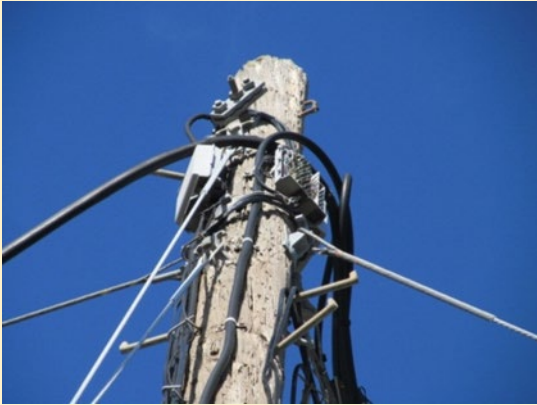
COMMUNICATION IN CLIMBING SPACE

At this Location:

Obstructed climbing space, access via bucket truck from street below. Also, look for clearance issues between communications facilities and the PG&E down guys.

**Perform Minor Work:** No**Write 3rd Party Notification:** No**Write EC Notification:** No

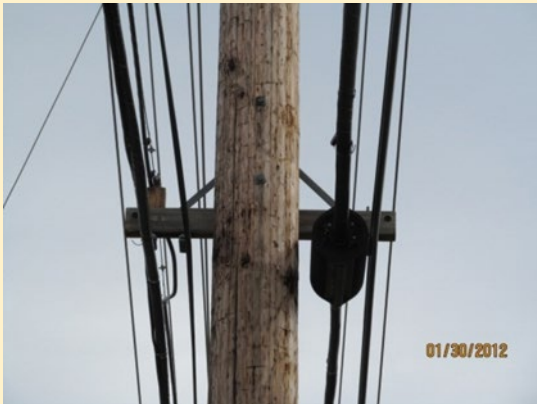
CLIMBING SPACE OBSTRUCTED

At this Location:

Climbing space obstruction by communication facilities on pole with equipment. Communication messengers are too close. No bucket truck access.

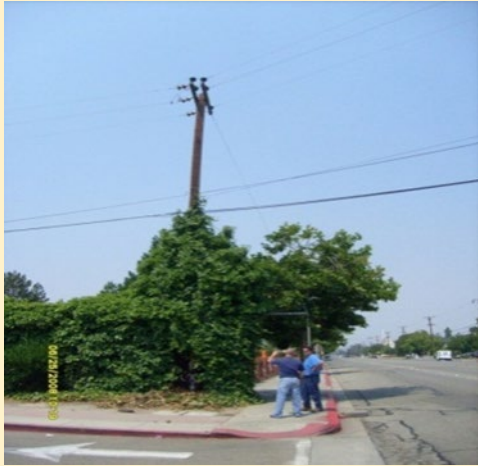
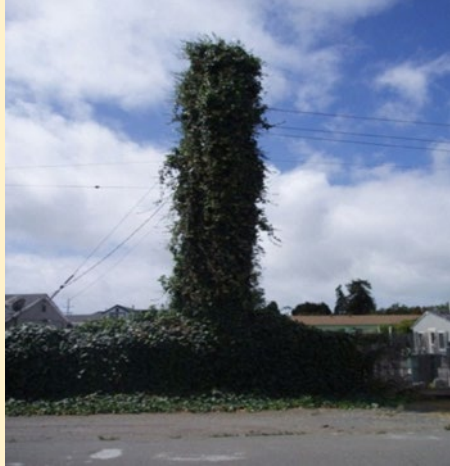
POLE WITH VEGETATION	IVY COVERED POLE

At this Location: 360° pole inspection not possible

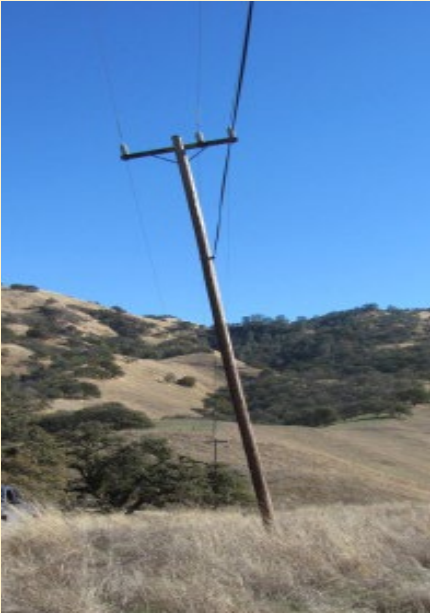
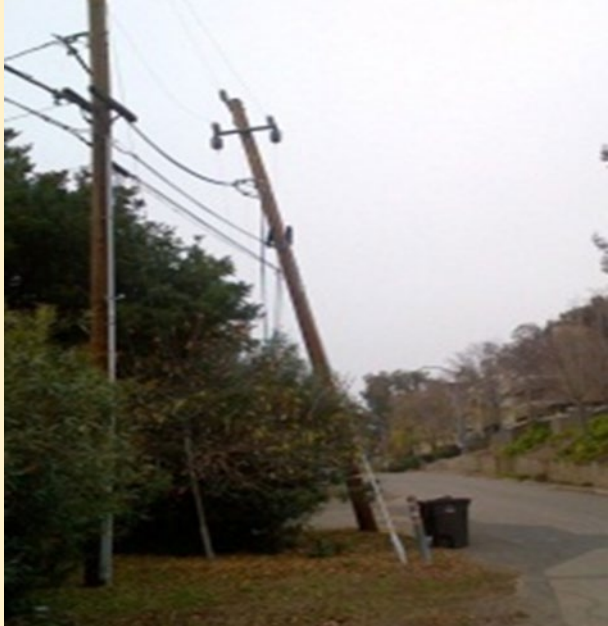
LEANING POLE	LEANING SLACK SPAN

<p>At this Location: Leaning pole greater than 10% out of plumb. No equipment, in rural area.</p> <p>

</p>
<p>Perform Minor Work: No</p>	<p>Perform Minor Work: No</p>
<p>Write 3rd Party Notification: No</p>	<p>Write 3rd Party Notification: No</p>
<p>Write EC Notification: Yes FDA= Pole / Leaning / Adjust</p>	<p>Write EC Notification: Yes FDA= Pole / Leaning / Replace</p>
<p>Priority= Minimum E Tag, depending on exposure</p>	<p>Priority= Minimum E Tag, depending on exposure</p>

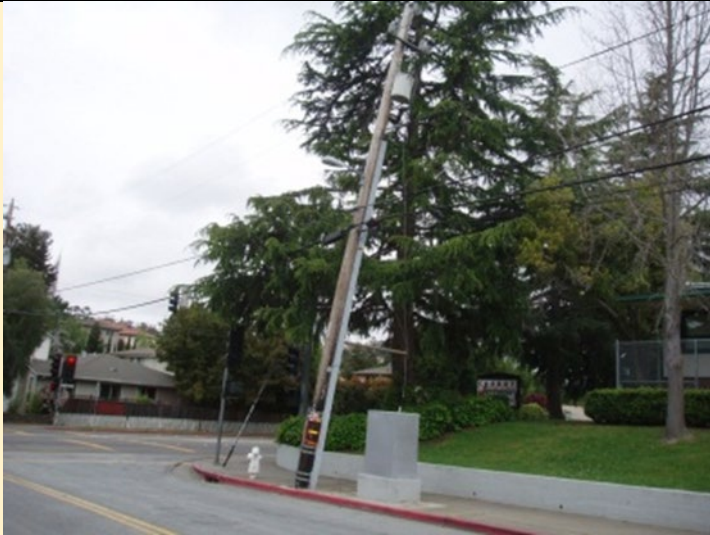
STUBBED POLE LEANING TOWARDS SCHOOL	POLE BENDING 3 POT TRANSFORMER IN BUCK POSITION

<p>At this Location: Stubbed pole leaning more than 10% and less than 20% towards school, supported by down guy. Pole Bands are loose due to additional deterioration of the pole.</p>

FDA= Pole / Lean / Replace

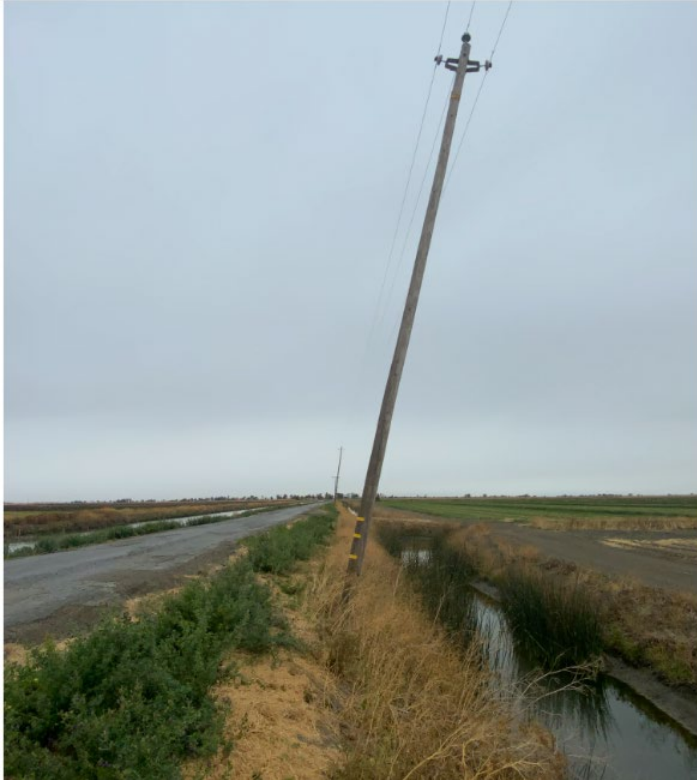
LEANING POLE

At this Location: Leaning pole greater than 20% out of plumb. No equipment, in rural area.

Priority= Minimum X Tag, depending on exposure.

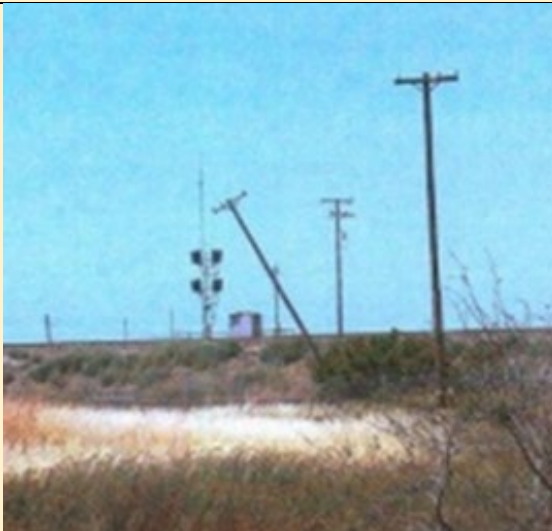
POLE LEANING NEAR RAILROAD TRACKS

At this Location: Severe lean greater than 20% with low conductor over railroad.

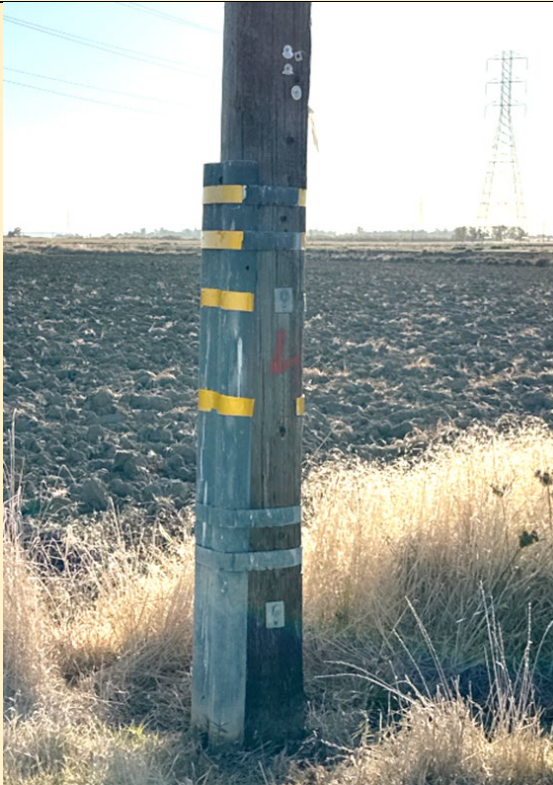
STUBBED POLE – DOES NOT NEED REPAIR

At this Location: Metal stubbed pole.

Refer stub pole procedure.

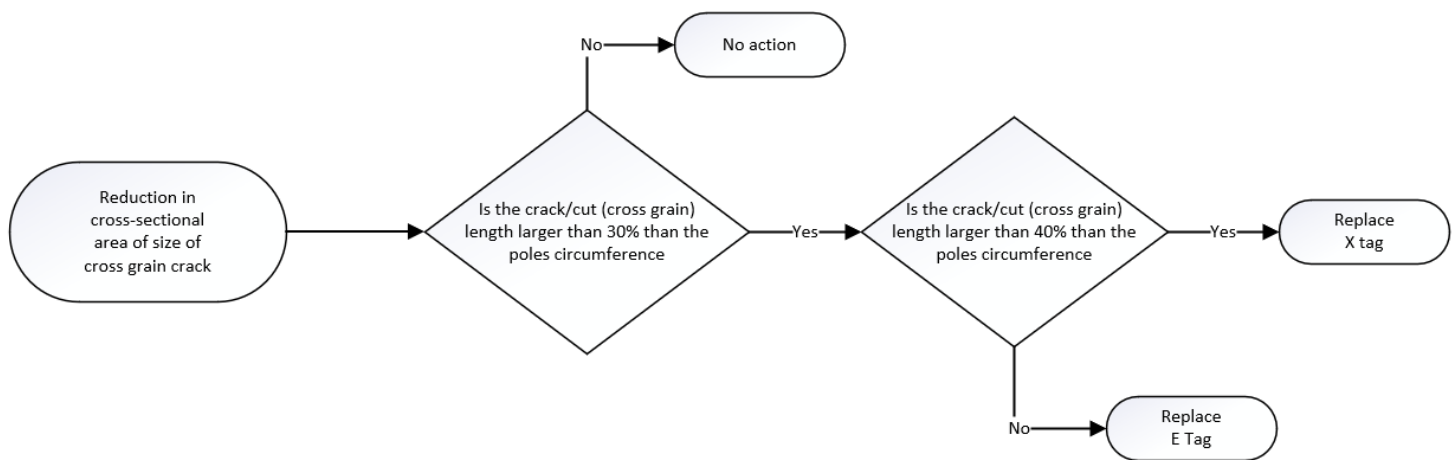
Figure 1: Schematics of a Pole Cross Section

General Guidance: Slice is a reduction in cross sectional area. It could be horizontal and can include mechanical damage, horizontal cracks, or cuts into pole. Circumferential damage to only 1 side of the pole. If the damage is large enough in relation to the size of the pole, write EC tag for Pole / Broken / Damage / Replace. In the long text of the EC notification, document approximate percentage of damage to circumference.

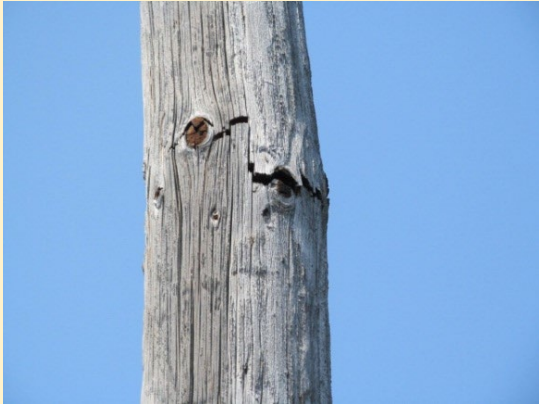
BROKEN POLE

At this Location: Broken pole, not supported.

Perform Minor Work: No
	Write 3rd Party Notification: No
	Write EC Notification: Yes FDA= Pole / Broken/Damaged / Replace Priority= A Tag, Follow the Emergency Procedure Note: Flow chart doesn't lead us here, but inspector should use knowledge as a lineman to identify

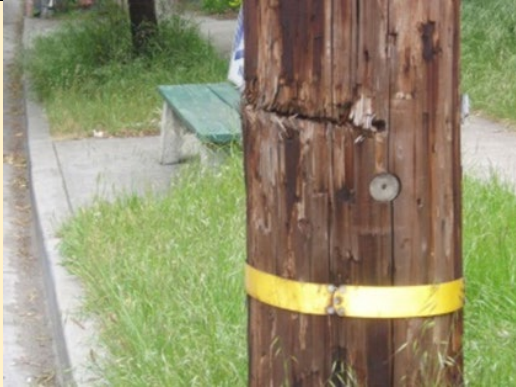
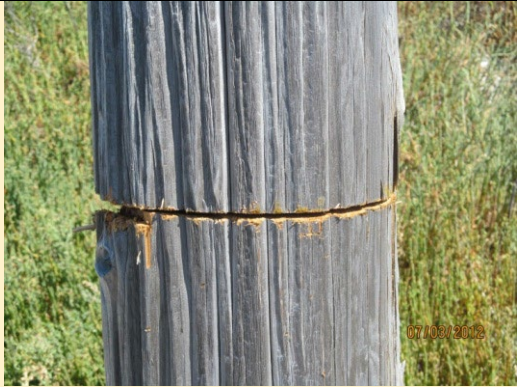
CUT INTO POLE

At this Location: Vandalized pole. Chain saw cut into lower portion of pole. Arc length 20 inches (>40% circumference)

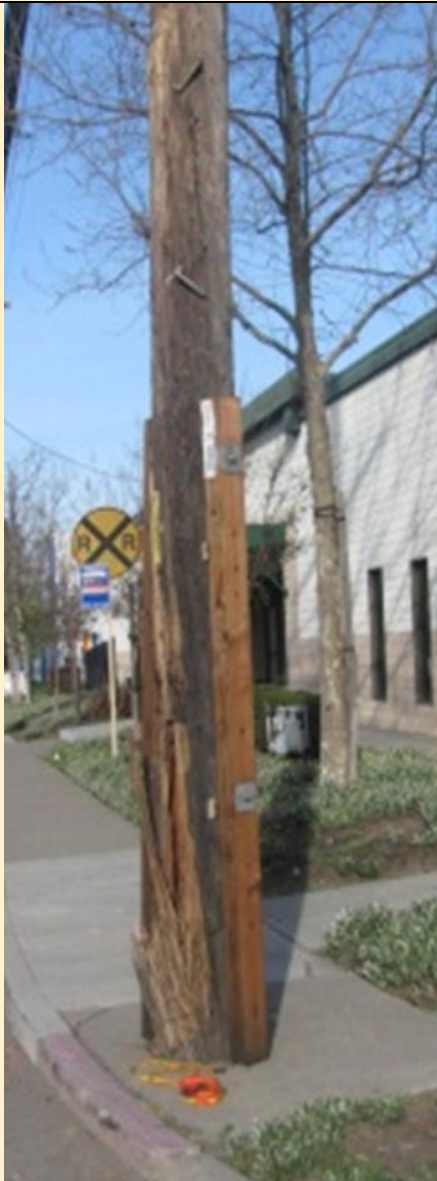
VEHICLE DAMAGE, TEMP REPAIRS MADE

At this Location: Pole damaged by vehicle. Cross-arm acting as Splint installed as temporary repair. Circumference of pole at base is 32 inches. Arc length of damage is 18 inches. (>40% circumference)

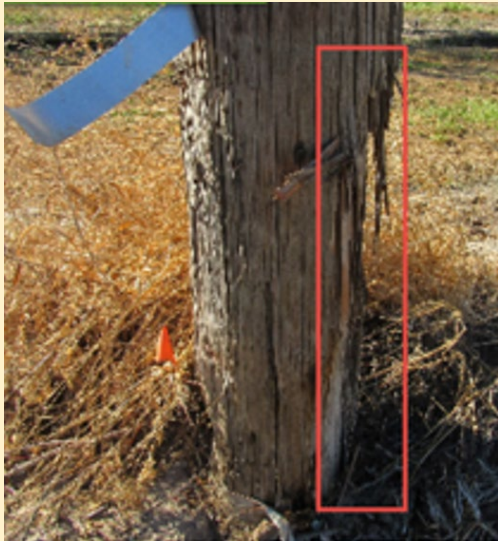
SIGNIFICANT ARC LENGTH DAMAGE (TRACTOR DAMAGE)

At this Location: Significant arc length damage (Tractor Damage). Refer to reduction in cross-sectional area flow chart.

Priority= Minimum E Tag, depending on exposure

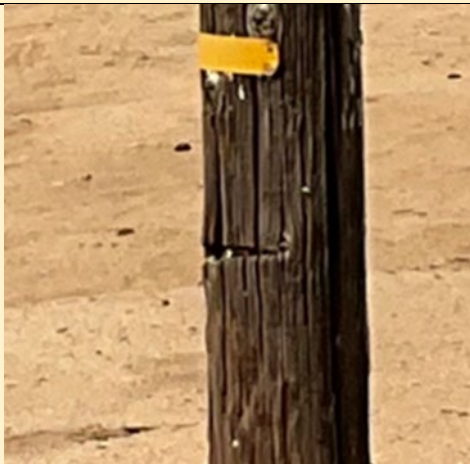
CUT INTO POLE

At this Location: Cut into pole. Not a deep cut, no strain on pole, no public exposure. Refer to reduction in cross-sectional area flow chart above.

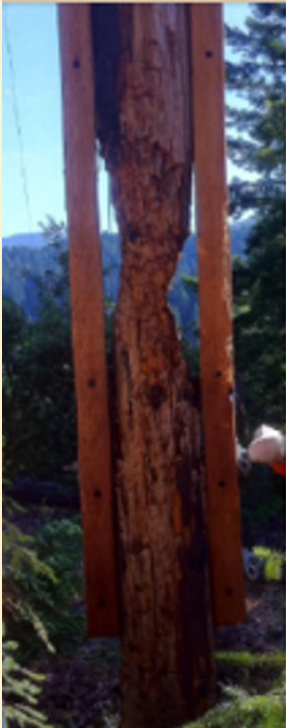
SIGNIFICANT REDUCED CIRCUMFERENCE (BEAR DAMAGE)

At this Location: Significant Reduced Circumference (Bear Damage). Temporary Repairs made.

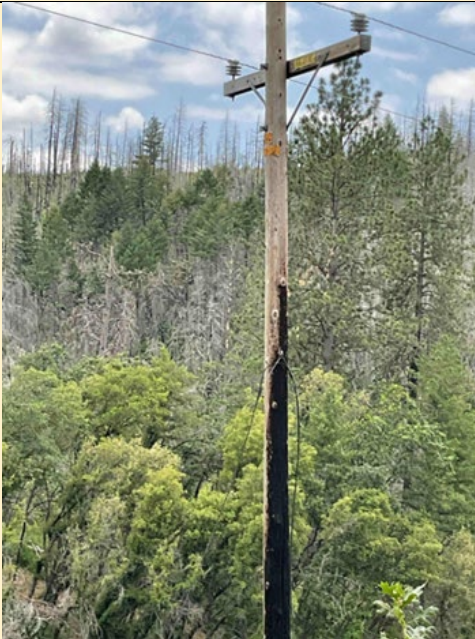
BURNT POLE

At this Location:

Pole is burnt. Scrape pole to ensure circumference is not impacted.

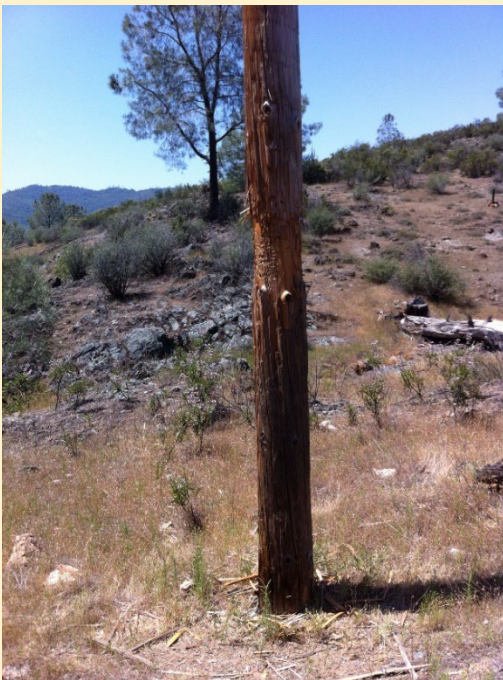
DAMAGE TO POLE FROM SPECIFIC EVENT

Pole has reduced circumference; healthy wood has 32 inches and damaged section has 27 inches.
Pole= ~15% circumference reduction

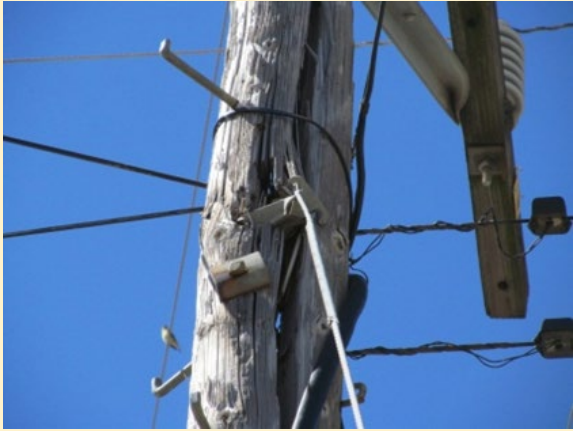
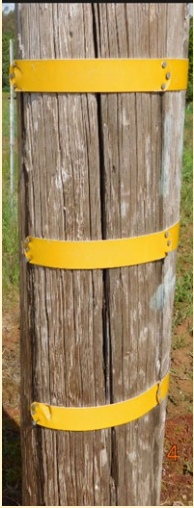
POLE SPLIT AT COMMUNICATION LEVEL	POLE CHECK

<p>At this Location: Pole split, can see daylight through pole at communication level. Joint pole.</p>

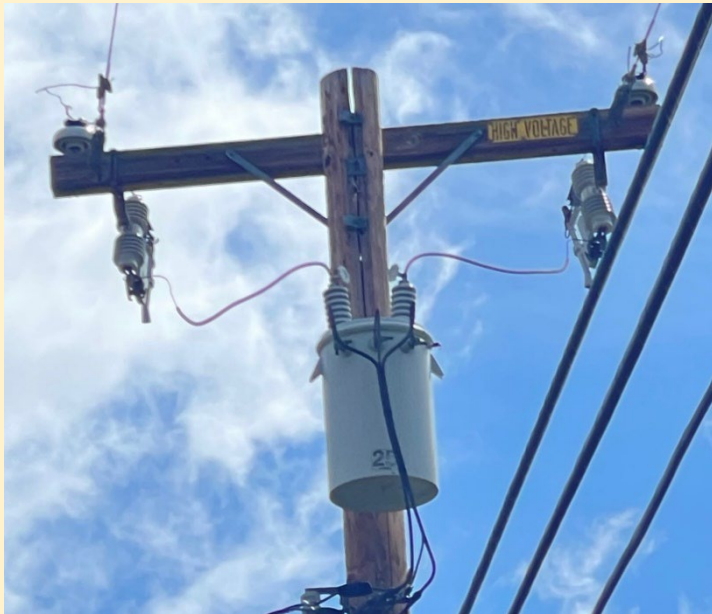
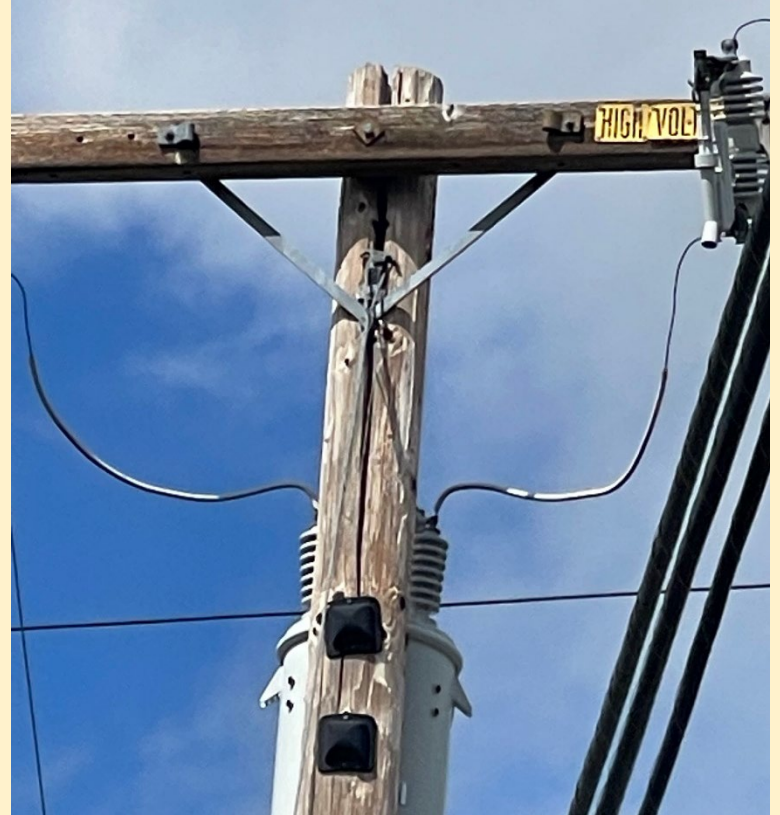
POLE SPLIT

At this Location: Pole top split and can see daylight. Dead end single guy, down guy fixture has moved and slid down from original location onto the brace. Cross-arm brace hardware also compromised. No split bolt.

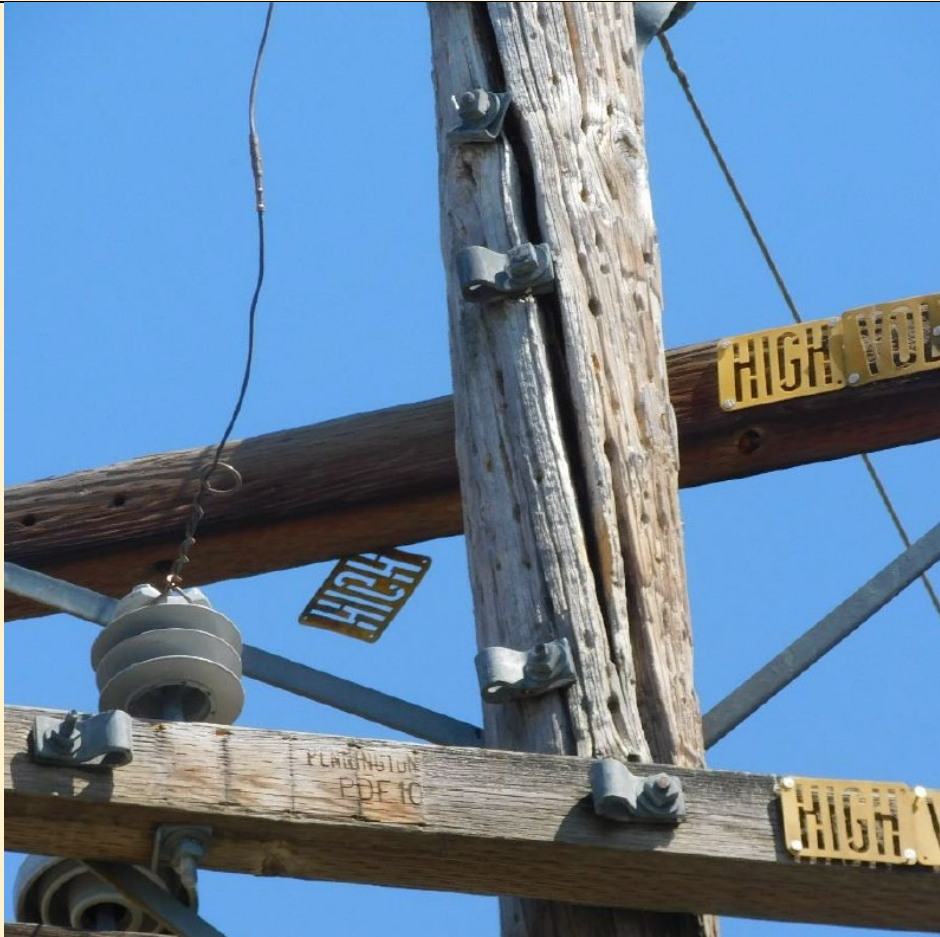
POLE SPLIT

At this Location: Checks are opening on the pole at the equipment level. Multiple checks, possible movement on the cross-arm hardware, at the brace bolt on the top cross-arm. Hardware sinking in, pole twist spiral.

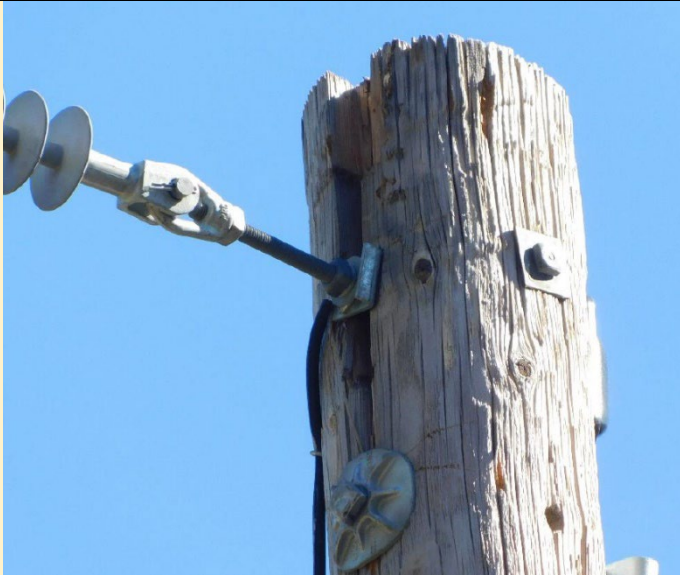
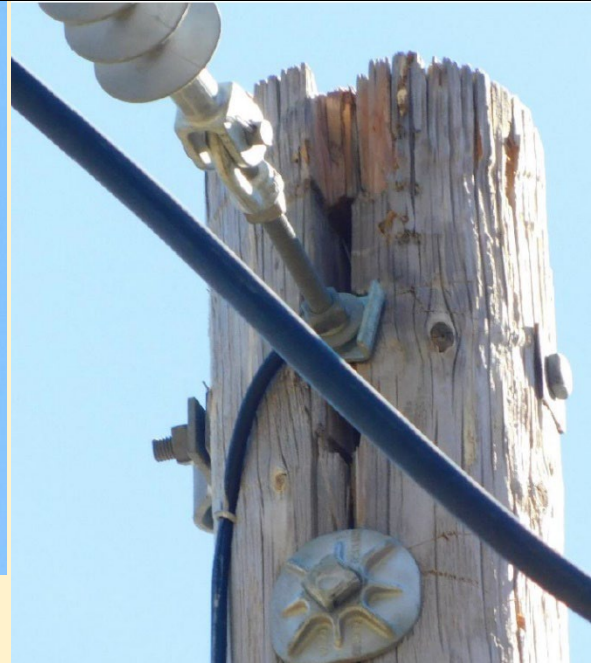
POLE SPLIT

At this Location: Split in the pole top has been corrected with a split bolt, but the dead end has moved and is laying on top of the split bolt.

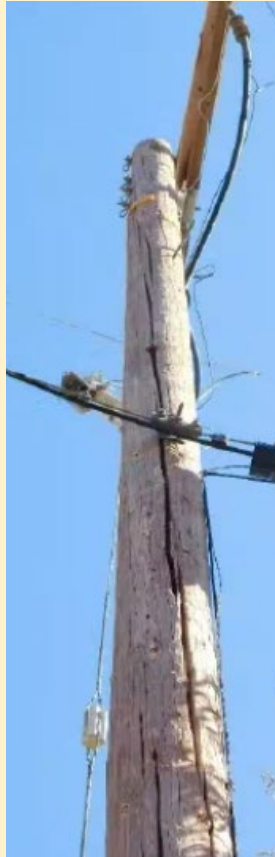
POLE CHECKS

At this Location: Pole Checks. Multiple vertical cracks running down pole are not at the points of attachment affecting the hardware. No compelling abnormal conditions to report.

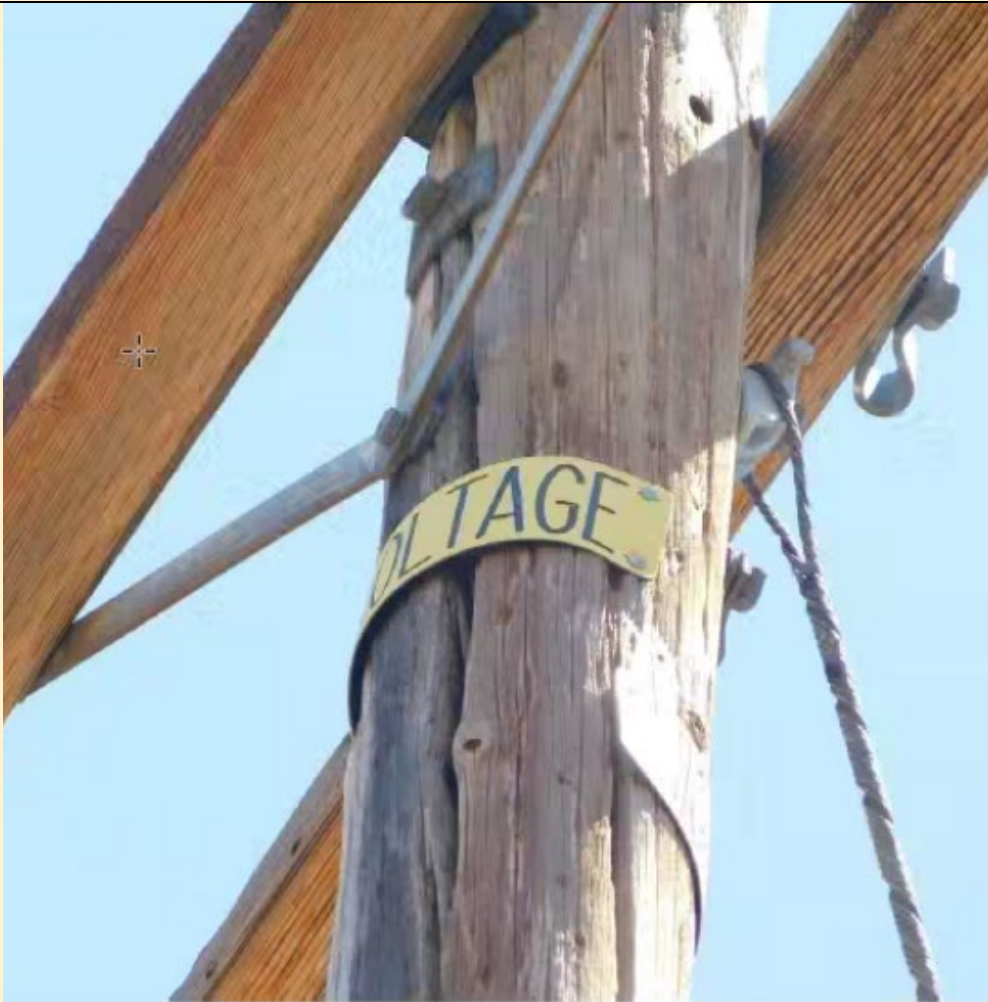
POLE CHECK

At this Location: Pole checks at the equipment level attachments but not affecting the hardware. Not a compelling abnormal condition.

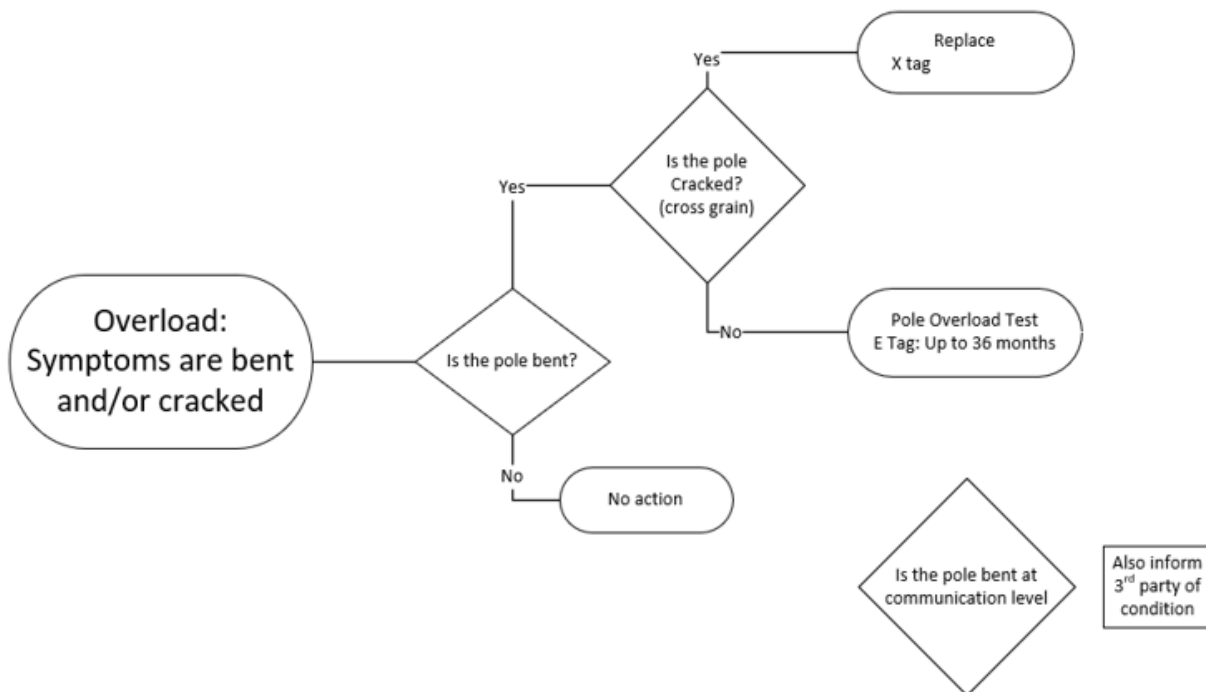
Common drivers for deformed poles: Improper/lack of guying, third party attachment.

Review clearances to verify no reduced clearance issues, all levels of clearance requirements that could result in contact, fire risk, or public safety.

Minor Work: No

EC Notification: Follow flow chart.

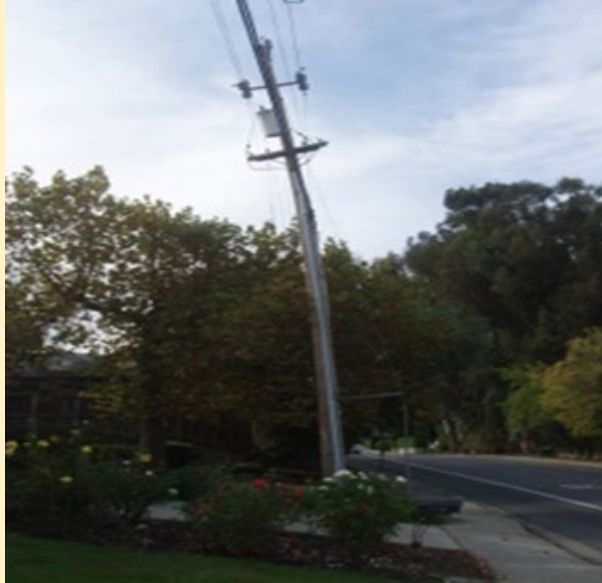
POLE BENT 4 FEET OUT OF LINE

At this Location: Pole is bent 4 feet out of line and has horizontal crack. Deformed in the middle of the pole, towards vegetation.

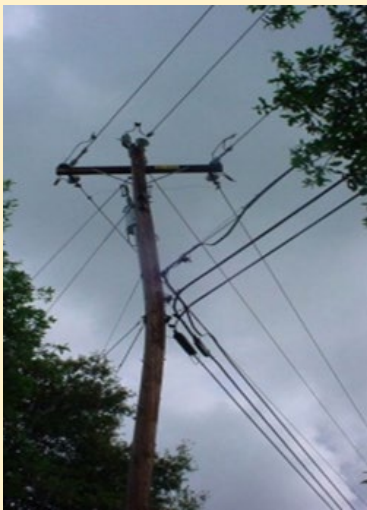
INADEQUATE SUPPORT AT COMMUNICATIONS LEVEL

At this Location: Pole is bent at communication level. No horizontal crack. Two guys stabilizing communication level.

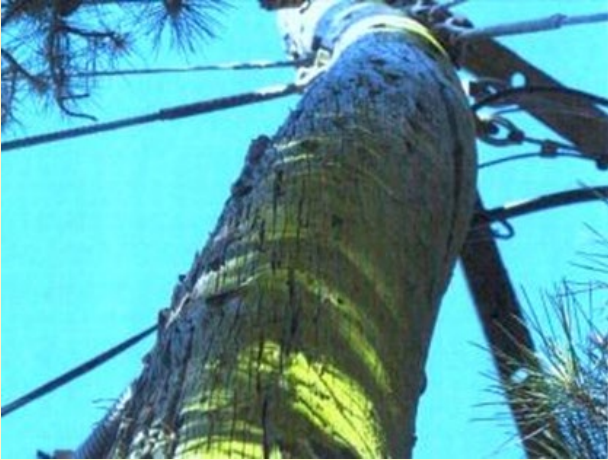
OVER STRESSED POLE	UNBALANCED LOAD AT TOP

<p>At this Location: Pole is twisted, cracked, due to communication. Field comments "overloaded by communications". No horizontal crack.</p>

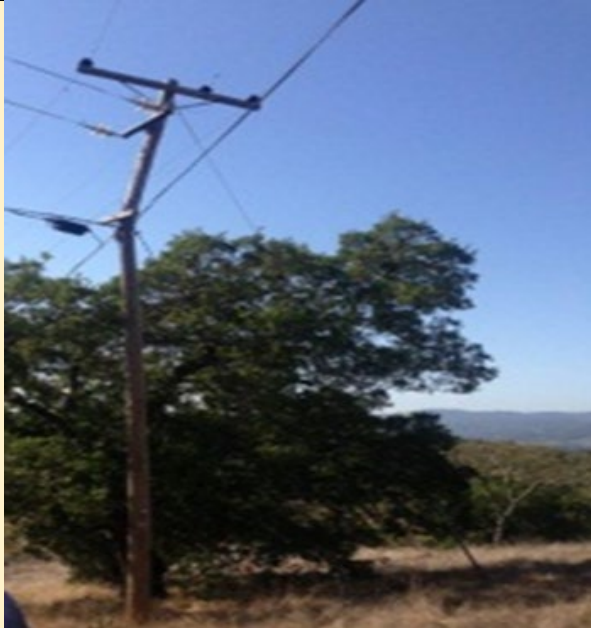
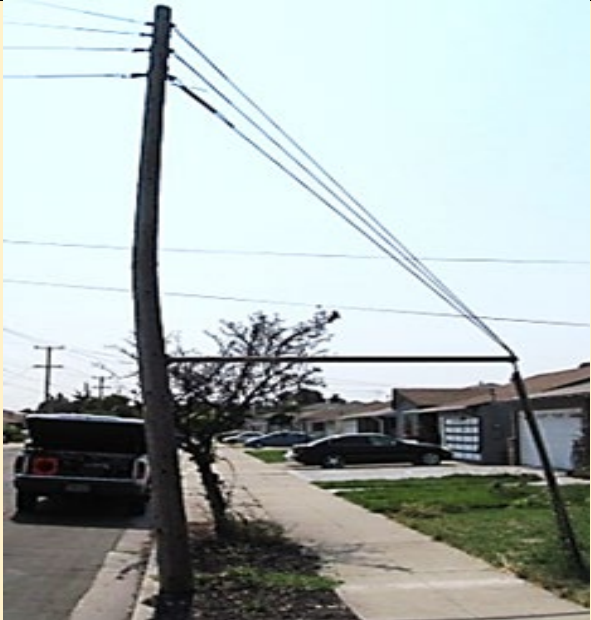
OVERLOAD BENT	
POLE BROKEN AT THE COMMUNICATION LEVEL	POLE BENT AT MIDDLE SECTION

At this Location: Pole is bent and has horizontal crack. Pole broken at the communication level.

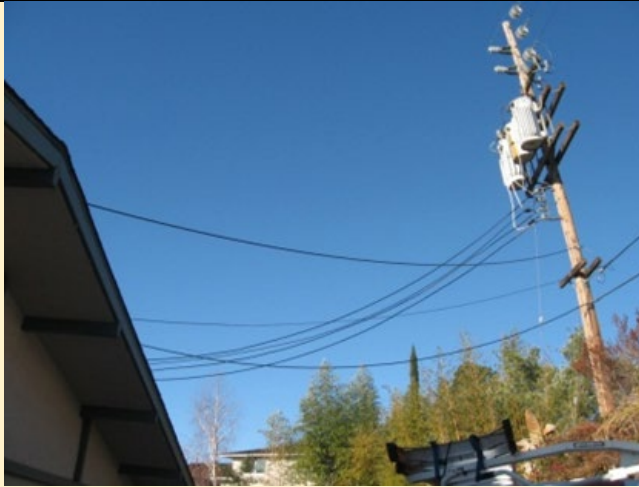
POLE BENDING 3 POT TRANSFORMER IN BUCK POSITION

At this Location: Pole is leaning less than 10% out of plumb, bending in direction of offset equipment. Pole is not cracked.

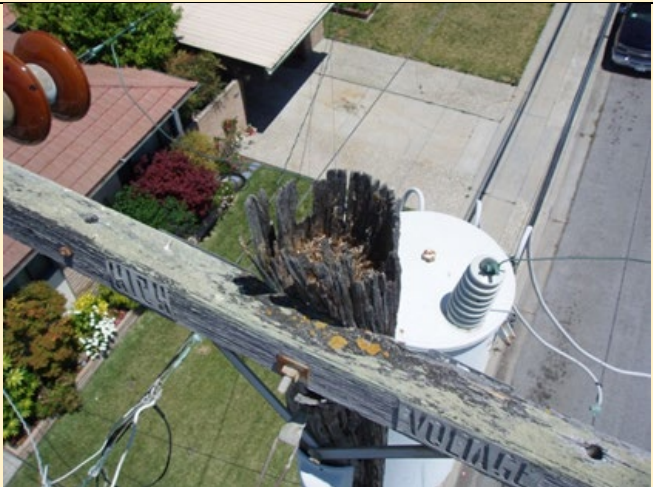
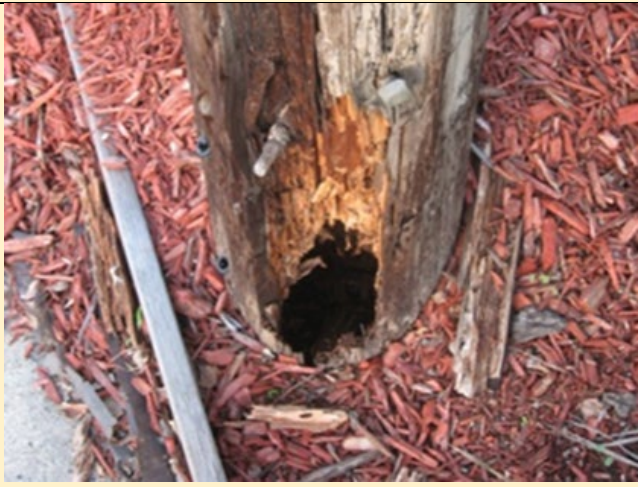
DECAY OF POLE OVER TIME	SEVERE DETERIORATION AT GROUND LEVEL

At this Location: Pole top decayed

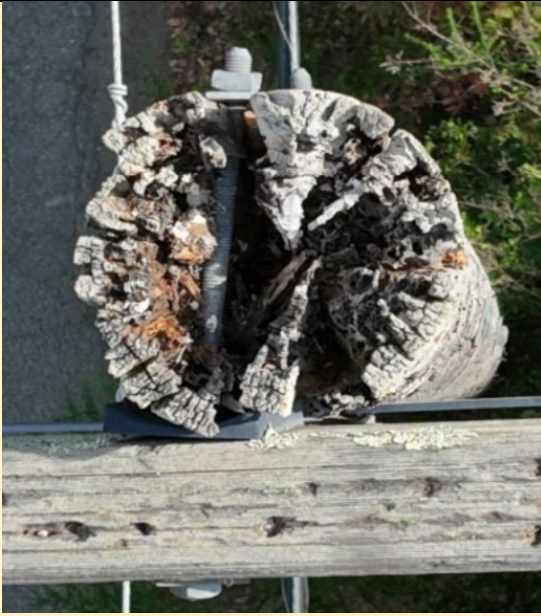
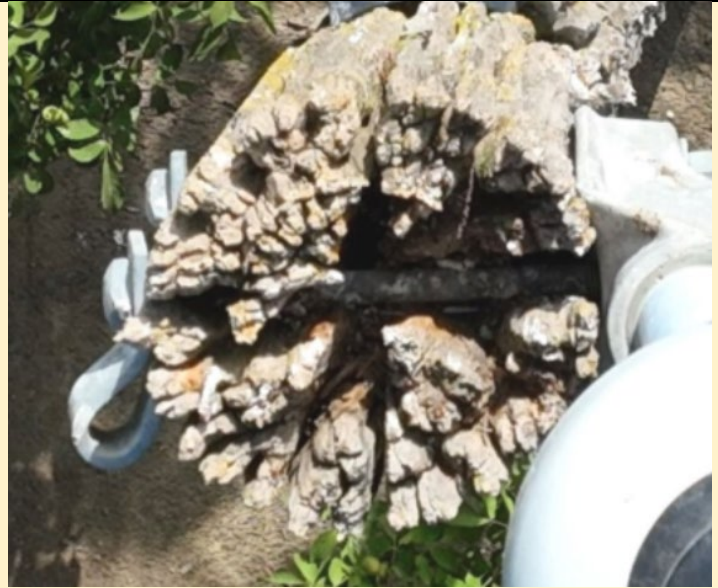
DECAY OF POLE OVER TIME – AERIAL VIEW

At this Location: Pole top decayed.

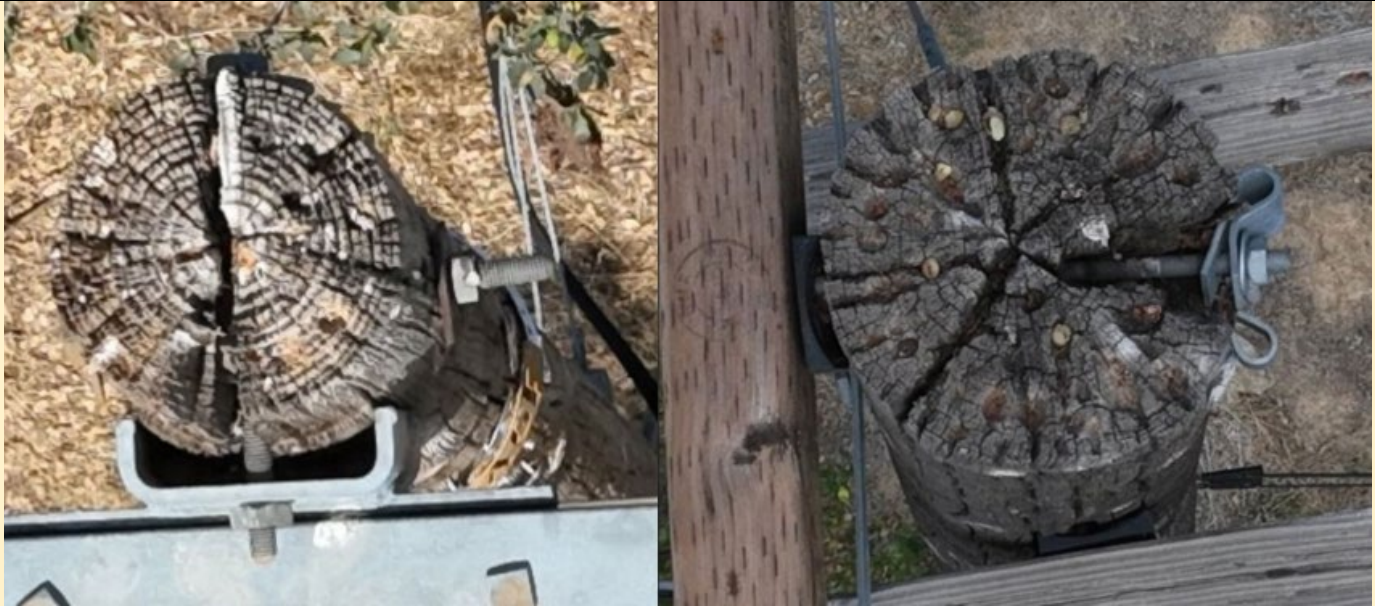
DECAY OF POLE OVER TIME – AERIAL VIEW

At this Location: Pole top decayed.

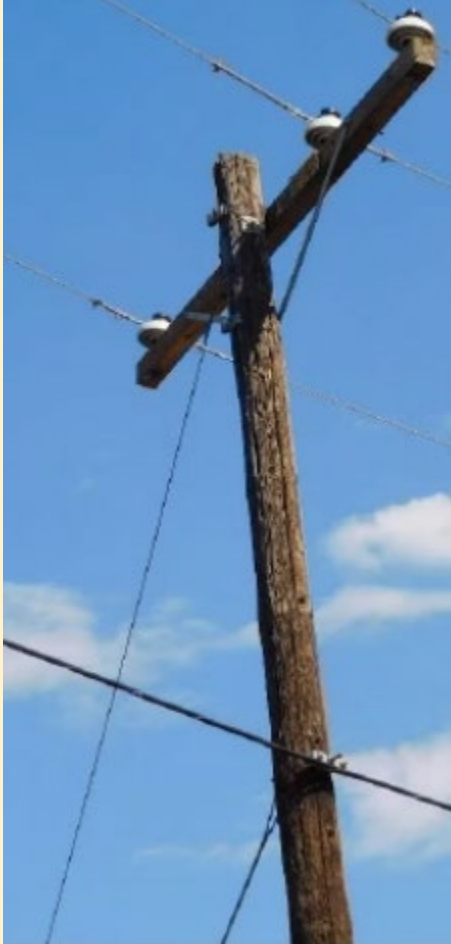
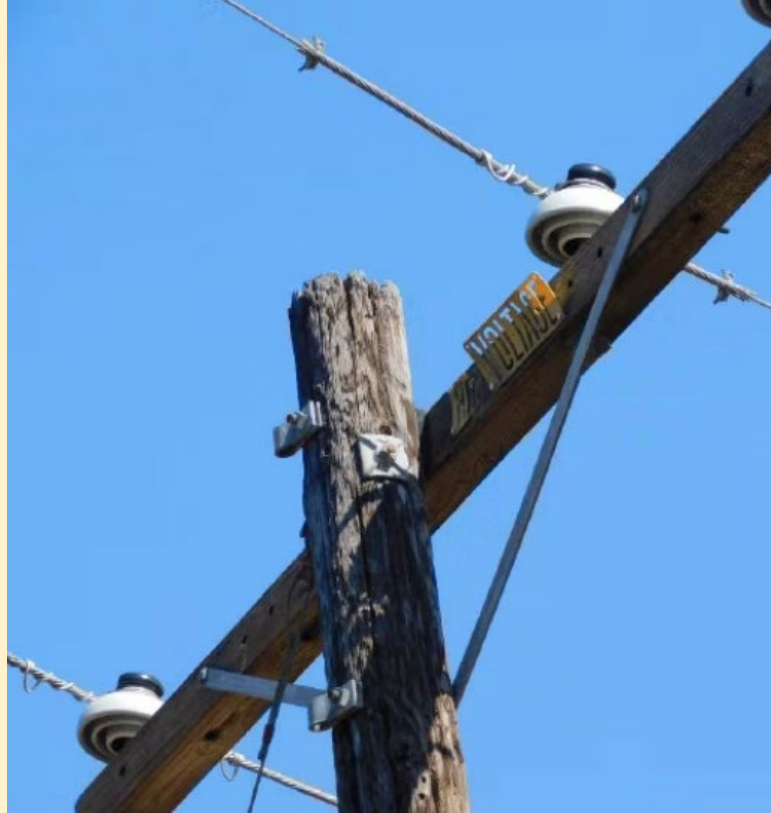
DECAYED POLE, MULTIPLE ISSUES

At this Location: Pole has multiple conditions: Pole in poor condition, decayed, and extensive weathering, and pole top rot. Pole checks alone are not a compelling abnormal condition, but in combination with all the other conditions, write EC tag.

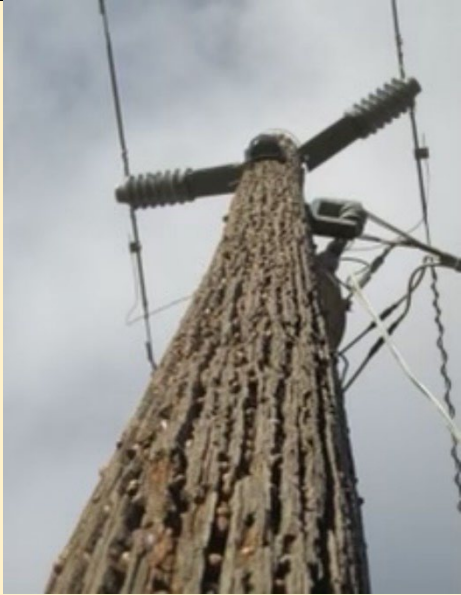
WOODPECKER DAMAGE <1 INCH HOLES

At this Location: Holes are less than 1 inch in diameter and acorn/feeder holes cover more than 50% of the pole surface in a 3 ft section.

Perform Minor Work: No
	Write 3rd Party Notification: No
	Write EC Notification: Yes FDA= Pole / Woodpecker Damage / Replace Priority= Minimum E Tag, depending on exposure.

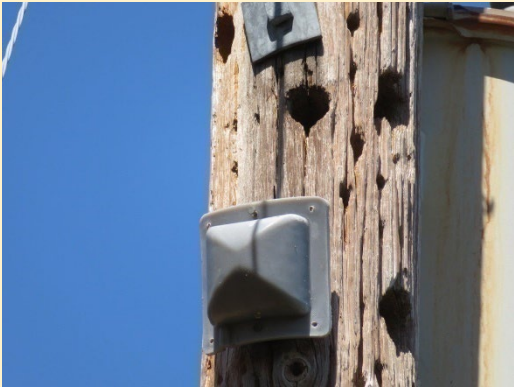
WOODPECKER DAMAGE 1-3 INCH HOLES

At this Location: There are multiple holes that the sum of the holes widths is greater than 9 inches in any 1 ft section.

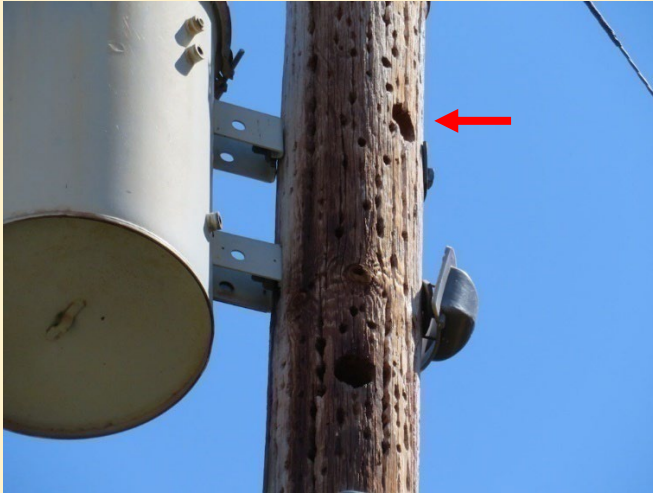
WOODPECKER DAMAGE 1-3 INCHES

At this Location: The sum of the holes are less than 9 inches. Woodpecker holes are within 2 inches of the attachment hardware on the surface of the pole.

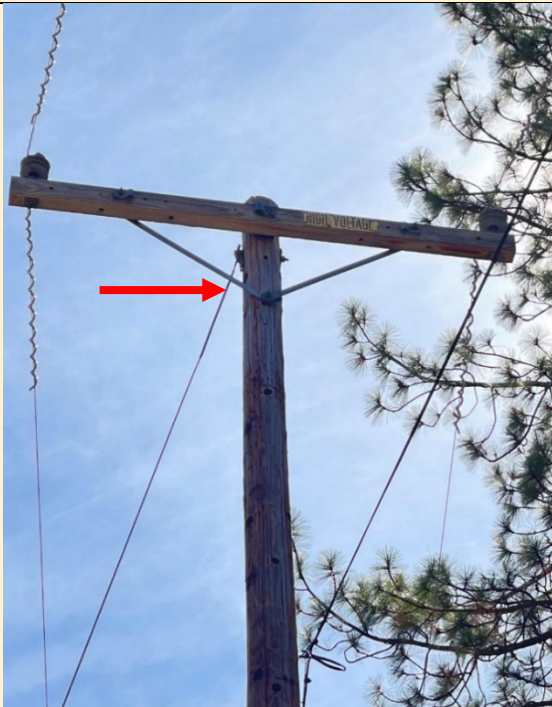
WOODPECKER DAMAGE 1-3 INCHES

At this Location: Single hole 1-3 inches within 2 inches from attachment hardware.

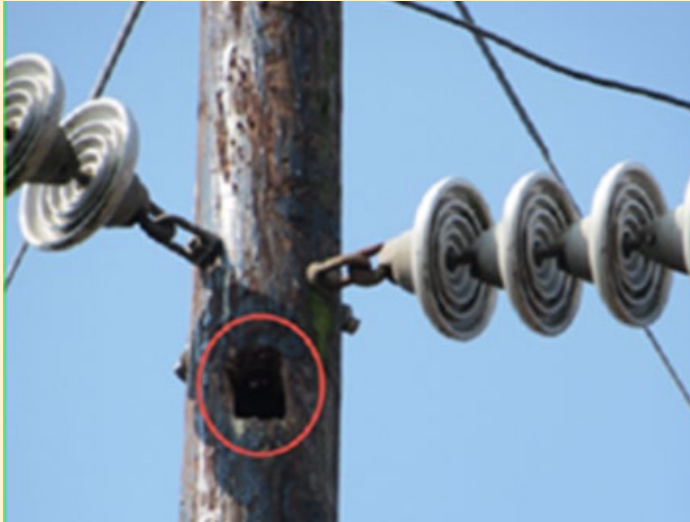
WOODPECKER DAMAGE >3 INCHES

At this Location: Woodpecker hole is greater than 3 inches, less than 12 feet from top of pole, and within 2 inches from attachment hardware.

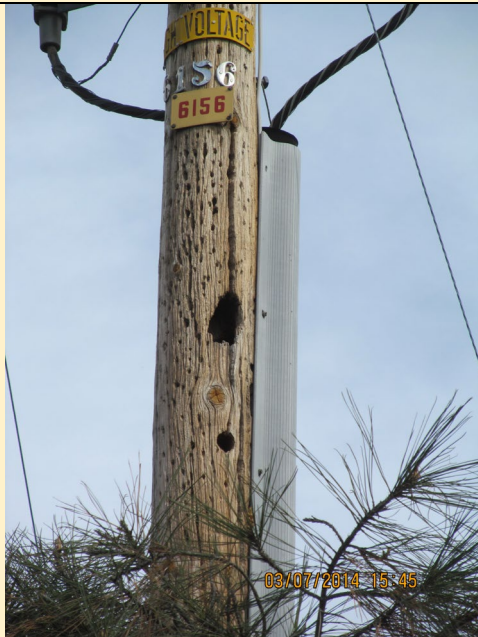
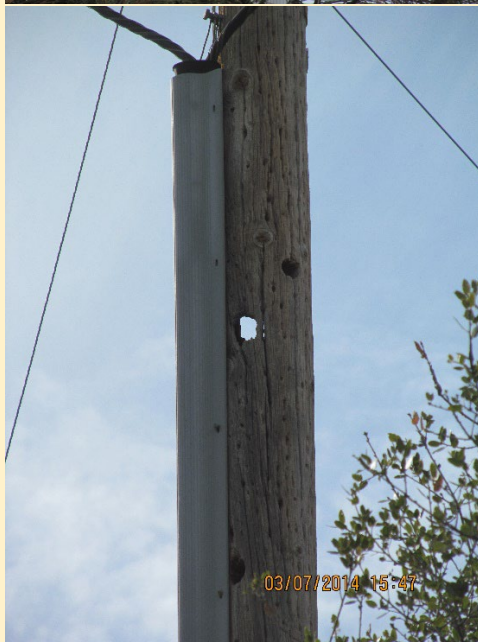
WOODPECKER DAMAGE NESTNG CAVITY

At this Location: A through hole counts as 2 holes. The 3 holes within a 1-foot section added together are greater than 9 inches.

FDA= Pole / Woodpecker Damage / Replace

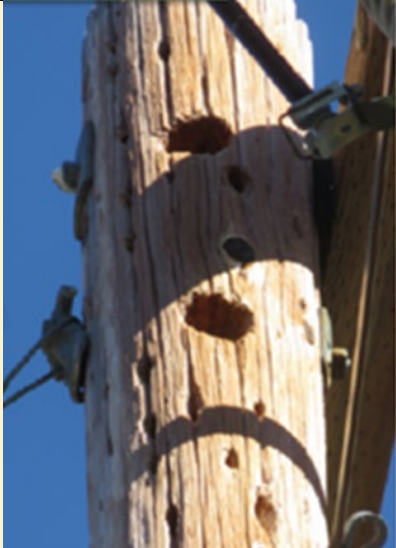
WOODPECKER DAMAGE 1-3 INCHES

At this Location: The sum of the holes are less than 9 inches. Woodpecker holes are not within 2 inches from attachment hardware.

FDA= Pole / Woodpecker Damage / Repair

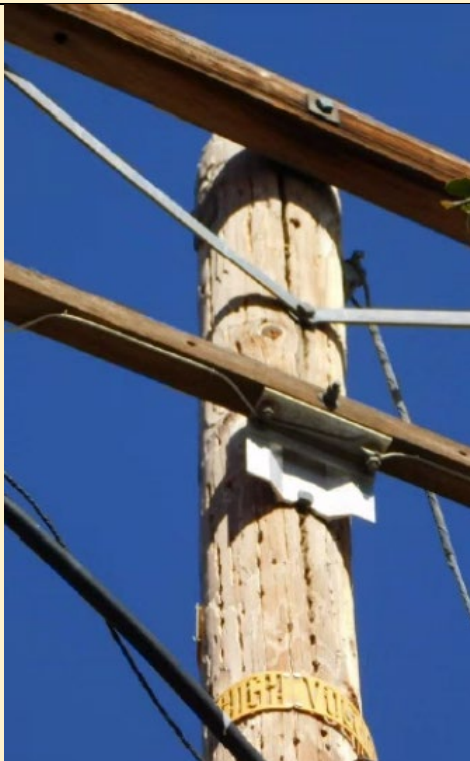
WOODPECKER DAMAGE <1 INCH HOLES

At this Location: Holes are less than 1 inch in diameter and acorn/feeder holes do not cover more than 50% of the pole surface in a 3 ft section.

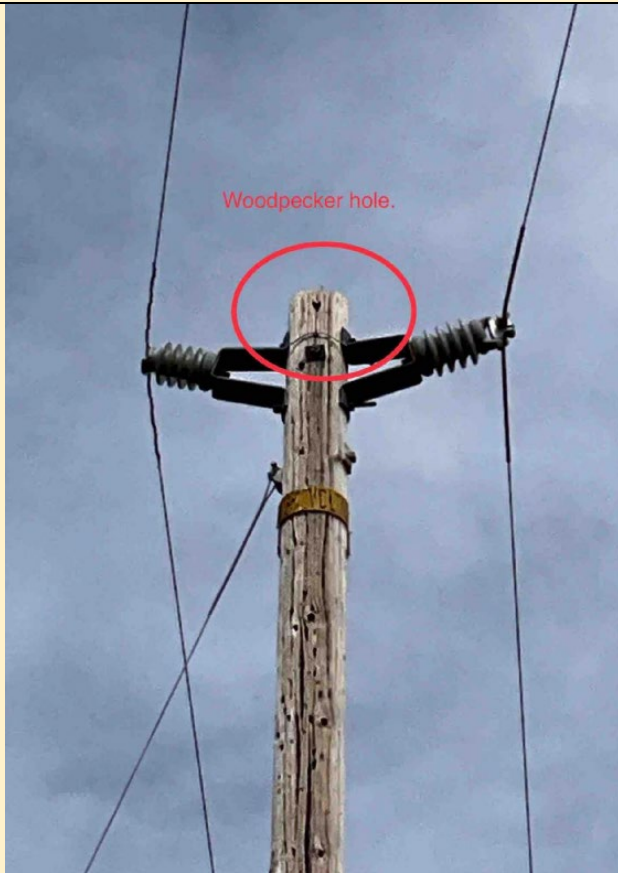
WOODPECKER DAMAGE <1 INCH

At this Location: Woodpecker hole less than 1 inch, damage is within 6 inches from top. Holes cover less than 50% of the pole surface in a 3 ft section.

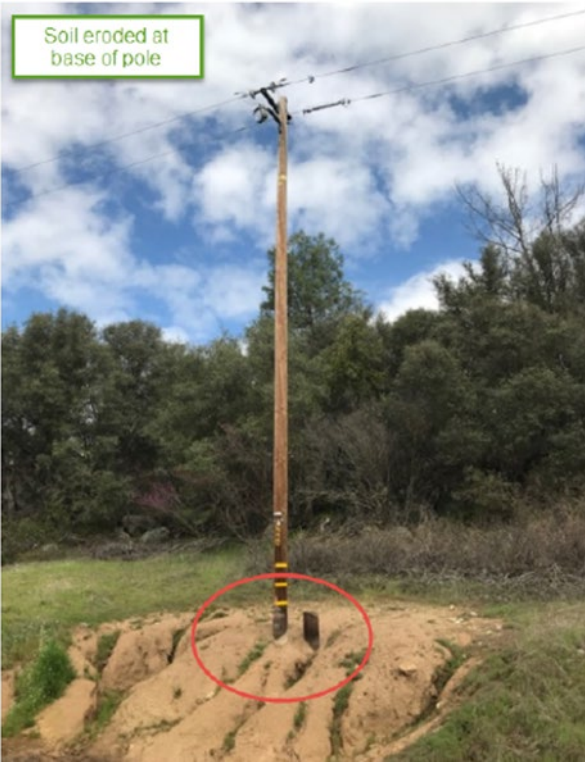
SOIL ERODED AT BASE OF POLE

At this Location: a large amount of soil was washed or eroded away at the base of a pole, Not leaning.

Perform Minor Work: No
	Write 3rd Party Notification: No
	Write EC Notification: Yes FDA= Pole / Soil Eroded / Graded / Replace
	Priority= Minimum E Tag, depending on exposure.
