Job Aid: Overhead Assessment

TD- 2305M-JA02
WMP-Discovery2023-2025 DR SPD 024-Q003Atch02
Publication: 01/06/2025 Effective: 01/14/2025

Rev: 14

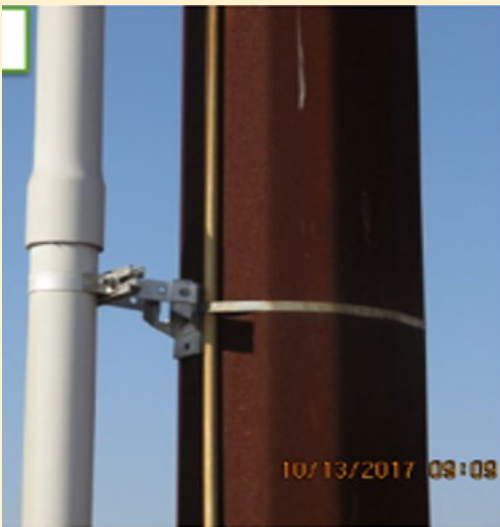
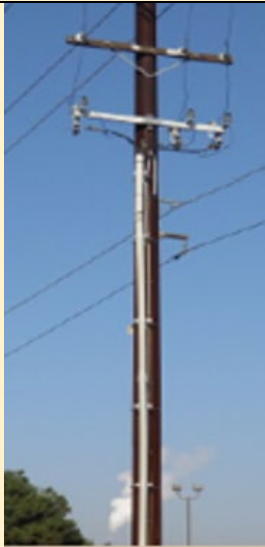
RISER ON STEEL TRANSMISSION POLE

<p>At this Location: Steel Transmission Structure with Distribution underbuilds with external riser on steel pole.</p> <p>

General Guidance: Steel Transmission Structure with Distribution Underbuilds with **external** riser present. If observed, yes, create EC notification to relocate riser.

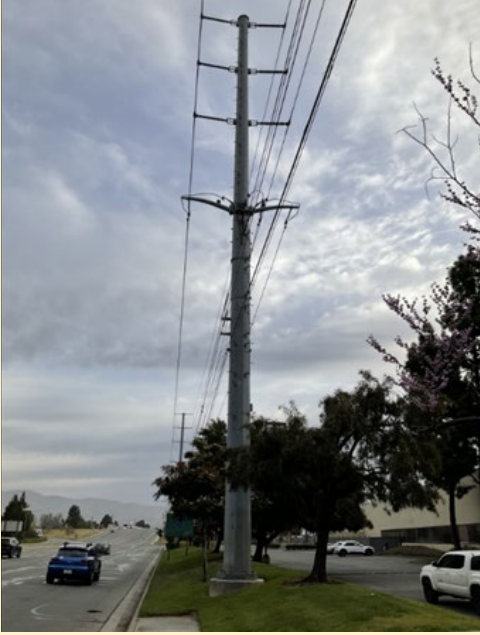
STEEL TRANSMISSION STRUCTURE WITH DISTRIBUTION UNDERBUILD WITH INTERNAL RISER WITHIN STEEL POLE

Note: Presents of distribution riser on steel transmission pole exposes customer equipment to transmission flashover voltages.

<p>At this Location: Steel Transmission Structure with Distribution underbuilds with internal riser within steel pole.</p> <p>

General Guidance: Structure must be steel Transmission Structure with Distribution Underbuilds with **internal riser** within steel pole. If observed, yes, create EC notification to relocate riser.

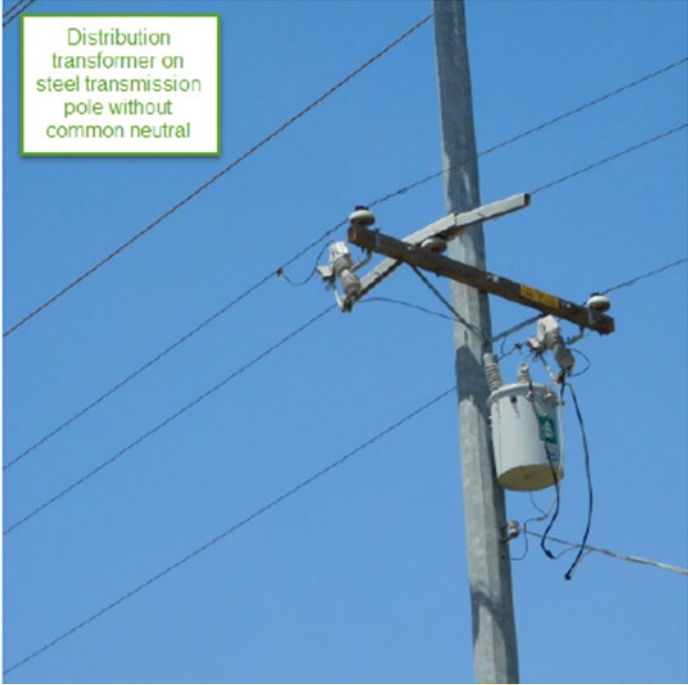
DISTRIBUTION TRANSFORMER ON STEEL TRANSMISSION POLE WITHOUT COMMON NEUTRAL

At this Location: Distribution transformer on steel transmission pole without common neutral.

General Guidance: If observed, yes, create EC notification to relocate the transformer.

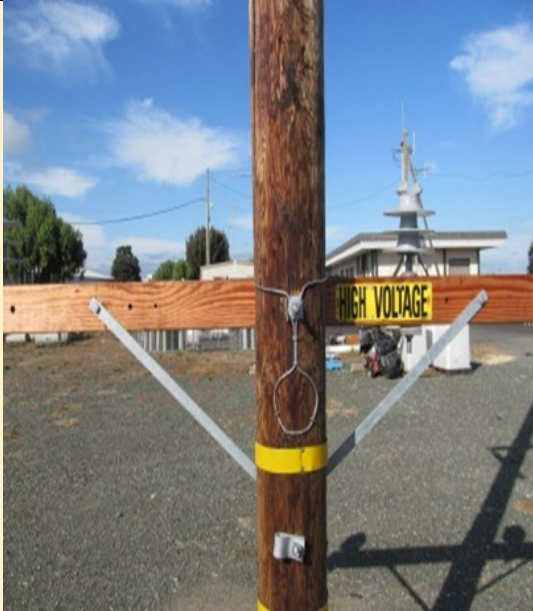
WOOD CROSSARM ON WOOD TRANSMISSION POLE WITH DISTRIBUTION UNDERBUILD BRIDGING

<p>Bridging Example</p> <div>

General Guidance: If observed, yes, create EC notification to repair or install missing bridging.

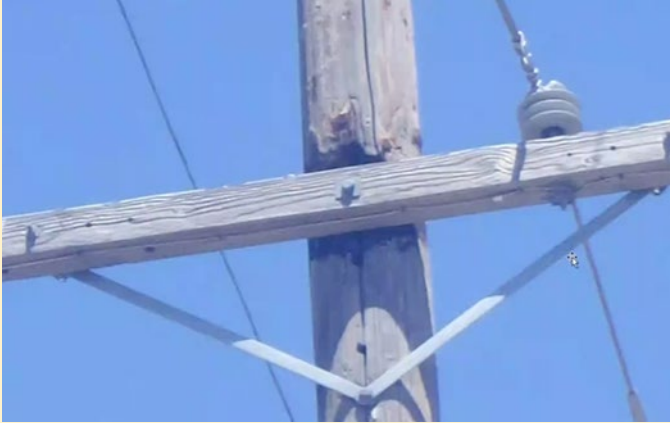
BURNT POLE DUE TO MISSING BRIDGING

At this Location: Transmission pole with missing bridging on the distribution cross-arm, burnt pole, assess pole.

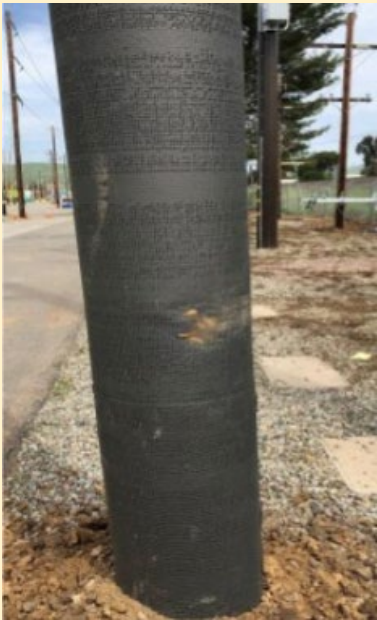
DAMAGED INTUMESCENT POLE WRAP

At this Location: Damaged intumescent pole wrap.

Perform Minor Work: Yes, if safe to do so.
	Write 3rd Party Notification: No
	Write EC Notification: Yes, if minor work cannot be completed. FDA= Hardware/Framing / Broken/Damaged / Repair or Replace Priority= E Tag

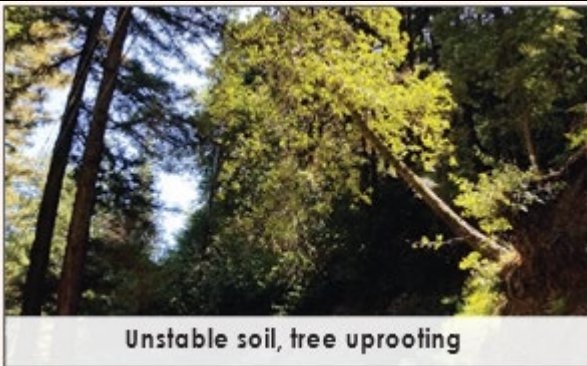
ACTIVELY FALLING TREE

Unstable soil, tree uprooting

Observed Tree Condition: Actively Falling Tree

Immediate Action Required: Yes, first responder to stay on site until hazard has been made safe

EC Notification Priority: A tag, follow emergency process.

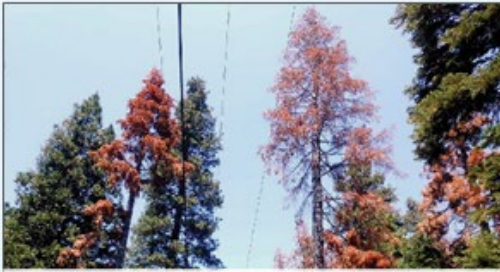
Dying tree, all brown needles, not dormant

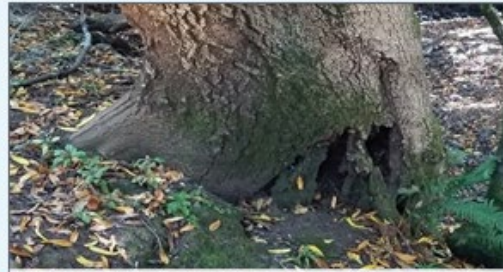
Cavity at base of tree

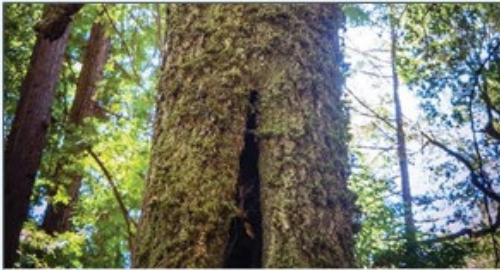
Deep cavity in trunk below tree connect point

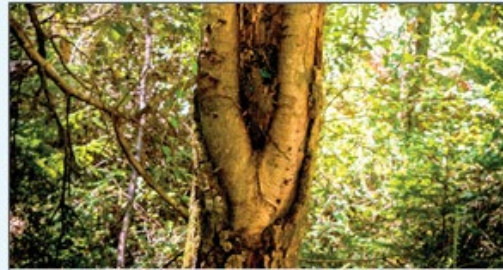
Major wound on trunk

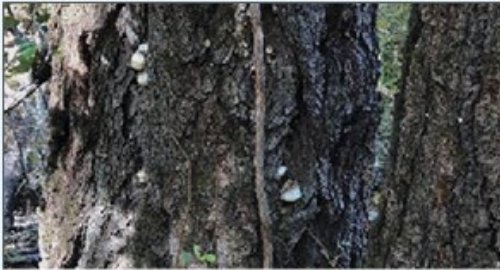
White or black mushrooms on tree

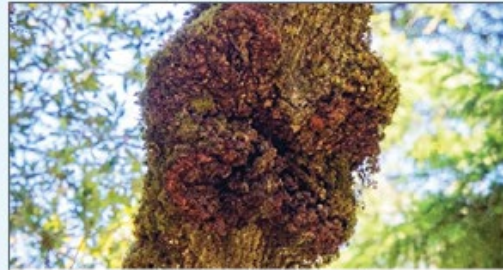
Minor wound on trunk

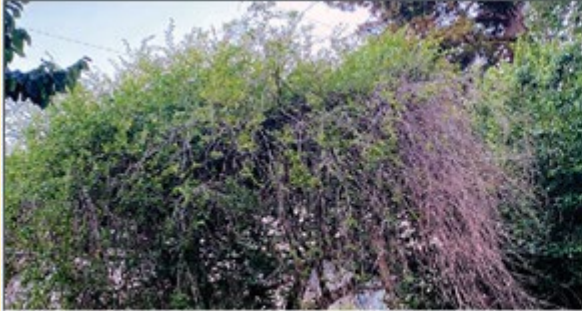
Declining branches beyond normal aging

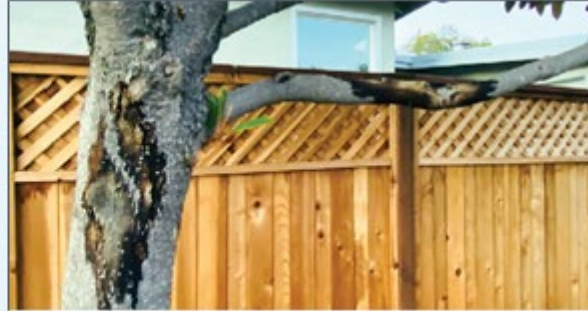
Significantly weeping

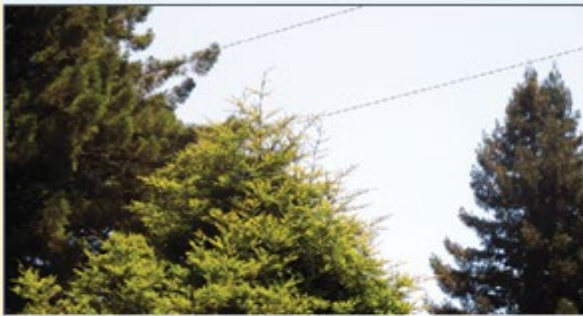
Healthy redwood

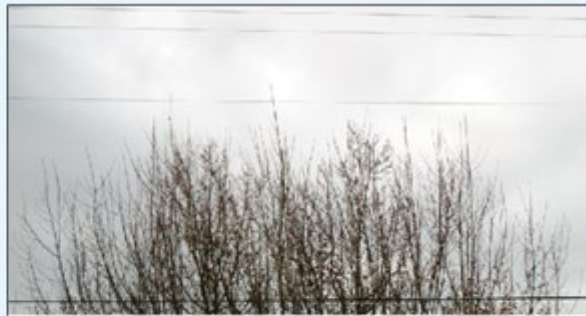
Healthy deciduous tree in winter with leaf drop

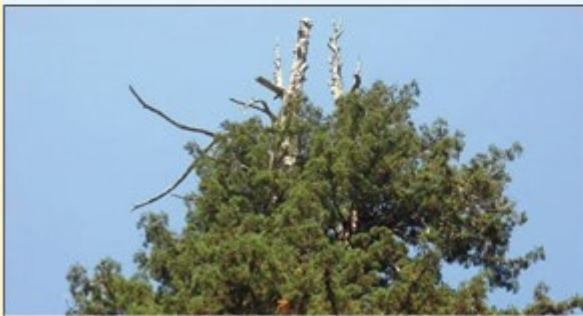
Dead top but the rest of the tree is healthy

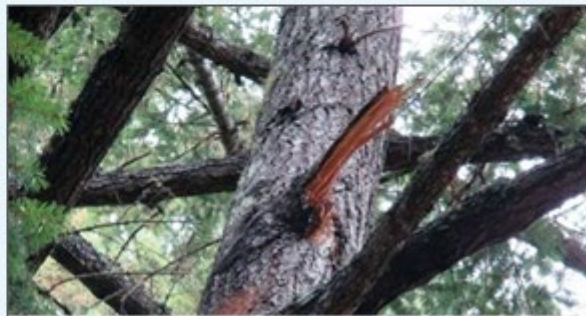
Broken branch but the rest of the tree is healthy

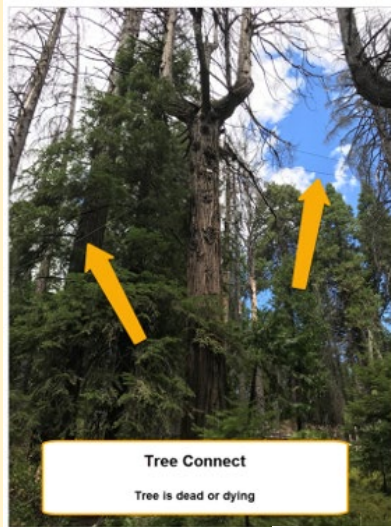
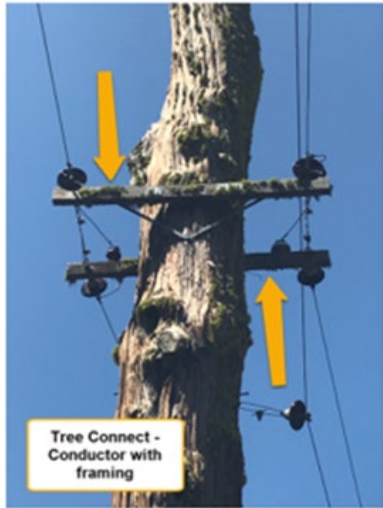
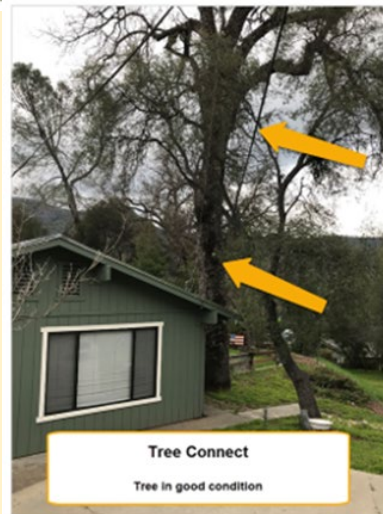
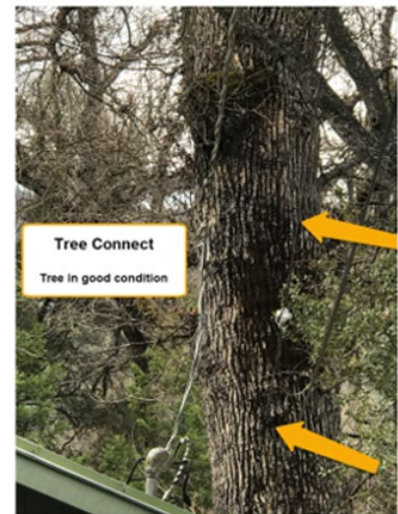
TREE CONNECTS

At this Location: Tier 3 area, tree connect on dead/dying tree; attachments are solid.

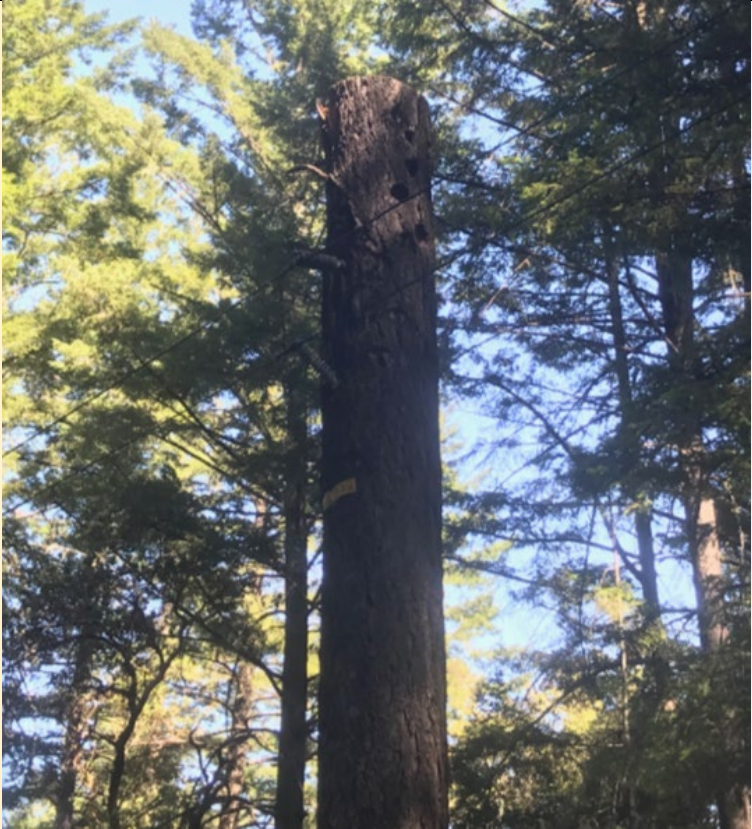
TREE CONNECT ON DEAD/DYING TREE

<p>At this Location: Tier 2 area, tree connect on dead/dying tree with multiple woodpecker holes and damaged primary insulators.</p> <p>

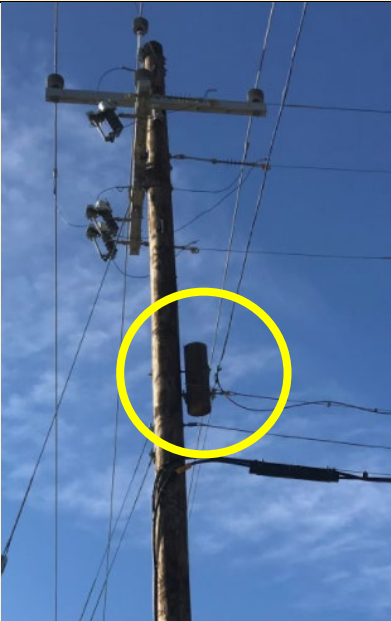
BUDDY POLE

At this Location: Buddy pole is properly supported.

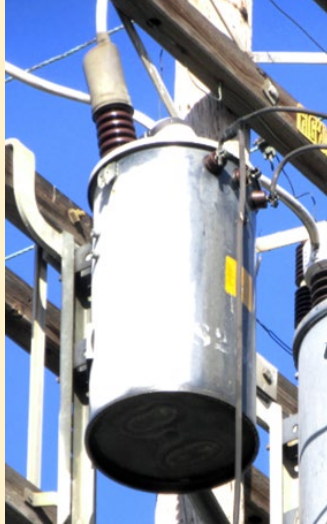
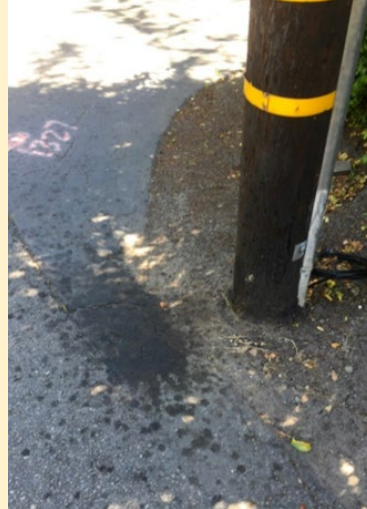
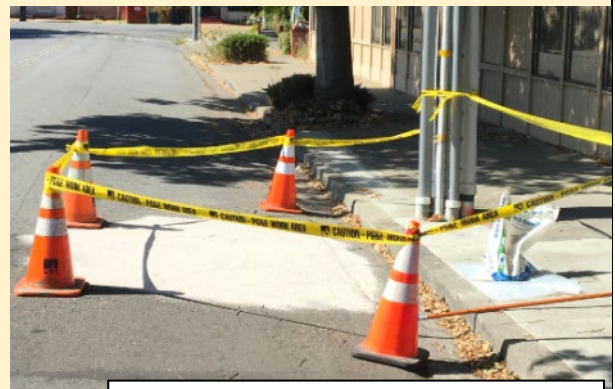
LEAKING OH TRANSFORMER, OIL ON THE GROND

At this Location: Leaking OH transformer, oil on the ground.

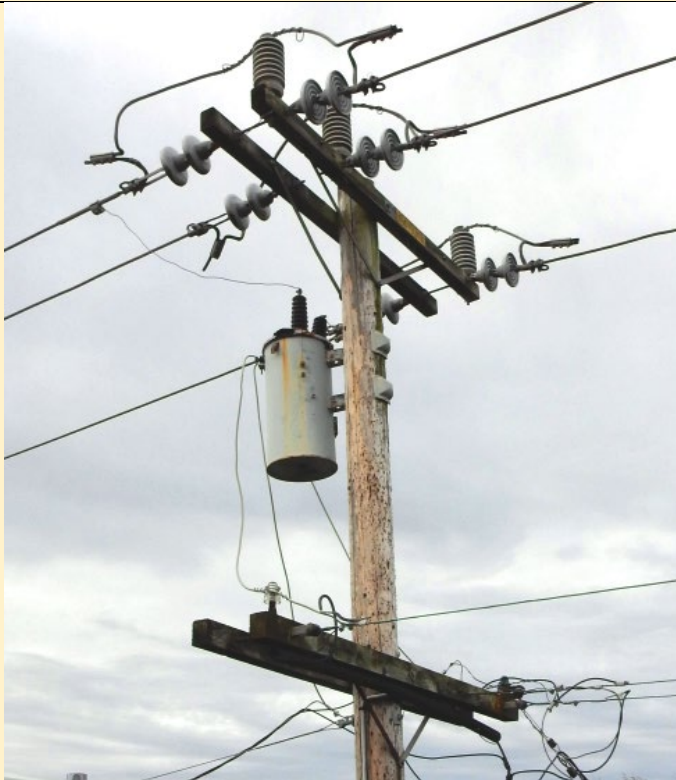
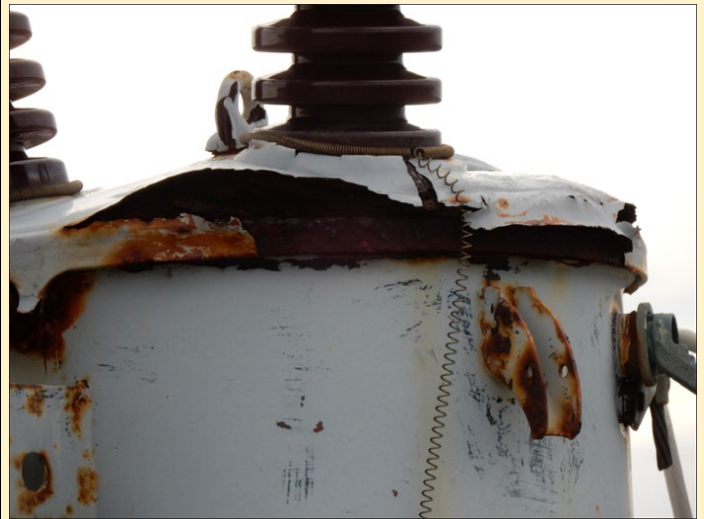
TRANSFORMER CORROSION

At this Location: Transformer with heavy corrosion has breached integrity of tank. Hole in lid of tank.
NOTE: Refer to spill matrix when oil release is confirmed or found.

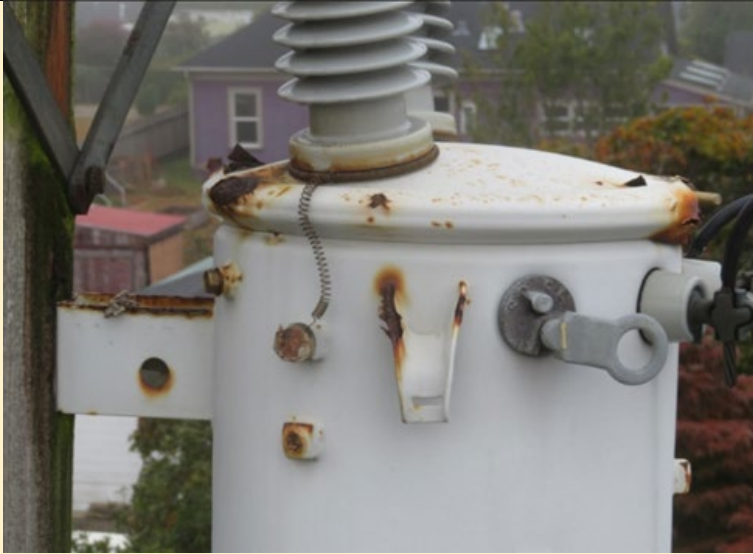
OH CORROSION

At this Location: Corrosion Weakening Integrity of Tank. Metal is separating into layers. Corrosion will breach tank.

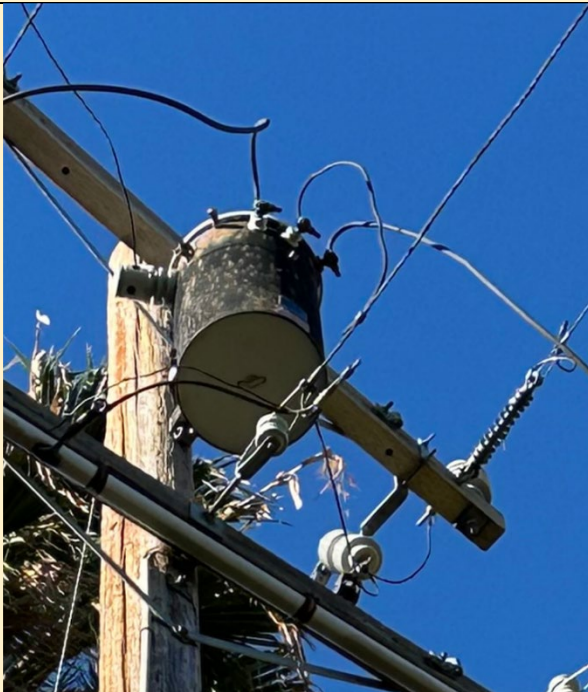
TRANSFORMER NOT CORRODED

At this Location: Transformer paint has deteriorated to primer. Black on transformer is not corrosion. No action.

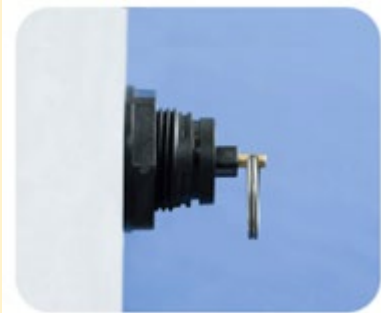
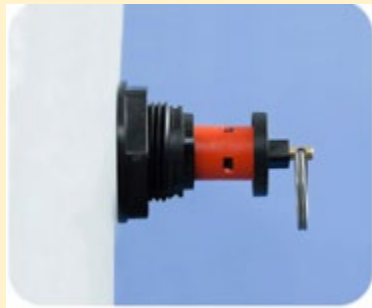
TRANSFORMER INTERNAL FAULT DEVICE ACTIVATED

Not Activated	Activated
<p>At this Location: Transformer internal fault device activated, indicating overheating, and the orange band is visible. Not to be confused with pressure relief valve.</p> <p>

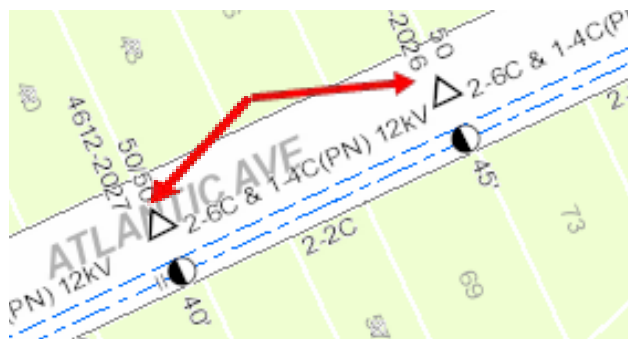
Banked transformers on separate poles should be identified as banked.

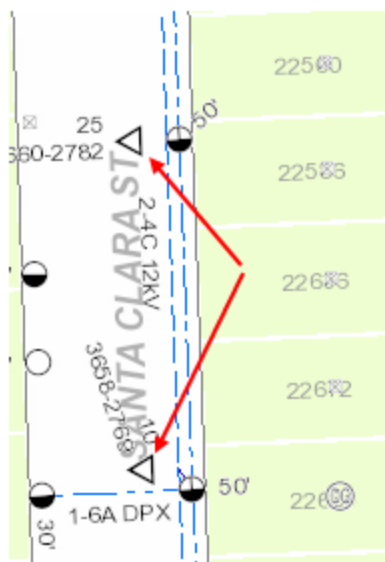
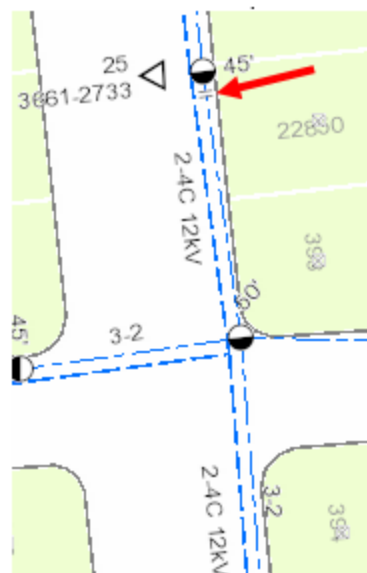
OH Paralleled Transformers

OH Transformers separated by bobs are ok

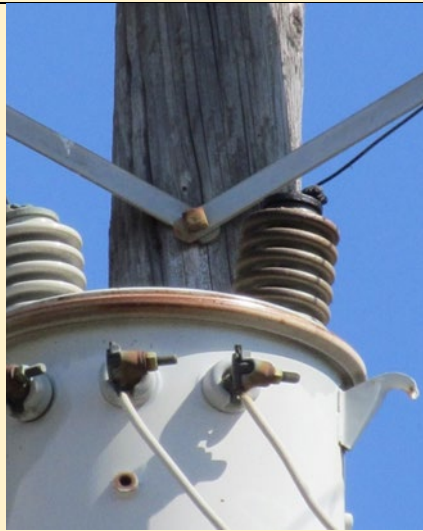
FLASHED INSULATOR ON TRANSFORMER

At this Location: Flashed insulator on transformer

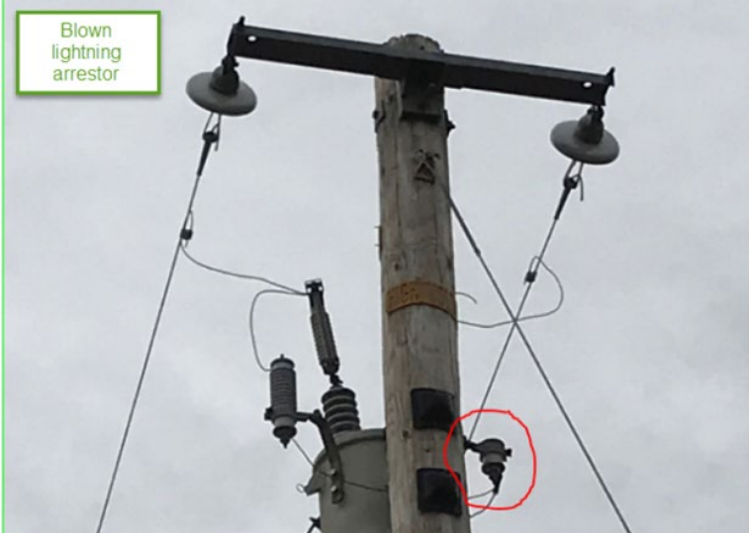
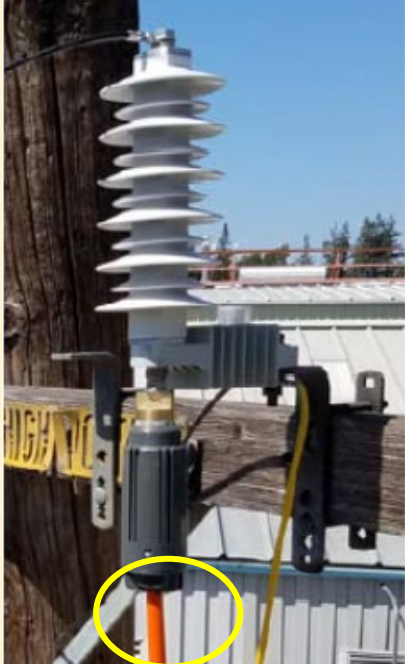
NON-EXEMPT SURGE ARRESTOR BLOWN	EXEMPT ABB-TYPE ARRESTOR BLOWN

At this Location: Non-Exempt Surge Arrester Blown

Perform Minor Work: No	Perform Minor Work: No
Write 3rd Party Notification: No	Write 3rd Party Notification: No
Write EC Notification: Yes FDA= Lightning Arrester / Broken/Damaged / Replace Priority= E Tag, depending on exposure	Write EC Notification: Yes FDA= Lightning Arrester / Broken/Damaged / Replace Priority= E Tag, depending on exposure

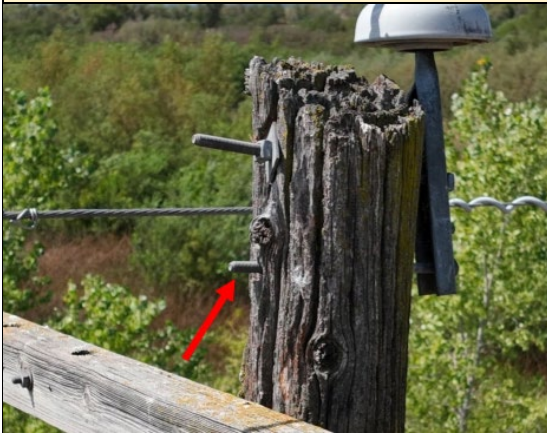
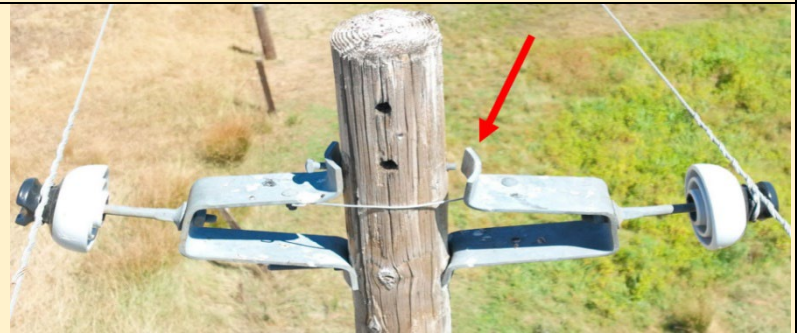
MISSING HARDWARE IMPACTING INTEGRITY – Aerial View

At this Location: The nut on the through bolt has come off of the king pin.

FDA = Hardware / Missing / Install

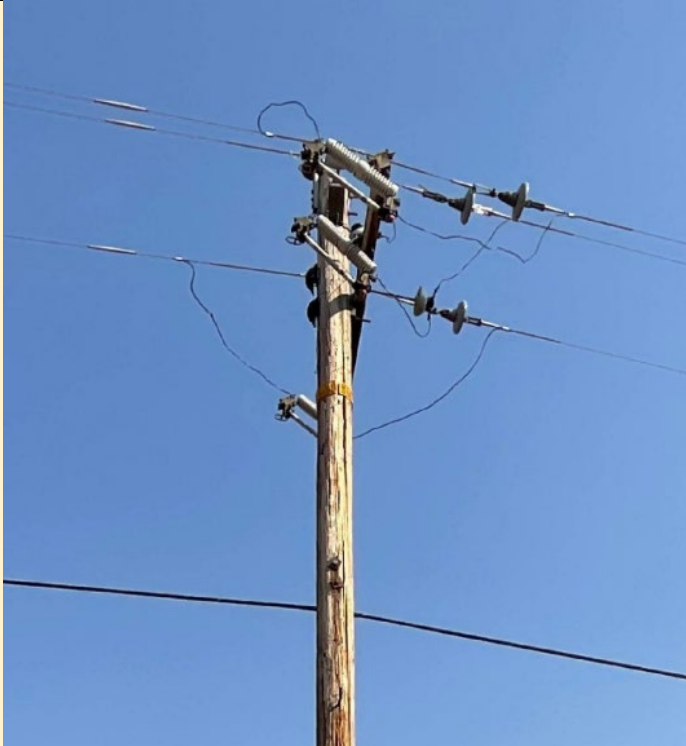
LOOSE HARDWARE

At this Location: Loose hardware involving cutouts. Arm loose/deteriorated causing the cutouts to almost be in underslung position.
	Perform Minor Work: No
	Write 3rd Party Notification: No
	Write EC Notification: Yes FDA: Hardware / Loose / Adjust Priority: E Tag, depending on exposure.

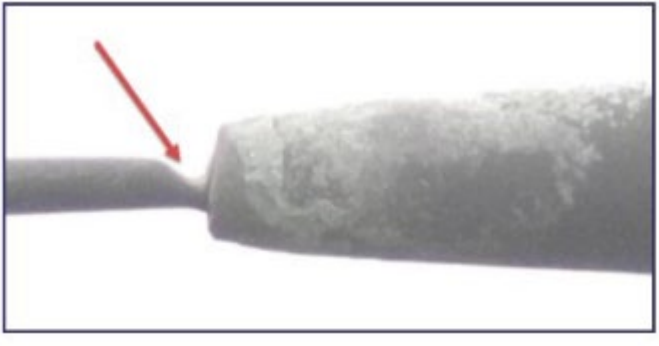
NECKING OF CONDUCTOR

At this Location: Solid wire next to automatic splice has extreme (>40%) conductor necking.

Perform Minor Work: No
	Write 3rd Party Notification: No
	Write EC Notification: Yes FDA = Conductor / Broken/Damaged / Repair Priority = A tag, depending on exposure.

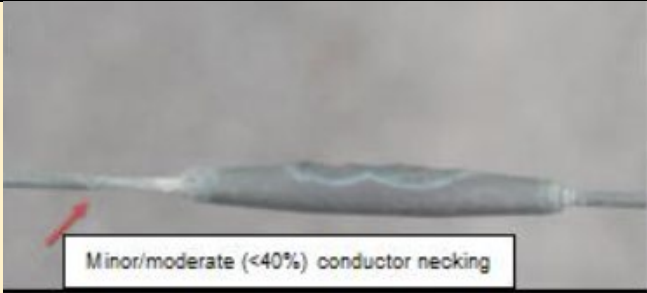
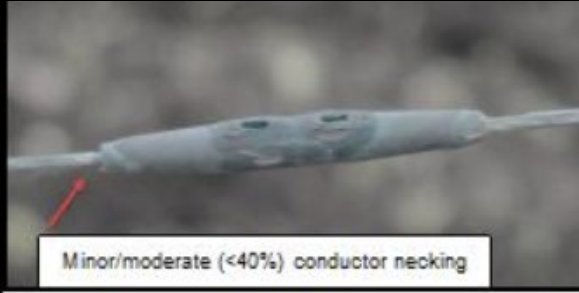
NECKING OF CONDUCTOR

At this Location: Solid wire next to automatic splice has minor/moderate (< 40%) conductor necking.

Perform Minor Work: No	
Write 3rd Party Notification: No	
Write EC Notification: Yes FDA = Conductor / Broken/Damaged / Repair Priority = B Tag, depending on exposure

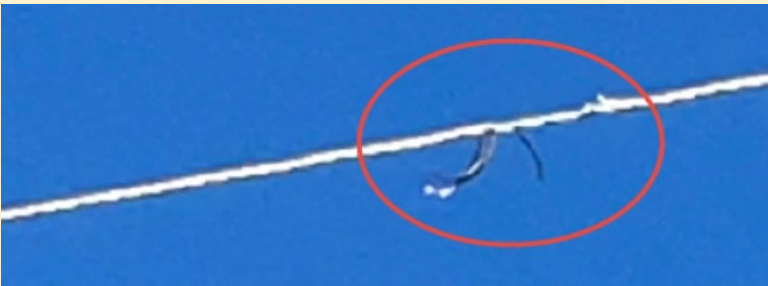
GUN SHOT DAMAGE

At this Location: More than 30% broken strands.

Perform Minor Work: No
	Write 3rd Party Notification: No
	Write EC Notification: Yes
	FDA: FDA = Conductor / Broken/Damaged / Repair or Replace Priority: A Tag or X Tag depending on exposure.

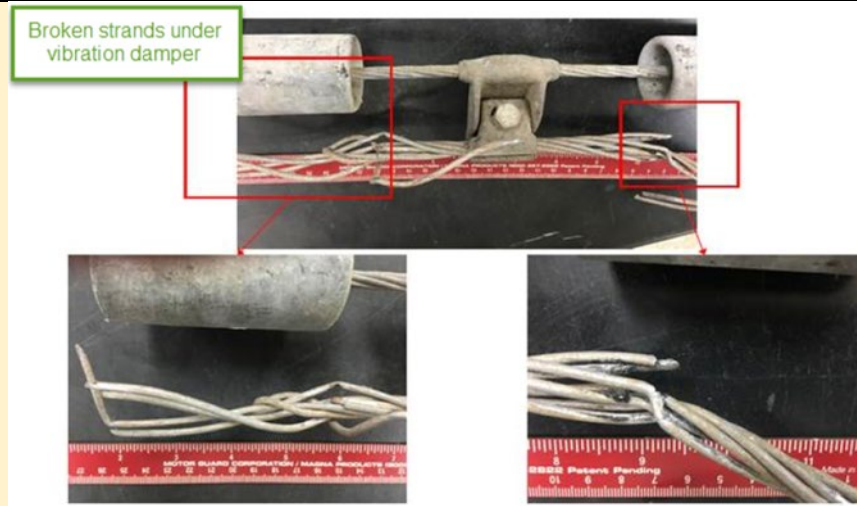
BROKEN STRANDS UNDER VIBRATION DAMPER

At this Location: Broken strands (more than 30%) under vibration Damper

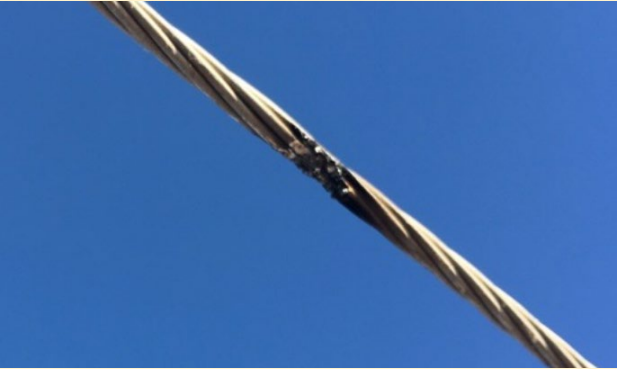
BURNT CONDUCTOR PRIMARY OR SECONDARY

At this Location: Burnt Conductor, midspan, primary or secondary.

Perform Minor Work: No
	Write 3rd Party Notification: No
	Write EC Notification: Yes
	FDA: FDA = Conductor / Burnt / Repair or Replace Priority: E Tag, depending on exposure

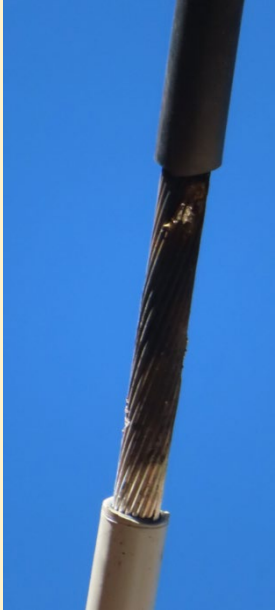
EXPOSED PRIMARY COVERED CONDUCTOR TREE WIRE, BURNT CONDUCTOR

<p>At this Location: Tree Wire conductor exposed and burnt, loss of cross-sectional area.</p> <p><i>Note: Tree wire refer to page 122.</i></p> <div>

</div>
	Perform Minor Work: No
	Write 3rd Party Notification: No
	Write EC Notification: Yes FDA= Tree Wire / Exposed / Repair FDA= Conductor / Burnt / Repair Priority: E Tag, depending on exposure

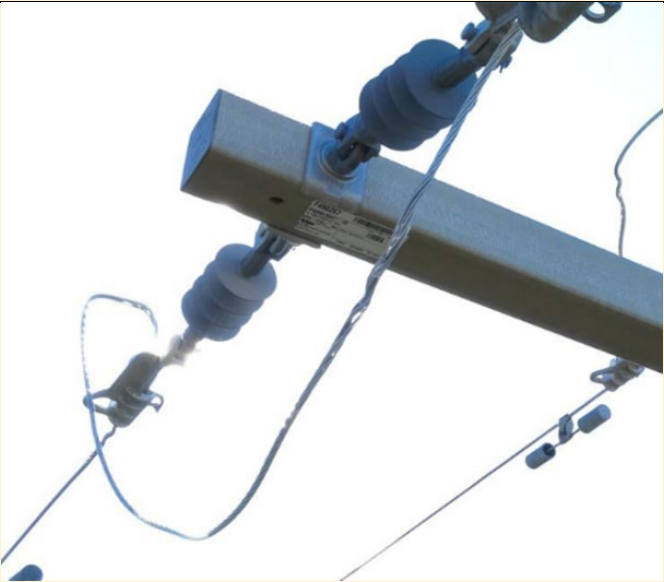
BIRD CAGING ON JUMPER NOT UNDER TENSION

At this Location: Bird caging on jumper not under tension.

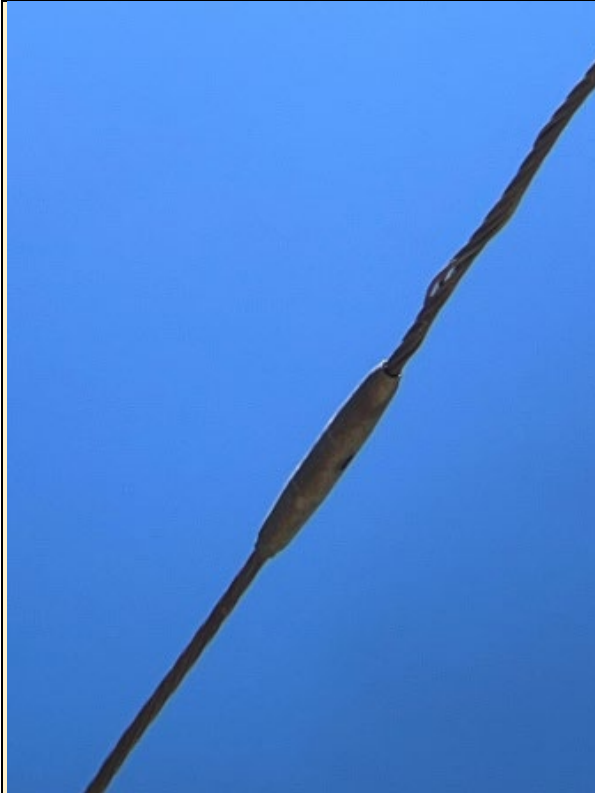
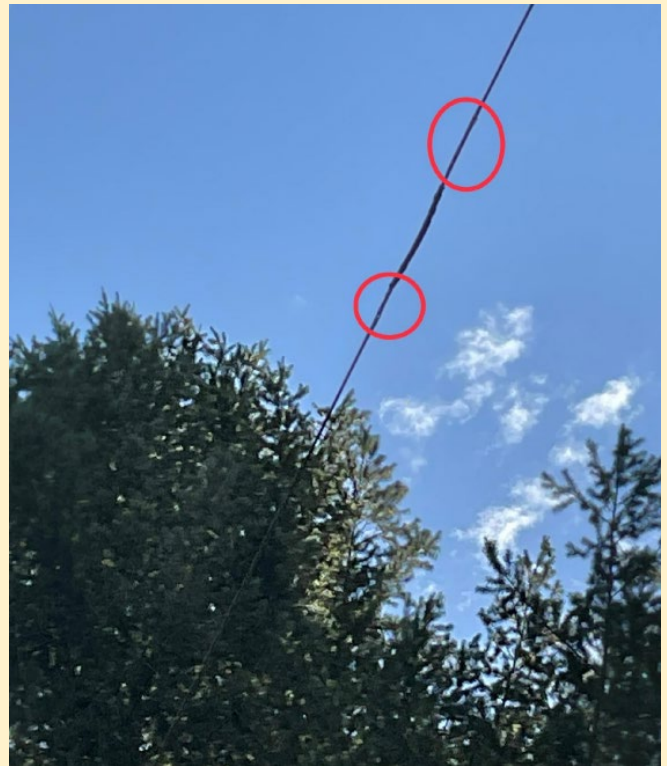
BIRD CAGING GUY WIRE

At this Location: Bird caging guy wire

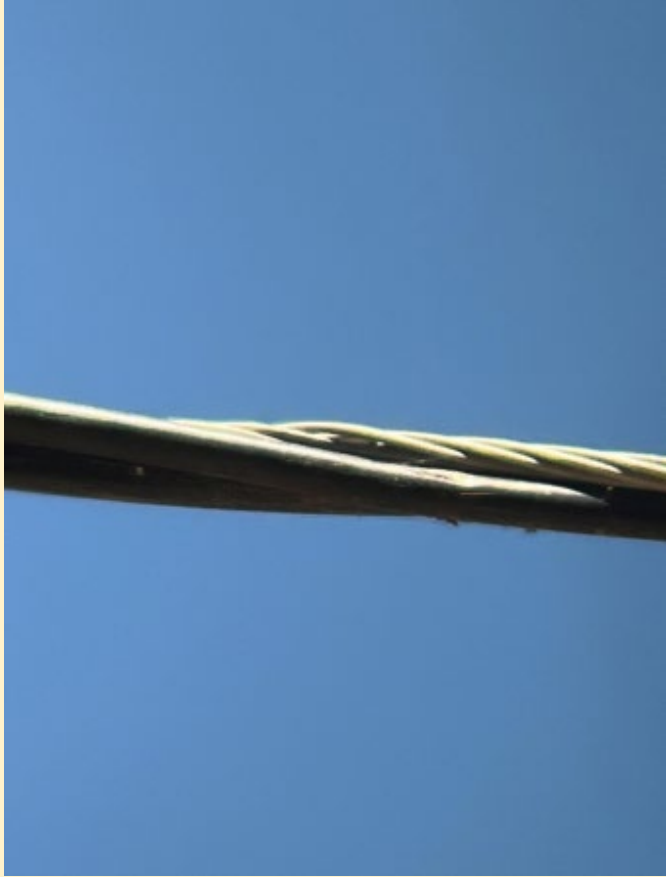
BIRD CAGING SERVICE NEUTRAL

At this Location: Bird caging on service neutral. Not excessive bird caging.

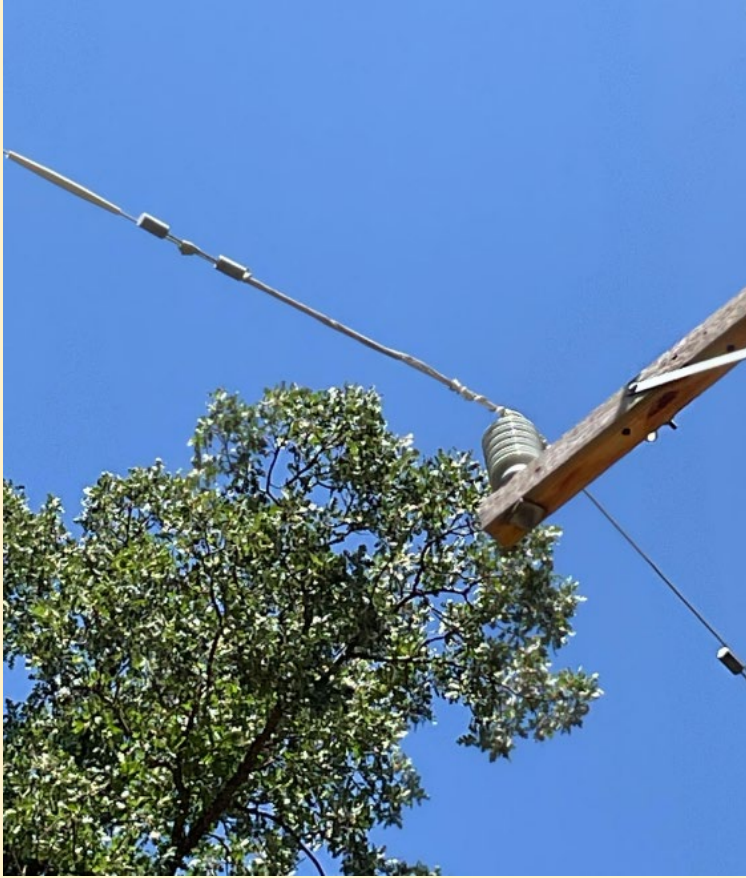
BIRD CAGING ON ARMOR ROD NON-COMPELLING

At this Location: Bird caging on armor rod. Not excessive.

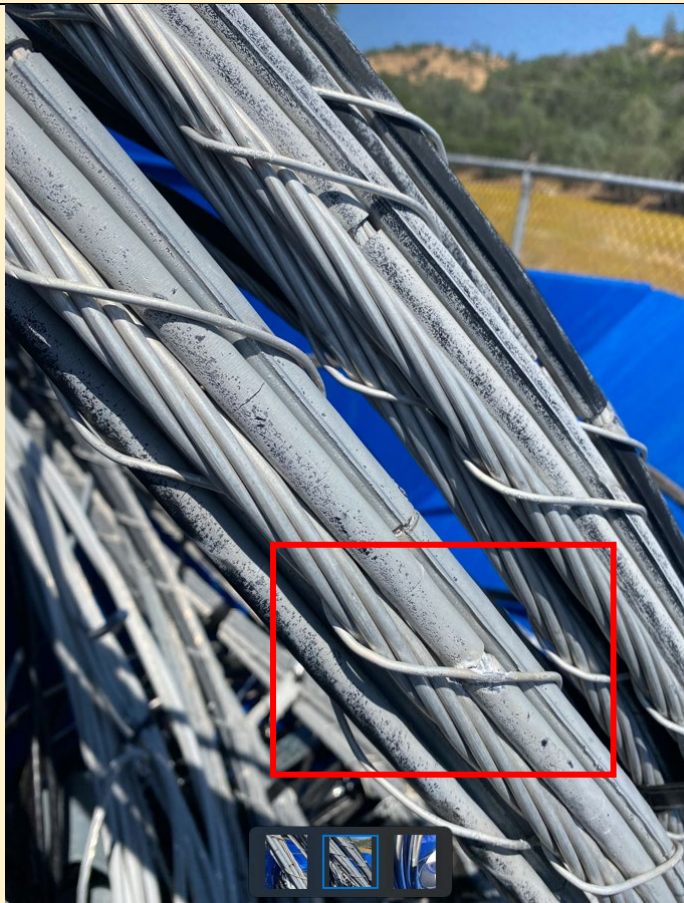
CRACKED SERVICE

At this Location: Corrosion, lashing is fused to conductor, hot leg is clearly exposed.

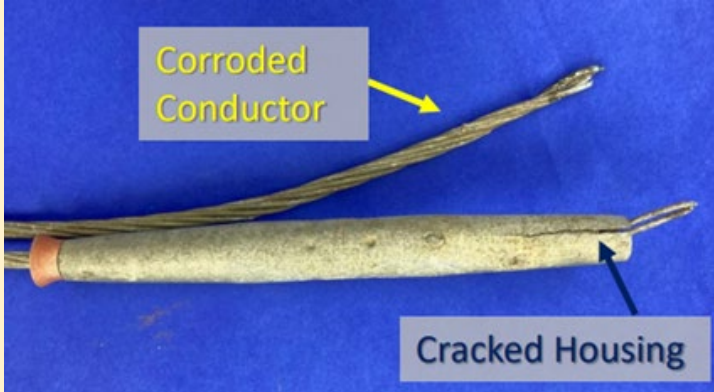
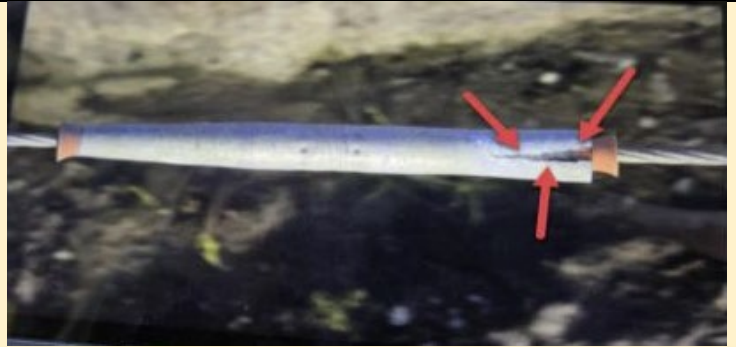
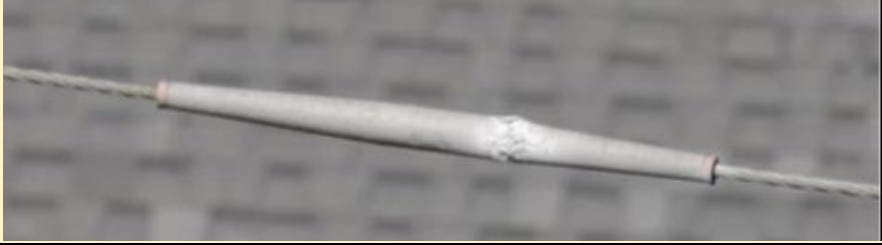
DAMAGED, CORRODED, CRACKED SPLICES OR AUTOMATIC DEAD-ENDS

At this Location: Crack is longitudinal AND compromises end(s) of splice

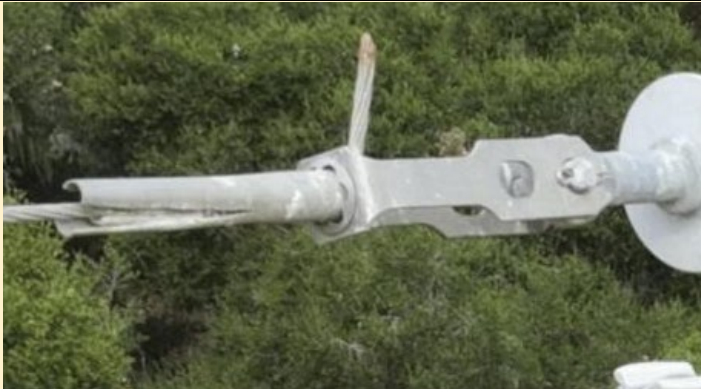
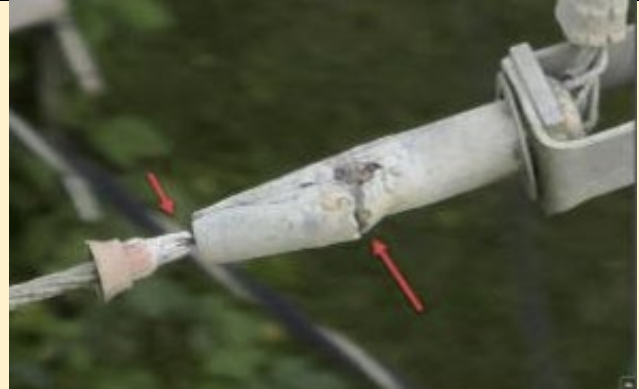
BROKEN DEAD-END

At this Location: Longitudinal crack to end of dead-end.

Priority = A Tag, follow emergency process

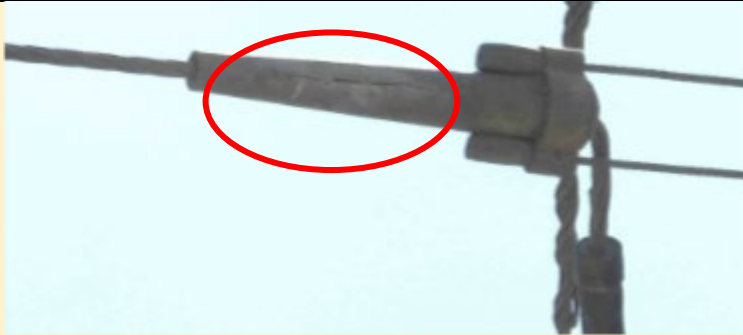
CRACKED DEAD END AND SPLICE

At this Location: Longitudinal (Horizontal) cracking in the middle of splice, NOT extending to the end.

FDA= Conductor / Broken Splice / Damaged Replace

Priority = X Tag, depending on exposure.

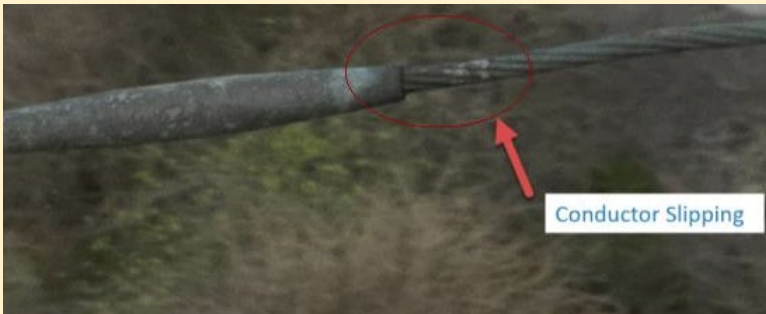
CONDUCTOR SLIPPING

At this Location: Conductor slipping from splice. Visual marking of conductor has been moved compared to end of splice.

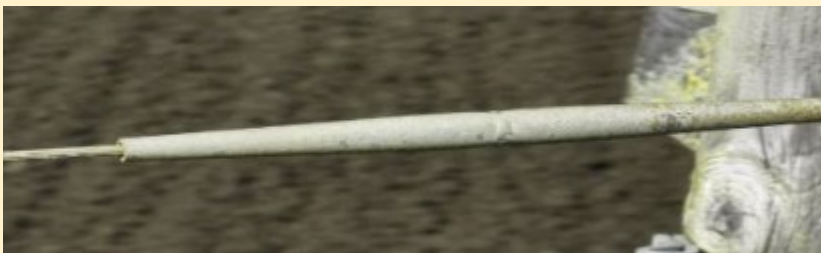
NON-COMPELLING SPLICE EXAMPLE

At this Location: No cracking or physical degradation. Minor corrosion and missing pilot funnels, is not an abnormal compelling condition.

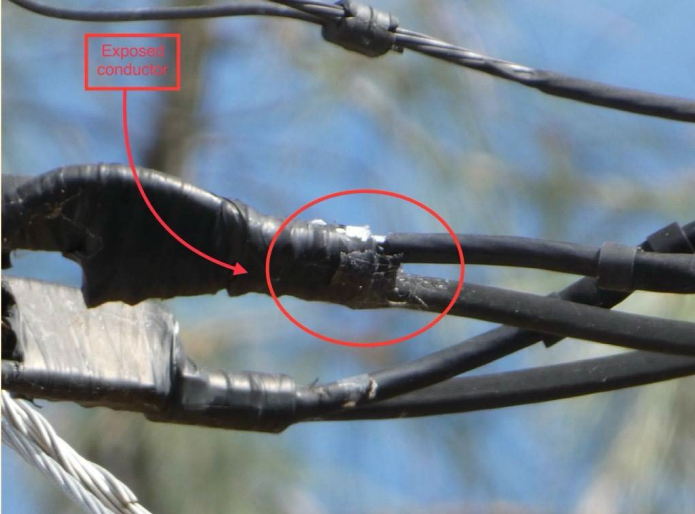
CONNECTOR WITH DETERIORATED TAPE

At this Location: Deteriorated tape insulation, potential cross-phasing.

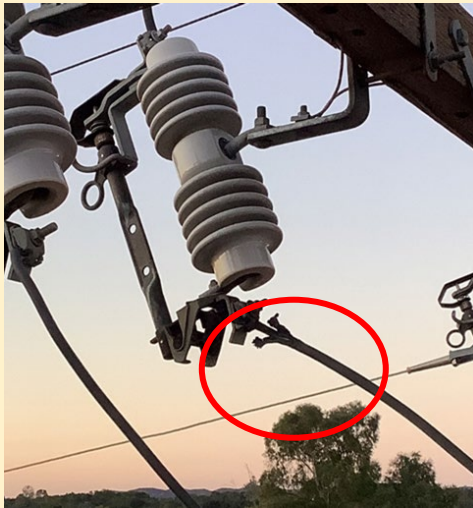
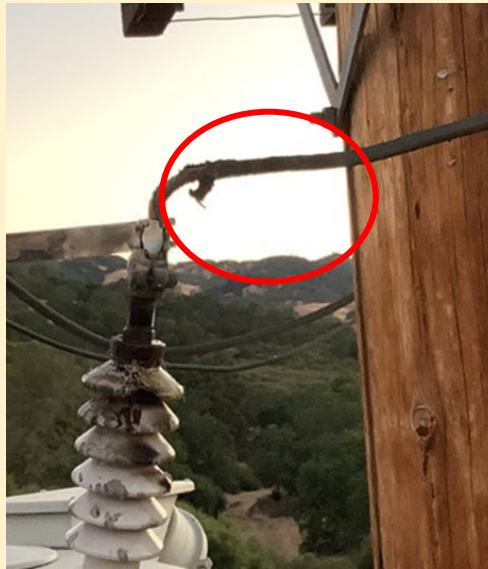
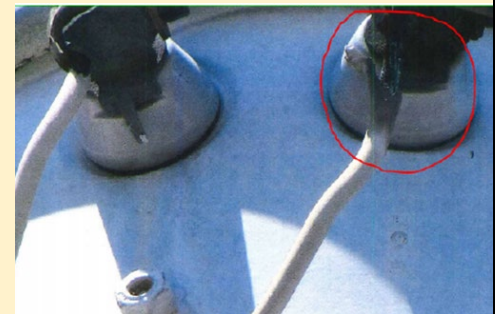
BURT JUMPER

At this Location: Primary jumpers and / or transformer secondary connection jumpers frayed and burnt. Insulation showing signs of deforming.

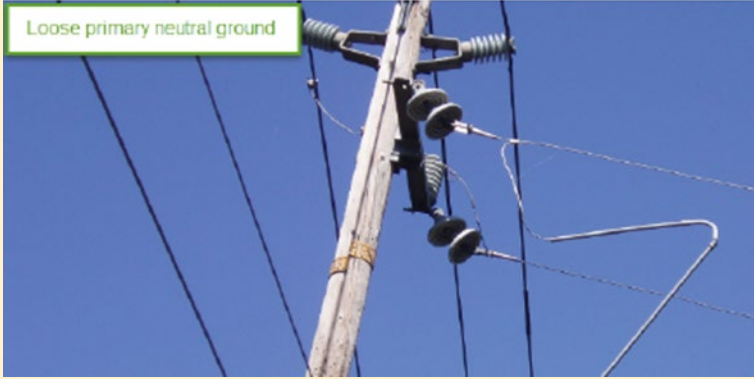
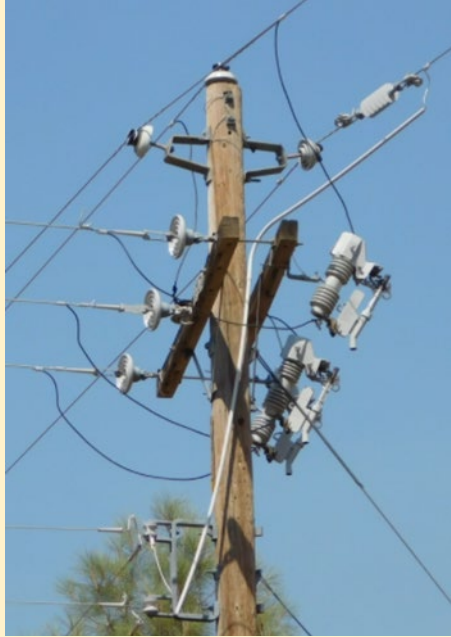
LOOSE PRIMARY NEUTRAL GROUND

At this Location: Loose primary neutral ground run, unsupported conductor, hanging.

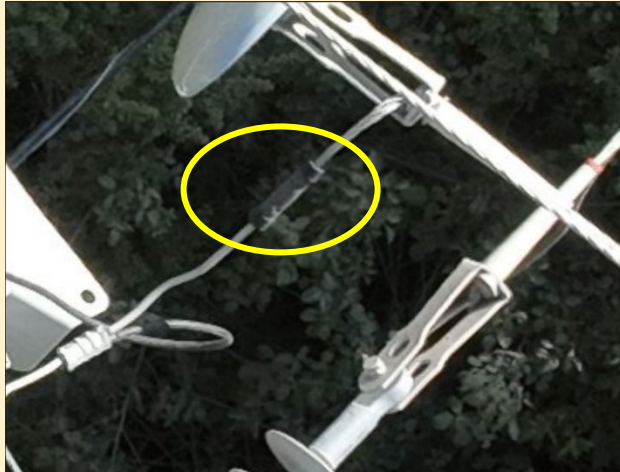
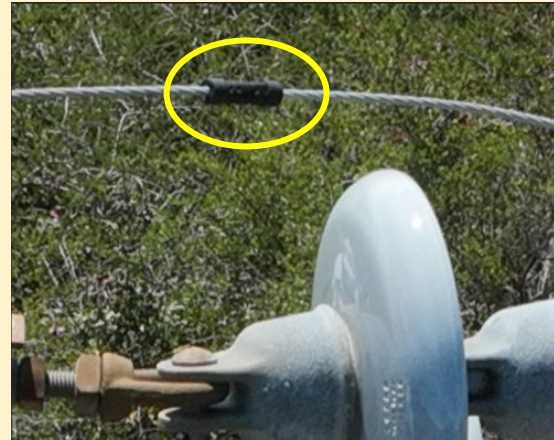
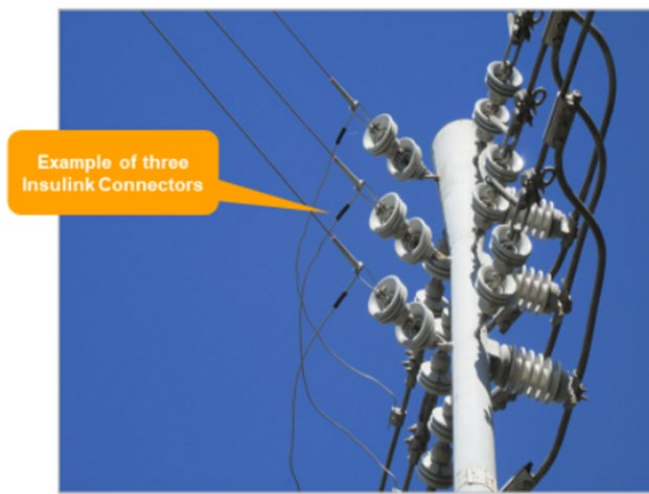
SECONDARY CONNECTOR INSTALLED ON PRIMARY

At this Location: Secondary connector installed on primary.

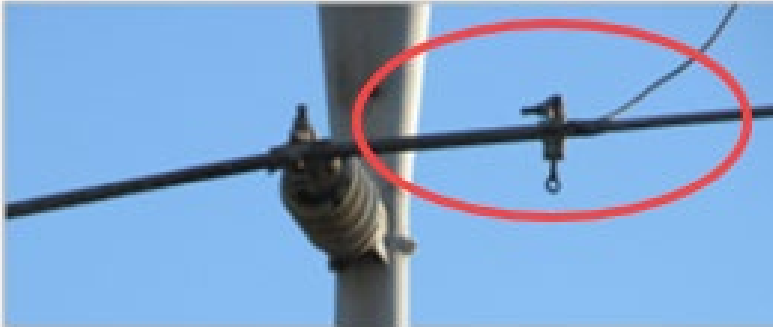
INCORRECTLY INSTALLED CHANCE CLAMP

<p>Tap clamp on armor rod installed incorrectly.</p>	<p>At this Location: Incorrectly installed per note C above - chance clamp on armor rod.</p> <p>
