Job Aid: Overhead Assessment

TD- 2305M-JA02
WMP-Discovery2023-2025 DR SPD 024-Q003Atch02
Publication: 01/06/2025 Effective: 01/14/2025

Rev: 14

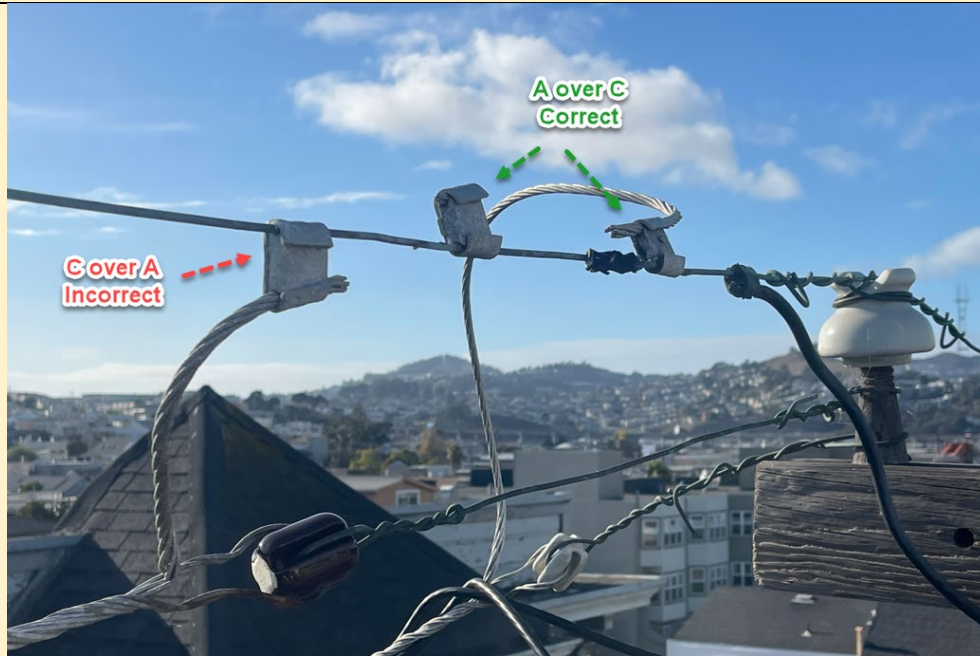
ALUMINUM OVER COPPER

At this Location Copper over Aluminum Installation.

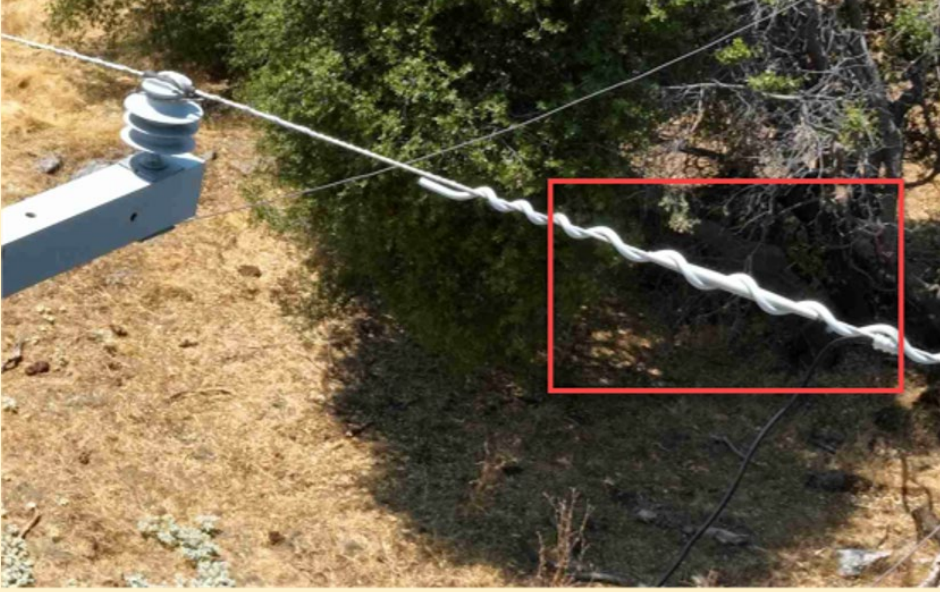
SPIRAL DAMPNER

At this Location: Spiral dampener installed over splice preventing free movement.

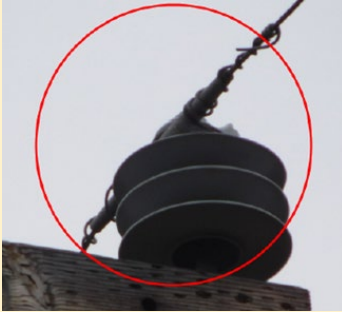
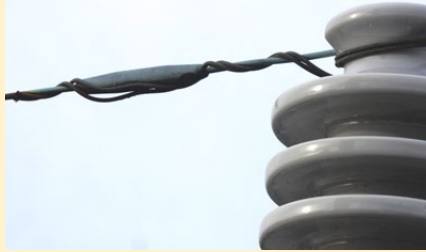
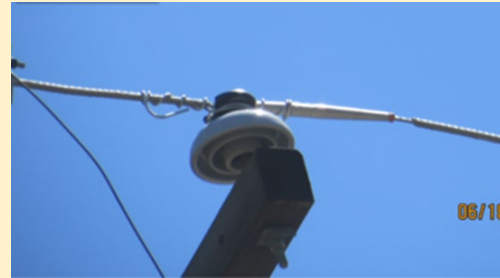
SPLICES TIED INTO THE INSULATOR OR UNDER THE TIE WIRE

At this Location: Splice under the tie wire or tied into the insulator.

FDA = Conductor / Splice Tied In / Replace

Priority = E Tag, depending on exposure

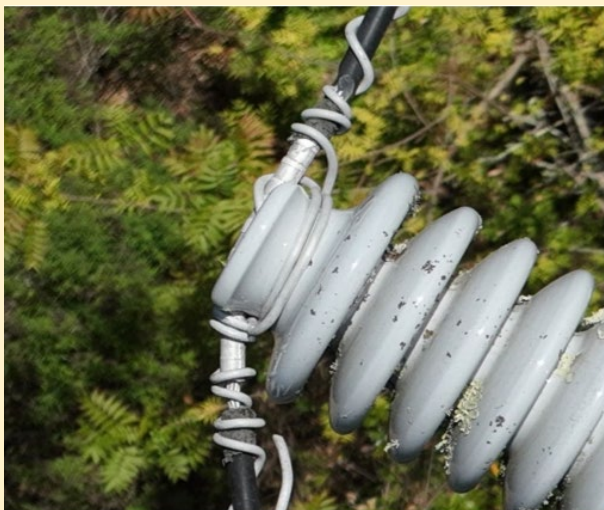
SPLICES TIED INTO THE INSULATOR OR UNDER THE TIE WIRE – AERIAL VIEW

At this Location: Splice under the tie wire or tied into the insulator. Splice bent / damaged.

Note: Example of insignificant contamination on insulator. Non-compelling condition.

FDA = Conductor / Splice Tied In / Replace

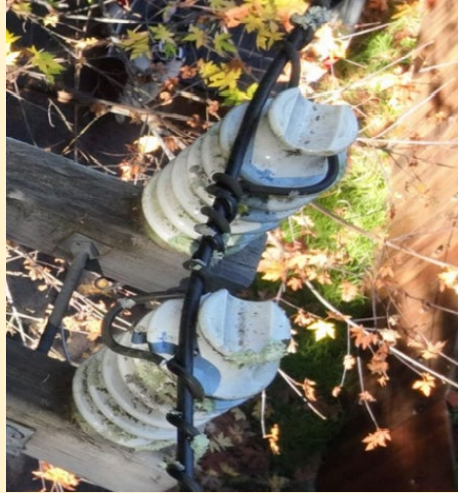
LOOSE TIE WIRE

At this Location: Loose tie wire

FDA = Tie wire / Broken/Damaged / Repair / Replace

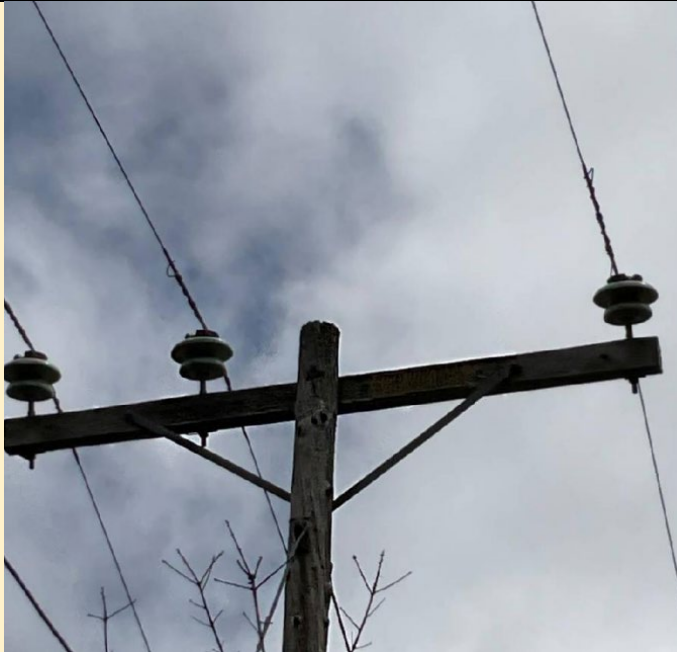
TIE WIRE LOOSE

At this Location: Tie wire loose allowing insulators to spin, conductor not seated properly in the insulator saddle.

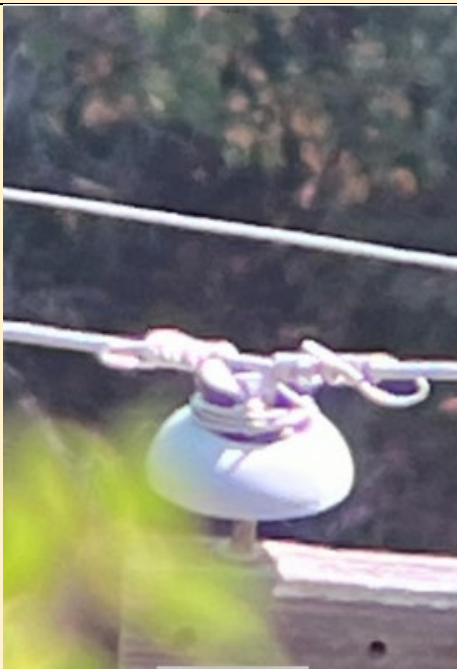
INSULATOR GROOVE

At this Location: Up-strain on the conductor and the tie is not tight enough to secure the conductor in the insulator saddle.

FDA= Tie wire / Broken/Damaged / Repair / Replace

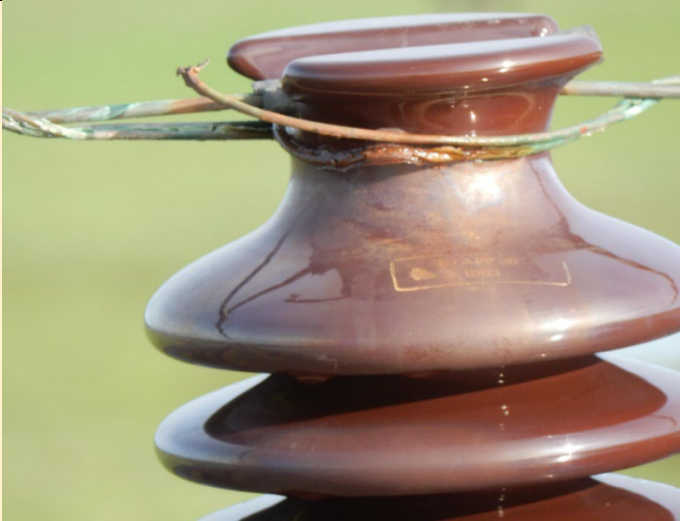
TIE WIRE CORRODED

At this Location: Tie wire is corroded, strand is broken.

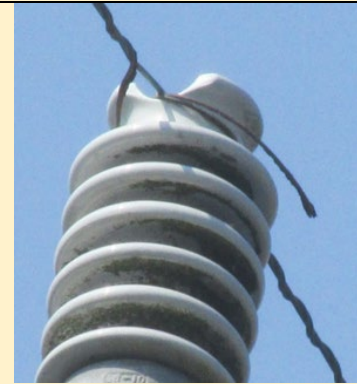
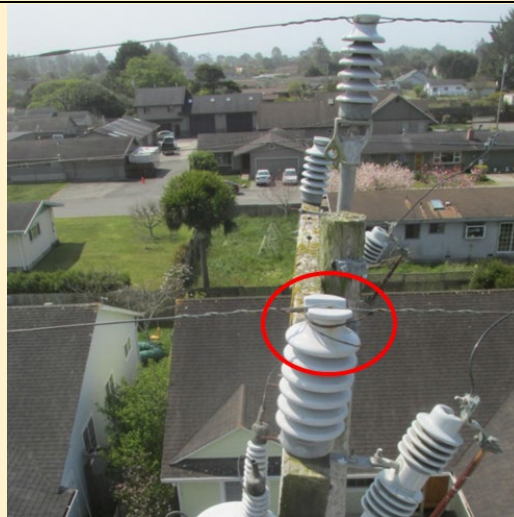
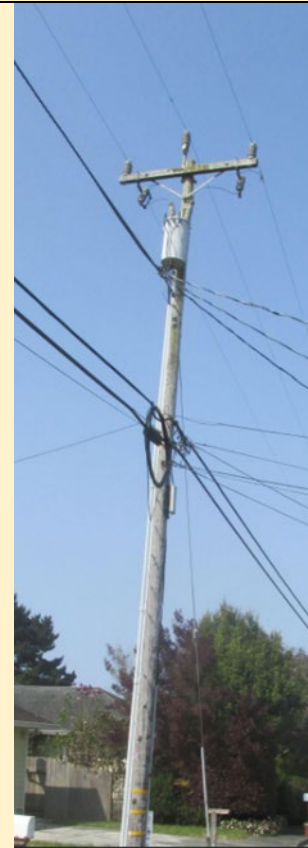
BROKEN / CORRODED TIE WIRE

At this Location: Corroded and broken tie wire, top tie, with one strand remaining, held in correct position by downward force.

FDA = Tie wire / Broken/Damaged / Repair / Replace

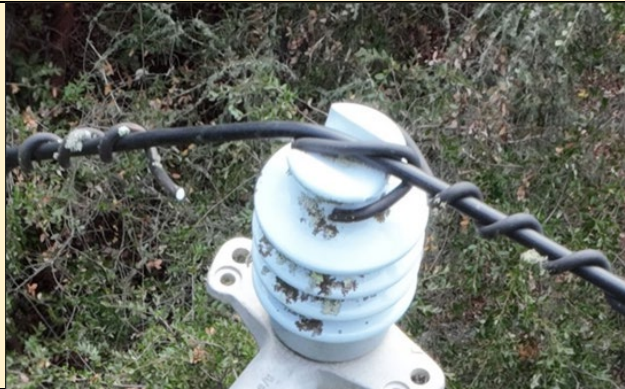
BROKEN / CORRODED TIE WIRE

At this Location: Broken tie wire

FDA = Tie wire / Broken/Damaged / Repair / Replace

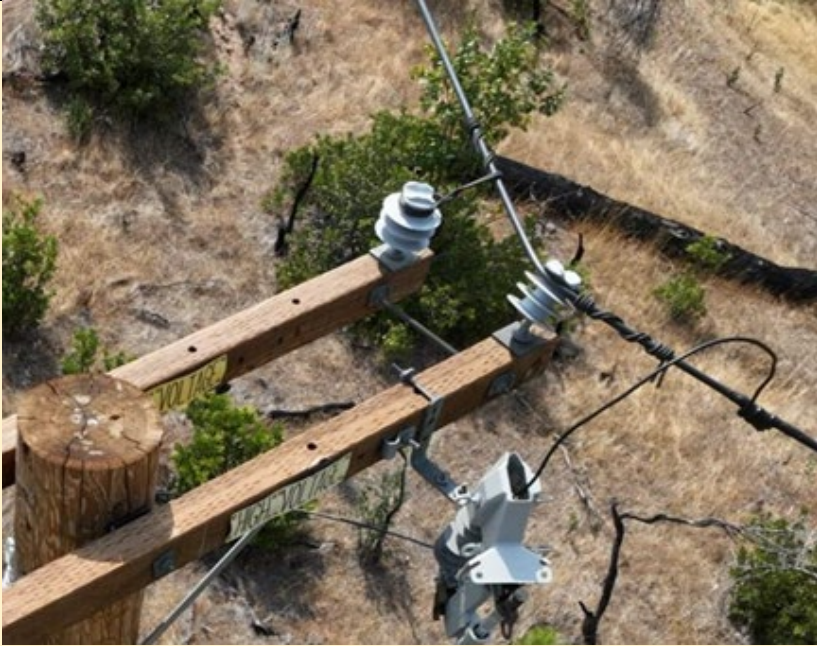
ANGLE POLE WITH TIE WIRE, BENT STEEL PIN

At this Location: Angle pole with post top insulator, where the inside angle insulator conductor is only being supported by tie wire (non-clamped). Post top insulator steel pin is bent.

Perform Minor Work: No
	Write 3rd Party Notification: No
	Write EC Notification: Yes
	FDA= Tie wire / Broken/Damaged / Repair / Replace
	Priority = X Tag, depending on exposure.

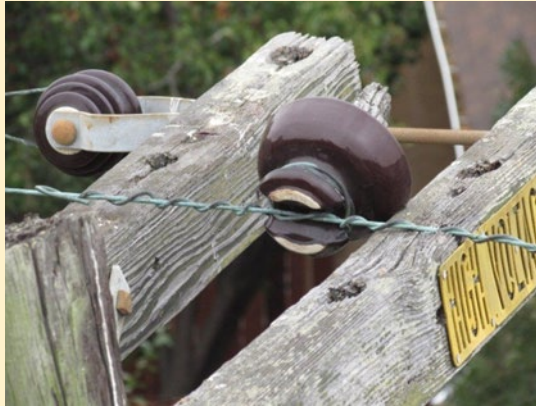
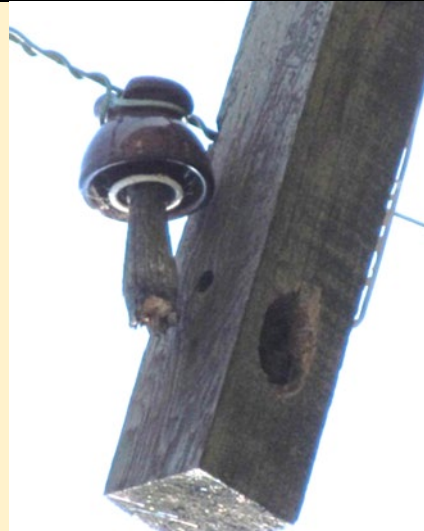
FLOATER – CONDUCTOR TOUCHING CROSSARM

At this Location: Insulator lying on its side. Conductor lying on crossarm regardless of Primary or Secondary.

FDA= Crossarm / Decayed/Rotten / Replace

FDA= Conductor / Floater / Repair

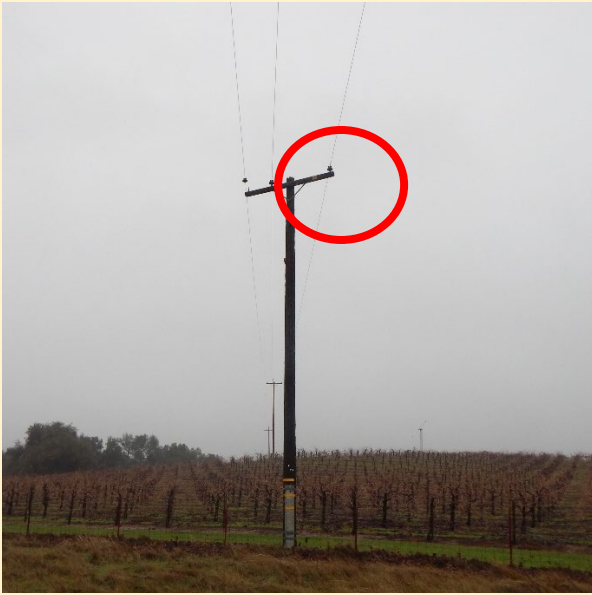
FLOATER

At this Location: Floater, conductor is not contacting the arm. Rotten crossarm.

FDA=Crossarm / Decayed/Rotten/ Replace

FDA= Conductor / Floater / Repair

Priority= X Tags, however extenuating circumstances may escalate to A Tag (*refer to clearance section when there is reduced clearance do to not tied to structure*).

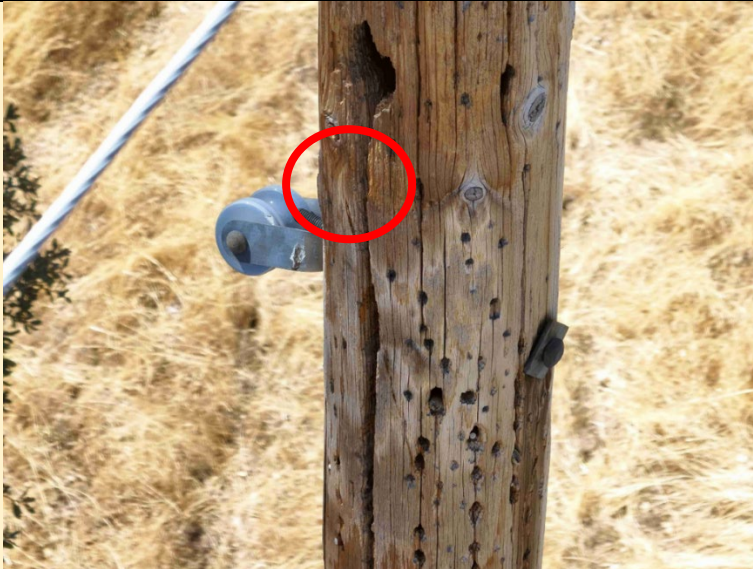
COMMON NEUTRAL FLOATER

At this Location: Common neutral floater not touching structure.

FDA= Conductor / Floater / Repair

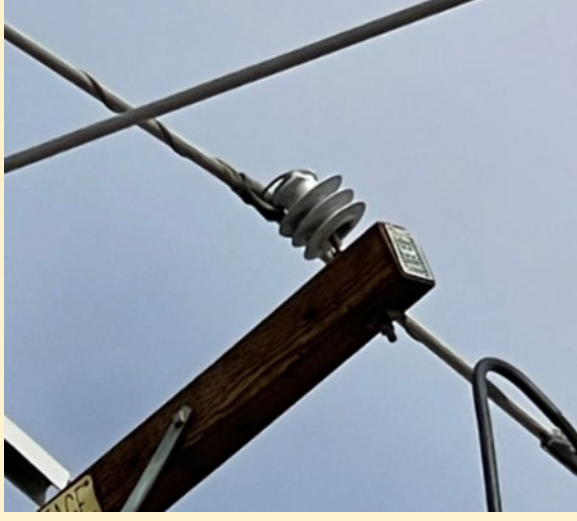
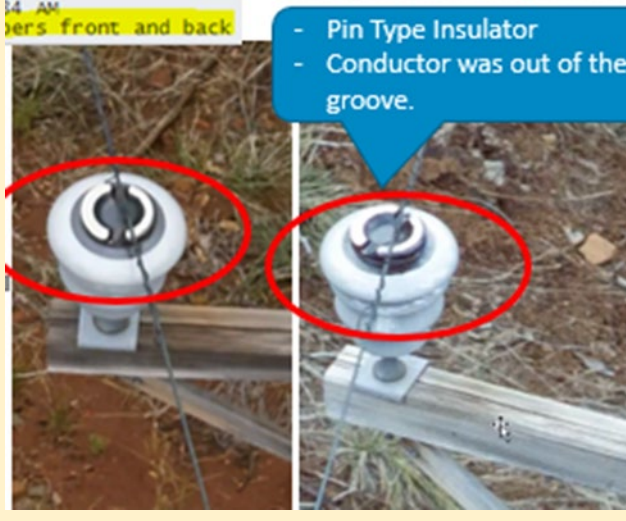
CONDUCTOR TIED TO SIDE OF SKIRT, NOT IN GROOVE	TIE WIRE BROKEN / LOOSE / NOT IN GROOVE

<p>At this Location: Insulator spun, and conductor tied on the skirt.</p> <div data-bbox="203 1297 337 1360">

</div>	<p>At this Location: Tie Wire Broken / Loose / Not in Groove</p> <div data-bbox="792 1297 862 1360">

</div>
<p>Perform Minor Work: No</p>	<p>Perform Minor Work: No</p>
<p>Write 3rd Party Notification: No</p>	<p>Write 3rd Party Notification: No</p>
<p>Write EC Notification: Yes</p> <p>FDA = Tie Wire / Broken/Damaged / Replace</p> <p>Priority = X tag, depending on exposure.</p>	<p>Write EC Notification: Yes</p> <p>FDA = Tie Wire / Improperly Installed / Repair</p> <p>Priority = X tag, depending on exposure.</p>

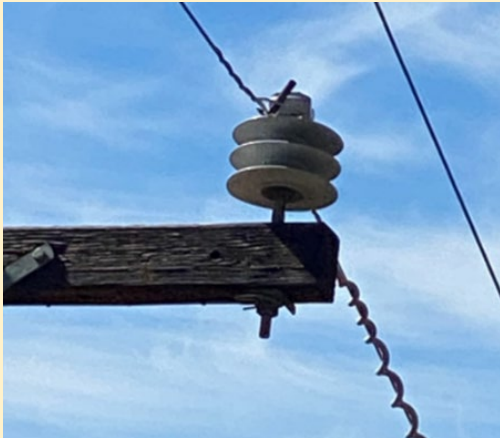
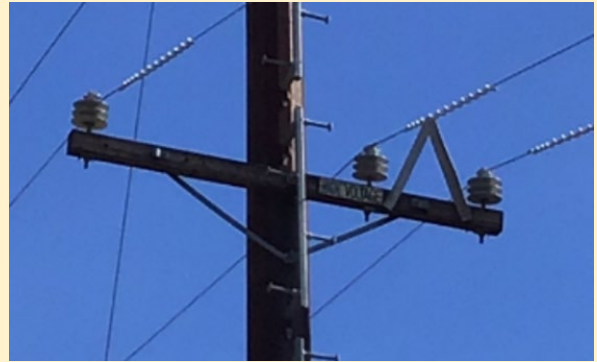
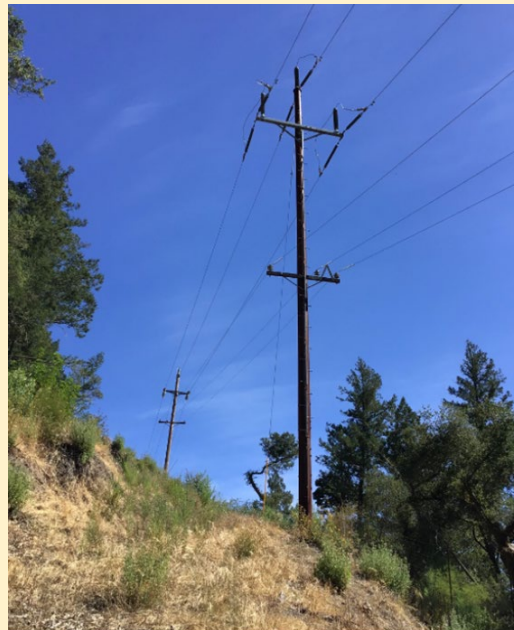
QUESTIONABLE TIE WIRE

At this Location: Not obvious if it is still attached. Insulator has spun.

FDA = Tie wire / Broken/Damaged / Repair / Replace

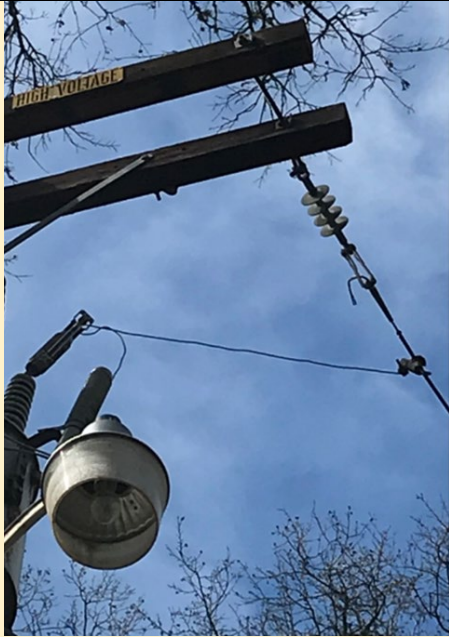
JUMPER TENSION

At this Location: Jumper Tension, pulling over cutout.

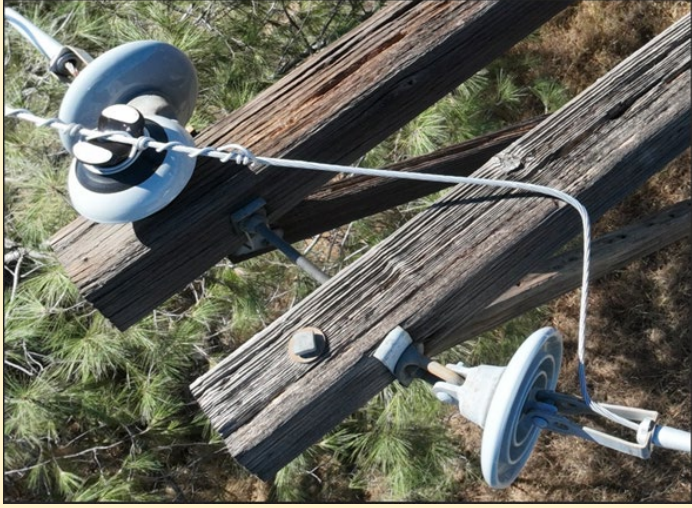
INSUFFICIENT CLEARANCE – AERIAL VIEW

At this Location: Over the top jumper laying on cross-arm.

Perform Minor Work: No
	Write 3rd Party Notification: No
	Write EC Notification: Yes FDA: Jumper / Clearance / Impaired / Adjust Priority: A Tag, Follow the emergency process

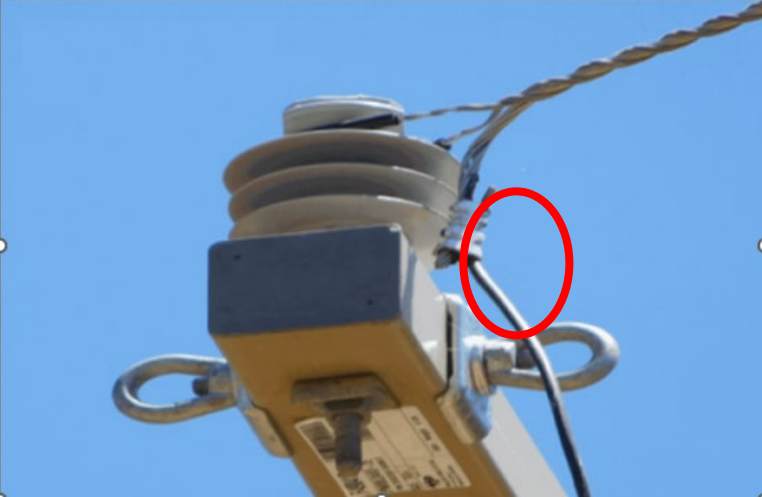
INSUFFICIENT CLEARANCE

At this Location: Insufficient clearance between connector and cross-arm

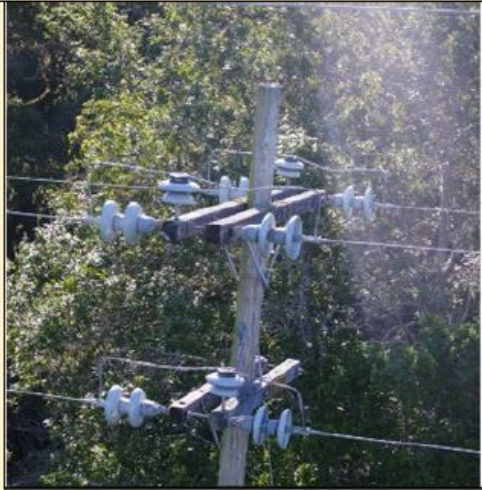
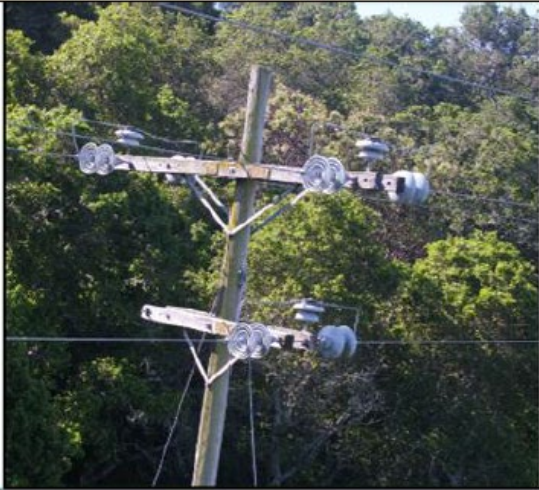
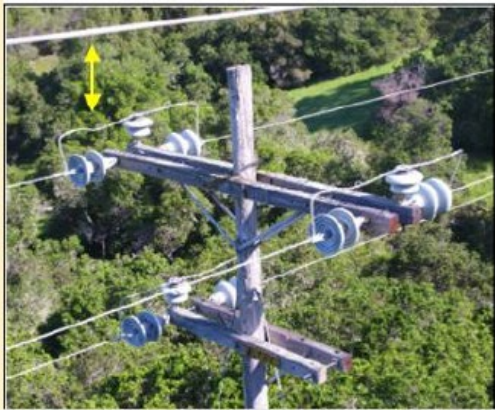
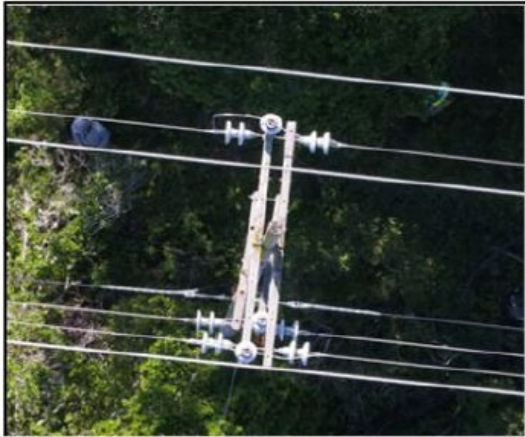
UNSUPPORTED TRANSMISSION LINE WITH DIMINISHED CLEARANCE

<p>At this Location: Unsupported transmission line with diminished clearance to the distribution level seen from the ground or aerial.</p> <p>

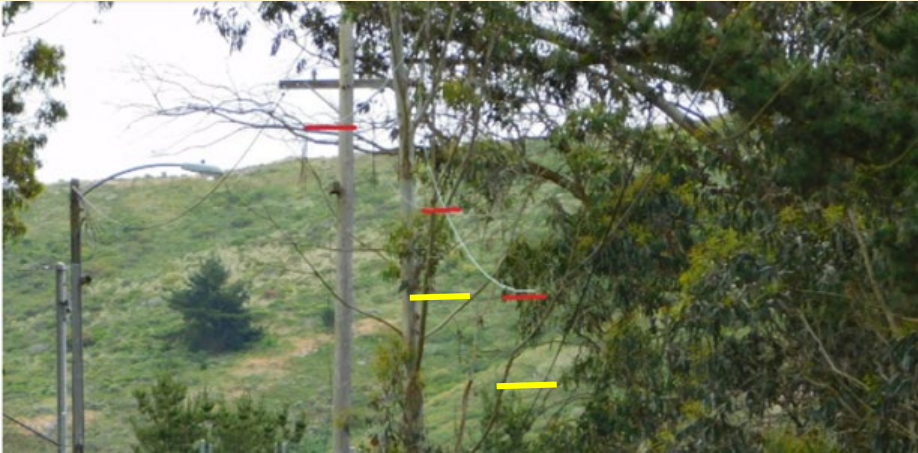
SAGGING CONDUCTOR

At this Location: Sagging Conductor

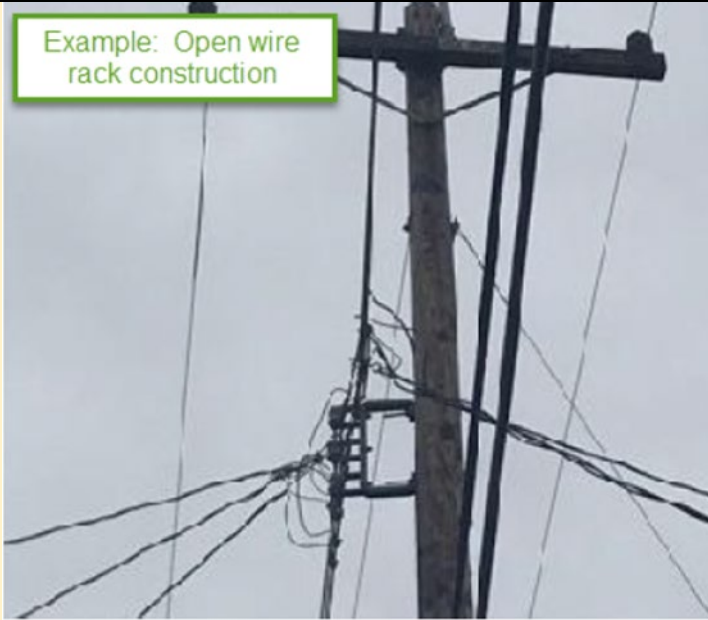
Example: Open wire
rack construction

At this Location: Span length >135' missing spreader bracket for open wire extended rack construction.

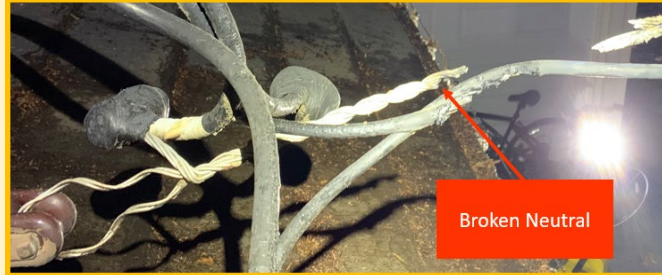
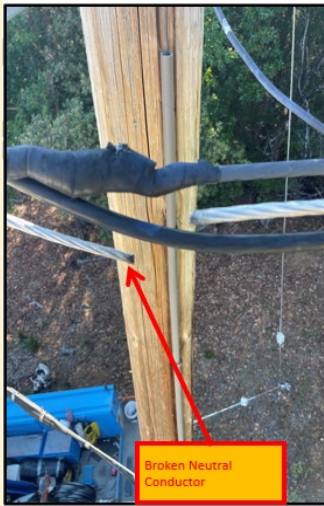
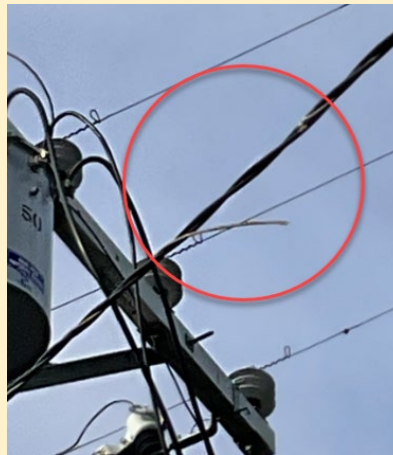
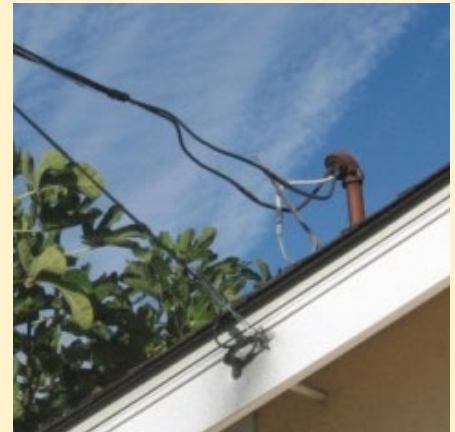
BROKEN OR OPEN SERVICE NEUTRAL

At this Location: Broken / Open Service neutral.

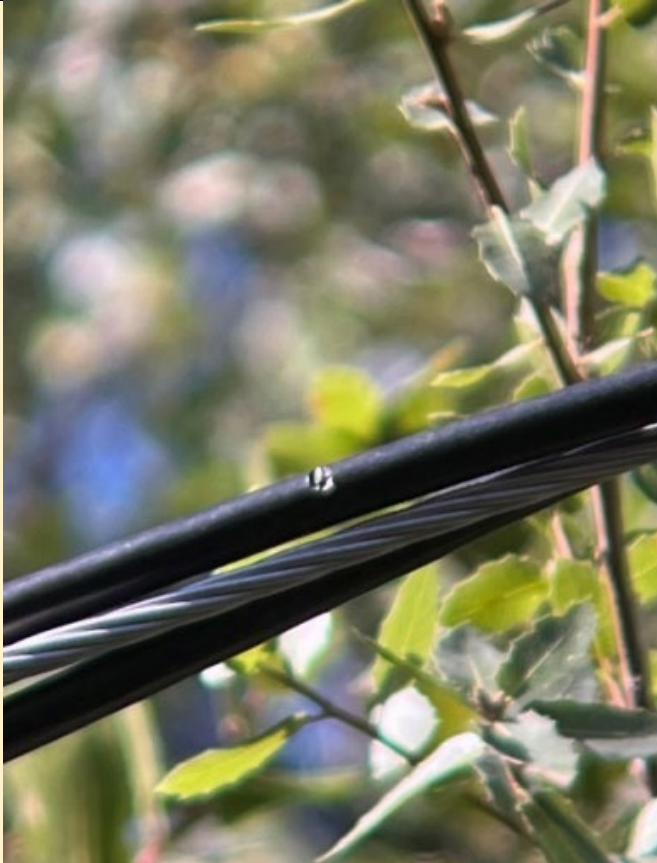
EXAMPLE OF DAMAGE BEFORE INSTALLATION

At this Location: Service insulation damaged on the surface.

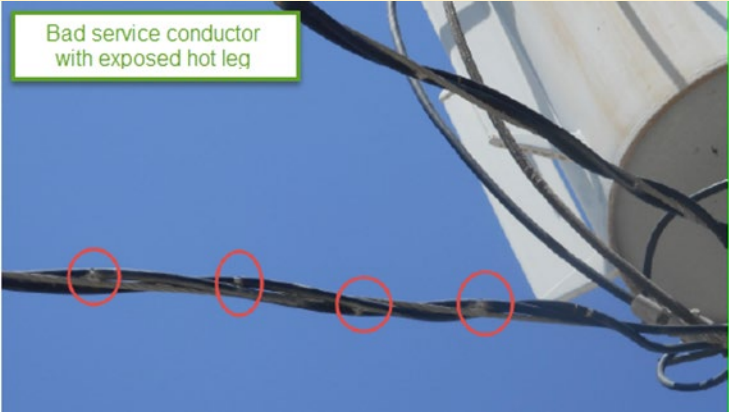
BAD SERVICE CONDUCTOR WITH EXPOSED HOT LEG

<p>At this Location: Bad service conductor with exposed hot leg, bundled with a potential to cross phase.</p> <p>

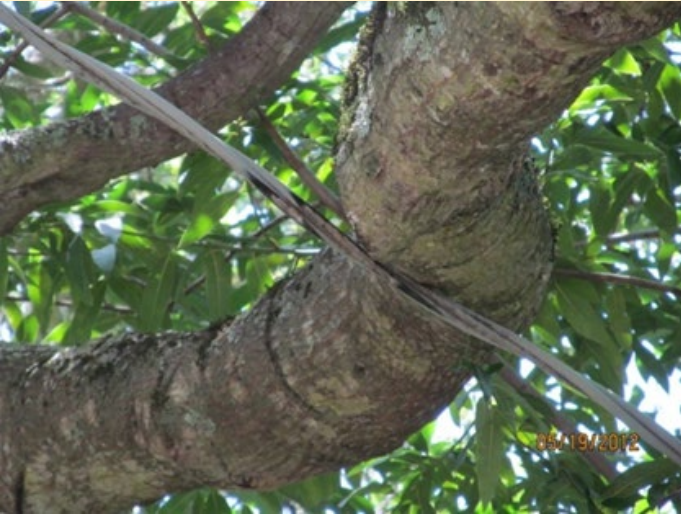
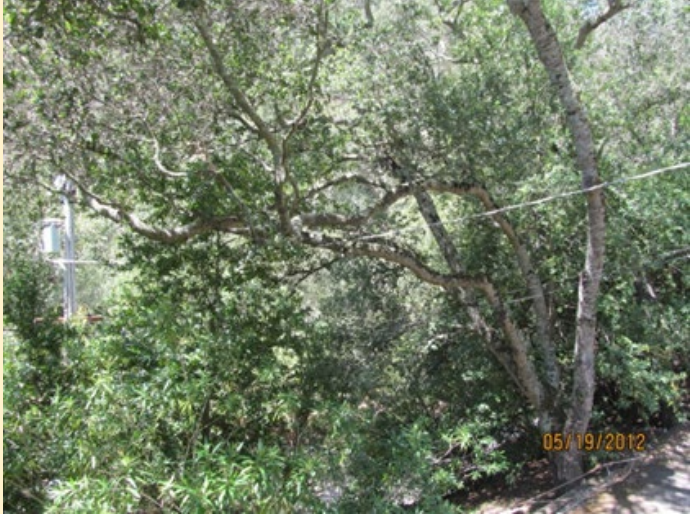
OVERHEAD SERVICE STRAIN OR ABRASION	OVERHEAD SERVICE STRAIN OR ABRASION

<p>At this Location: Service strain abrasion, with possible burning at some sections. Damaged insulation.</p>

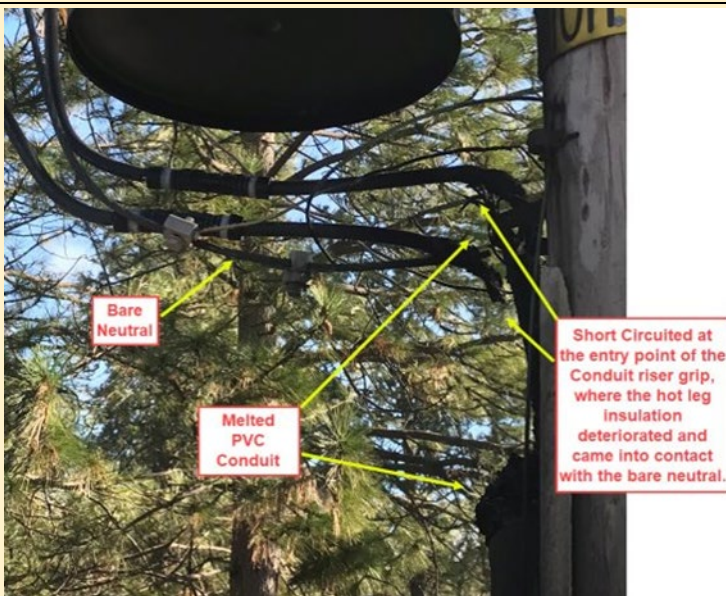
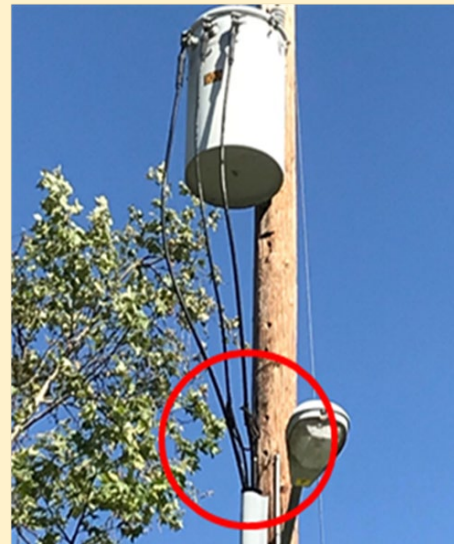
SECONDARY SERVICE RISER DROPS

At this Location: hot leg insulation frayed at the point of entry point of the molding exposing the conductor into contact with the neutral

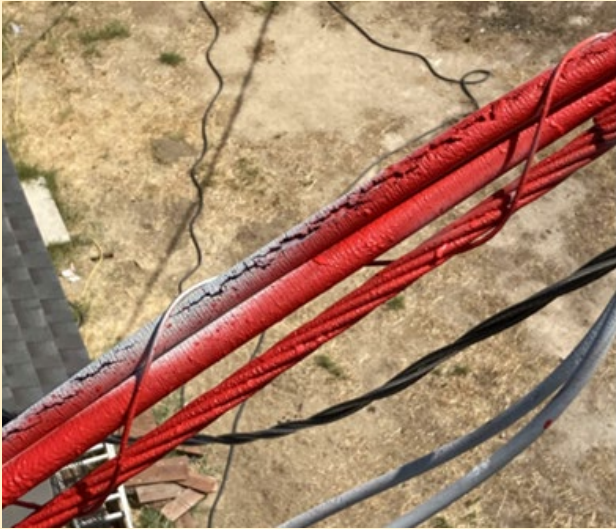
DAMAGED / CRACKED GREY SERVICE

<p>At this Location: Cracked grey service / Aerial cable. Older grey services tend to crack and will appear to have rings around the protective coating/insulation. Loose lashing, visually cracked, discoloration/corrosion, Degradation. No evidence of arching.</p> <p>

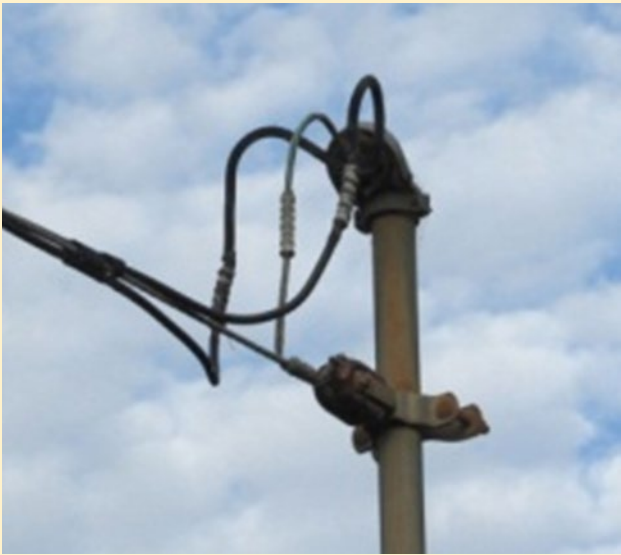
EXPOSED SERVICE CONNECTOR

At this Location: Exposed Conductors, with an acceptable air gap between conductors

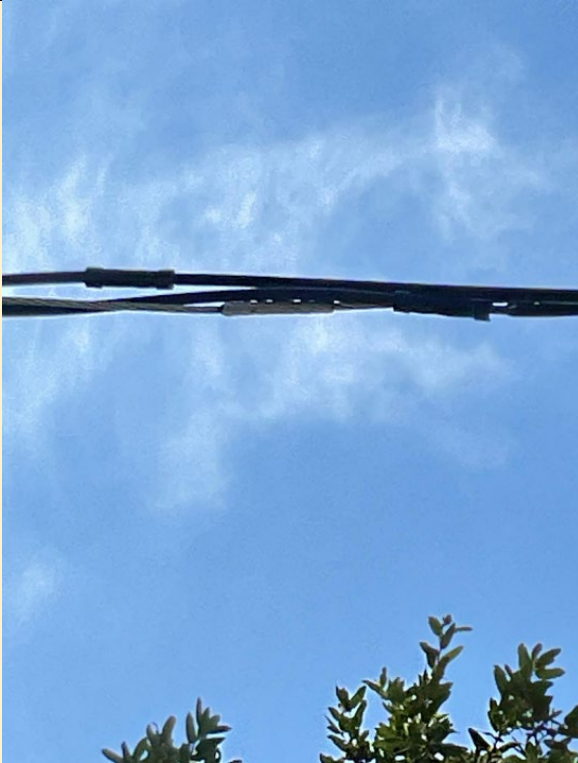
EXPOSED CONDUCTOR

At this Location: Hot leg is exposed next insulink.

Perform Minor Work: Yes

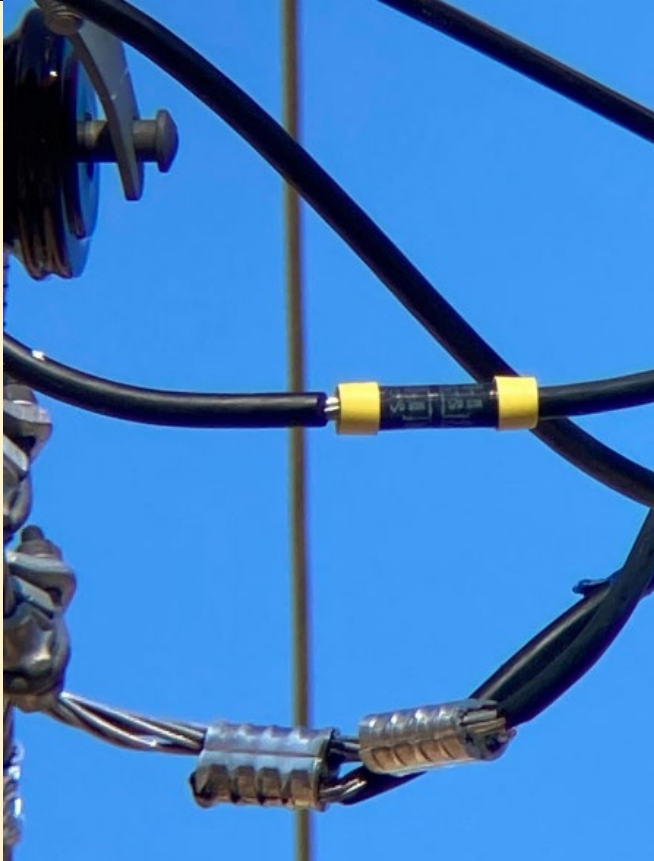
EXPOSED CONDUCTOR

At this Location: Hot leg exposed next to insulink

Perform Minor Work: Yes

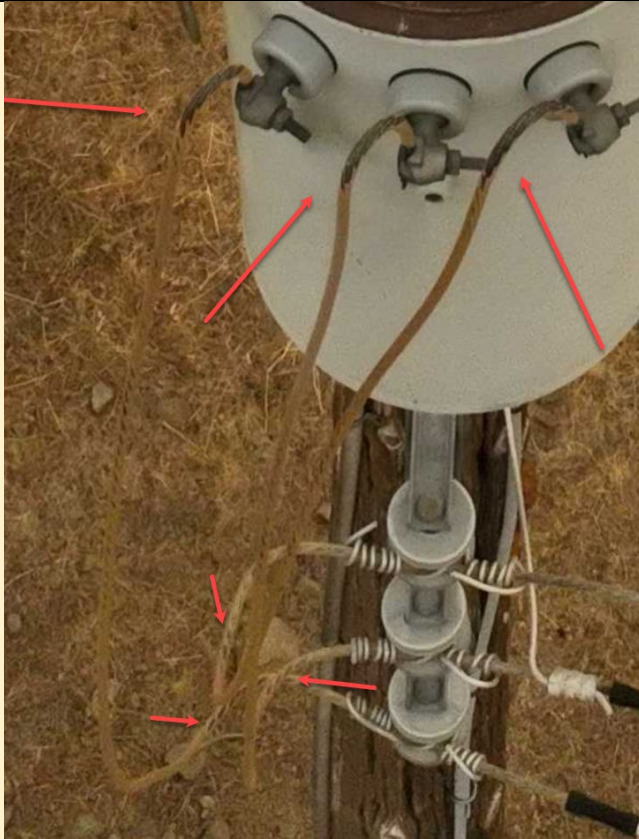
INSULATION DETERIORATED

At this Location: Coated insulation wire has deteriorated. Exposed wire on secondary buss wire.

Consider replacing buss wire if repairing insulation would be inadequate.

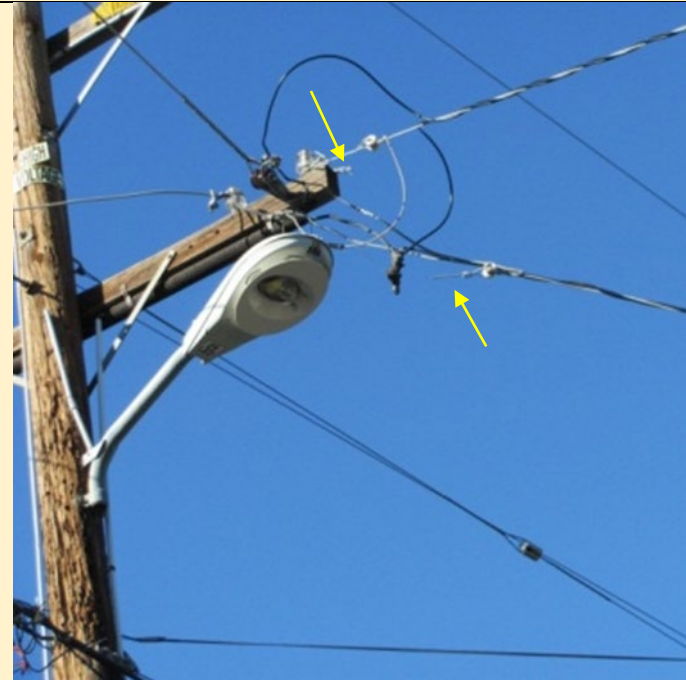
HARDWARE BROKEN

At this Location: The #6 solid copper is broken causing strain on the conductor. Unsecured service.
	Perform Minor Work: Yes, if safe to do so
	Write 3rd Party Notification: No
	Write EC Notification: Yes, if minor work cannot be performed. FDA= Hardware / Framing / Broken/Damaged / Repair Priority = E Tag, consider X tag or A tag, depending on length of service and exposure.

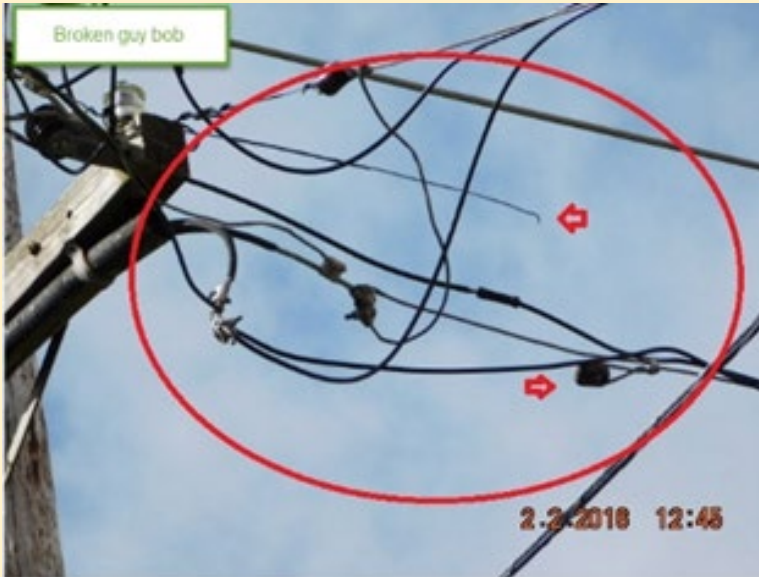
BROKEN SERVICE BOB

At this Location: Broken service Insulator which has become unattached between the copper wire and the insulator.

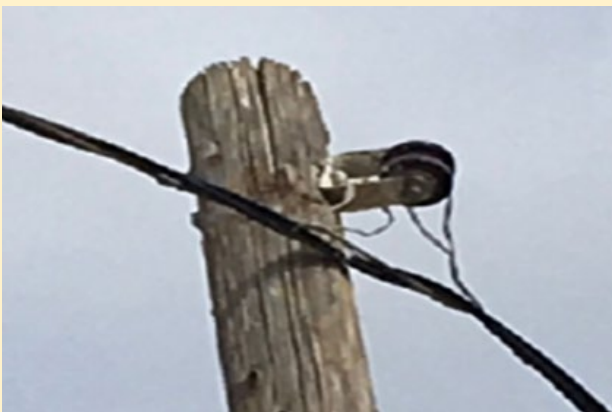
PREFORM NOT ATTACHED TO INSULATOR

At this Location: Preform not attached to the insulator, rural area, low exposure with no vehicular access.

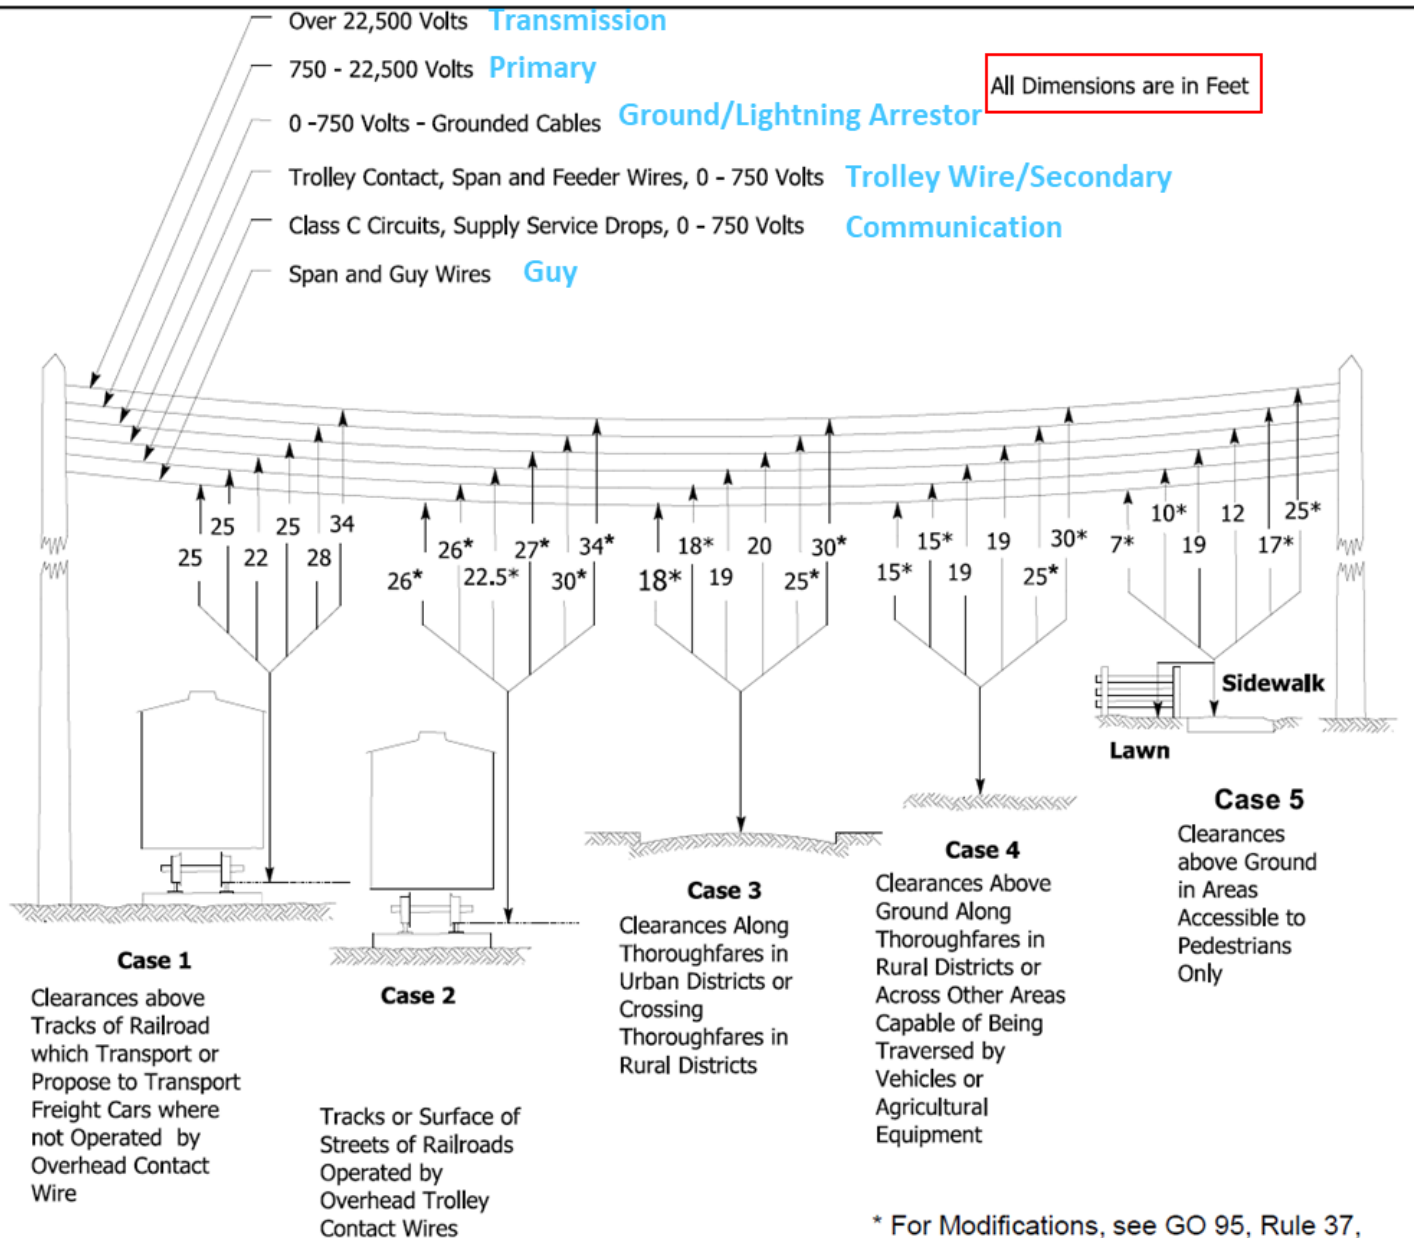
Ground Clearances - General

All Dimensions are in Feet

* For Modifications, see GO 95, Rule 37, Table 1, Cases 1 to 5

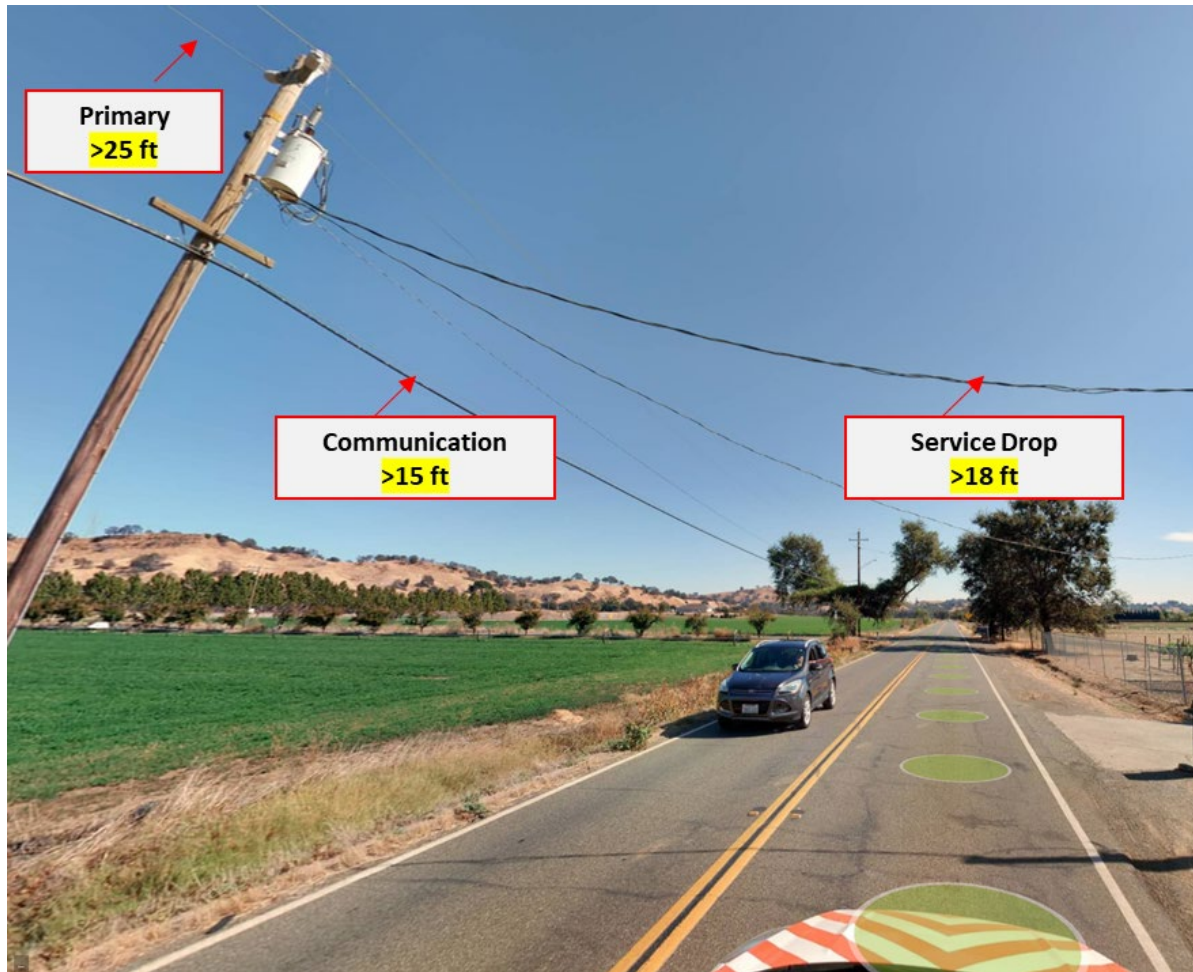
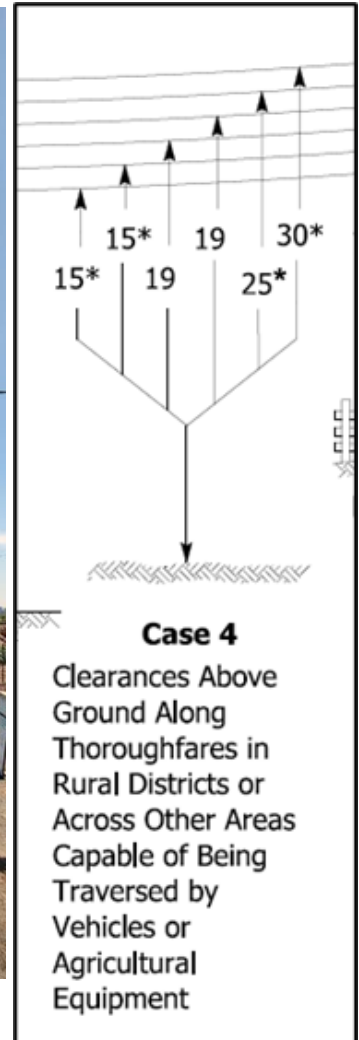
Case 4: Along or Crossing a Rural Road

NOTE: Due to the fisheye lens and the online street view, the poles appear to be leaning but are not.
