Job Aid: Overhead Assessment

TD- 2305M-JA02
WMP-Discovery2023-2025 DR SPD 024-Q003Atch02
Publication: 01/06/2025 Effective: 01/14/2025

Rev: 14

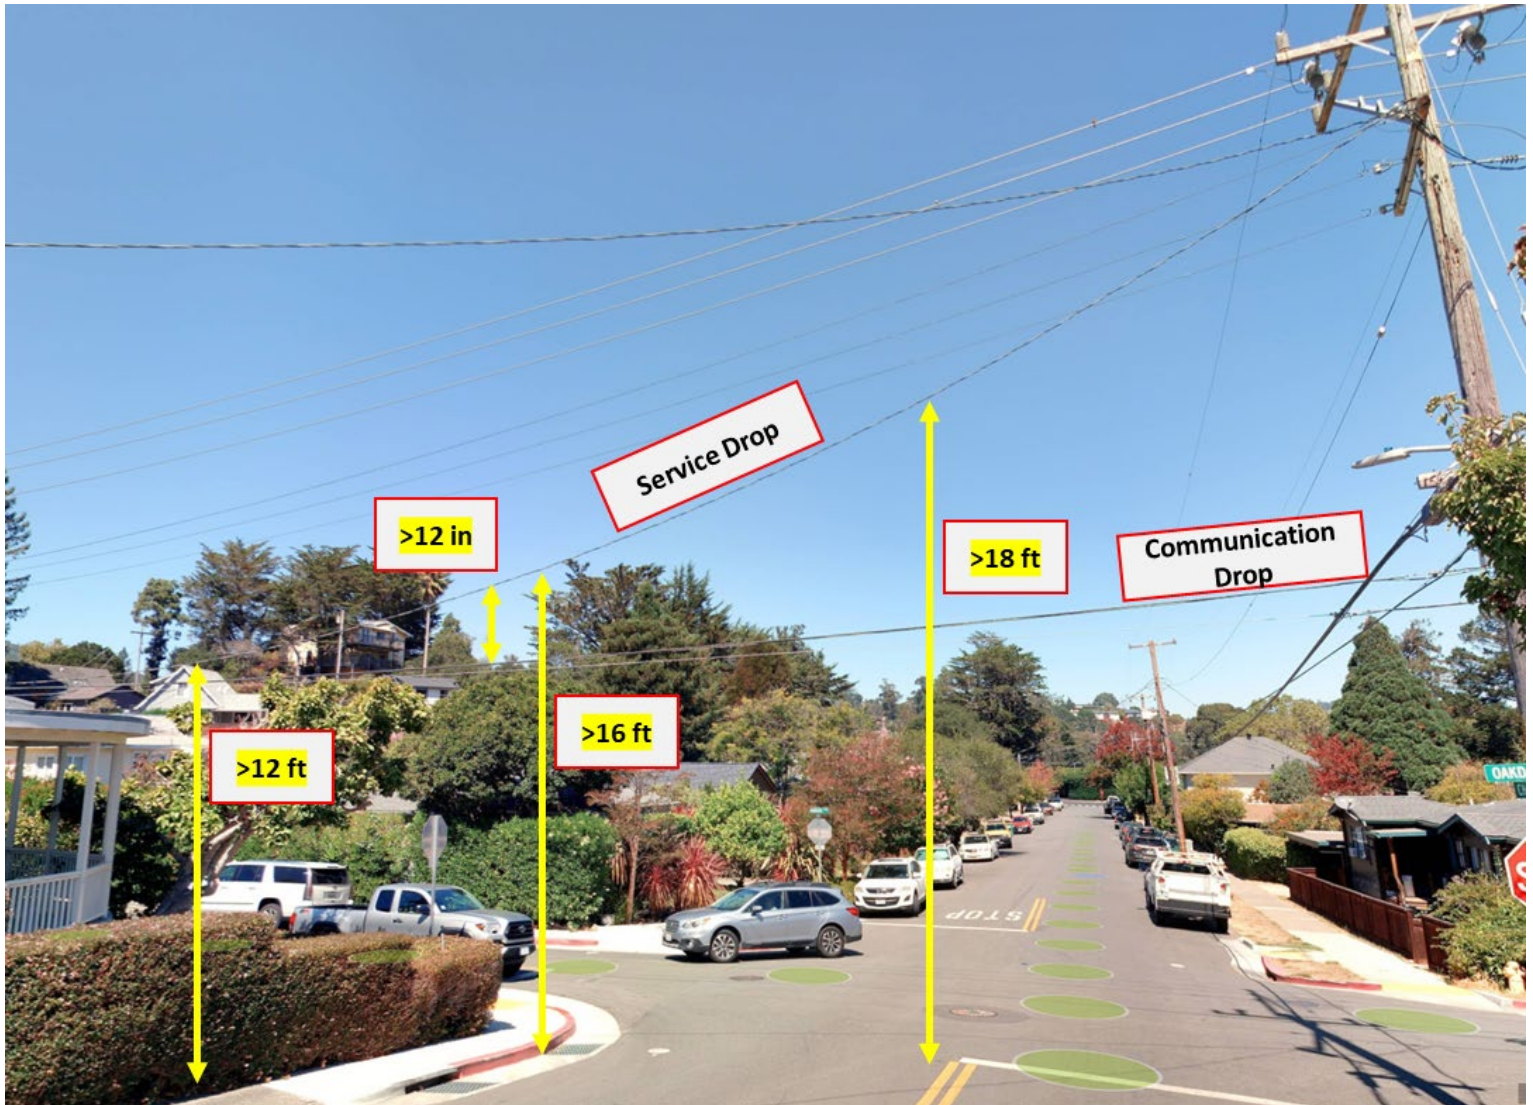
Service Drop – Residential

NOTE: Due to the fisheye lens and the online street view, the poles appear to be leaning but are not.

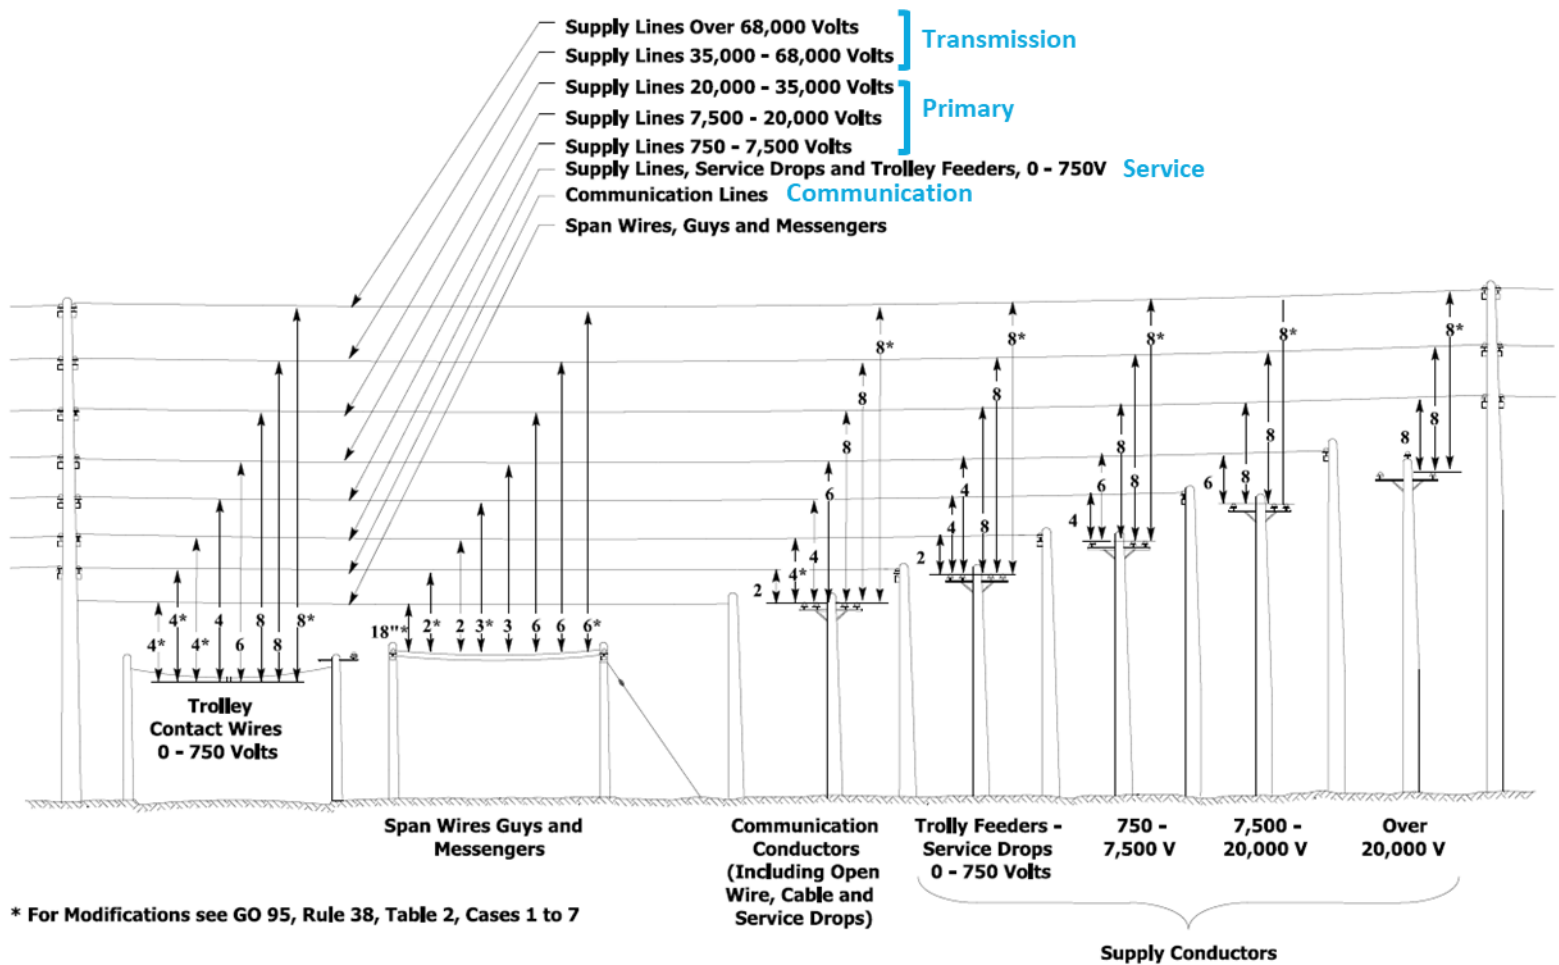
Conductor to Conductor Clearances - Crossings

- 300kV plus transmission circuits require 156 inches of clearance to the primary.

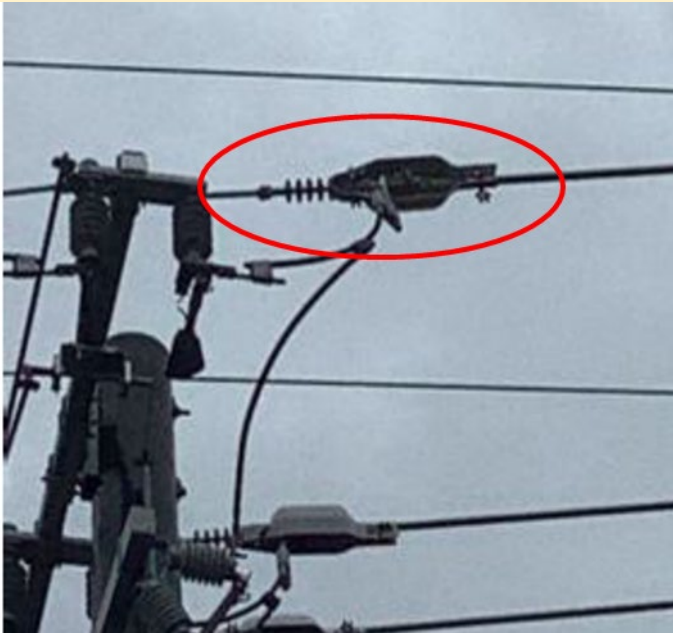
MIS-ALIGNED DEAD-END COVERS

At this Location: Dead-End Cover mis-aligned on tree wire construction.

Perform Minor Work: Yes, if safe to do so. Install anti-rotation Clamp
	Write 3rd Party Notification: No
	Write EC Notification: Yes FDA= Dead End Cover / Broken/Damaged / Replace OR FDA= Dead End Cover / Broken/Damaged / Repair Priority = F Tag, depending on exposure

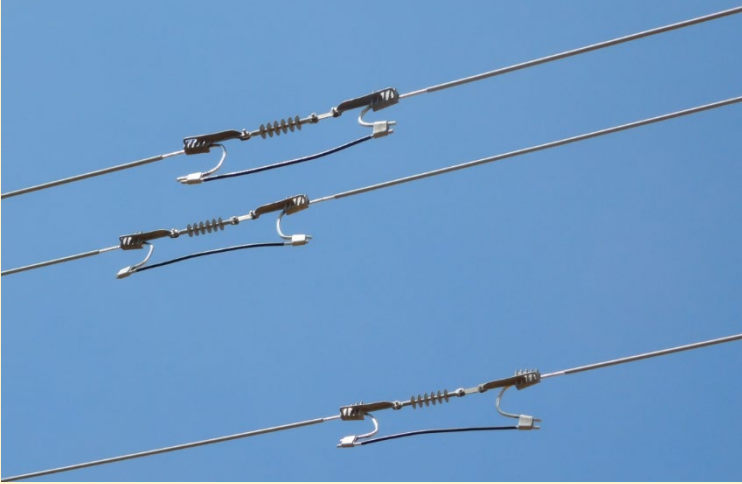
Exposed Primary Covered Conductor – Flying Bells, Wedge Connectors not removed after Work

At this Location: Flying Bells installed in on primary tree wire, now have exposed connectors and conductor.

Perform Minor Work: No
	Write 3rd Party Notification: No
Write EC Notification: Yes	
FDA: Tree Wire / Exposed / Repair	
Priority: F Tag, depending on exposure

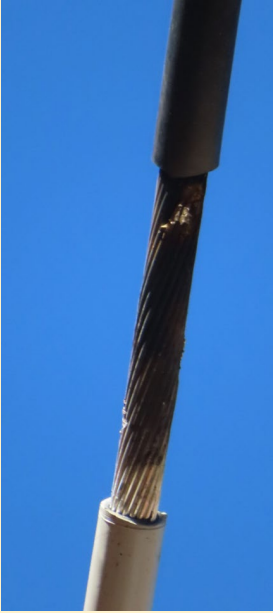
Exposed Primary Covered Conductor Tree Wire, Burnt Conductor

At this Location: Tree Wire conductor exposed and burnt.

Perform Minor Work: No
	Write 3rd Party Notification: No
	Write EC Notification: Yes FDA= Tree Wire / Exposed / Repair FDA= Conductor / Burnt / Repair Priority: E Tag, depending on exposure

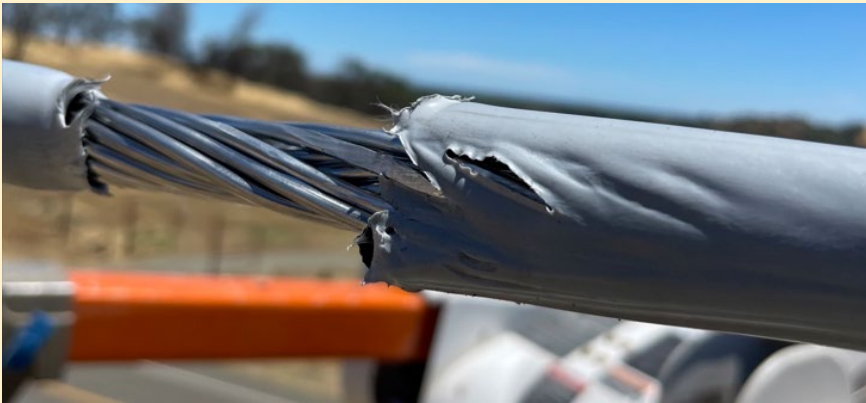
Exposed Primary Covered Conductor Tree Wire

At this Location: Tree Wire jacket cut into, and bare conductor exposed
	Perform Minor Work: No
	Write 3rd Party Notification: No
	Write EC Notification: Yes
	FDA: Tree Wire / Exposed / Repair Priority: F Tag, depending on exposure

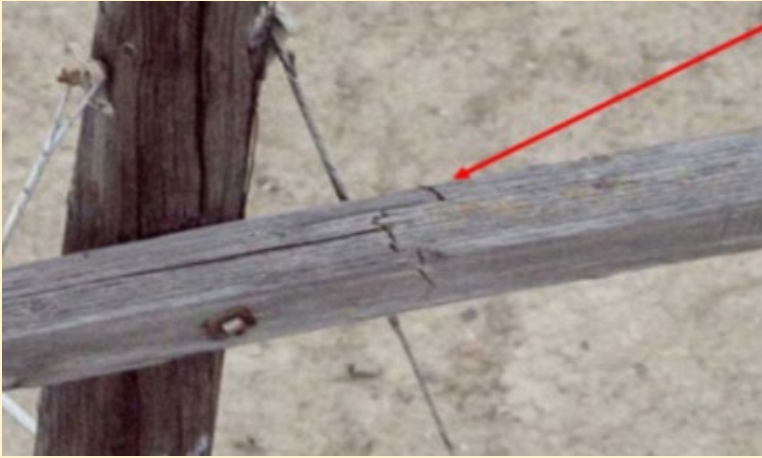
Cracked Cross-Arm – Aerial View

At this Location: Top view of a cracked cross-arm on top and sides. May not be seen from the ground.

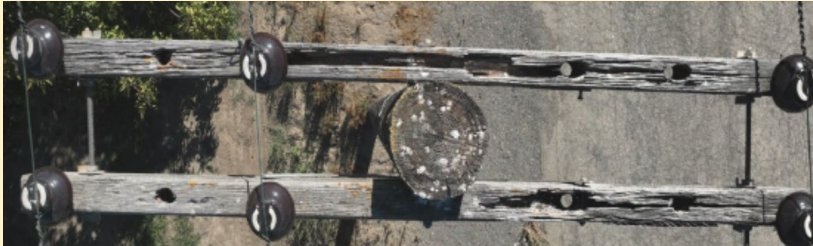
Deteriorated Cross-Arm – Aerial View

At this Location: Top view of a Deteriorated/Rotten cross-arm. May not be seen from the ground. Quarter brace hardware coming loose.

FDA = Cross-arm / Broken/Damaged / Replace

Priority = Minimum B tag, consider A Tag for conditions such as conductor size, double / single arm, exposure, etc.

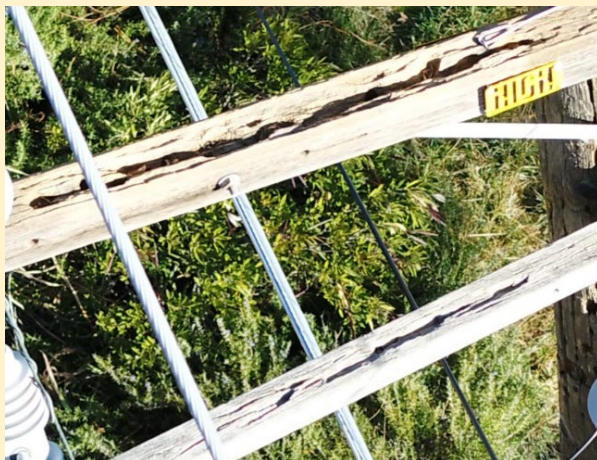
At this Location: Deteriorated Cross-Arm – Aerial View

FDA = Cross-arm / Broken/Damaged / Replace

Priority = Minimum B tag, consider A Tag for conditions such as conductor size, double / single arm, exposure, etc.

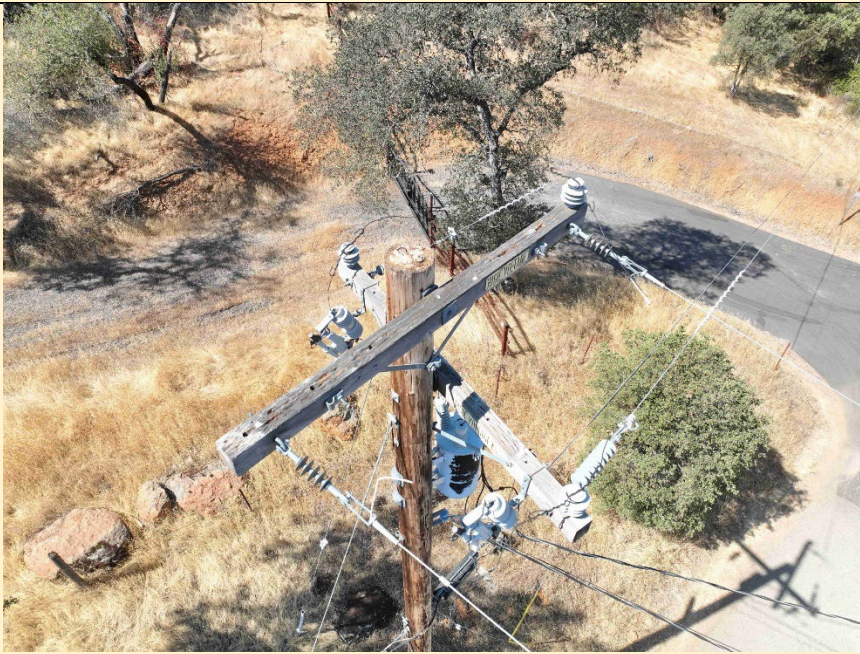
CROSSARM DOES NOT NEED REPLACEMENT

At this Location: Crossarm looks good. Prefabricated holes, not woodpecker. No replacement needed.

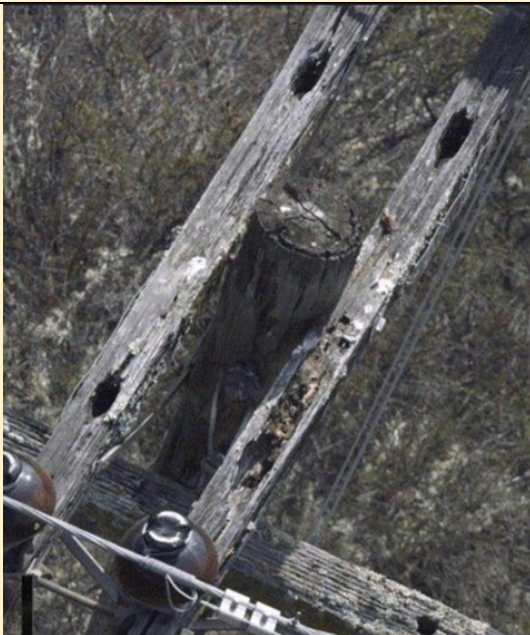
Deteriorated Cross-Arm – Aerial View

At this Location: Deteriorated/Rotten Cross-Arm – Aerial View

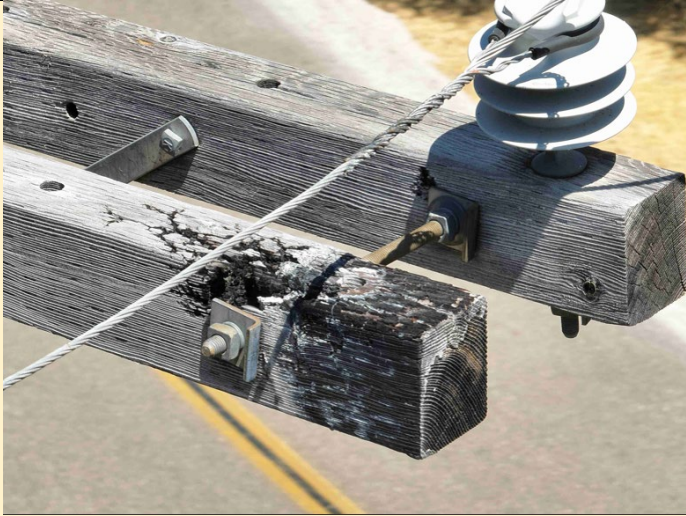
BURNT CROSSARM – Aerial View

At this Location: Arching on crossarm.

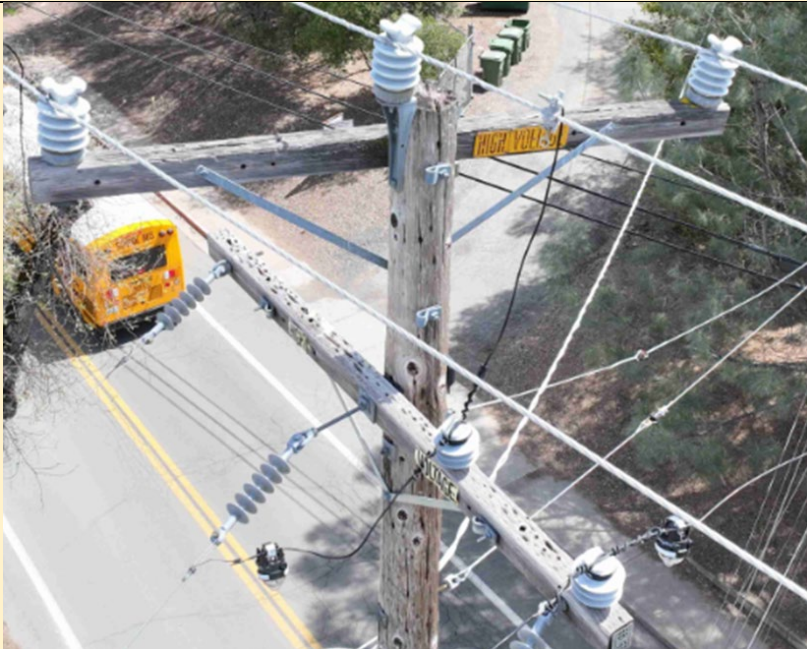
CROSSARM DOES NOT NEED REPLACEMENT

At this Location: Crossarm looks good.
Follow woodpecker process flow.

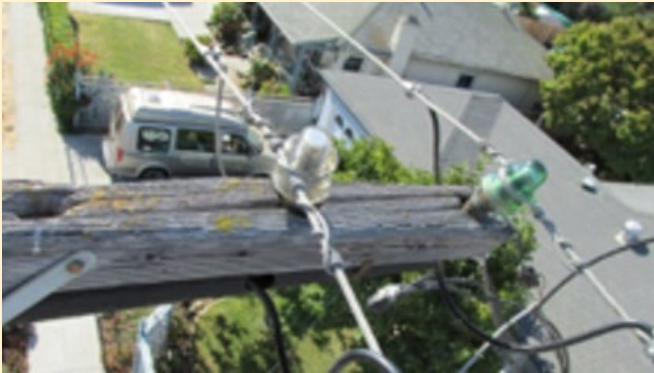
SECONDARY SQUATTER & DECAYED CROSSARM

At this Location: Secondary Squatter and decayed crossarm, replace wood crossarm with composite arm.
	Perform Minor Work: No
	Write 3rd Party Notification: No
	Write EC Notification: Yes FDA= Crossarm Decayed / Rotten / Replace FDA= Secondary Squatter / Broken/Damaged / Replace Priority= E Tag, at minimum, next inspection cycle; based on field condition and exposure, corrosion, etc.; prioritize as needed (A, B, E, or F)

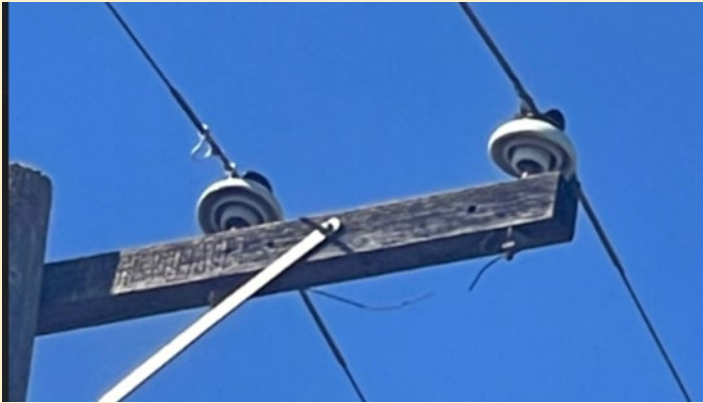
BONDING

At this Location: Broken or unattached bonding

Perform Minor Work: No
	Write 3rd Party Notification: No
	Write EC Notification: Yes
	FDA = Bonding / Broken/Damaged / Replace Priority = E Tag, up to 36 months depending on exposure

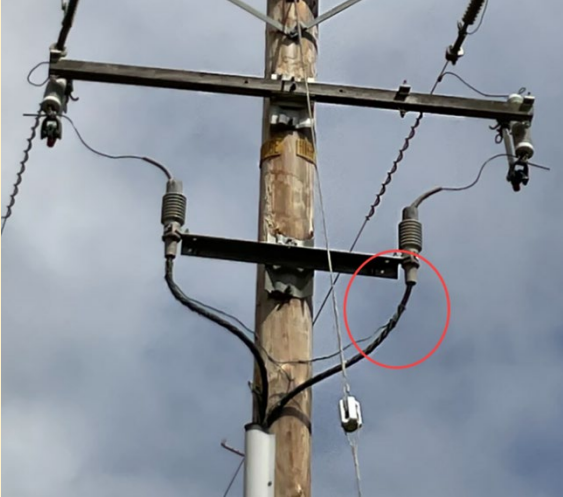
CONCENTRIC HAS COME LOOSE

At this Location: Concentric has come loose and no longer connected to insulator. This Termination is not grounded, and leakage current is being carried on the semi con jacket of the cable. The distance between the concentric and porcelain termination should be minimal.

Perform Minor Work: No
	Write 3rd Party Notification: No
	Write EC Notification: Yes FDA: Ground / Missing/ Install FDA: Riser / Pothead Broken/Damaged / Replace Priority: Minimum F Tag, depending on exposure

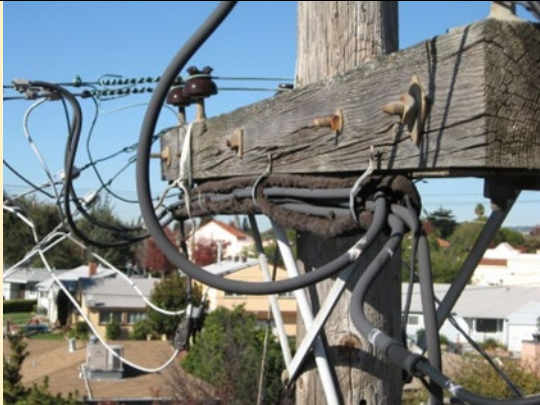
UNDER-ARM BUS LOOSE & DETERIORATED

At this Location: UAB deteriorated, partial repair with rope, secured with one strap.

Perform Minor Work: No	
Write 3rd Party Notification: No	
Write EC Notification: Yes	
FDA= Under-Arm Bus / Broken/Damaged / Repair	
Priority = At minimum – must write up as F Tag, next inspection cycle; based on field condition and exposure, corrosion, etc.; prioritize as needed (A, B, E, or F)

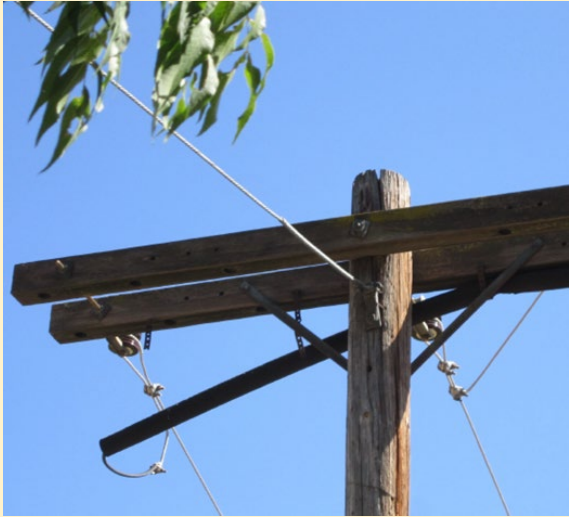
UNDER-ARM BUS LOOSE

At this Location: UAB Loose, unattached and hanging.

Perform Minor Work: No
	Write 3rd Party Notification: No
	Write EC Notification: Yes FDA= Under-Arm Bus / Broken/Damaged / Repair Priority= E Tag, depending on exposure

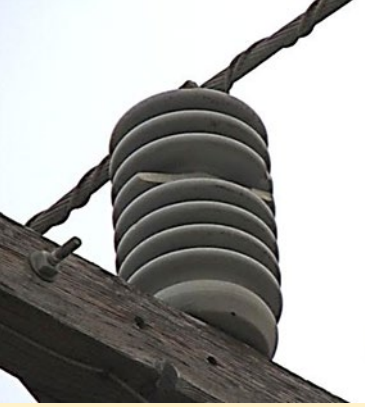
DAMAGED INSULATOR

At this Location: Damaged insulator, Replace all insulators and the arm.

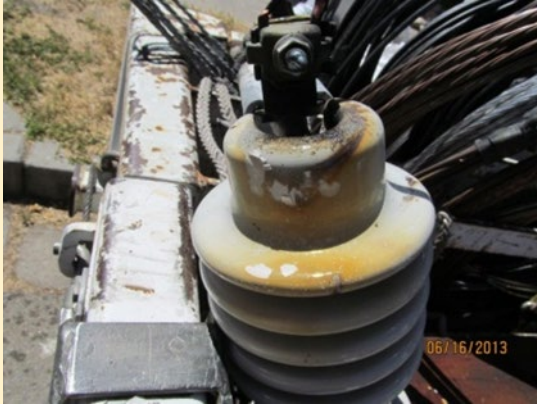
FLASHED INSULATOR POTHEAD

**At this Location:** Flashed pothead

**Perform Minor Work:** No**Write 3rd Party Notification:** No**Write EC Notification:** Yes, or COE (see a set of combo cutouts at location follow COE process)**FDA=** Riser / Pothead / Flashed / Replace**Priority=** F Tag At minimum, next inspection cycle; based on field condition and exposure, corrosion, etc.; prioritize as needed (A, B, E, or F)

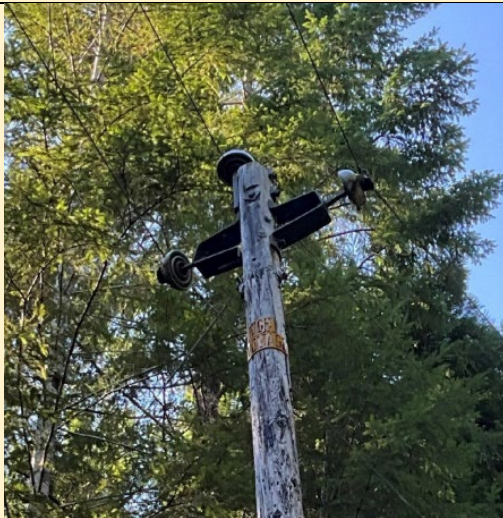
CONTAMINATED INSULATOR

**At this Location:** Significant contamination, no signs of tracking

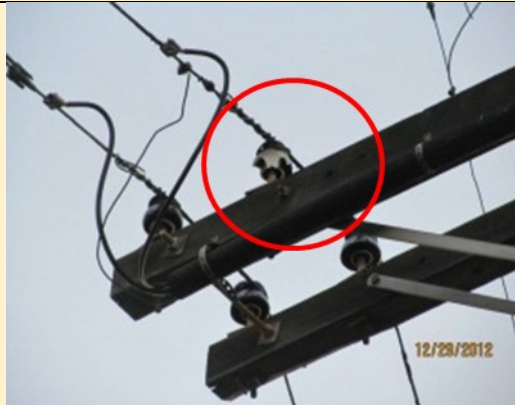
BROKEN SECONDARY INSULATOR

At this Location: Broken secondary insulator. Strain is controlled by the second insulator on the Double arm construction.

Priority= E Tag, depending on exposure

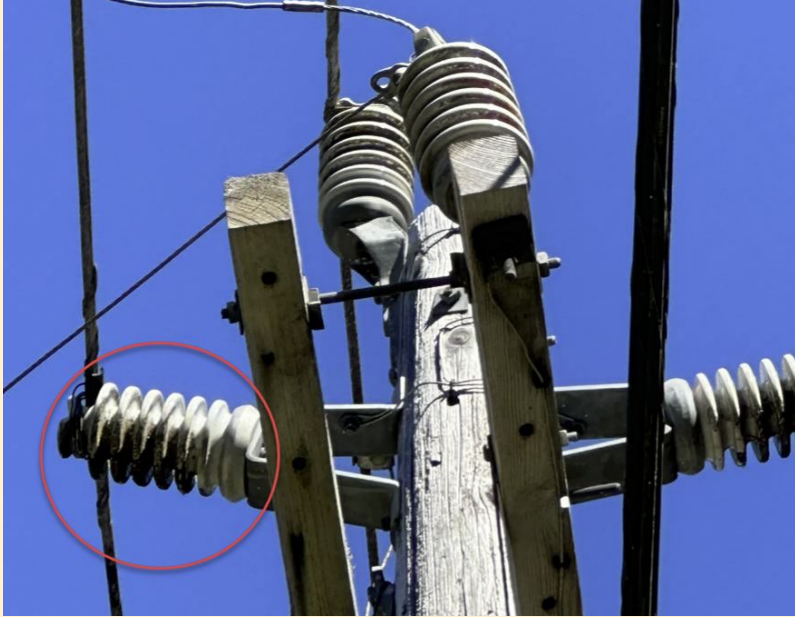
CONTAMINATED INSULATOR

At this Location: Significant contamination, no signs of tracking

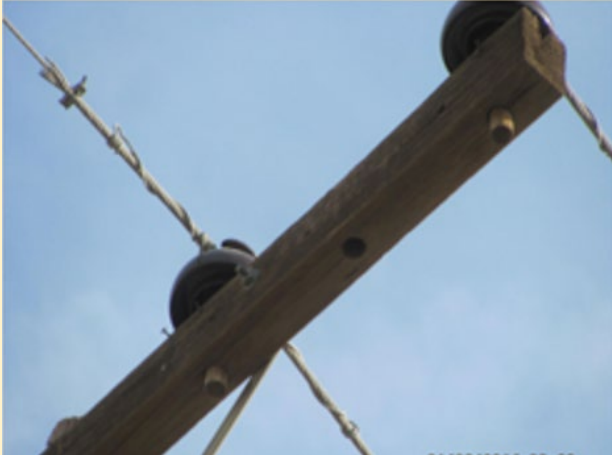
PRIMARY SQUATTER

At this Location: 2 Primary wood pin squatters, replace wood crossarm with composite arm.

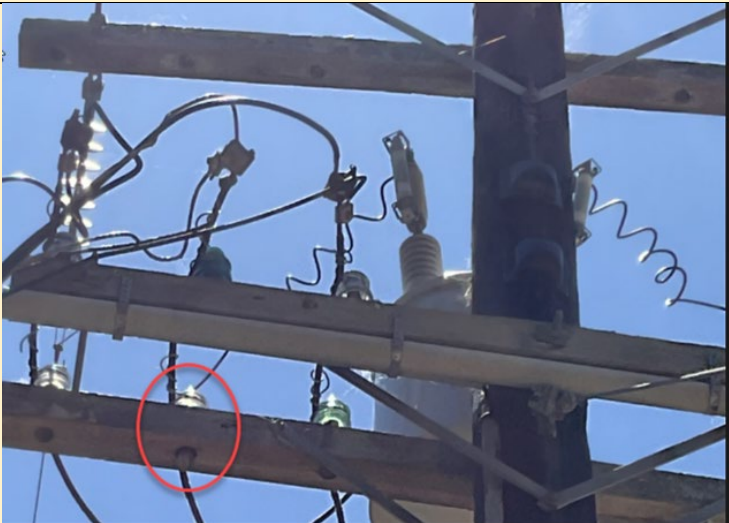
Secondary Squatter, Crossarm in good shape

At this Location: Secondary Squatter, crossarm in good shape

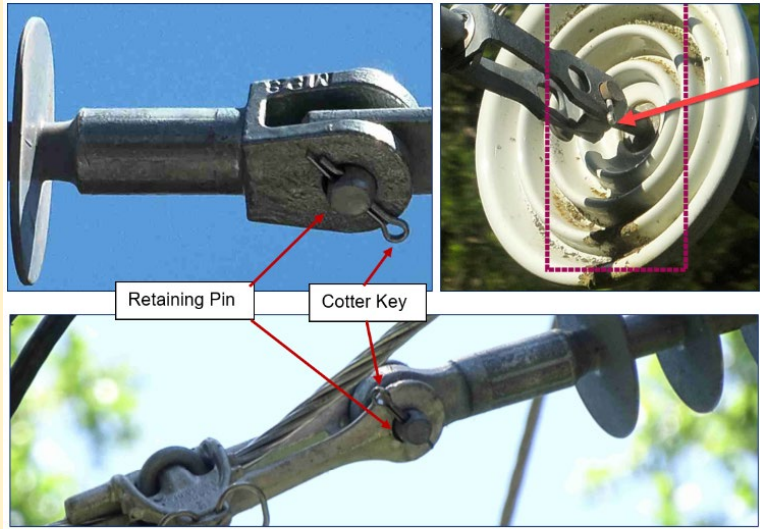
PIN FULLY SEATED / COTTER KEY PARTIALLY BACKED OUT

<p>Retaining Pin Cotter Key</p> <p>Figure 1. Cotter Key partially backed out of Retainer Pin channel</p>	<p>At this Location: Cotter Key partially backed out. Pin is fully seated.</p> <p>

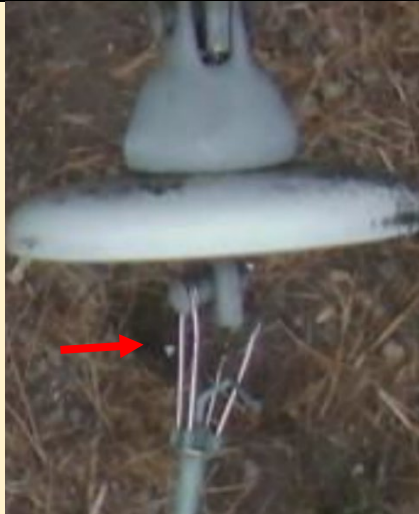
RETAINER PIN COMING LOOSE, ALMOST PULLED OUT

At this Location: Retainer Pin coming loose, almost pulled out. Has slipped off one ear.

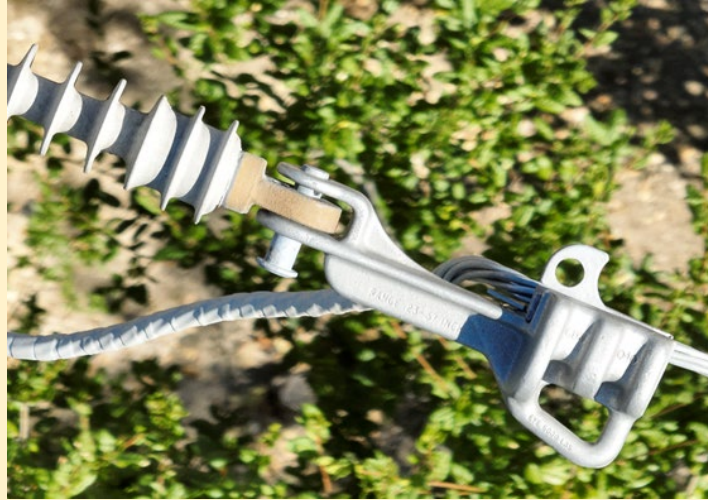
COTTER KEY – RESTING ON BOTH EARS

At this Location: Resting on both ears.

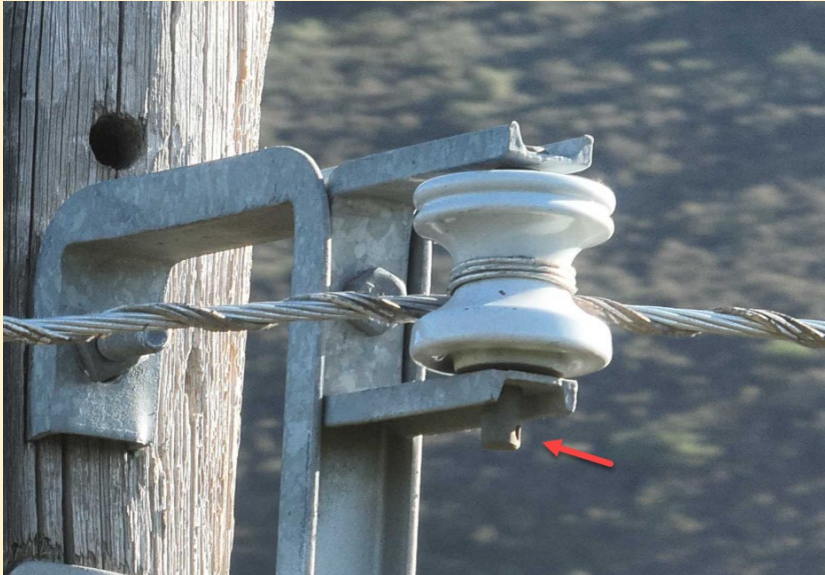
COTTER KEY MISSING – PIN FULLY SEATED

At this Location: Cotter key missing, pin has downward force on head of pin (~45 degrees) and is fully seated.

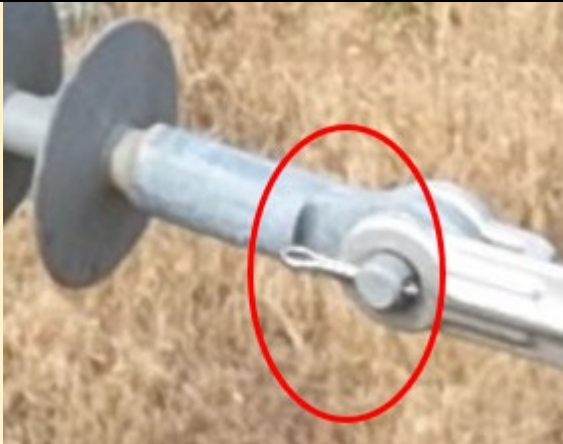
COTTER KEY BACKED OUT

At this Location: Cotter Key partially backed out. Pin is fully seated.

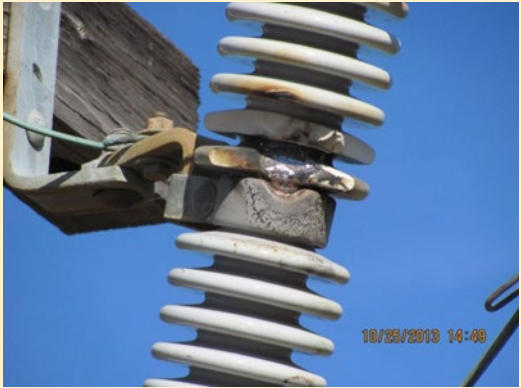
BROKEN DAMAGED CROSSARM MOUNTED CUTOUT	BROKEN CUTOUT

At this Location: Broken/Flashed cutout, ensuring bond wire is attached to the bracket.	At this Location: Broken Cutout
Perform Minor Work: No	Perform Minor Work: No
Write 3rd Party Notification: No	Write 3rd Party Notification: No
Write EC Notification: Yes FDA = Cutout / Broken/Damaged / Replace Priority = E Tag, depending on exposure, no COE	Write EC Notification: Yes FDA = Cutout / Broken/Damaged / Replace Priority = A Tag, Follow the emergency process

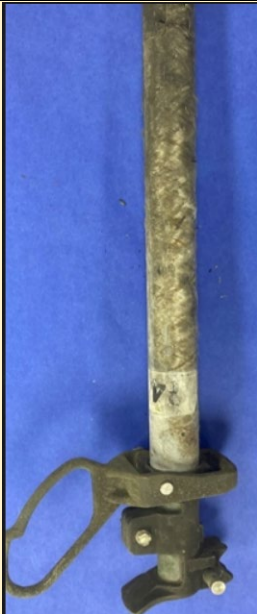
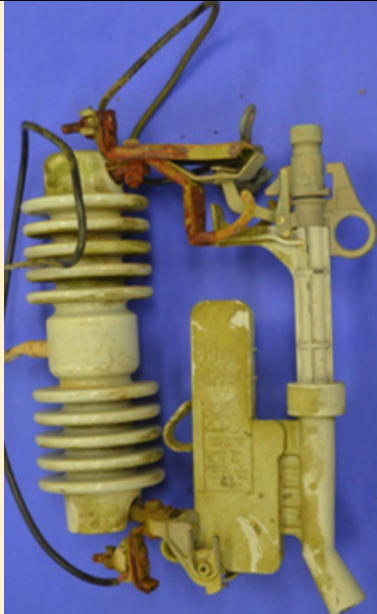
PART 63 POWER FUSE	PART 44/75 FAULT TAMER

<p>At this Location: Fiberglass layer exposed.</p> <p>

</p>	<p>At this Location: Excessive cutout corrosion leading to corrosion on the metal components of the FT Fuse, deteriorated housing on the FT Fuse will not contain an arc withing the snuffing tube. Any reasonable suspicion of damage that will not be able to operate correctly.</p> <p>

</p>
Perform Minor Work: No	Perform Minor Work: No
Write 3rd Party Notification: No	Write 3rd Party Notification: No
<p>Write EC Notification: Yes</p> <p>FDA = Cutout / Broken/Damaged / Replace</p> <p>And</p> <p>FDA= Fuse / Broken/Damaged / Replace</p> <p>Priority = E Tag, depending on exposure</p>	<p>Write EC Notification: Yes</p> <p>FDA = Cutout / Broken/Damaged / Replace</p> <p>And</p> <p>FDA= Fuse / Broken/Damaged / Replace</p> <p>Priority = E Tag, depending on exposure</p>

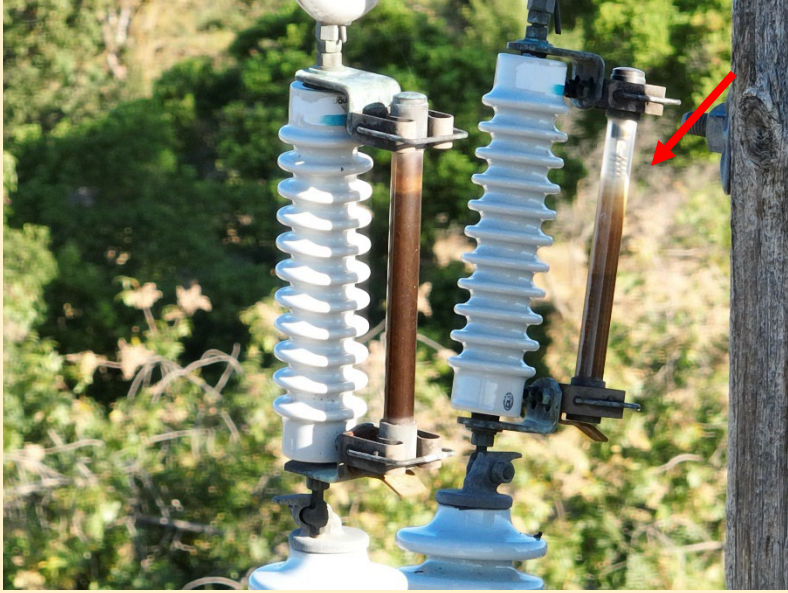
FUSE

At this Location: Liquid fuse is low.

Perform Minor Work:
	Write 3rd Party Notification:
	Write EC Notification: Yes FDA = Cutout / Broken/Damaged / Replace And FDA= Fuse / Broken/Damaged / Replace Priority = E Tag, depending on exposure

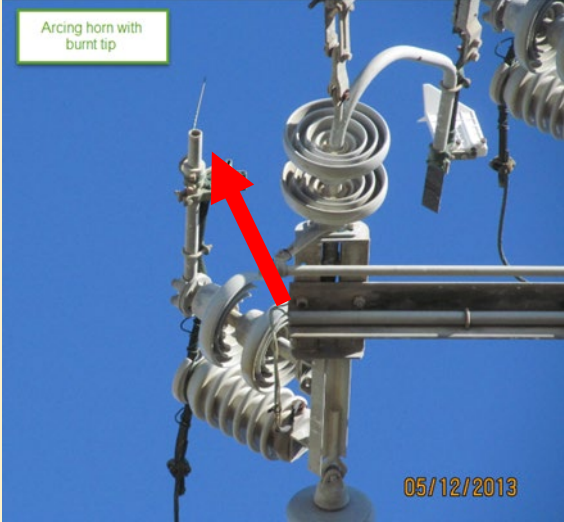
Arcing horn with burnt tip

At this Location: Arcing horn with burnt tip, also has broken insulator.

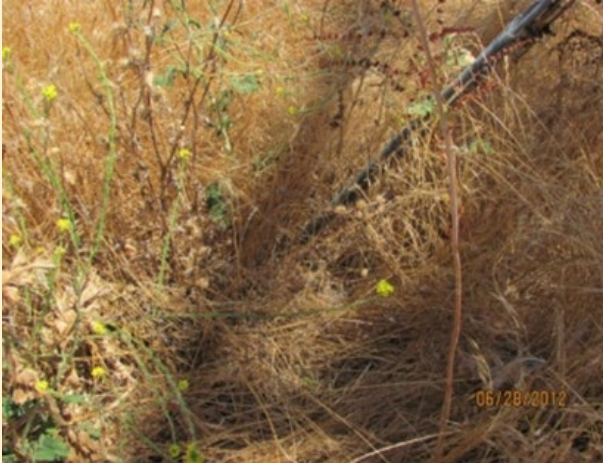
BURIED ANCHOR

<p>Before: Vegetation covers anchor</p>

</div>	
<p>Perform Minor Work: Yes, remove the vegetation. Yes, expose the top of the anchor head and evaluate condition/corrosion. Yes, preferred method is to adjust anchor by adding extension</p>	
<p>Write 3rd Party Notification: No</p>	
<p>Write EC Notification: Yes, if cannot be addressed as minor work. FDA= Anchor / Soil/Eroded/Graded / Replace (if the anchor cannot be adjusted)</p>	
<p>Priority= F Tag, depending on exposure.</p>

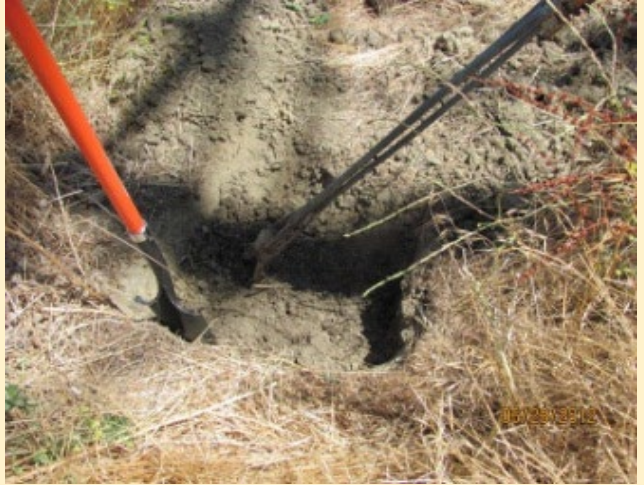
<p>After: Vegetation cleared from anchor</p>
<p>At this Location: Anchor head below grade overgrown with vegetation. After minor work inspector decides if the anchor can be adjusted or needs replaced.</p> <div>

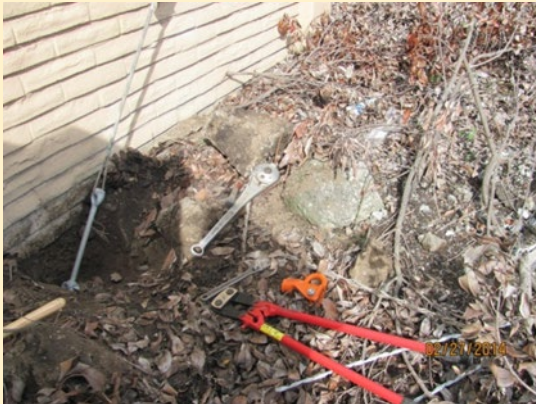
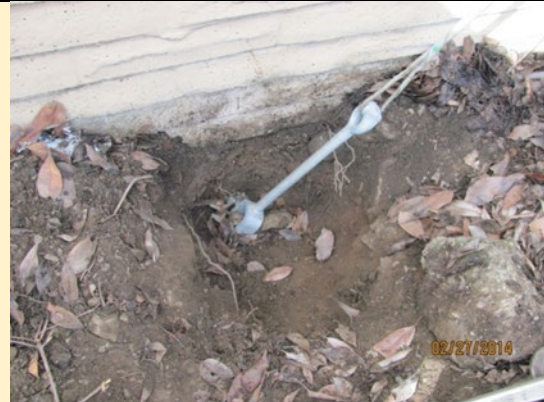
ANCHOR EXTENSION

Anchor extension

At this Location: Inspector performed minor work, exposed anchor, evaluated anchor to be in good condition so that extension could be installed, then installed extension. (Back fill not shown)

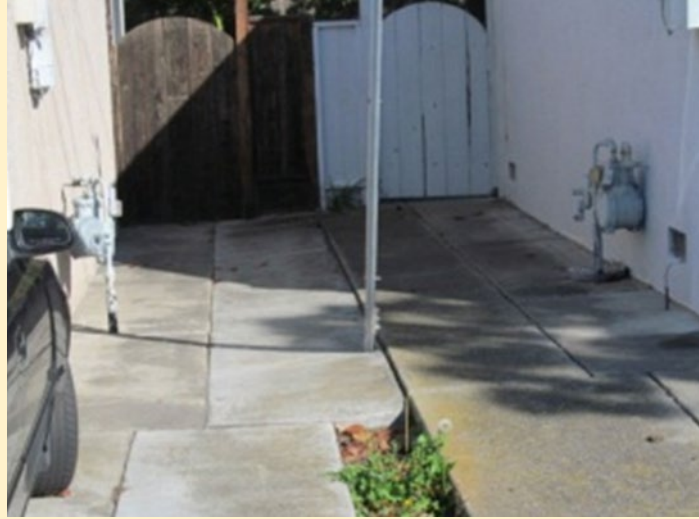
ANCHOR COVERED BY CONCRETE

At this Location: Anchor covered by concrete.

FDA= Anchor / Soil / Eroded /Graded / Replace

Priority= F Tag, depending on exposure.

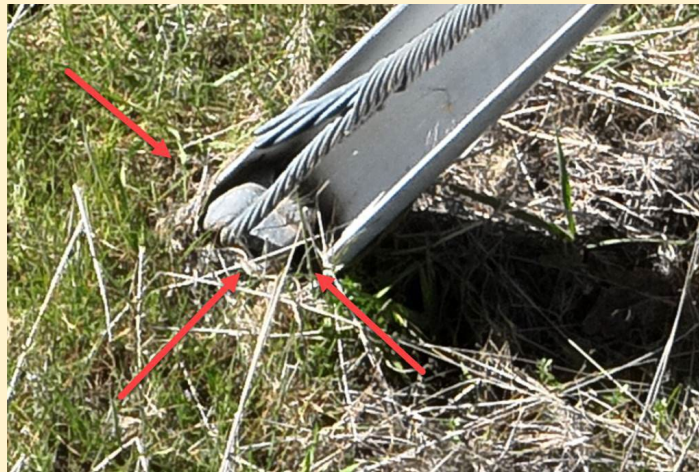
ANCHOR

At this Location: Anchor not buried.

Perform Minor Work: No	
Write 3rd Party Notification: No	
Write EC Notification: Yes	
FDA= Anchor / Soil / Eroded / Graded / Replace	
Priority= F Tag, depending on exposure.

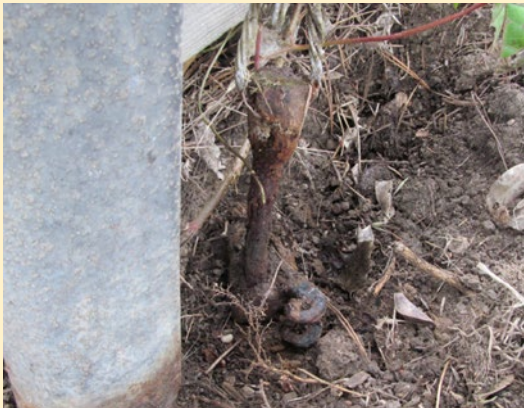
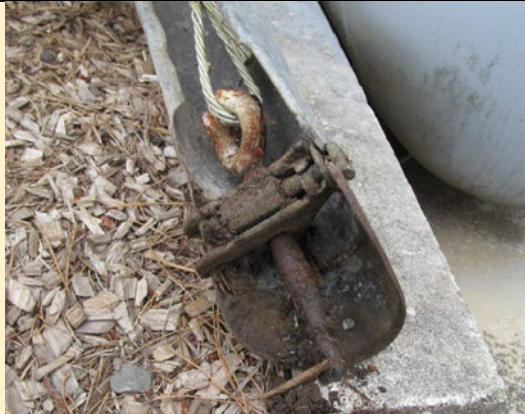
ANCHOR ROD WITH SIGNIFICANT CORROSION	
Anchor above ground	Below

At this Location: Corroded Anchor, with material loss. See “pencil” in photo.

Perform Minor Work: No	
Write 3rd Party Notification: No	
Write EC Notification: Yes FDA= Anchor / Corroded / Replace Priority= E Tag, depending upon exposure

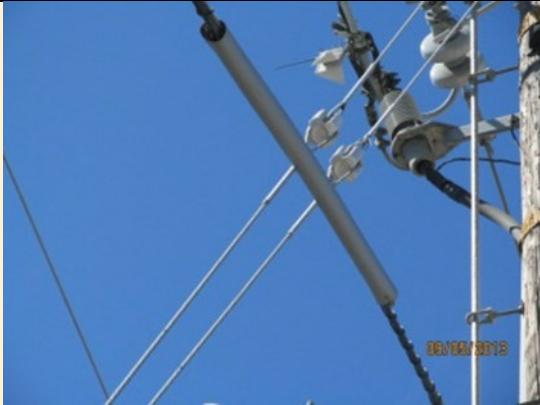
At this Location: Acceptable solution through plastic barrier

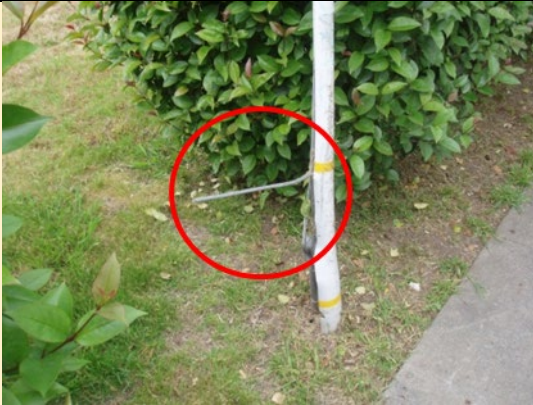
At this Location: Guy tail extends beyond the preform, <u>Near sidewalk, safety hazard.</u>

Perform Minor Work: No	Perform Minor Work: Yes, if safe to do so
Write 3rd Party Notification: No	Write 3rd Party Notification: No
Write EC Notification: No	Write EC Notification: Yes, only if unable to perform minor work. FDA= Guy / Broken/Damaged / Repair Priority= E Tag, depending upon exposure

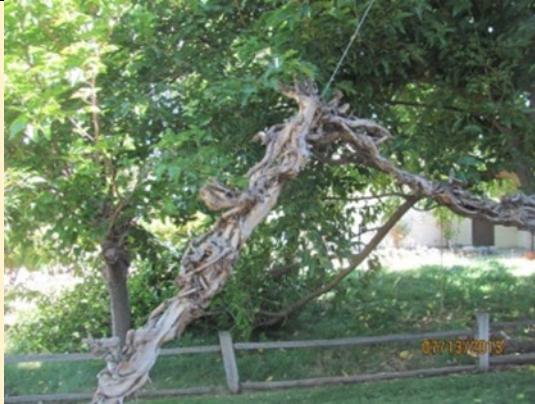
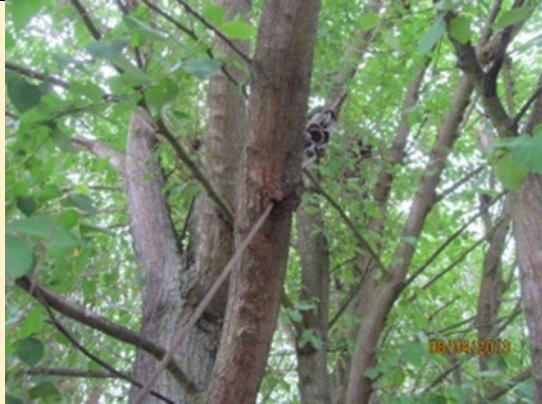
OVERGROWN GUY	TREE GROWING AROUND GUY

<p>At this Location: Extensive dead ivy covering half of length of guy, below the bob. Write EC Notification if there is damage to the guy.</p>

Perform Minor Work: No	Perform Minor Work: No
Write 3rd Party Notification: No	Write 3rd Party Notification: No
<p>Write EC Notification: Yes</p> <p>FDA= Guy / Broken/Damaged / Replace</p> <p>Priority= Minimum F Tag, depending upon exposure</p>	<p>Write EC Notification: Yes</p> <p>FDA= Guy / Broken/Damaged / Replace</p> <p>Priority= Minimum F Tag, depending upon exposure</p>

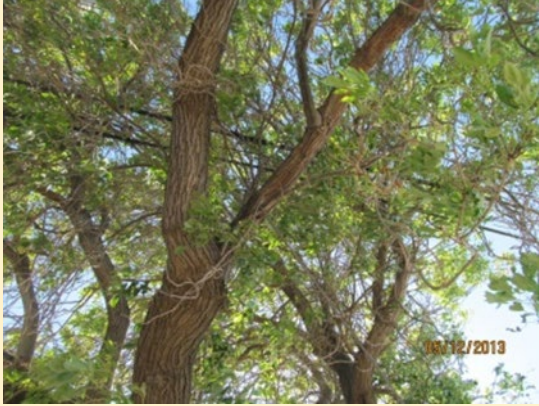
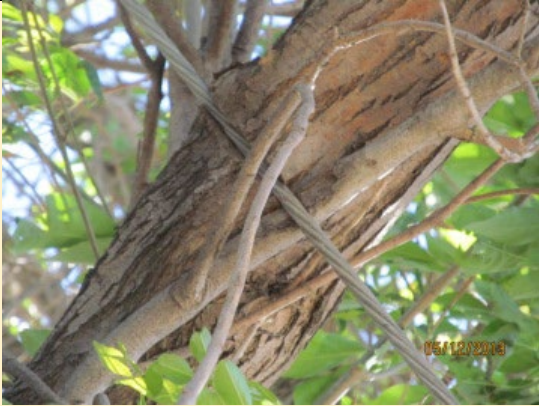
TREE LIMB GROWING AROUND GUY	
Guy through tree	Close-Up

At this Location: Tree limb growing around guy, below the bob	
Perform Minor Work: No	
Write 3rd Party Notification: No	
Write EC Notification: Yes	
FDA= Guy / Broken/Damaged / Replace	
Priority= F Tag, depending upon exposure

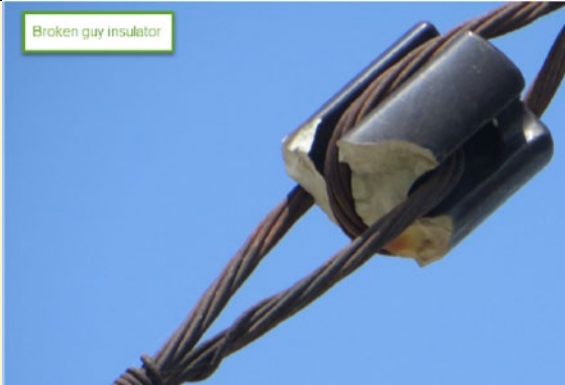
BROKEN GUY INSULATOR

**At this Location:** Broken guy insulator**Perform Minor Work:** No**Write 3rd Party Notification:** No**Write EC Notification:** Yes**FDA=** Guy / Broken/Damaged / Replace**Priority=** E Tag, depending upon exposure

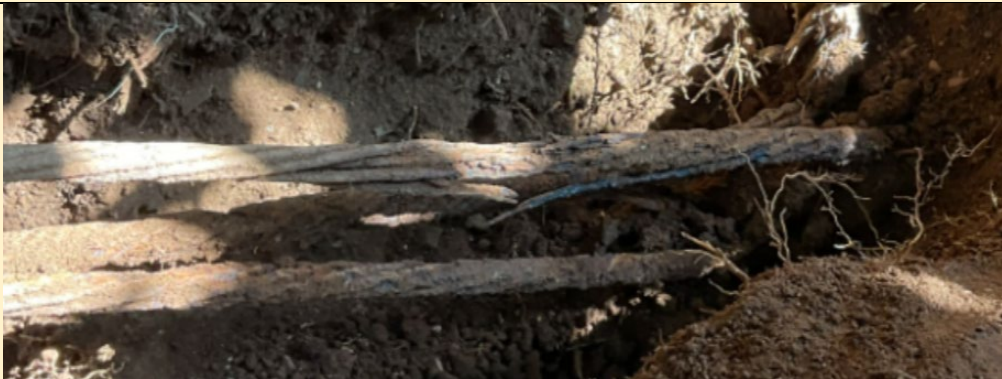
GUY CORRODED AND MISSING STRANDS

**At this Location:** Guy corroded and missing strands**Perform Minor Work:** No**Write 3rd Party Notification:** No**Write EC Notification:** Yes**FDA=** Guy / Corroded / Replace**Priority=** F Tag, depending on exposure.

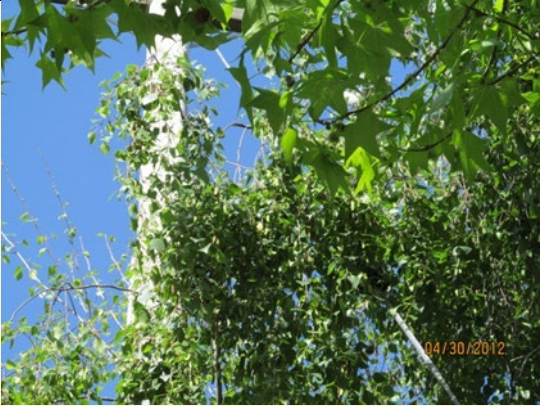
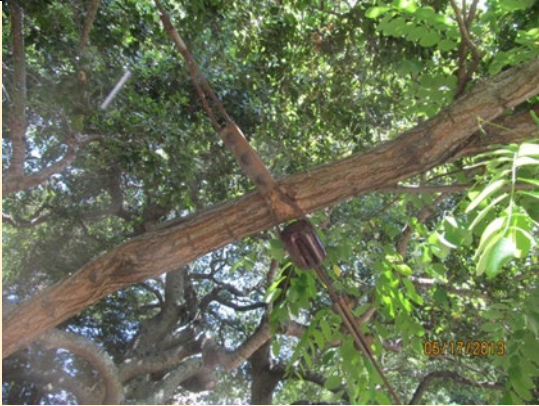
DOWN GUY GROUNDED ABOVE GUY INSULATOR	DOWN GUY GROUNDED ABOVE GUY INSULATOR CAUSING STRAIN AND ABRASION

<p>At this Location: Vine growing up and across the guy insulator grounding the guy.</p>

Perform Minor Work: Yes	Perform Minor Work: Yes
Write 3rd Party Notification: No	Write 3rd Party Notification: No
<p>Write EC Notification: Yes, only if minor work cannot be performed.</p> <p>FDA=Guy / Overgrown / Trim</p> <p>Priority= F Tag, depending upon exposure</p> <p>*Note: If signs of burning/tracking or straining/abrasion, consider higher priority.</p>	<p>Write EC Notification: Yes, only if minor work cannot be performed.</p> <p>FDA=Guy / Strain/Abrasion / Remove</p> <p>FDA=Guy / Overgrown / Trim</p> <p>Priority= F Tag, depending upon exposure</p> <p>*Note: If signs of burning/tracking or straining/abrasion, consider higher priority.</p>

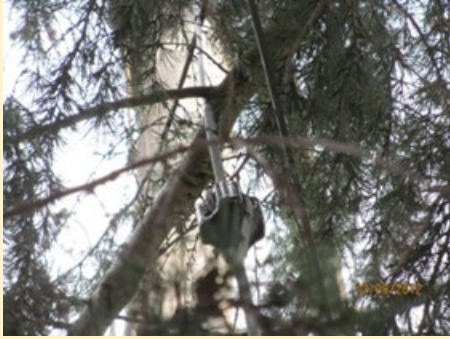
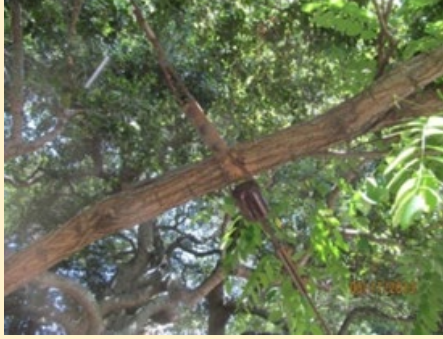
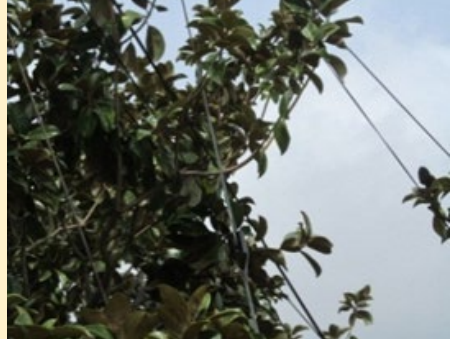
GUY GROUNDED BY VEGETATION		
Guy grounded. by vegetation	Guy grounded. by vegetation	Guy overgrown by vegetation

At this Location: Guy grounded by vegetation, above the bob.

Perform Minor Work: Yes		
Write 3rd Party Notification: No		
Write EC Notification: Yes, only if minor work cannot be performed. FDA= Guy / Overgrown / Trim Priority= F Tag, depending upon exposure *Note: If signs of burning/tracking or straining/abrasion, consider higher priority.

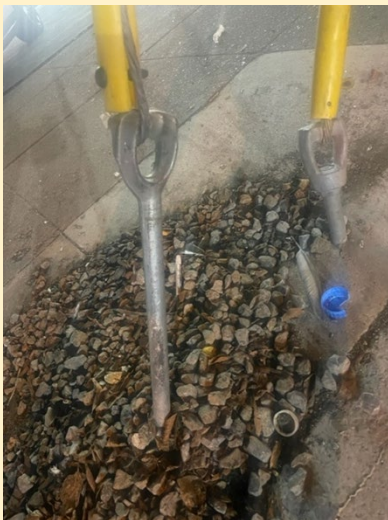
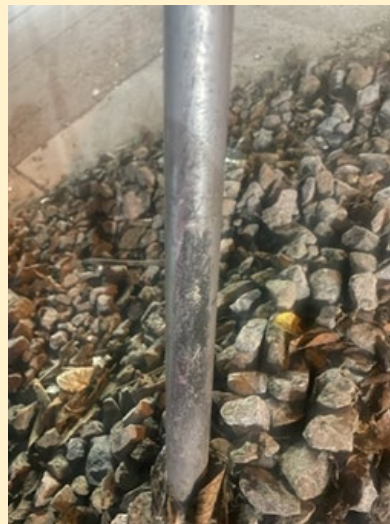
MISSING MARKER AND VISUAL STRIPS

At this Location: Missing marker and visual strips. After marker is fixed, visual strips are still missing. Evidence of tire marks on anchor.

FDA= Guy Marker/Missing/Install

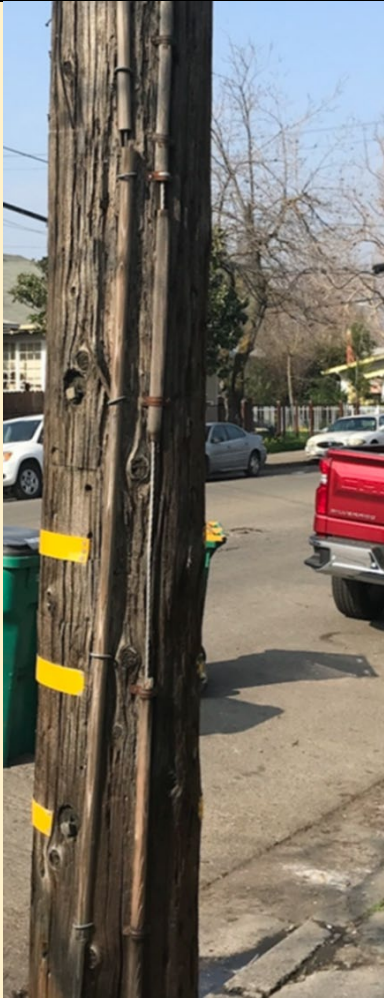
EXPOSED GROUND

<p>At this Location: Exposed grounds near sidewalk.</p>
