Job Aid: Overhead Assessment

TD- 2305M-JA02
WMP-Discovery2023-2025 DR SPD 024-Q003Atch02
Publication: 01/06/2025 Effective: 01/14/2025

Rev: 14

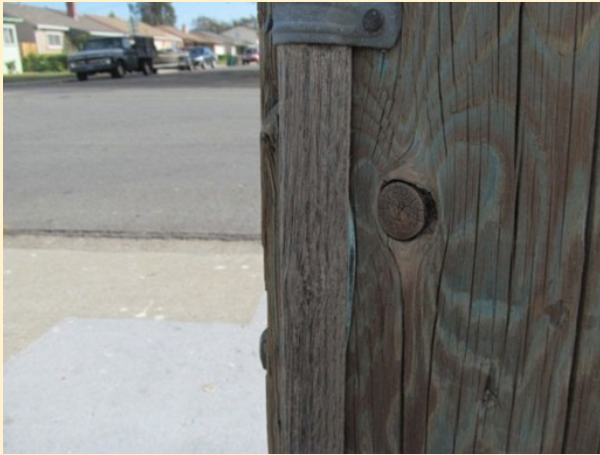
Before: Copper Wire sticking out from under the wood molding

At this Location: Wood molding with ground exposed

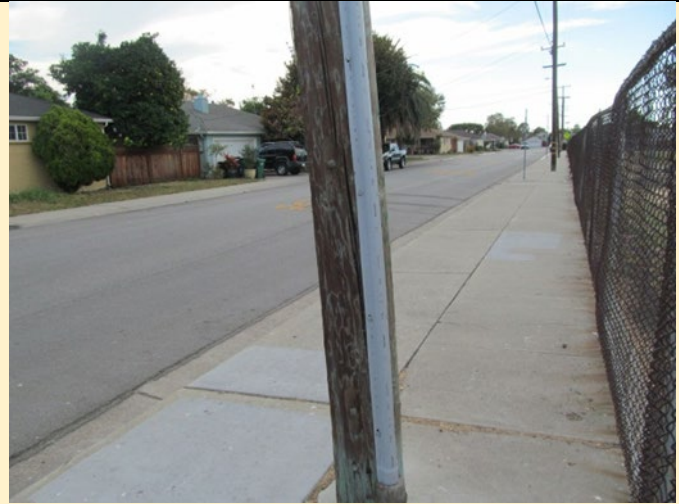
After: 1.5-inch u-shaped molding installed over existing wood molding

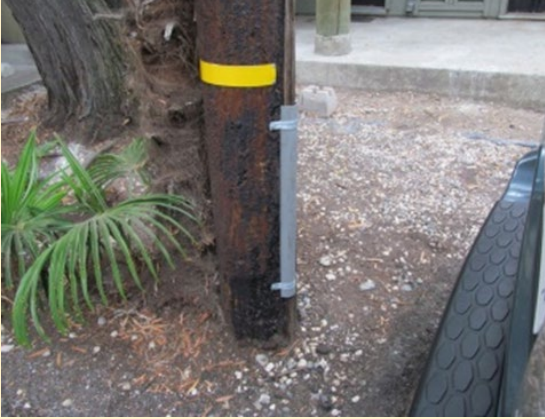
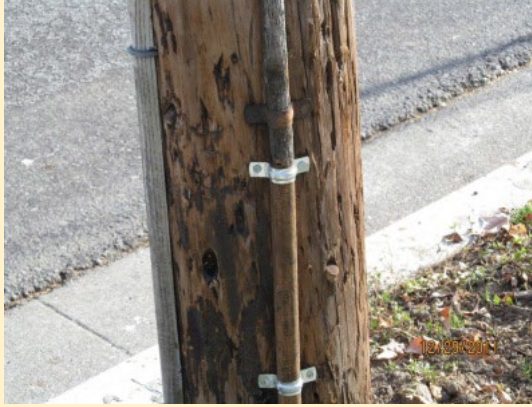
REPAIR WITH 2" PLASTIC	REPAIR WITH WOOD MOLDING

At this Location: Condition acceptable after repair of exposed ground

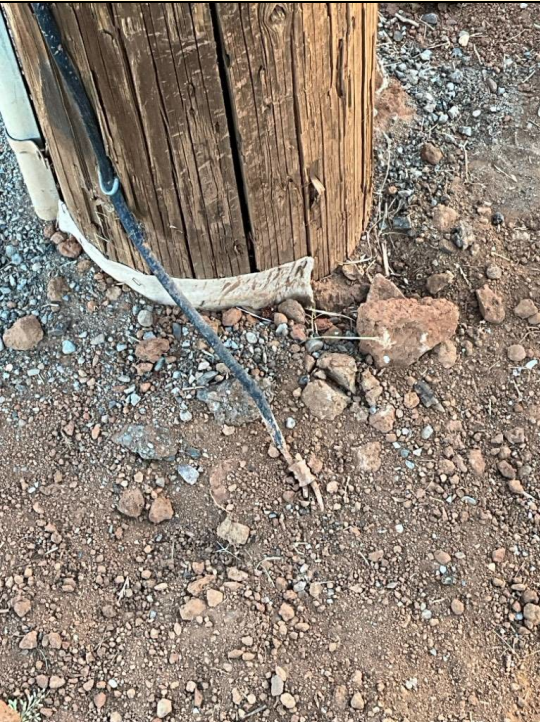
EXPOSED GROUND

<p>At this Location: Insulated grounds that does not need molding. Connector to driven ground is exposed.</p> <p>

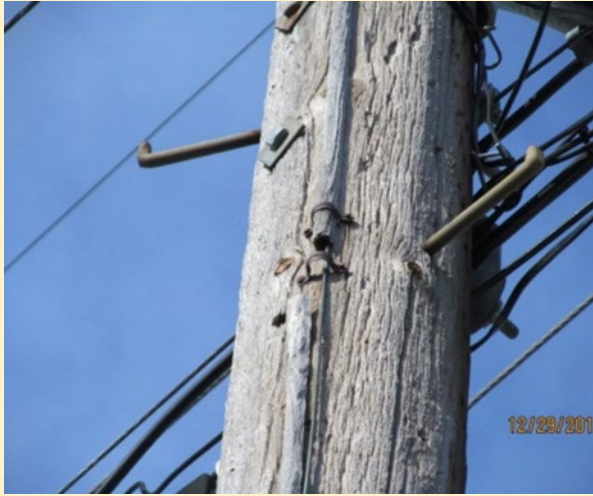
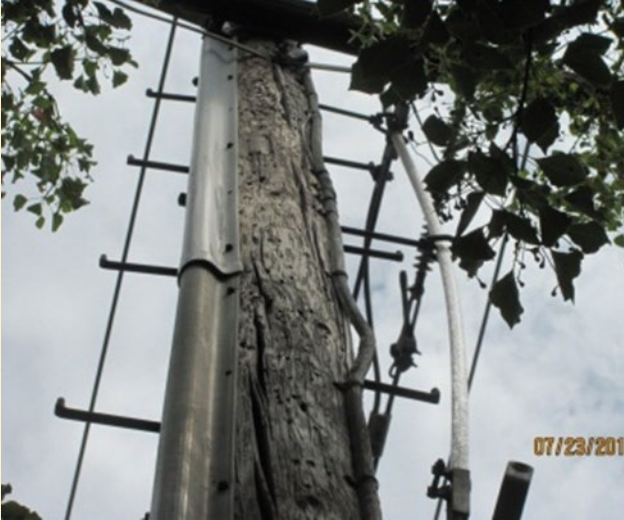
EXPOSED GROUND AT COMMUNICATION LEVEL	EXPOSED GROUND DUE TO TWISTED MOLDING

<p>At this Location: Exposed ground at communications level. Wood molding broken in climbing space.</p>

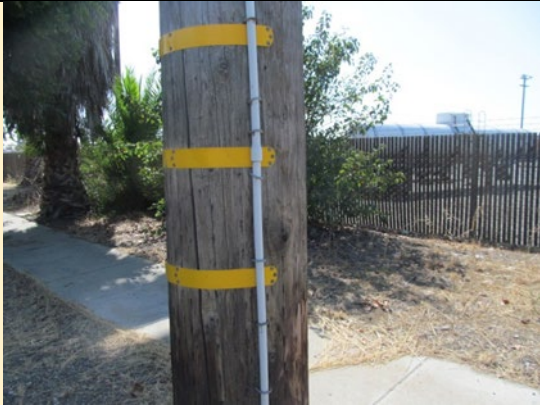
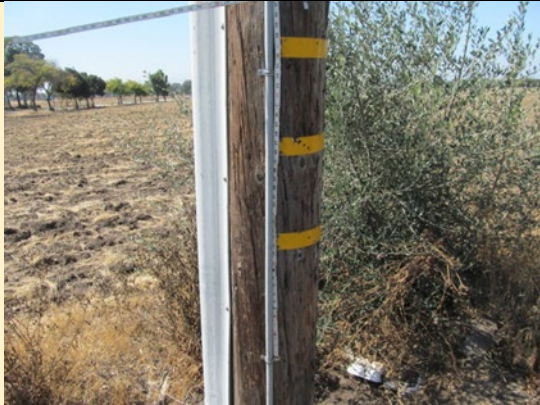
MOLDING SECURED	MOLDING SECURED

<p>At this Location: Molding adequately secured with staples upon arrival. No action is required.</p> <p>Note: Molding for phone ground installed on vis strips is non-compelling.</p>

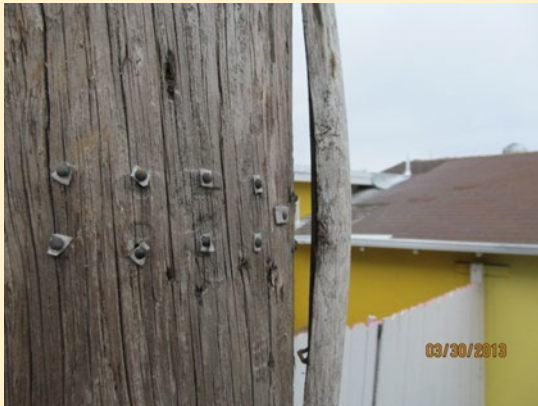
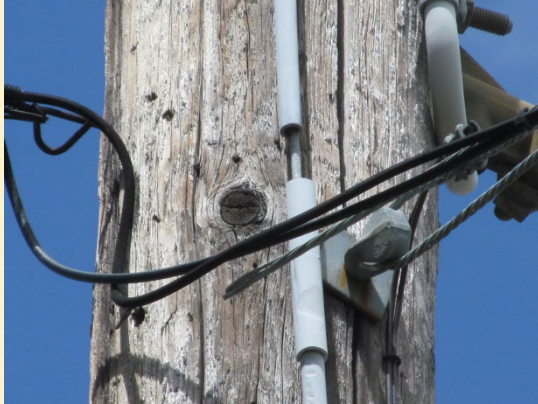
WOOD MOLDING ABOVE 8', NOT SECURE EXPOSING GROUND	PVC MOLDING ABOVE 8', NOT SECURE EXPOSING GROUND

<p>At this Location: PG&E solely owned pole, Wood molding is not secure allowing human contact.</p>

<p>At this Location: At communication level, PVC molding not secure, due to failure of previous repairs, allowing human contact.</p>

<p>Perform Minor Work: Yes, if safe to do so</p>	<p>Perform Minor Work: Yes, if safe to do so</p>
<p>Write 3rd Party Notification: No</p>	<p>Write 3rd Party Notification: No</p>
<p>Write EC Notification: No</p>	<p>Write EC Notification: Yes, only if unable to perform minor work.</p> <p>FDA= Ground / Exposed / Repair</p> <p>Priority= F Tag At minimum – next inspection cycle; based on field condition and exposure, corrosion, etc.; prioritize as needed (A, B, E, or F)</p>

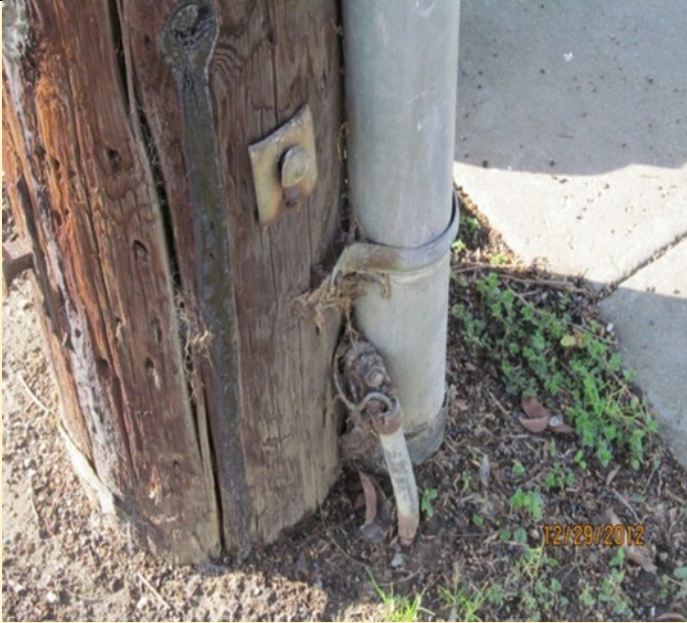
EXPOSED GROUND ROD

At this Location: Exposed ground rod, public exposure.

Perform Minor Work: Yes, at minimum make safe
	Write 3rd Party Notification: No
	Write EC Notification: Yes FDA= Ground / Exposed / Repair Priority= A Tag, emergency – due to public exposure at ground level, if minor work not done. (Incorporate E tag if in areas of no or low public exposure.)

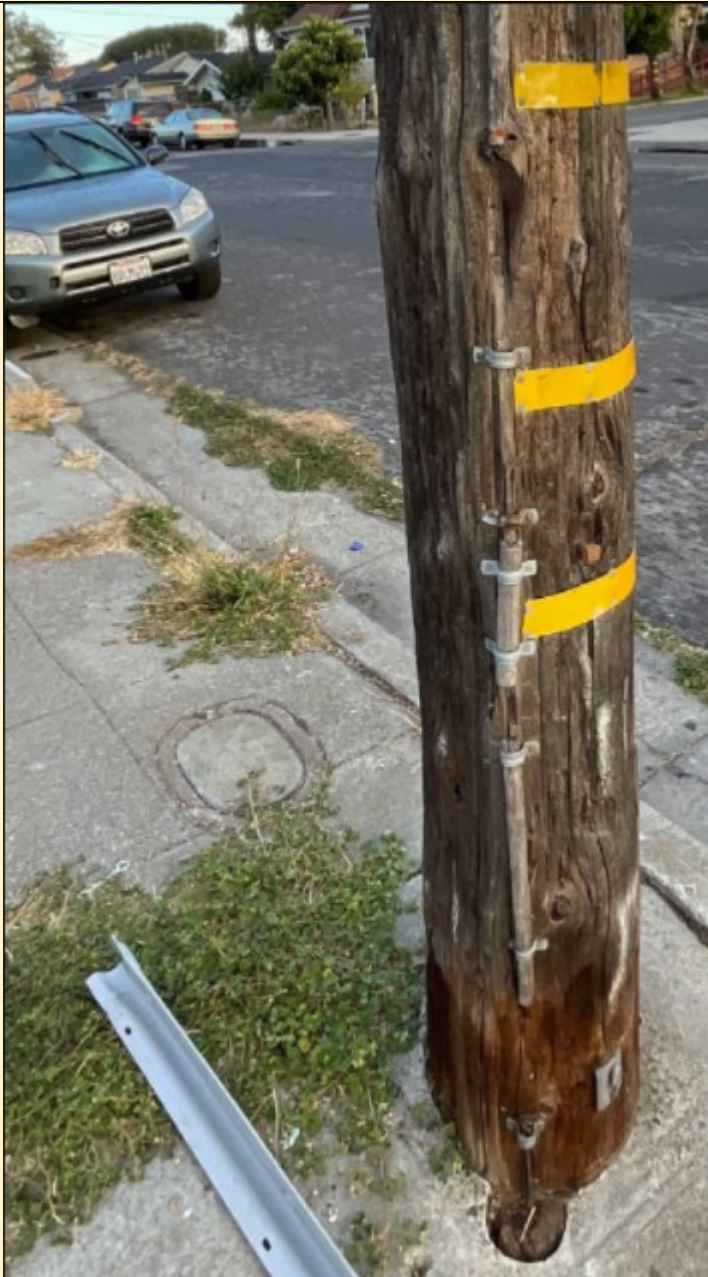
BROKEN GROUND RUN

At this Location: Transformer ground has broken, below 8', in the sidewalk, exposed to the public.

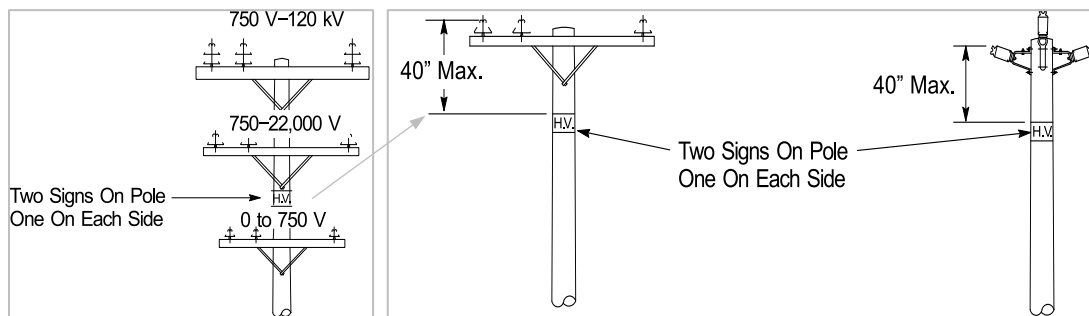
High Voltage Sign Requirements (if Minor Work is performed):

When installing *new* high voltage signs using one option, inspectors are not required to remove signs previously installed under different options.

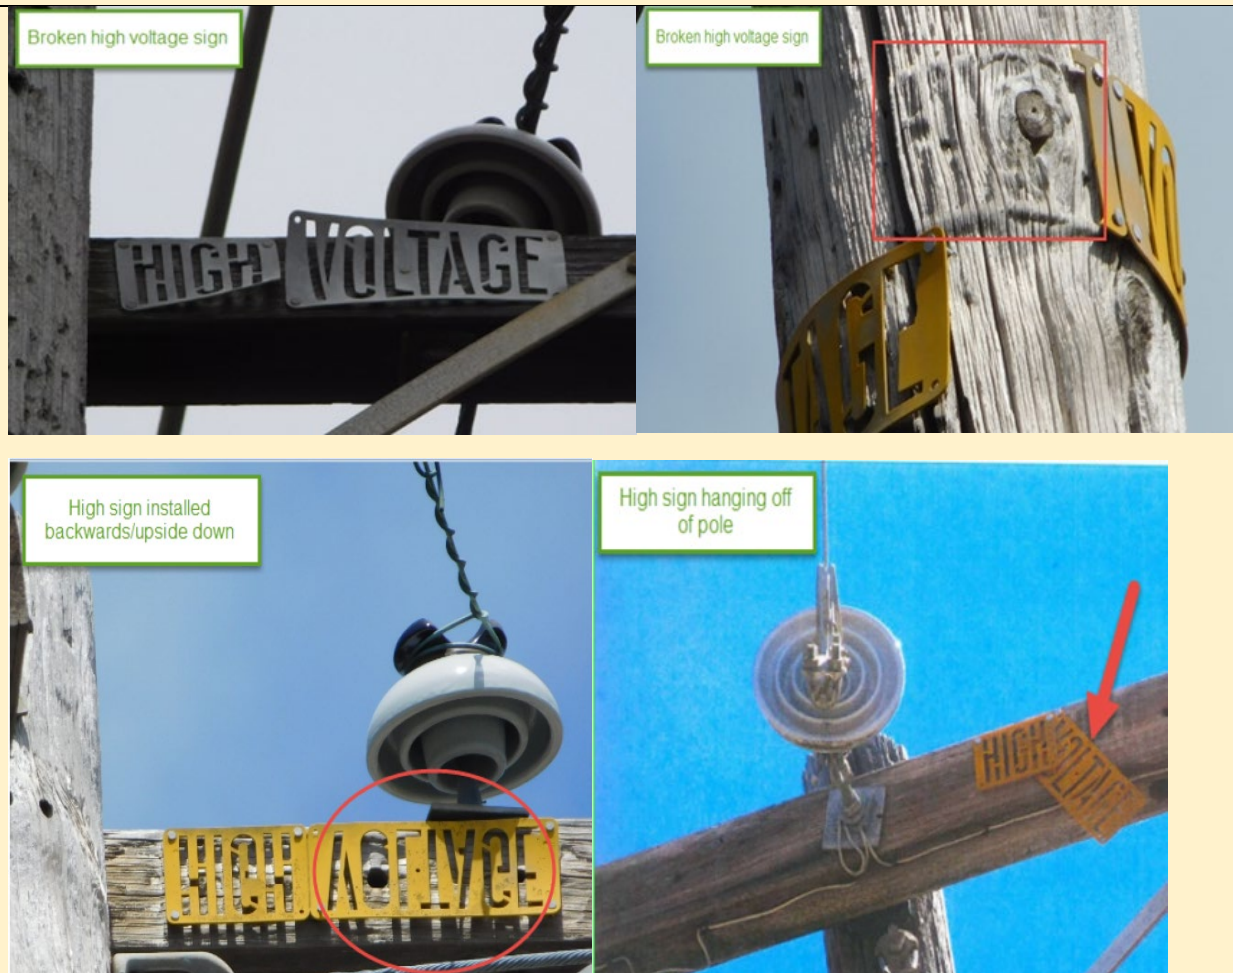
BROKEN HIGH SIGN

At this Location: Broken High Sign

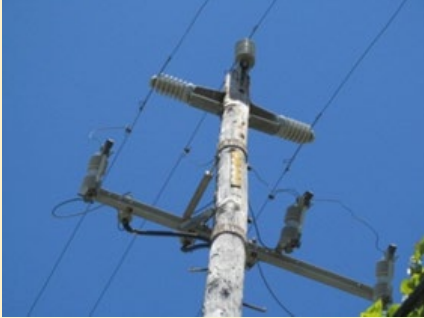
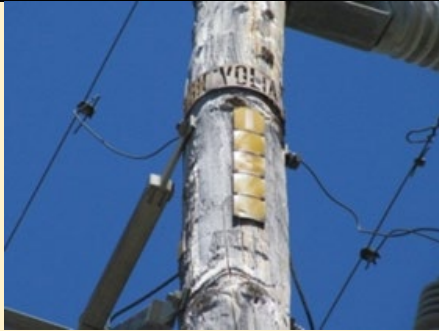
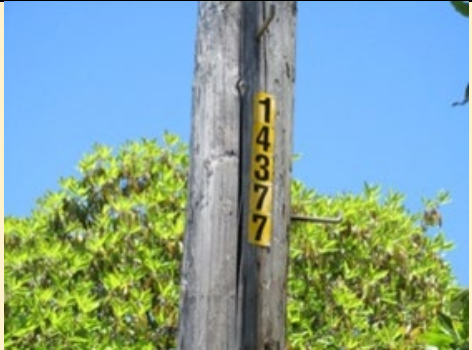
FADED OPERATING NUMBER		
Before: Faded operating number	Close Up	After: Minor work completed, operating number applied below operating position.

At this Location: Operating number is faded.

Perform Minor Work: Yes		
Write 3rd Party Notification: No		
Write EC Notification: Yes, only if minor work cannot be performed. FDA= Operating Numbers / Broken/Damaged / Replace Priority= E Tag, depending on exposure.

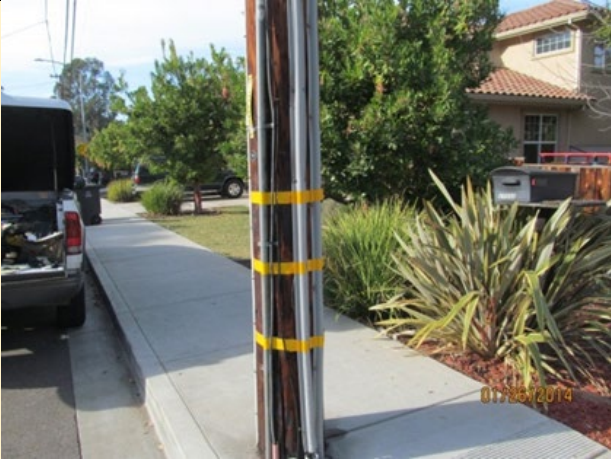
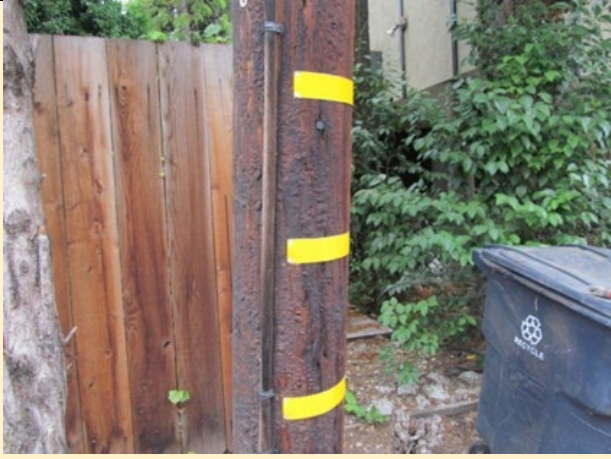
ACCEPTABLE	
ADHESIVE VISIBILITY STRIPS	CLEARANCE FROM GROUND

<p>At this Location: Acceptable application of plastic and adhesive visibility strips.</p> <p>Note: Molding for phone ground installed on vis strips is non-compelling.</p>

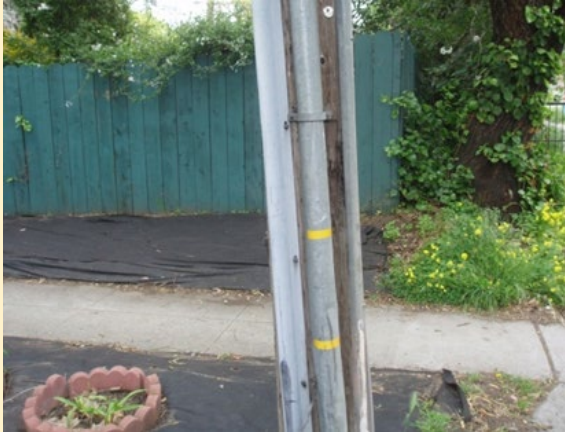
INADEQUATE VISIBILITY STRIPS

At this Location: Pole with vehicular exposure. Two small sections of yellow adhesive visibility strips.

FDA= Vis-Strips / Broken/Damaged / Replace

Priority= F Tag, depending on exposure

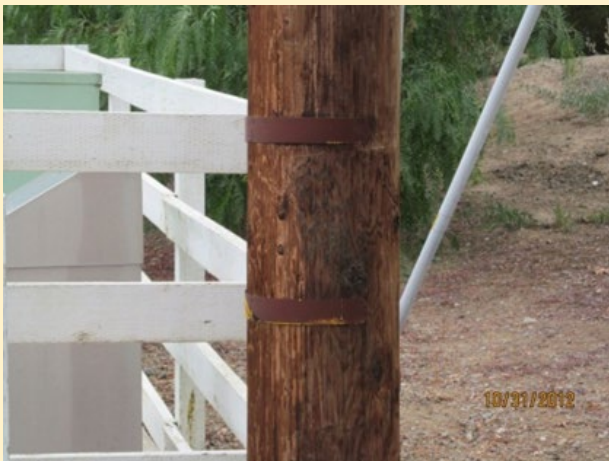
VISIBILITY STRIPS PAINTED OVER NO LONGER REFLECTIVE

At this Location: Visibility strips painted brown (3PrdP visibility strip located above not shown in picture).

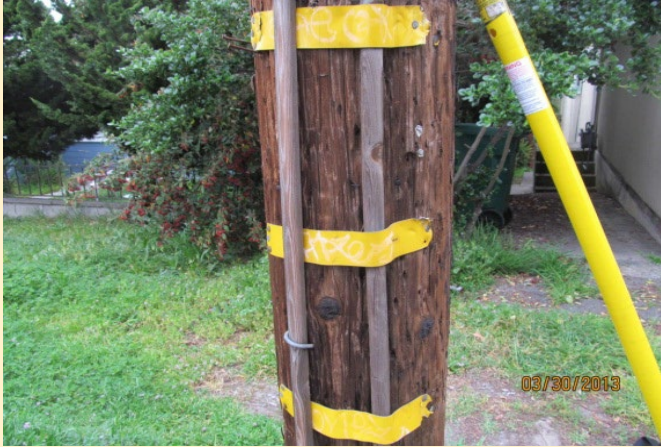
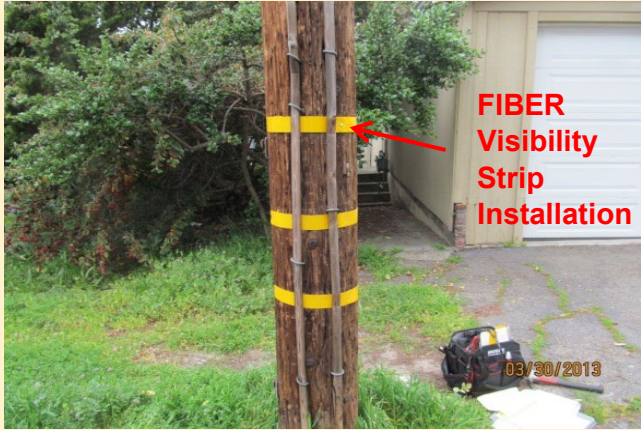
METAL OVER MOLDING	
Before	After

<p>At this Location: Metal visibility strips under wood molding and over wood molding with protruding edge.</p> <p>

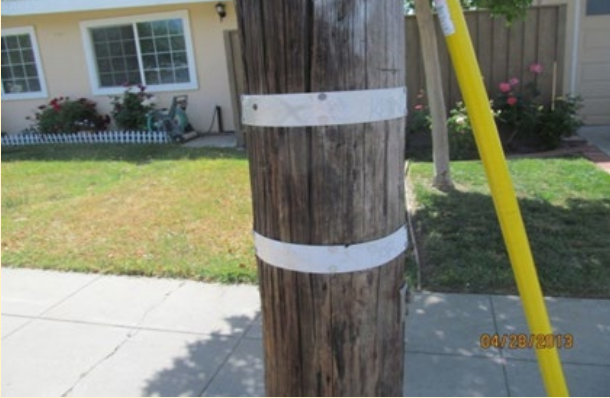
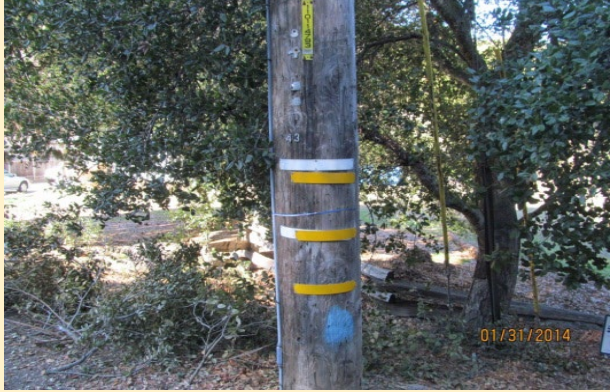
OLD METHOD VISIBILITY STRIPS NOT YELLOW	OLD AND NEW VISIBILITY STRIPS NOT YELLOW

At this Location: Aged visibility strips have lost reflectivity.

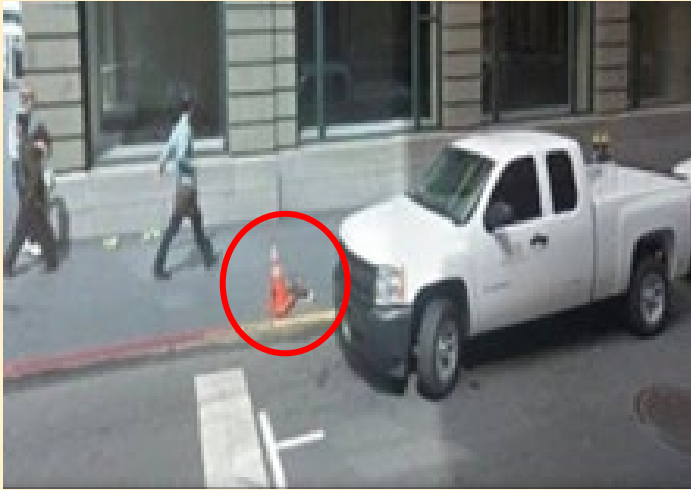
MISSING STREET LIGHT	LEANING AGGREGATE POLE

<p>At this Location: Cone indicates location of missing decorative streetlight and pole. Exposed wire is de-energized.</p> <p>

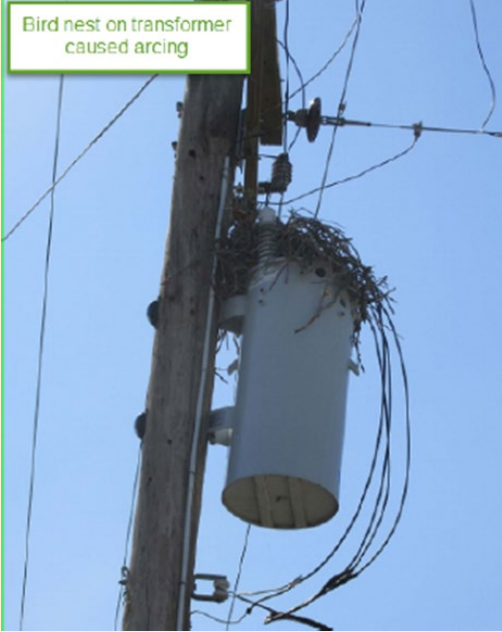
BIRD NEST ON TRANSFORMER

At this Location: Bird Nest on transformer, abandoned, touching high side jumper.

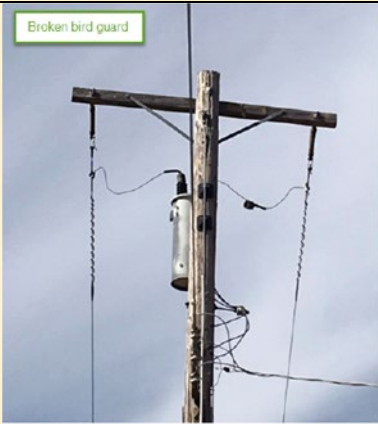
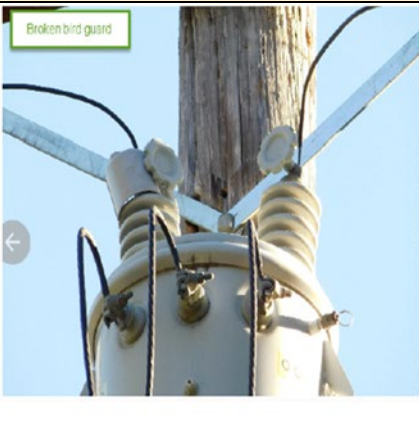
BROKEN INSULATOR COVERS		
<div>

</div>	At this Location: Broken insulator covers.	
	<div>

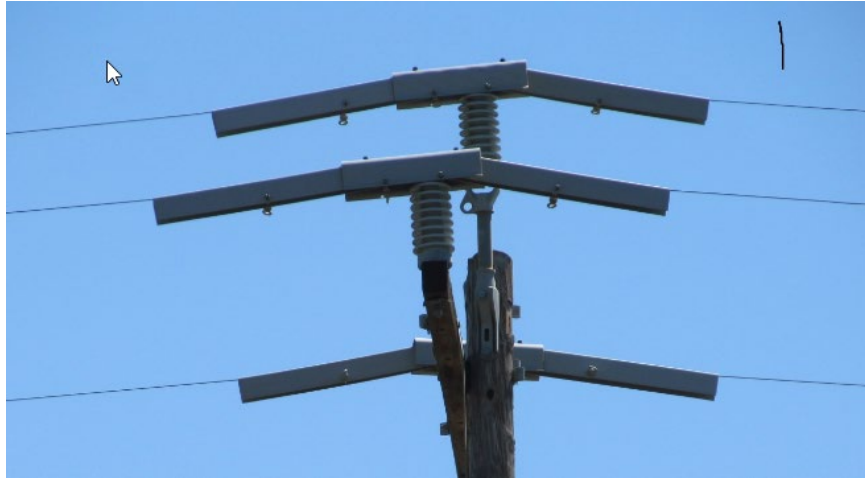
Bird protection

Center phase cover installed on conductor.

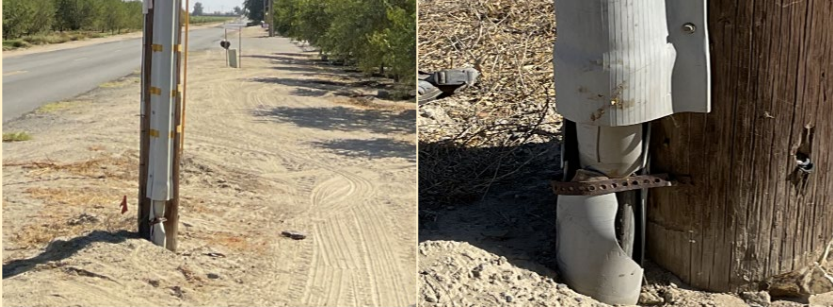
BROKEN RISER

At this Location: Riser molding is broken exposing conductors.

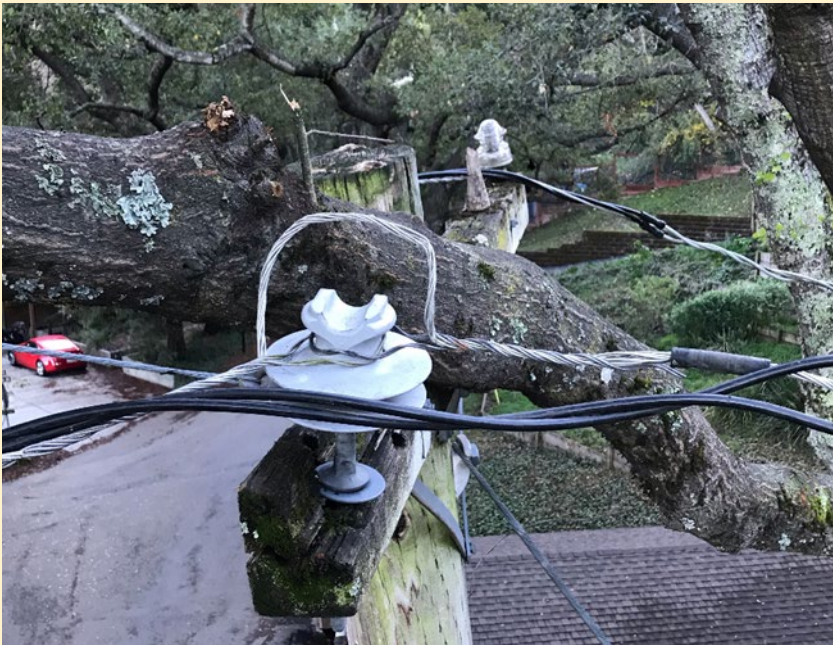
LARGE BRANCH BROKEN

At this Location: Large branch broken on cross-arm. Cross-arm in poor condition. No charring visible.

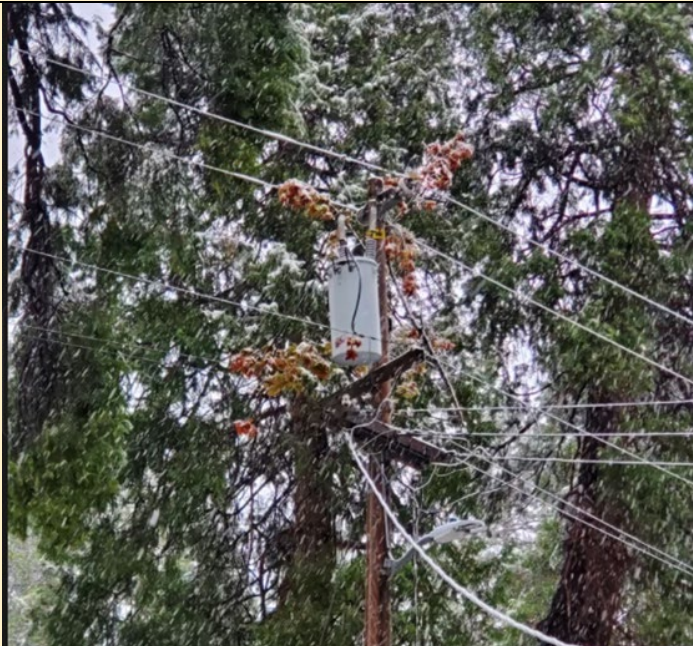
DEAD TREE BRANCH FELL INTO PRIMARY

At this Location: Dead tree branch fell into primary. No charring visible.

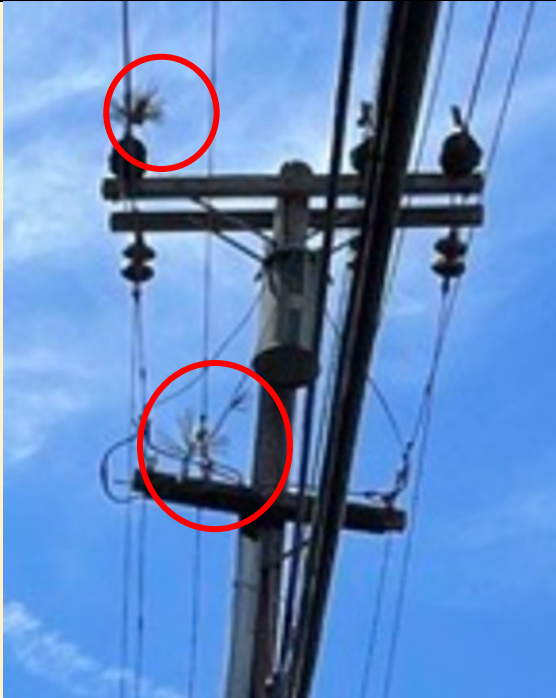
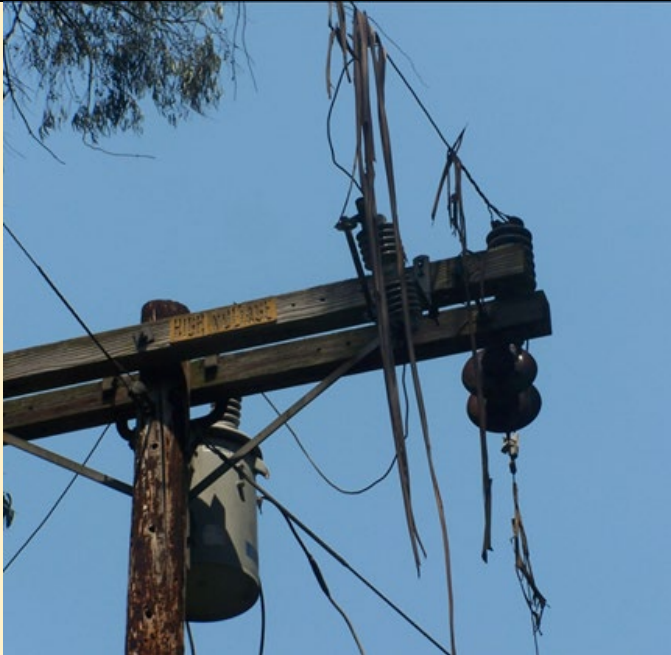
SMALL BRANCHES ON PRIMARY AND SECONDARY	LONG TREE BARK HANGING ON PRIMARY CONDUCTOR

<p>At this Location: Small branches (foreign debris) on primary and secondary. Too small to cause a cross-phase or damage.</p> <p>

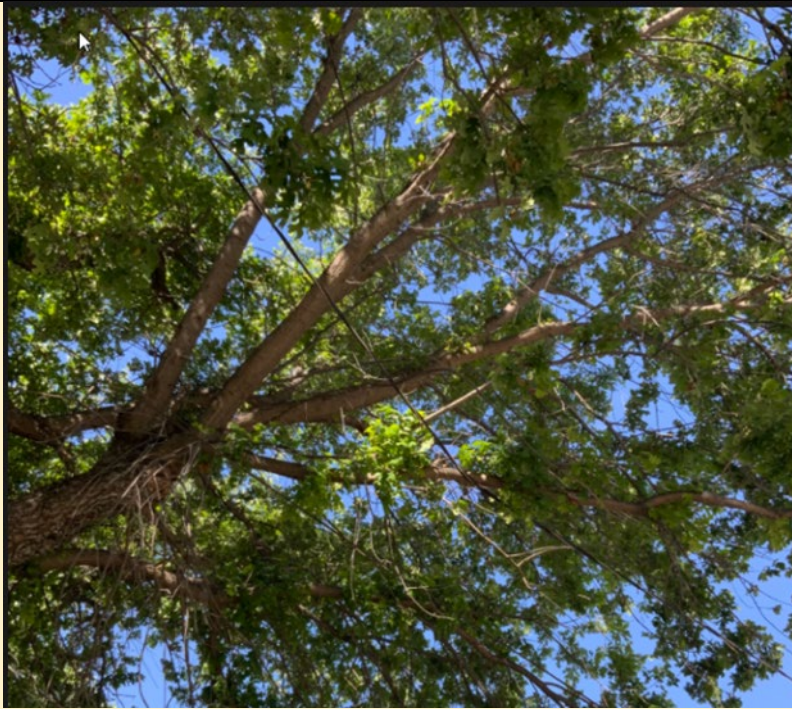
TREE STRAIN ON SERVICE DROP

At this Location: Tree strain on service drop.

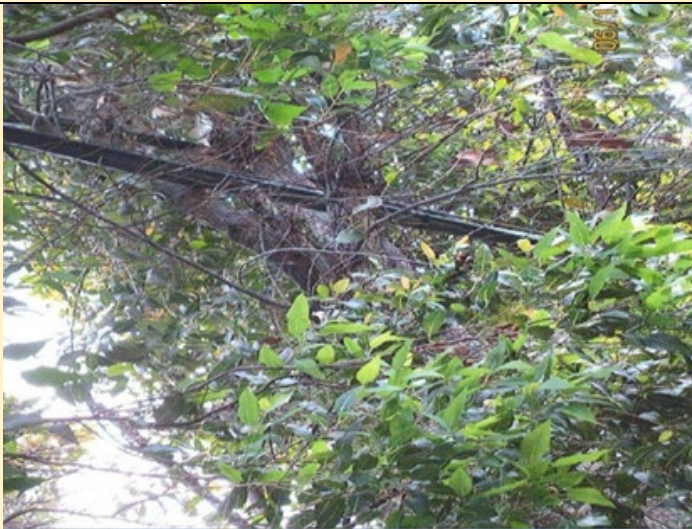
PHONE TREE CONDITION

At this Location: Tree putting strain on the pole, due to communication line.

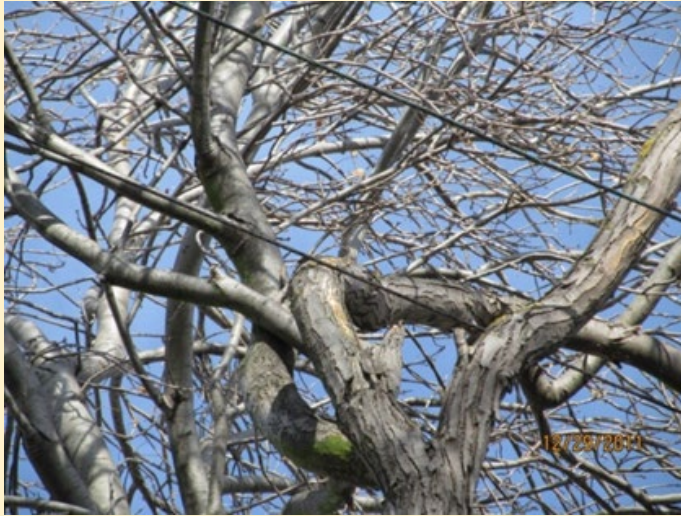
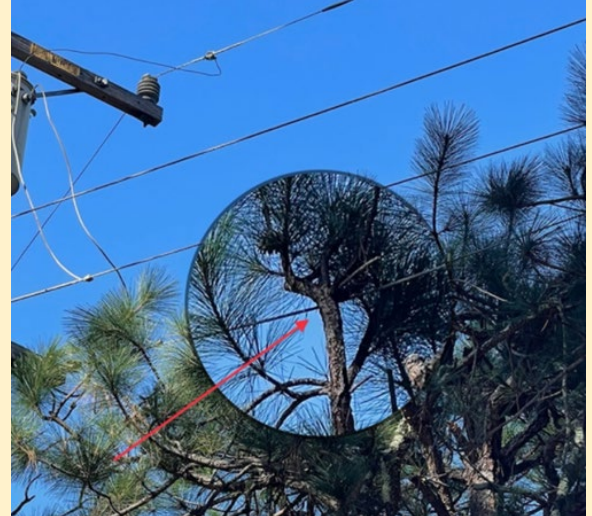
SECONDARY HARD AGAINST TREE

SECONDARY OVERGROWN REDUCING CONDUCTOR CLEARANCES

At this Location: Secondary conductor resting on tree/vegetation. Tree causing strain on open wire secondary, **feeding more than one customer.**

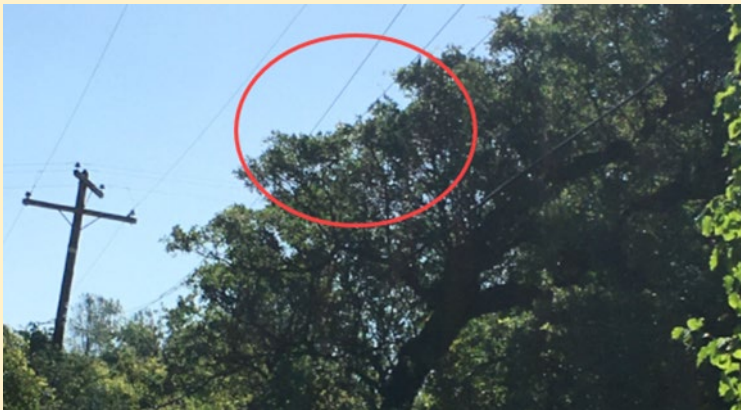
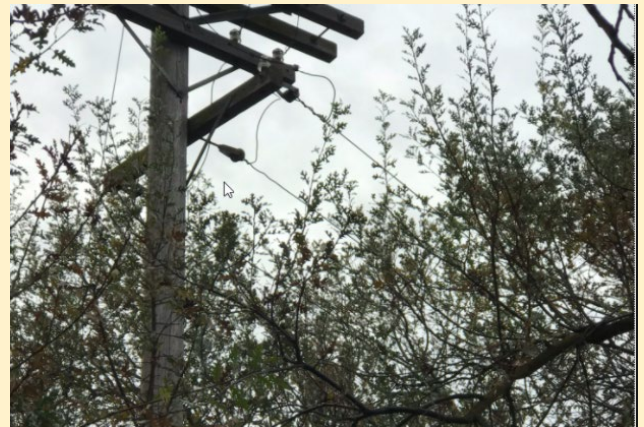
TREE GROWING INTO BARE OPEN WIRE SECONDARY OR BARE OPEN WIRE SERVICE, NO STRAIN OR ABRASION

At this Location: Tree grown around bare open wire secondary, no strain or abrasion. Spreader bracket already installed.

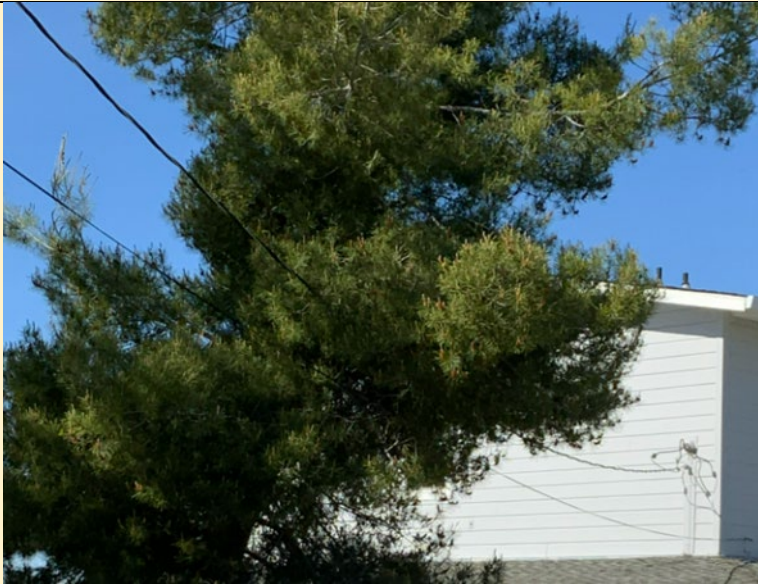
TREE GROWING AROUND SERVICE, NO STRAIN OR ABRASION

At this Location: Tree grown around service, no strain or abrasion.

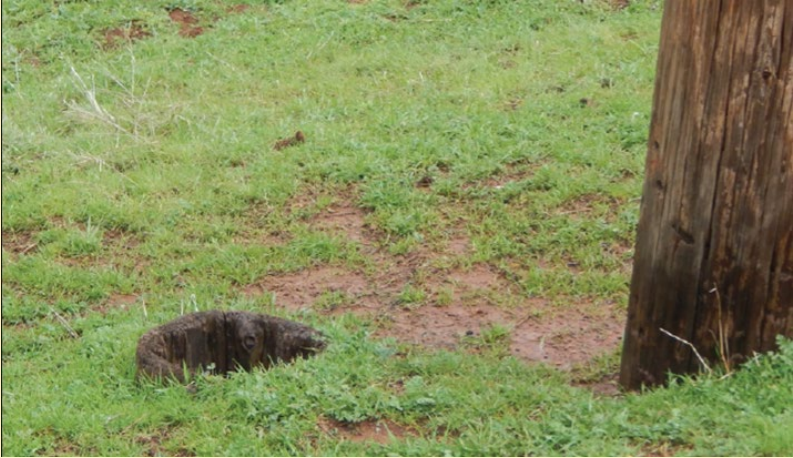
ABANDONED POLE BUTT – HOLLOWED OUT BELOW GROUND LEVEL

At this Location: Abandoned Pole Butt with a safety issue such as a tripping hazard, hollowed out below ground level.

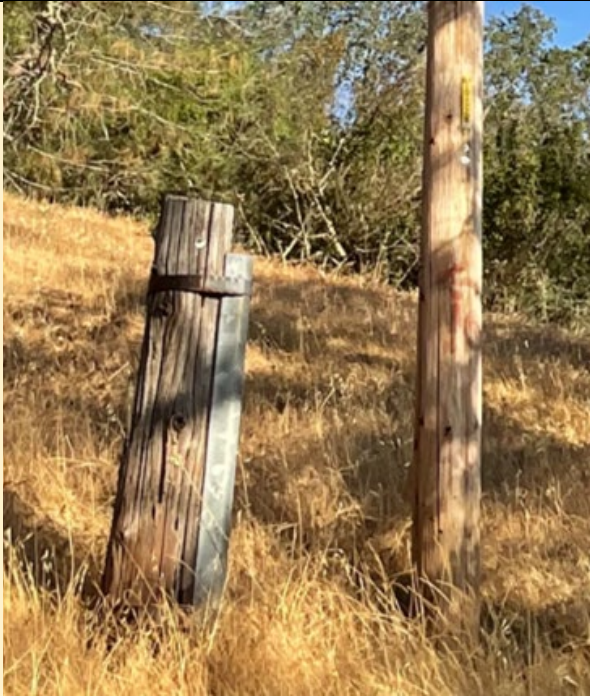
ABANDONED POLE BUTT

At this Location: Abandoned Pole Butt, low risk

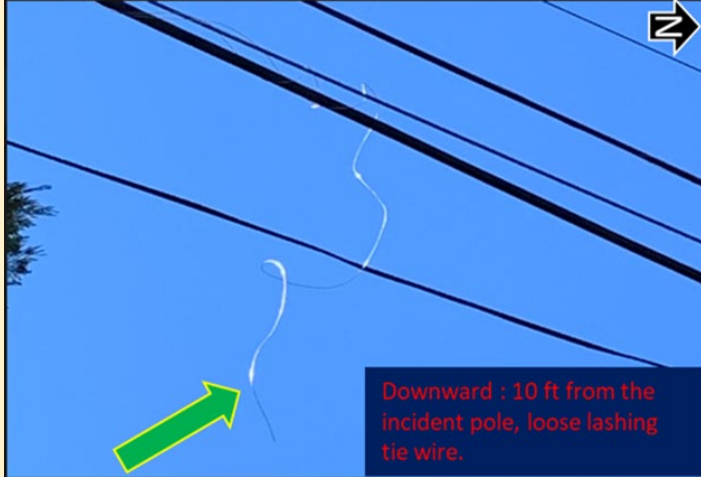
Before

3rd PARTY CABLE LOOSE LASHING LONG ENOUGH TO WHIP INTO POWER LINES

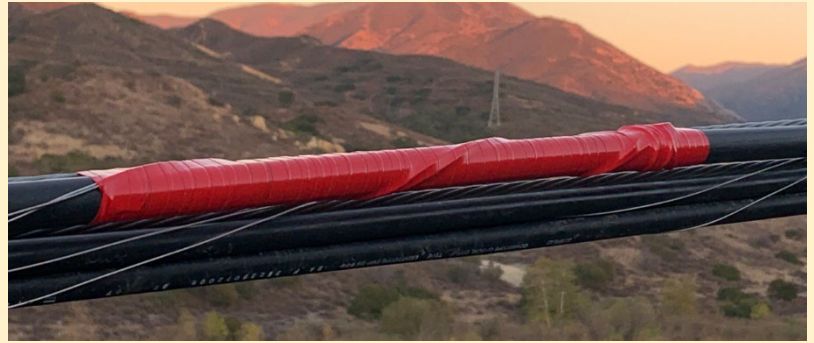
At this Location: 3rd party communication line has a loose lashing long enough to whip into power lines. Stand-by situation.

After - Snip Lashing and Tape

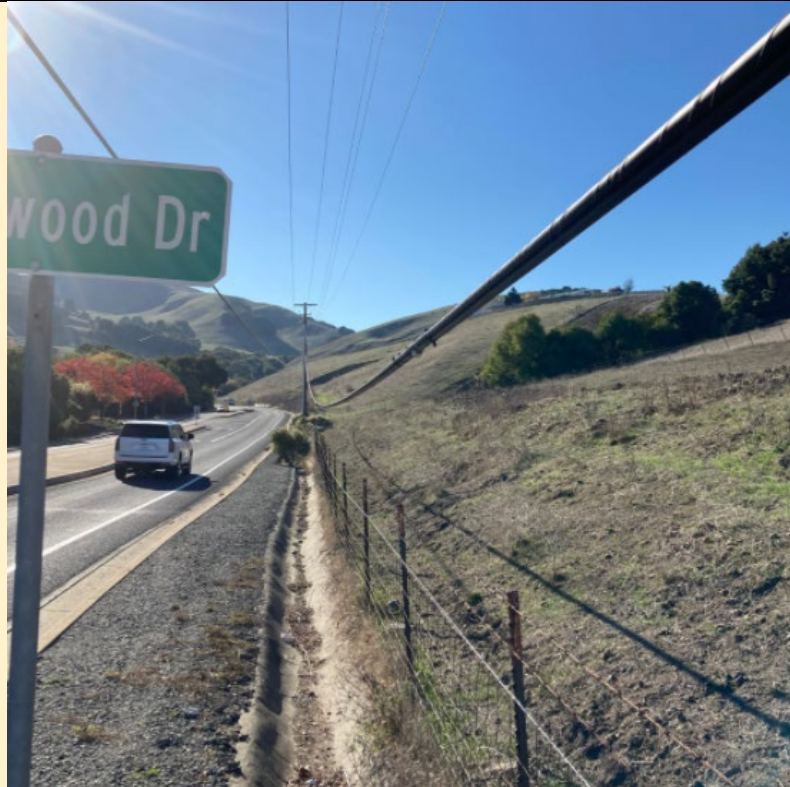
COMMUNICATION LINE EXTREMELY SAGGED

At this Location: Comm sag 6' above the road, off the road, no potential for vehicle contact.

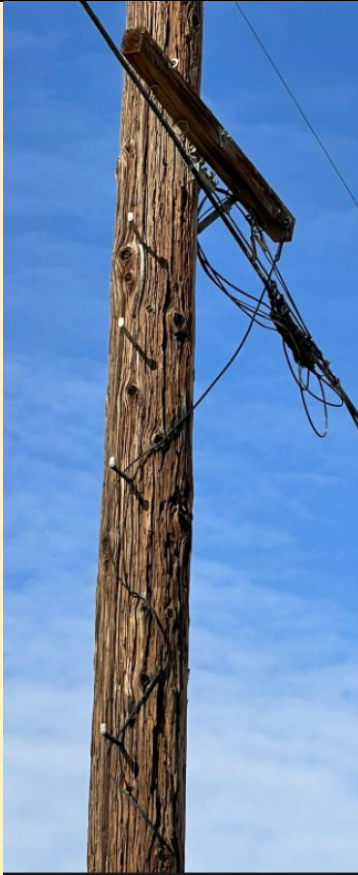
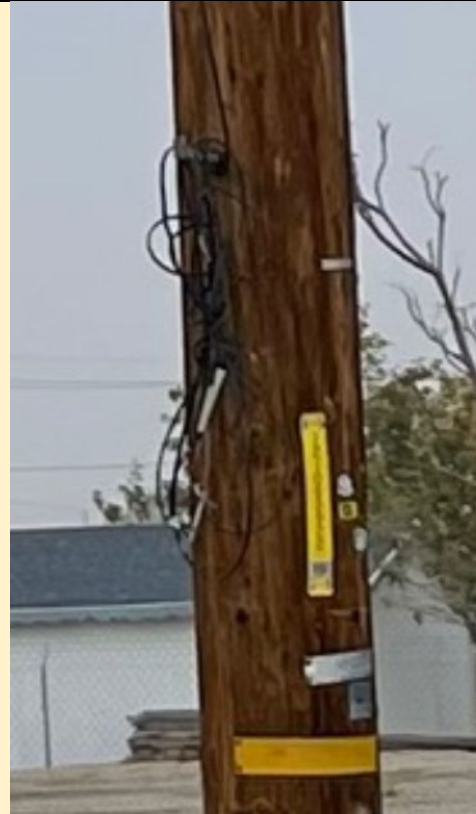
ABANDONED PHONE DROP

At this Location: Abandoned Phone Drop with potential of public safety exposure.

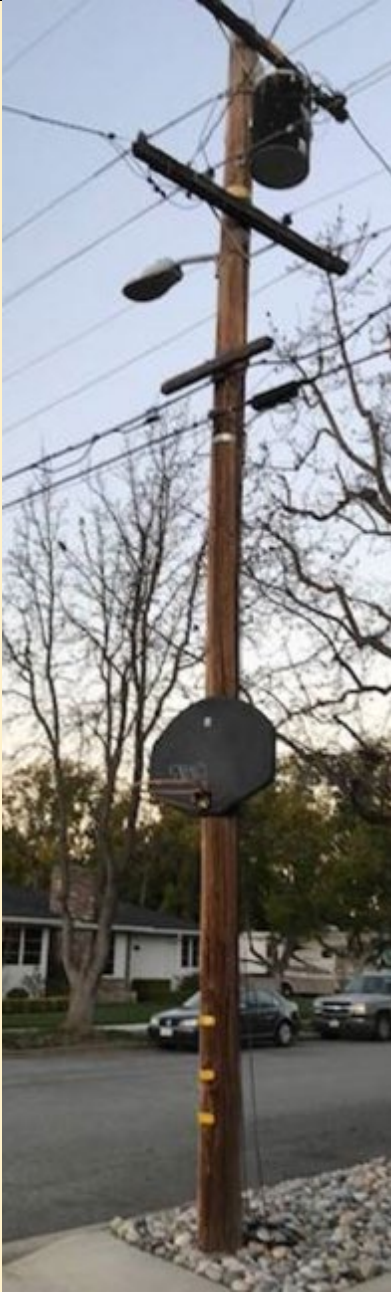
UNAUTHORIZED ATTACHMENT

At this Location: Basketball Hoop Installed on a PG&E pole.
	Perform Minor Work: No
	Write 3rd Party Notification: Yes, Level 3 priority.
	Write EC Notification: No

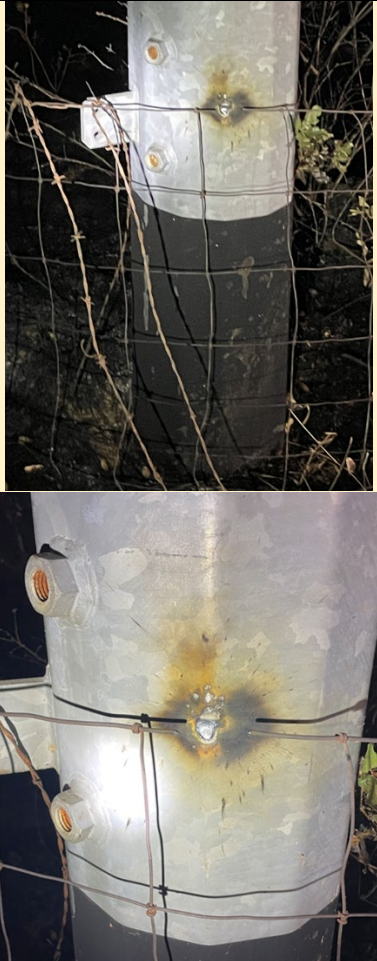
METAL POLE IN FENCE

At this Location: Metal attachment on metal structure. Fence can become energized.
	Perform Minor Work: Work with Supervisor to resolve immediate hazard.
	Write 3rd Party Notification: Yes, Level 1 priority.
	Write EC Notification: No
