Pacific Gas & Electric Company
ELC (Corp ID 39)
Status of Advice Letter 5847E
As of August 10, 2020

Subject: Grant of Easement to California Department of Water Resources for Relocation Work Related to the Oroville Spillway Incident Request for Approval under Public Utilities Code Section 851 and General Order 173

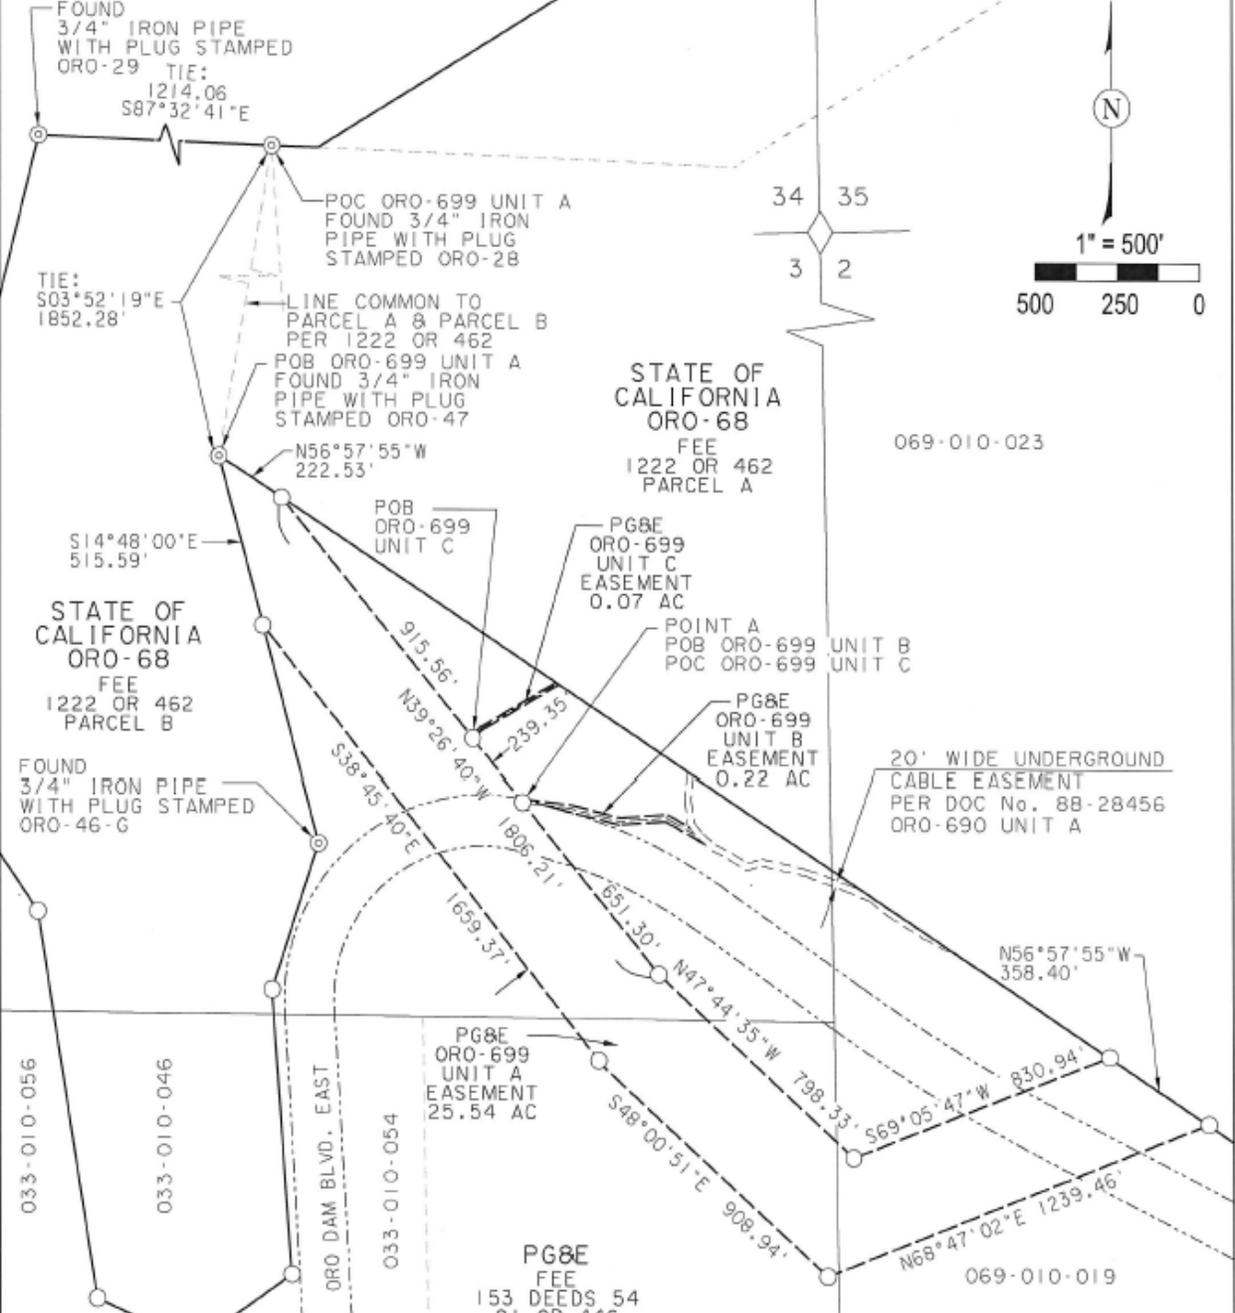
ORO-699

T. 19 N., R. 4 E.
SECTIONS 2 & 3

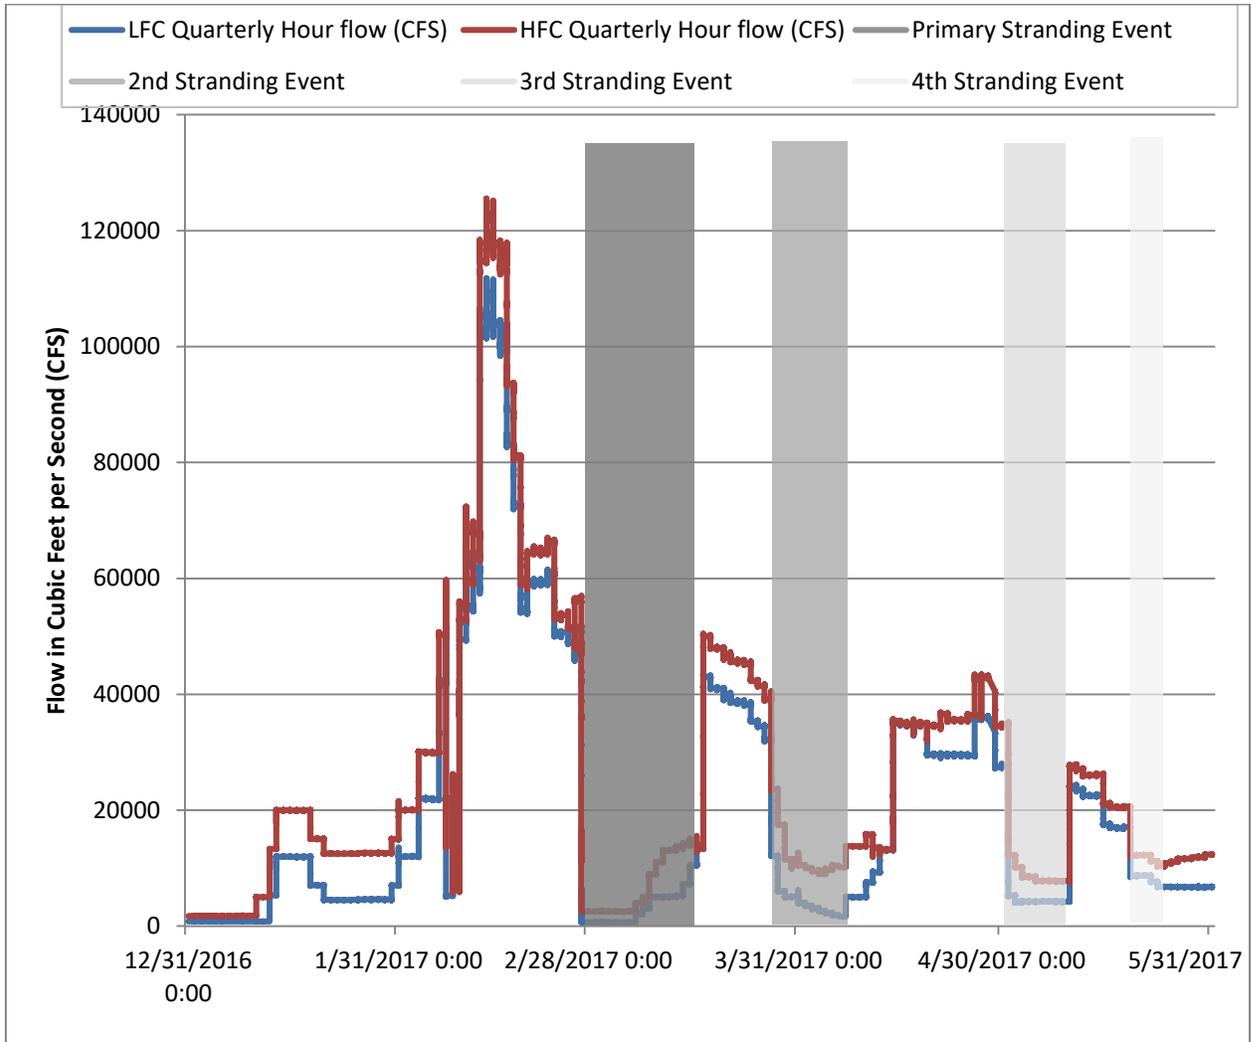
Figure 7.10-1. Changes in hourly flow levels (cubic feet per second: cfs) in the Low Flow Channel (LFC) and High Flow Channel (HFC) of the lower Feather River from base flows of 600 cfs for December through May, 2017. The primary flow reduction (Primary Stranding Event) occurred on February 27, 2017. Sampling weeks (stranding and fish rescue surveys) are shaded from lighter to darker gray for Week 1 (02/27/2017-03/03/2017), Week 2 (03/07/2017-03/09/2017), Week 3 (03/14/2017-03/15/2015) and Week 4 (05/22/17-05/25/17). Surveys occurred during Week 1 and Subsequent efforts continued during Weeks 2, 3, and 4. EDNA sampling also occurred during later reductions.

Measures taken: On February 27, 2017, release rates from Oroville Dam FCO spillway were rapidly decreased to accommodate the required (emergency) assessments and continued to decrease until 0 cfs was released over the FCO spillway on February 28. There was concern that damage to FCO Spillway may be exacerbated during flow reductions below about 40,000 cfs due to the possibility of increased head cut erosion. Due to this concern flows could not be reduced as normal and rapid reductions ensued. On February 27 flow to the Feather River LFC was reduced from approximately 56,000 cfs to 600 cfs and in the HFC to approximately 2500 cfs (Figure 7.10-1). Three subsequent, although smaller reductions occurred during emergency operations through May. During the rapid reductions flows never went below minimums for either the low flow or high flow channel. Emergency down-ramping ceased in late May.

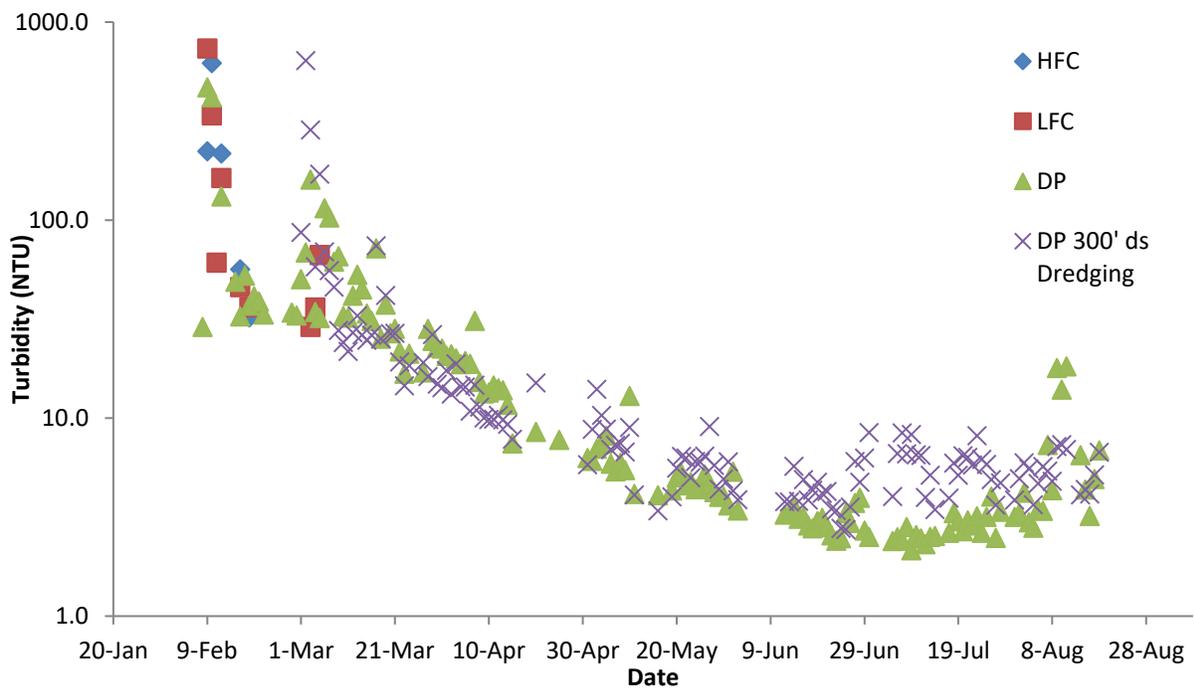
Figure 7.10-2. Turbidity (NTU) measured in the Feather River in the high flow channel (HFC), low flow channel (LFC), Diversion Pool (DP), and DP 300 ft downstream of the dredging in 2017. Note log scale on y-axis for turbidity.

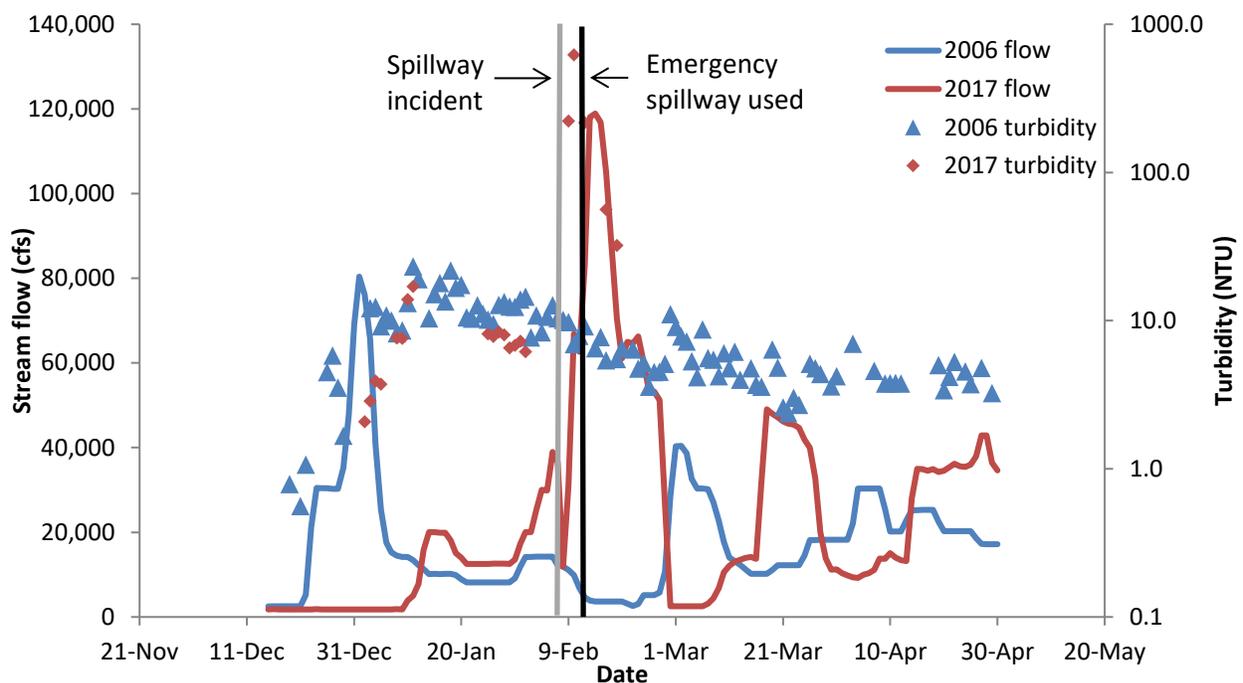
Figure 7.10-3. Streamflow (cfs) and available turbidity (NTU) data for the high flow channel in 2006 and 2017. Note log scale on secondary y-axis for turbidity.

Although turbidity and suspended solids were high during and immediately following the incident, sustained flow pulses >40,000 cfs in spring of 2017 may have flushed sediment deposited during the incident and reduced or eliminated future impacts on spawning habitat and macroinvertebrate production. Furthermore, 2006 turbidity data demonstrates that increased turbidity is normal under higher flow events (Figure 7.10-3), although short-term turbidity experienced in 2017 was unusually high. Elevated turbidity may have had positive effects by providing increased cover during juvenile salmonid emigration as well as by providing substrate for riparian vegetation recruitment.

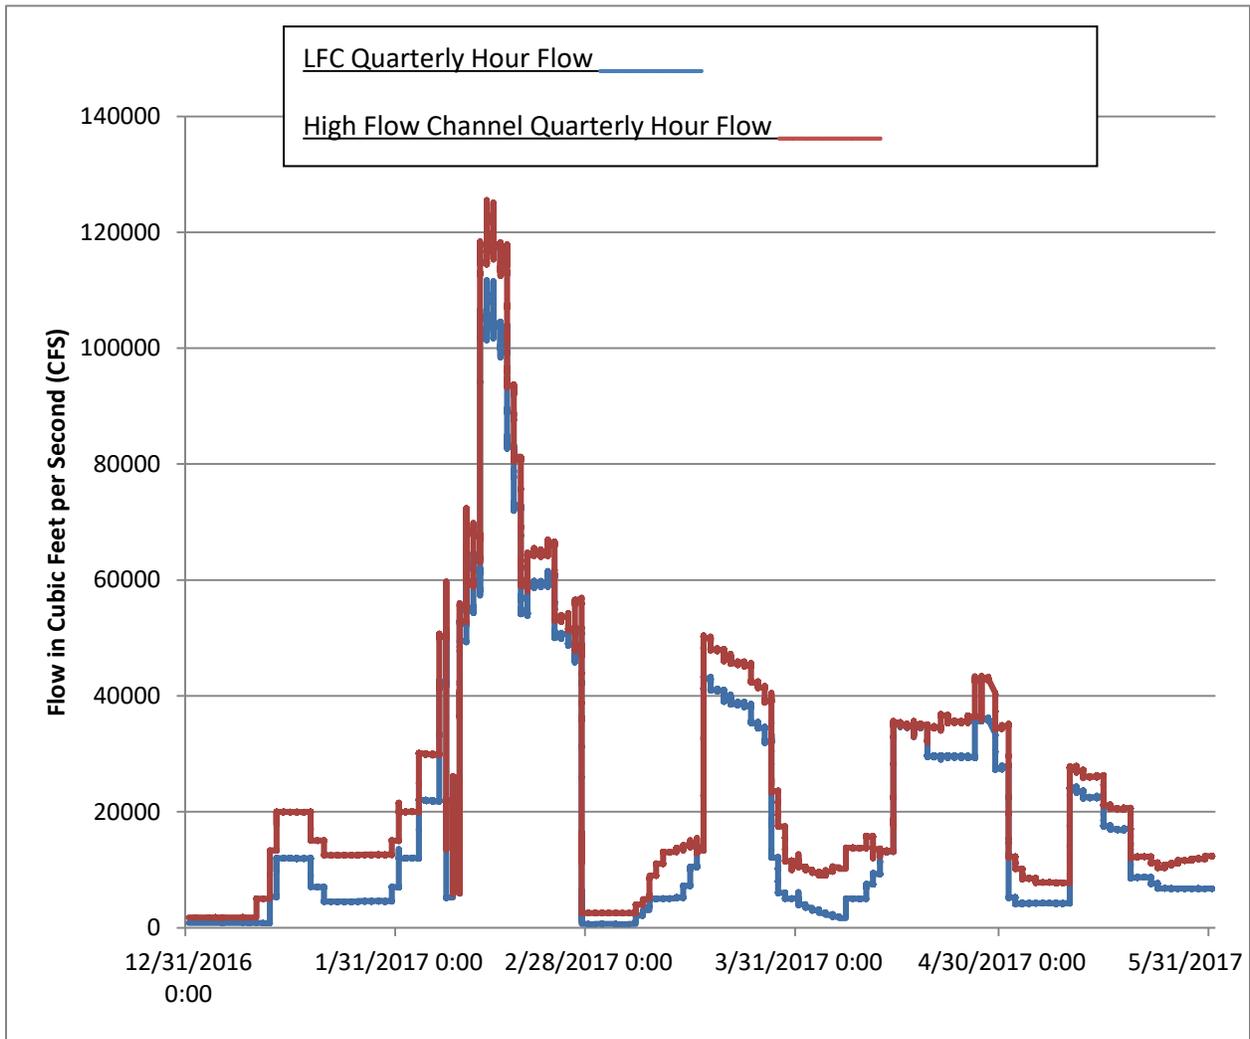
Figure 7.10-4. Graph depicting instances when down-ramping rates were unusually fast.

During the spillway incident, down-ramping rates were unusually fast on four separate occasions: 2/27, 3/27, 5/1, and 5/18 (Figure 4). These periods are when flow effects related to the spillway incident may have affected special status species.

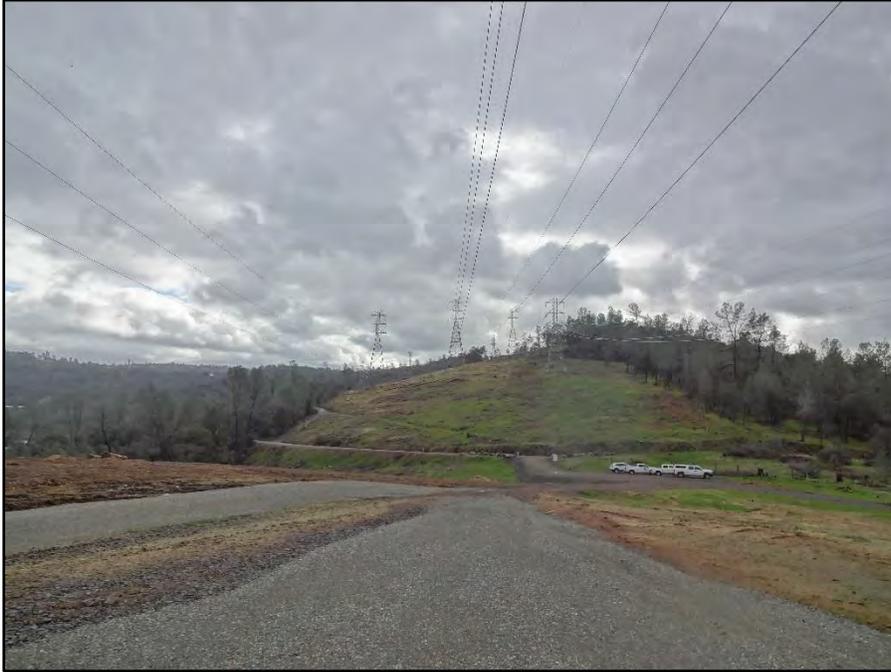
View of the tower transmission lines/easement area from the Northwest corner of the subject property looking Southwest.

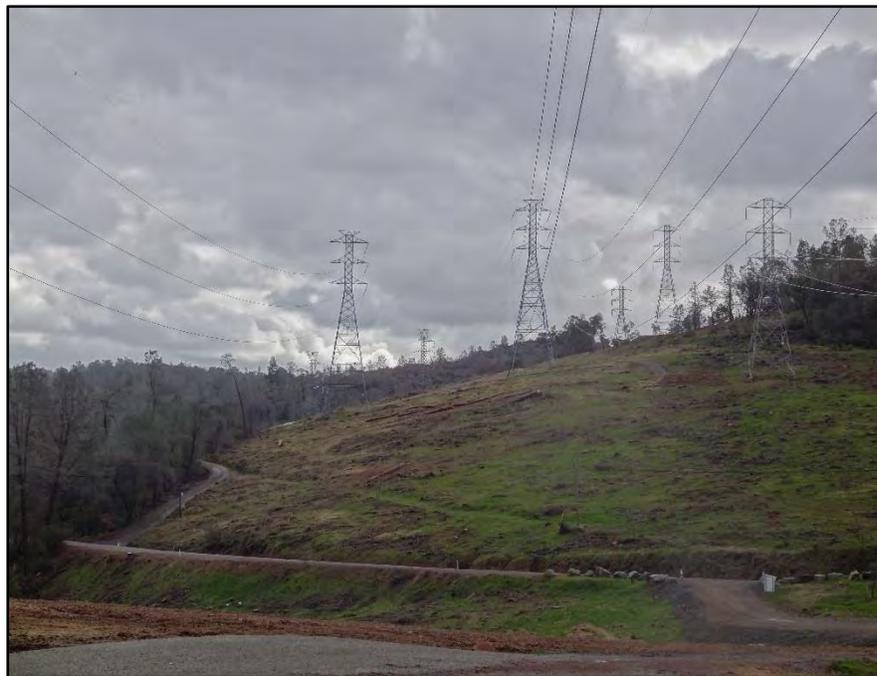
View of the tower transmission lines/easement area from the Northwest corner of the subject property looking Southwest.

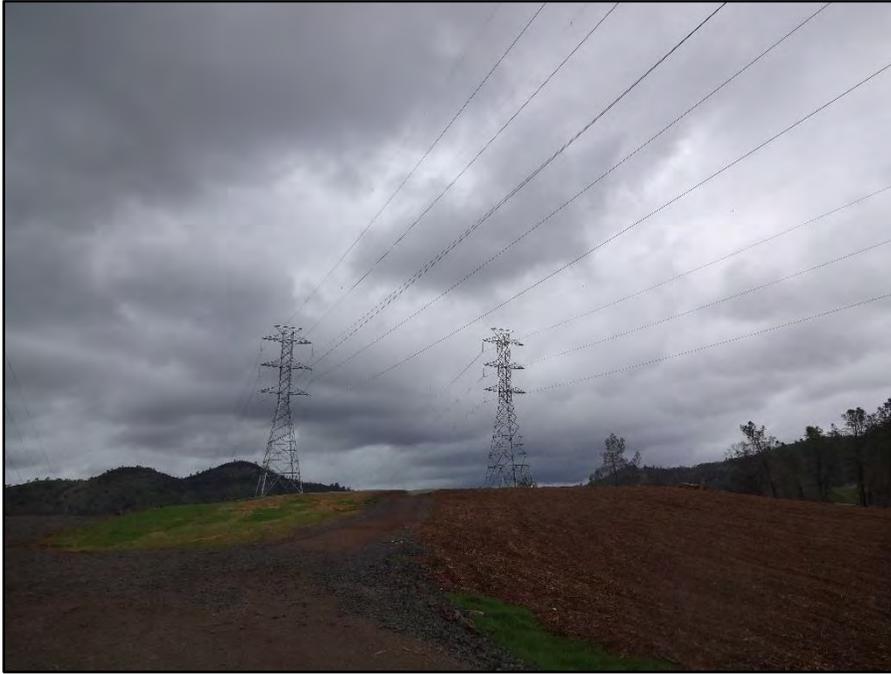
View of the tower transmission lines/easement area from the Northwest corner of the subject property looking Northwest.

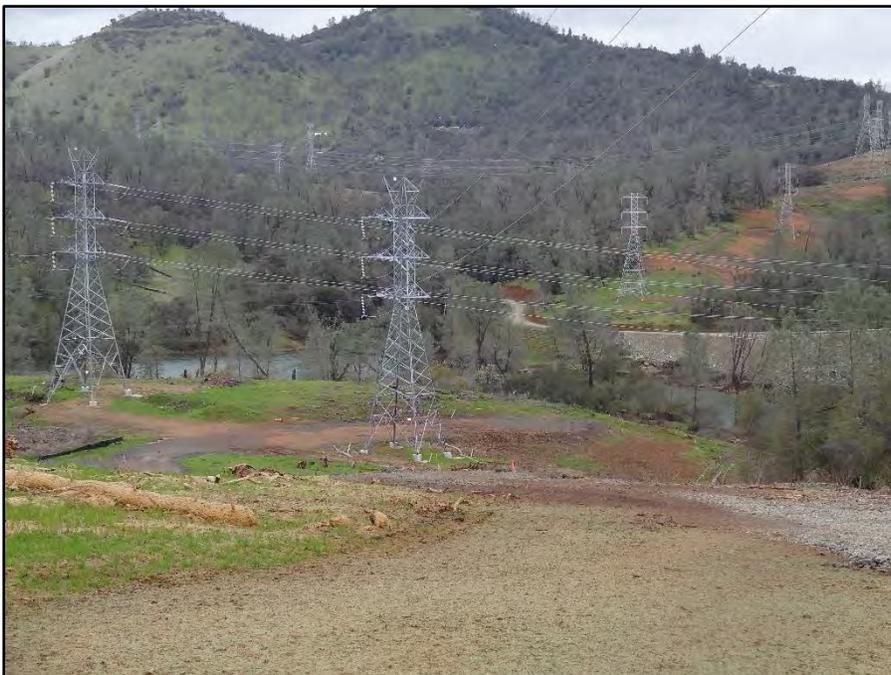
View of the tower transmission lines/easement area from the Northwest corner of the subject property looking Northwest.

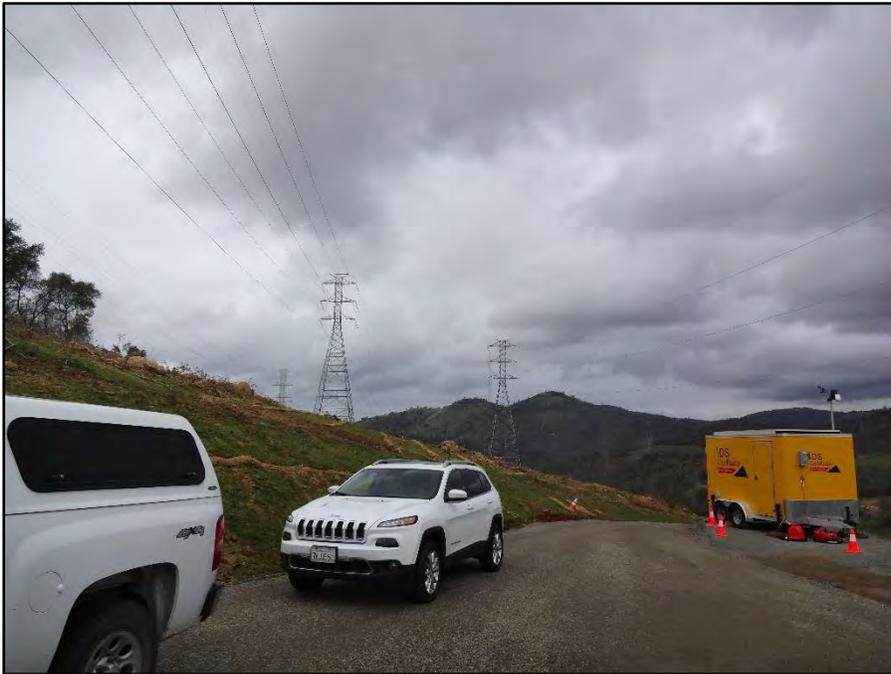
View of the tower transmission lines/easement area from the middle of the subject property looking Northwest.

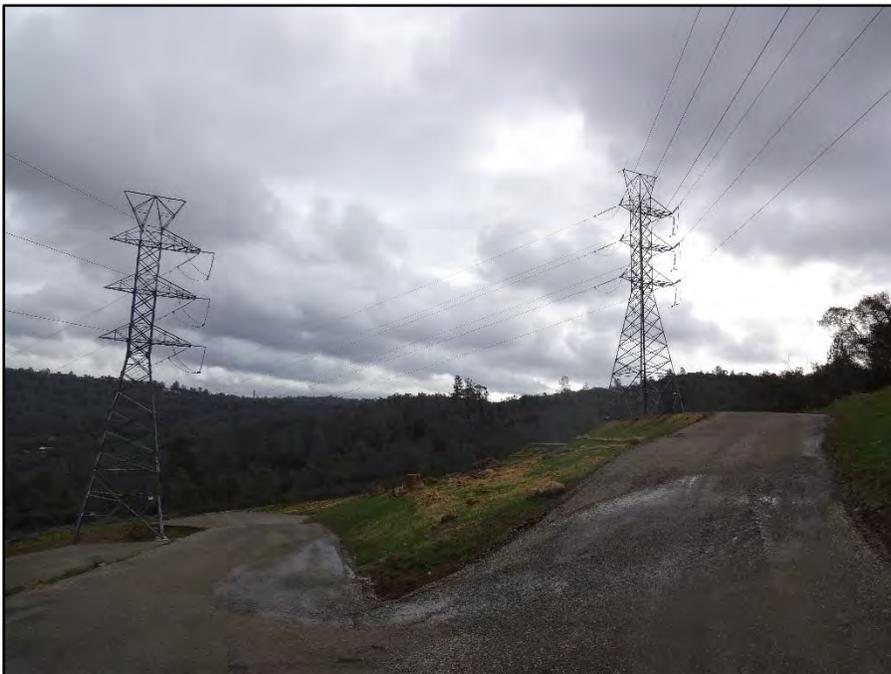
View of the tower transmission lines/easement area from the middle of the subject property looking Southeast.

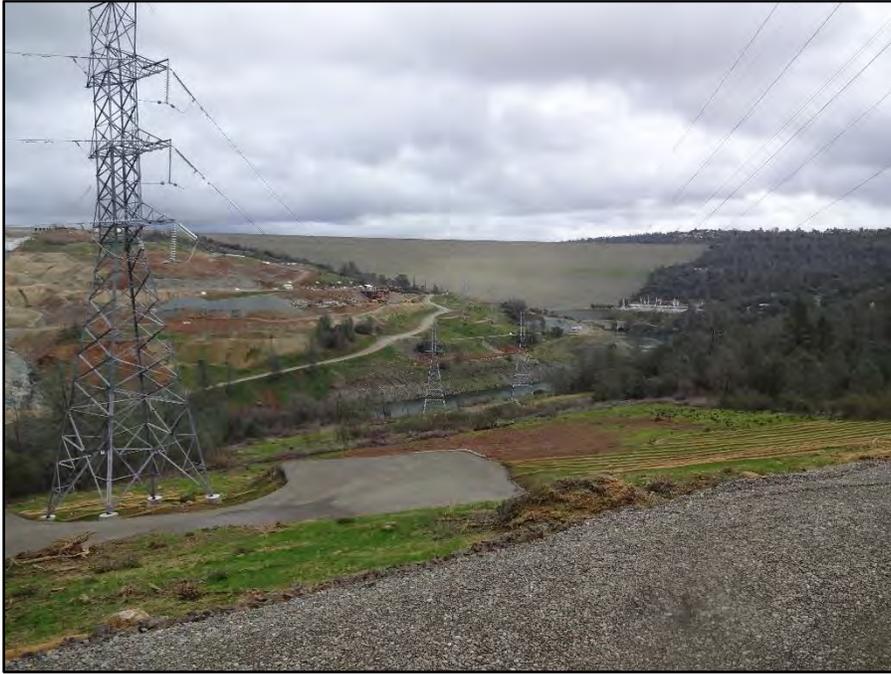
View of the tower transmission lines/easement area from the middle of the subject property looking Northeast (Oroville Dam in the background).

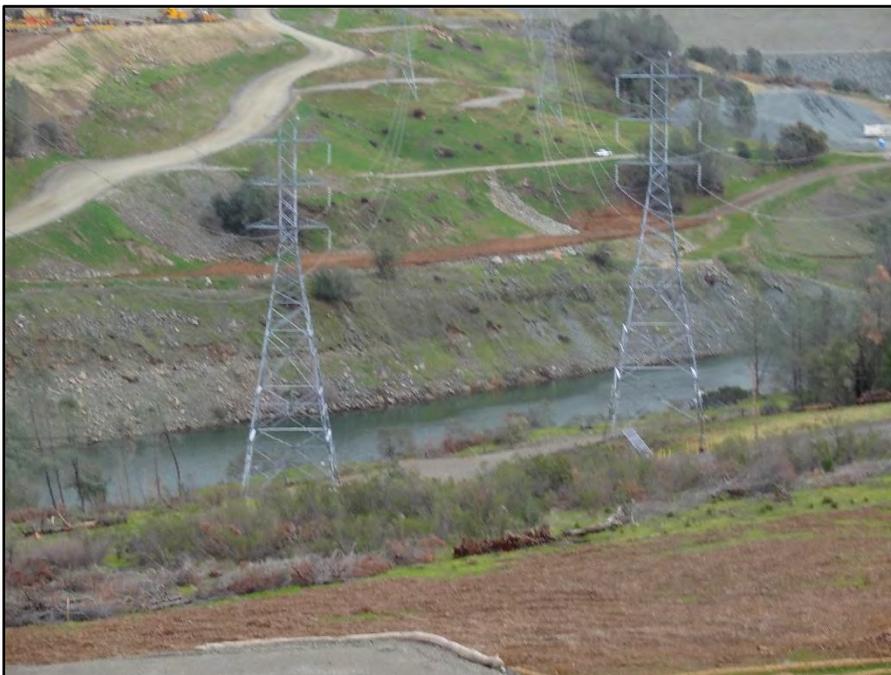
View of the tower transmission lines/easement area from the middle of the subject property looking Northeast.

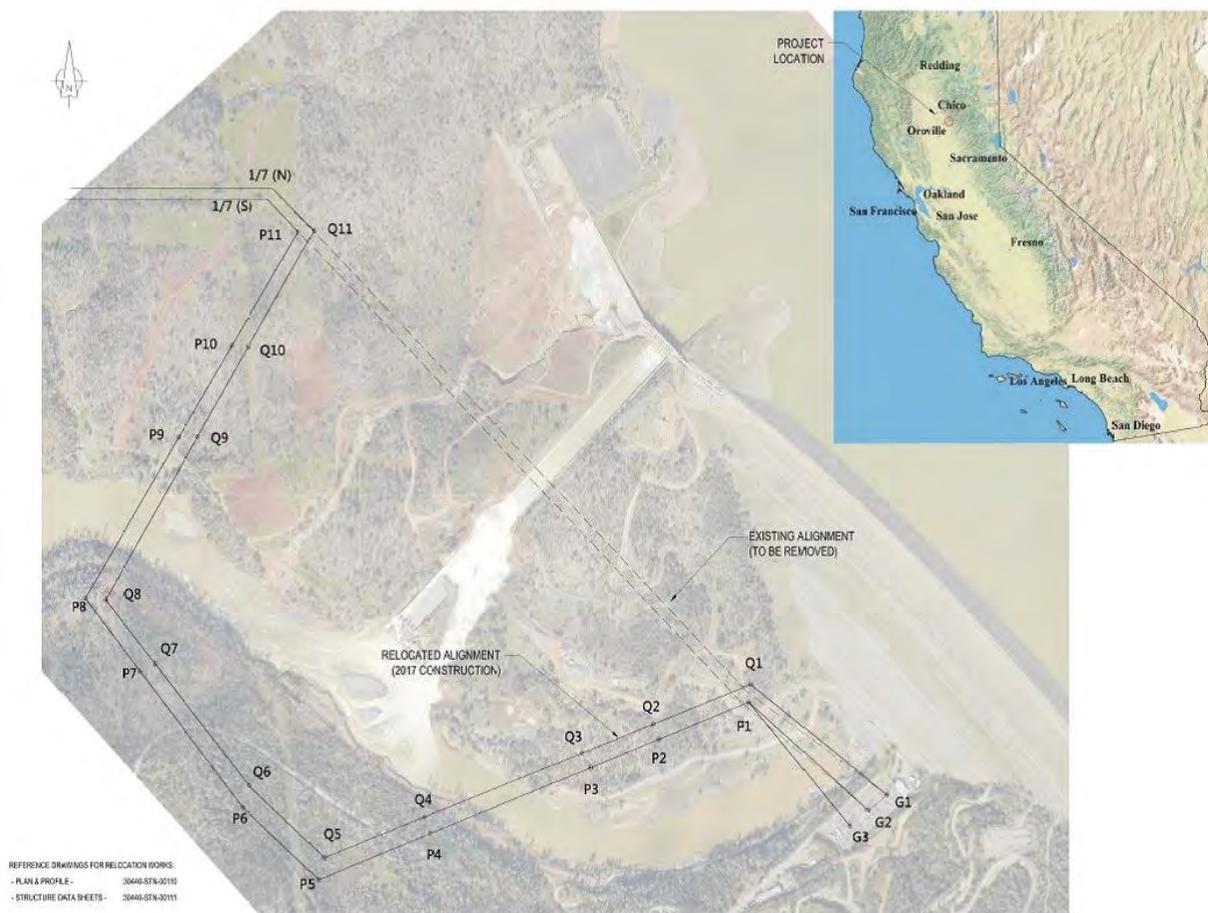
Figure 2. Proposed Realignment of Primary Transmission Lines from Hyatt Pumping-Generating Plant (source: California DWR).

The licensee states that it would secure the necessary easements for the work from PG&E and file revised project boundary and exhibit maps to reflect the new alignment.
