Pacific Gas and Electric Company

EPIC Final Report

EPIC 1.09B/1.10B – Test New Remote Monitoring and Control Systems for T&D Assets / Demonstrate New Strategies and Technologies to Improve the Efficacy of Existing Maintenance and Replacement Programs

Network Condition Based Maintenance

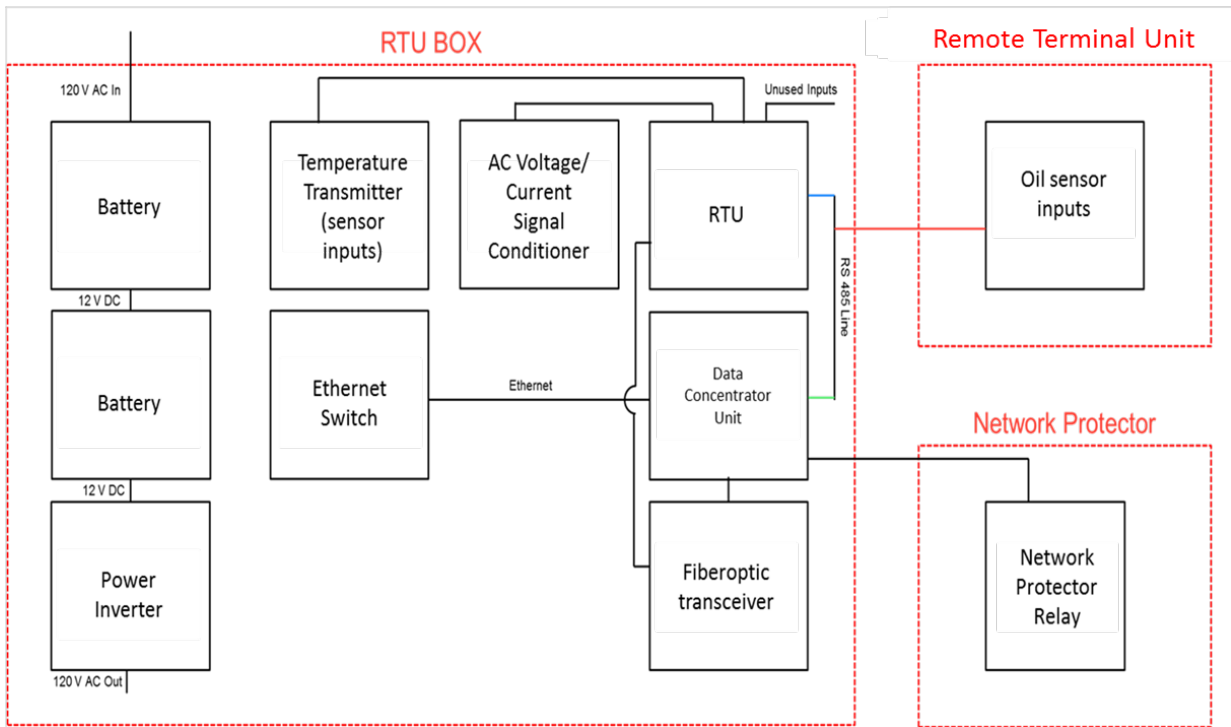
Figure 3-1 Local SCADA system components schematic

On a local distribution vault system level, multiple data points are collected from condition monitoring sensors by a local remote terminal unit (RTU), which then communicates this information to a local data concentrator unit via serial communication line. Live sensor data is then reported through the data concentrator and is recorded and stored in the SCADA database.

The schematic in Figure 3-1 below highlights the typical local connections in this type of system:

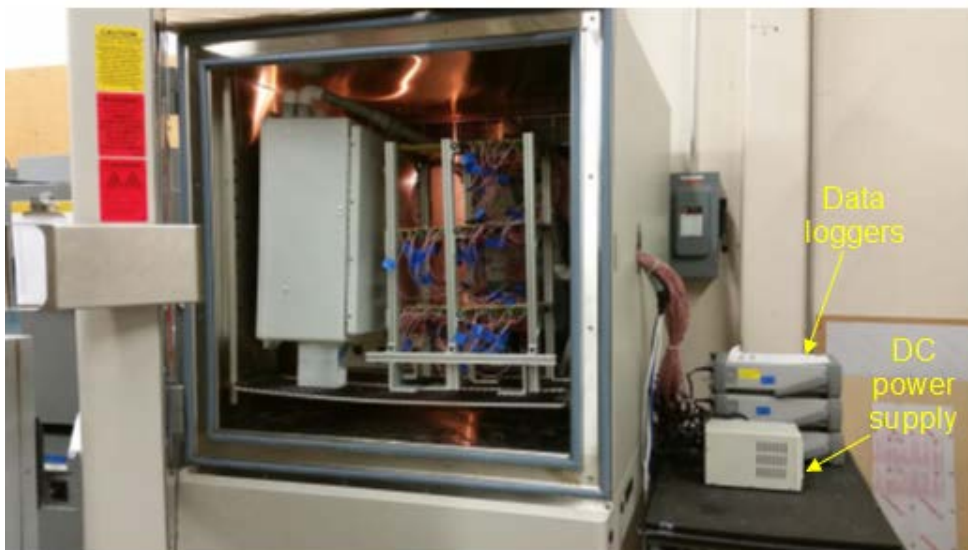
Figure 4-1 Environmental chambers used for accelerated lifecycle testing

A laboratory demonstration was performed to simulate an accelerated lifetime to establish a baseline of performance representing approximately 30 years of equipment life. This testing was performed by placing the test equipment inside an environmental chamber and exposing them to high humidity and cycling temperatures. Approximately 2500 hours of usable data comprising over 1.7 million data points were collected during several months of testing. Testing included running the SCADA equipment under normal operating conditions within an environmental chamber leveraging multiple temperature and humidity cycles, averaging with approximately 90% relative humidity with cycles of temperature between 25°C up to maximum 75°C. See Appendix B for further details of relevant standards related to environmental testing.

Figure 4-1 depicts the test set up leveraged for accelerated lifecycle testing.

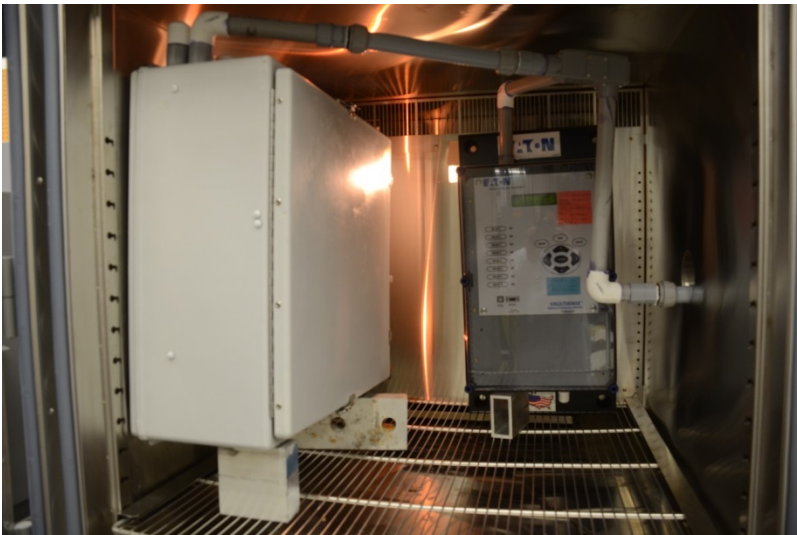
Figure 4-2 SCADA Equipment Test Set Up

The project team operated a RTU box and a data concentrator unit within the environmental chamber. Wiring connections were made between the two units inside the environmental chamber through conduits similar to actual PG&E installations. Connection was also made between the RTU box and a network relay outside the environmental chamber. The state of the network relay switch was reported to the data concentrator within the RTU box via a serial connection. A data concentrator web interface was accessed through a secure Local Area Network (LAN) and the webpage was periodically recorded for any sign of malfunction in the system or the sensor readings. Approximately 1400 cycles of temperature with different profiles were applied during the environmental chamber testing.

Figure 4-2 depicts the set up leveraged for SCADA equipment accelerated lifecycle testing.

Approximately 1400 cycles of temperature with different temperature and humidity profiles were applied during the environmental chamber testing. The serial communication between the RTU box and the data concentrator was lost twice during this time period. The first instance occurred after approximately 416 cycles. The second instance occurred after approximately 1217 cycles in the environmental chamber.

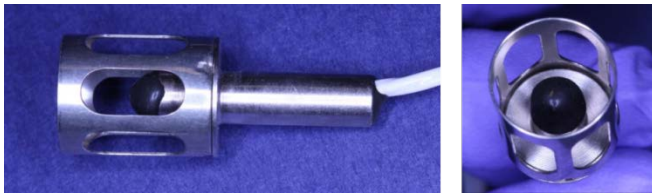
Figure 5-2 Ambient Temperature Sensor Inside the RTU

Sensor Location	Result
Inside the RTU box	Passed all cycles of testing without equipment failure. No obvious evidence of corrosion, likely attributable to the fact that they were not directly exposed to the high humidity of the test chamber. (Figure 5-2)
Inside the data concentrator	No equipment failure, however partial delamination was observed (loss of mechanical toughness due to separation of material layers). Likely attributable to partial exposure of the sensor to the elements through the potting material on the sensor (sealant to exclude moisture and corrosive elements). (Figure 5-3)
Outside the RTU box	Experienced one equipment failure of one sensor after approximately 1200 cycles in the environmental chamber, mostly likely attributable to direct exposure to the humidity of the test chamber. There was evidence of corrosion visible on the sensor. Also visible was discoloration and irregularities in the potting material that covers the sensing element. (Figure 5-4)

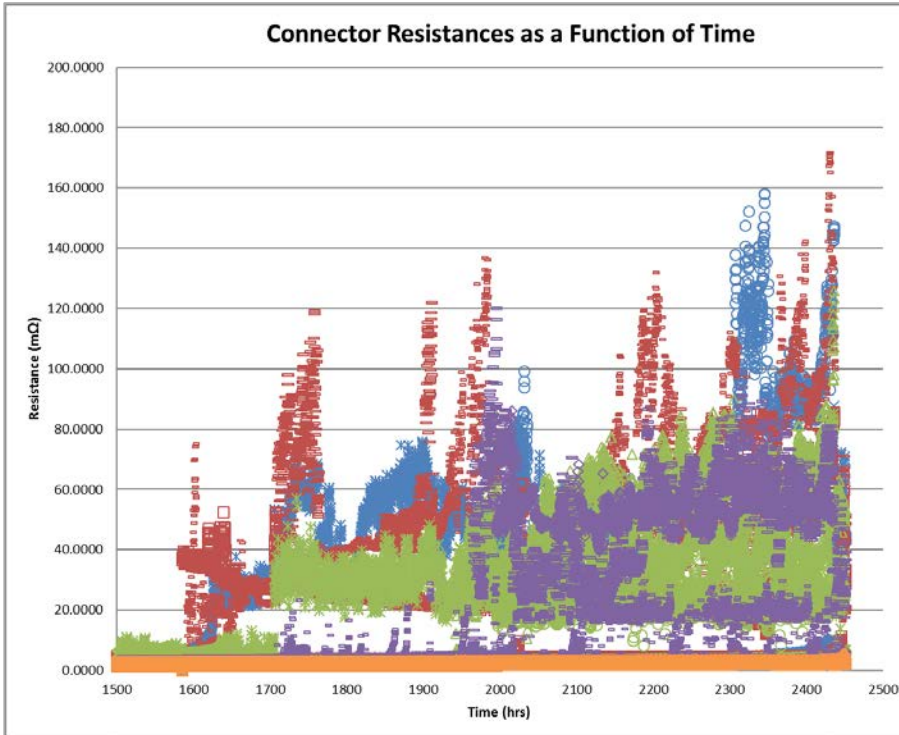
Figure 5-6 Plot of all the connector resistances measured over time

Some of the connection resistances started from less than 10 milliohms and increased to near 180 milliohms for approximately 2450 hours-worth of data during this test. Although the increase in overall resistance of the connectors is considerable, a connector with 180 milliohm contact resistance is not expected to be problematic for applications such as the ones in the RTU box and the data concentrator. As shown in Figure 5-7, non-pinned connections had greater resistance increases than pinned connections.

Overall, test data on electrical connections showed the development of corrosion due high temperature and humidity levels, but the quality of the electrical connection did not significantly change. Connectors currently in use showed strong performance as accelerated life testing showed no significant difference between all connectors and wire end types under test. Additionally, resistances for each connector type would increase and decrease during the course of the test. This could be as a result of the slow process of corrosion material buildup at the surfaces of the electrical connections and intermittently making and breaking contacts through corrosion products at the surfaces.

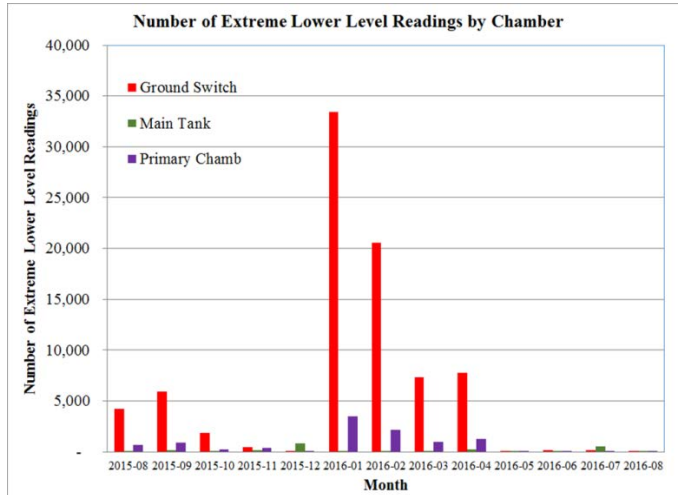
Figure 5-9 Number of Extreme Lower Level Readings by Chamber

Result: Oil pressure and level sensors have significantly higher rates of false readings than oil temperature sensors. This may be attributable to sensor connection placement, as sensor connections made in the data concentrator expansion board (from the ground switch) were more likely to have a false reading.

Figure 5-9 illustrates that false readings were occurring significantly more regularly from the ground switch chambers than main tank or primary chamber. Additionally, Figure 5-10 illustrates that most of these false readings are associated with the oil pressure sensors, which provide data to the data concentrator “extension board” instead of to the main board.

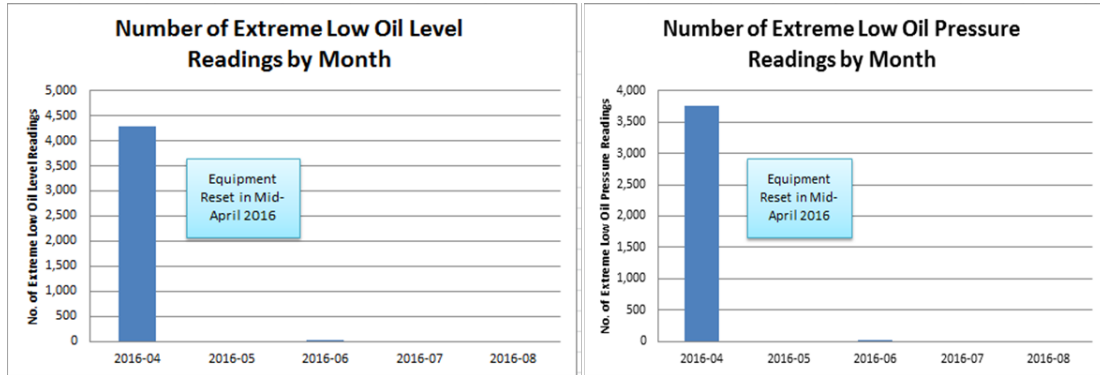
Figure 5-11 No. of Extreme Low Oil Sensor Readings by Month

Result: As illustrated in Figure 5-11, the data suggests that some of the equipment had relatively high counts of bad data prior to reset, and that the number of bad data suddenly dropped to zero immediately following a reset. This indicates the likelihood of effectiveness of remote resetting to eliminate extreme low readings of the oil level and pressure sensor data. It further indicates that the source of the bad data may not be the physical sensor equipment because a sensor problem cannot be fixed by remote resetting of the equipment.
