## Pacific Gas and Electric Company

### EPIC Final Report

**Project** *EPIC 2.34 Predictive Risk Identification with Radio Frequency (RF) Added to Line Sensors*

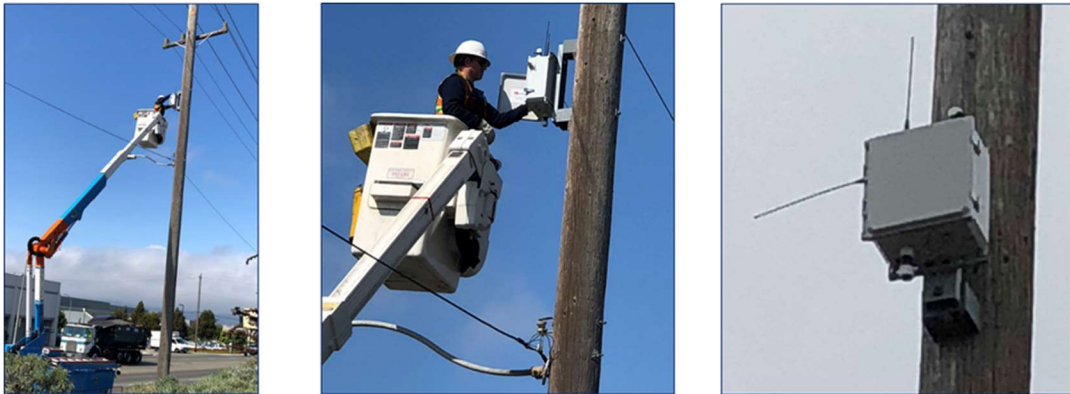
Figure 3. DRLM Sensor Installation

Figure 3 shows the DRLM sensor and gateway during installation, and mounted to a pole.

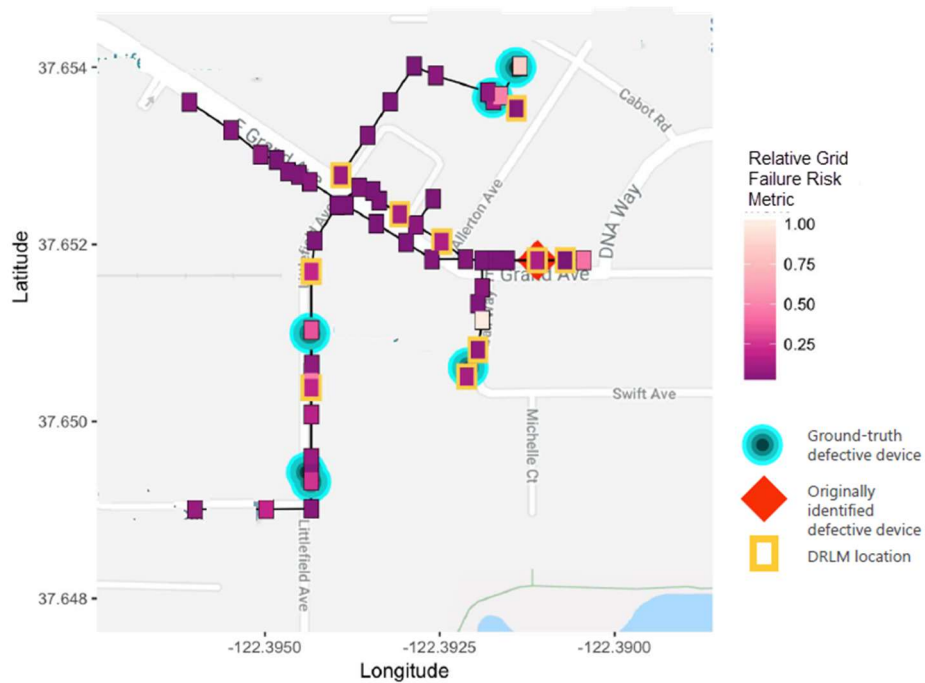
Figure 5. Machine-Learning Model Accuracy

The final inferred deteriorated equipment locations are shown in Figure 5, where distribution poles are represented by rectangles shaded with predicted relative Grid Failure Risk Metric. The lightest colored rectangles indicate poles with highest Risk Metric. The DRLM sensor poles are indicated by rectangles with a yellow border. At the end of the field trial on 10/22/2018, engineers verified ground-truth defective equipment poles with commercial directional ultrasonic acoustic measurement tools, and located five asset issues indicated by the blue circles. The model forecast degraded equipment locations within 0 to 2 conductor spans from field verified locations.

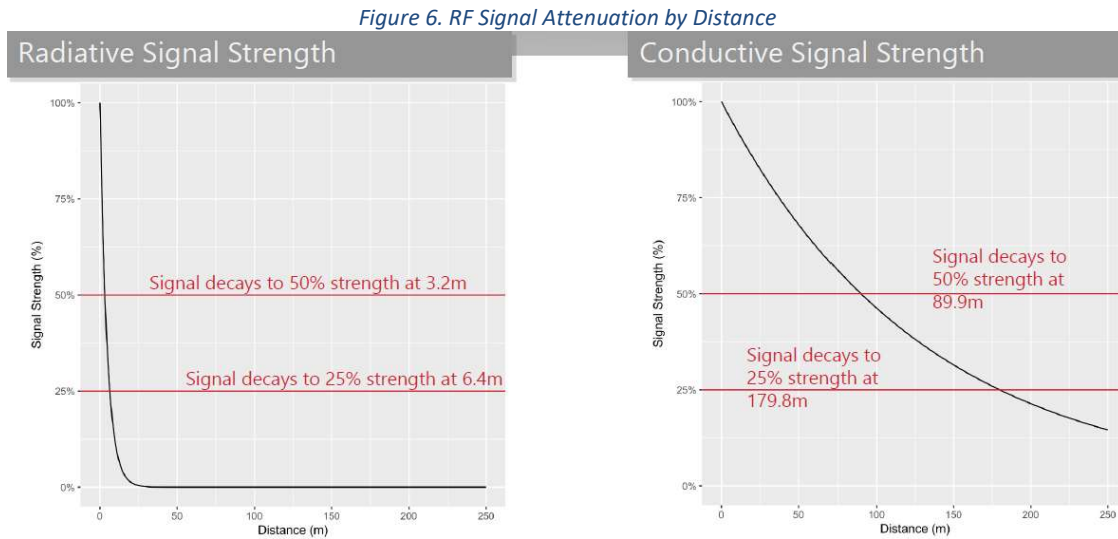
Conducted RF Emissions travel 30x as far as radiated emissions. Figure 6 shows the signal attenuation by distance.

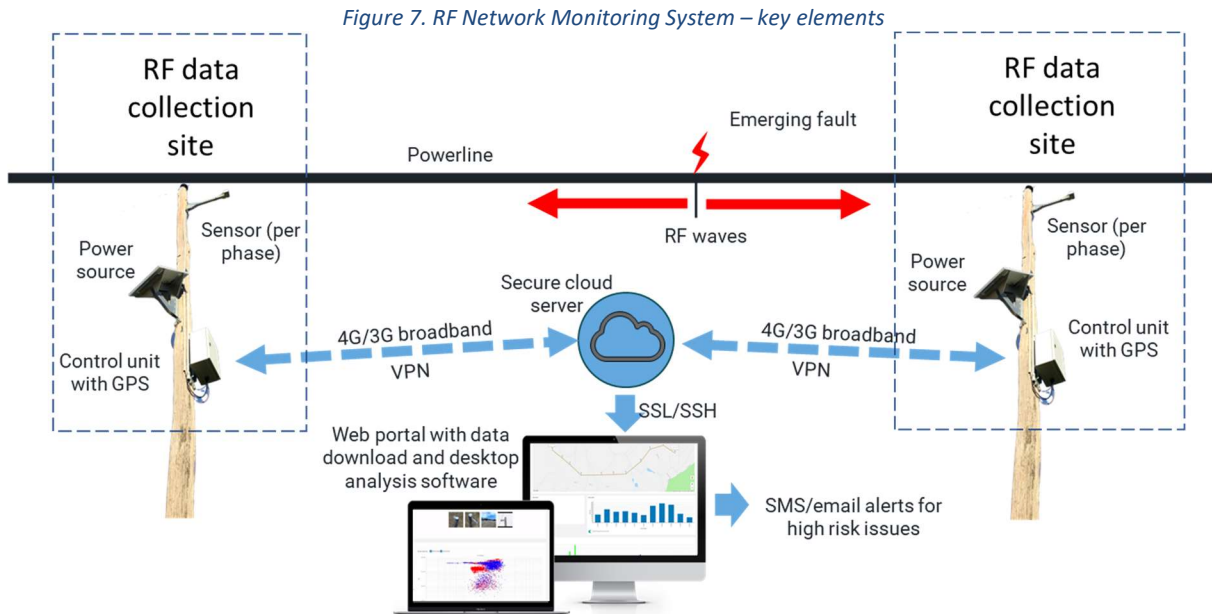
The RF network monitoring system is illustrated schematically in Figure 7. The tangible elements of the system are a set of pole-mounted RF data collection units spread across the network at (nominal) three-mile spacing. The more complex and powerful elements of the system are a set of ‘big data’ processes and algorithms running on secure cloud-based IT infrastructure accessed by utility teams from their desktops via encrypted secure browser sessions.

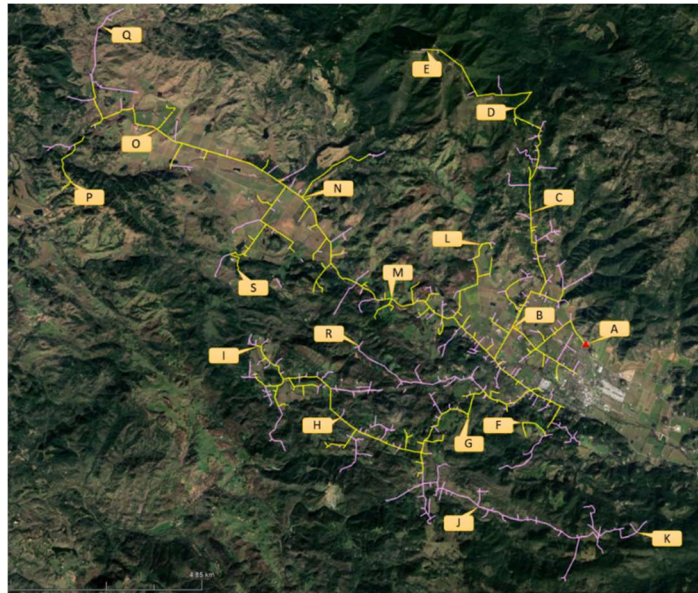
*Figure 8. Feeder concept plan showing suggested RF data collection sites*

Using PG&E's network GIS data, the supplier developed concept plans showing suggested locations of RF data collection units to give effective coverage of the selected circuits. Each suggested RF data collection site was audited by PG&E to verify cellular data service coverage, pole mechanical design, pole 'real estate', and construction access. In some cases, PG&E moved the planned location to accommodate constraints in these site qualifications.

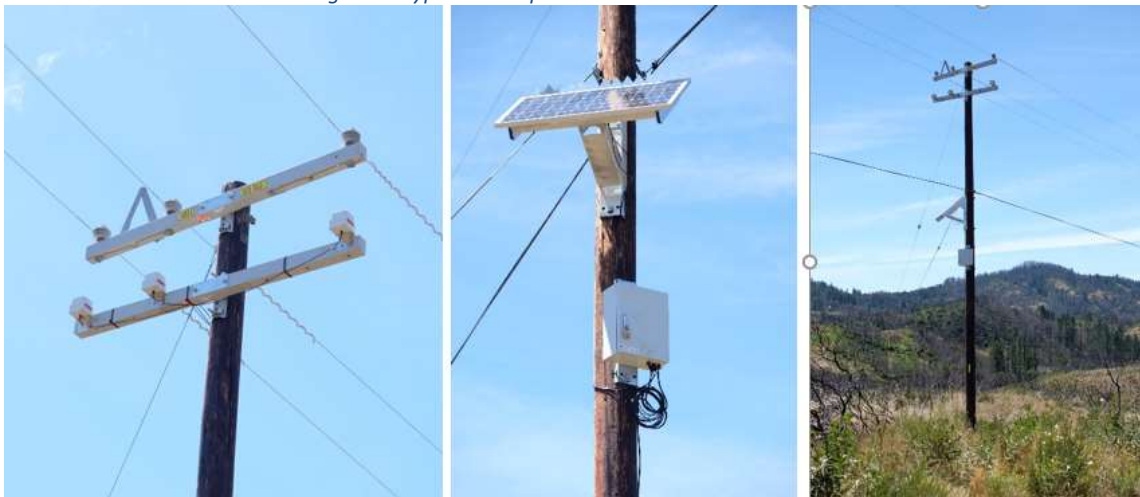
*Figure 9. Typical solar-powered RF data collection unit*

Installation of the 19 RF data collection units on a Napa Valley Area Circuit 1101 commenced mid-June 2019 and continued at a pace determined by construction resource availability through September 2019. Original plans to use AC-powered sensors with a potential transformer on the adjacent pole were not feasible due to the long conductor spans in the area. Solar power was used for the majority of the installations.

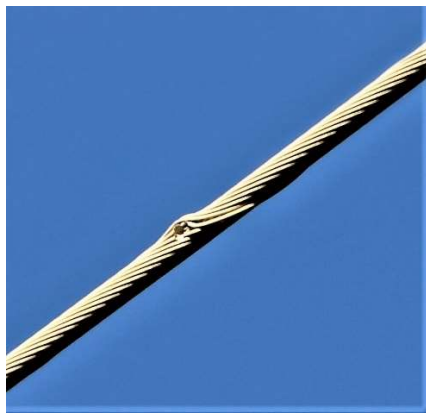
Figure 10. Examples of conductor damage found by the RF network monitoring system

Following commissioning of RF network monitoring of Sensor Path D-E in August 2019, the RF network monitoring system detected multiple instances of conductor damage on a high-altitude section of powerline exposed to extreme wind speeds and temperatures. The damage included: broken conductor strands; residual damage from conductor slap; and conductor bird-caging. The RF network monitoring system also identified gunshot damage on a conductor near feeder substation. Figure 10 shows examples of conductor damage.

Broken strands

Conductor slap damage (molten droplets, broken strands)

Gunshot damage

Bird-caging

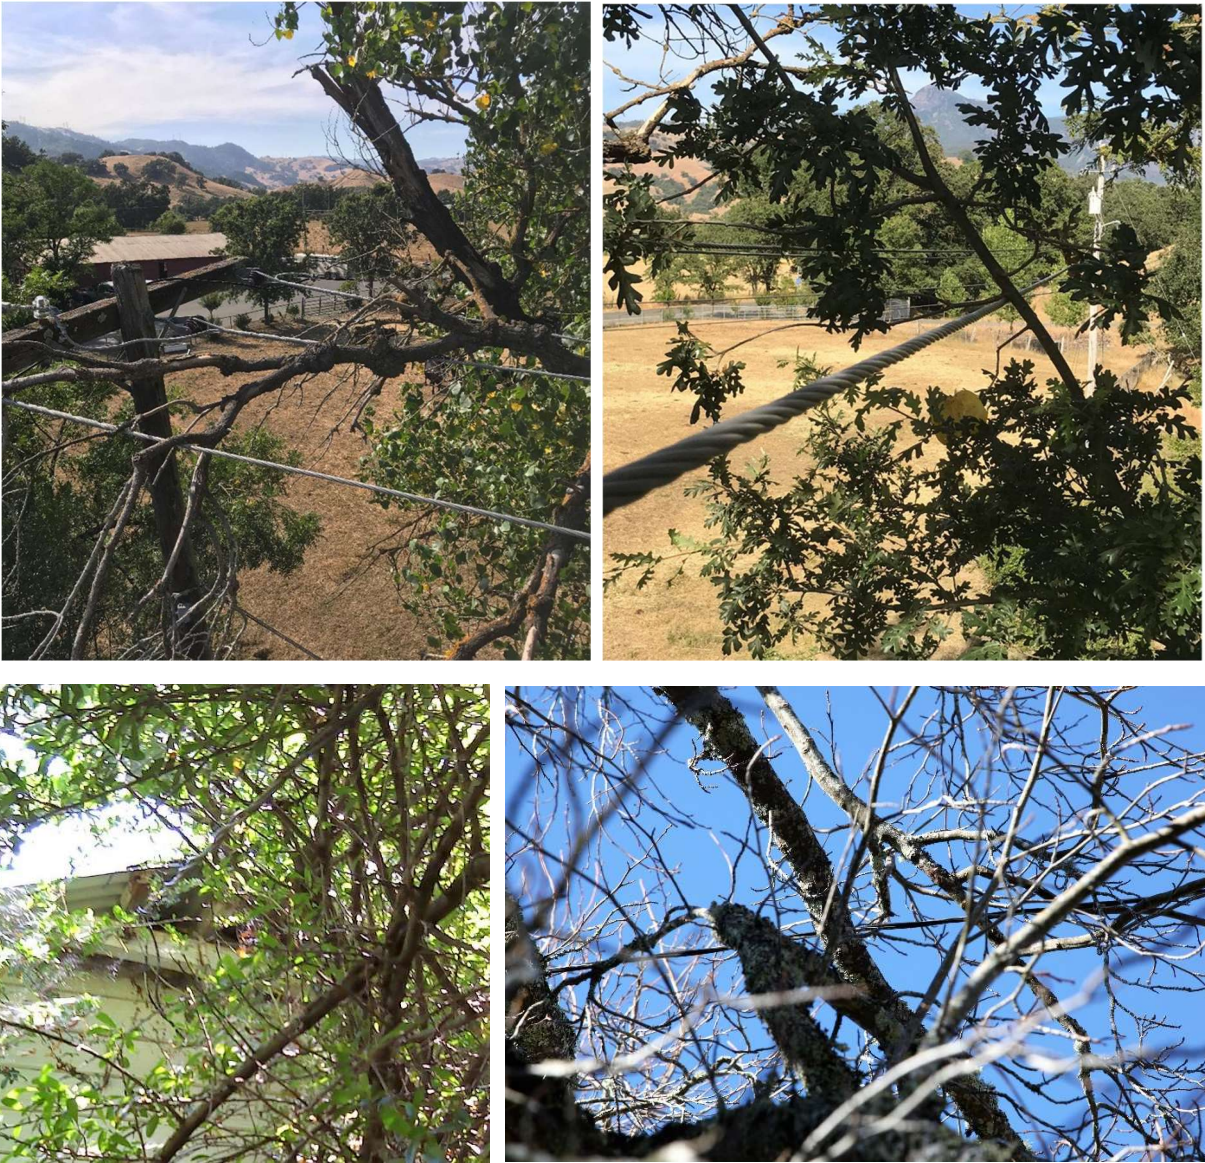
Figure 11. Examples of vegetation on secondary conductors

Other similar instances were detected and located during the course of the trial, but they were not confirmed by inspection prior to their disappearance coincident with passage of a fire through the area. Figure 11 shows examples of vegetative encroachment detected by the technology.

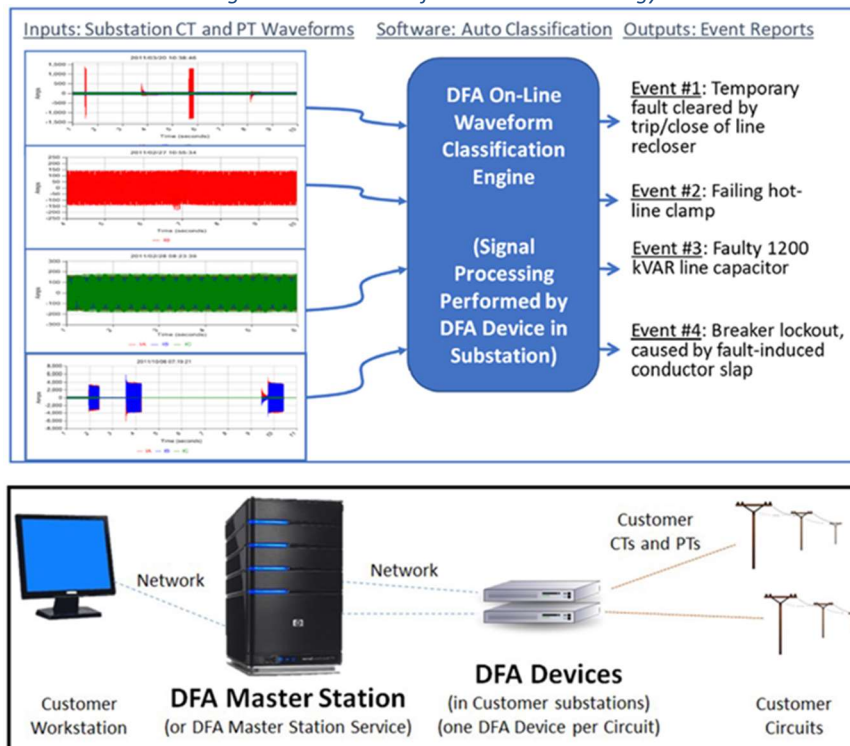
Figure 12. Overview of the ECCVM Technology

The ECCVM technology was developed over several decades by Texas A&M Engineering and the Electric Power Research Institute, Inc (EPRI). The initial effort was focused on improvement of system reliability and was built on early high-impedance fault detection work. Texas A&M hypothesized that failing equipment would causing arcing well in advance of ultimate failure and the key to anticipating failure through electric signal monitoring was detection of this arcing.

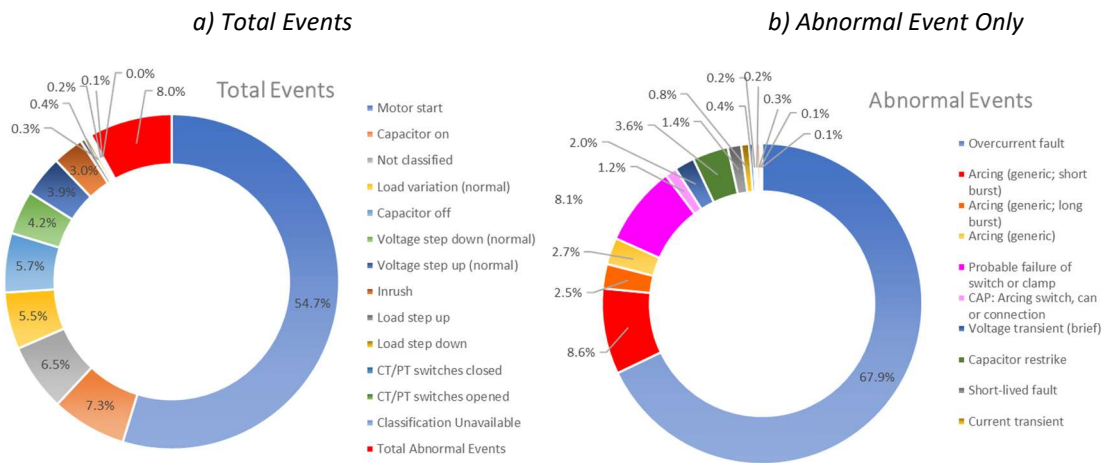
Figure 13. ECCVM Events Captured by ECCM to the end of May 2020

The abnormal events (faults, arcing, transients, unbalanced capacitor switching) represented over 8% of the total number events in the same period. This seems reasonable since it can be assumed that the distribution systems should behave normally most of the time. Of the abnormal events the majority (68.7%) are overcurrent faults, however, 21.4% events are low energy arcing. Figure 13 shows a chart of the percentage of different types of abnormal events capture in this time frame.

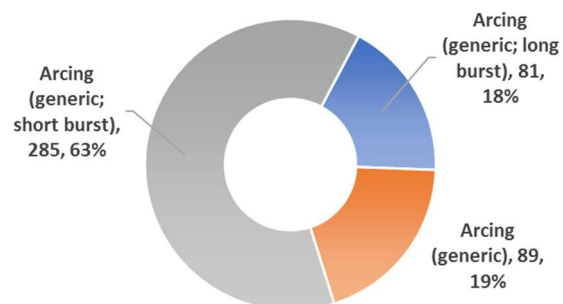
*Figure 14. ECCVM Recorded Shunt-Arcing Events by Type*

1. Arcing: generic – 2 to 3 cycles
2. Arcing: short burst – less than 2 cycles
3. Arcing: long burst – more than 3 cycles

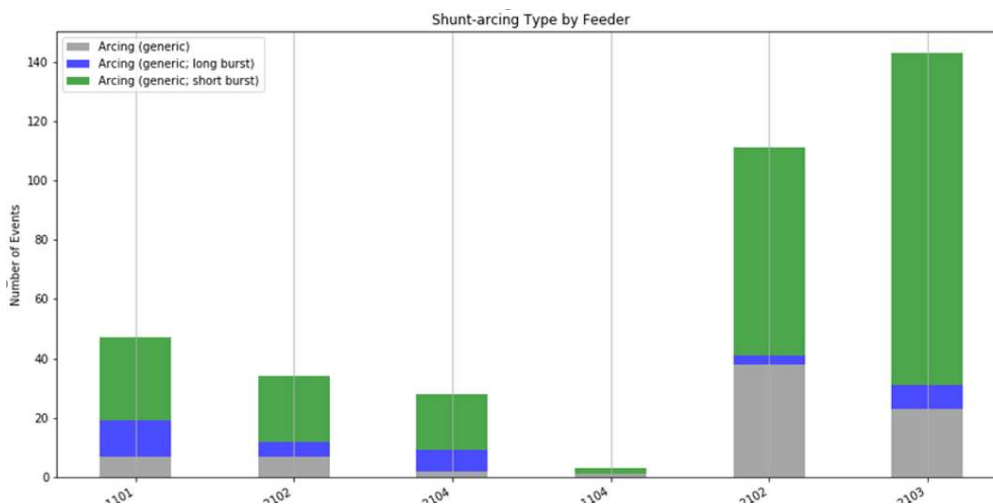
Figure 15. ECCVM Recorded Shunt-Arcing Events by Feeder

There has been a total of 429 shunt arcing events captured by the ECCVM sensors for this project since its inception until the end of April 2020. Figure 15 shows the breakdown by shunt-arcing type for the recorded events, with short burst being the most common. Figure 15 shows the number of shunt-arcing events for each of the six feeders with ECCVM installed. The first feeder is monitored with the RF sensors. The other feeders have no other sensor package that has the potential for capturing shunt-arcing events.

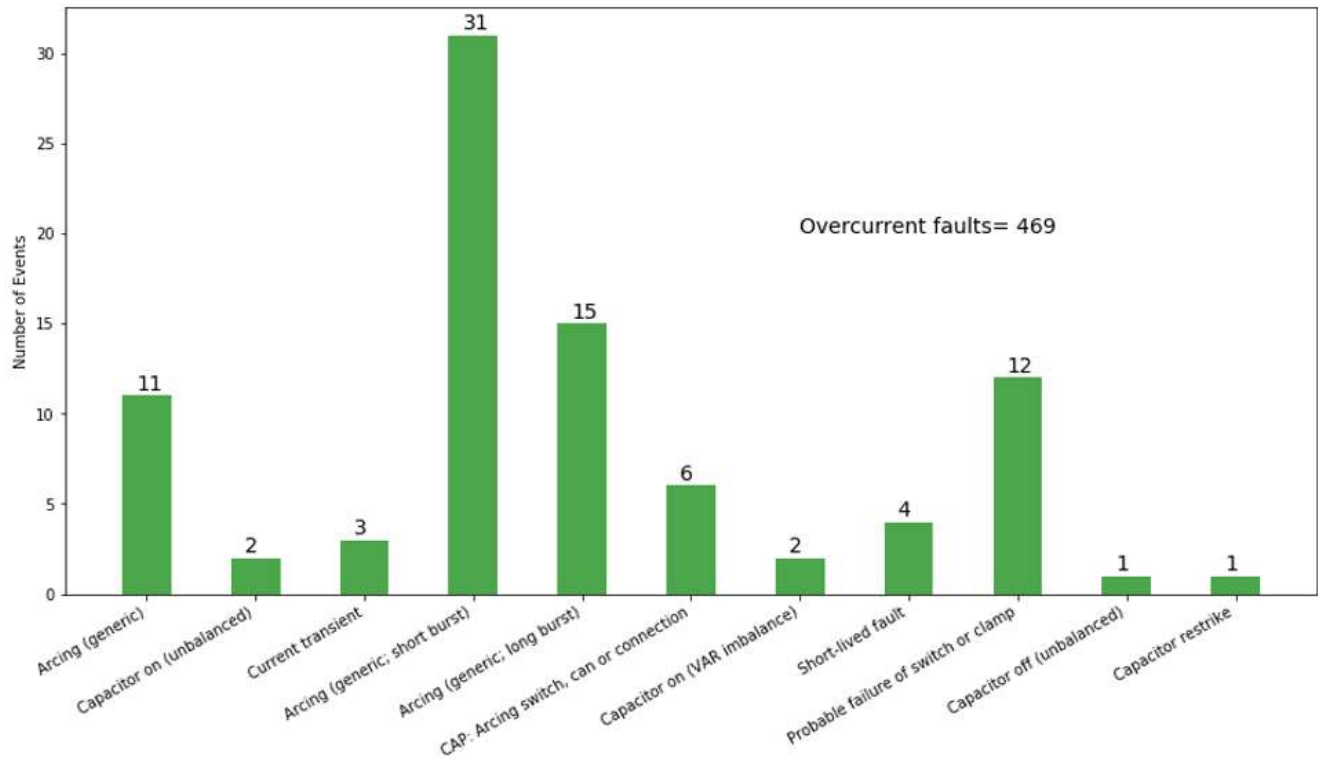
Figure 21. ECCVM Captured Abnormal Events on the circuit

Figure 21 shows the different types of abnormal event that were capture by ECCVM on the EFD monitored circuit. This figure does not include overcurrent fault, there were 469 overcurrent faults on the circuit during the project. Of these events the RF sensors capture majority of the 12 “Probable failure of switch or clamps” and only one part of a shunt arcing event. This is in part because of the difference in monitoring strategies of the two sensor packages.
