Exponent<sup>®</sup>

**Effectiveness and  
Implementation  
Considerations of Covered  
Conductors: Testing and  
Analysis**

December 22, 2022

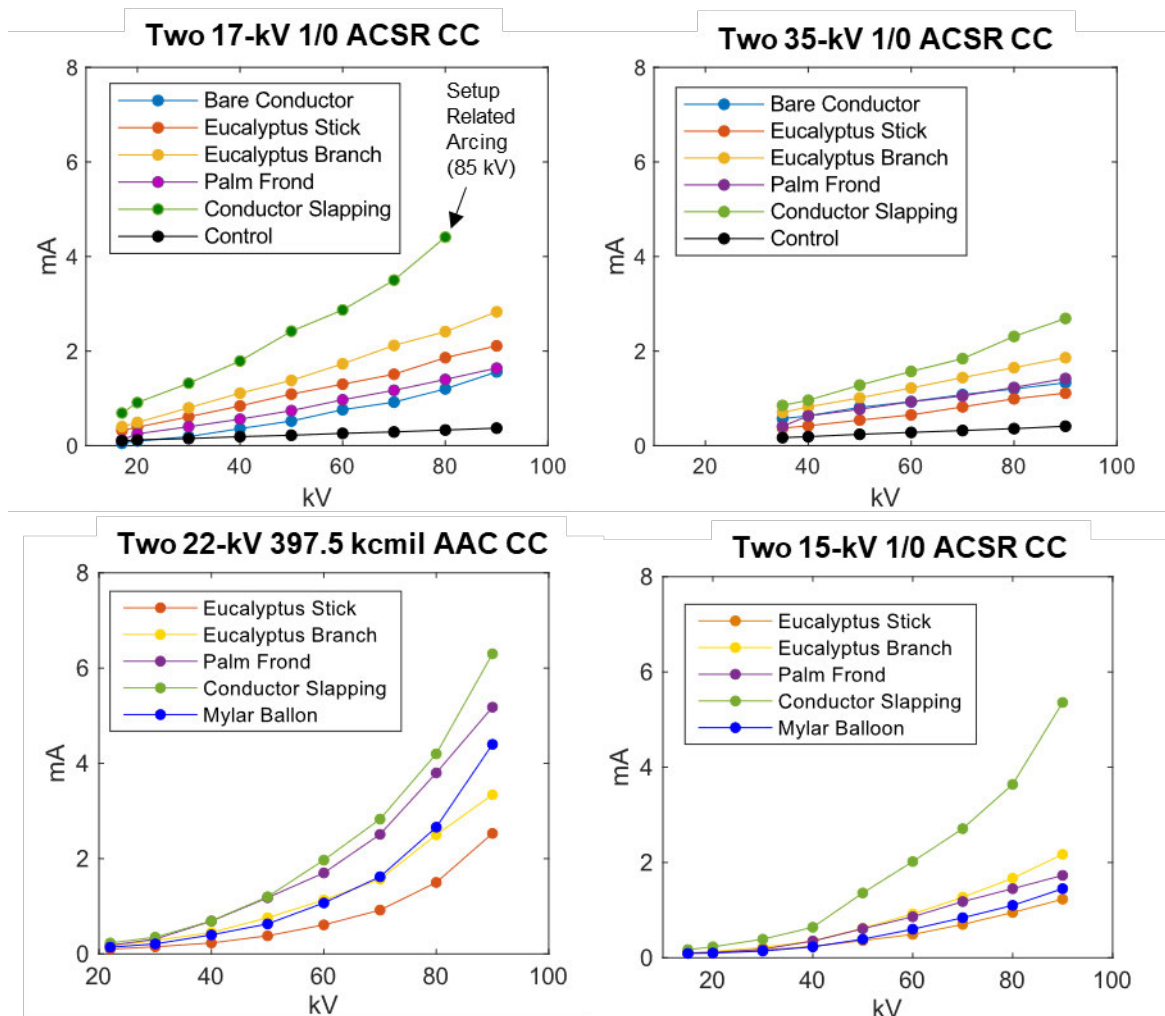
Figure 12. Leakage current as a function of voltage for two 17-kV ACSR CCs (top left), two 35-kV ACSR CCs (top right), two 22-kV AAC CCs (bottom left), and two 15-kV ACSR CCs (bottom right) with various bridging objects.

Control tests were performed on the 17-kV and 35-kV ACSR CCs to better understand the effects of coupling on the measured current at ground. The setup for the control tests was identical to the foreign object contact tests, but no foreign object was used to bridge the two phases. The measured leakage currents at the rated voltages were approximately 0.1 mA and 0.2 mA for the 17-kV and 35-kV ACSR CCs, respectively. The measured leakage current at 90 kV was approximately 0.4 mA for both conductor classes (Figure 12).

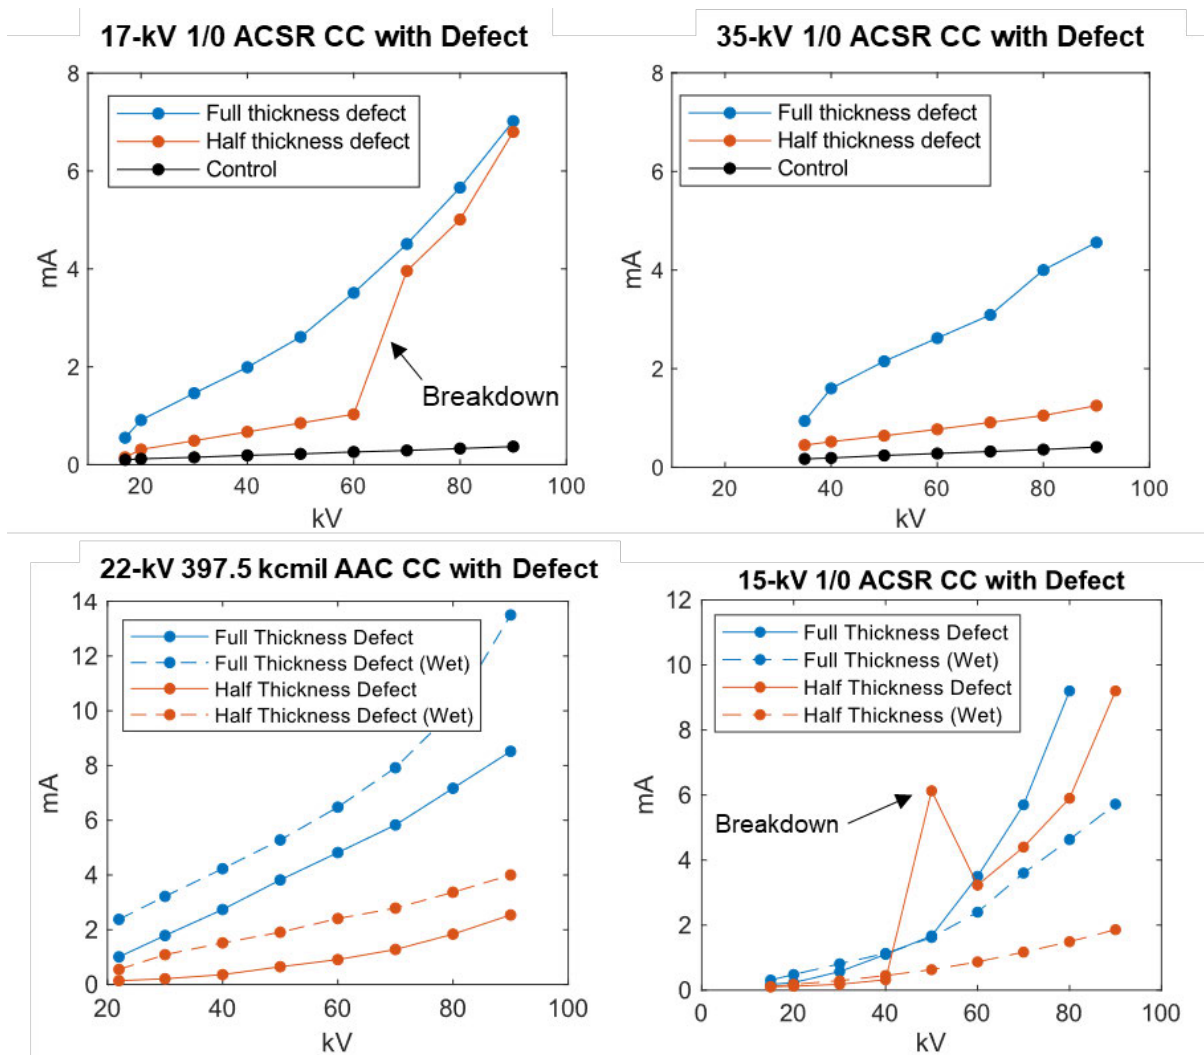
Figure 15. Leakage current as a function of voltage for one CC with a flaw and one standard CC for 17-kV ACSR (top left), 35-kV ACSR (top right), 22-kV AAC (bottom left), and 15-kV ACSR (bottom right).

The plots in Figure 15 present leakage currents as a function of applied voltage for the four conductor classes. Prior to breakdown, leakage currents for the half-thickness insulation flaw tests were similar to those of the standard CCs. Following the formation of the pinhole, leakage currents for the half-thickness flaw were elevated and were similar to those of the full-thickness flaw. No insulation breakdown or current increase was observed for the 35-kV ACSR CC.

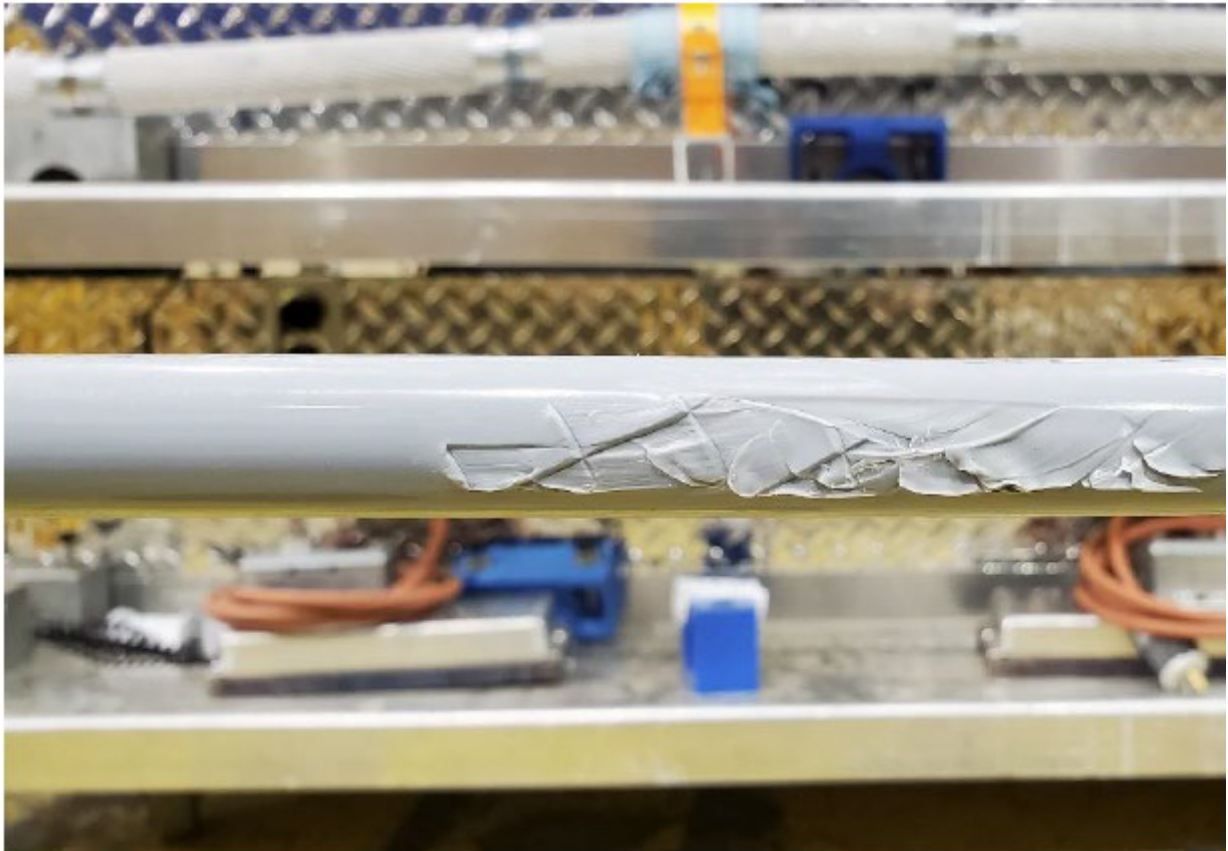
Figure 67. A representative post-test image of a 17-kV ACSR CC showing superficial damage to the polymer sheath caused by slippage.

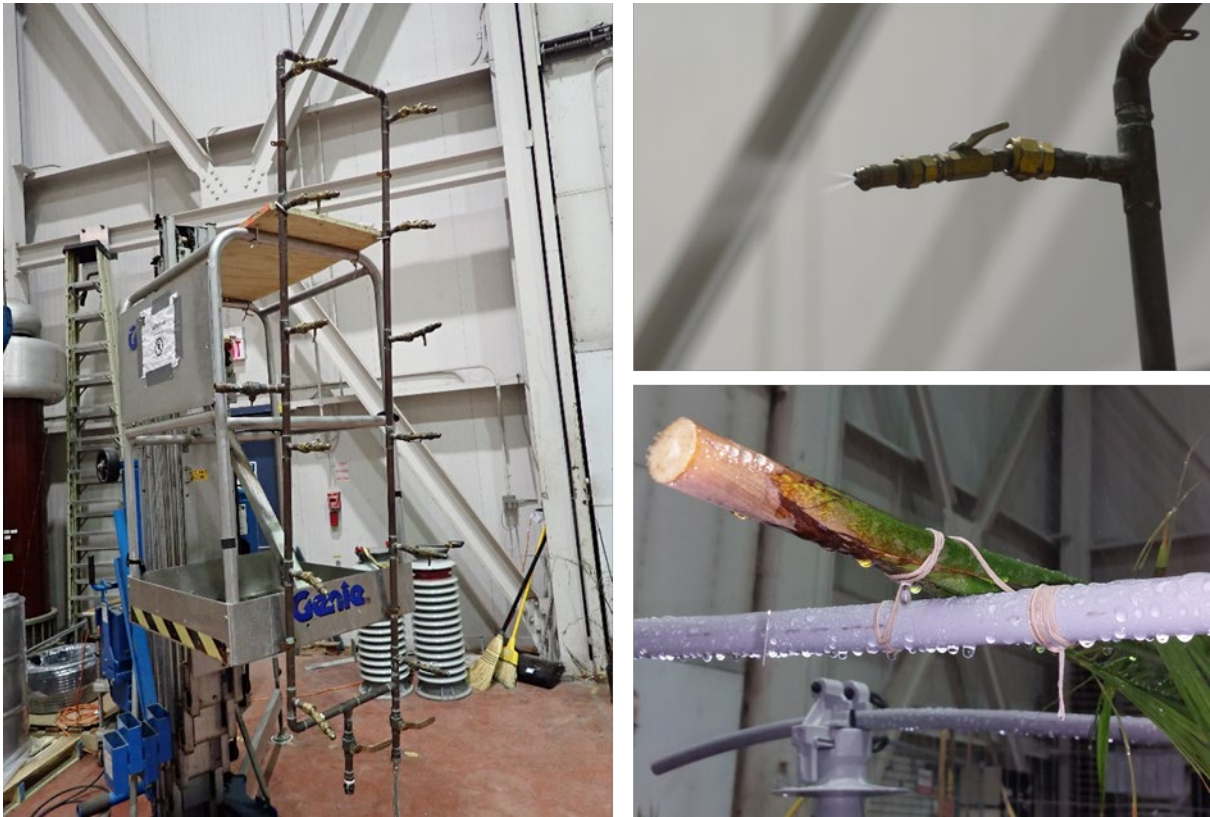
Figure A4. Wet test setup for phase-to-phase contact tests.

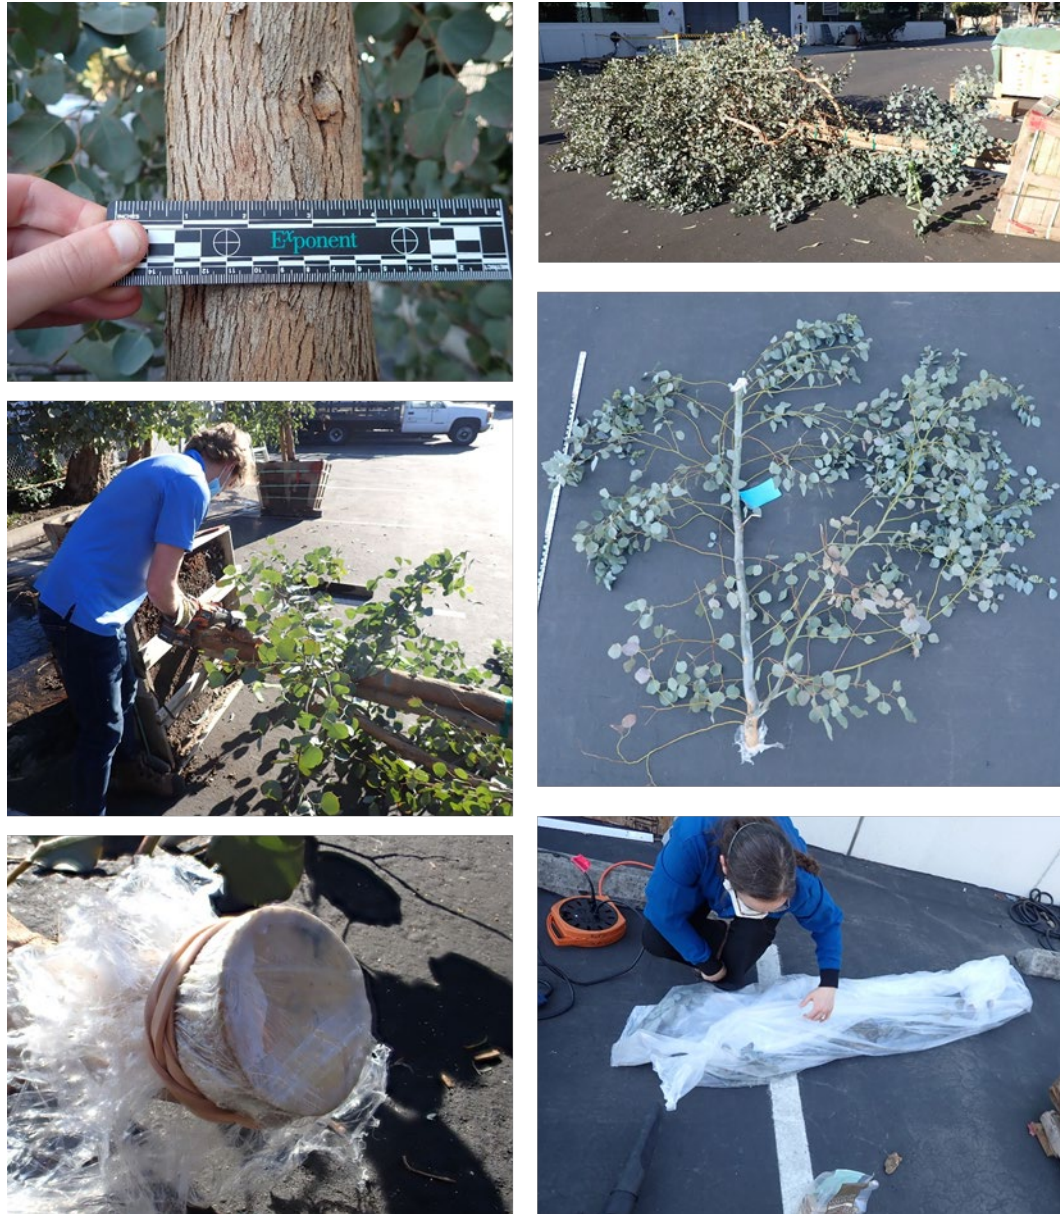
Figure A5. Cutting and preparation of leafy eucalyptus branches for phase-to-phase arc testing.

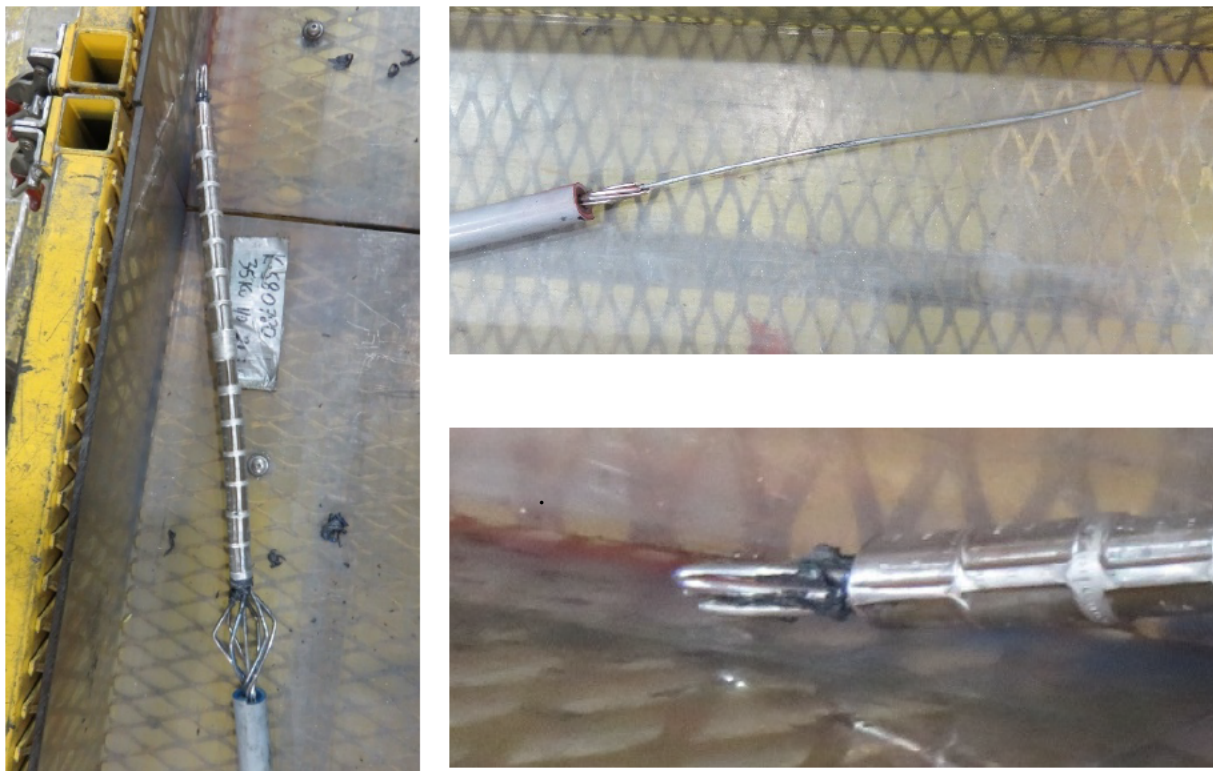
**Figure 6-8: Sample 1.2.1 after test (conductor failed at North end of splice)**

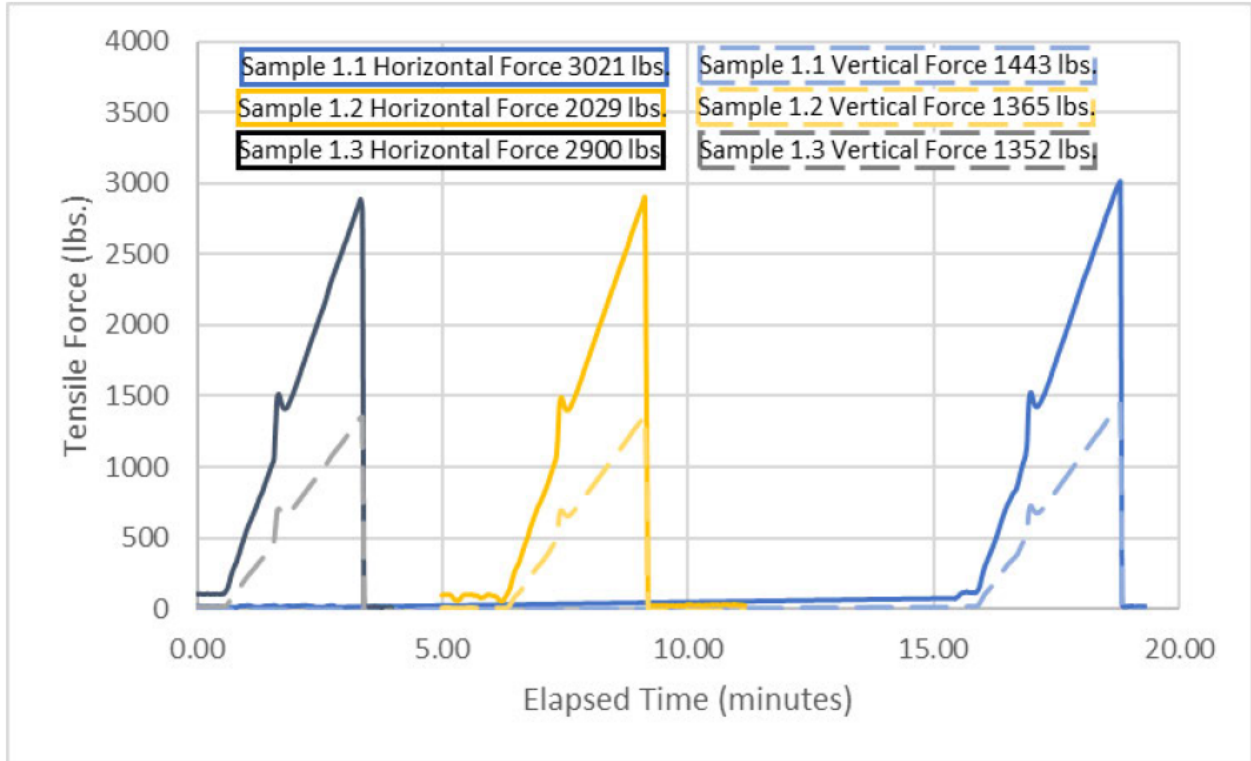
**Figure 6-1: Test Load Profile: 17KV #2 AWG, 7 CU Conductor**
