Pacific Gas and Electric Company

EPIC Final Report

| Project | <i>EPIC 3.46 – Advanced Electric Inspection Tools – Wood Poles</i> |

| Reference Name | <i>Radiography of Utility Wood Poles</i> |

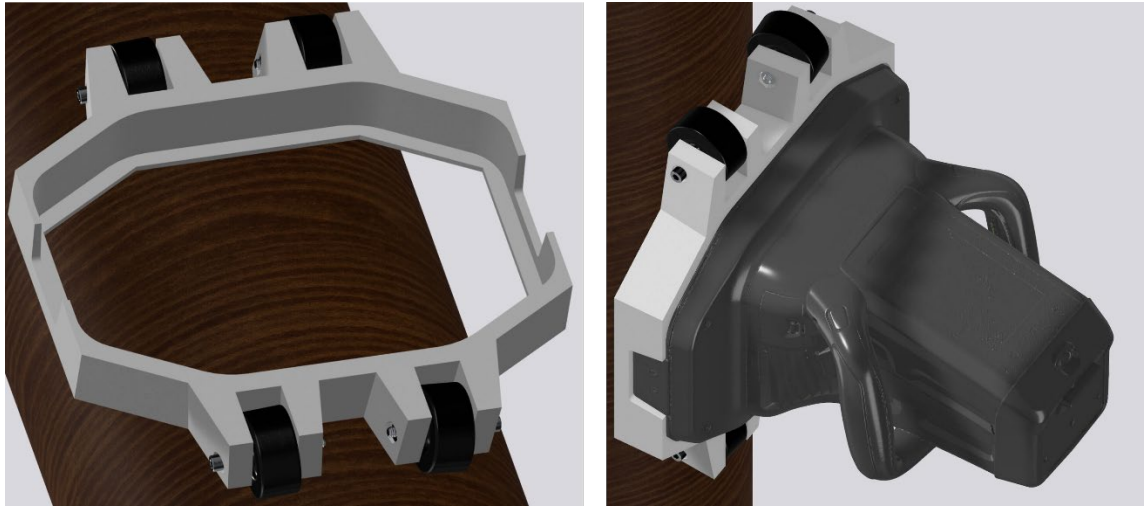
Figure 100 - 3D Design of Bracket with Wheels

A custom bracket would further improve the real-time x-ray image quality along with reducing the physical effort to operate the instrument, The ATS 3D scanning team designed (Figure 10)

and 3D printable bracket and added purchased wheels. The design allowed the operator to manage the scanning operation more consistently.
