**SF X (Mission)  
Substation Outage Event  
December 20, 2025**

**Direct Cause Evaluation**

Pacific Gas and Electric Company  
300 Lakeside Drive  
Oakland, California 94612

May 5, 2026

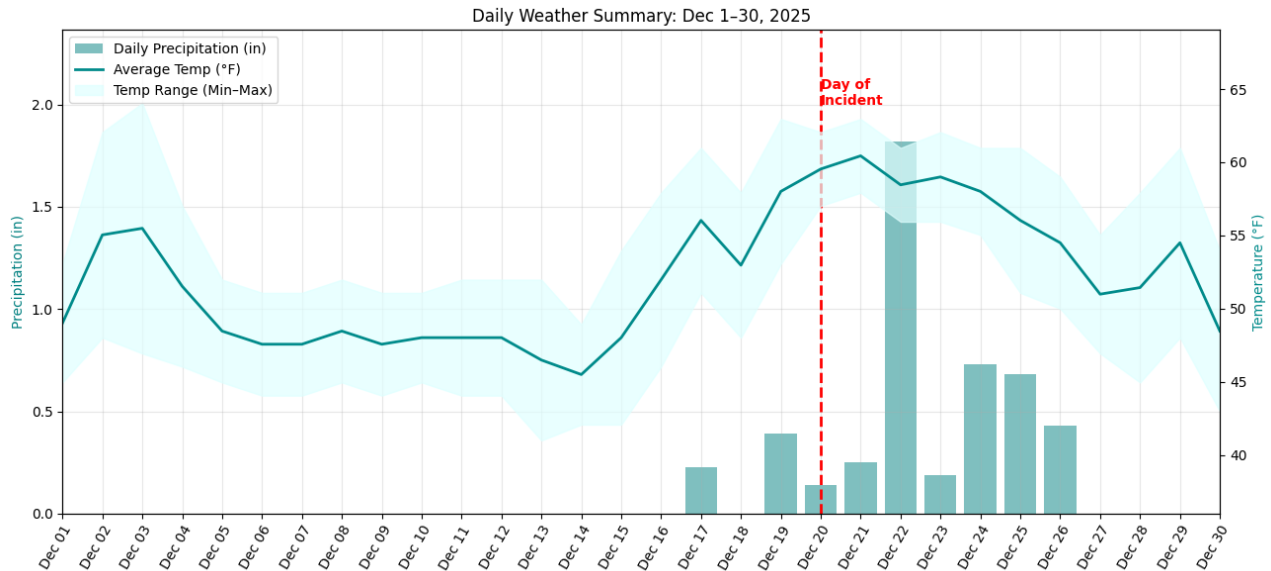
As shown in Figure 10, this is exactly the weather pattern that preceded the arc-flash event: two weeks of cool temperatures (averaging around 50°F) from December 1 through December 15, followed by a storm front that brought in higher temperatures (close to 60°F) and rain starting on December 17. The high dew points associated with that warmer rain event (close to 60°F) may have resulted in condensation on cool, unheated surfaces within the building that had come into thermal equilibrium with the approximate 50°F temperatures of the prior two weeks and were below the dew point of the ventilation air. Such cool surfaces could include electrical equipment that is either de-energized and/or not supplied with supplemental heat (as was the case for the Incident Cubicle). Weather data collected from the official National Weather Service San Francisco Airport Weather Station (NWS Code: KSFO), located approximately 13 miles from Mission Substation, indicate that the conditions at the time of the arc-flash event were around 57°F and 94% humidity, which corresponds to a dew point of 55°F.<sup>37</sup> A dew point of 55°F means that condensation will occur on any surface that is below 55°F. It should be noted that weather data from a personal weather station (PWS Code: KCASANFR1753<sup>38</sup>) located less than one mile from Mission Substation indicates the conditions at the time of the event were around 59.9°F and 99% humidity, with a dew point of 59.5°F.<sup>39</sup>

Figure 10. Daily Precipitation and Temperature data.<sup>40</sup>

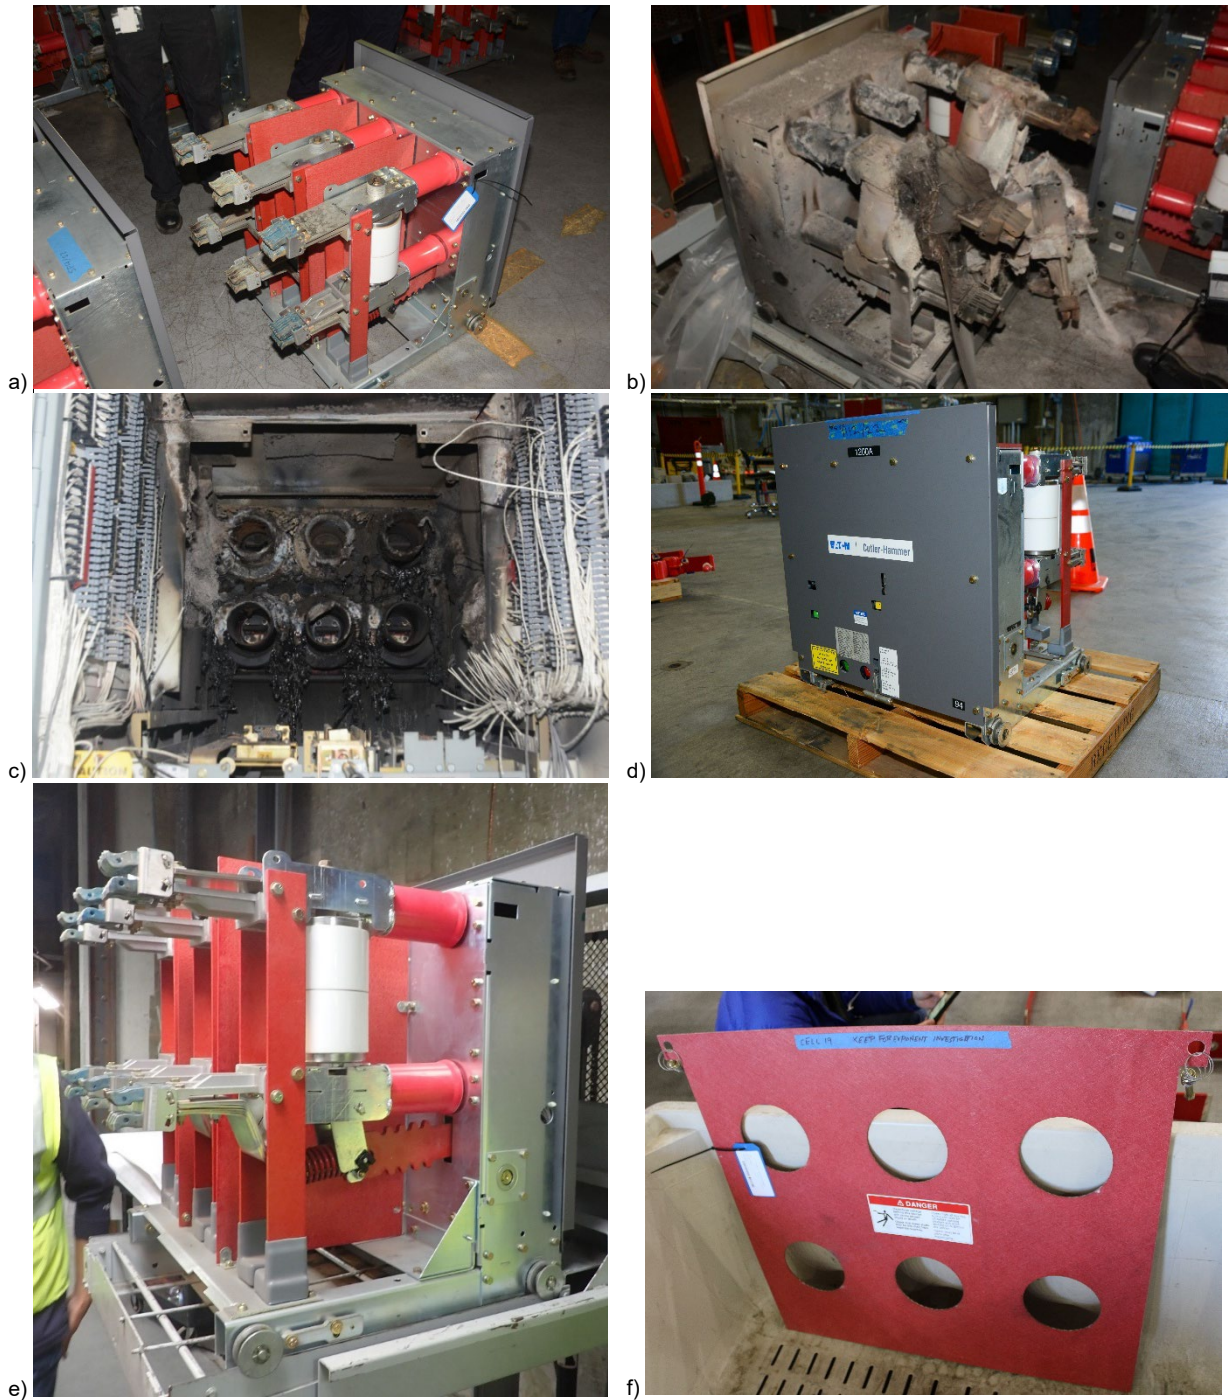
Figure 11. Examples of evidence collected by PG&E: a) Circuit Breaker No. 56 - Replaced from Top of Cell No. 5 prior to Incident; b) Circuit Breaker No. 52 from Top of Cell No. 5 (Incident Breaker No. 52); c) Cell No. 5 top cubicle (Incident Cubicle); d) Circuit Breaker No. 94 from the lower cubicle of Cell No. 5; e) Circuit Breaker No. 79 from Bottom of Cell No. 19; and f) Barrier insulating board from Bottom of Cell No. 19.

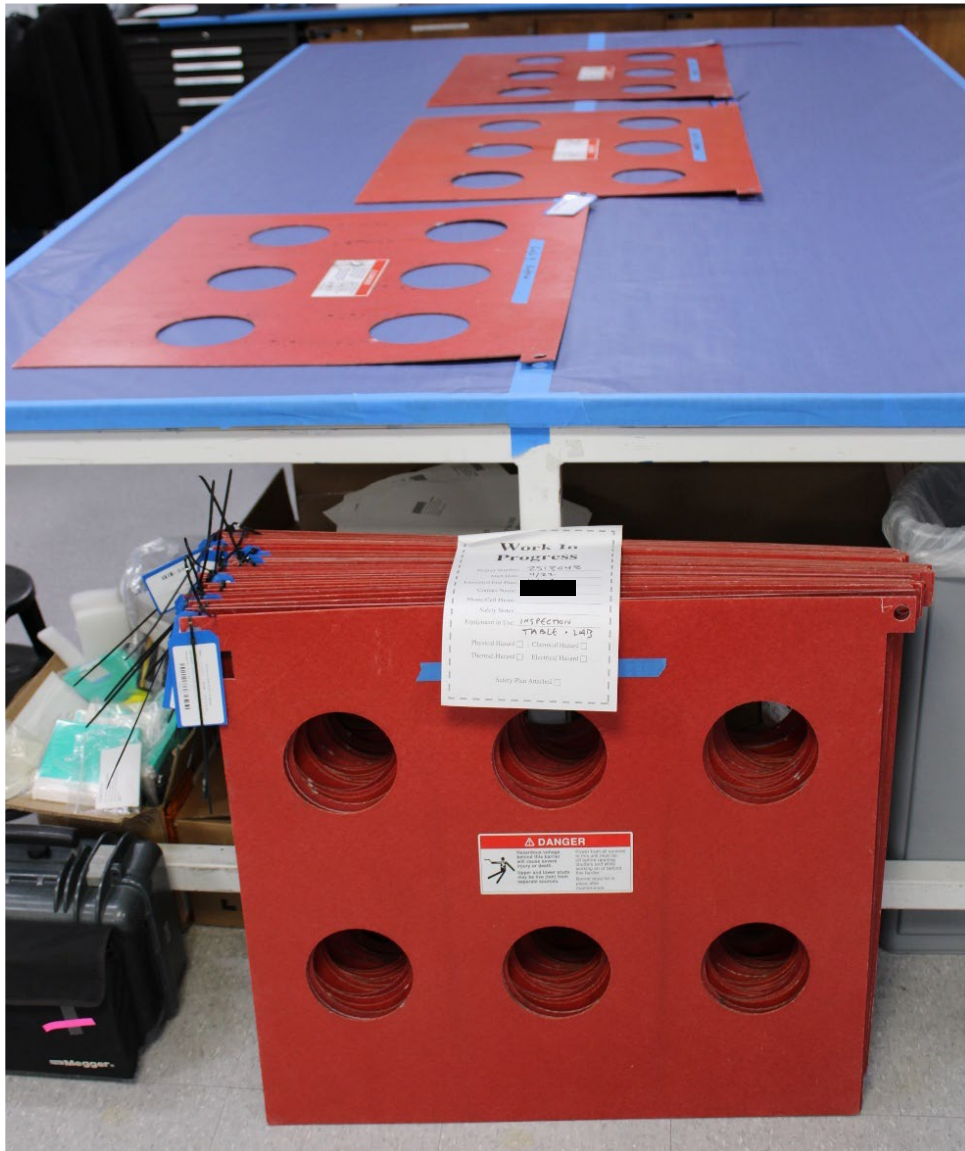
Figure 28. Additional Insulating Boards from the 12 kV bus section of the Mission Substation transferred to Exponent for laboratory examination.

Several of the barrier insulating boards exhibited signs of mechanical damage as well as thermal damage, consistent with previously observed damage patterns indicating contact between the breaker arms and the edges of the through-holes. Two boards showing more pronounced damage, specifically the barrier insulating boards from Cell No. 6 and Cell No. 10, bottom cubicles, were selected for additional examination (Figure 29 and Figure 30). The barrier insulating board from Cell No. 10, bottom cubicle, also showed signs of mechanical damage indicating physical contact with the breaker arm (Figure 31).

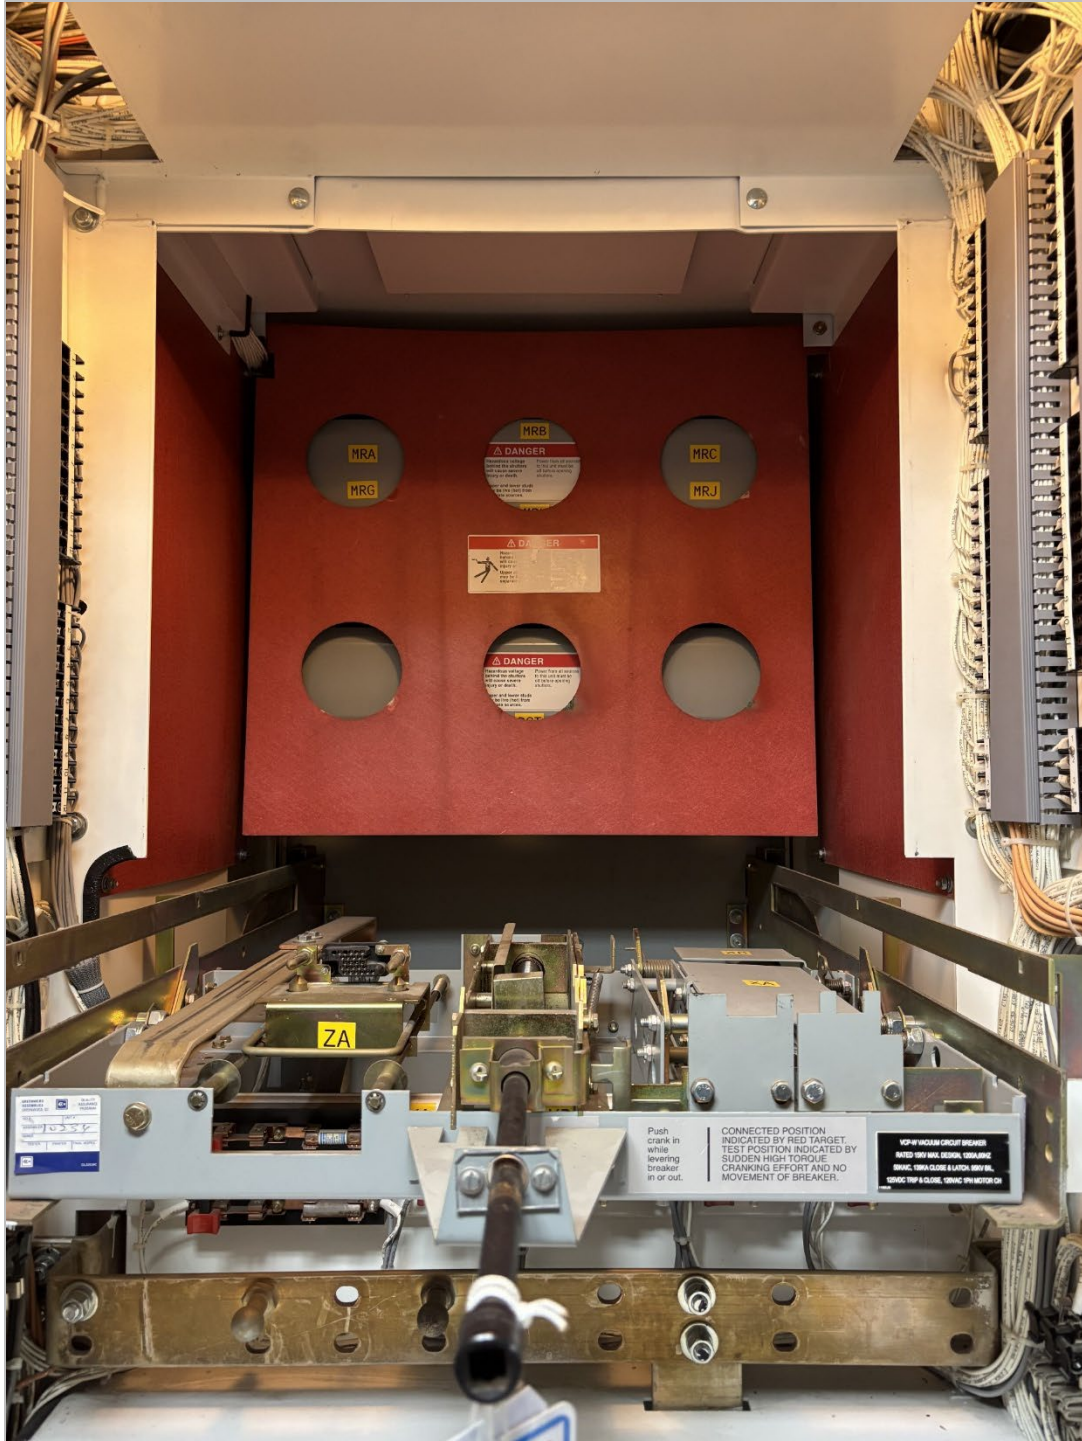
Circuit Breaker No. 56 received a mechanism service in November 2017, which did not result in any corrective notifications. On November 2, 2025, Circuit Breaker No. 56 reportedly failed the high pot test during its 8-year mechanism service. The interrupter bottles were reported as “bad” with “condensation seen coming from CB 56 vacuum bottles during the high-pot test,” damaged flex connectors, suspected hard water mineral deposits, and signs of damage on the X-1112/12-line side center phase female contact. “Minor” damage to the Incident Cubicle was reported, including debris and surface rust on hardware within the cubicle, and “burned spots” and “warping” of the Insulation Board (Figure 44 and Figure 45). PG&E reportedly performed several visual inspections of the reported damage, including an inspection of Bus 1 Section D on November 16, 2025. As a result, PG&E created corrective notification LC 132018244 on Circuit Breaker No. 56, noting it had water damage, replaced it with Incident Breaker No. 52, and reportedly cleaned the cubicle, including wiping down the breaker-facing (front) surface of the Incident Insulating Board and vacuuming the interior of the Incident Cubicle. The Incident Insulating Board was not reportedly removed, and consequently the CT-facing side (back) was neither inspected nor cleaned. The inspections did not identify any sources of water intrusion into the Incident Cubicle.

Figure 44. Incident Cubicle (X-1112/12). Photo taken November 6, 2025 (courtesy PG&E).
