This job aid provides consistent evaluation of all dielectric self-supporting cable (ADSS) in transmission lines, and consistent decision-making.

## ADSS Inspections

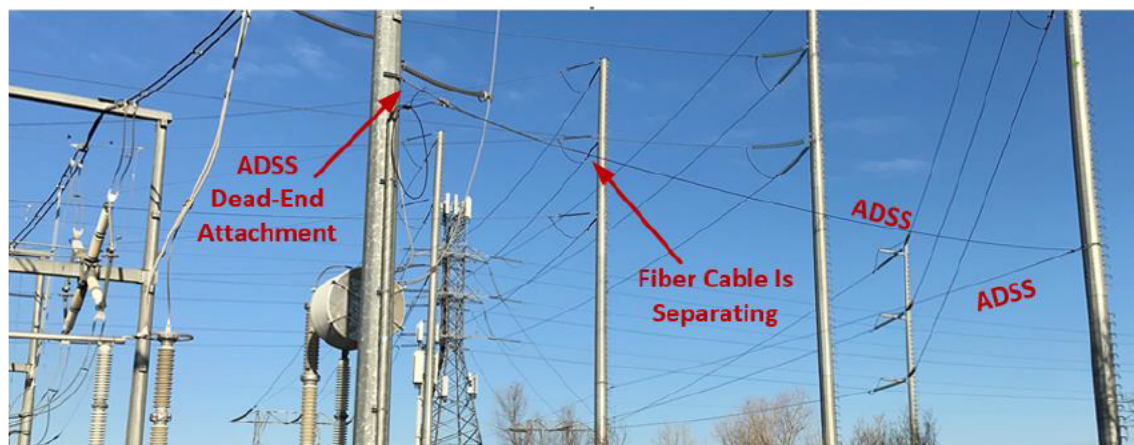
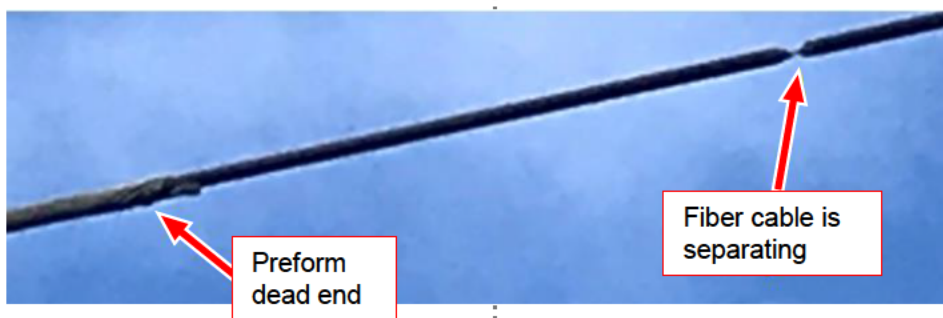
### 8 Mile Substation

**Damaged/Separating/Cable Breach**  
ADSS cable (continued)

1. Initiate SAP Notification, Priority Code A.
2. T-Line to make the situation safe with preform safety snubs.
  - If the situation cannot be made safe and cable removal is the only option, contact IT immediately, so that IT can notify the appropriate lines of business and 3rd party customers of the emergency outage.
3. Notify IT by calling the ENOC at [REDACTED].
  - Document the date, time, and the name of the person at the ENOC who took the call.
  - Capture this information in the comments field of the SAP notification.
4. Take close-up photos of the condition found.

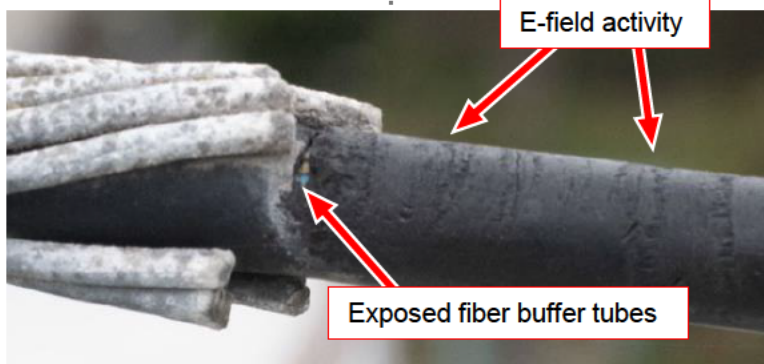
**E-field Damage:** Cable jacket has been breached; blue buffer tube is exposed, as well as the orange aramid yarn. Cable separation and complete failure will occur.

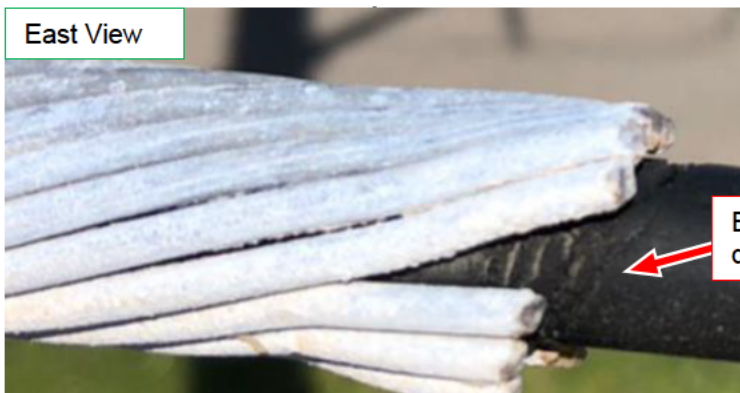
East View

Sometimes one image is not good enough to show the severity of the damage to the cable. The side views below do not show the extent of the damage, as well as the top view does.

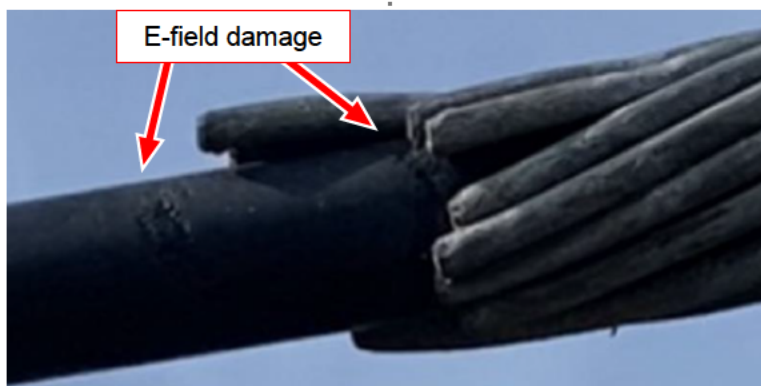
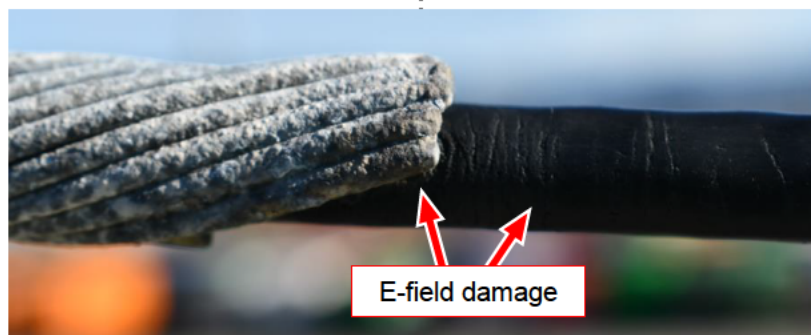
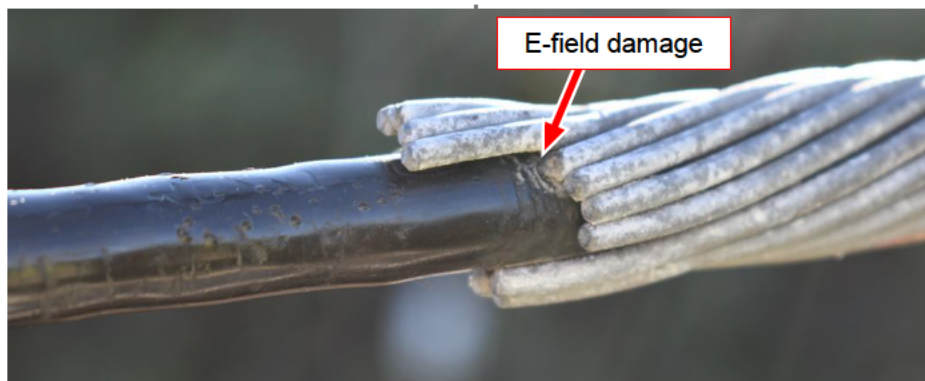
If signs of E-field damage are present, conduct an up-close inspection of the cable to determine the severity of the degradation and whether the cable has been breached.

1. Initiate SAP Notification, Priority Code E (3 months)
2. Install preform safety snub.
3. Take close-up photos of the condition found.

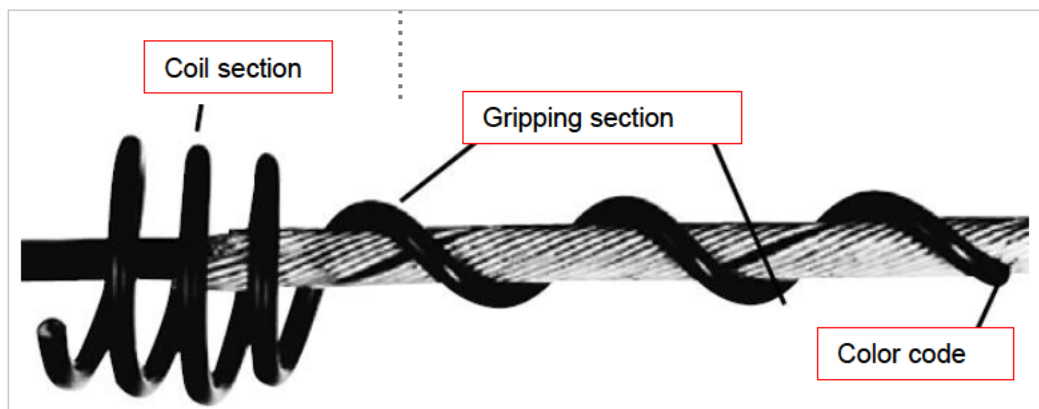
## Correct Installation of Corona Coil

- For voltage levels below 69 kV, there is no minimum distance requirement.
  - Adjust improperly placed corona coils to the standard installation configuration.
