Preliminary Ignition Investigation Report

Ignition Database Index:	20240347
Electric Incident Investigation (EII) Number:	N/A
Incident Name:	Bucks Fire
PG&E Facility Ignition?	Yes
CPUC Reportable Ignition?	Yes
Date & Time of Incident:	May 1, 2024, at 1348 Hours
Street Address:	Silver Lake Road and Bucks Lake Road
City:	Meadow Valley
County:	Plumas
Latitude/Longitude:	39.928003, -121.083794
State Responsibility Area (SRA) / Local Responsibility Area (LRA) / Federal Responsibility Area (FRA)	Federal Responsibility Area (FRA)
PG&E Division:	North Valley
High Fire Threat District (HFTD):	Tier 2
High Fire Risk Area (HFRA):	Yes
EPSS Buffer:	No
Fire Index Area (FIA):	285
Fire Potential Index (FPI) Rating: FIA	R1
Fire Potential Index (FPI) Rating: Circuit	R1
Was there a PSPS event at the time of ignition?	No
Suspected Initiating Event:	Contact- 3 rd Party
Failure Driver:	Contact from Object
Failure Sub-driver:	Vegetation Contact
Circuit:	GANSNER 1101
Circuit Protection Zone:	GANSNER 11012006

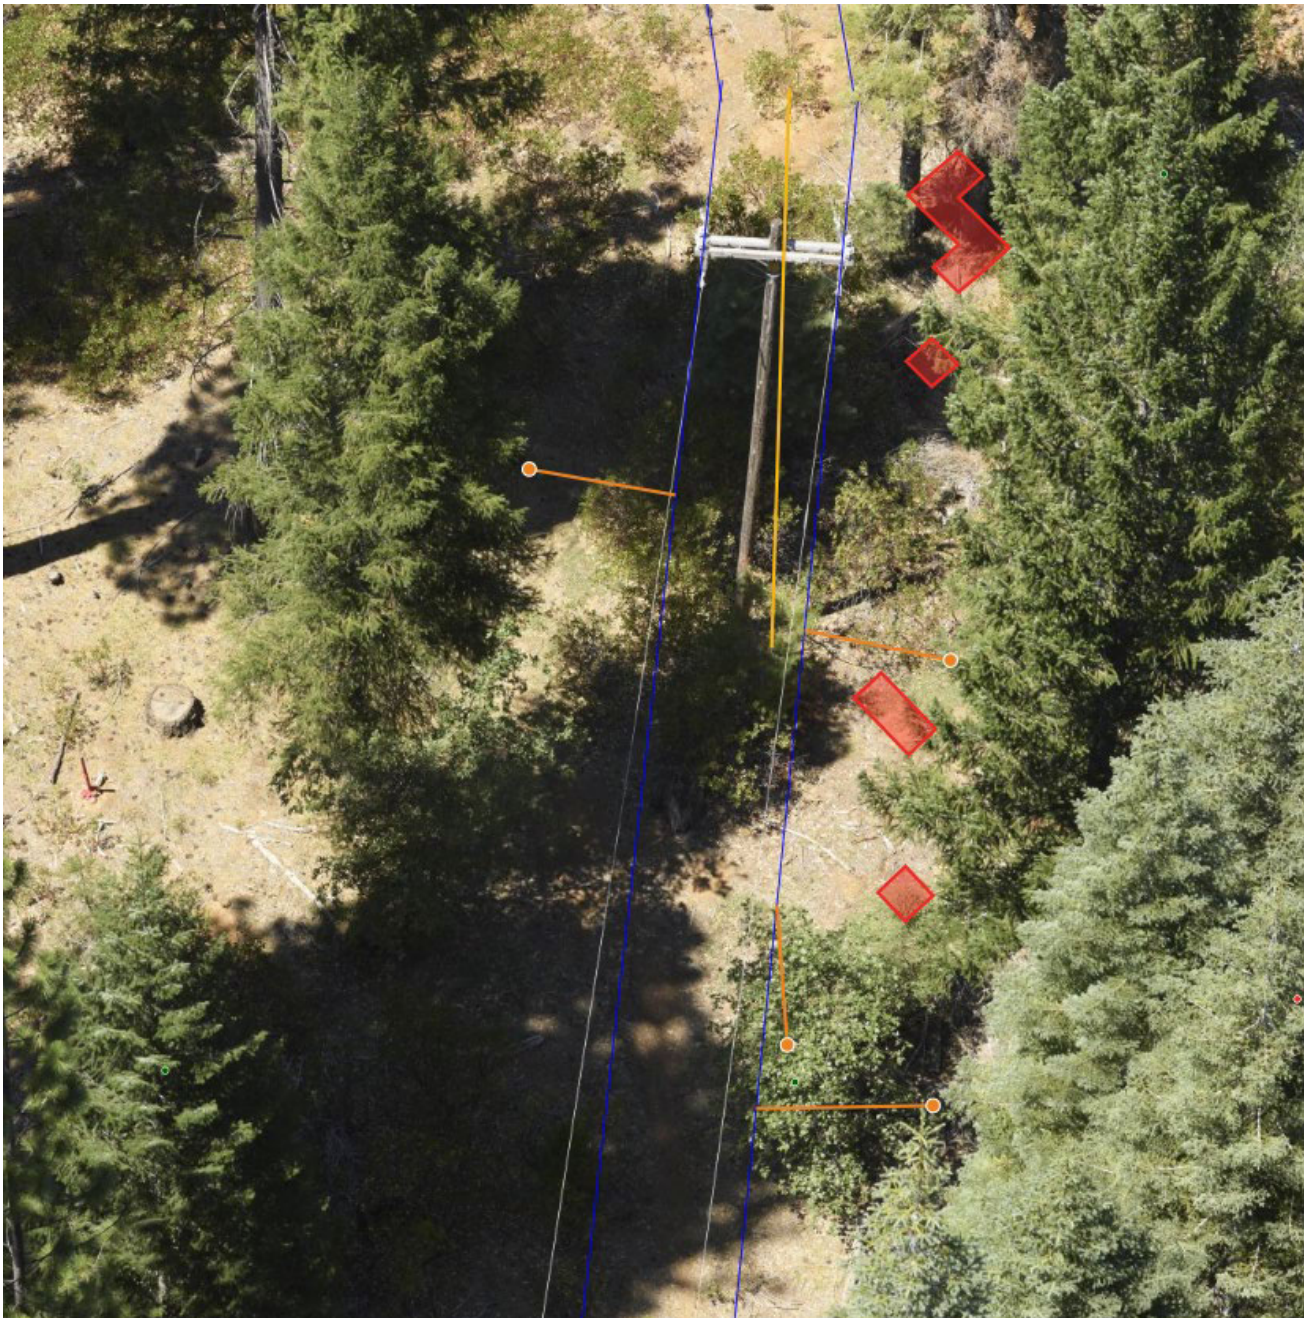
Figure 3 – Overview map showing distribution circuit and the area flown by drone
